Asbestos Demolition Survey Report

Job Ref No: **429965**, Account Ref No: **23400**, Contract Ref No: **57008**

Kier Hardie Way Garages, RM9 4BS

Title: Kier Hardie Way Garages - Asbestos Demolition Survey and Visual Asbestos Survey of green spaces/tarmac areas

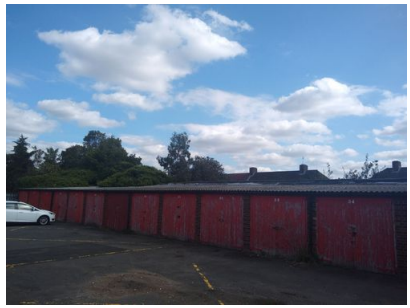
Building	Level	Location	Item / Product Examined	Sample No.	Material Description	Fibre Type	Material Score	Extent	Risk Level Assessment	Initial Control Recommendation	Photograph
Keir Hardie Garages	0	001/Externals to Garages 23-38	Roof	429965-3	Asbestos-containing cement	Chrysotile	4	120 Sqm	R3	Remove

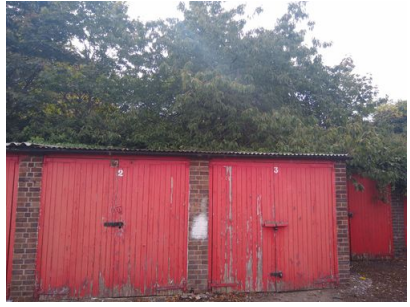
Keir Hardie Garages	0	002/Externals to Garages 39-6	Roof	429965-6	Asbestos-containing cement sheets	Chrysotile	4	40 Sqm	R3	Remove

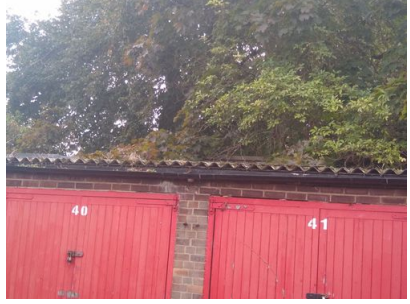
Keir Hardie Garages	0	002/Externals to Garages 39-6	Roof	429965-3	Asbestos-containing cement	Chrysotile	4	60 Sqm	R3	Remove

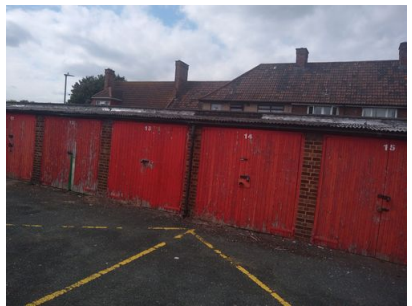
Building	Level	Location	Item / Product Examined	Sample No.	Material Description	Fibre Type	Material Score	Extent	Risk Level Assessment	Initial Control Recommendation	Photograph
Keir Hardie Garages	0	003/Externals to Garages 7-22	Roof	429965-6	Asbestos-containing cement	Chrysotile	4	100 Sqm	R3	Remove

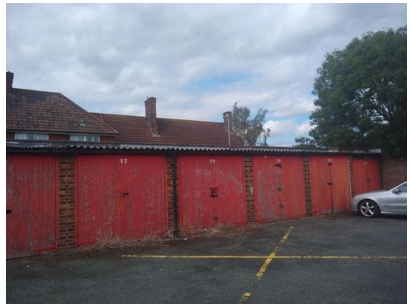
Keir Hardie Garages	0	003/Externals to Garages 7-22	Roof	429965-1	Asbestos-containing cement	Chrysotile	4	20 Sqm	R3	Remove

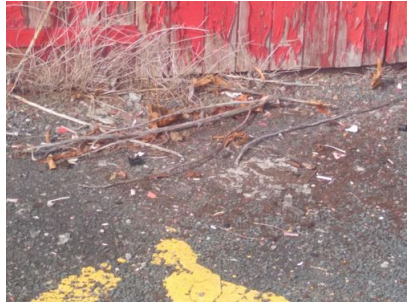
Keir Hardie Garages	9	999/externals to Tarmac/Greenspace	Felt debris	429965-2	Asbestos-containing bituminous felt	Chrysotile	3	Small Quantity Observed	R3	Remove

R3
		💬 Small amount observed in front of garage 14									
Broken slate	Slate

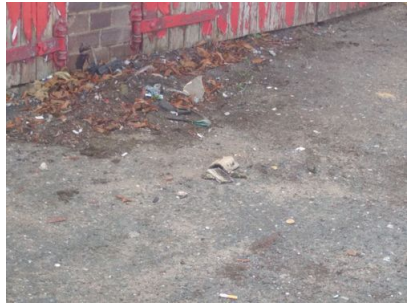
Building	Level	Location	Item / Product Examined	Sample No.	Material Description	Fibre Type	Material Score	Extent	Risk Level Assessment	Initial Control Recommendation	Photograph
Keir Hardie Garages	9	999/externals to Tarmac/Greenspace	Cement sheet debris	429965-1	Asbestos-containing cement	Chrysotile	4	Small Quantity Observed	R3	Remove

R3
		💬 Found in multiple areas, likely from roof damage									
Felt debris	Asbestos-containing bituminous felt	Sample	429965-2	Small Quantity Observed	1	1	0	Chrysotile	3	2
