Asbestos Management Survey Report

Job Ref No: **429973**, Account Ref No: **23400**, Contract Ref No: **54543**

Goresbrook Road, RM9 6XS

Title: Visual Asbestos Survey of green space

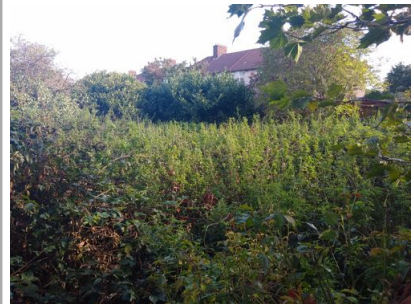
Building	Level	Location	Item / Product Examined	Accessibility		Access Comments	Photograph
Goresbrook Road	9	999/externals	Back end of greenland	Limited Access	Reasons of health and safety

🗨️ Unable to survey the rear end of greenland due to extremely overgrown nettles and other plants preventing both access and a thorough survey to the ground
