**LBBB Surveys
Highland Avenue**

**Utility Mapping Survey
Site Report
Project No. 2176**

Prepared by:
Piotr Wegiel
40SEVEN Limited

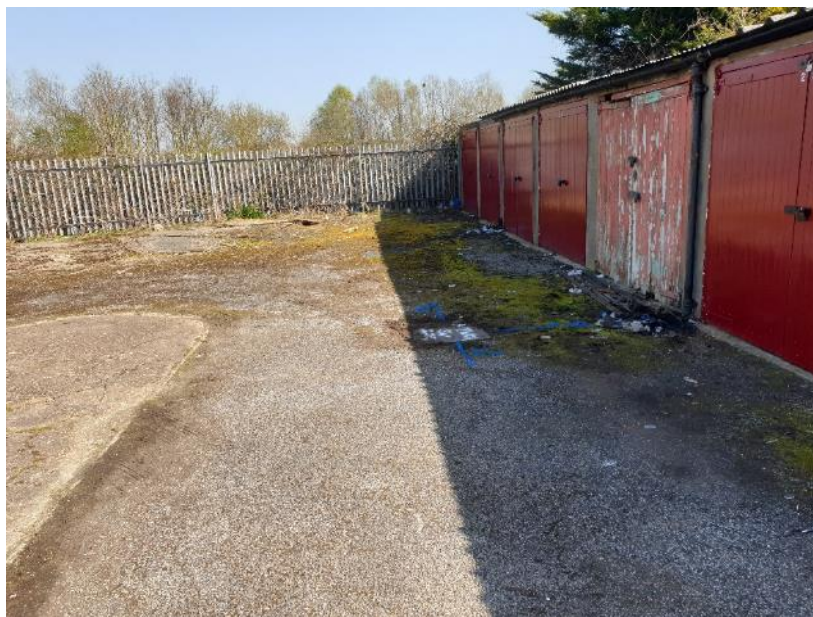
Photo 1

Description: General view of survey extents.

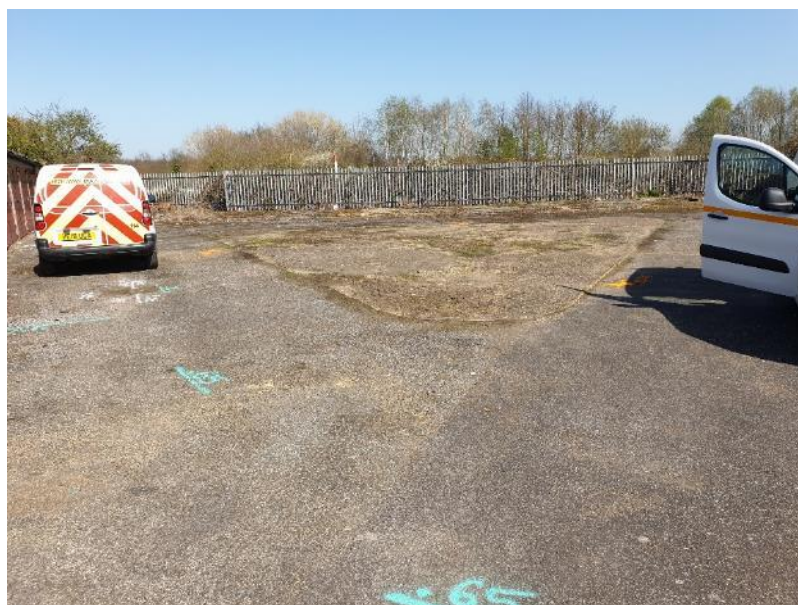
Photo 2

Description: General view of survey extents.

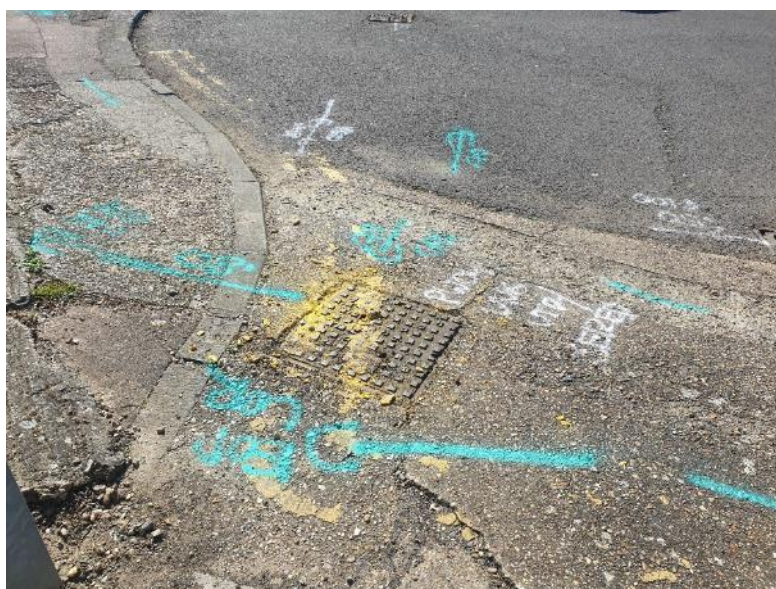
Photo 3

Service	Comment Number	Successes / Problems Differences between survey & "Stats"
Drainage	1	Several drainage manholes identified within survey area. Unable to trace most of routes due to poor condition and silted chambers. Routes presented as assumed and partially confirmed by GPR.
	2	Unable to survey surface water manhole due to seized cover. Routes transferred from the records.
Other	1	Two unknown routes located and traced by active induction techniques within survey area. Possible water pipes.
	2	Old lamp post position shown by locals during survey. Unable to confirm visually or by tracing techniques. Possible old electric cable buried within survey area.
GPR Scans	1	A PAS128 M3 GPR survey has been carried out across the site where possible.
	2	The radar reflects changes in the electrical properties of materials in the sub-surface. The data prevents definition of unknown targets.
	3	Two unknown targets detected within the survey extents although only partially in some areas due to losses of reflection. Unable to associate any fittings or features in the vicinity to help establish utility types.

Description: Seized surface water manhole cover. Unable to lift.

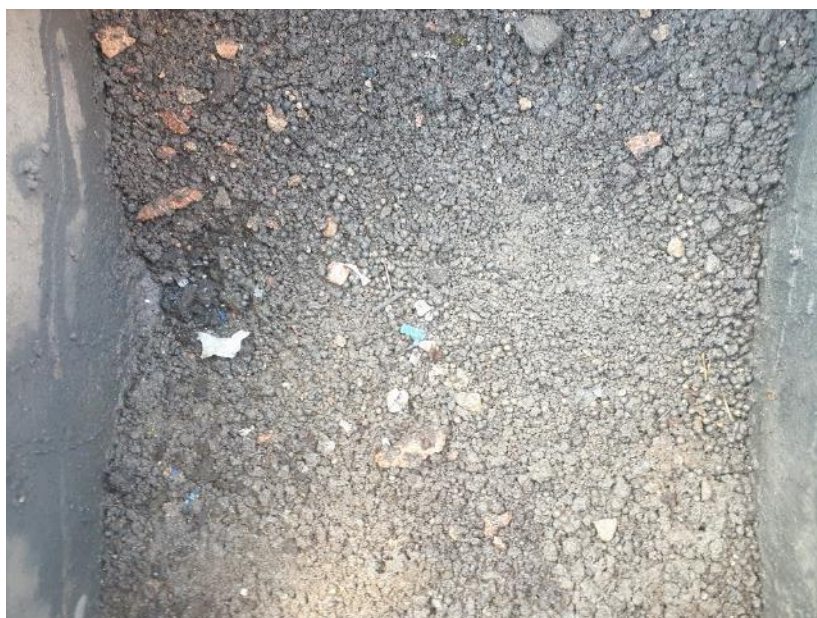
Photo 4

Description: Silted surface drainage water. Unable to survey.

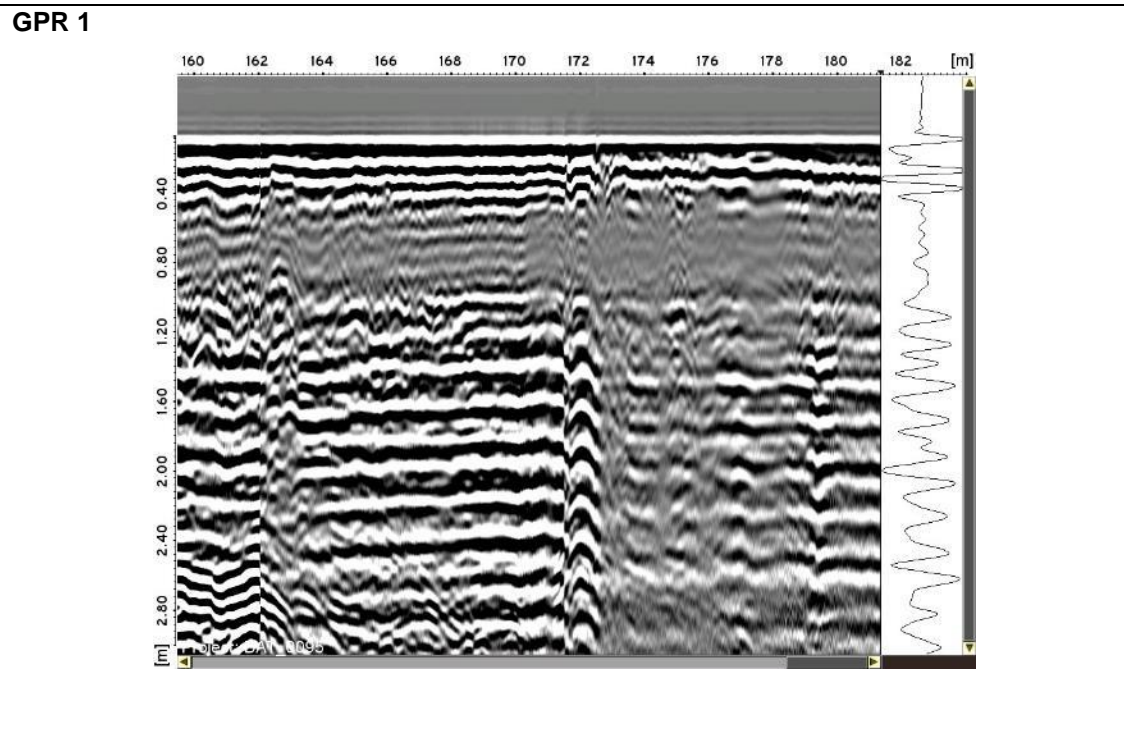
Description: Ground Penetrating Radar Image 1.

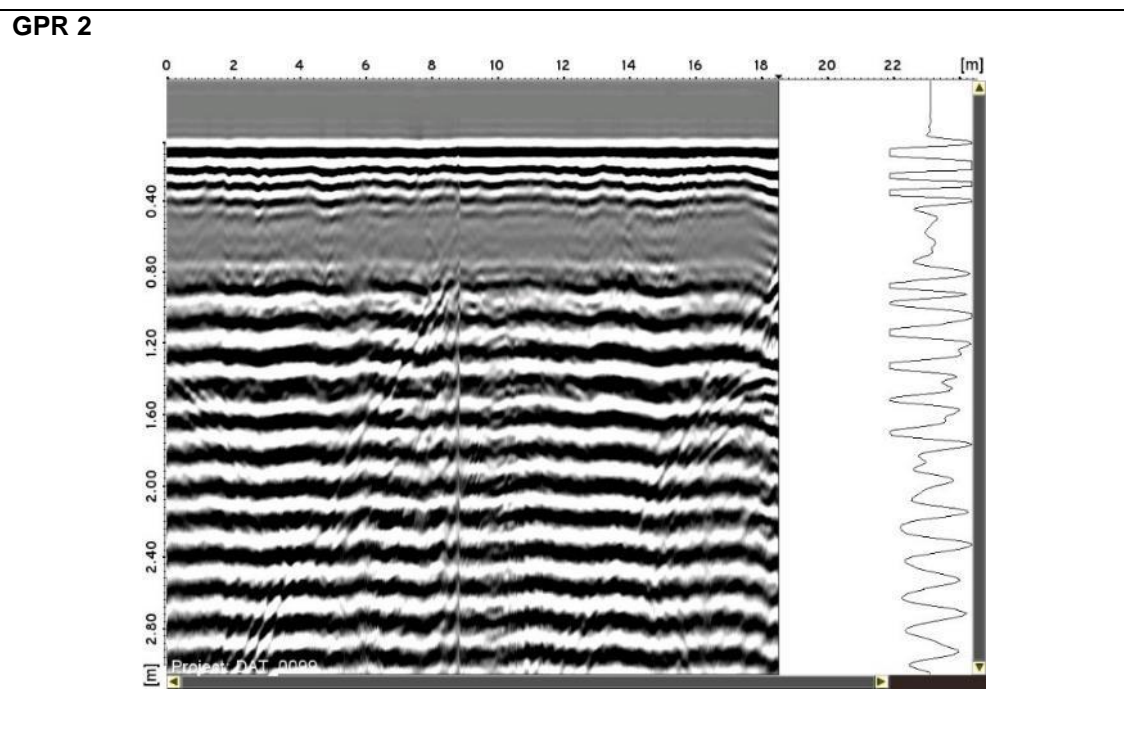
Description: Ground Penetrating Radar Image 2.
