Asbestos Survey Report and Register

Survey Type:	Asbestos Demolition Survey
Site:	Highland Avenue Garages, Romford, London, RM10 7AS
Surveyor:	Ben James
Contract:	C23061-L
Survey Date:	29th March 2021
Report Date:	11th April 2021
Client:	Arcadis Part 2nd Floor, Charter House, Cambridge, CB2 1LA

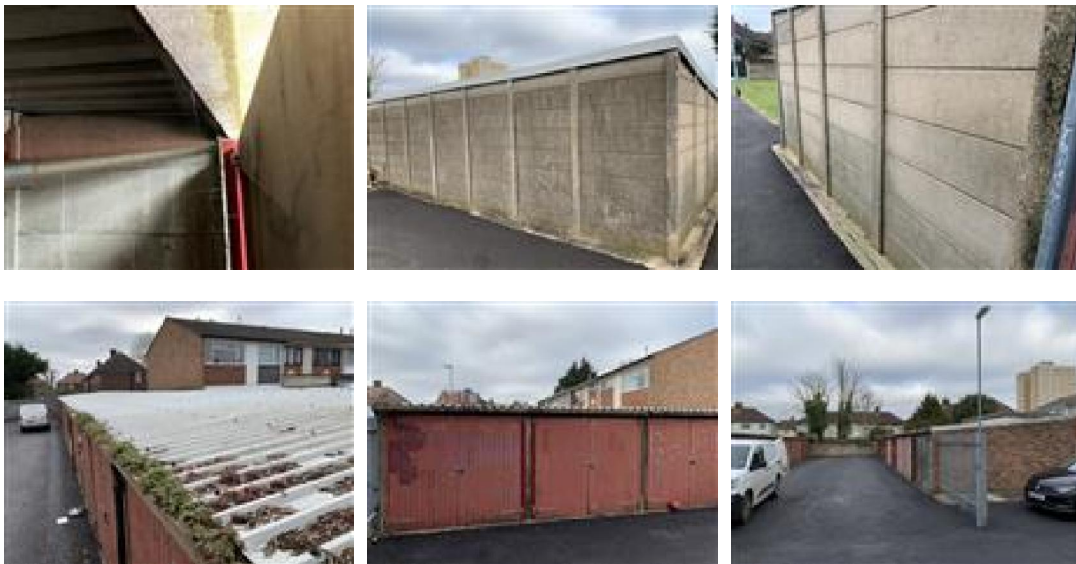
Building	Site 14
Floor	General Building Description
Surveyors Notes:	<p>Floors comprised of concrete.</p> <p>Walls comprised of concrete block work and standard brick work.</p> <p>Ceiling comprised of timber joists with corrugated tin roof.</p> <p>External areas and other construction details included timber garage doors with modern iron mongery. Modern locks and padlocks. A combination of metal and plastic rainwater goods, mineral felt to concrete guttering, timber soffits, no plastic damp proof course to brick garages, no visible damp proof course to concrete garages.</p>

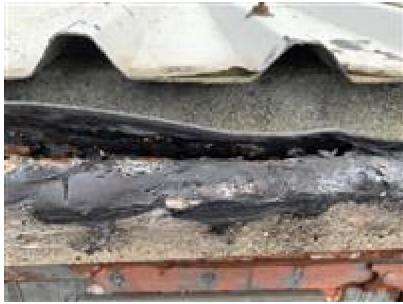
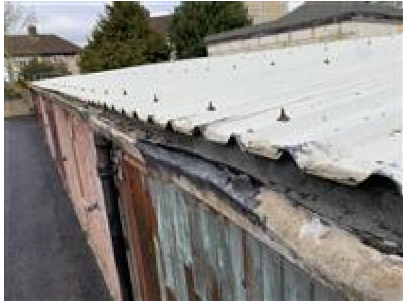
Contract No: C23061-L	Client: Arcadis	Location Ref ID: BJ001	
Site: Highland Avenue, RM10 7AS		Survey Date: 29/03/2021	
Building:	Site 14

Floor:	External		
Room Area:	External 099		
Description:	Bitumen Adhesive to Mineral Felt		
Quantity:	= 20 Sq m

Accessibility:	Easy		
Product Type:	1 - Bituminous Product		
Damage Extent:	1 - Low damage		
Surface Treatment:	0 - Composite	Re-inspection Due:	N/A
Asbestos Type:	No Asbestos Detected	Sample Ref:	Sampled 01
Material Assessment:		No Asbestos Detected	
Comments: Bitumen adhesive used to stick down modern mineral felt lining the concrete guttering across the top of the right hand side garages.			
Recommendations: No further action.

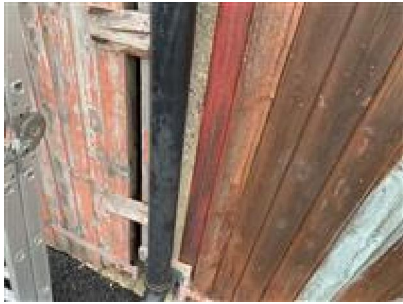
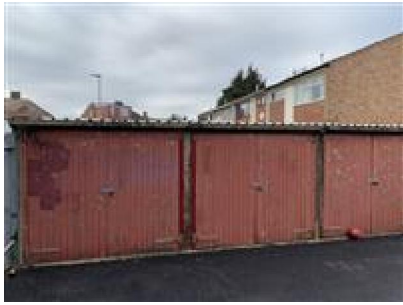
Contract No: C23061-L	Client: Arcadis	Location Ref ID: BJ002	
Site: Highland Avenue, RM10 7AS		Survey Date: 29/03/2021	
Building:	Site 14

Floor:	External		
Room Area:	External 099		
Description:	Putty To Timber Doors		
Quantity:	= 100 Lin m

Accessibility:	Medium		
Product Type:	1 - Putty		
Damage Extent:	3 - High damage		
Surface Treatment:	0 - Composite	Re-inspection Due:	N/A
Asbestos Type:	No Asbestos Detected	Sample Ref:	Sampled 02
Material Assessment:		No Asbestos Detected	
Comments: Putty sealant between the timber garage door frame work and the masonry walls.			
Recommendations: No further action
