**The Observatory, Green Hill, Woolwich, London SE18 – Condition Report Addendum**

## Condition Report

**The Observatory, Green Hill, Woolwich, London SE18**

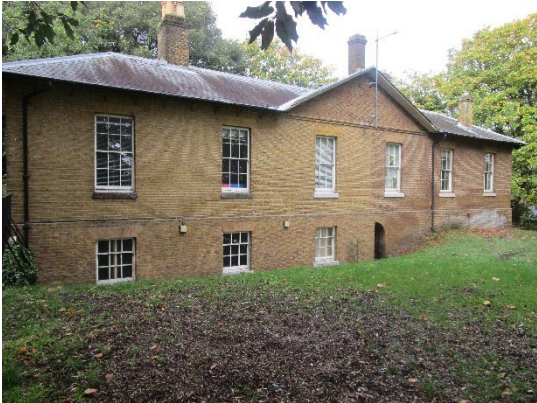
3.3.4	There is an area of rising damp at the base of the north section elevations, resulting in staining and efflorescence. There are internal signs of water damage at the base of the walls in the most northerly room. It is likely that ground levels have risen around the base of the elevations and we recommend that earth against the elevations is lowered, and a gravel drainage strip installed to reduce moisture levels in this area. The efflorescence should be cleaned and damaged internal plasterwork hacked off and renewed. (See photos 1 and 3).	2

Photo No	Photograph Description	Photograph
1.	General view of the east elevation with efflorescence staining visible on the right.

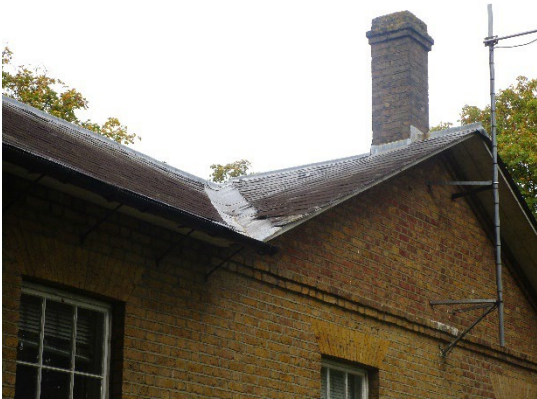
Condition and Principal Observations	Risk Rating
<p>stained with drip marks and finishes are failing. There is an area of water staining and mould growth to the ceiling of the basement stair lobby immediately below this area. Within the women's WC the angle bead next to the window recess is corroding, resulting in staining down the wall. This may be due to the roof leaking above, or due to condensation from inadequate ventilation. (See photos 14 and 16 to 18).</p>	
<p>3.5.5 The pitched roof is leaking in several locations but it was not possible to determine if this is historic or on-going. The principal area of ingress is over the central east elevation fire escape, immediately above the electrical distribution board. The elevation protrudes slightly in this location, with a parapet above and a small length of drainage channel draining to a hopper. This is likely blocked and the channel lining may be damaged. This requires investigation and repair. There is a further area of ingress staining next to the north roof access hatch, along with a hairline crack north to south across the centre of the room. There are slipped slates in locations across the roofs and a number of previous tingle repairs. All slipped or missing slates should be replaced to match the existing slates. (See photos 2 and 18).</p>	2

2.	Areas of slipped slates.

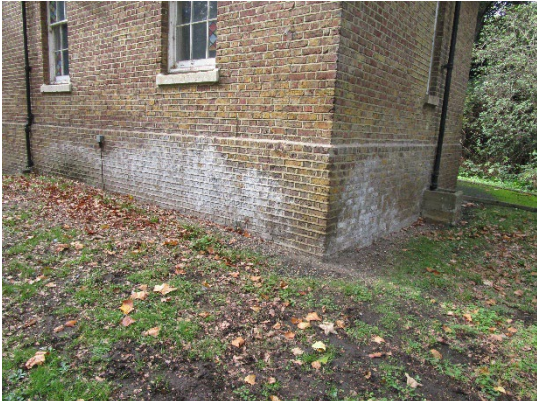
3.	Efflorescence staining suggesting rising damp.

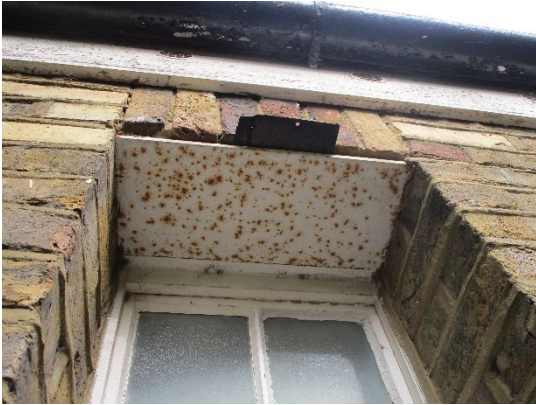
3.6.5	The windows to the entrance extension are in a very poor condition. All of these should be replaced. Some of them have extensive decay that is beyond repair and the window to the women's WC has signs of beetle infestation. The steel lintels to these windows are corroding. This corrosion should be removed, the steel treated, and the lintels redecorated. (See photo 4).	2

Photo No	Photograph Description	Photograph
4.	Corroding metal lintels.

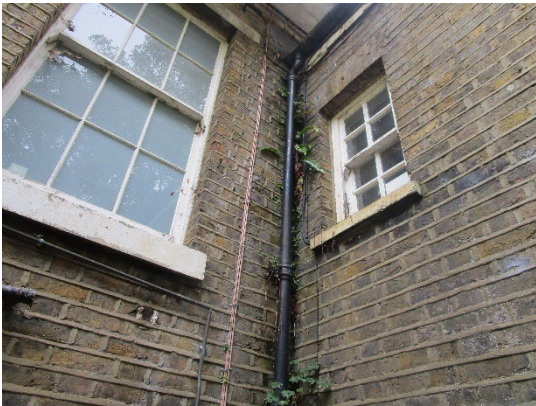
<p>3.3.9 A number of historic patch repairs have been carried out to the brickwork elevations of varying qualities, and there are various unsympathetic fixings including an antenna and cabling. Any redundant fixings should be removed. There are localised areas of impact damage to more vulnerable locations such as at low level and sills. The elevations are generally stained and would benefit from cleaning, including removal of bird droppings where birds perch on the antenna fixing brackets.</p>	3
<p>3.3.10 There is vegetation and ivy growth up and around the base of the elevations, particularly around the main entrance. This should be cleared to prevent it contributing to water ingress issues. (See photos 5 and 6).</p>	3

<p>3.5.6 Long term roof leaks may have resulted to timber decay to sections of the roof structure. Access should be provided to the roof void for inspection by a Structural Engineer. (See photo 18).</p>	2
<p>3.5.7 The pitched roof soffit boards are stained, with localised areas of decay, and require redecoration. The flat roof fascia boards are decayed and should be replaced.</p>	3
<p>3.5.8 There are a number of areas of damage to rainwater goods and areas where downpipes appear to be blocked, resulting in moss growth and staining to surrounding areas. Repairs should be carried out, all debris cleared, and downpipes rodded through to clear any blockages. These also have areas of corrosion that should be treated. All of the metal rainwater goods require redecoration. The rainwater outlets are blocked with debris. These should be cleared and a below ground drainage survey carried out. (See photo 5).</p>	3

5.	Example of blocked and leaking rainwater goods.

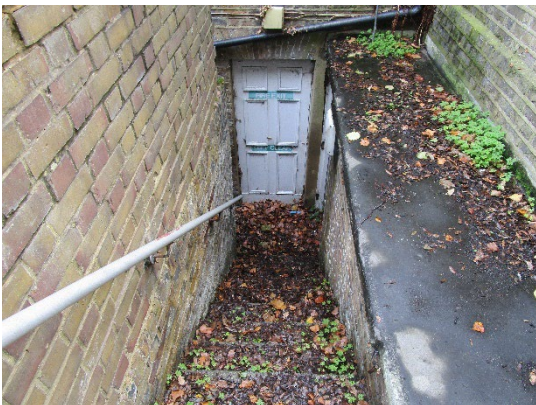
6.	Debris and vegetation covering fire escape route.

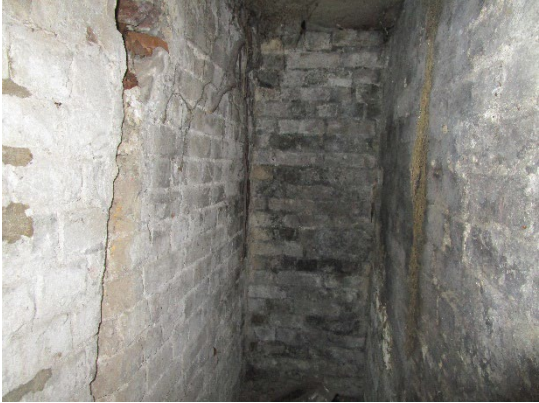
Photo No	Photograph Description	Photograph
7.	Poor condition of brickwork within the undercroft next to the basement fire escape.

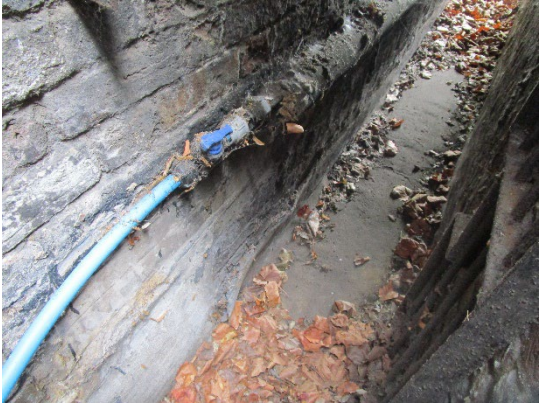
8.	Damaged lining to the basement drainage gulley.

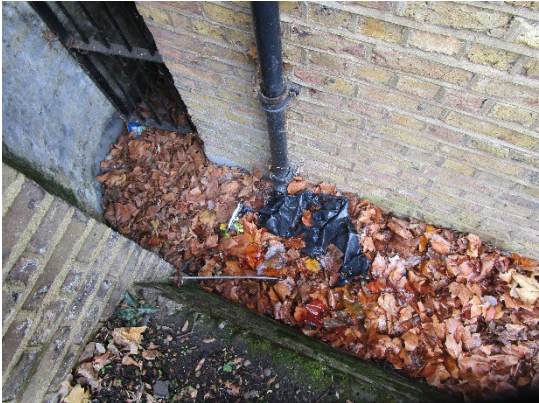
9.	Drainage gulley blocked with leaves and debris.

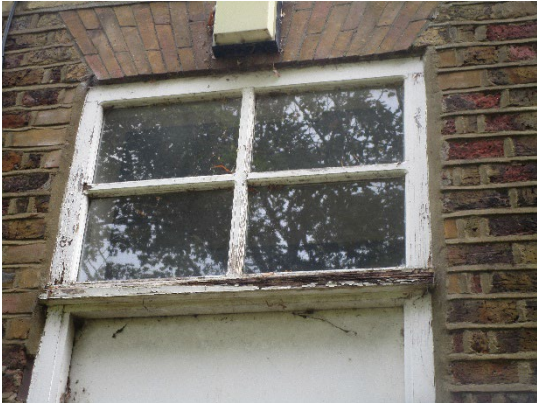
3.6.6	It was not possible to confirm if the glazing to the fanlights over the west elevation fire doors was fire rated. These are also heavily decayed and so should be replaced with windows of a suitable fire rating. (See photo 10).	2

4.1.4 Externally, fire escape routes were overgrown and had a build-up of vegetation and debris. These should be cleared.	1
4.1.5 As noted under item 3.6, it was not possible to confirm if the glazing to the fanlights over the west elevation fire doors was fire rated. These are also heavily decayed and so should be replaced with windows of a suitable fire rating. (See photo 10).	2

Photo No	Photograph Description	Photograph
10.	Example of decayed window to be replaced.

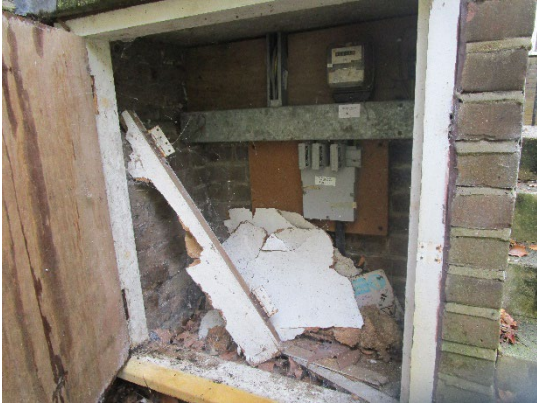
Condition and Principal Observations	Risk Rating
3.6.7 The basement fire escape door within the former interrogation room is leaking at the base, resulting in stained finishes. The external escape stairs beyond are blocked with leaves and debris, resulting in a build-up of moisture against the door. This should be cleared. (See photos 6 and 20).	3
3.6.8 The doors to both the gas and electricity supply cupboards (located below the ground floor fire escape access stairs) are damaged and should be replaced. (See photo 11).	3

11.	Electricity mains cupboard door damaged and to be replaced.

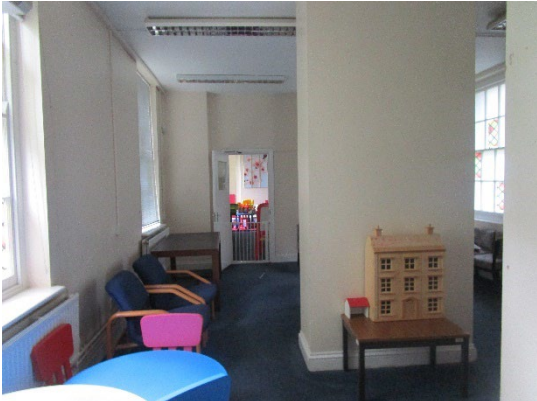
3.7.10	Finishes throughout are worn with extensive wear and tear. These should be renewed before the building is put to a new use. In some locations there are holes and penetrations from redundant or removed fittings. Floor finishes are particularly aged, with some areas of splits or patching. We recommend that these are replaced. (See photo 12).	3

12.	General view of internal areas.

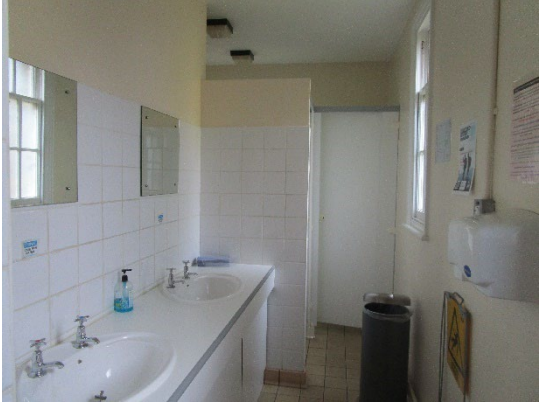
Condition and Principal Observations	Risk Rating
3.8.2 The WC fitout is dated and is likely to require full refurbishment to meet modern expectations, depending on the building's future use. Grouting is stained and sealant degraded, and this should be addressed in the short term. (See photo 13).	3

Photo No	Photograph Description	Photograph
13.	General view of WC finishes.

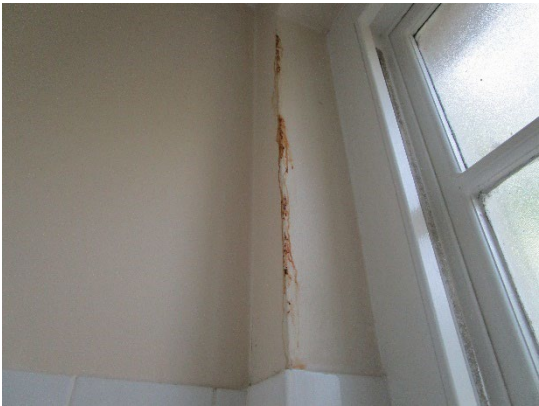
14.	Angle bead corroding in the women's WC.

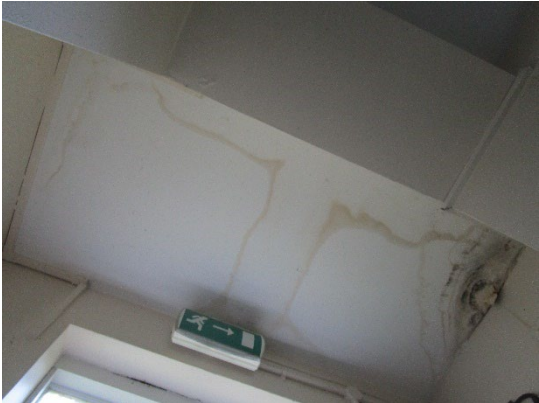
15.	Water ingress staining over the fire escape exit and electrical distribution board.

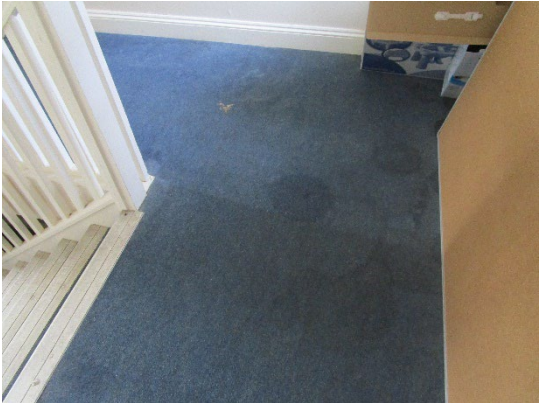
Photo No	Photograph Description	Photograph
16.	Water dripping from ceiling onto the floor after period of rain.

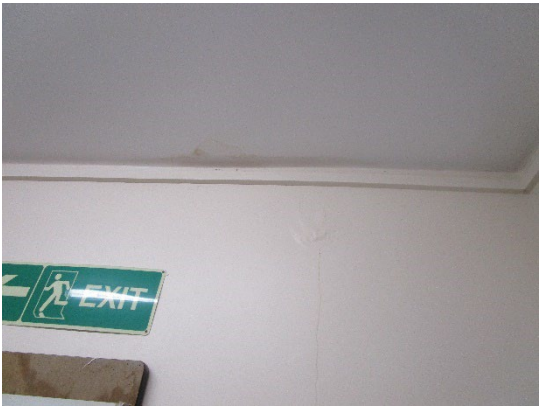
Description	
3.4.2	There is a timber staircase leading down to the basement, located in the entrance hall extension.
Condition and Principal Observations	
3.4.3	The suspended timber floor is slightly spongy immediately inside the main entrance door. There is also evidence (see item 3.5.4) that water ingress from roof leaks is percolating through into the basement below the entrance lobby. Water ingress may be resulting in decay to the suspended floor structure. It should be exposed for inspection as part of any repair works. (See photos 17 and 18).

17.	Water ingress staining to the entrance lobby wall, over area of ingress in the basement.

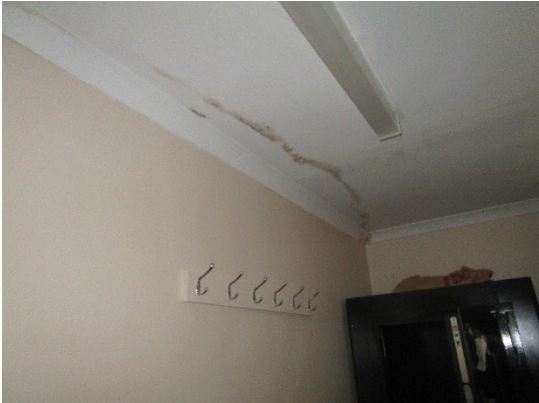
3.2.4	There is water ingress staining and mould growth at high level in the north-west corner of the basement stair lobby. The staining is focused below an area of ingress from the roof to the the entrance lobby above. This appears likely to be related to the roof leaks, rather than penetrating damp through the basement walls. Repairs should be undertaken and the affected finishes made good. (See photo 18).	2

18.	Water ingress staining to the basement stair lobby ceiling, below the leak identified in the photo above.

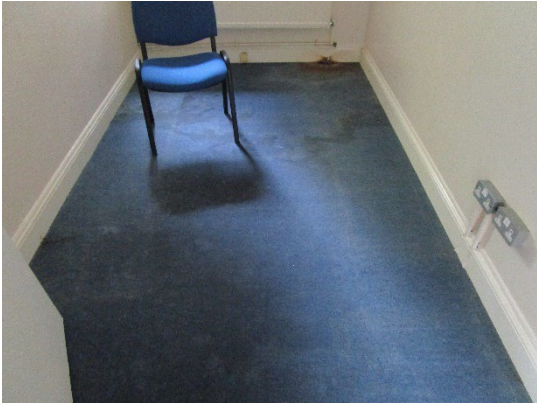
3.7.7	In the south-east corner of the basement there is a large area of carpet staining concentrated around a radiator valve. This appears to have been leaking and it is unclear if this has been repaired. If not, this should be carried out and floor finishes replaced. (See photo 19).	3

Photo No	Photograph Description	Photograph
19.	Water ingress staining to the basement carpet finishes, spreading from below the radiator valve.

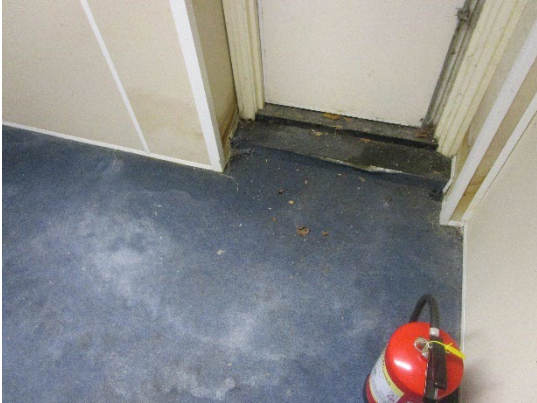
20.	Staining to carpet finishes around the basement fire escape, blocked with vegetation and debris externally.

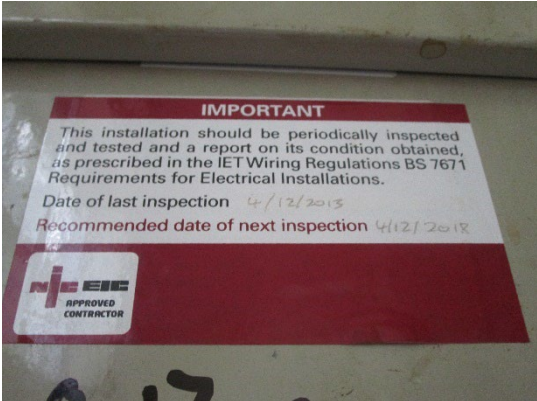
3.10.10	<p>The electrical distribution board labelling shows that the last EICR (electrical installation condition record) was carried out on 04 December 2013 and was due for retesting on 04 December 2018. This should be carried out at five yearly intervals so is very overdue for renewal. It is below an area of water ingress, potentially a health and safety issue if water is reaching the distribution board. (See photo 21).</p>

21.	Labelling on the distribution board showing the EICR was due in December 2018.
