Asbestos Survey Report and Register

Survey Type:	Asbestos Demolition Survey
Site:	Fambridge Road Garages, Romford, London, RM8 1NS
Surveyor:	Ben James
Contract:	C23061-F
Survey Date:	30th March 2021
Report Date:	11th April 2021
Client:	Arcadis Part 2nd Floor, Charter House, Cambridge, CB2 1LA

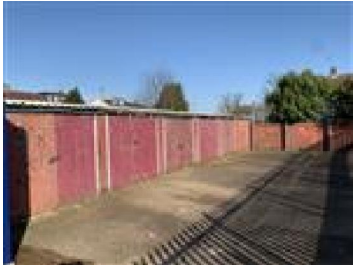
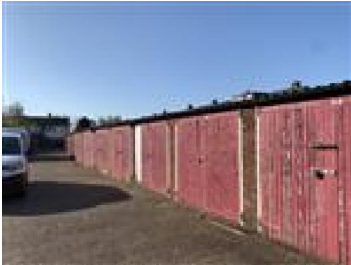
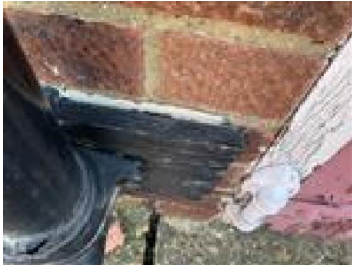
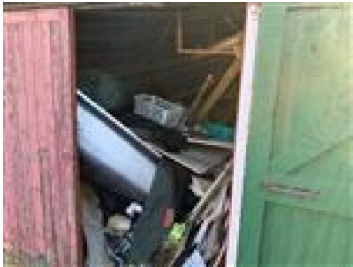
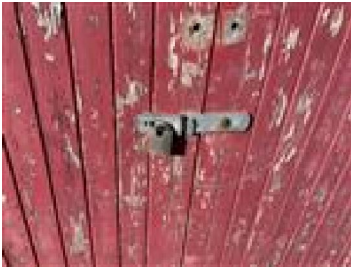
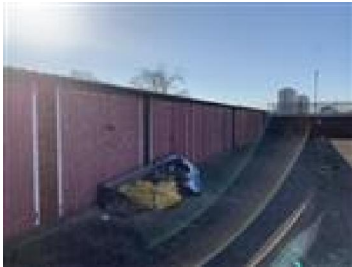
Building	Sites 1-3
Floor	General Building Description
Surveyors Notes:	<p>Floors comprised of concrete.</p> <p>Walls comprised of brick work and block work.</p> <p>Ceilings comprised of timber joists with corrugated tin ceiling panels.</p> <p>External areas and other construction details included timber garage doors and frame work, timber soffits, plastic and metal rainwater goods and down pipes, bitumen damp proof course.</p>
Photos:

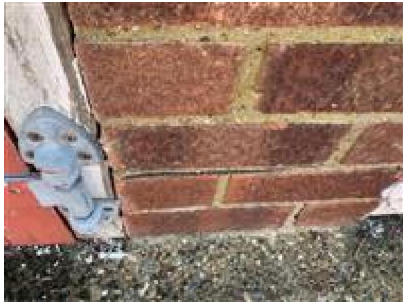
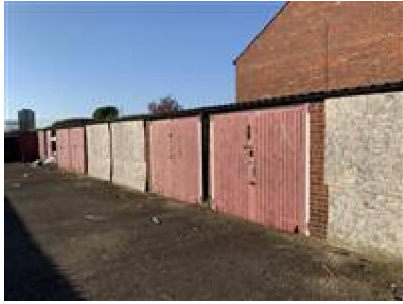
Contract No: C23061-F	Client: Arcadis	Location Ref ID: BJ001	
Site: Fambridge Road, RM8 1NS		Survey Date: 30/03/2021	
Building:	Sub Site 1

Floor:	External		
Room Area:	External 099		
Description:	Bitumen a damp Proof Course		
Quantity:	= 100 Lin m

Accessibility:	Easy		
Product Type:	1 - Bituminous Product		
Damage Extent:	1 - Low damage		
Surface Treatment:	0 - Composite	Re-inspection Due:	N/A
Asbestos Type:	No Asbestos Detected	Sample Ref:	Sampled 01
Material Assessment:		No Asbestos Detected	
Comments: Bitumen damp proof course running at low level to masonry walls across both garages.			
Recommendations: No further action.

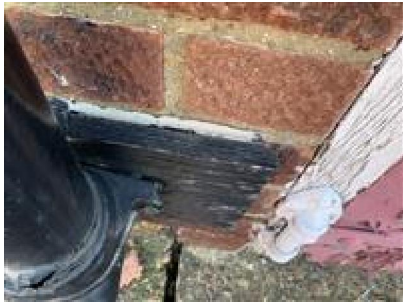
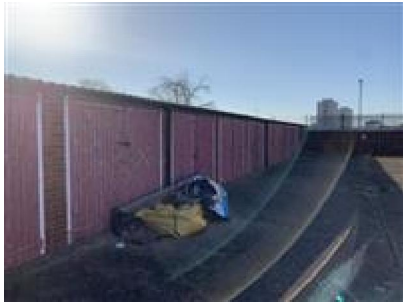
Contract No: C23061-F	Client: Arcadis		Location Ref ID: BJ002	
Site: Fambridge Road, RM8 1NS			Survey Date: 30/03/2021	
Building:	Sub Site 1

Floor:	External			
Room Area:	External 099			
Description:	Putty To Timber Panel			
Quantity:	= 1 Lin m

Accessibility:	Medium			
Product Type:	1 - Putty			
Damage Extent:	2 - Medium damage			
Surface Treatment:	0 - Composite	Re-inspection Due:	N/A	
Asbestos Type:	No Asbestos Detected	Sample Ref:	Sampled 02	
Material Assessment:		No Asbestos Detected		
Comments: Putty to timber panel fixing down pipe to the walls.				
Recommendations: No further action.

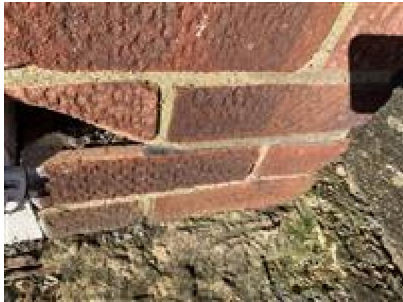
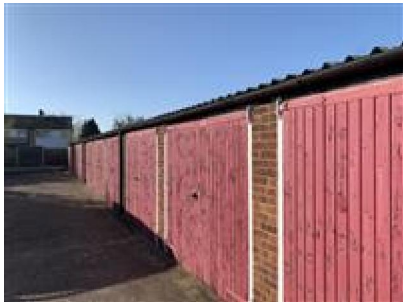
Contract No: C23061-F	Client: Arcadis	Location Ref ID: BJ003	
Site: Fambridge Road, RM8 1NS		Survey Date: 30/03/2021	
Building:	Sub Site 2

Floor:	External		
Room Area:	External 099		
Description:	Bitumen a damp Proof Course		
Quantity:	= 200 Lin m

Accessibility:	Easy		
Product Type:	1 - Bituminous Product		
Damage Extent:	1 - Low damage		
Surface Treatment:	0 - Composite	Re-inspection Due:	N/A
Asbestos Type:	No Asbestos Detected	Sample Ref:	Sampled Reference 01
Material Assessment:		No Asbestos Detected	
Comments: Bitumen damp proof course running at low level to masonry walls across all garages.			
Recommendations: No further action.

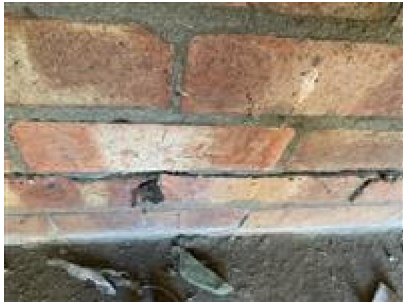
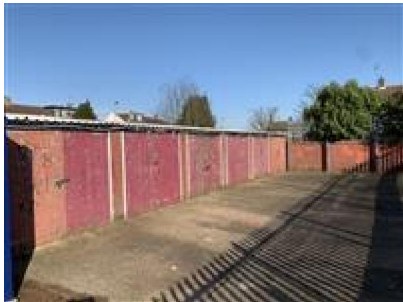
Contract No: C23061-F	Client: Arcadis	Location Ref ID: BJ004	
Site: Fambridge Road, RM8 1NS		Survey Date: 30/03/2021	
Building:	Sub Site 3

Floor:	External		
Room Area:	External 099		
Description:	Bitumen a damp Proof Course		
Quantity:	= 50 Lin m

Accessibility:	Easy		
Product Type:	1 - Bituminous Product		
Damage Extent:	1 - Low damage		
Surface Treatment:	0 - Composite	Re-inspection Due:	N/A
Asbestos Type:	No Asbestos Detected	Sample Ref:	Sampled Reference 02
Material Assessment:		No Asbestos Detected	
Comments: Bitumen damp proof course running at low level to masonry walls across all garages.			
Recommendations: No further action.
