## Demolition

Site address: Recreation Road Garages, Southall, UB2 5PE

| Report Number | Report Issue Number | Date of Issue |
|---|---|---|
| S-21632-70-001 | 01 | 19/12/2024 |

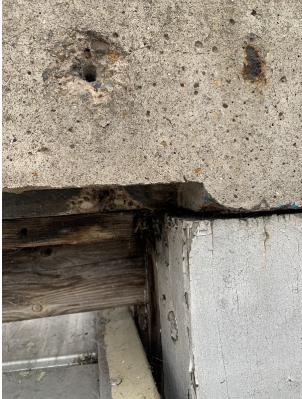
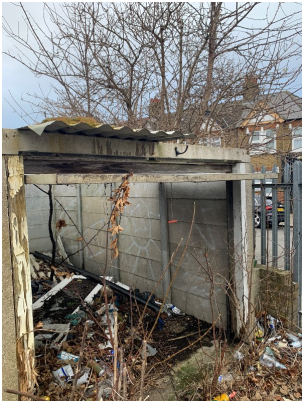
Assessment No: 01

Area No: G.02

Room Use: Garage 1

| Room element | Door frame | |
| Asbestos Type | NADIS | |
| Item | Mastic to frames | |
| Extent | 4M | |

| Risk Score | 0 |
| Risk Category | E |

| Recommendations | No action required |
