**S I L V E R D E L L**

**Report For  
English Partnership**

**Type 2 Asbestos Survey  
Cane Hill Hospital  
Coulsden  
Surrey  
CU5**

| SILVERDELL PROJECT No: | Y3303 |

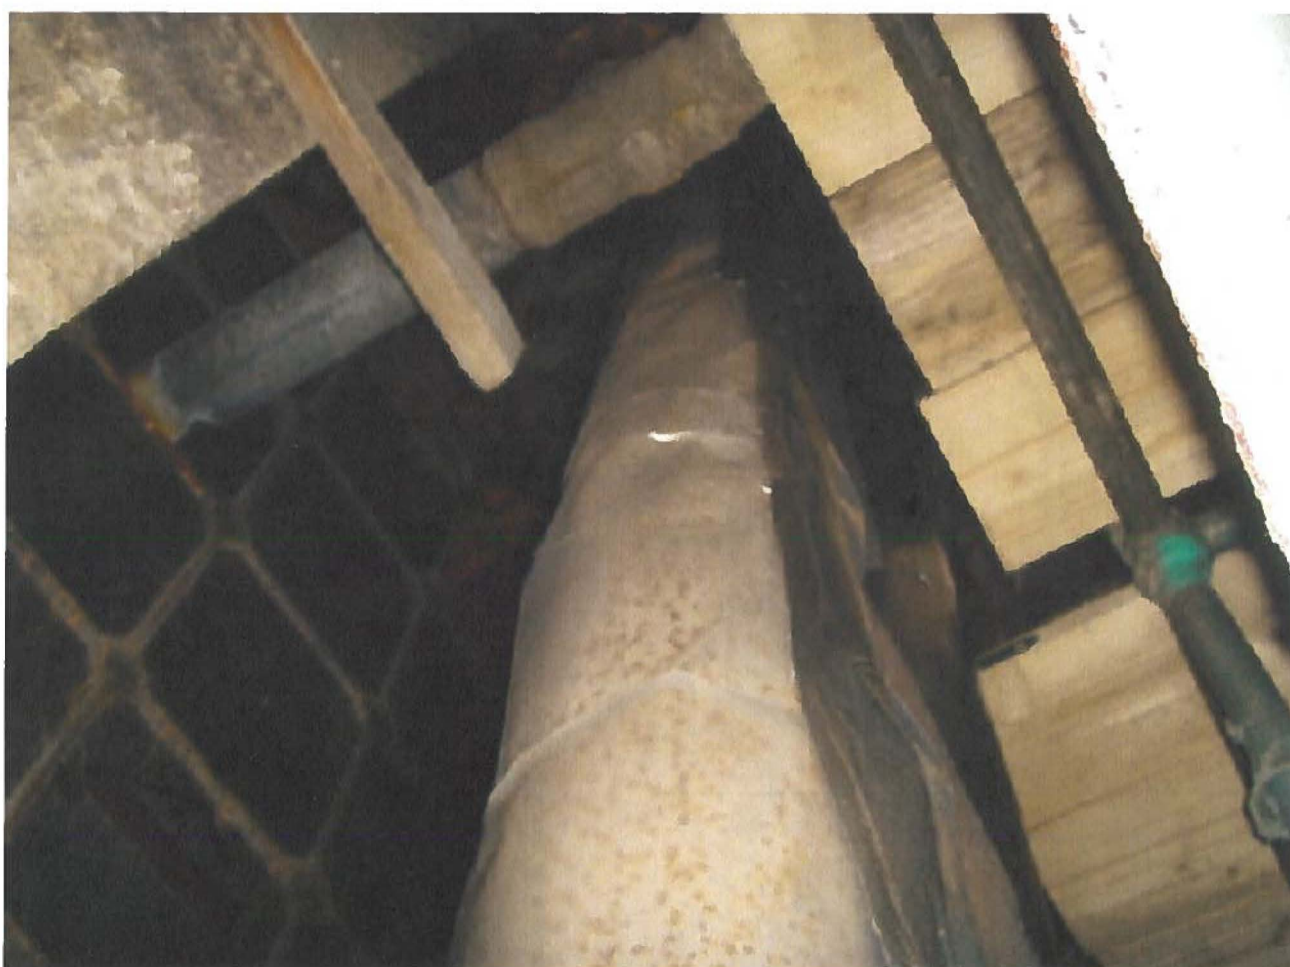
| <b>Survey Type</b> | - | Type 3 - PreDemolition/Major Refurbishment Survey | <b>Photograph No.</b> | - | 058 |

| Building/Floor /<br>Room | Area ID | Surveyor's Observations | Asbestos<br>Present | Material<br>Assessment<br>Page No(s) |
|---|---|---|---|---|
| Cane Hill Hospital<br>Tower Block<br>First floor<br>Tower Block | Area6453 | Scaffolding to floor<br>Solid brick walls<br>Timber soffit<br>Timber stairs<br><b>Presumed residue to pipework<br/>running up wall</b> | <b>Asbestos<br/>Present</b> | Pages: 10 - 11 |

| English Partnership | | | |
|---|---|---|---|
| <b>Description</b> | Residue to pipework | <b>Job Status</b> | Surveyed |

| <b>Asbestos Type</b> | - | Amosite (brown) | <b>Damage Extent</b> | - | Medium Damage: Significant breakage of materials |
| <b>Product Type</b> | - | Insulation | <b>Surface Treatment</b> | - | Unsealed |
| <b>Quantity</b> | - | = 8 Lin M | <b>Hazard Rating</b> | - | 10 |

| <b>Recommendations:</b> | - | Remove under fully controlled conditions. |

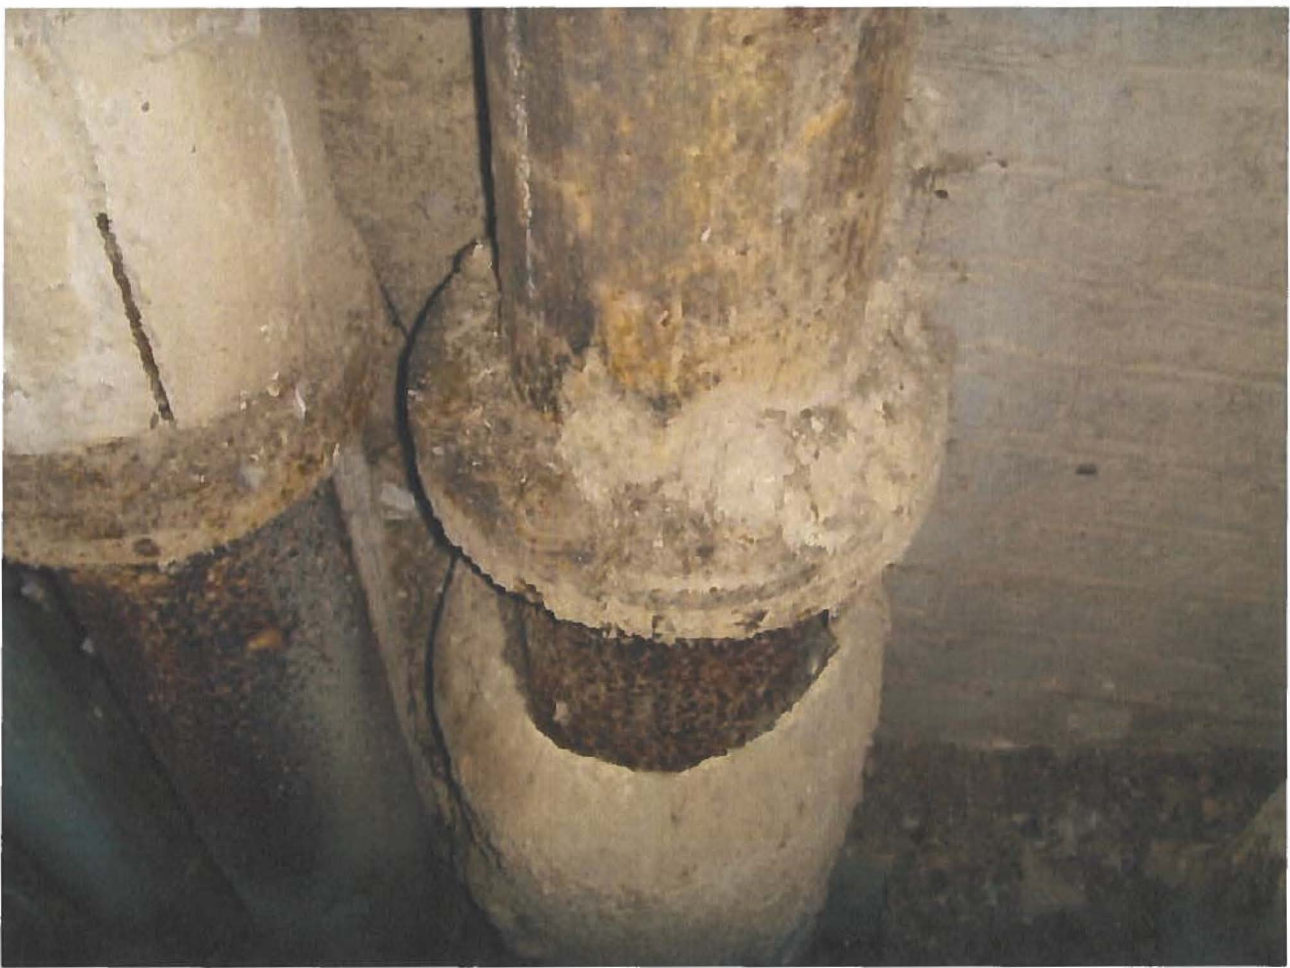
| Survey Type | - | Type 3 -<br>PreDemolition/Major<br>Refurbishment Survey | Photograph N°. | - | 052 |

| English Partnership | | | |
|---|---|---|---|
| Description | Insulation to pipework running up wall | Asbestos Present | Yes |

| Asbestos Type | - | Chrysotile (white)<br>Crocidolite (blue) | Damage Extent | - | High Damage: Or<br>delamination of material |
| Product Type | - | Insulation | Surface Treatment | - | Part Sealed |
| Quantity | - | = 8 Lin M | Hazard Rating | - | 11 |

| TEST RESULTS | | | | |
|---|---|---|---|---|
| Y3303/2/002 | 178808 | Tower block, 2 <sup>nd</sup> floor, insulation to pipes | Insulation | CHRYSTOTILE CROCIDOLITE |

| Recommendations: | - | Remove under fully controlled conditions. |

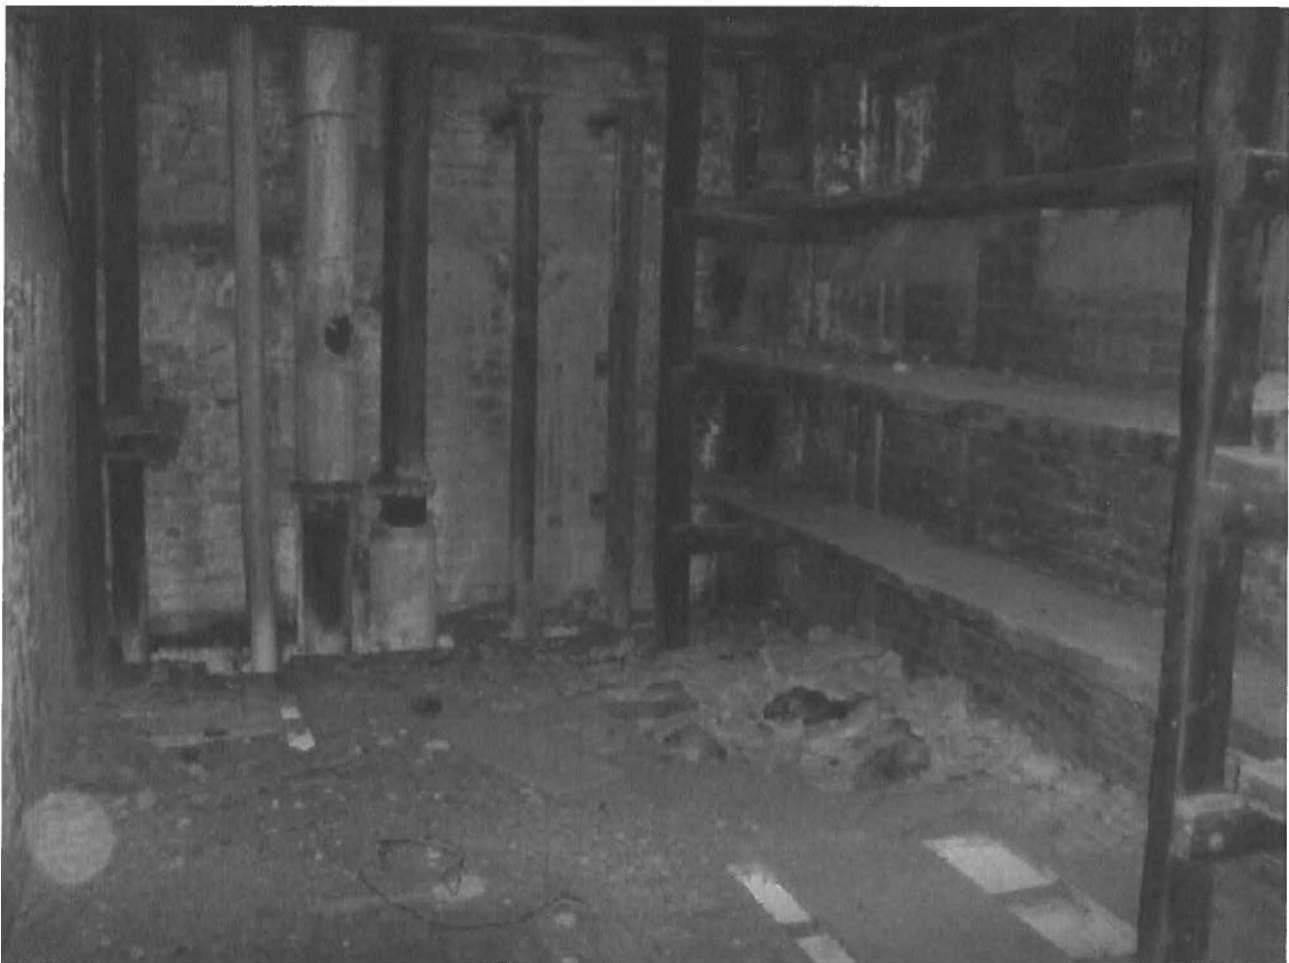
| Survey Type | - | Type 3 -<br>PreDemolition/Major<br>Refurbishment Survey | Photograph No. | - | 050 |

| English Partnership | | | |
|---|---|---|---|
| Description | Insulation to pipework running up wall | Asbestos Present | Yes |

| Asbestos Type | - | Chrysotile (white)<br>Crocidolite (blue) | Damage Extent | - | High Damage: Or<br>delamination of material |
| Product Type | - | Insulation | Surface Treatment | - | Part Sealed |
| Quantity | - | = 8 Lin M | Hazard Rating | - | 11 |

| Recommendations: | - | Remove under fully controlled conditions. |
