**Report For  
English Partnership**

**Type 2 Asbestos Survey  
Cane Hill Hospital  
Coulsden  
Surrey  
CU5**

| SILVERDELL PROJECT No: | Y3303 |

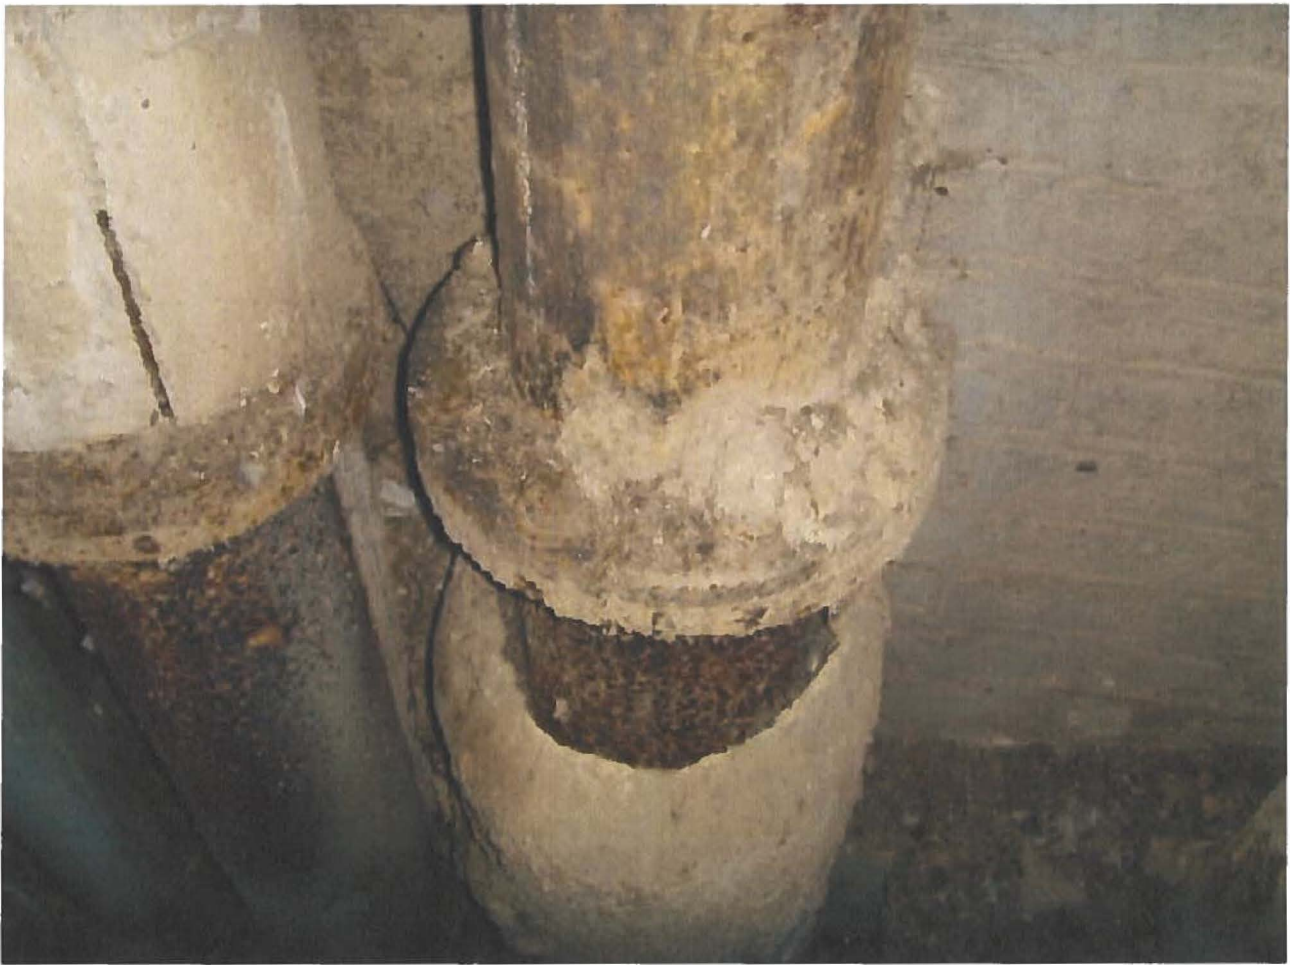
| Survey Type | - | Type 3 -<br>PreDemolition/Major<br>Refurbishment Survey | Photograph N°. | - | 052 |

| English Partnership | | | |
|---|---|---|---|
| Description | Insulation to pipework running up wall | Asbestos Present | Yes |

| Asbestos Type | - | Chrysotile (white)<br>Crocidolite (blue) | Damage Extent | - | High Damage: Or<br>delamination of material |
| Product Type | - | Insulation | Surface Treatment | - | Part Sealed |
| Quantity | - | = 8 Lin M | Hazard Rating | - | 11 |

| TEST RESULTS | | | | |
|---|---|---|---|---|
| Y3303/2/002 | 178808 | Tower block, 2 <sup>nd</sup> floor, insulation to pipes | Insulation | CHRYSTILE CROCIDOLITE |

| Recommendations: | - | Remove under fully controlled conditions. |
