### **WYG Type 3 Asbestos Survey Report Cane Hill, Coulsdon – Various sites Homes and Communities Agency June 2010**

| <b>Reference: REPORT/A061326-1/ASB3/JK/JUNE10/VI</b> | | | |

WYG Environment Planning Transport (WYG) was commissioned by the Homes and Communities Agency to undertake a WYG Type 3 survey at Cane Hill, Brighton Road, Coulsdon, CR5 3YL.

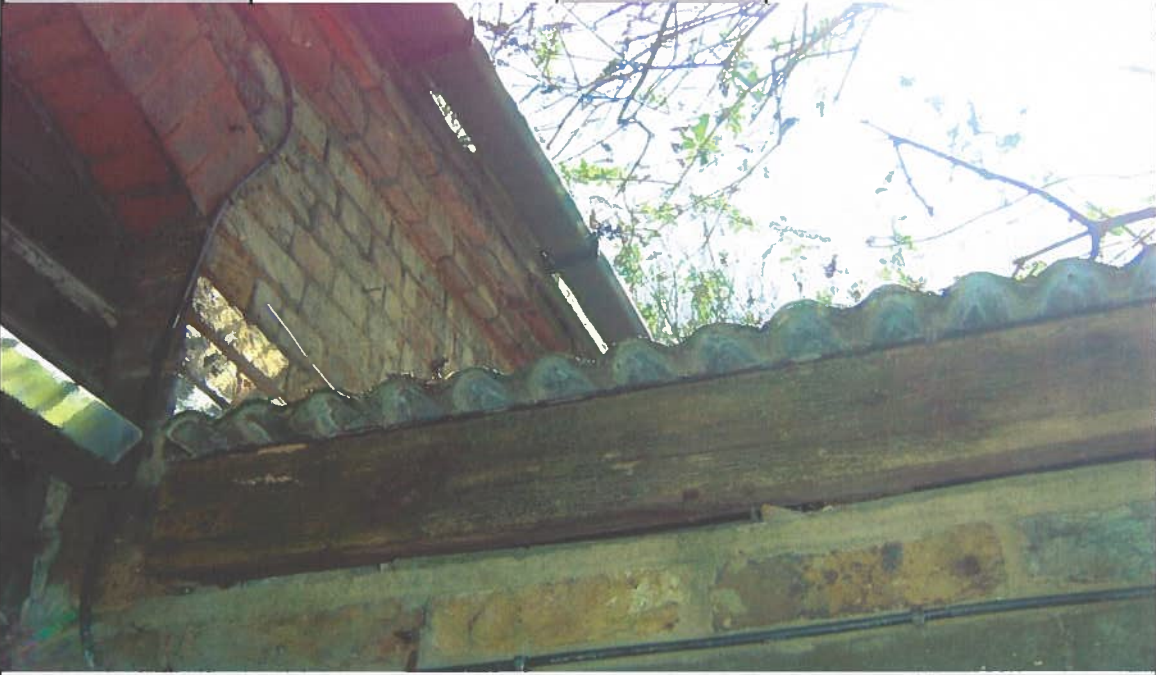
| Photo Number | 1 | Reference number | 210410JK01 |

| Notes | ACM:Asbestos Containing Material | | |

| Building | Sovereign House | Condition | Poor | 4 |

| Recommendation | Remove prior to work that will disturb this material | Assessment Score | 9 | |

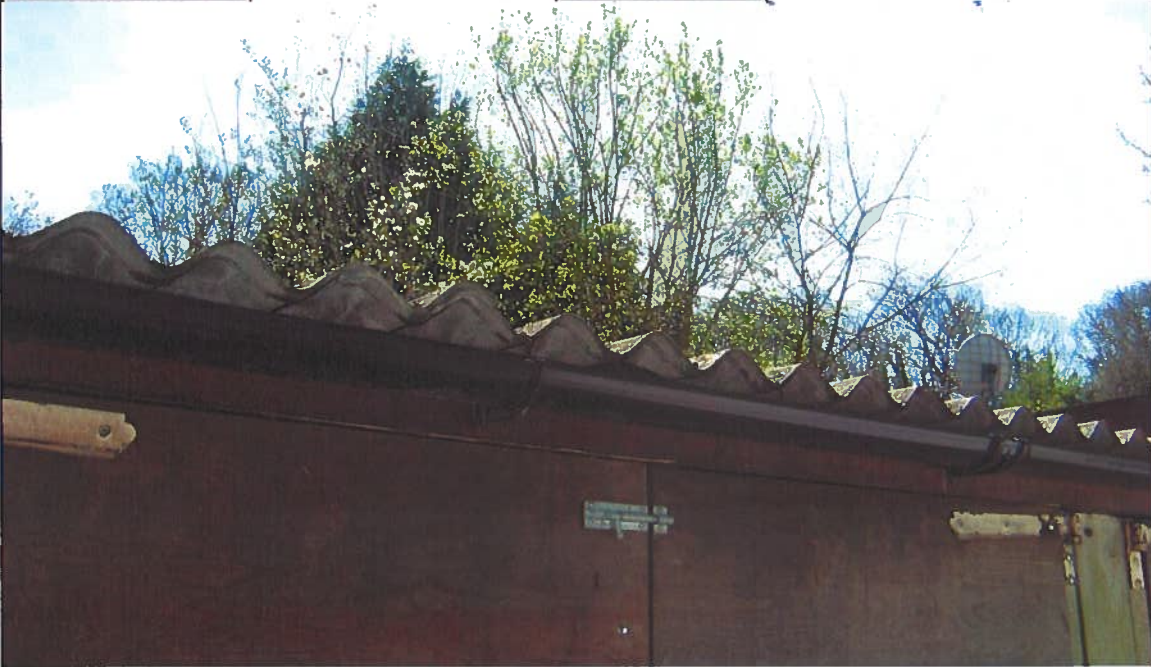
| Photo Number | 2 | Reference number | 210410JK02 |

| Notes | ACM:Asbestos Containing Material | | |

| Building | Sovereign House | Condition | Fair | 1 |

| Recommendation | Remove prior to work that will disturb this material | Assessment Score | 6 | |

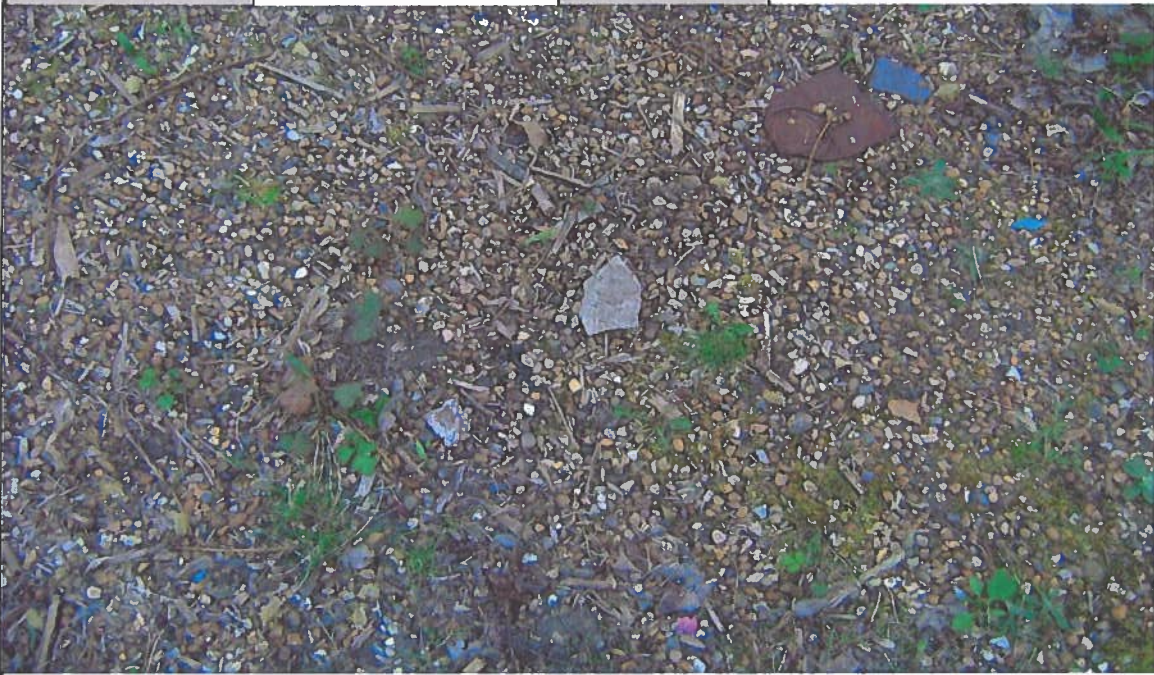
| Photo Number | 3 | Reference number | 210410JK03 |

| Notes | ACM:Asbestos Containing Material | | |

| Building | Sovereign House | Condition | Debris | 6 |

| Recommendation | Remove prior to work that will disturb this material | Assessment Score | 13 | |

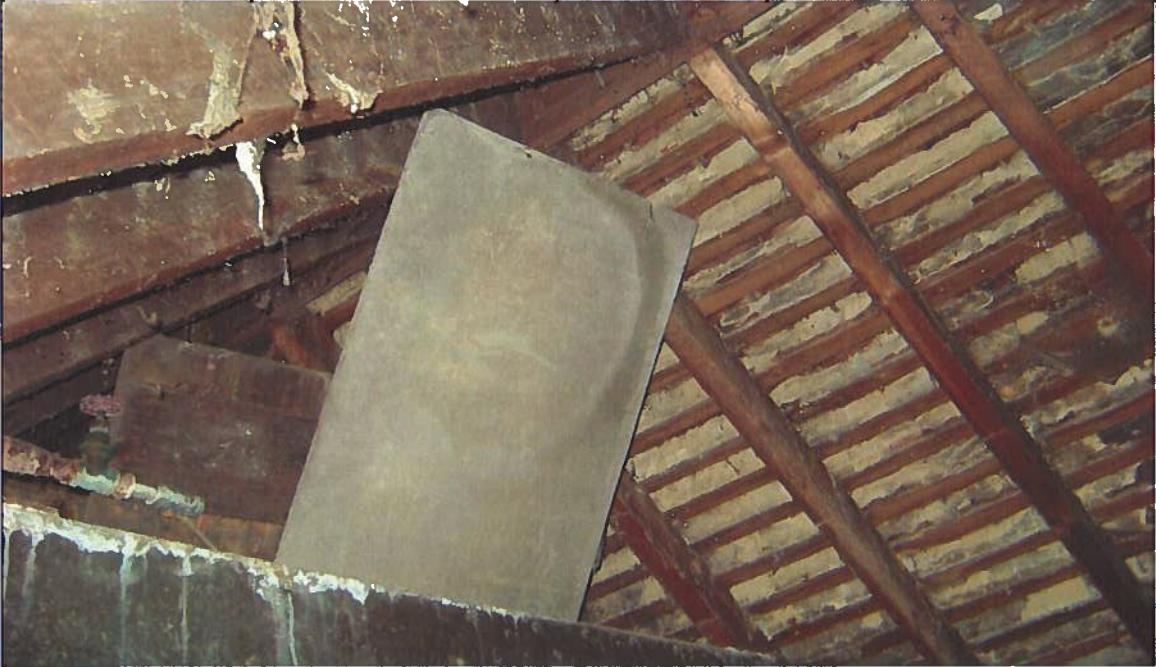
| Photo Number | 4 | Reference number | 220410JK04 |

| Notes | ACM:Asbestos Containing Material | | |

| Building | North Lodge | Condition | Fair | 1 |

| Recommendation | Remove prior to work that will disturb this material | Assessment Score | 7 | |

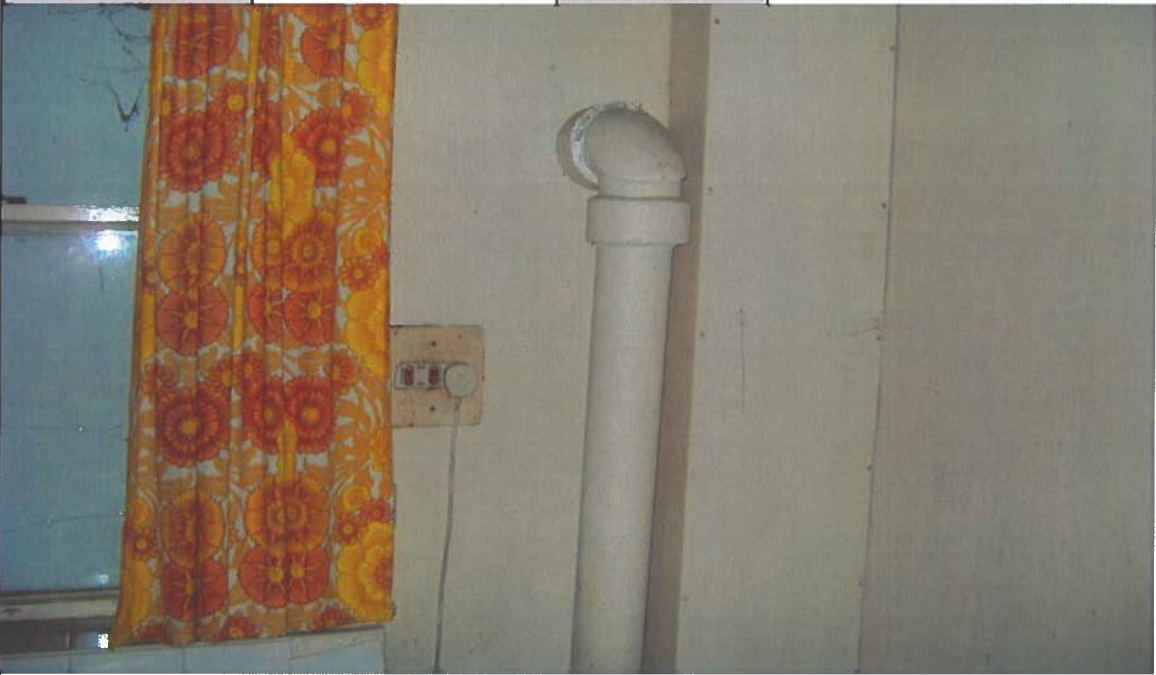
| Photo Number | 5 | Reference number | 220410JK05 |

| Notes | ACM:Asbestos Containing Material | | |

| Building | North Lodge | Condition | Fair | 1 |

| Recommendation | Remove prior to work that will disturb this material | Assessment Score | 5 | |

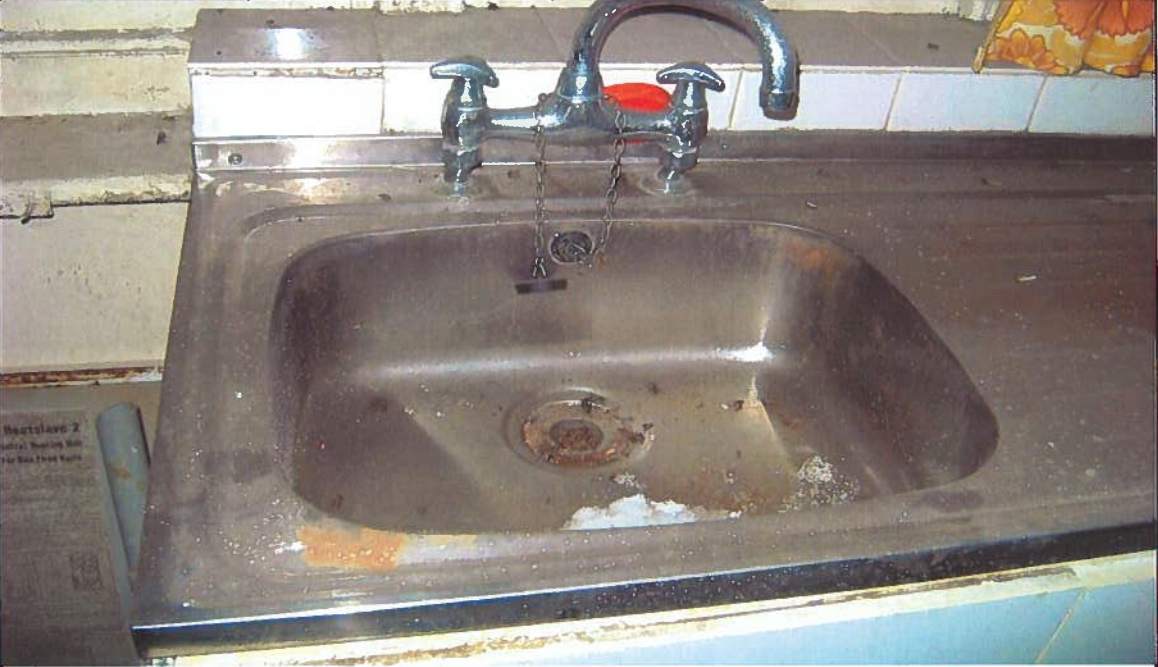
| Photo Number | 6 | Reference number | 220410JK06 |

| Notes | NADIS:No Asbestos Detected In Sample |

| Building | North Lodge | Condition | Fair | 1 |

| Recommendation | No further action required | Assessment Score | 0 | |

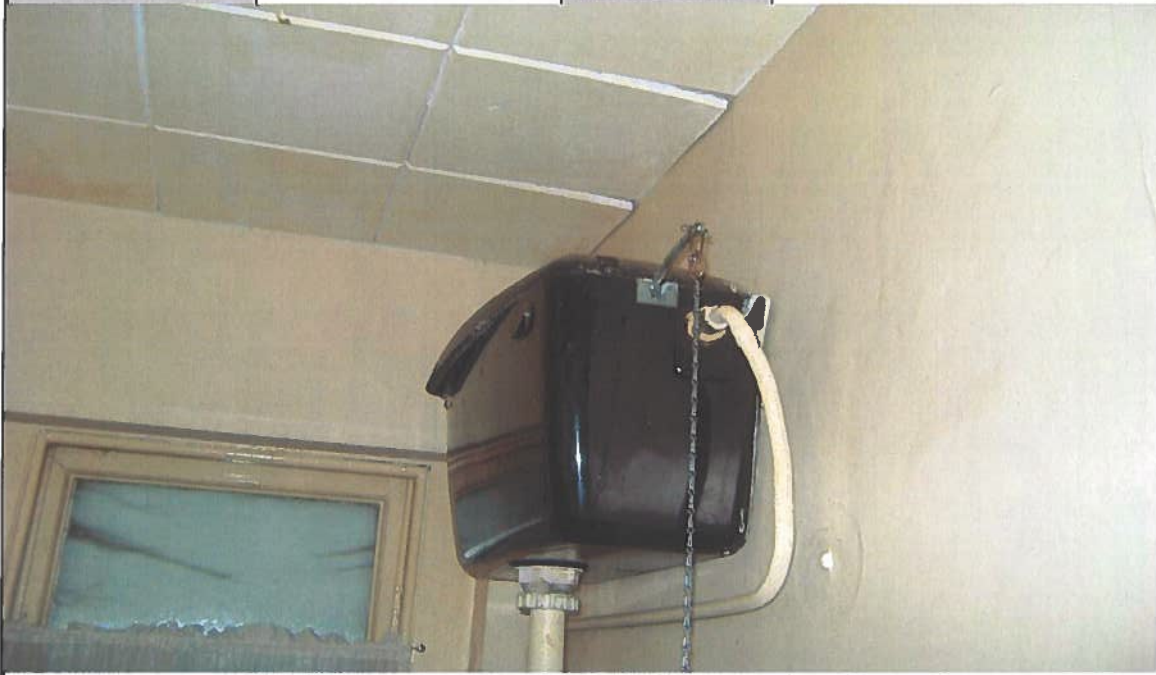
| Photo Number | 7 | Reference number | 220410JK07 |

| Notes | ACM:Asbestos Containing Material | | |

| Building | North Lodge | Condition | Fair | 1 |

| Recommendation | Remove prior to work that will disturb this material | Assessment Score | 4 | |

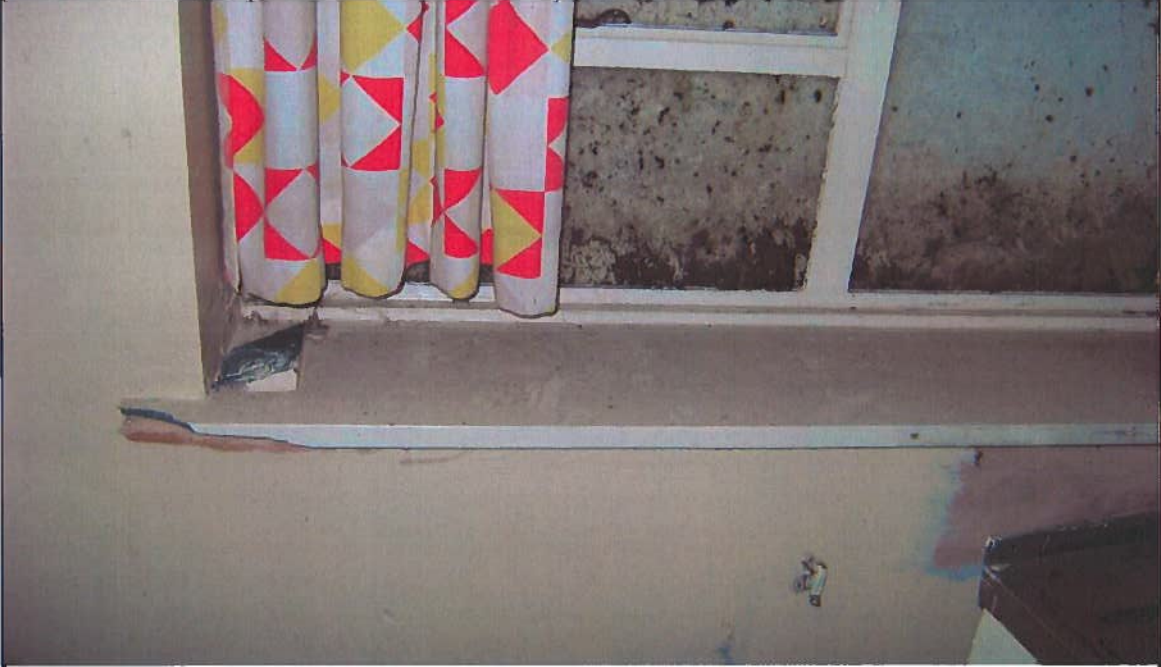
| Photo Number | 8 | Reference number | 220410JK08 |

| Notes | NADIS: No Asbestos Detected In Sample | | |

| Building | North Lodge | Condition | Poor | 4 |

| Recommendation | No further action required | Assessment Score | 0 | |

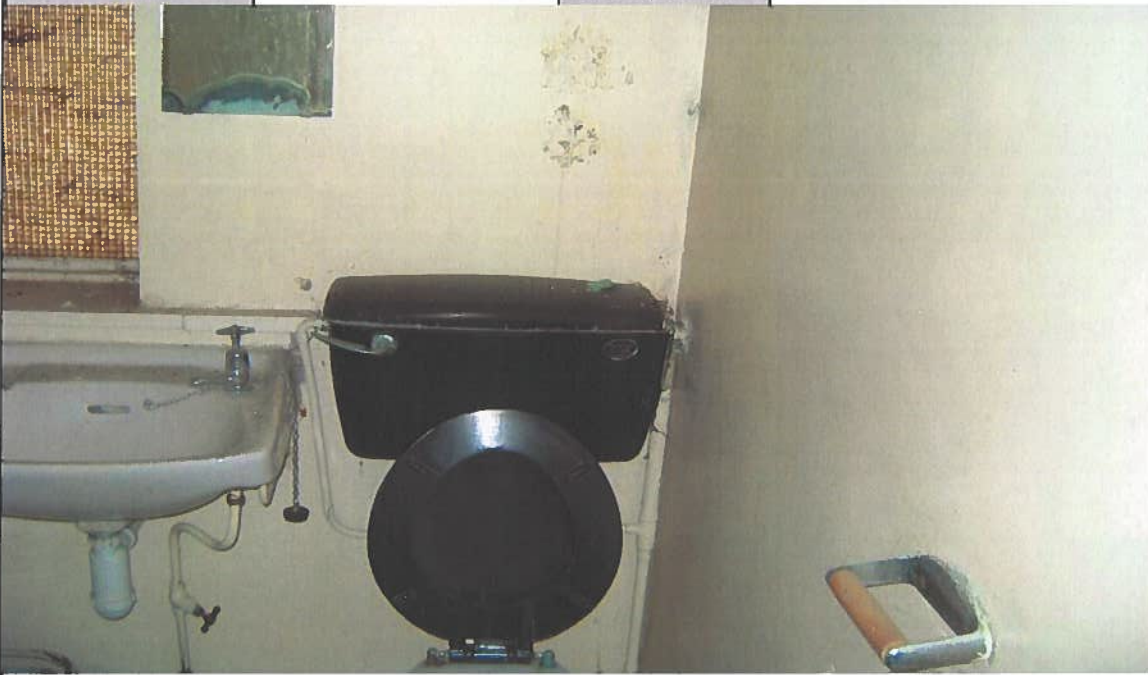
| Photo Number | 9 | Reference number | 220410JK09 |

| Notes | ACM:Asbestos Containing Material | | |

| Building | North Lodge | Condition | Fair | 1 |

| Recommendation | Remove prior to work that will disturb this material | Assessment Score | 6 | |

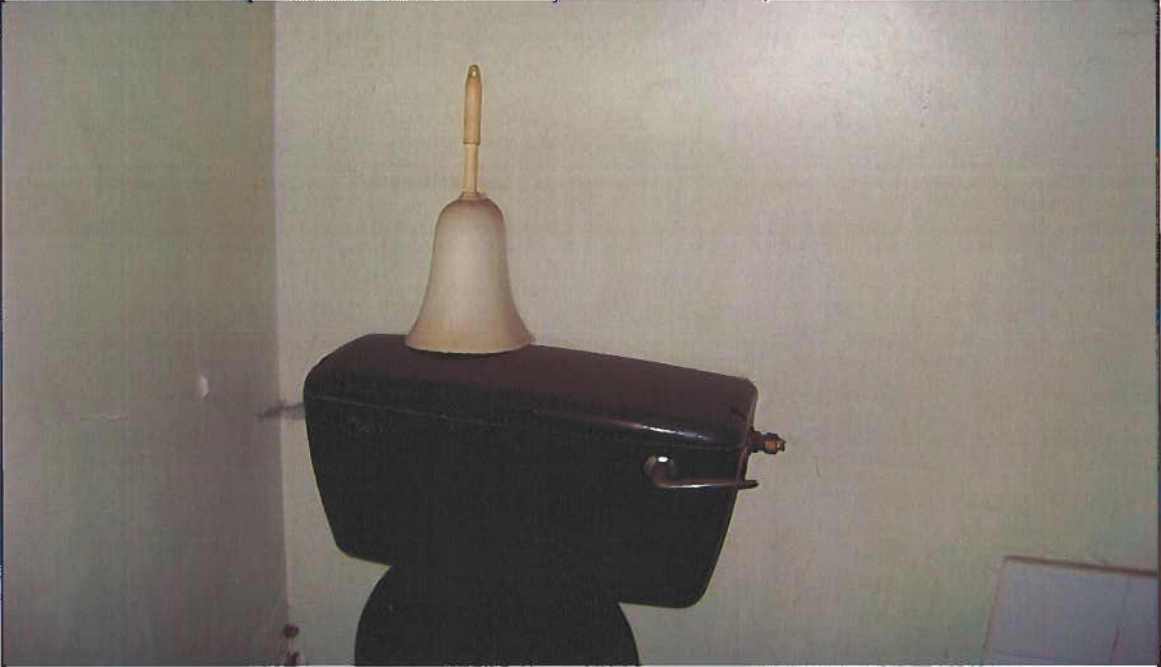
| Photo Number | 10 | Reference number | 220410JK10 |

| Notes | ACM:Asbestos Containing Material | | |

| Building | North Lodge | Condition | Fair | 1 |

| Recommendation | Remove prior to work that will disturb this material | Assessment Score | 6 | |

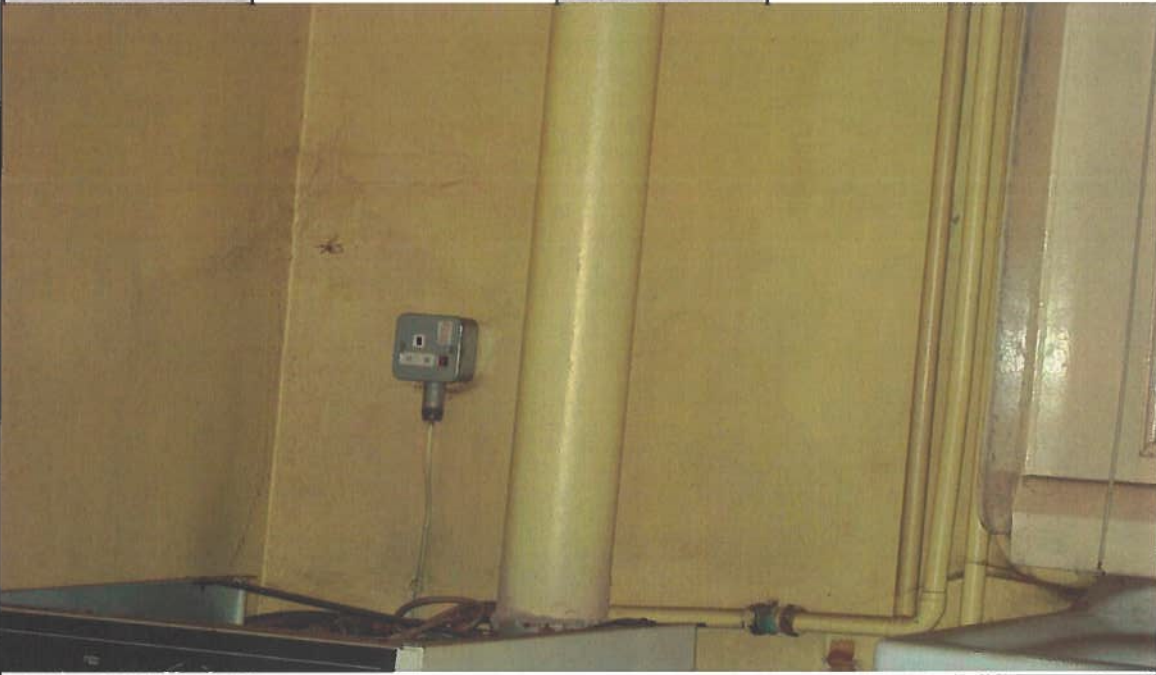
| Photo Number | 11 | Reference number | 220410JK11 |

| Notes | ACM:Asbestos Containing Material | | |

| Building | North Lodge | Condition | Fair | 1 |

| Recommendation | Remove prior to work that will disturb this material | Assessment Score | 5 | |

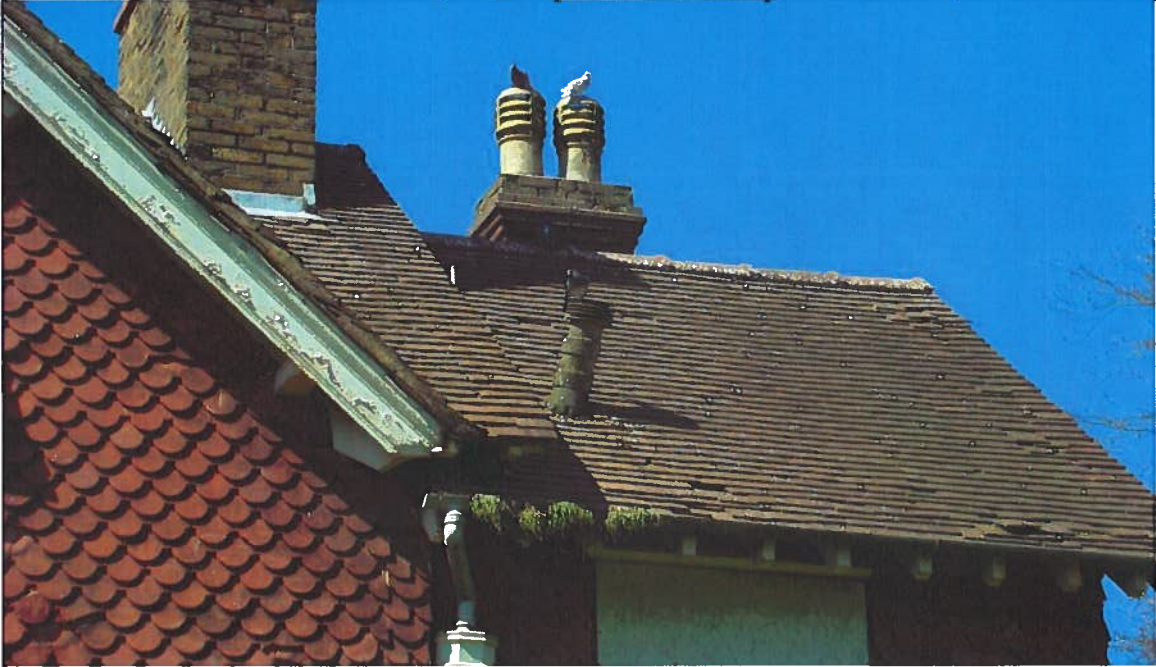
| Photo Number | 12 | Reference number | 220410JK12 |

| Notes | ACM: Asbestos Containing Material | | |

| Building | North Lodge | Condition | Fair | 1 |

| Recommendation | Remove prior to work that will disturb this material | Assessment Score | 6 | |

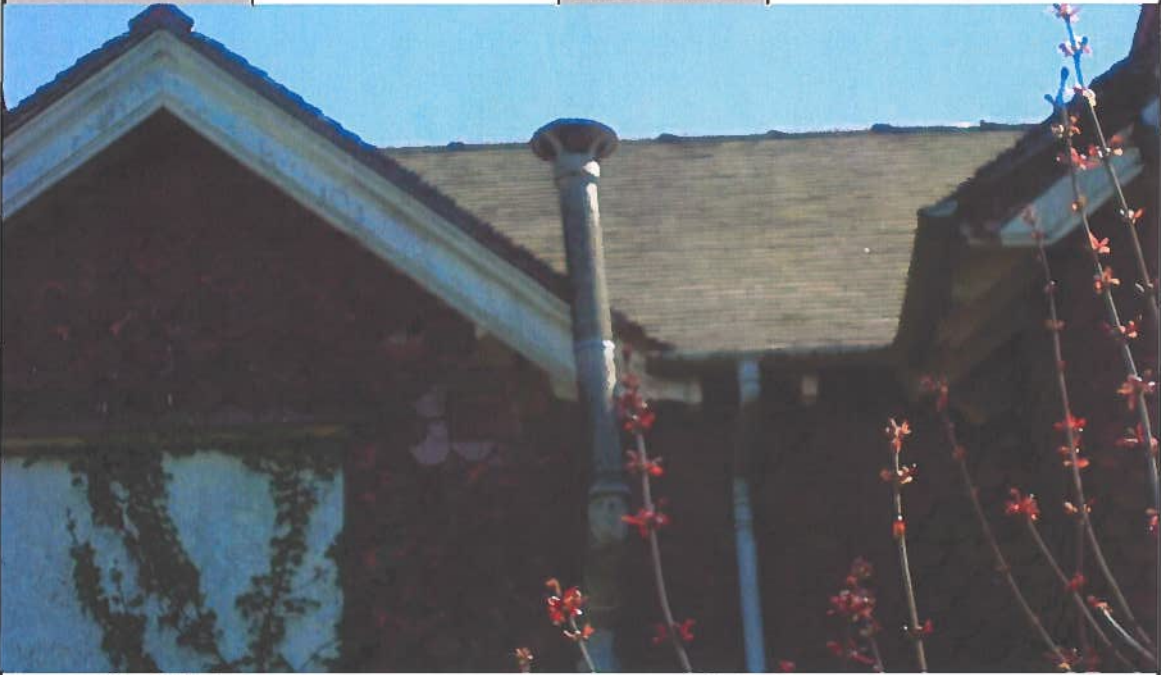
| Photo Number | 13 | Reference number | 220410JK13 |

| Notes | ACM:Asbestos Containing Material | | |

| Building | North Lodge | Condition | Fair | 1 |

| Recommendation | Remove prior to work that will disturb this material | | Assessment Score | 6 |

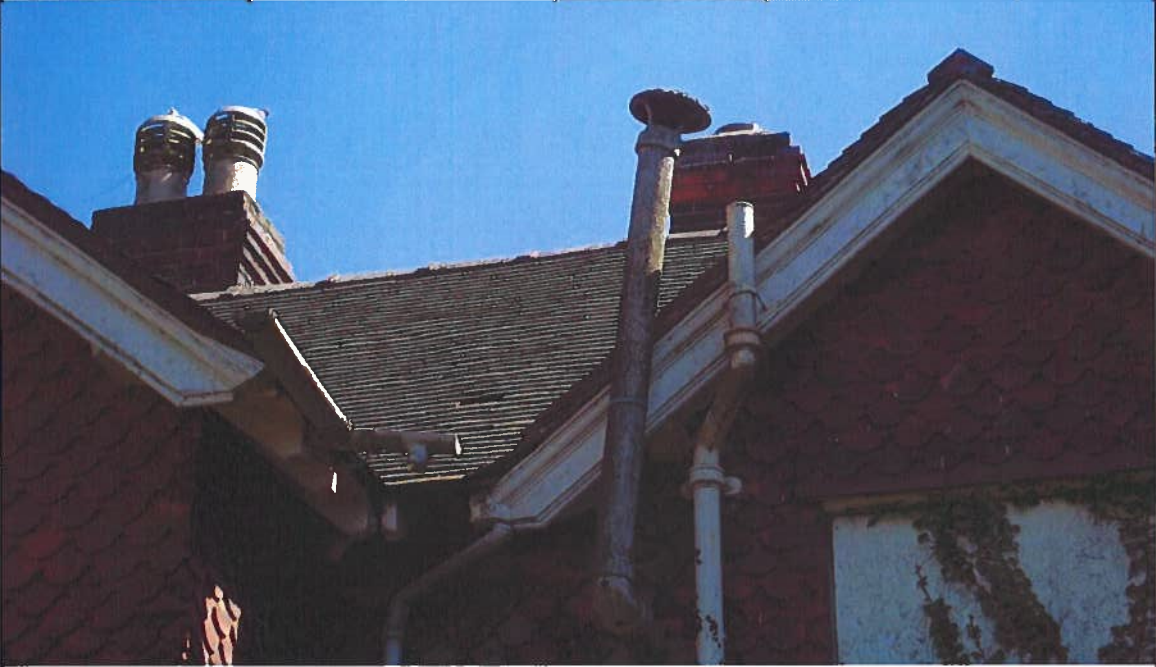
| Photo Number | 14 | Reference number | 220410JK14 |

| Notes | ACM:Asbestos Containing Material | | |

| Building | North Lodge | Condition | Fair | 1 |

| Recommendation | Remove prior to work that will disturb this material | Assessment Score | 6 | |

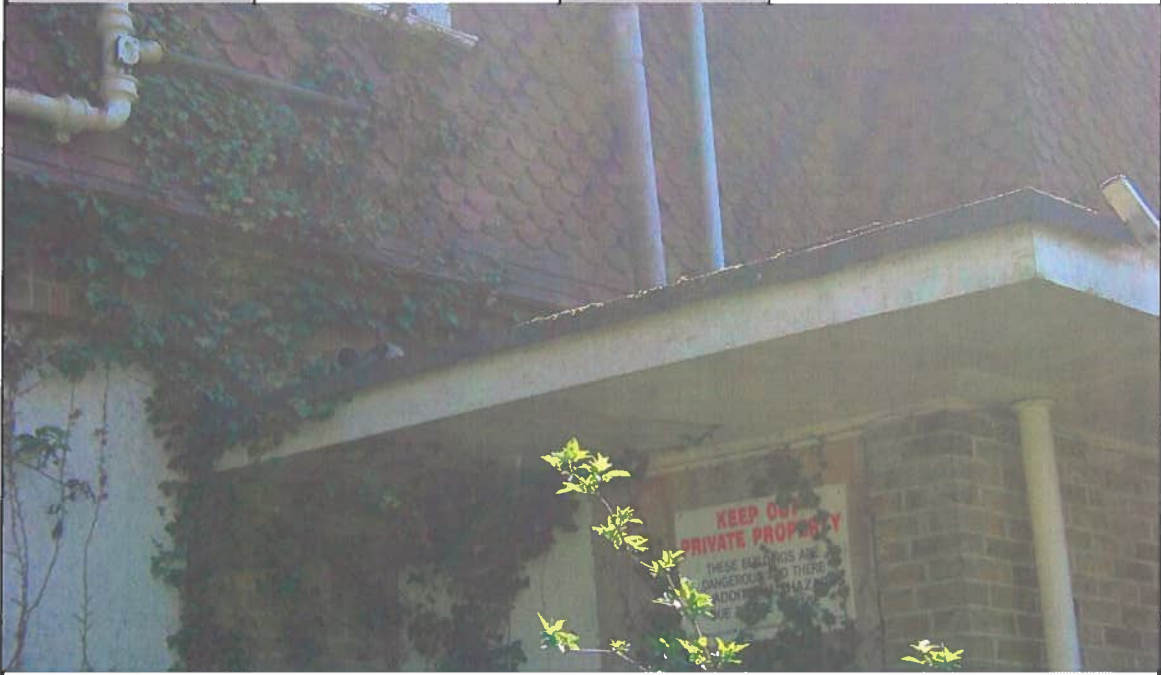
| Photo Number | 15 | Reference number | 220410JK15 |

| Notes | NADIS: No Asbestos Detected In Sample | | |

| Building | North Lodge | Condition | Poor | 4 |

| Recommendation | No further action required | Assessment Score | 0 | |

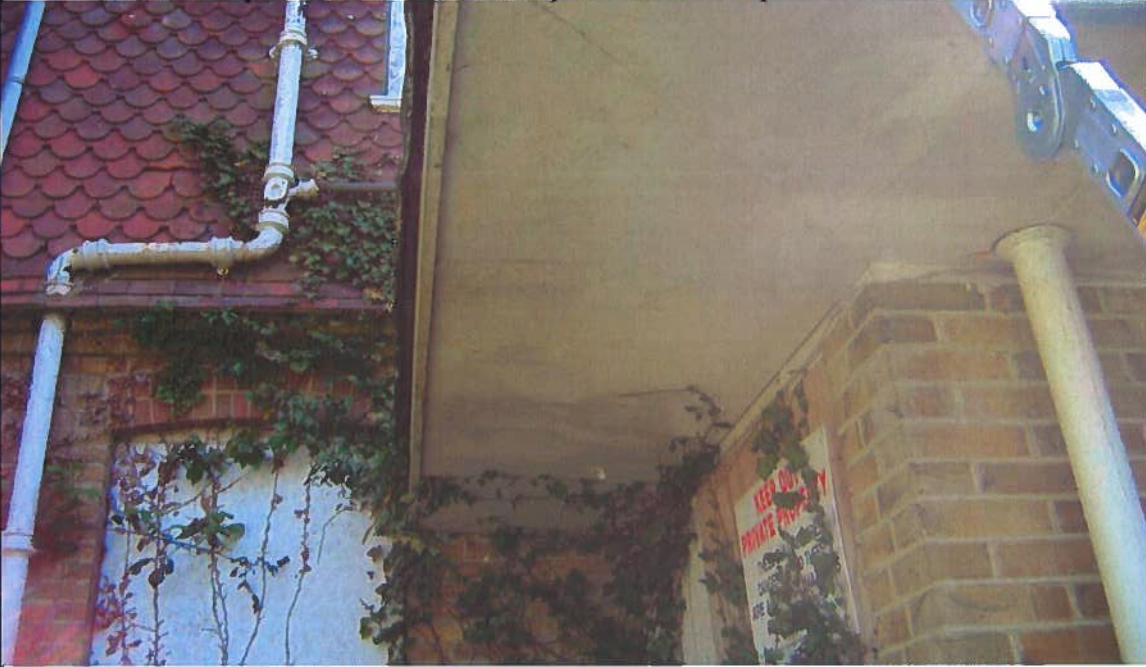
| Photo Number | 16 | Reference number | 220410JK16 |

| Notes | ACM: Asbestos Containing Material | | |

| Building | North Lodge | Condition | Poor | 4 |

| Recommendation | Remove prior to work that will disturb this material | Assessment Score | 9 | |

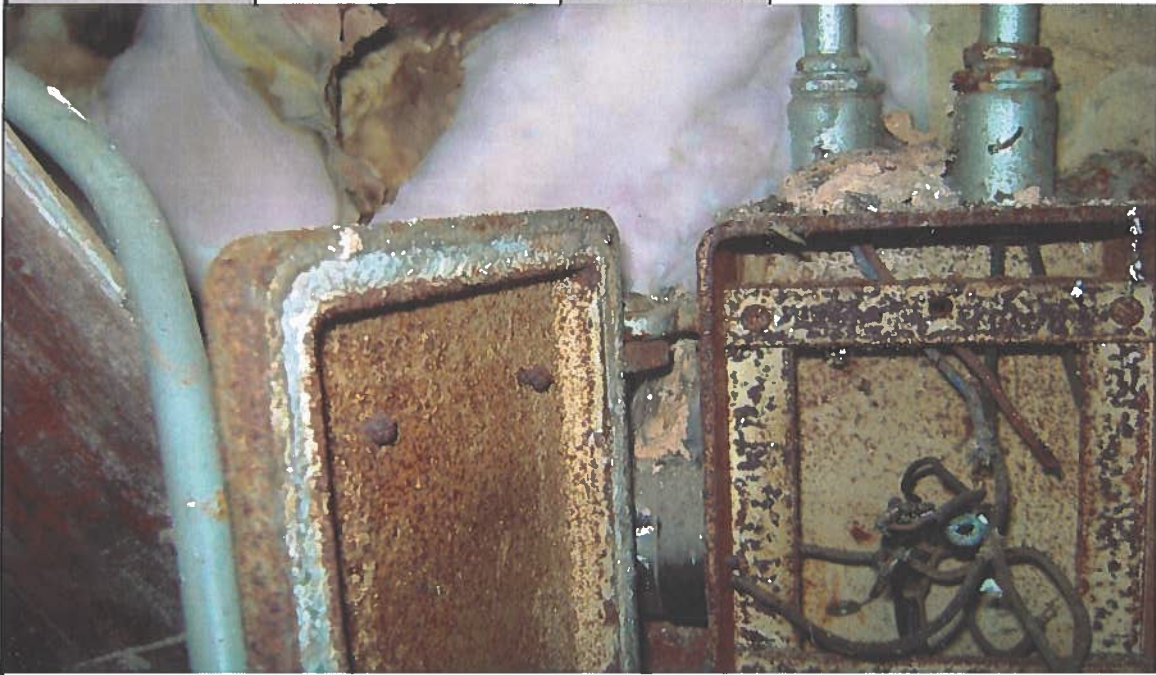
| Photo Number | 17 | Reference number | 220410JK17 |

| Notes | ACM:Asbestos Containing Material | | |

| Building | South lodge | Condition | Fair | 1 |

| Recommendation | Remove prior to work that will disturb this material | Assessment Score | 10 | |

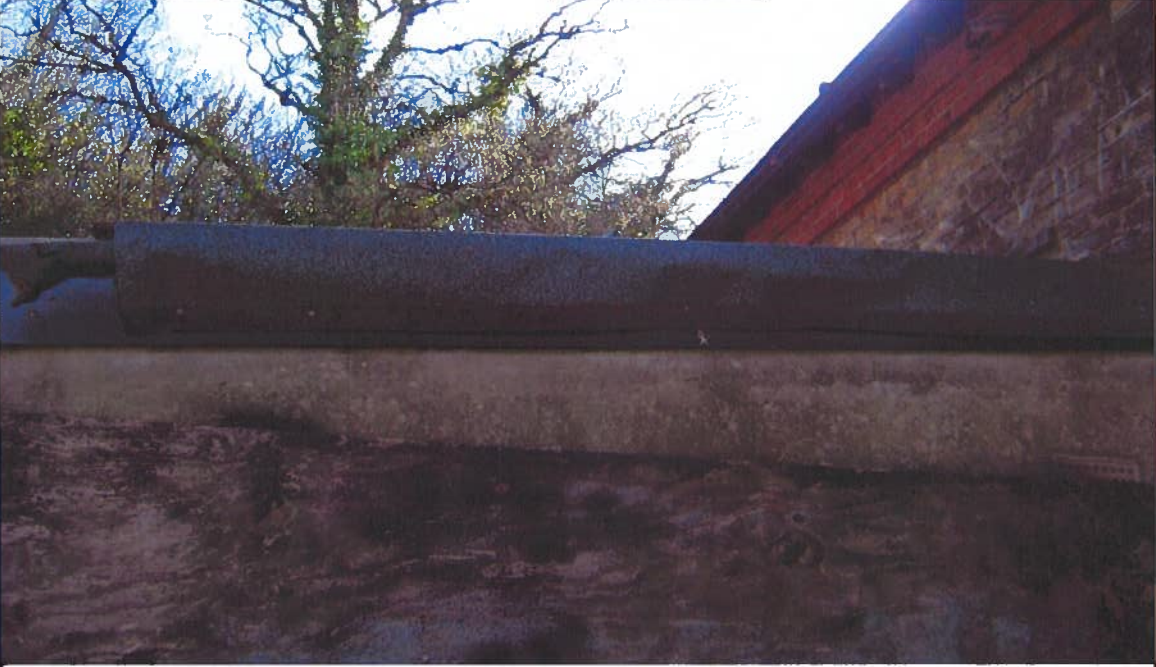
| Photo Number | 18 | Reference number | 220410JK18 |

| Notes | NADIS: No Asbestos Detected In Sample | | |

| Building | South lodge | Condition | Poor | 4 |

| Recommendation | No further action required | Assessment Score | 0 | |

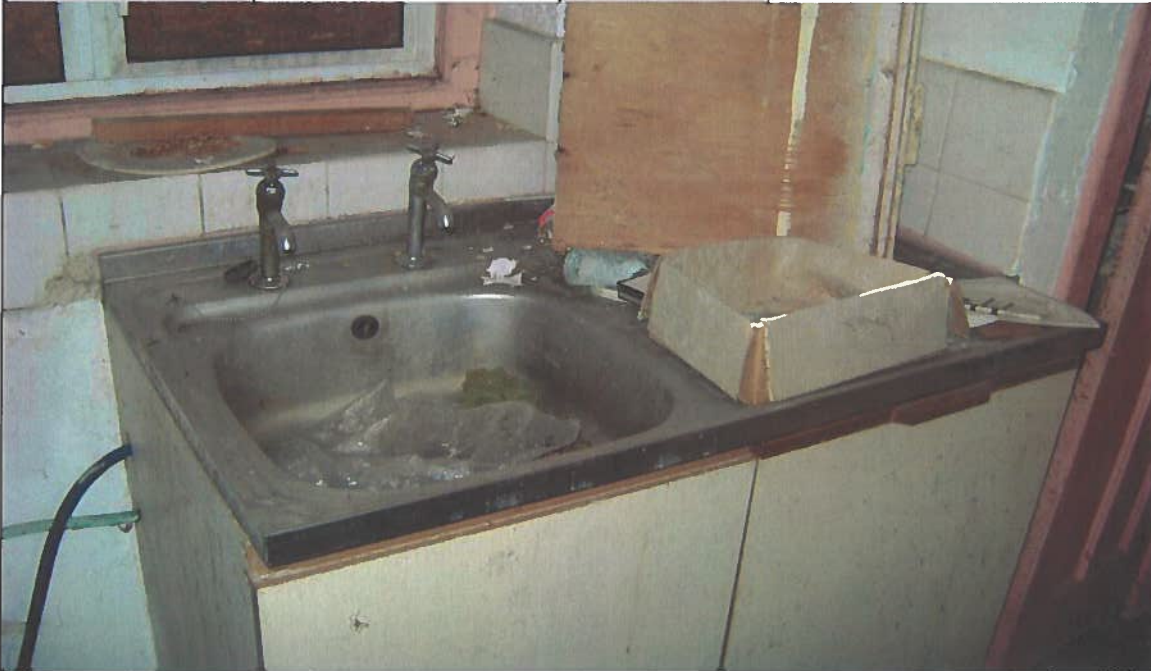
| Photo Number | 19 | Reference number | 230410JK19 |

| Notes | ACM: Asbestos Containing Material | | |

| Building | Meadow Lodge | Condition | Fair | 1 |

| Recommendation | Remove prior to work that will disturb this material | Assessment Score | 5 | |

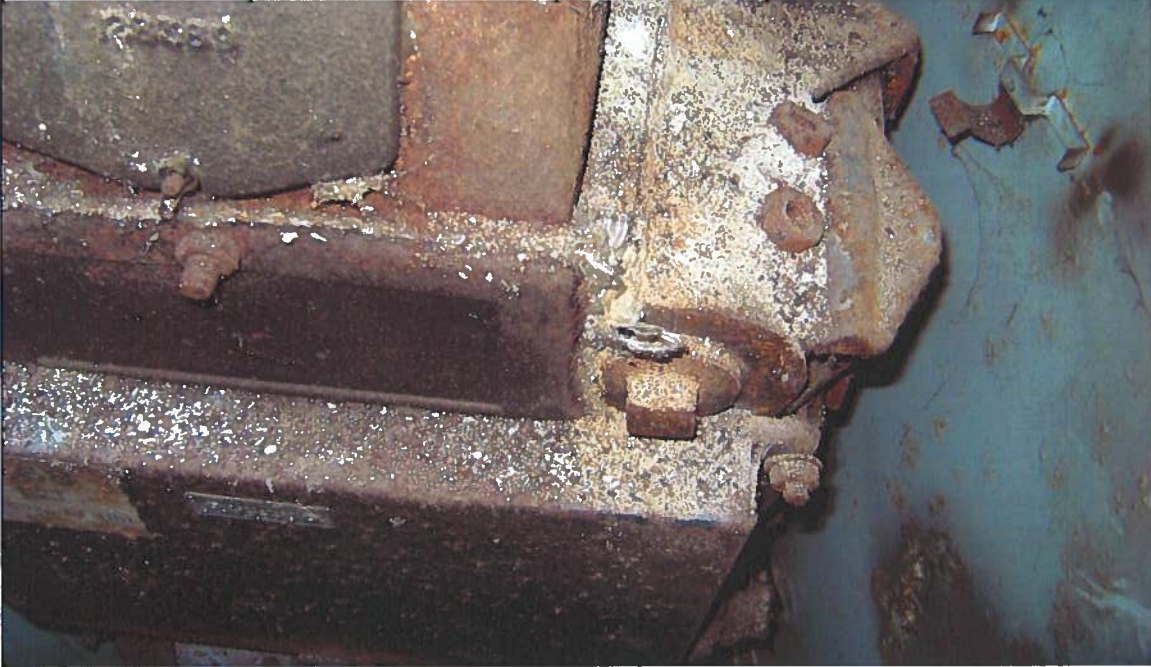
| Photo Number | 20 | Reference number | 230410JK20 |

| Notes | NADIS: No Asbestos Detected In Sample | | |

| Building | Meadow Lodge | Condition | Poor | 4 |

| Recommendation | No further action required | Assessment Score | 0 | |

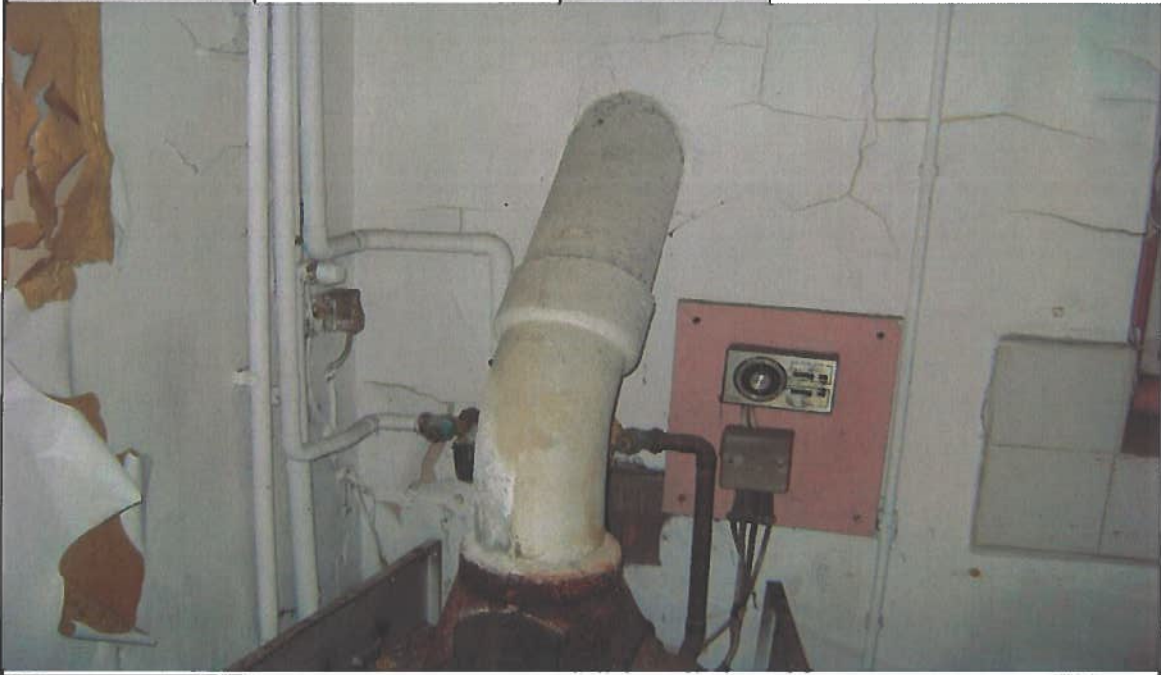
| Photo Number | 21 | Reference number | 230410JK21 |

| Notes | ACM:Asbestos Containing Material | | |

| Building | Meadow Lodge | Condition | Fair | 1 |

| Recommendation | Remove prior to work that will disturb this material | Assessment Score | 9 | |

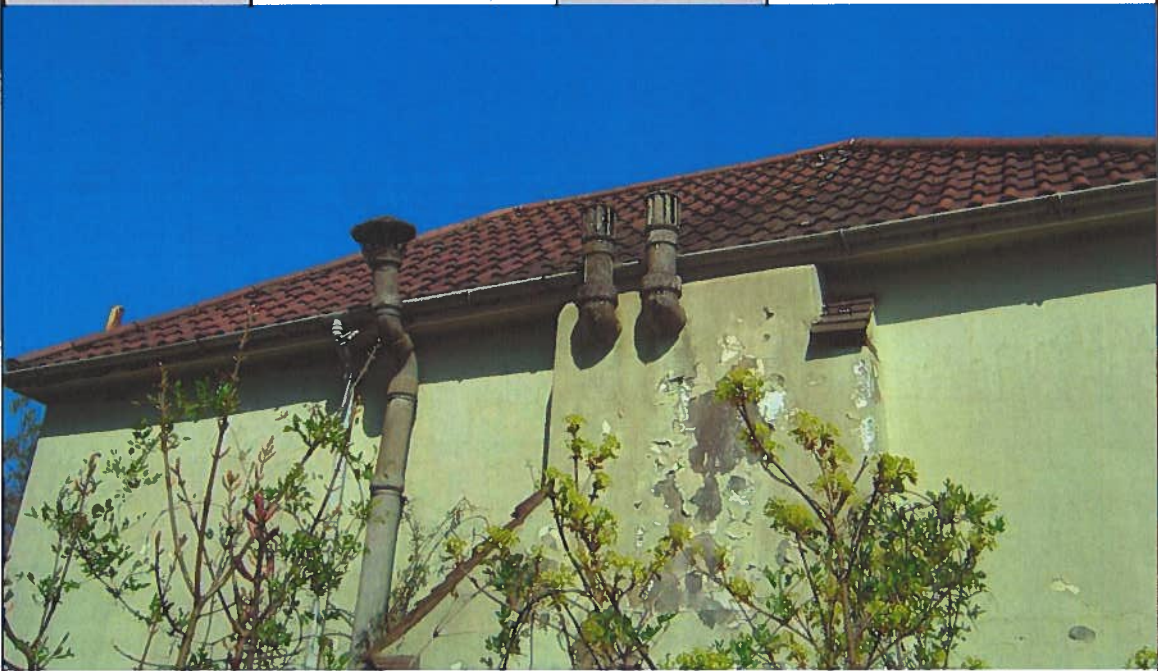
| Photo Number | 22 | Reference number | 230410JK22 |

| Notes | ACM:Asbestos Containing Material | | |

| Building | Meadow Lodge | Condition | Fair | 1 |

| Recommendation | Remove prior to work that will disturb this material | Assessment Score | 8 | |
