# Outline Condition Survey Report

## CAPITA SYMONDS

### Cane Hill Hospital – Building 5

File No: CS/022329  
Date of Inspection: 2<sup>nd</sup> November 2006

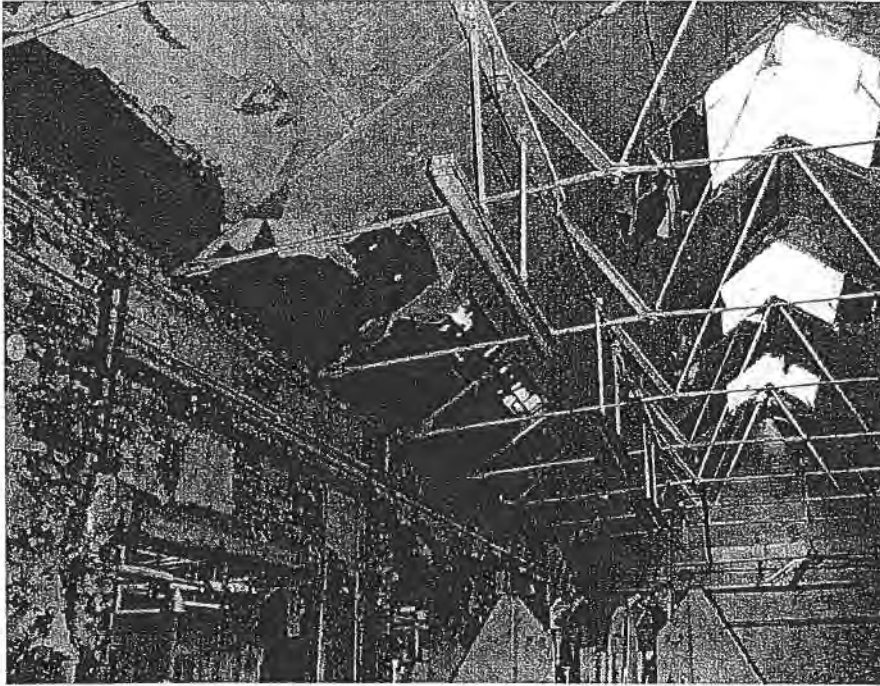
04 Interior of area 13A

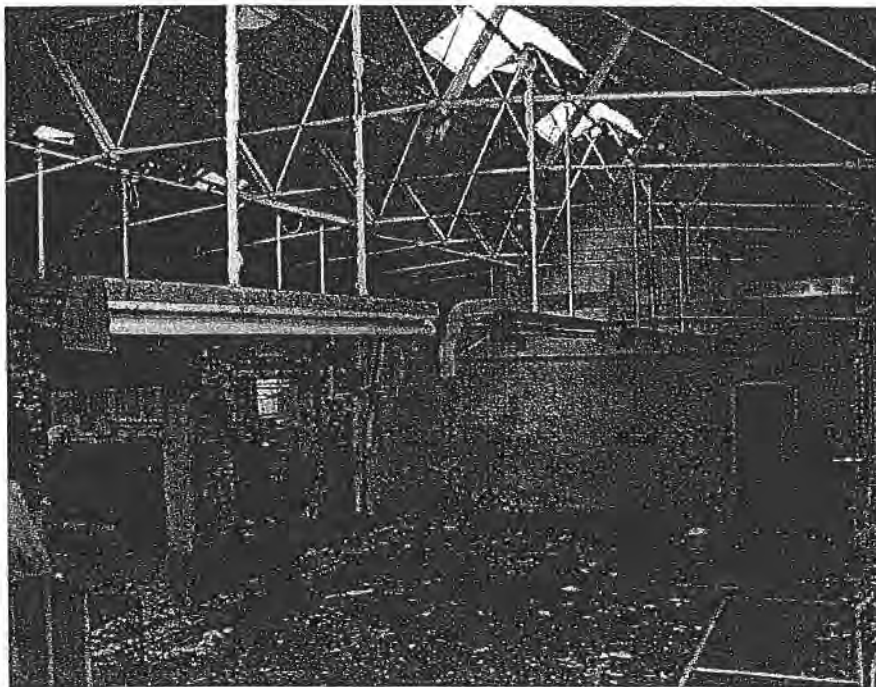
05 Typical condition of walls within 13A

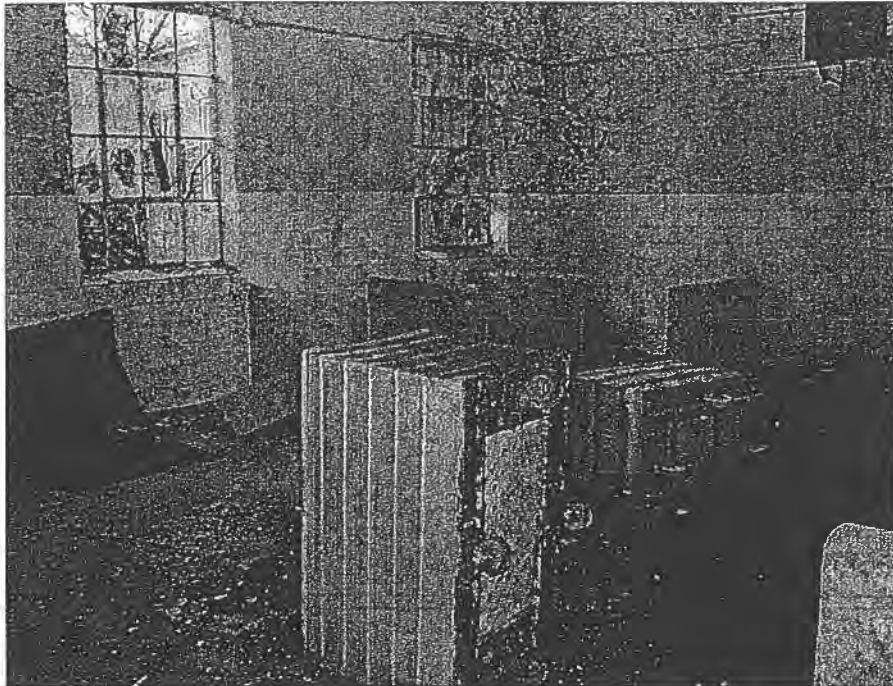
06 Typical condition of rooms within 13A

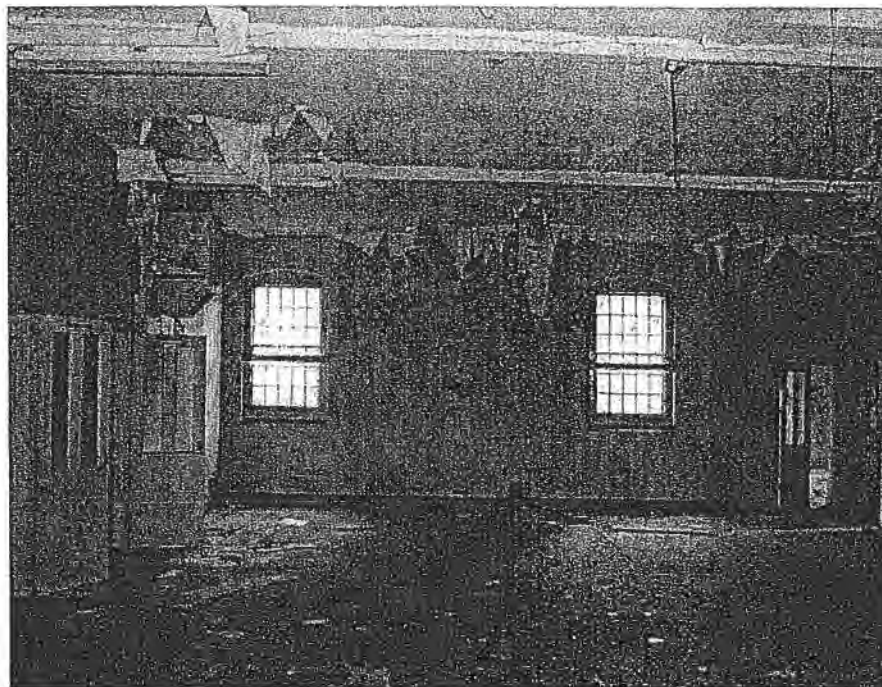
05 Condition within 14A

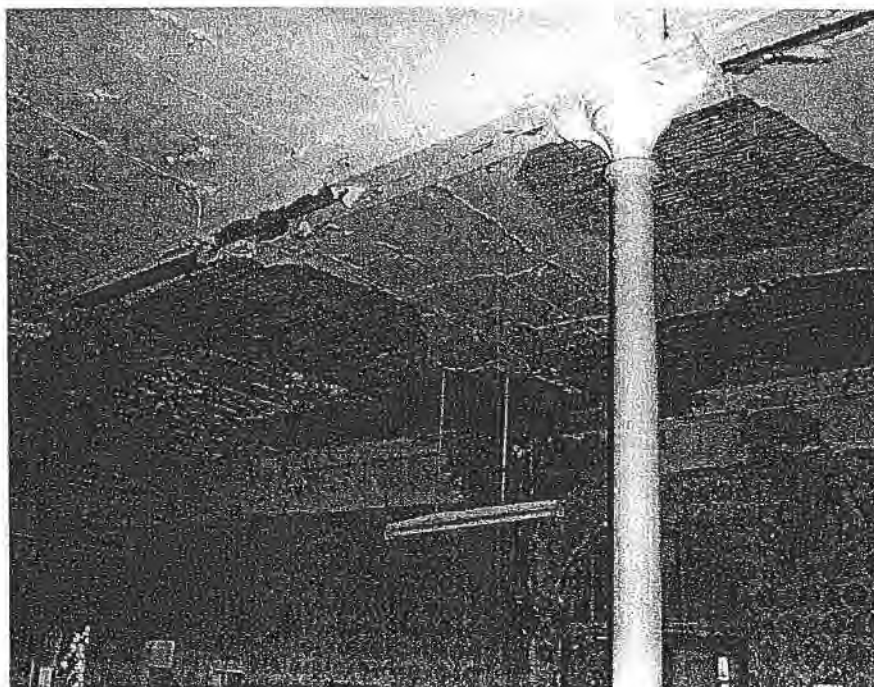
06 Failure of ceiling in 14A

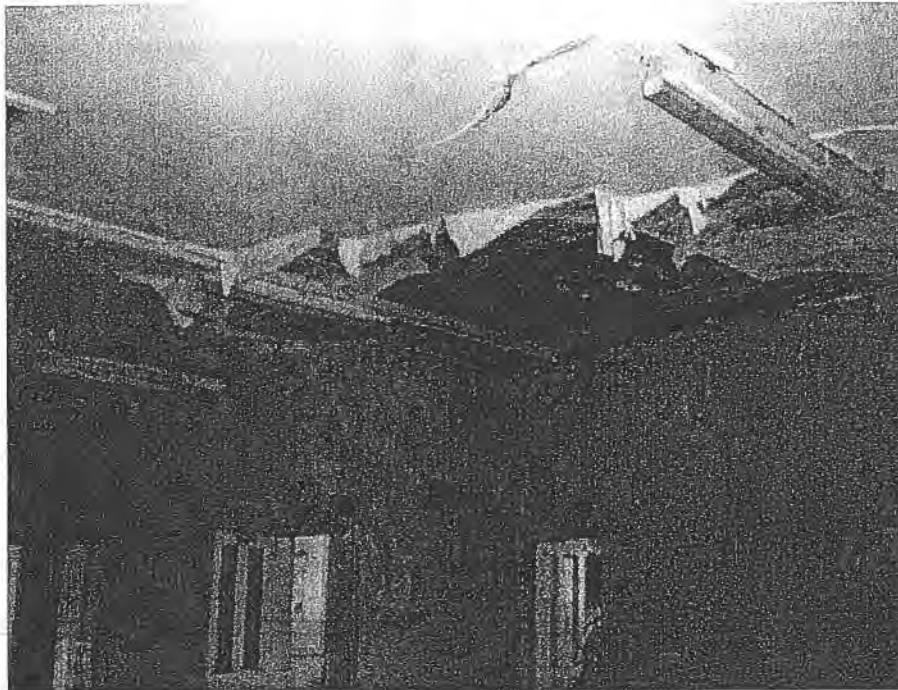
07 Water ingress through ceilings in 14A

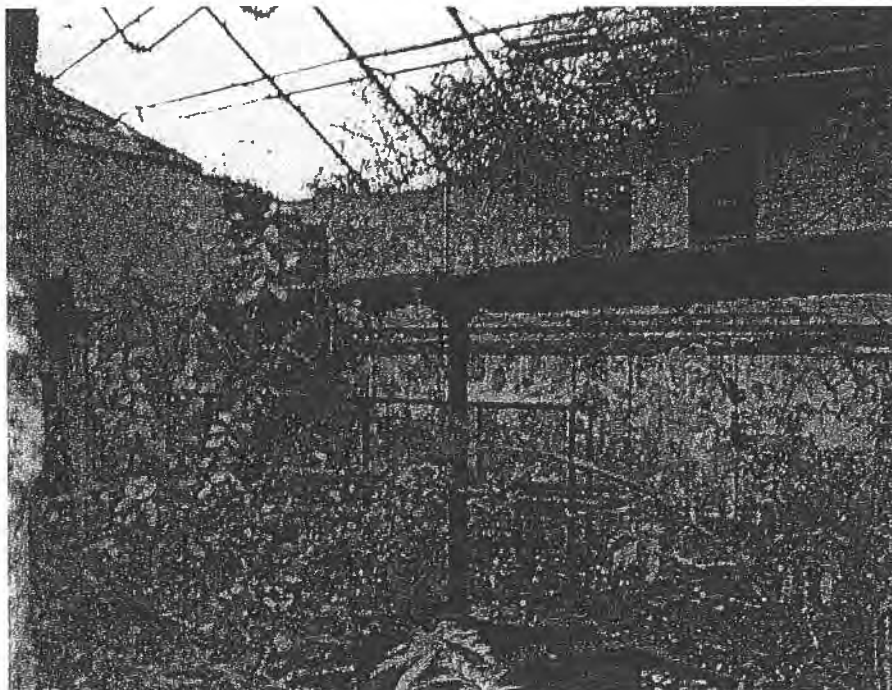
08 Fire damage to 14B

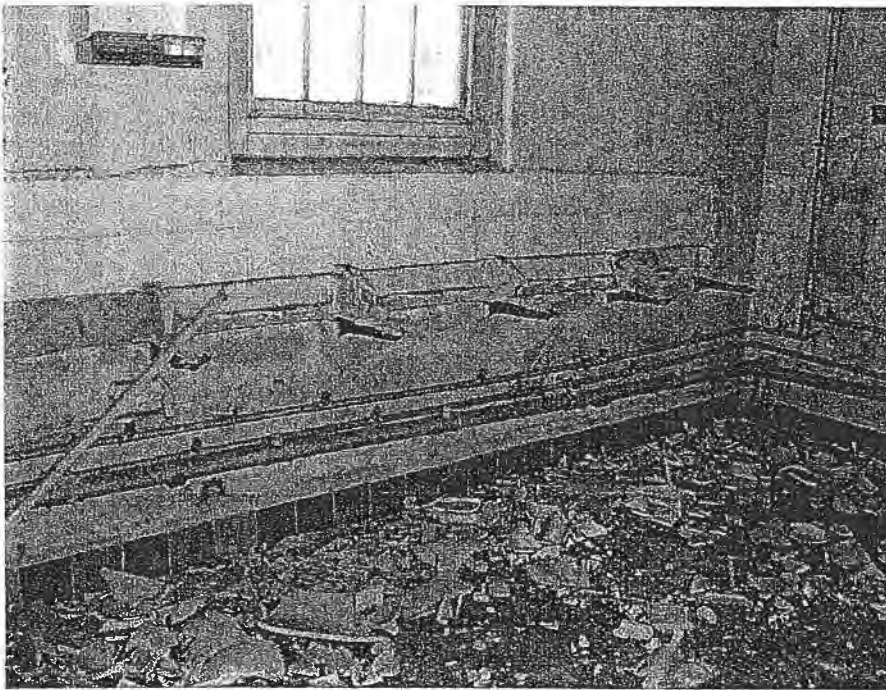
05 smashed sanitary ware on 1st floor

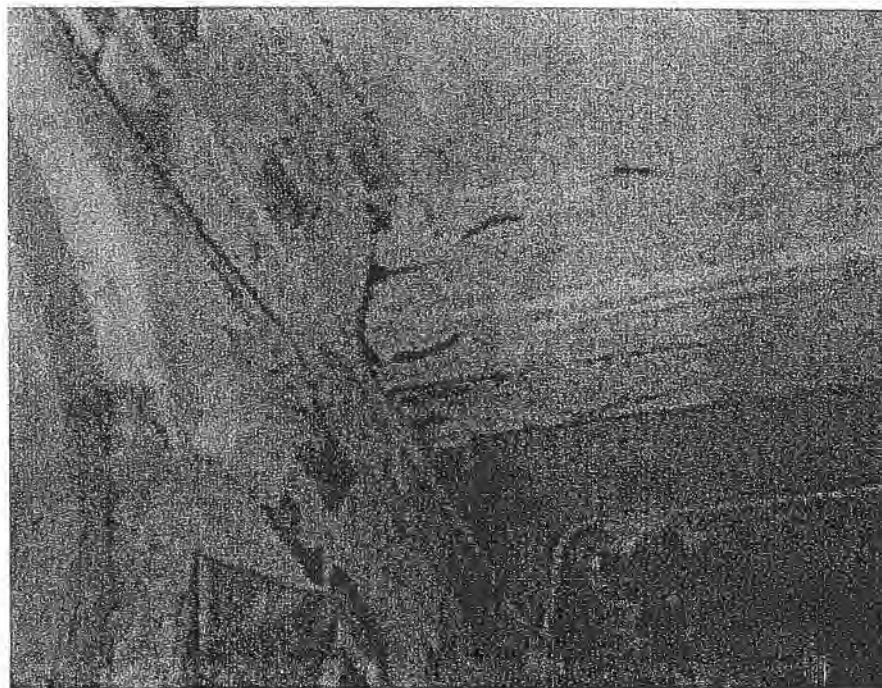
09 Rot decay to end of timber beam

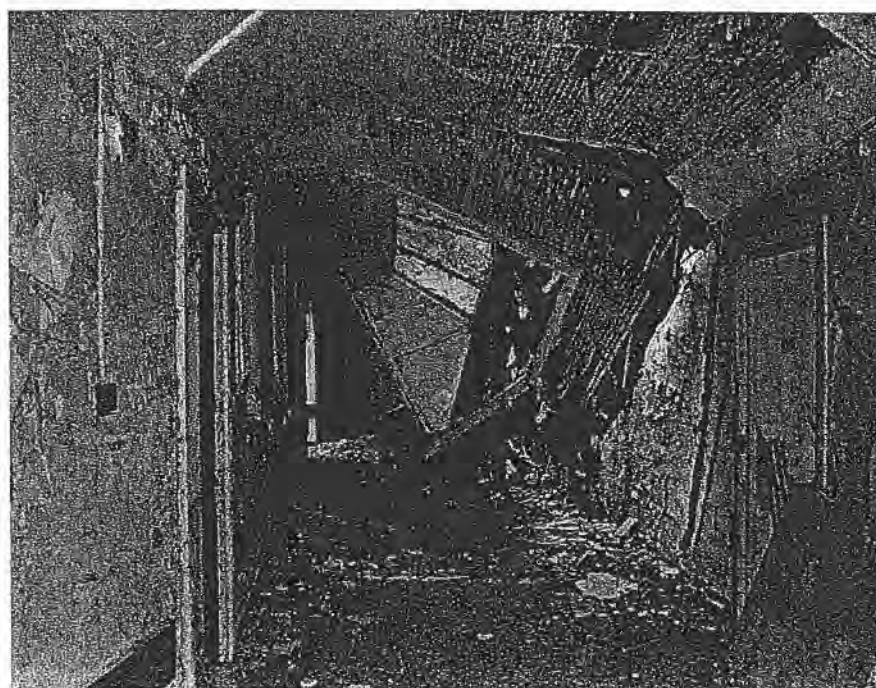
10 Collapse of roof structure to corridor

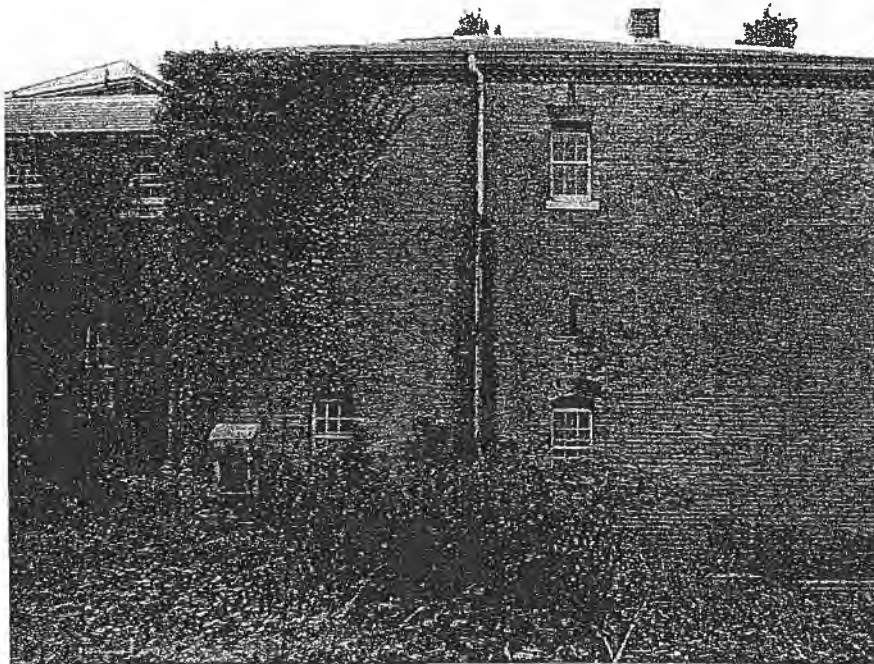
06 Damaged rainwater goods rear additon of 16B

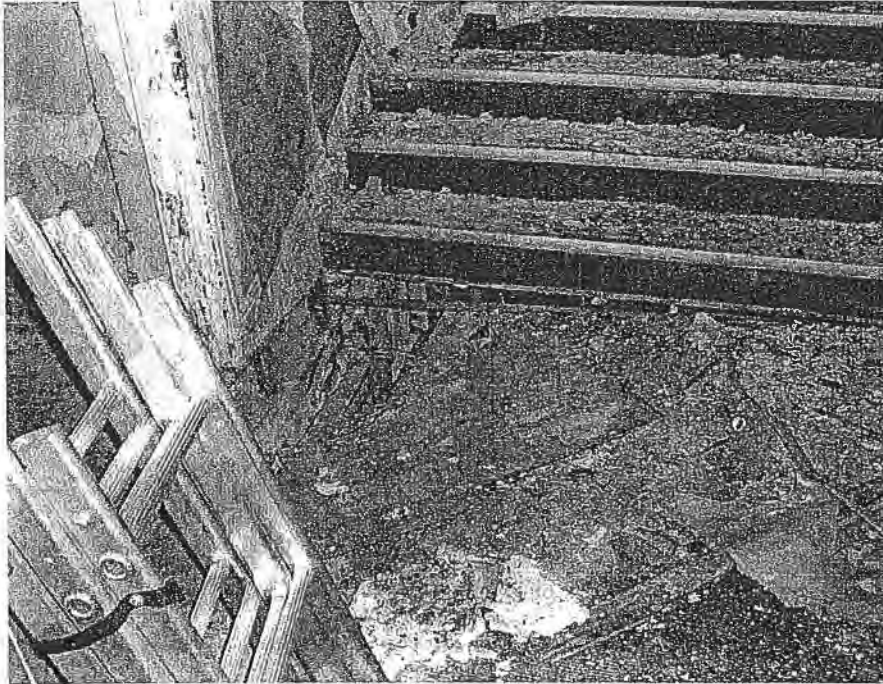
09 Decay to floor due to water ingress

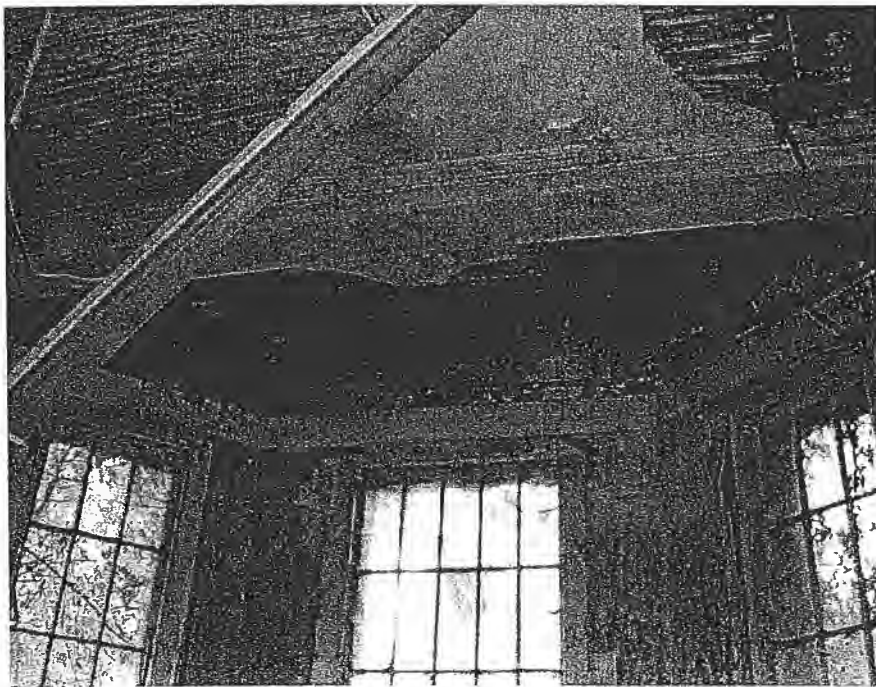
10 Damage to ceiling and walls below bay roof

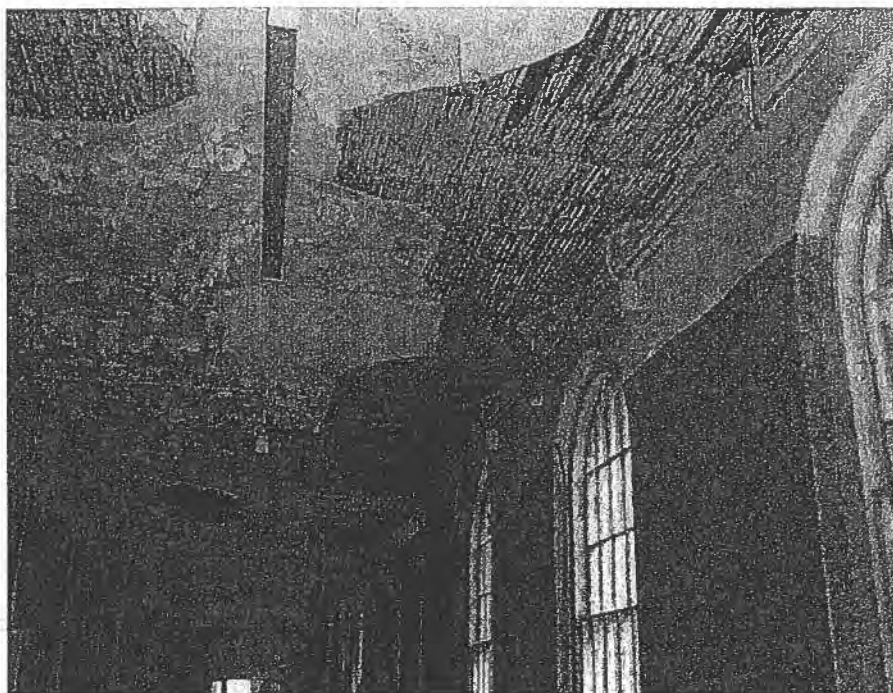
11 Damage to ceilings due to water ingress

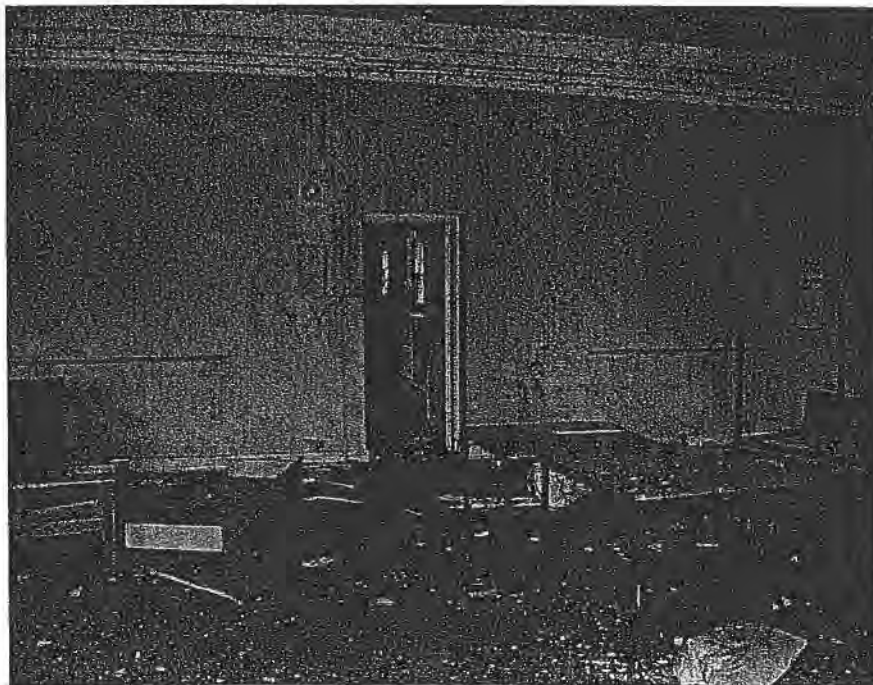
14 General condition of room within 16B

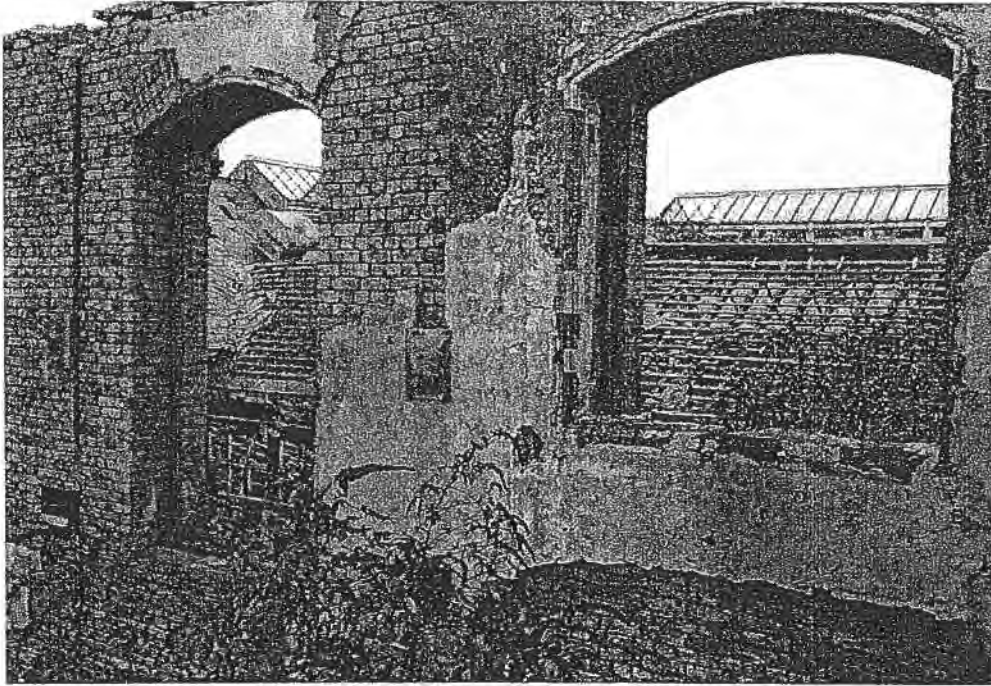
03. Fire damage to Building 18

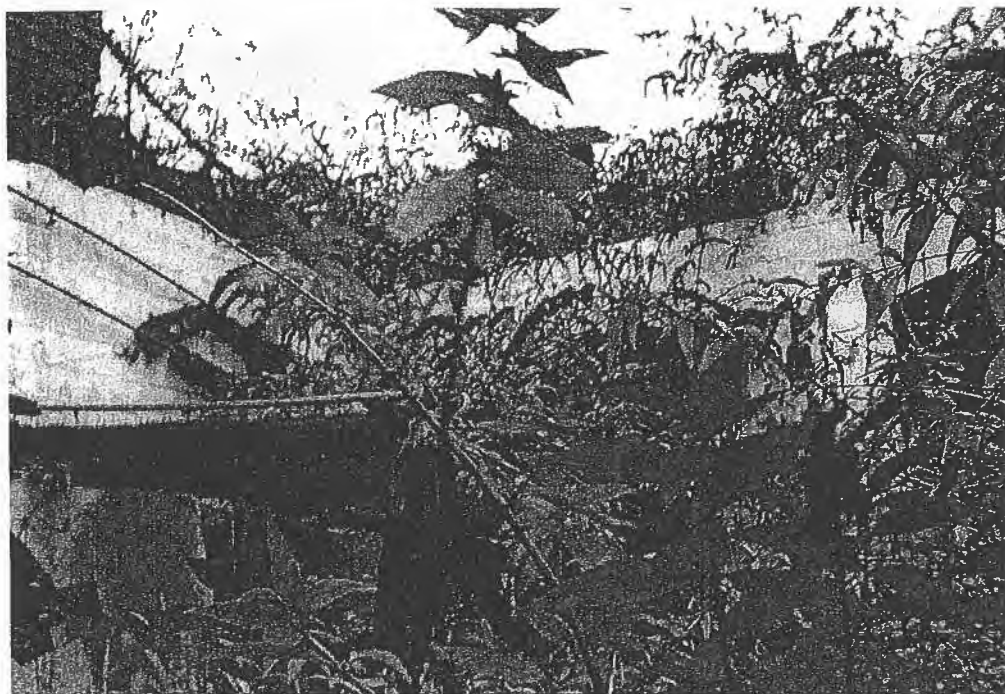
06. Fire damaged internal floors

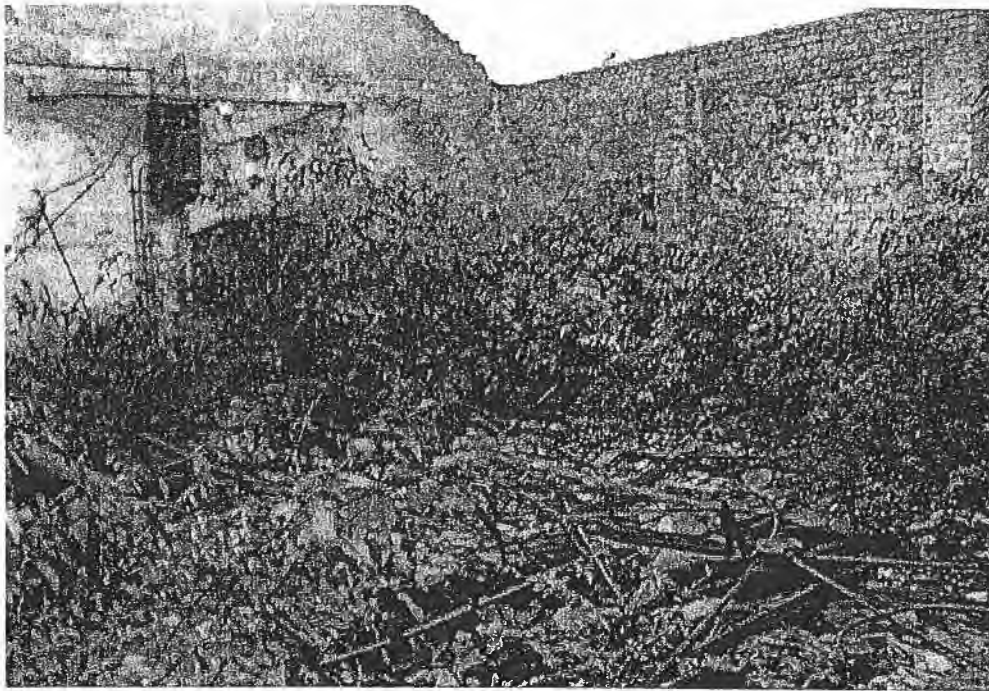
07. Collapsed internal floors

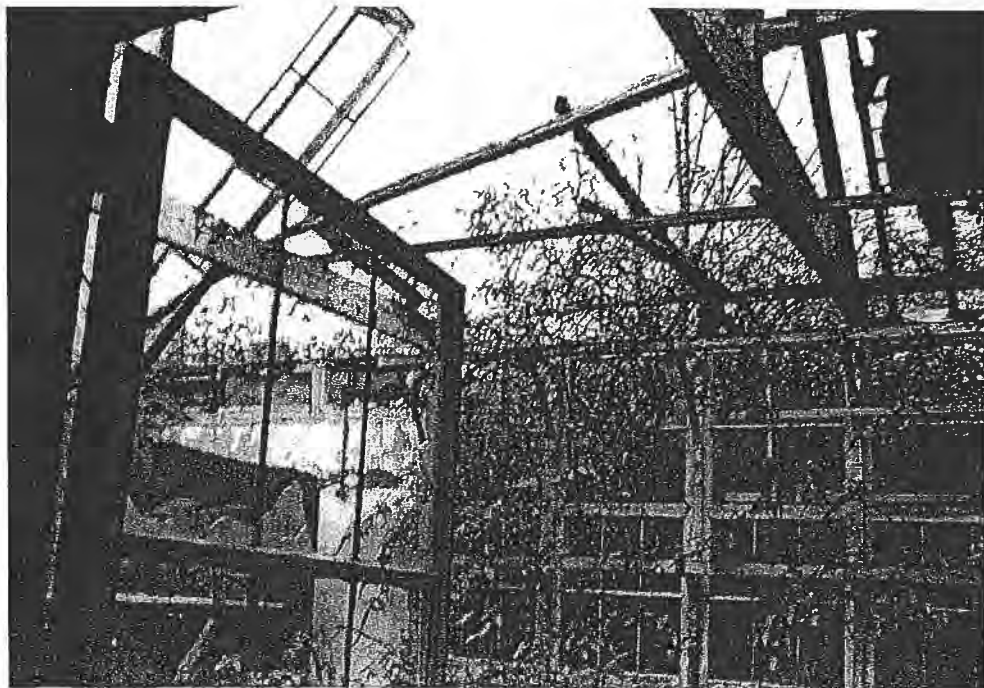
08. Fire damaged corridor

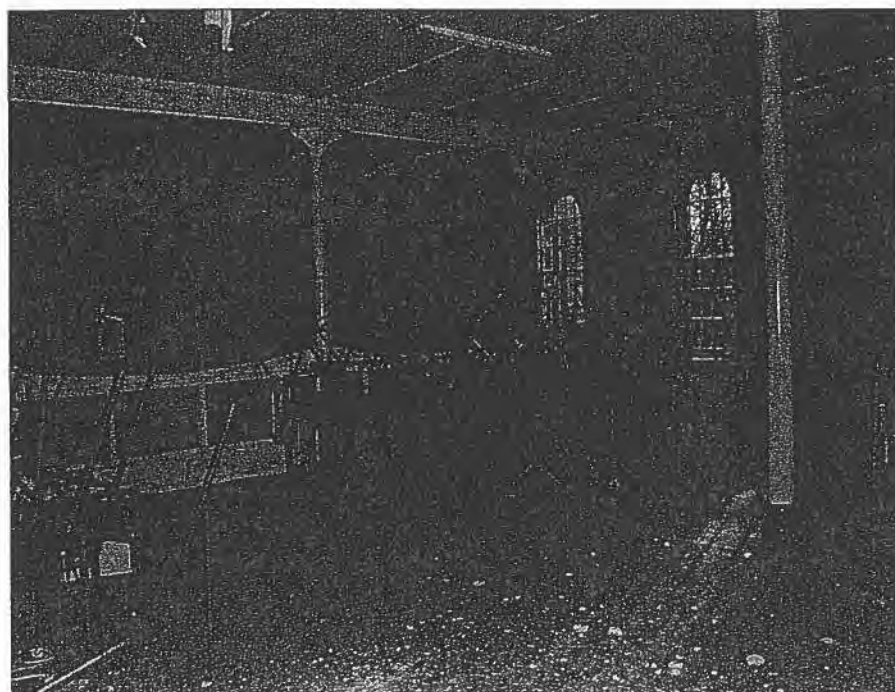
06. Deterioration to ceiling finishes

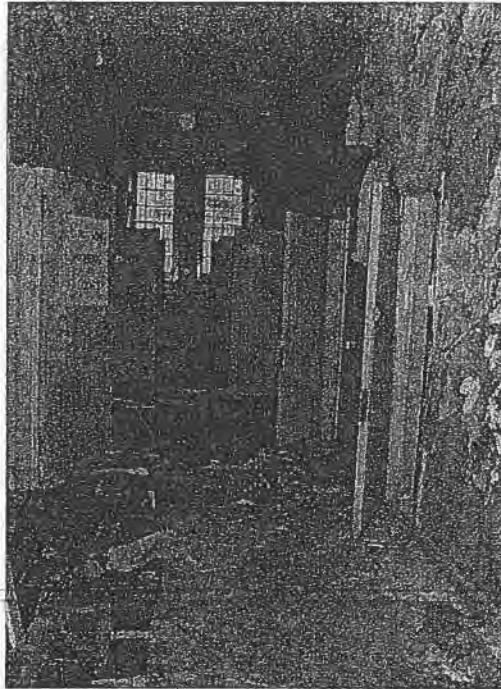
09 Condition of Grd floor rear addition to 20B

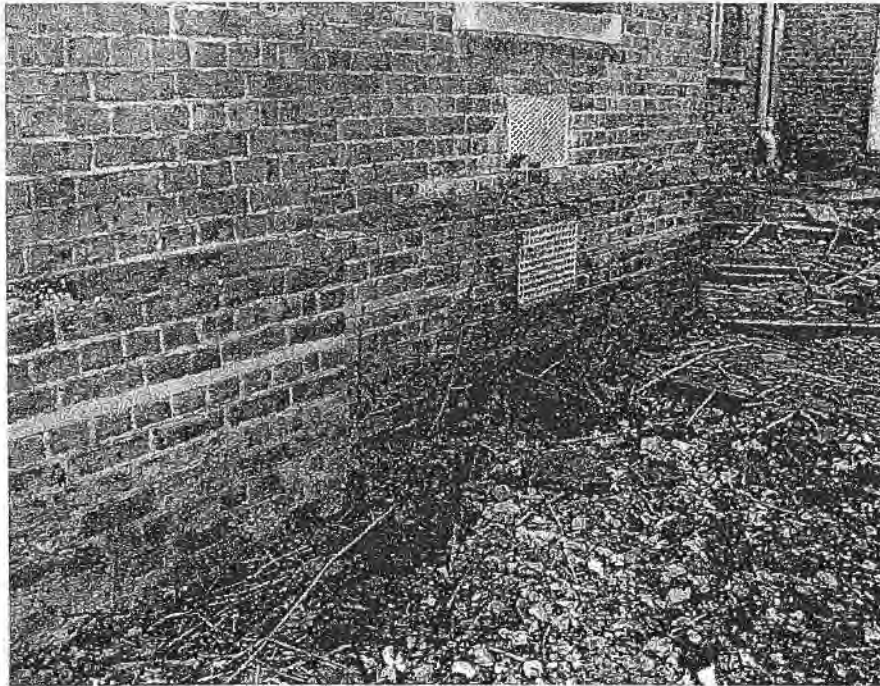
11 Spalling brickwork to 20B

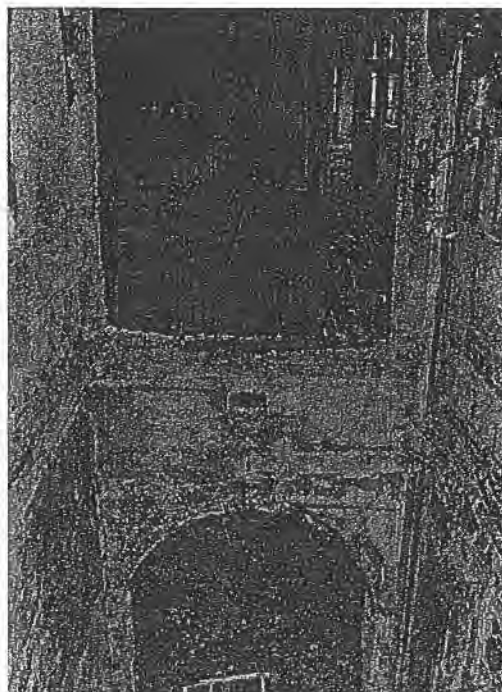
04 Fire damage within 21A

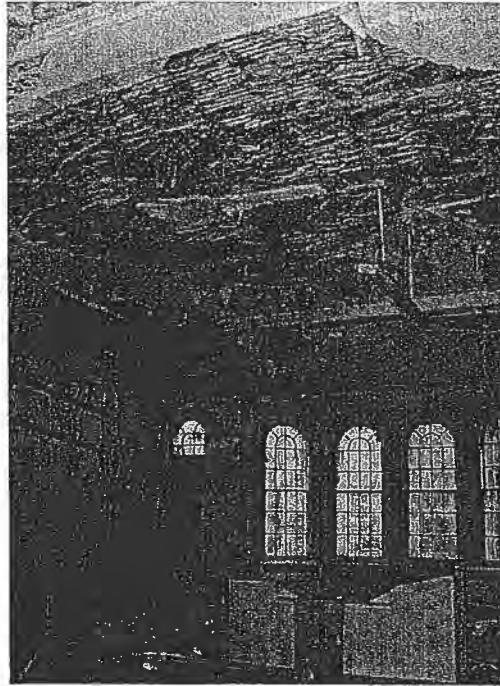
05 Failure of ceilings within 21A

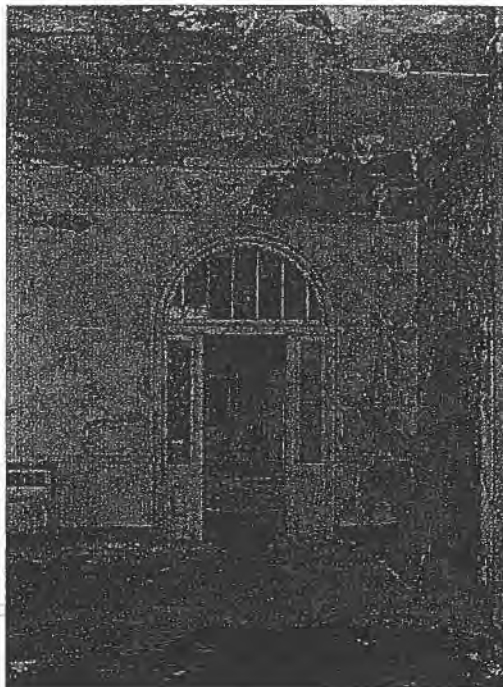
07 Damage to ground floor ceilings in 21A

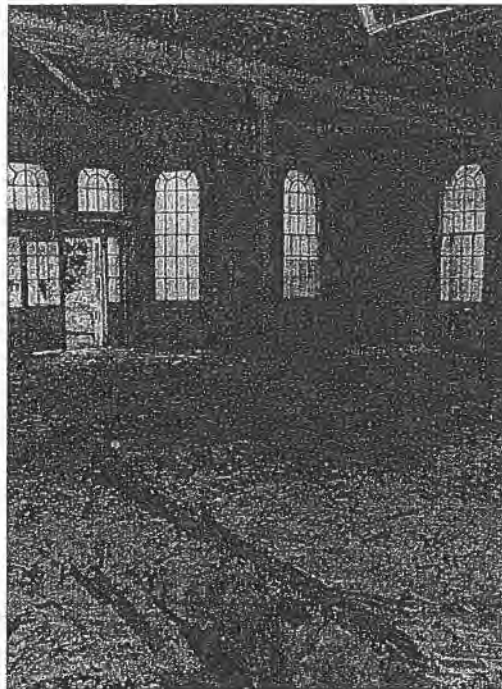
11 Failed 1st flr ceiling due to water ingress

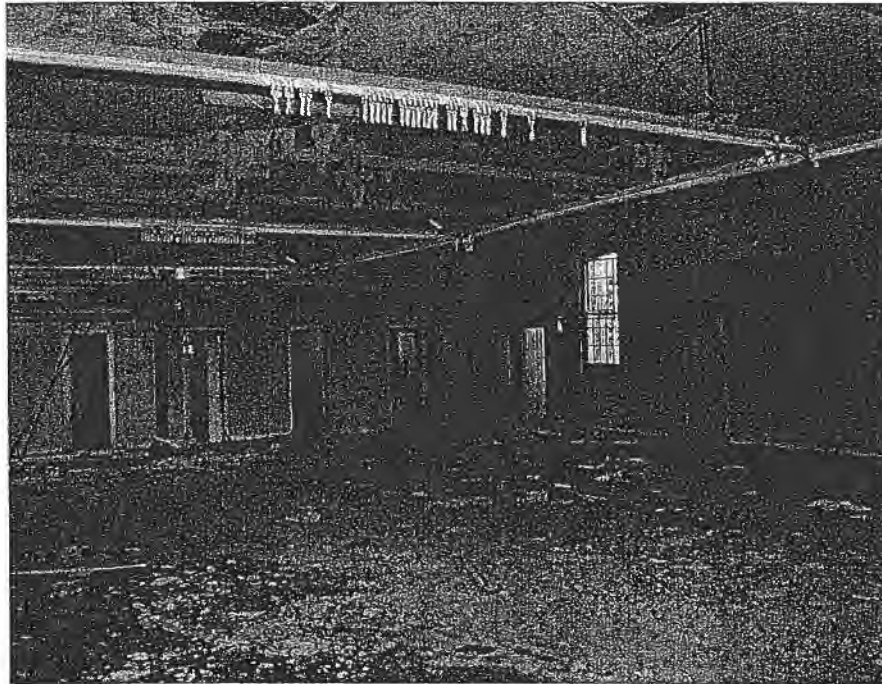
03. Deteriorated ceiling

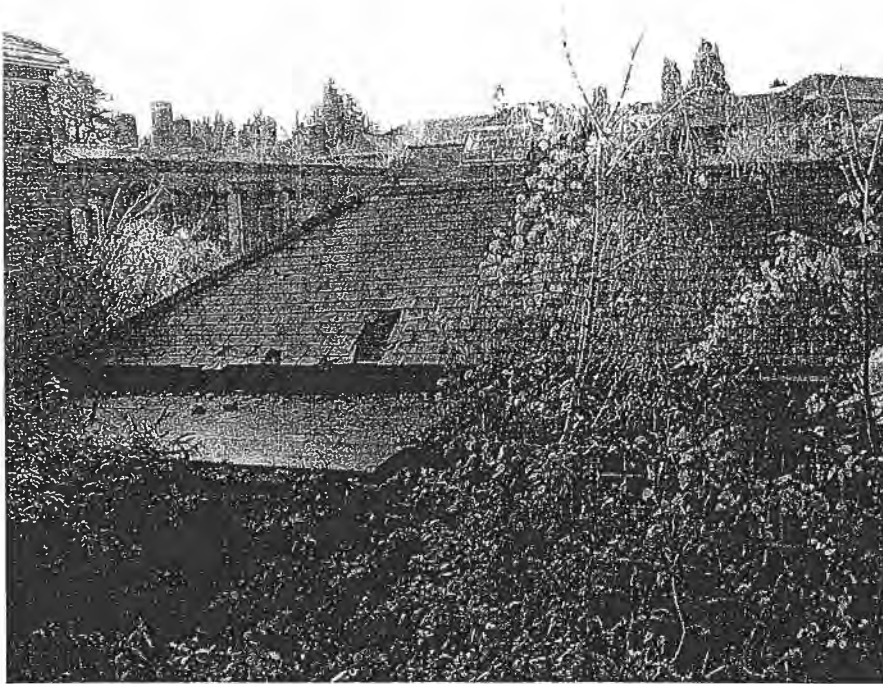
03. Deterioration to roof coverings

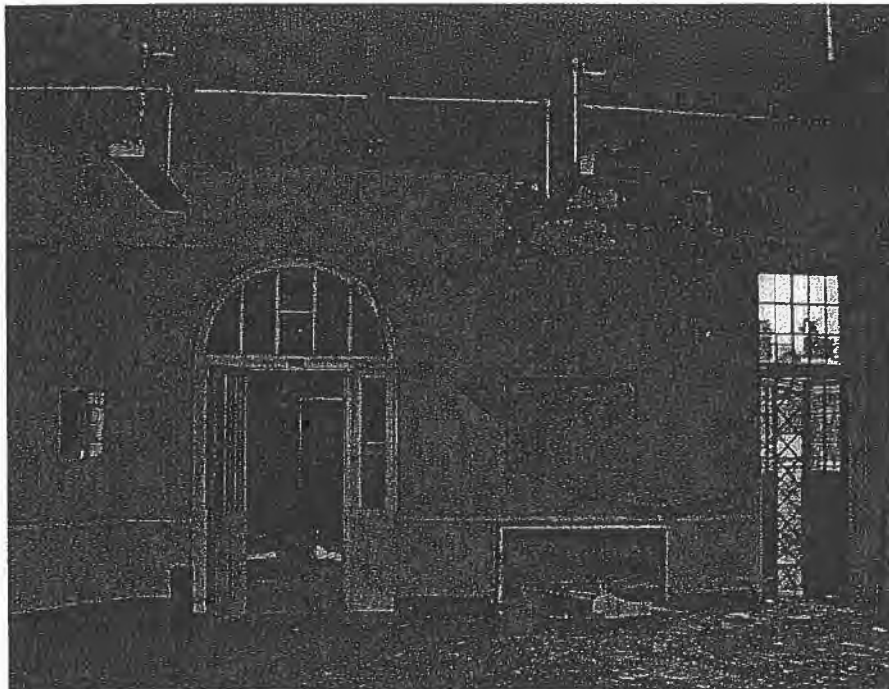
06 Damage to Ceiling

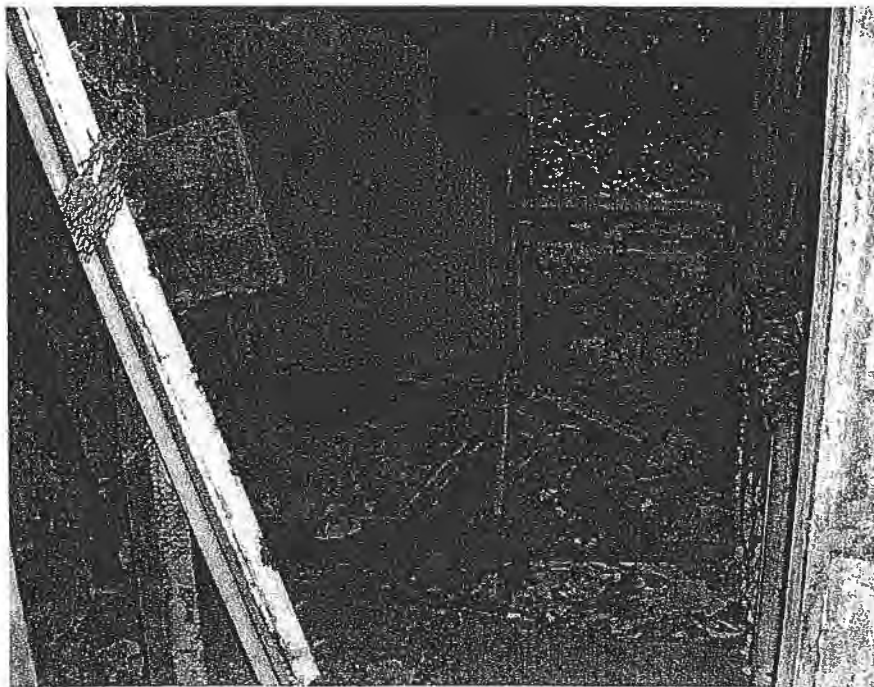
08 Damage to Ground Floor

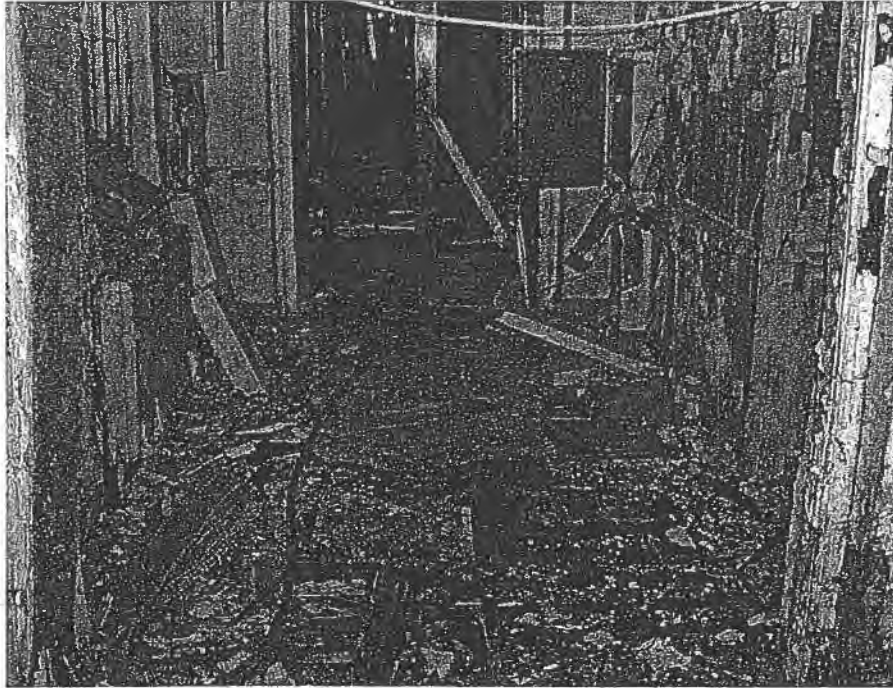
09 Floors to Link Corridor
