17 November 2006

Outline Condition Survey Report  
Cane Hill Hospital – Building 24

## **Outline Condition Survey Report**

**English Partnerships**

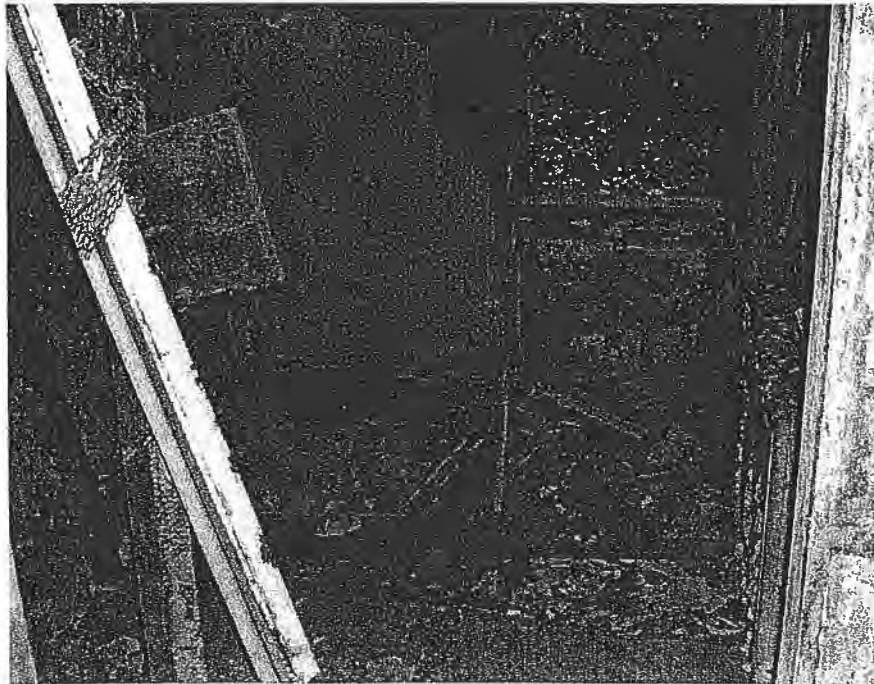
08 Damage to Ground Floor

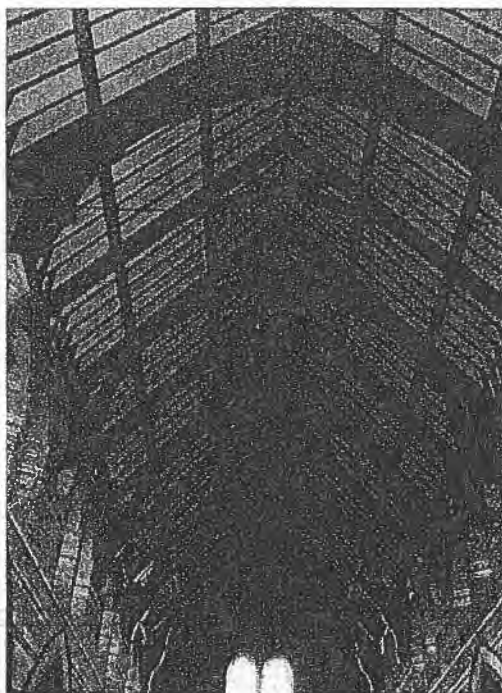
03 Roof structure

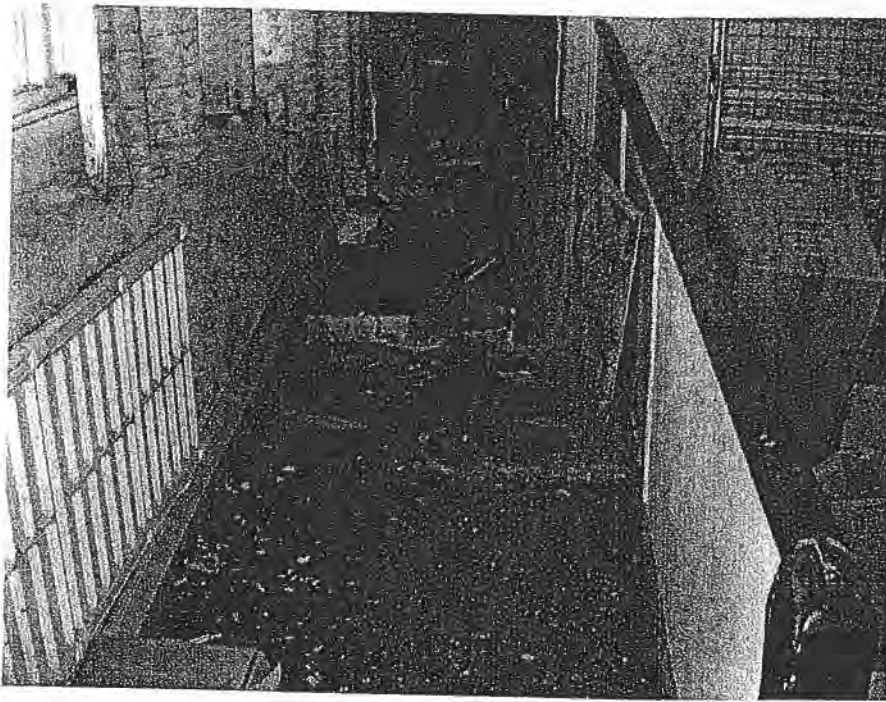
09 Damage to Floor

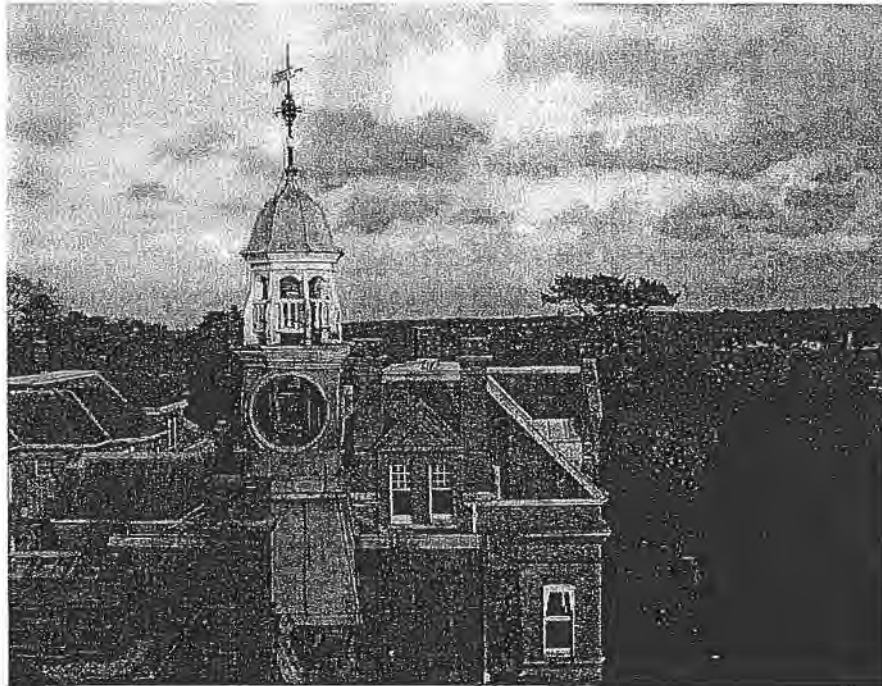
| BUILDING INSPECTION | |
|---|---|
| 3. | Clock tower & failing lead detailing |

03 Clock Tower & Failing Lead Detailing

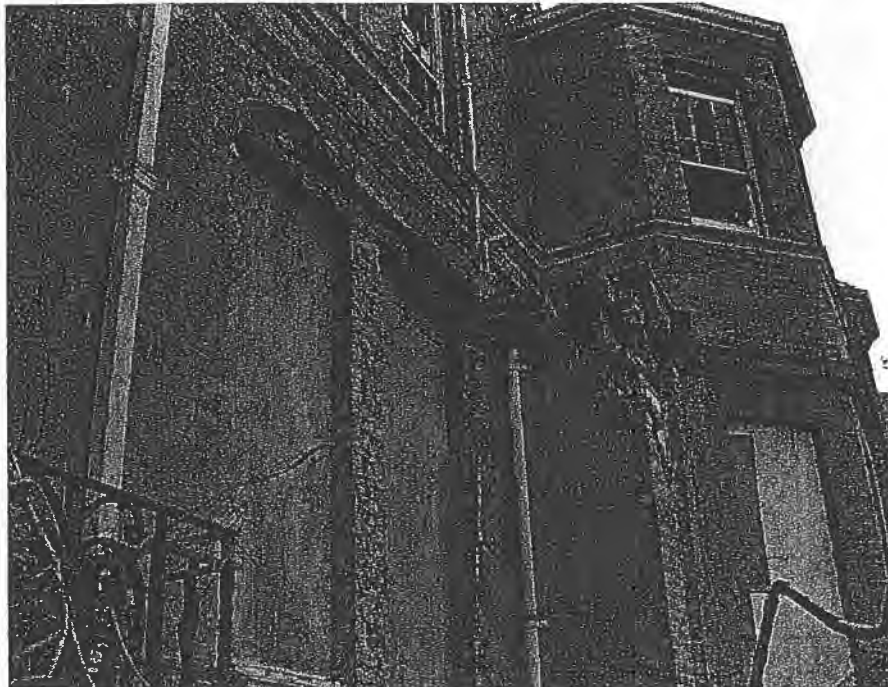
| Element Description | | Condition |
|---|---|---|
| | Structure & Foundations | The East Wing has suffered significant structural damage as a result of explosion. The remaining structure appears sound. The roof structure is robust and in sound condition. |

| BUILDING INSPECTION | |
|---|---|
| 6. | Structural damage to east elevation |

06 Structural Damage to East Wing

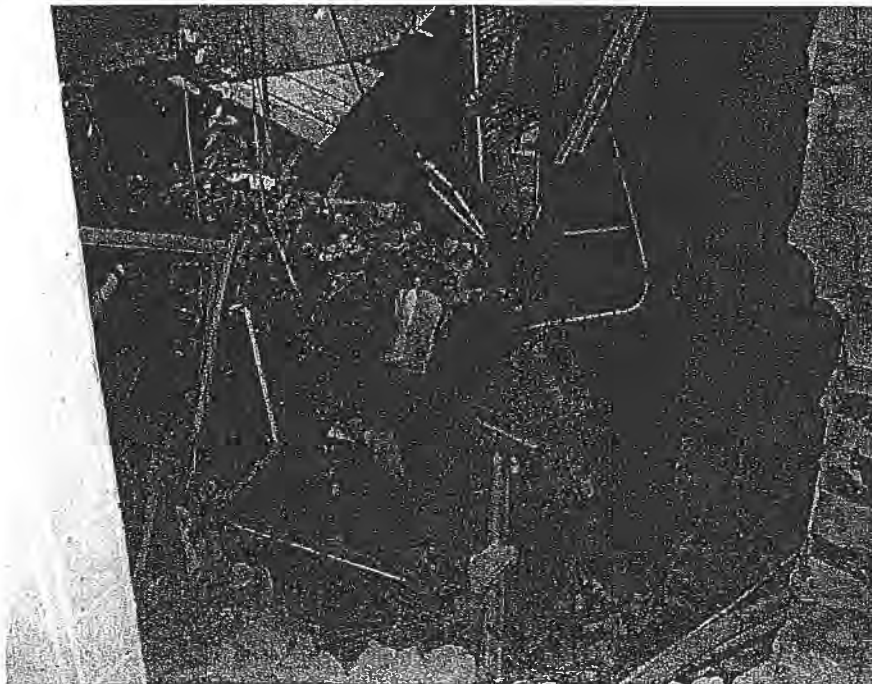
| Element Description | | Condition |
|---|---|---|
| | Floors are generally of suspended timber construction with a variety of floor finishes. Stairs and landings are of solid construction. | <p>Floors to the east wing have partially collapsed as a result of bomb damage.</p> <p>There is localised deterioration and damage to sections of the floor in the single storey corridor due to dry and wet rot, and there is a likelihood of concealed damage to remaining sections.</p> <p>There is also some localised sections of rotten timber flooring to the lower ground and ground level of the west wing.</p> |

| BUILDING INSPECTION | |
|---|---|
| 8. | Bomb damage to east wing |

08 Bomb Damage to East Wing

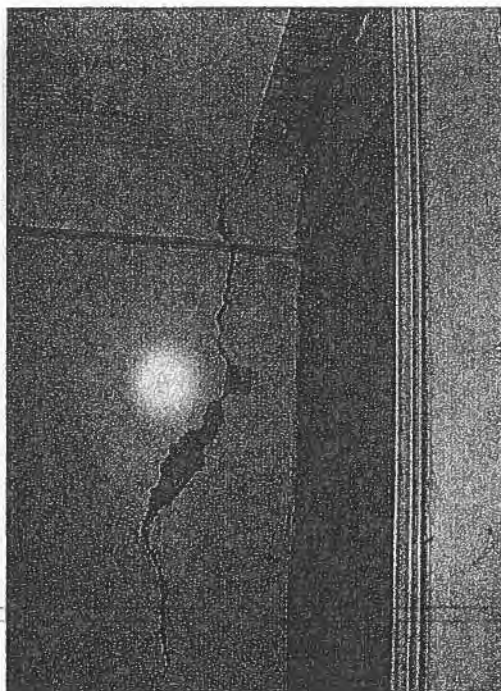
| BUILDING INSPECTION | |
|---|---|
| 9. | Structural cracking to east wing |

09 Structural Cracking to East Wing

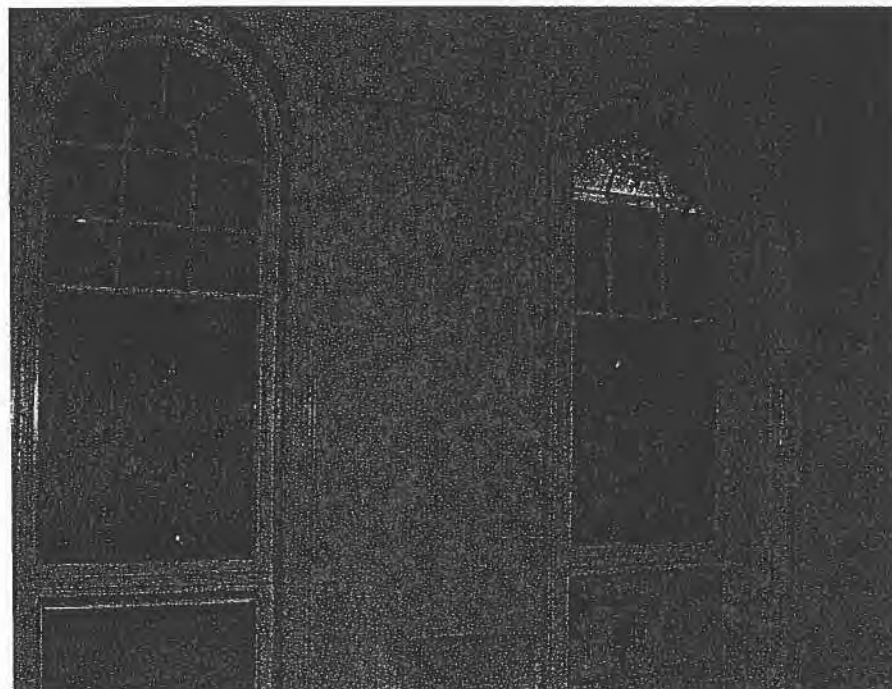
| BUILDING INSPECTION | |
|---|---|
| 14. | Boarded up windows at ground level |

14 Boarded Up Windows at Ground Level

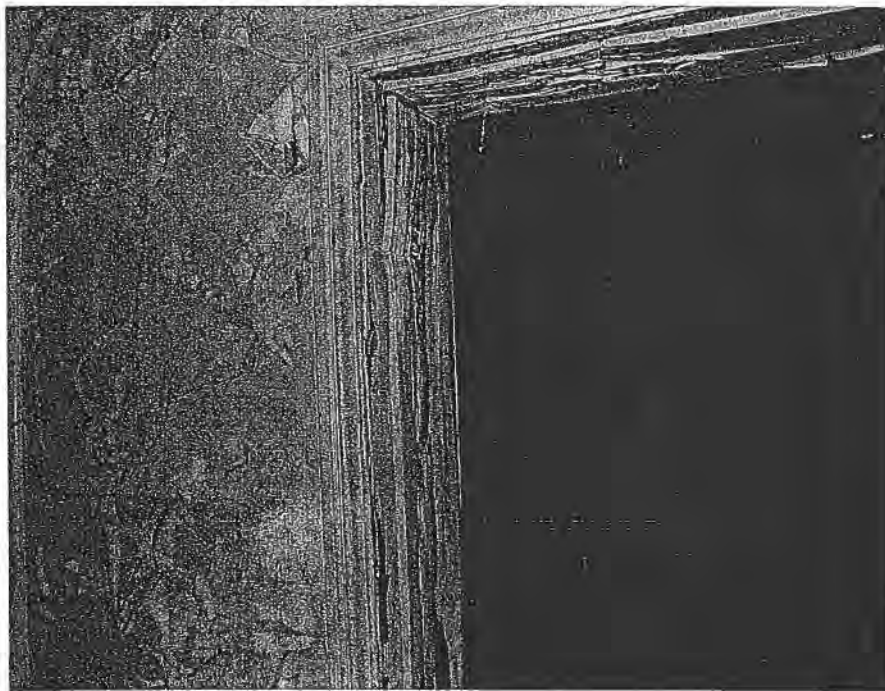
07 Dry rot to joinery

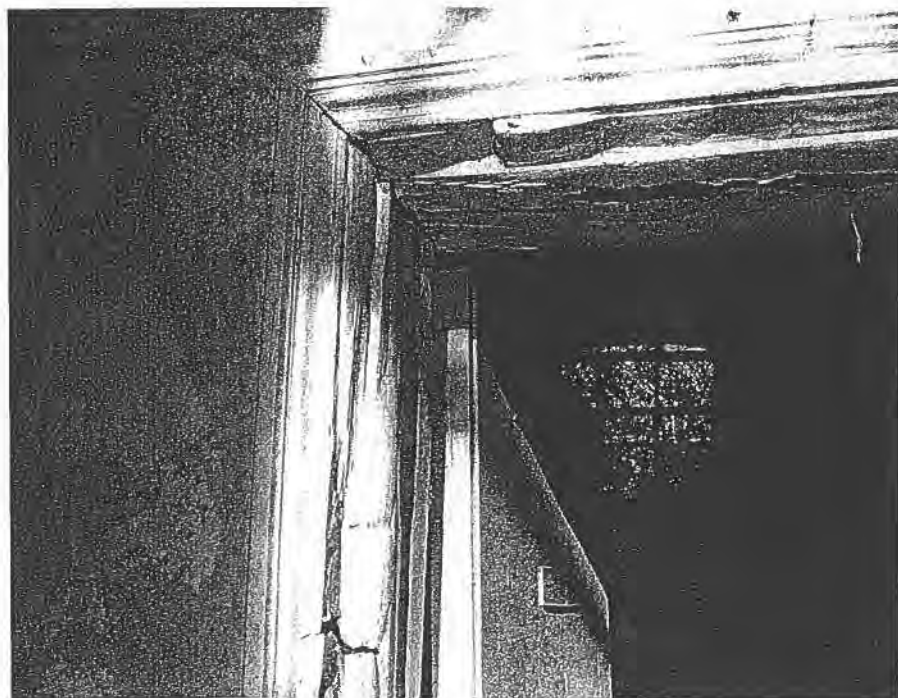
10 Dry rot to joinery at second floor level

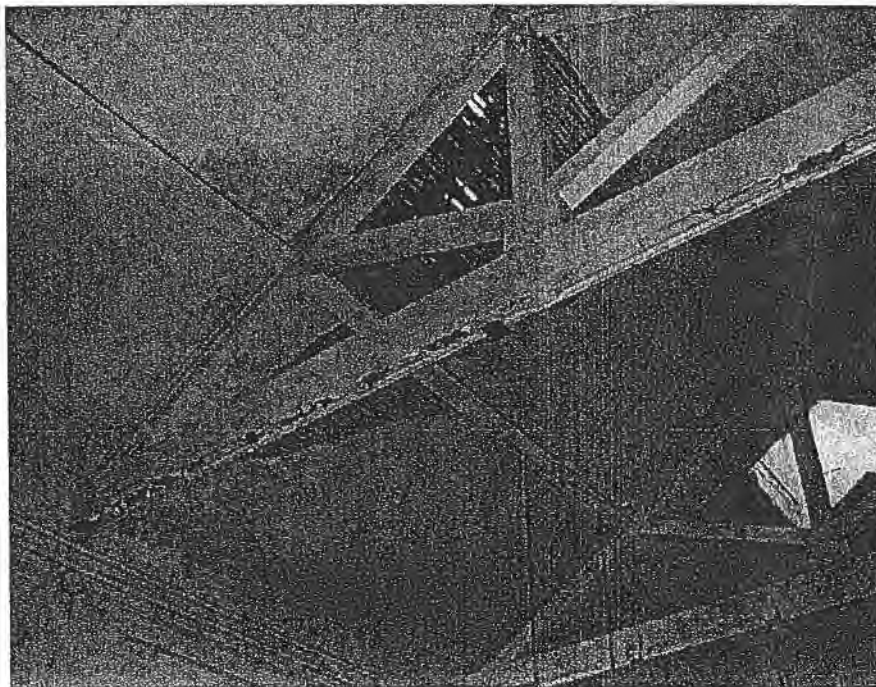
06 Failure of ceiling of 6A

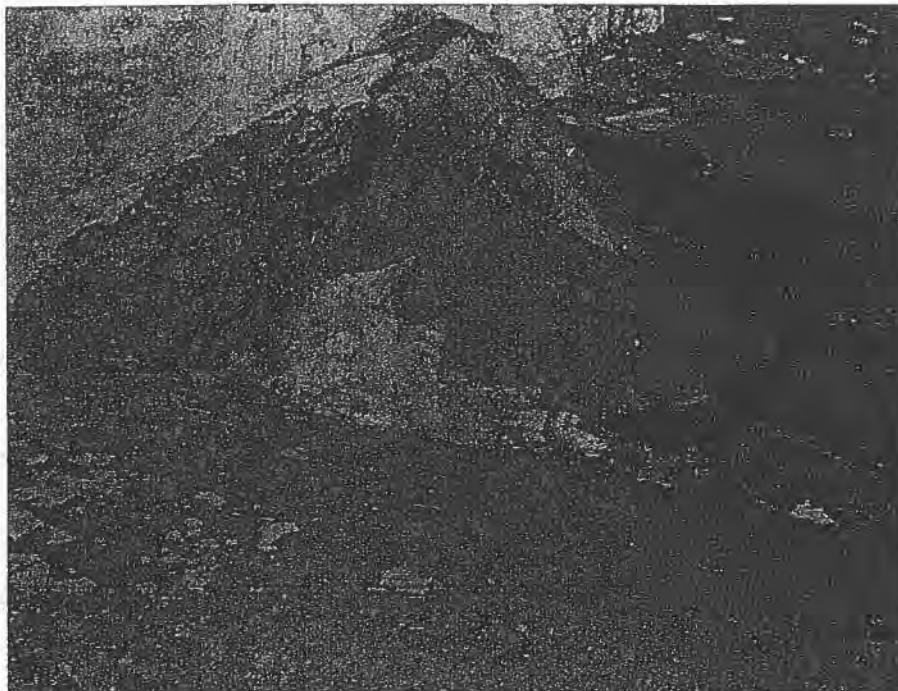
07 Failure of floor of 6A

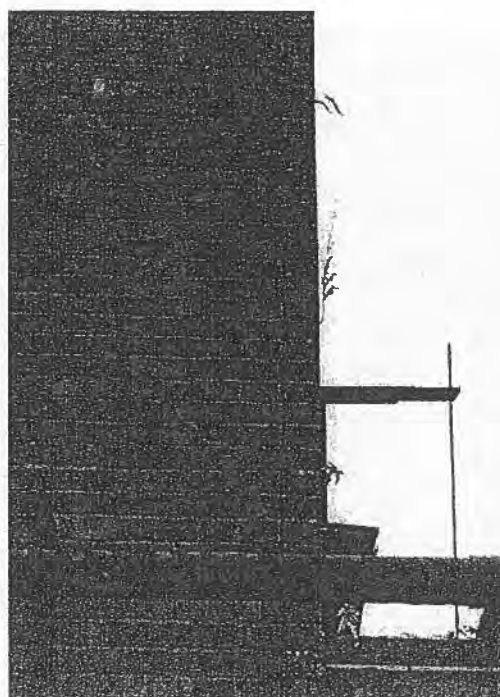
12 Vertical crack to corner of 6C

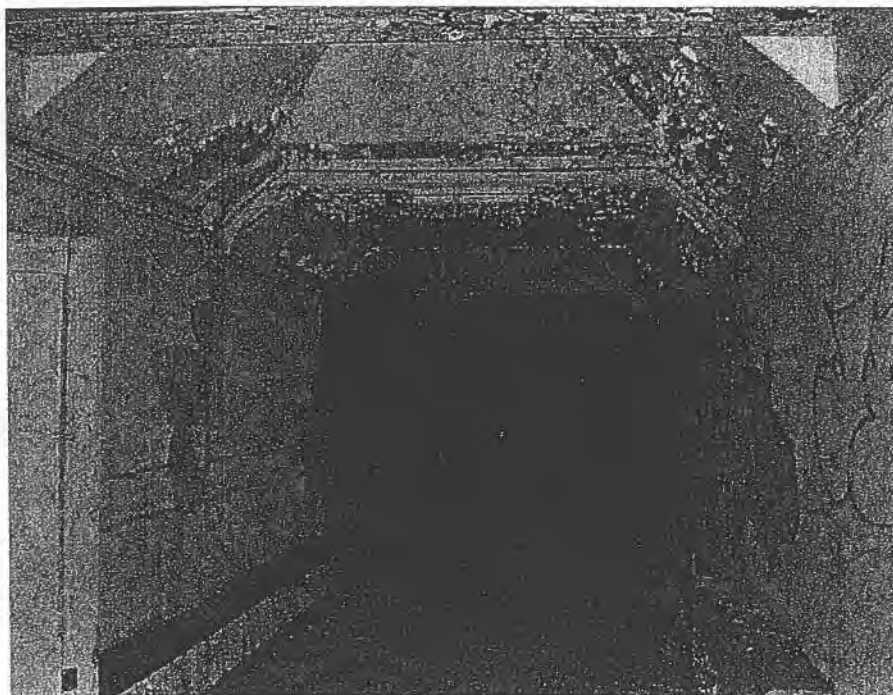
16 Failure to ceiling of link corridor

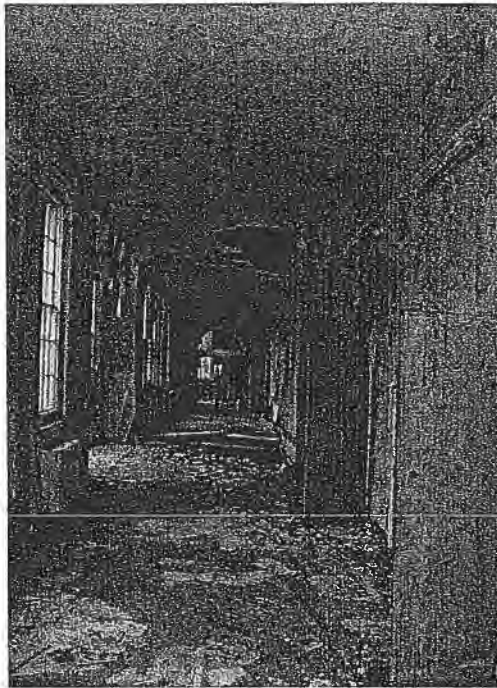
07 Damage to Ceiling & Floor

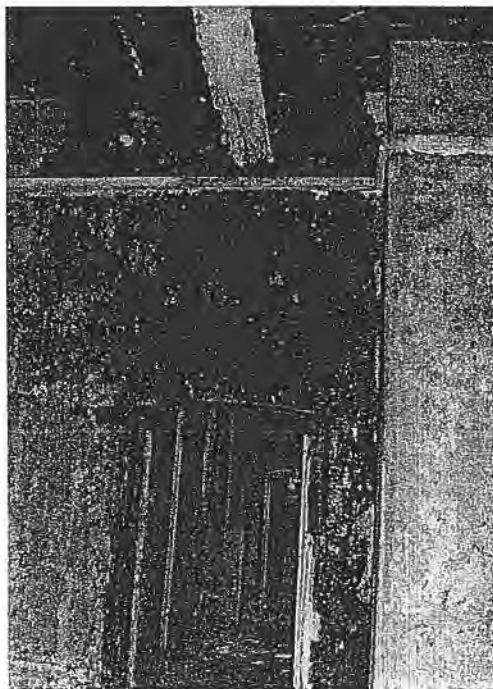
08 Mould Growth

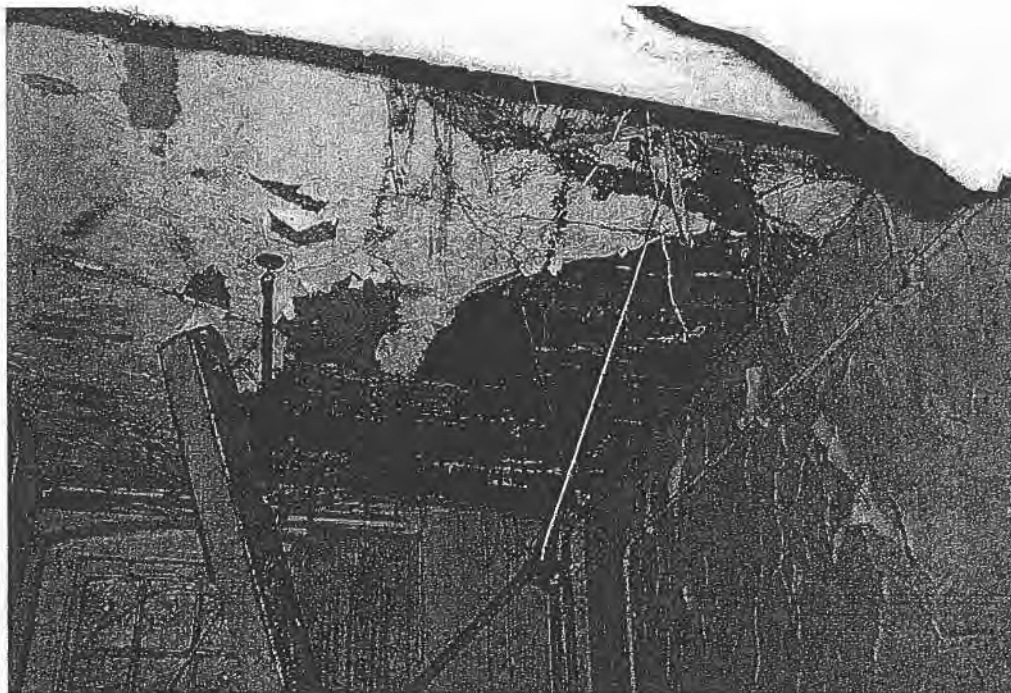
19 Rot to ceiling to Building C

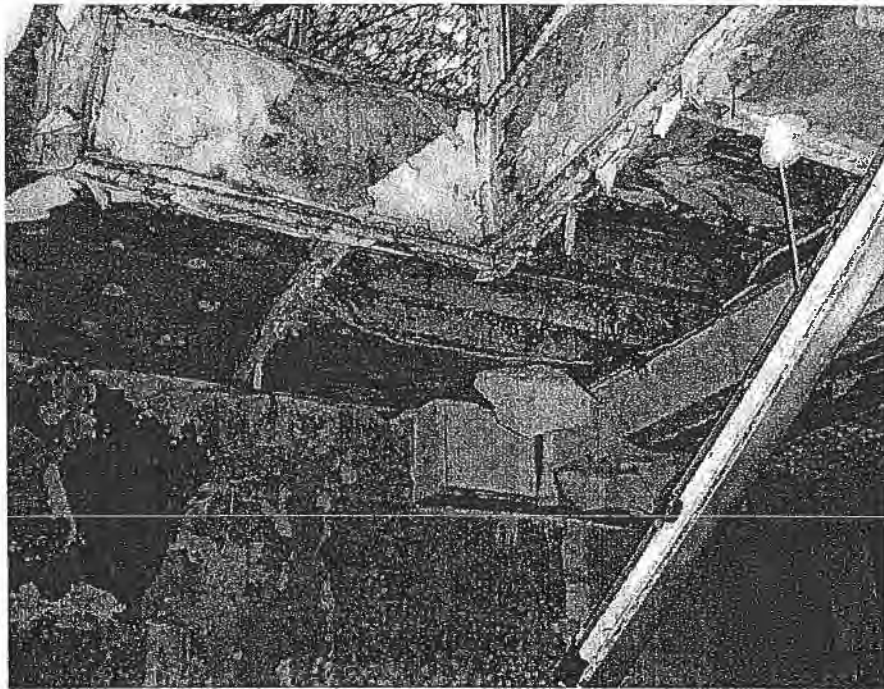
09 Failure of ceilings to 9A

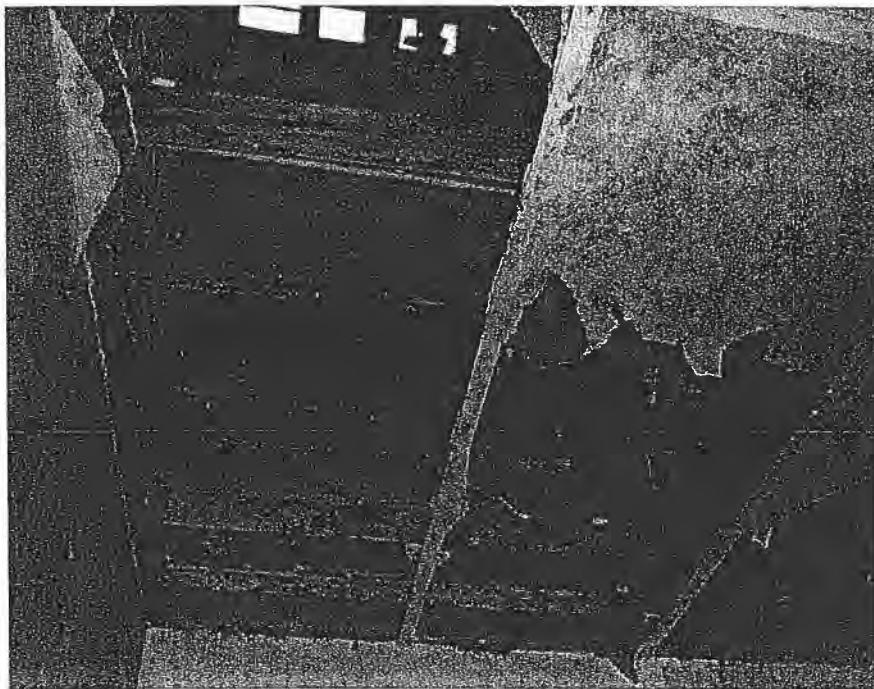
10 Failure of ceilings to 9B

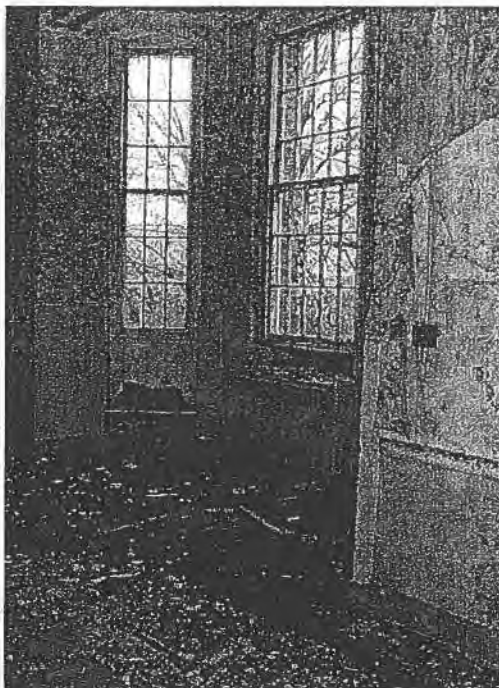
| BUILDING INSPECTION | |
|---|---|
| 5. | Extensive water damage to bay |

05 Extensive water damage to bay

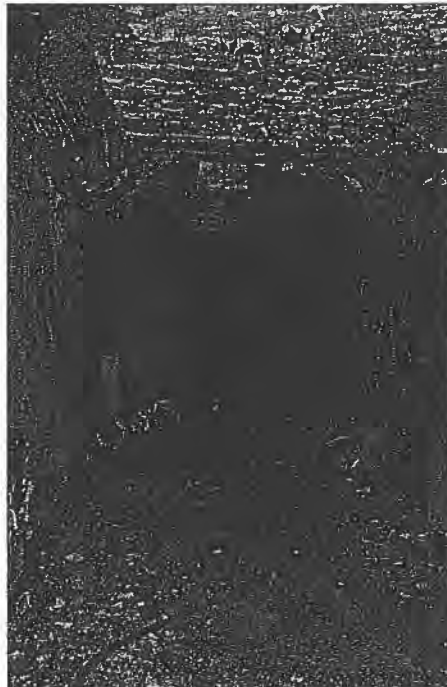
08 Deterioration to ceiling

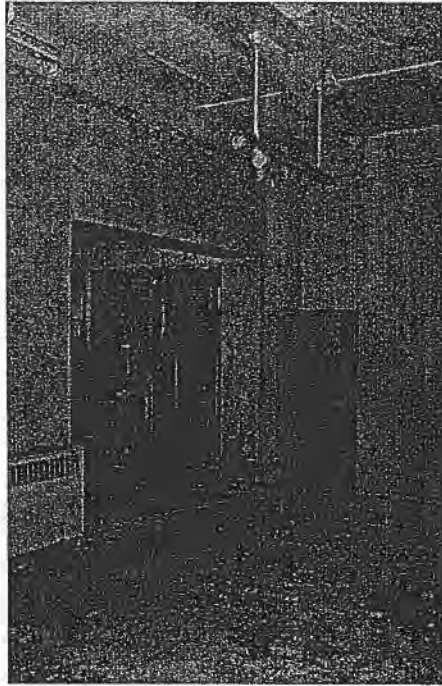
09 Water ingress to central building
