TYPE 3  
SURVEY, ASSESSMENT AND REGISTER OF  
ASBESTOS CONTAINING MATERIALS  
AT  
CANE HILL, COULSDON  
SURREY, CR5 3ES

*Report No. 06/B/8026*

*September 2006*

**Strategic Risk Management  
P.O. Box 167, Sandbach  
Cheshire, CW11 3WG**

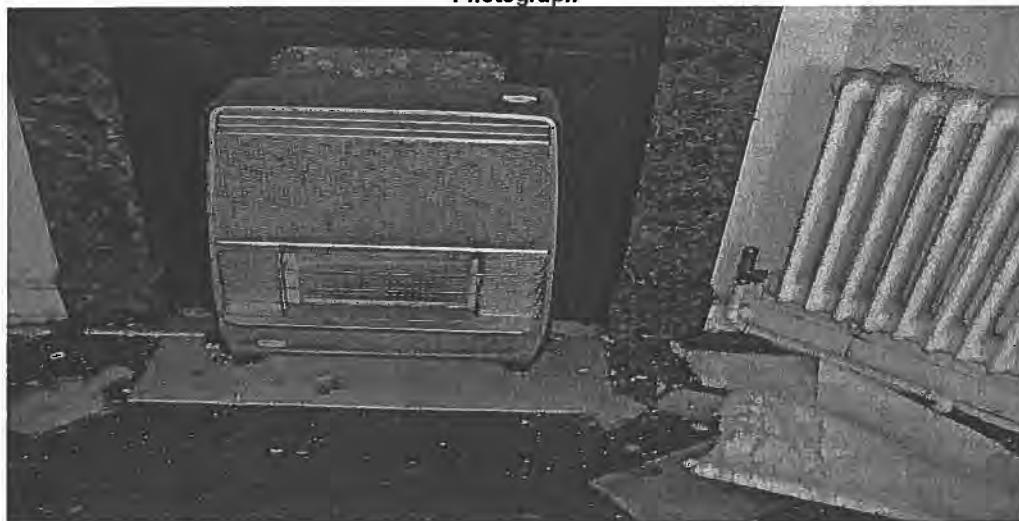
**Photograph**

| <b>Location of Survey</b><br>Cane Hill Hospital,<br>Cane Hill,<br>Coulston, Surrey,<br>CR5 3ES | | <b>Position of Sample/Photo</b><br>Reception Building<br>Second Floor<br>Rear Office<br>Panel beneath heater | | <b>Asbestos</b><br><br><b>Type</b> | Yes, Strongly<br>Presumed<br><br>Amosite (Brown)<br>Chrysotile (White) |

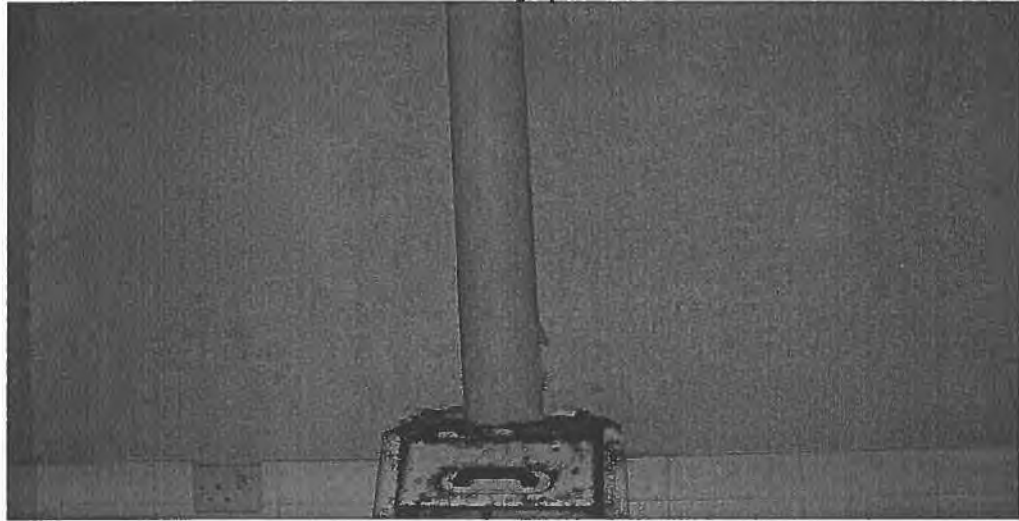
**Photograph**

| <b>Location of Survey</b><br>Cane Hill Hospital,<br>Cane Hill,<br>Coulsdon, Surrey,<br>CR5 3ES | <b>Position of Sample/Photo</b><br>Reception Building<br>Female Side, Loft<br>Redundant Panel | <b>Asbestos</b><br><br><b>Type</b> | Yes, Strongly Presumed<br><br>Amosite (Brown)<br>Chrysotile (White) |

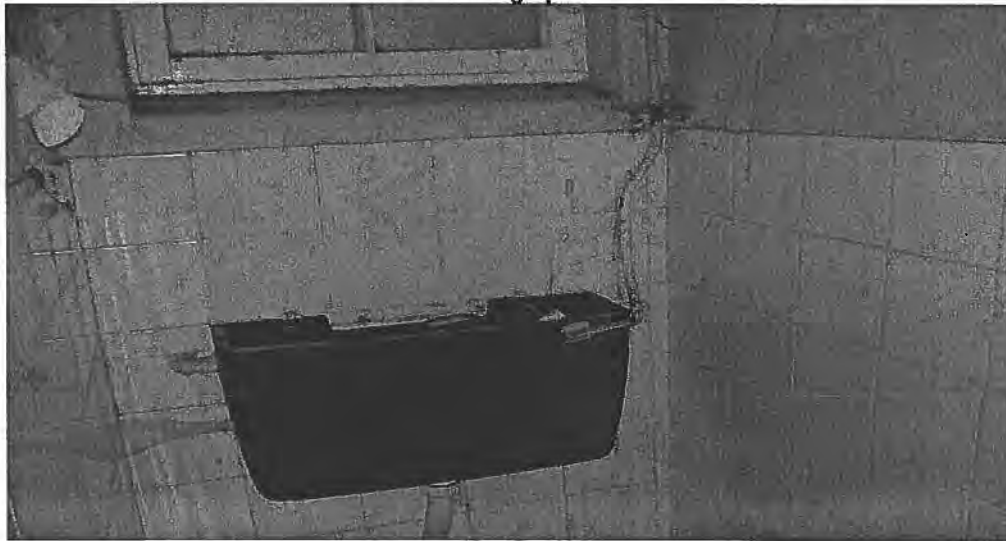
**Photograph**

| <b>Location of Survey</b><br>Cane Hill Hospital,<br>Cane Hill,<br>Coulston, Surrey,<br>CR5 3ES | | <b>Position of Sample/Photo</b><br>Reception Building<br>WC Cistern (X3) | <b>Asbestos</b><br><br><b>Type</b> | Yes, Strongly<br>Presumed<br><br>Amosite (Brown) |

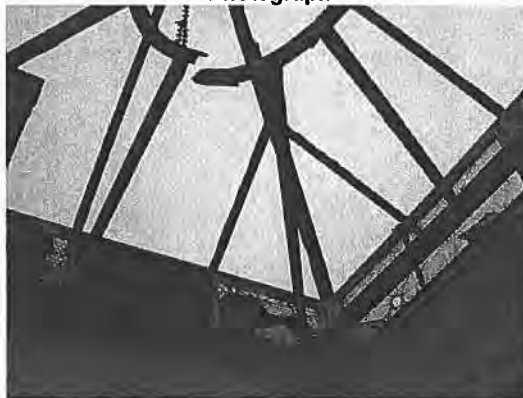
**Photograph**

| <b>Location of Survey</b><br>Cane Hill Hospital,<br>Cane Hill,<br>Coulsdon, Surrey,<br>CR5 3ES | | <b>Position of Sample/Photo</b><br>Hall/Chapel Area<br>Admin Office, Cementaceous<br>Roof Coating<br>Also noted throughout site | | <b>Asbestos</b><br><br><b>Type</b> | <b>No Asbestos<br/>Detected</b><br><br>N/A |

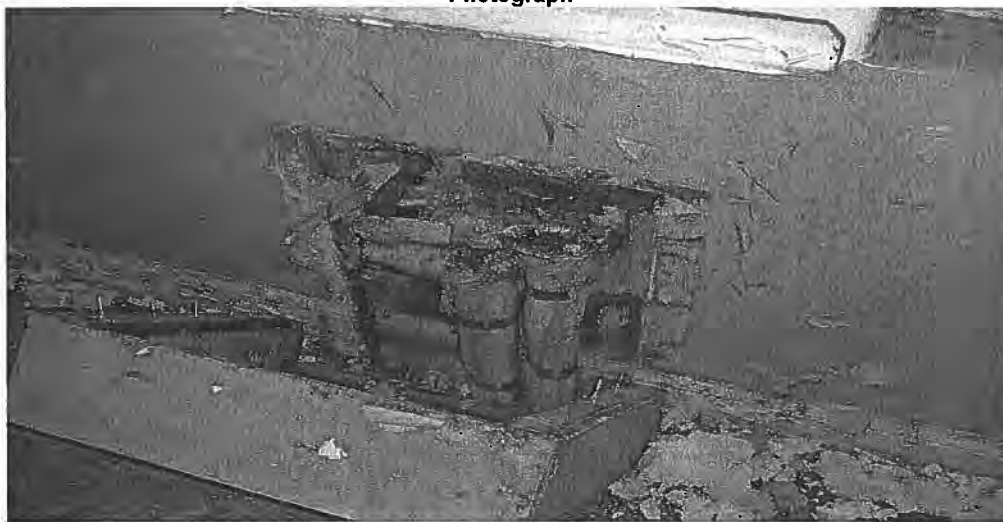
**Photograph**

| <b>Location of Survey</b><br>Cane Hill Hospital,<br>Cane Hill,<br>Coulston, Surrey,<br>CR5 3ES | | <b>Position of Sample/Photo</b><br>Olave Queens Ward<br>Corridor adjacent stairs<br>Low level foil corrugated paper<br>pipe lagging | | <b>Asbestos</b><br><br><b>Type</b> | Yes, Strongly<br>Presumed<br><br>Chrysotile (White) |

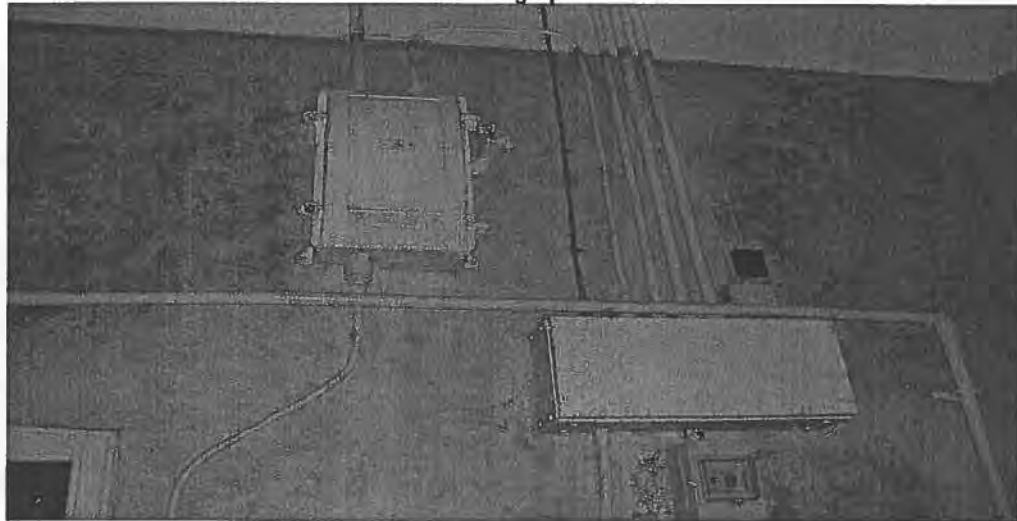
**Photograph**

| <b>Location of Survey</b><br>Cane Hill Hospital,<br>Cane Hill,<br>Coulsdon, Surrey,<br>CR5 3ES | <b>Position of Sample/Photo</b><br>Olive Queens Ward<br>Corridor adjacent stairs<br>Wall electrics | <b>Asbestos</b><br><br><b>Type</b> | Yes, Strongly<br>Presumed<br><br>Chrysotile (White) |

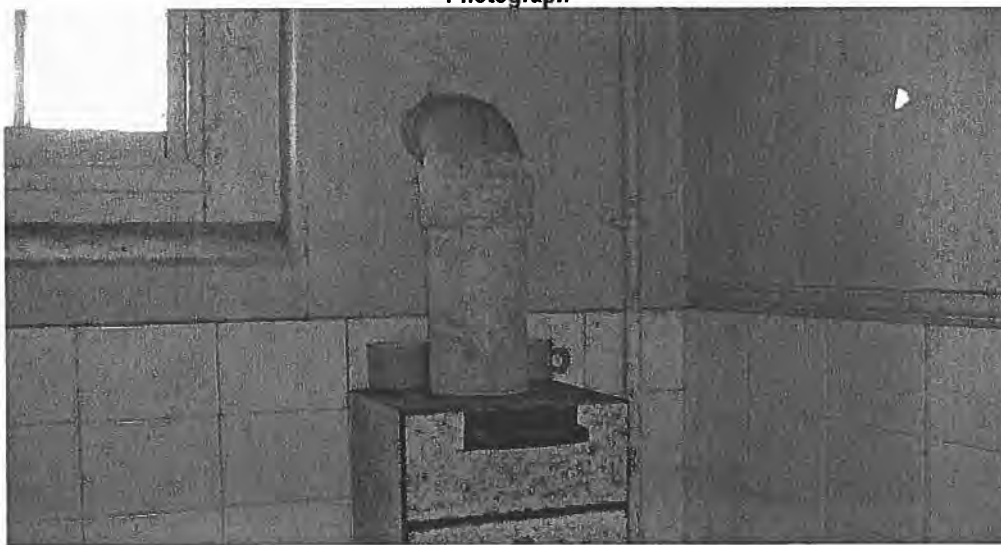
**Photograph**

| <b>Location of Survey</b><br>Cane Hill Hospital,<br>Cane Hill,<br>Coulston, Surrey,<br>CR5 3ES | | <b>Position of Sample/Photo</b><br>Olave Queens Ward<br>WC adjacent ward<br>Bunny Boiler Flue pipe<br>(& internal panels) | <b>Asbestos</b><br><br><b>Type</b> | Yes, Strongly<br>Presumed<br><br>Chrysotile (White) |

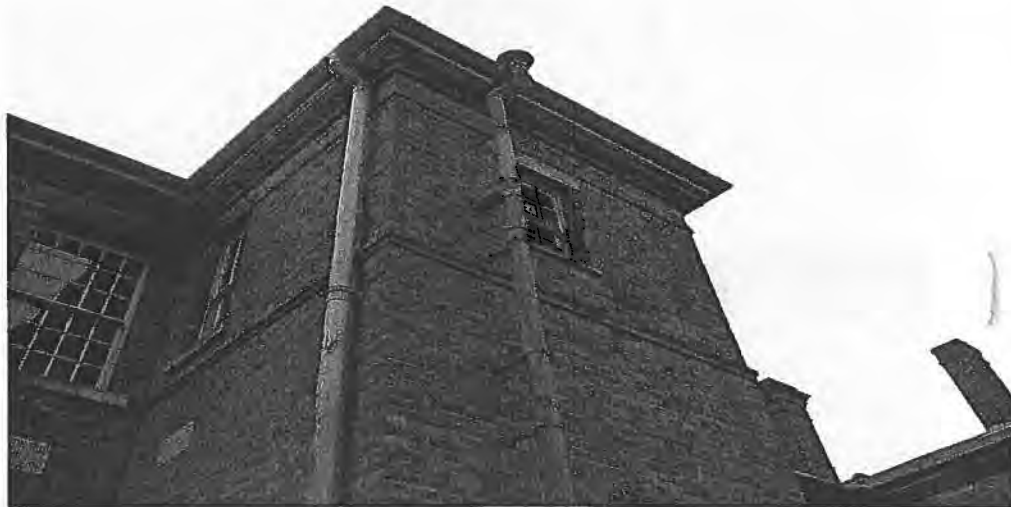
**Photograph**

| <b>Location of Survey</b><br>Cane Hill Hospital,<br>Cane Hill,<br>Coulston, Surrey,<br>CR5 3ES | | <b>Position of Sample/Photo</b><br>Olave Queens Ward<br>External flue pipe | | <b>Asbestos</b><br><br><b>Type</b> | Yes, Strongly<br>Presumed<br><br>Chrysotile (White) |

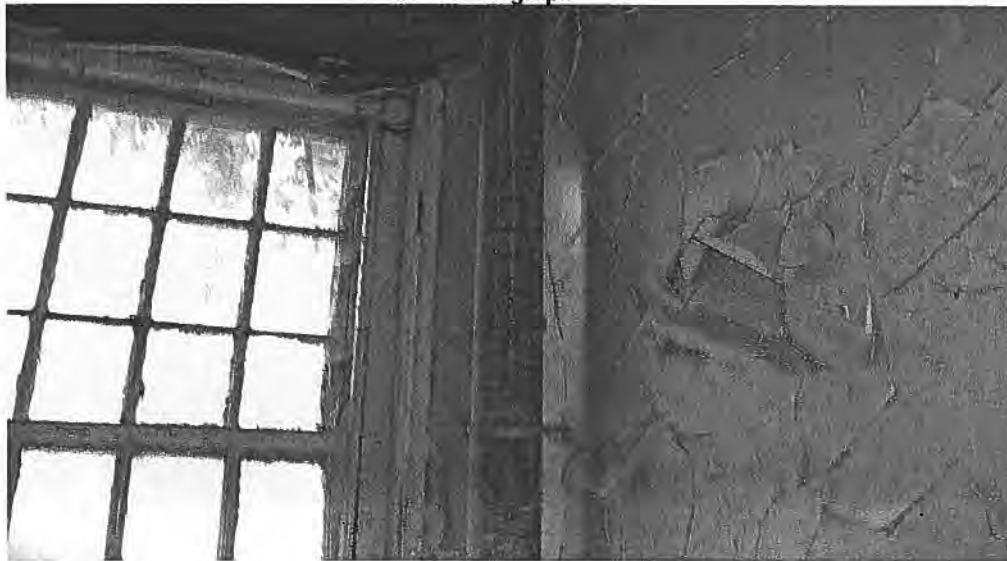
**Photograph**

| <b>Location of Survey</b><br>Cane Hill Hospital,<br>Cane Hill,<br>Coulston, Surrey,<br>CR5 3ES | | <b>Position of Sample/Photo</b><br>Browning Blake Ward<br>Room adjacent sun room<br>Flue pipe | | <b>Asbestos</b><br><br><b>Type</b> | Yes, Strongly<br>Presumed<br><br>Chrysotile (White) |

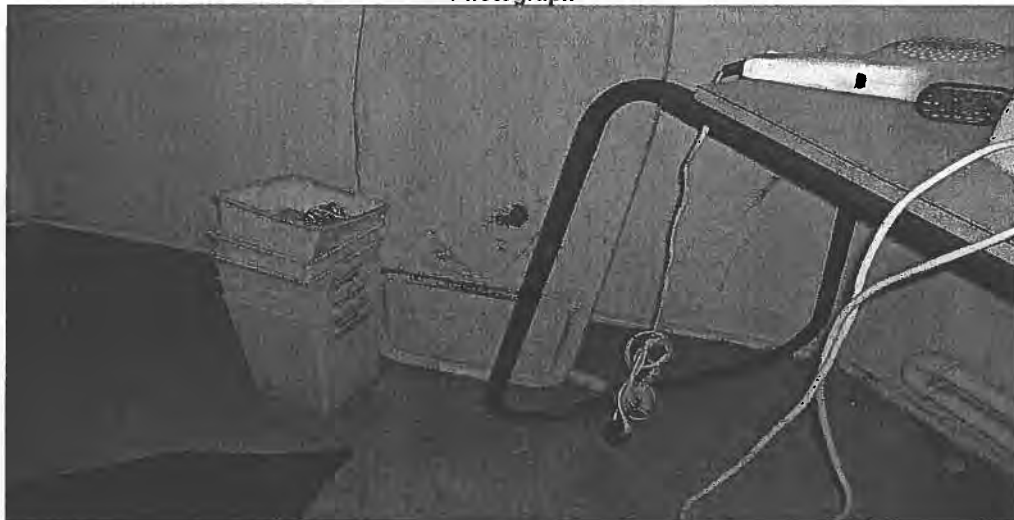
**Photograph**

| <b>Location of Survey</b><br>Cane Hill Hospital,<br>Cane Hill,<br>Coulsdon, Surrey,<br>CR5 3ES | | <b>Position of Sample/Photo</b><br>Browning Blake Ward<br>Office adjacent ward<br>Ironing Board Pad | | <b>Asbestos</b><br><br><b>Type</b> | <b>Yes, Strongly Presumed</b><br><br>Chrysotile (White) |

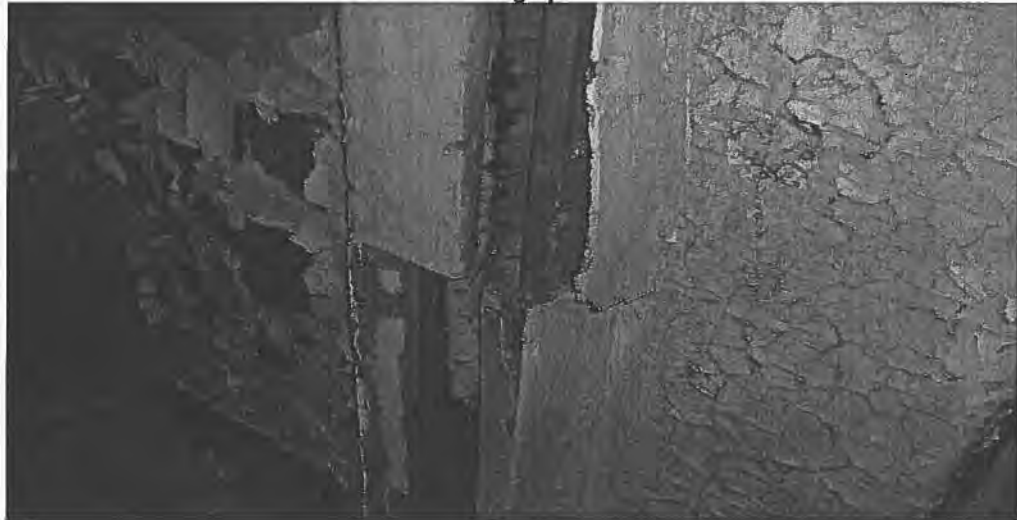
**Photograph**

| <b>Location of Survey</b><br>Cane Hill Hospital,<br>Cane Hill,<br>Coulsdon, Surrey,<br>CR5 3ES | <b>Position of Sample/Photo</b><br>Browning Blake Ward<br>Kitchen adjacent corridor<br>Rope to pipe work within wood<br>boxed riser | <b>Asbestos</b><br><br><b>Type</b> | Yes, Strongly<br>Presumed<br><br>Chrysotile (White) |
