### Asbestos Survey Report & Register

Survey Type:	Asbestos Demolition Survey
Site:	Garage Site 12, Rear of 1-18 Swann Court, 18 South Street, Isleworth, TW7 7AN
Surveyor:	Aaron Galyer
Contract:	S-07991
Survey Date:	03 April 2019
Report Date:	08 April 2019
Re-Inspection Due:	03 April 2020
Client:	Arcadis LLP PO Box 307, Manchester, M60 3NT

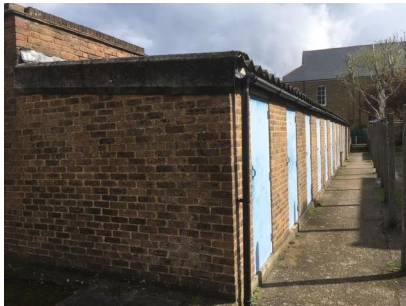
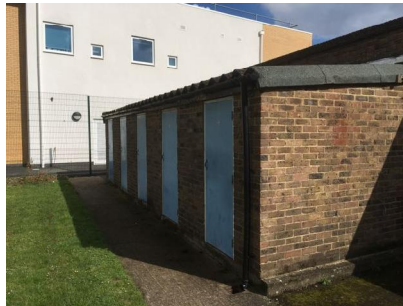
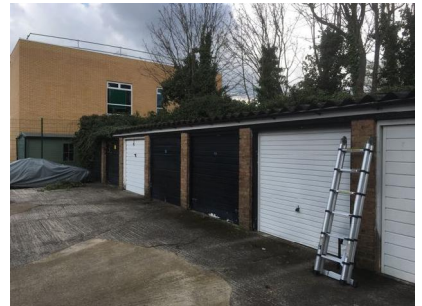
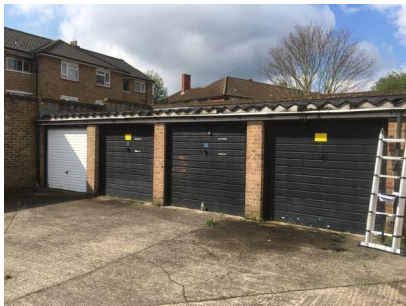
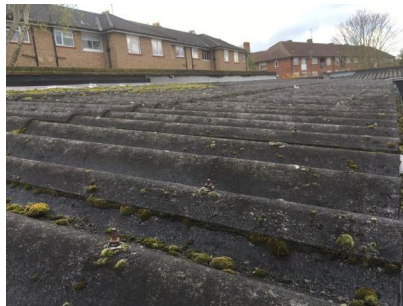
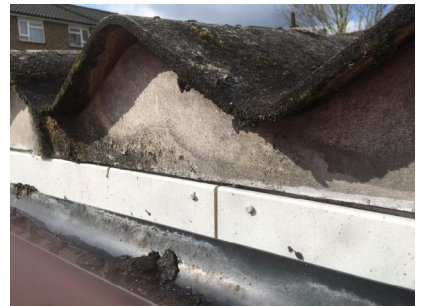
Area:	Garages (Site 12) - All Accessible Areas - All Floors
Floors:	Not accessed internal
Walls:	Not accessed internal
Ceilings:	Not access internal
External:	The external comprised of exposed brick, cement corrugated roof with cement end capping's to each garage, bitumen damp proof course, clay tiles to high level brickwork, concrete fascia panels painted black, timber surrounds to metal garage doors, metal and plastic rain water goods.

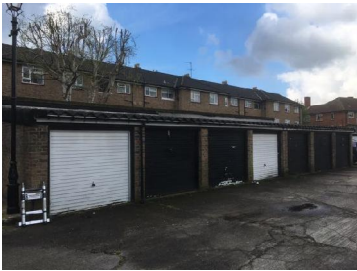
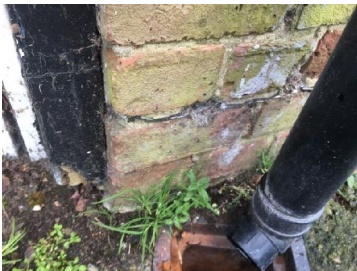
<b>Contract No:</b> S-07991	<b>Client:</b> Arcadis LLP	<b>Location Ref OSL:</b> OSL001	
<b>Site:</b> Garage Site 12, Rear of 1-18 Swann Court, 18 South Street, Isleworth, TW7 7AN		<b>Survey Date:</b> 03 April 2019	
<b>Building:</b>	Garage Site 12

<b>Floor:</b>	Ground Floor		
<b>Room Area:</b>	Block 1 Garages 001		
<b>Description:</b>	Bitumen Damp Proof Course		
<b>Quantity:</b>	40lm

<b>Accessibility:</b>	Easy		
<b>Product Type:</b>	1 - Bituminous Product		
<b>Damage Extent:</b>	1 - Low Damage		
<b>Surface Treatment:</b>	0 - Composite	<b>Re-inspection Due:</b>	N/A
<b>Asbestos Type:</b>	No Asbestos Detected	<b>Sample Ref:</b>	S01
<b>Material Assessment:</b>		<b>No Asbestos Detected</b>	
<b><u>Comments:</u></b> - Found to low level brickwork. The bitumen damp proof course ran around the entire perimeter of the garages and the rear store units attached to the garages. A composite sample was taken from various areas from the block of garages.

<b><u>Recommendations:</u></b> No action required

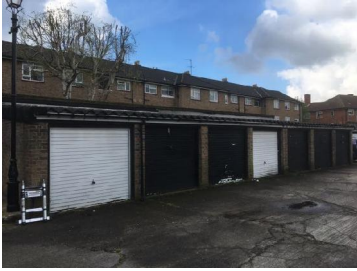
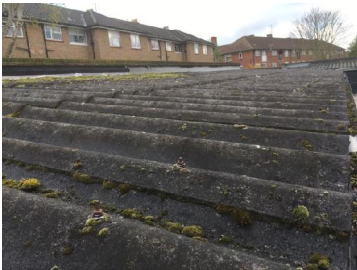
<b>Contract No:</b> S-07991	<b>Client:</b> Arcadis LLP	<b>Location Ref OSL:</b> OSL002	
<b>Site:</b> Garage Site 12, Rear of 1-18 Swann Court, 18 South Street, Isleworth, TW7 7AN		<b>Survey Date:</b> 03 April 2019	
<b>Building:</b>	Garage Site 12

<b>Floor:</b>	Ground Floor		
<b>Room Area:</b>	Block 1 Garages 001		
<b>Description:</b>	Cement Corrugated Roof & End Capping's		
<b>Quantity:</b>	70m <sup>2</sup>

<b>Accessibility:</b>	Medium		
<b>Product Type:</b>	1 - Cement Product		
<b>Damage Extent:</b>	1 - Low Damage		
<b>Surface Treatment:</b>	1 - Unsealed	<b>Re-inspection Due:</b>	03/04/2020
<b>Asbestos Type:</b>	1 - Chrysotile	<b>Sample Ref:</b>	S02
<b>Material Assessment:</b>		<b>Risk Score = 4</b> <b>Very Low</b>	
<b>Comments:</b> - <p>The cement corrugated roof was unsealed and found to the entire roof. The corrugated roof was bolted in place however it is not known what its bolted too as there was no access into the internal. There was end calling to either end of the garages which was unsealed cement also.</p>

<b>Recommendations:</b> <p>Remove</p> <p>The asbestos containing material should be removed and disposed of in full accordance with current and relevant legislation prior to the demolition of the building.</p>

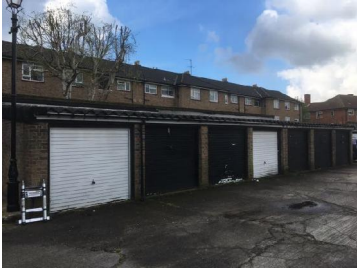
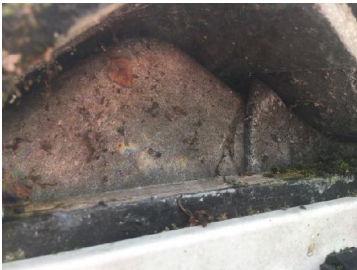
<b>Contract No:</b> S-07991	<b>Client:</b> Arcadis LLP	<b>Location Ref OSL:</b> OSL003	
<b>Site:</b> Garage Site 12, Rear of 1-18 Swann Court, 18 South Street, Isleworth, TW7 7AN		<b>Survey Date:</b> 03 April 2019	
<b>Building:</b>	Garage Site 12

<b>Floor:</b>	Ground Floor		
<b>Room Area:</b>	Block 1 Garages 001		
<b>Description:</b>	Cement Fascia Panel & Corrugated Roof		
<b>Quantity:</b>	70m <sup>2</sup>

<b>Accessibility:</b>	Medium		
<b>Product Type:</b>	1 - Cement Product		
<b>Damage Extent:</b>	1 - Low Damage		
<b>Surface Treatment:</b>	1 - Unsealed	<b>Re-inspection Due:</b>	03/04/2020
<b>Asbestos Type:</b>	1 - Chrysotile	<b>Sample Ref:</b>	S03
<b>Material Assessment:</b>		<b>Risk Score = 4</b> <b>Very Low</b>	
<b>Comments:</b> - <p>There was an unsealed cement fascia Panel sitting beneath the cement corrugated roof. It is presumed that this fascia Panel is part of a second layer of corrugated roof which runs beneath the top layer of cement roof sheets.</p>

<b>Recommendations:</b> <p>Remove</p> <p>The asbestos containing material should be removed and disposed of in full accordance with current and relevant legislation prior to the demolition of the building.</p>

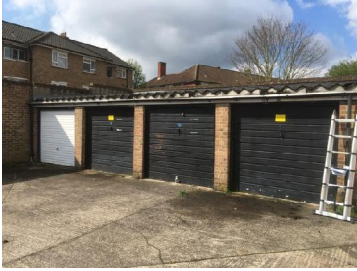
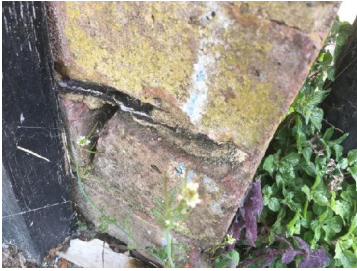
<b>Contract No:</b> S-07991	<b>Client:</b> Arcadis LLP	<b>Location Ref OSL:</b> OSL004	
<b>Site:</b> Garage Site 12, Rear of 1-18 Swann Court, 18 South Street, Isleworth, TW7 7AN		<b>Survey Date:</b> 03 April 2019	
<b>Building:</b>	Garage Site 12

<b>Floor:</b>	Ground Floor		
<b>Room Area:</b>	Block 2 Garages 002		
<b>Description:</b>	Bitumen Damp Proof Course		
<b>Quantity:</b>	30lm

<b>Accessibility:</b>	Easy		
<b>Product Type:</b>	1 - Bituminous Product		
<b>Damage Extent:</b>	1 - Low Damage		
<b>Surface Treatment:</b>	0 - Composite	<b>Re-inspection Due:</b>	N/A
<b>Asbestos Type:</b>	No Asbestos Detected	<b>Sample Ref:</b>	S04
<b>Material Assessment:</b>		<b>No Asbestos Detected</b>	
<b><u>Comments:</u></b> - Found to low level brickwork. The bitumen damp proof course ran around the entire perimeter of the garages and the rear store units attached to the garages. A composite sample was taken from various areas from the block of garages.

<b><u>Recommendations:</u></b> No action required

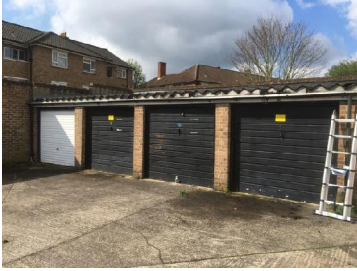
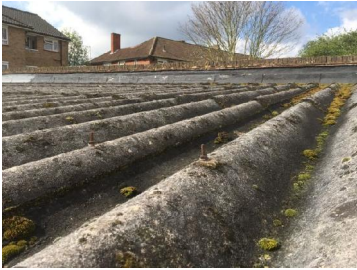
<b>Contract No:</b> S-07991	<b>Client:</b> Arcadis LLP	<b>Location Ref OSL:</b> OSL005	
<b>Site:</b> Garage Site 12, Rear of 1-18 Swann Court, 18 South Street, Isleworth, TW7 7AN		<b>Survey Date:</b> 03 April 2019	
<b>Building:</b>	Garage Site 12

<b>Floor:</b>	Ground Floor		
<b>Room Area:</b>	Block 2 Garages 002		
<b>Description:</b>	Cement Corrugated Roof & End Capping's		
<b>Quantity:</b>	40m <sup>2</sup>

<b>Accessibility:</b>	Medium		
<b>Product Type:</b>	1 - Cement Product		
<b>Damage Extent:</b>	1 - Low Damage		
<b>Surface Treatment:</b>	1 - Unsealed	<b>Re-inspection Due:</b>	03/04/2020
<b>Asbestos Type:</b>	1 - Chrysotile	<b>Sample Ref:</b>	S05
<b>Material Assessment:</b>		<b>Risk Score = 4</b> <b>Very Low</b>	
<b>Comments:</b> - <p>The cement corrugated roof was unsealed and found to the entire roof. The corrugated roof was bolted in place however it is not known what its bolted too as there was no access into the internal. There was end calling to either end of the garages which was unsealed cement also.</p>

<b>Recommendations:</b> <p>Remove</p> <p>The asbestos containing material should be removed and disposed of in full accordance with current and relevant legislation prior to the demolition of the building.</p>

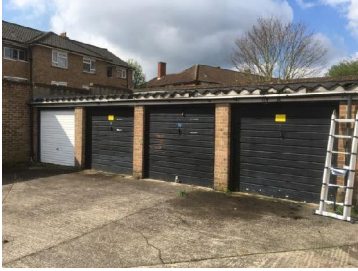
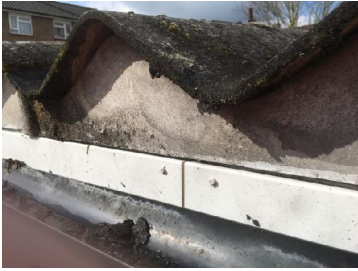
<b>Contract No:</b> S-07991	<b>Client:</b> Arcadis LLP	<b>Location Ref OSL:</b> OSL006	
<b>Site:</b> Garage Site 12, Rear of 1-18 Swann Court, 18 South Street, Isleworth, TW7 7AN		<b>Survey Date:</b> 03 April 2019	
<b>Building:</b>	Garage Site 12

<b>Floor:</b>	Ground Floor		
<b>Room Area:</b>	Block 2 Garages 002		
<b>Description:</b>	Cement Fascia Panel & Corrugated Roof		
<b>Quantity:</b>	70m <sup>2</sup>

<b>Accessibility:</b>	Medium		
<b>Product Type:</b>	1 - Cement Product		
<b>Damage Extent:</b>	1 - Low Damage		
<b>Surface Treatment:</b>	1 - Unsealed	<b>Re-inspection Due:</b>	03/04/2020
<b>Asbestos Type:</b>	1 - Chrysotile	<b>Sample Ref:</b>	S06
<b>Material Assessment:</b>		<b>Risk Score = 4</b> <b>Very Low</b>	
<b>Comments:</b> - <p>There was an unsealed cement fascia Panel sitting beneath the cement corrugated roof. It is presumed that this fascia Panel is part of a second layer of corrugated roof which runs beneath the top layer of cement roof sheets.</p>

<b>Recommendations:</b> <p>Remove</p> <p>The asbestos containing material should be removed and disposed of in full accordance with current and relevant legislation prior to the demolition of the building.</p>

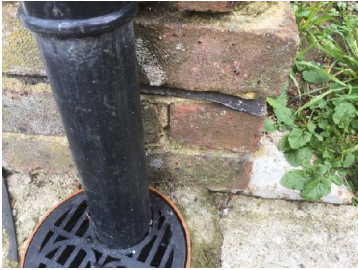
<b>Contract No:</b> S-07991	<b>Client:</b> Arcadis LLP	<b>Location Ref OSL:</b> OSL007	
<b>Site:</b> Garage Site 12, Rear of 1-18 Swann Court, 18 South Street, Isleworth, TW7 7AN		<b>Survey Date:</b> 03 April 2019	
<b>Building:</b>	Garage Site 12	 	
<b>Floor:</b>	Ground Floor		
<b>Room Area:</b>	Block 3 Garages 003		
<b>Description:</b>	Bitumen Damp Proof Course		
<b>Quantity:</b>	40lm

<b>Accessibility:</b>	Easy		
<b>Product Type:</b>	1 - Bituminous Product		
<b>Damage Extent:</b>	1 - Low Damage		
<b>Surface Treatment:</b>	0 - Composite	<b>Re-inspection Due:</b>	03/04/2020
<b>Asbestos Type:</b>	1 - Chrysotile	<b>Sample Ref:</b>	S07
<b>Material Assessment:</b>		<b>Risk Score = 3</b> <b>Very Low</b>	
<b>Comments:</b> - <p>Found to low level brickwork. The bitumen damp proof course ran around the entire perimeter of the garages and the rear store units attached to the garages. A composite sample was taken from various areas from the block of garages.</p>

<b>Recommendations:</b> <p>Remove</p> <p>The asbestos containing material should be removed and disposed of in full accordance with current and relevant legislation prior to the demolition of the building.</p>

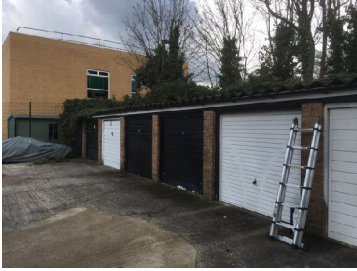
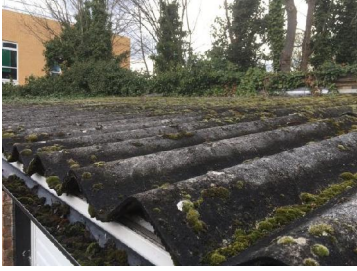
<b>Contract No:</b> S-07991	<b>Client:</b> Arcadis LLP	<b>Location Ref OSL:</b> OSL008	
<b>Site:</b> Garage Site 12, Rear of 1-18 Swann Court, 18 South Street, Isleworth, TW7 7AN		<b>Survey Date:</b> 03 April 2019	
<b>Building:</b>	Garage Site 12

<b>Floor:</b>	Ground Floor		
<b>Room Area:</b>	Block 3 Garages 003		
<b>Description:</b>	Cement Corrugated Roof & End Capping's		
<b>Quantity:</b>	70m <sup>2</sup>

<b>Accessibility:</b>	Medium		
<b>Product Type:</b>	1 - Cement Product		
<b>Damage Extent:</b>	1 - Low Damage		
<b>Surface Treatment:</b>	1 - Unsealed	<b>Re-inspection Due:</b>	03/04/2020
<b>Asbestos Type:</b>	1 - Chrysotile	<b>Sample Ref:</b>	S08
<b>Material Assessment:</b>		<b>Risk Score = 4</b> <b>Very Low</b>	
<b>Comments:</b> - <p>The cement corrugated roof was unsealed and found to the entire roof. The corrugated roof was bolted in place however it is not known what its bolted too as there was no access into the internal. There was end calling to either end of the garages which was unsealed cement also.</p>

<b>Recommendations:</b> <p>Remove</p> <p>The asbestos containing material should be removed and disposed of in full accordance with current and relevant legislation prior to the demolition of the building.</p>

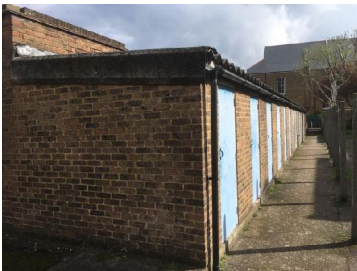
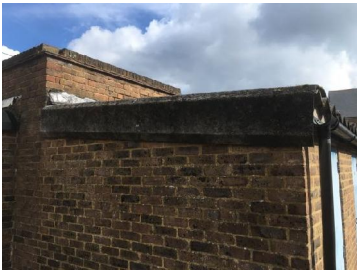
<b>Contract No:</b> S-07991	<b>Client:</b> Arcadis LLP	<b>Location Ref OSL:</b> OSL009	
<b>Site:</b> Garage Site 12, Rear of 1-18 Swann Court, 18 South Street, Isleworth, TW7 7AN		<b>Survey Date:</b> 03 April 2019	
<b>Building:</b>	Garage Site 12

<b>Floor:</b>	Ground Floor		
<b>Room Area:</b>	Block 1 Garages 001		
<b>Description:</b>	Cement Corrugated Roof & End Capping's		
<b>Quantity:</b>	40m <sup>2</sup>

<b>Accessibility:</b>	Medium		
<b>Product Type:</b>	1 - Cement Product		
<b>Damage Extent:</b>	1 - Low Damage		
<b>Surface Treatment:</b>	1 - Unsealed	<b>Re-inspection Due:</b>	03/04/2020
<b>Asbestos Type:</b>	1 - Chrysotile	<b>Sample Ref:</b>	Sample Reference 02
<b>Material Assessment:</b>		<b>Risk Score = 4</b> <b>Very Low</b>	
<b>Comments:</b> - Found to the stores attached at the rest of the garages. The cement was unsealed and there was end capping to the stores also.			
<b>Recommendations:</b> Remove The asbestos containing material should be removed and disposed of in full accordance with current and relevant legislation prior to the demolition of the building.

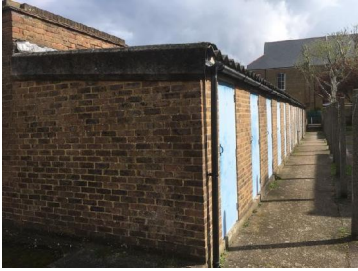
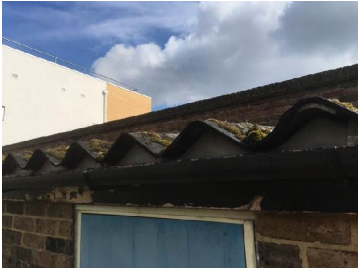
<b>Contract No:</b> S-07991	<b>Client:</b> Arcadis LLP	<b>Location Ref OSL:</b> OSL010	
<b>Site:</b> Garage Site 12, Rear of 1-18 Swann Court, 18 South Street, Isleworth, TW7 7AN		<b>Survey Date:</b> 03 April 2019	
<b>Building:</b>	Garage Site 12

<b>Floor:</b>	Ground Floor		
<b>Room Area:</b>	Block 1 Garages 001		
<b>Description:</b>	Cement Fascia Panel & Corrugated Roof		
<b>Quantity:</b>	40m <sup>2</sup>

<b>Accessibility:</b>	Medium		
<b>Product Type:</b>	1 - Cement Product		
<b>Damage Extent:</b>	1 - Low Damage		
<b>Surface Treatment:</b>	1 - Unsealed	<b>Re-inspection Due:</b>	03/04/2020
<b>Asbestos Type:</b>	1 - Chrysotile	<b>Sample Ref:</b>	Sample Reference 03
<b>Material Assessment:</b>		<b>Risk Score = 4</b> <b>Very Low</b>	
<b>Comments:</b> - <p>There was an unsealed cement fascia Panel sitting beneath the cement corrugated roof. It is presumed that this fascia Panel is part of a second layer of corrugated roof which runs beneath the top layer of cement roof sheets.</p>

<b>Recommendations:</b> <p>Remove</p> <p>The asbestos containing material should be removed and disposed of in full accordance with current and relevant legislation prior to the demolition of the building.</p>

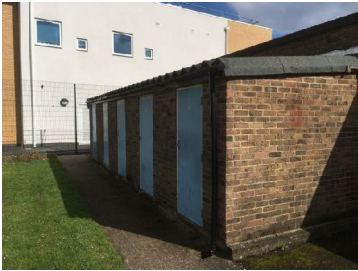
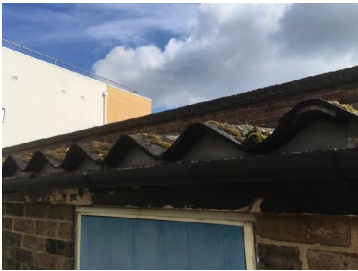
<b>Contract No:</b> S-07991	<b>Client:</b> Arcadis LLP	<b>Location Ref OSL:</b> OSL011	
<b>Site:</b> Garage Site 12, Rear of 1-18 Swann Court, 18 South Street, Isleworth, TW7 7AN		<b>Survey Date:</b> 03 April 2019	
<b>Building:</b>	Garage Site 12

<b>Floor:</b>	Ground Floor		
<b>Room Area:</b>	Block 3 Garages 003		
<b>Description:</b>	Cement Corrugated Roof & End Capping's		
<b>Quantity:</b>	15m <sup>2</sup>

<b>Accessibility:</b>	Medium		
<b>Product Type:</b>	1 - Cement Product		
<b>Damage Extent:</b>	1 - Low Damage		
<b>Surface Treatment:</b>	1 - Unsealed	<b>Re-inspection Due:</b>	03/04/2020
<b>Asbestos Type:</b>	1 - Chrysotile	<b>Sample Ref:</b>	Sample Reference 02
<b>Material Assessment:</b>		<b>Risk Score = 4</b> <b>Very Low</b>	
<b><u>Comments:</u></b> - Found to the stores attached at the rest of the garages. The cement was unsealed and there was end capping to the stores also.			
<b><u>Recommendations:</u></b> Remove The asbestos containing material should be removed and disposed of in full accordance with current and relevant legislation prior to the demolition of the building.
