### Asbestos Survey Report & Register

Survey Type:	Asbestos Demolition Survey
Site:	Garage Block at 20 Byfield Road, Isleworth, TW7 7AF
Surveyor(s):	Aaron Galyer & Liam Bates
Contract:	S-10023
Survey Date:	04 September 2019
Report Date:	10 September 2019
Client:	Arcadis LLP PO Box 307, Manchester, M60 3NT

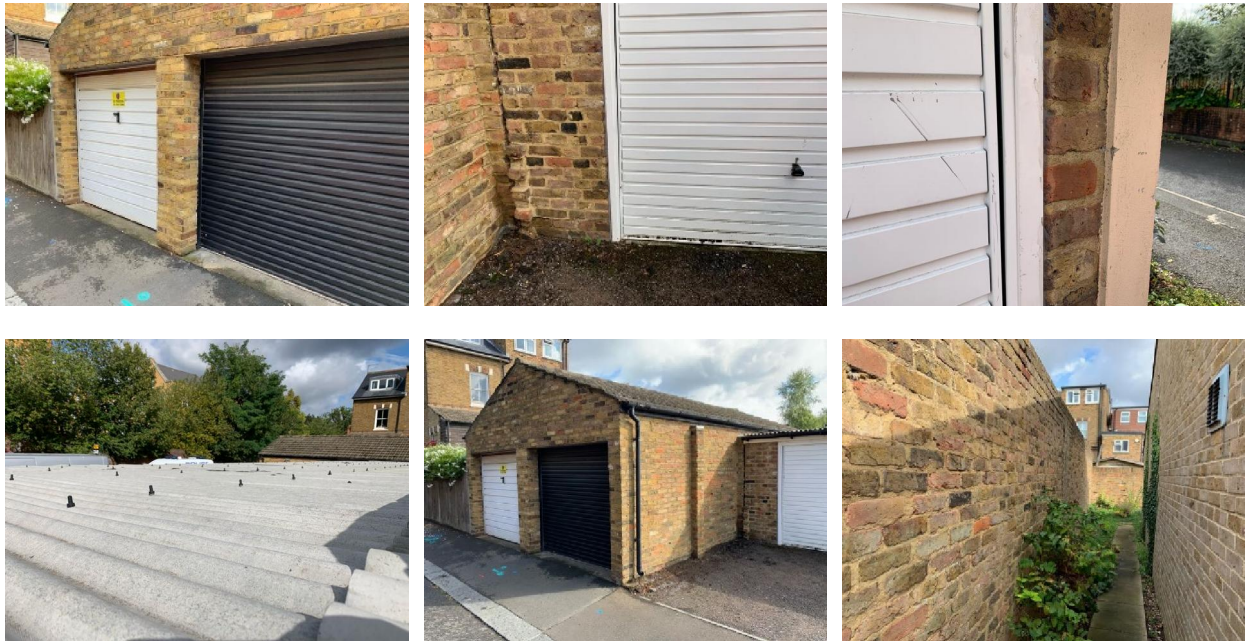
Area:	Garages - all areas - ground floor.
Floors:	The floors comprised of concrete. Only the external was accessed, internally could not be accessed as garages were locked.
Walls:	The walls comprised of brick.
Ceilings:	The ceilings comprised of cement profile sheet roof and clay tiled roof.
External:	The external comprised of UPVC & timber fascias, plastic gutters and downpipes, damp proof course, metal garage doors with metal/UPVC framework.

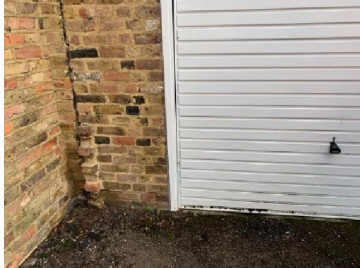
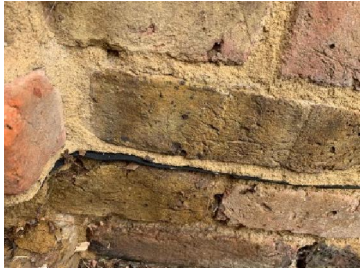
<b>Floor:</b>	Ground Floor		
<b>Room Area:</b>	External 099		
<b>Description:</b>	Bitumen Damp Proof Course		
<b>Quantity:</b>	50lm

<b>Accessibility:</b>	Difficult		
<b>Product Type:</b>	1 - Bituminous Product		
<b>Damage Extent:</b>	1 - Low Damage		
<b>Surface Treatment:</b>	0 - Composite	<b>Re-inspection Due:</b>	N/A
<b>Asbestos Type:</b>	No Asbestos Detected	<b>Sample Ref:</b>	S01
<b>Material Assessment:</b>		<b>No Asbestos Detected</b>	
<b>Comments:</b> - Bitumen damp proof course found to low level wall. Ran the perimeter of the garages to all brickwork.			
<b>Recommendations:</b> No action required

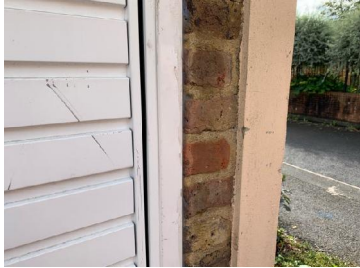
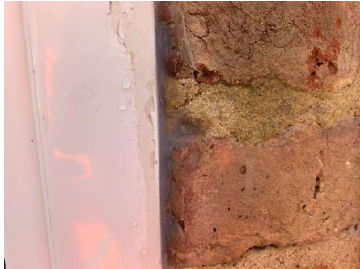
<b>Floor:</b>	Ground Floor		
<b>Room Area:</b>	External 099		
<b>Description:</b>	Putty to Doors		
<b>Quantity:</b>	24lm

<b>Accessibility:</b>	Medium		
<b>Product Type:</b>	1 - Putty		
<b>Damage Extent:</b>	1 - Low Damage		
<b>Surface Treatment:</b>	0 - Composite	<b>Re-inspection Due:</b>	N/A
<b>Asbestos Type:</b>	No Asbestos Detected	<b>Sample Ref:</b>	S02
<b>Material Assessment:</b>		<b>No Asbestos Detected</b>	
<b>Comments:</b> - Putty was to door joints to all door frames.			
<b>Recommendations:</b> No action required

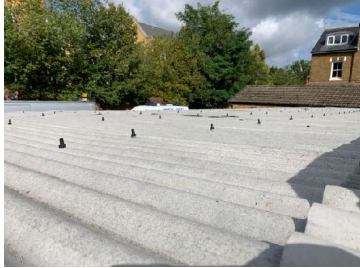
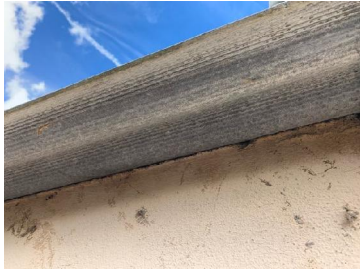
<b>Floor:</b>	Ground Floor		
<b>Room Area:</b>	External 099		
<b>Description:</b>	Cement Roof sheet		
<b>Quantity:</b>	90m <sup>2</sup>

<b>Accessibility:</b>	Difficult		
<b>Product Type:</b>	1 - Cement Product		
<b>Damage Extent:</b>	1 - Low Damage		
<b>Surface Treatment:</b>	1 - Unsealed	<b>Re-inspection Due:</b>	N/A
<b>Asbestos Type:</b>	No Asbestos Detected	<b>Sample Ref:</b>	S03
<b>Material Assessment:</b>		<b>No Asbestos Detected</b>	
<b>Comments:</b> - Cement roof sheets covering all roof areas.			
<b>Recommendations:</b> No action required

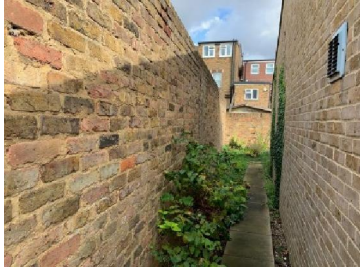
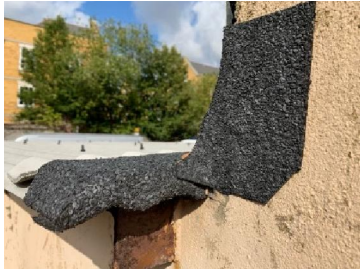
<b>Floor:</b>	Ground Floor		
<b>Room Area:</b>	External 099		
<b>Description:</b>	Felt to roof		
<b>Quantity:</b>	18lm

<b>Accessibility:</b>	Difficult		
<b>Product Type:</b>	1 - Bituminous Product		
<b>Damage Extent:</b>	1 - Low Damage		
<b>Surface Treatment:</b>	0 - Composite	<b>Re-inspection Due:</b>	N/A
<b>Asbestos Type:</b>	No Asbestos Detected	<b>Sample Ref:</b>	S04
<b>Material Assessment:</b>		<b>No Asbestos Detected</b>	
<b>Comments:</b> - Felt to rear joint of garage roof and wall.			
<b>Recommendations:</b> No action required

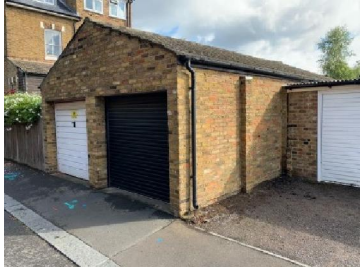
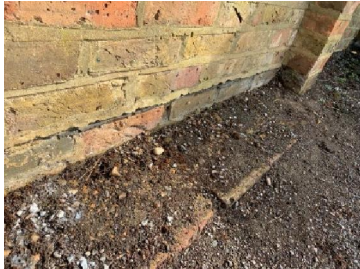
<b>Floor:</b>	Ground Floor		
<b>Room Area:</b>	External 099		
<b>Description:</b>	Bitumen Damp Proof Course		
<b>Quantity:</b>	30lm

<b>Accessibility:</b>	Difficult		
<b>Product Type:</b>	1 - Bituminous Product		
<b>Damage Extent:</b>	1 - Low Damage		
<b>Surface Treatment:</b>	0 - Composite	<b>Re-inspection Due:</b>	N/A
<b>Asbestos Type:</b>	No Asbestos Detected	<b>Sample Ref:</b>	S05
<b>Material Assessment:</b>		<b>No Asbestos Detected</b>	
<b>Comments:</b> - Bitumen damp proof course found to low level wall. Ran the perimeter of the garages to all brickwork. Visually different from OSL001.			
<b>Recommendations:</b> No action required
