Asbestos Survey Report and Register

Survey Type:	Asbestos Demolition Survey
Site:	Garage Sites (Kennedy Avenue), Enfield, London, EN3 4PN
Surveyor	Tom Newton
Contract:	C28647
Survey Date:	20th January 2022
Report Date:	26th January 2022
Re-inspection Due:	20th January 2023
Client:	Arcadis Part 2nd Floor, Charter House, Cambridge, CB2 1LA

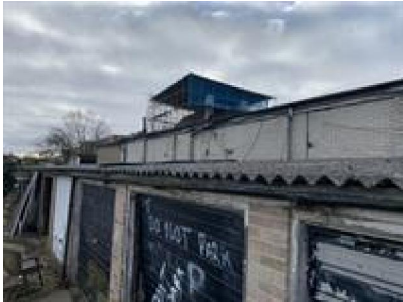
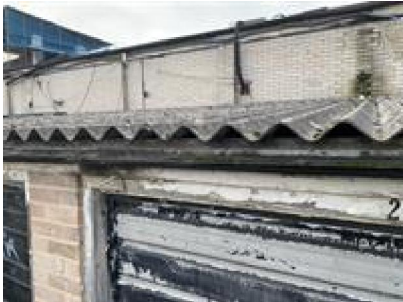
Contract No: C28647	Client: Arcadis	Location Ref ID: TN001	
Site: Garage Sites (Kennedy Avenue), Enfield, London, EN3 4PN		Survey Date: 20/01/2022	
Building:	Main

Floor:	Externals		
Room Area:	Blocks 1 and 2		
Description:	Cement profile roof		
Quantity:	= 150 Sq m

Accessibility:	Medium		
Product Type:	1 - Cement Product		
Damage Extent:	1 - Low damage		
Surface Treatment:	1 - Unsealed	Re-inspection Due:	N/A
Asbestos Type:	No Asbestos Detected	Sample Ref:	Sampled S01
Material Assessment:		No Asbestos Detected	
<u>Comments:</u> In amongst the positive roof sheets were modern replacement sheets. These have been sampled separately. However, the entire roof should be considered as a consistent cement based product.			
<u>Recommendations:</u> No further action.

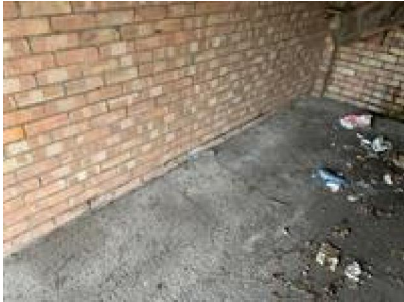
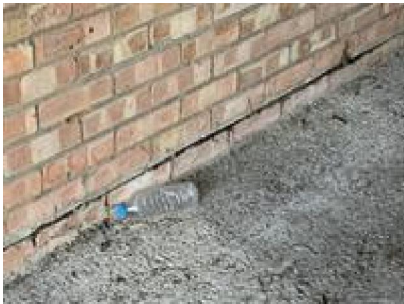
Contract No: C28647	Client: Arcadis	Location Ref ID: TN002	
Site: Garage Sites (Kennedy Avenue), Enfield, London, EN3 4PN		Survey Date: 20/01/2022	
Building:	Main

Floor:	Externals		
Room Area:	Block 1 001		
Description:	Bitumen Damp Proof Course		
Quantity:	= 150 Lin m

Accessibility:	Easy		
Product Type:	1 - Bituminous Product		
Damage Extent:	1 - Low damage		
Surface Treatment:	0 - Composite	Re-inspection Due:	N/A
Asbestos Type:	No Asbestos Detected	Sample Ref:	Sampled S02
Material Assessment:		No Asbestos Detected	
Comments: Seen internally and externally.			
Recommendations: No further action.

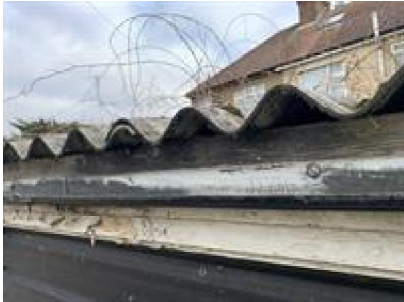
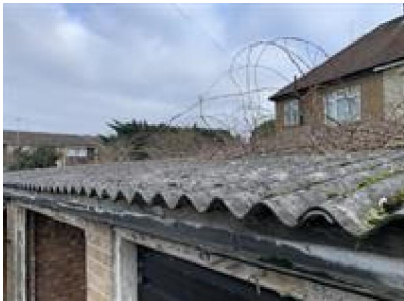
Contract No: C28647	Client: Arcadis	Location Ref ID: TN003	
Site: Garage Sites (Kennedy Avenue), Enfield, London, EN3 4PN		Survey Date: 20/01/2022	
Building:	Main

ID No / Sample No	Risk:	Room / Area:	Product Type:	Asbestos Type:	Extent:
TN003 / Sampled S03	Very Low	Main Externals Blocks 1 and 2	Cement Profile Roof/1 - Unsealed	Chrysotile	= 300 Sq m

Floor:	Externals		
Room Area:	Blocks 1 and 2		
Description:	Cement Profile Roof		
Quantity:	= 300 Sq m

Accessibility:	Medium		
Product Type:	1 - Cement Product		
Damage Extent:	1 - Low damage		
Surface Treatment:	1 - Unsealed	Re-inspection Due:	20/01/2023
Asbestos Type:	1 - Chrysotile	Sample Ref:	Sampled S03
Material Assessment:		Risk Score = 4 Very Low	
Comments: Cement profile roof.			
Recommendations: Remove The asbestos containing material should be removed and disposed of in full accordance with current and relevant legislation prior to demolition of the building.

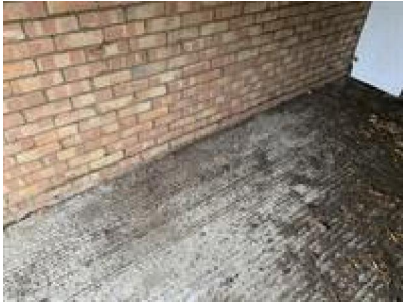
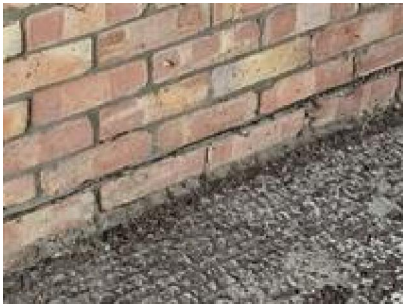
Contract No: C28647	Client: Arcadis	Location Ref ID: TN004	
Site: Garage Sites (Kennedy Avenue), Enfield, London, EN3 4PN		Survey Date: 20/01/2022	
Building:	Main

Floor:	Externals		
Room Area:	Block 2 002		
Description:	Bitumen Damp Proof Course		
Quantity:	= 150 Lin m

Accessibility:	Easy		
Product Type:	1 - Bituminous Product		
Damage Extent:	1 - Low damage		
Surface Treatment:	0 - Composite	Re-inspection Due:	N/A
Asbestos Type:	No Asbestos Detected	Sample Ref:	Sampled S04
Material Assessment:		No Asbestos Detected	
Comments: Seen internally and externally.			
Recommendations: No further action.
