Asbestos Survey Report and Register

Survey Type:	Asbestos Demolition Survey
Site:	Garage Site 1, Ivy Road, Enfield, London, N14 4LP
Surveyor	Tom Newton
Contract:	C28585A
Survey Date:	20th January 2022
Report Date:	25th January 2022
Re-inspection Due:	20th January 2023
Client:	Arcadis Part 2nd Floor, Charter House, Cambridge, CB2 1LA

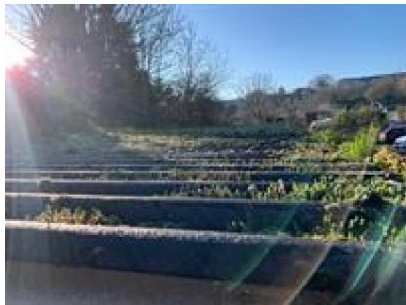
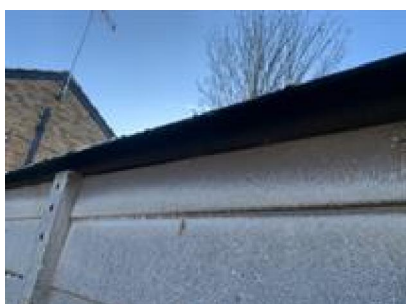
Contract No: C28585A	Client: Arcadis	Location Ref ID: TN001	
Site: Garage Site 1, Ivy Road, Enfield, London, N14 4LP		Survey Date: 20/01/2022	
Building:	Main

Floor:	Externals		
Room Area:	External 099		
Description:	Corrugated Cement Roof Sheets		
Quantity:	= 80 Sq m

Accessibility:	Difficult		
Product Type:	1 - Cement Product		
Damage Extent:	1 - Low damage		
Surface Treatment:	1 - Unsealed	Re-inspection Due:	20/01/2023
Asbestos Type:	1 - Chrysotile	Sample Ref:	Sampled S01
Material Assessment:		Risk Score = 4 Very Low	
Comments: Consistent with all connected roofs.			
Recommendations: Remove The asbestos containing material should be removed and disposed of in full accordance with current and relevant legislation prior to demolition of the building.

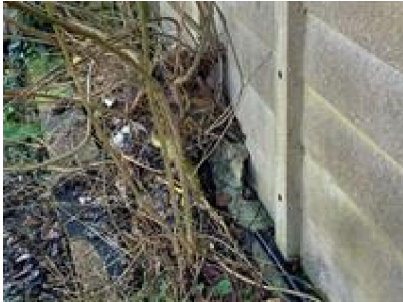
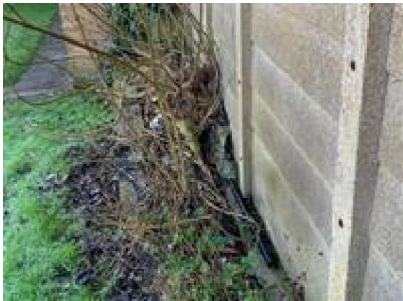
Contract No: C28585A	Client: Arcadis	Location Ref ID: TN002	
Site: Garage Site 1, Ivy Road, Enfield, London, N14 4LP		Survey Date: 20/01/2022	
Building:	Main

ID No / Sample No	Risk:	Room / Area:	Product Type:	Asbestos Type:	Extent:
TN002 / Sampled S02	Low	Main External	Cement Debris To Floor Beside Garage 9/1 - Unsealed	Chrysotile	= 2 Sq m
TN001 / Sampled S01	Very Low	Main External	Corrugated Cement Roof Sheets/1 - Unsealed	Chrysotile	= 80 Sq m

Floor:	Externals		
Room Area:	External 099		
Description:	Cement Debris To Floor Beside Garage 9		
Quantity:	= 2 Sq m

Accessibility:	Easy		
Product Type:	1 - Cement Product		
Damage Extent:	3 - High damage		
Surface Treatment:	1 - Unsealed	Re-inspection Due:	20/01/2023
Asbestos Type:	1 - Chrysotile	Sample Ref:	Sampled S02
Material Assessment:		Risk Score = 6 Low	
<u>Comments:</u> Cement debris to floor.			
<u>Recommendations:</u> Remove The asbestos cement debris should be removed and disposed of in full accordance with current and relevant legislation.
