Asbestos Survey Report and Register

Survey Type:	Asbestos Demolition Survey
Site:	Garage Site 2, Ivy Road, Enfield, London, N14 4LP
Surveyor	Tom Newton
Contract:	C28585B
Survey Date:	20th January 2022
Report Date:	25th January 2022
Re-inspection Due:	20th January 2023
Client:	Arcadis Part 2nd Floor, Charter House, Cambridge, CB2 1LA

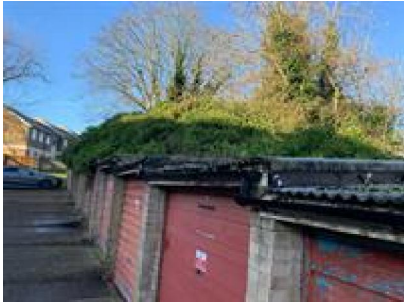
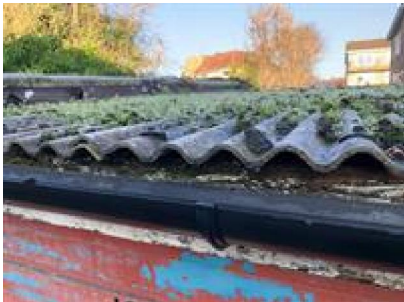
Contract No: C28585B	Client: Arcadis	Location Ref ID: TN001	
Site: Garage Site 2, Ivy Road, Enfield, London, N14 4LP		Survey Date: 20/01/2022	
Building:	Main

Floor:	Externals		
Room Area:	External 099		
Description:	Cement Corrugated Roof Sheets		
Quantity:	= 120 Sq m

Accessibility:	Difficult		
Product Type:	1 - Cement Product		
Damage Extent:	2 - Medium damage		
Surface Treatment:	0 - Composite	Re-inspection Due:	N/A
Asbestos Type:	No Asbestos Detected	Sample Ref:	Sampled S01
Material Assessment:		No Asbestos Detected	
<u>Comments:</u> Missing and cracked in some areas.			
<u>Recommendations:</u> No further action.

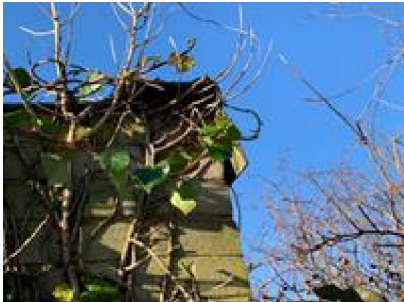
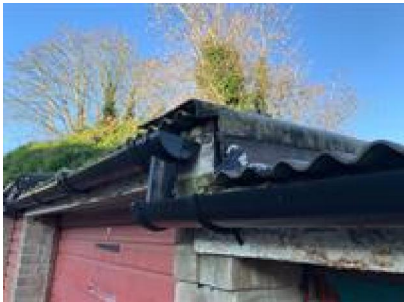
Contract No: C28585B	Client: Arcadis	Location Ref ID: TN002	
Site: Garage Site 2, Ivy Road, Enfield, London, N14 4LP		Survey Date: 20/01/2022	
Building:	Main

Floor:	Externals		
Room Area:	External 099		
Description:	Cement Edge Capping Between Garages And Overlapping The Back Of Garages		
Quantity:	= 60 Lin m

Accessibility:	Medium		
Product Type:	1 - Cement Product		
Damage Extent:	1 - Low damage		
Surface Treatment:	1 - Unsealed	Re-inspection Due:	N/A
Asbestos Type:	No Asbestos Detected	Sample Ref:	Sampled S02
Material Assessment:		No Asbestos Detected	
Comments: Located between garages and capping the back wall of garages.			
Recommendations: No further action.

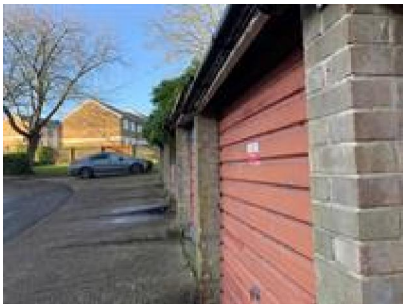
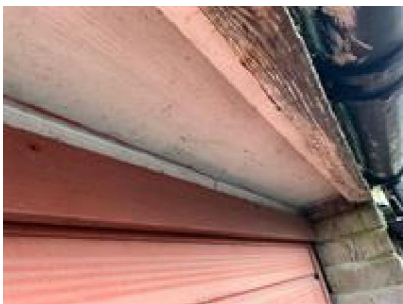
Contract No: C28585B	Client: Arcadis	Location Ref ID: TN003	
Site: Garage Site 2, Ivy Road, Enfield, London, N14 4LP		Survey Date: 20/01/2022	
Building:	Main

ID No / Sample No	Risk:	Room / Area:	Product Type:	Asbestos Type:	Extent:
TN003 / Sampled S03	Low	Main External	Insulating Board Soffits To Front Of Garages/1 - Sealed	Amosite, chrysotile	= 30 Lin m

Floor:	Externals		
Room Area:	External 099		
Description:	Insulating Board Soffits To Front Of Garages		
Quantity:	= 30 Lin m

Accessibility:	Difficult		
Product Type:	2 - Insulating board		
Damage Extent:	1 - Low damage		
Surface Treatment:	1 - Sealed	Re-inspection Due:	20/01/2023
Asbestos Type:	2 - Amosite, chrysotile	Sample Ref:	Sampled S03
Material Assessment:		Risk Score = 6 Low	
<u>Comments:</u> Missing on 6 and 8 and 11.			
<u>Recommendations:</u> Remove The asbestos containing material should be removed and disposed of in full accordance with current and relevant legislation prior to demolition of the building.

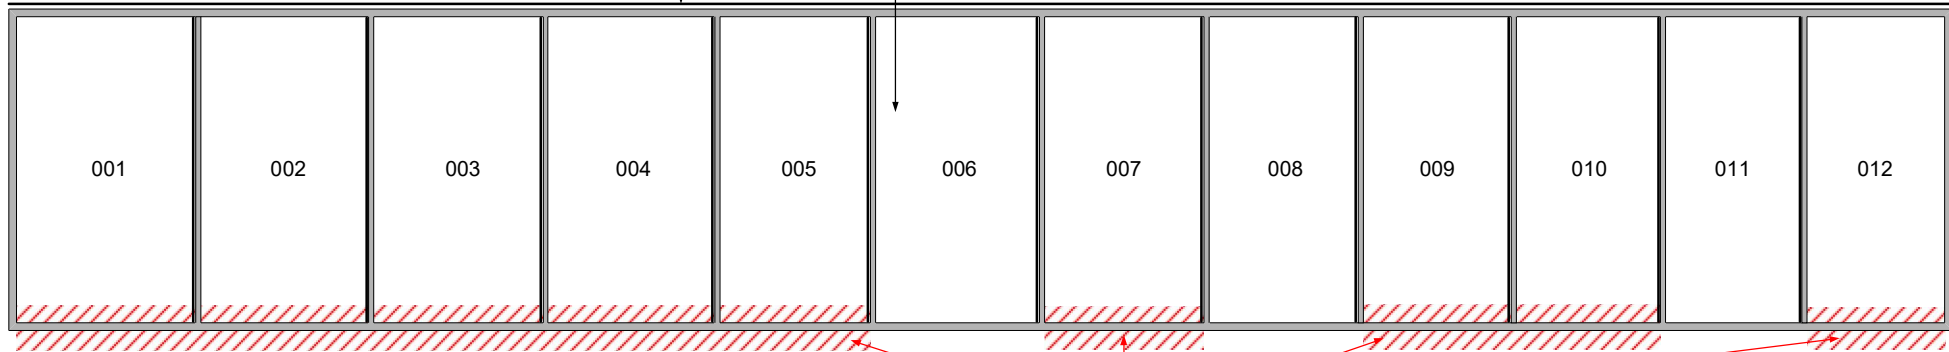
Block 2

TN002
S02
Cement

TN001
S01
Cement

TN003
S03
Insulating
Board
