# Public Realm, Walking and Cycling Strategy

**OOPR**  
OLD OAK & PARK ROYAL  
WALKING, CYCLING &  
PUBLIC REALM

*PERS Audit*

## Old Oak & Park Royal Walking, Cycling, Streets and Public Realm Strategy: PERS audit

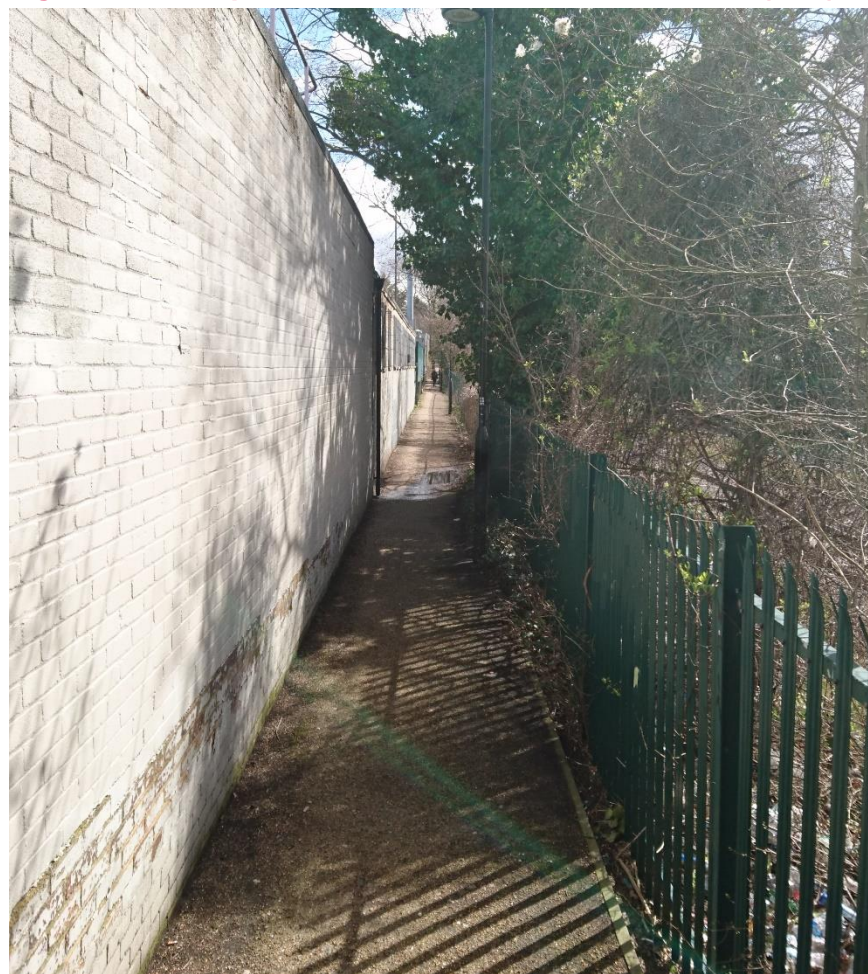
- 4.1.8 As presented in section 3.3, the study area is characterised by a high rate of violent and sexual crime. The experience of on-street auditing was that the main streets through Old Oak Common and Park Royal had some footfall during daylight hours and some form of street lighting. Yet there are large sections of these streets with predominantly inactive frontages since many of the industrial estates have an internal layout and back onto the main roads through the area.
- 4.1.9 Furthermore, there are several key routes into the study area where pedestrians have large sections with no fronting or overlooking activity at all. These include the Stonebridge Park station link over the North Circular (R9a), the Park Royal station link (R8b and R10), the cemetery link between North Acton station and Park Royal Road (R9b), and the succession of railway tunnels on Old Oak Common lane (R6b).

**Figure 4-3: Footpath link towards North Acton station (R9b)**

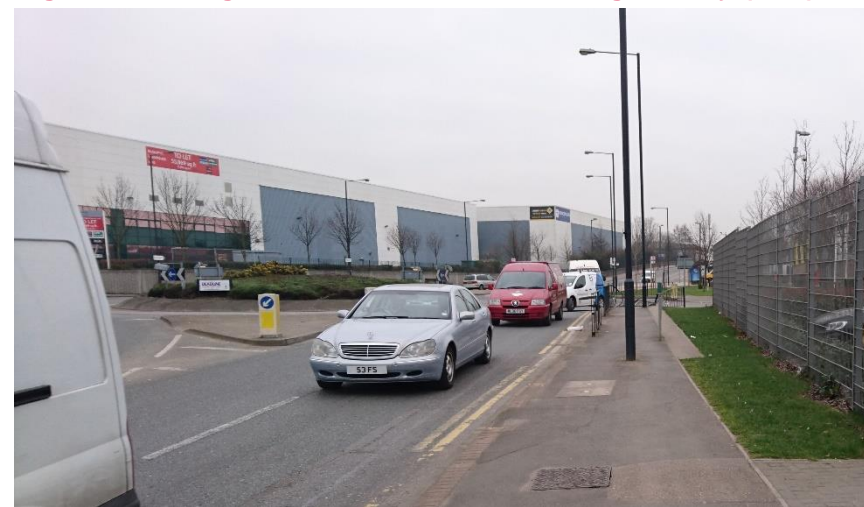
- 4.1.13 The vast majority of the study area is dominated by industrial land use. The quality of the pedestrian experience when walking in these areas is generally negative due to the presence of large blank walls and routes along busy roads with a very high proportion of HGVs.

**Figure 4-4: Large units with no street-facing activity (R9a)**

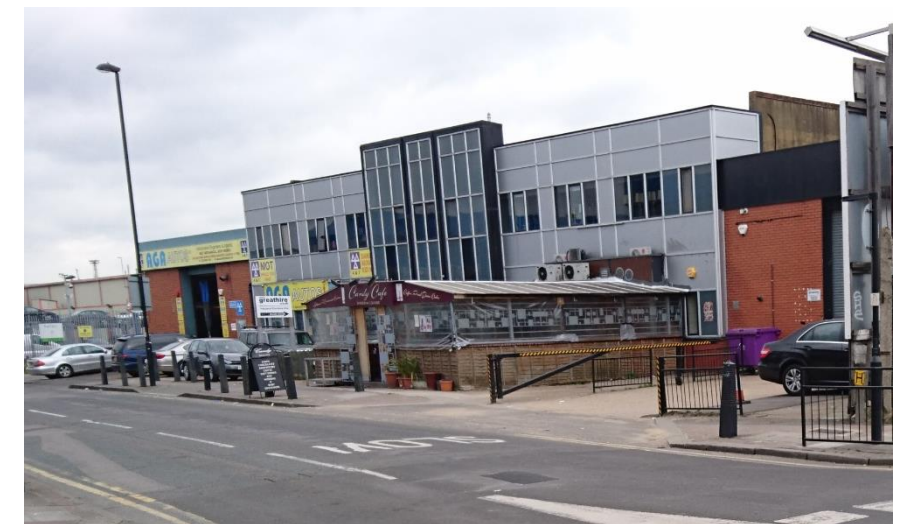
- 4.1.14 The perception of quality of the environment does depend on the nature of the industrial frontages though. In some areas with smaller unit sizes and some street-facing units there is more visual interest and the passer-by can catch glimpses of the adjacent places of work. Yet the more interesting environments are often those that generate the most conflict with pedestrians if they spill out onto the footway

**Figure 4-5: Smaller unit sizes with street-facing activity (R7)**

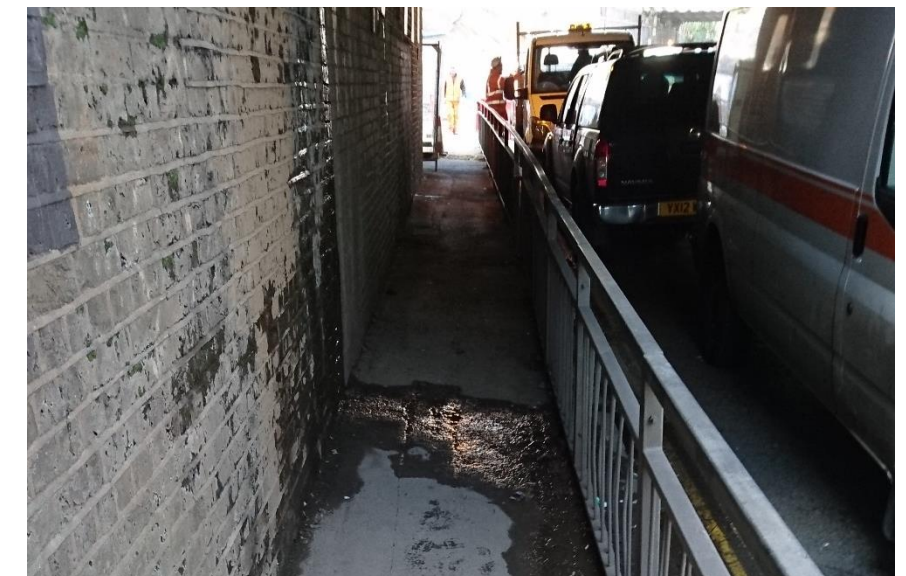
- 4.2.3 The vast majority of links in the study area have enough space to provide effective footway width for the level of flows currently experienced.
- 4.2.4 Narrower footways are encountered in the railway tunnels on Old Oak Common Lane (L17 and L18), and the provision of guardrails reduces the effective width yet further. The capacity in these tunnels will prove challenging if pedestrian flows increase with development in the area.

Figure 4-8: Narrow footways in railway tunnels (L17)

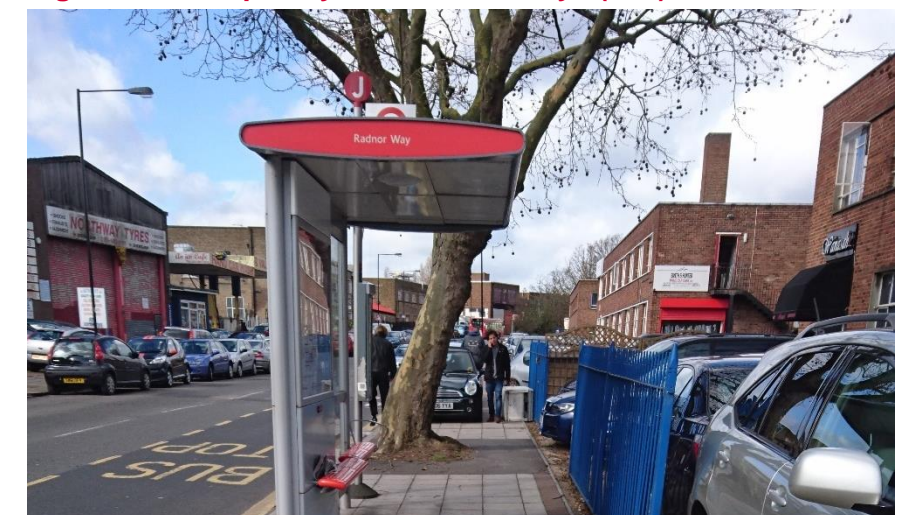
- 4.2.5 In most of the study area, the effective pedestrian space available is determined mainly by the positioning of obstructions in the footway. For example, it is not uncommon in this area that large road signs aimed at HGVs travelling at speed are mounted on two poles in the footway.
- 4.2.6 The blocking of footway space is most acute in several areas with a clustering of automotive related industries (L31, L24 and L27). The merging of workshop space and footway frequently leads to footways being blocked. While these are some of the more amenable pedestrian environments in Park Royal in terms of street-facing activity, they frequently fail to provide to a minimum effective width allowing passage by all users.

Figure 4-9: Frequently blocked footways (L31)

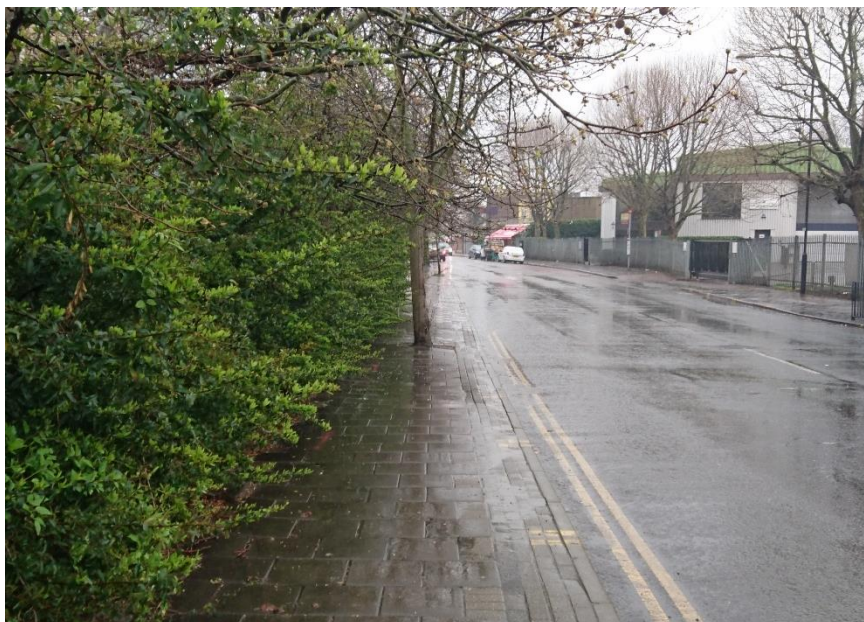
- 4.2.7 One section of footway adjacent to Central Middlessex Hospital (L34) is effectively blocked by overhanging vegetation. The remaining footway width is unacceptable, especially for an approach route to a major hospital.

**Figure 4-10: Overhanging vegetation (L34)**

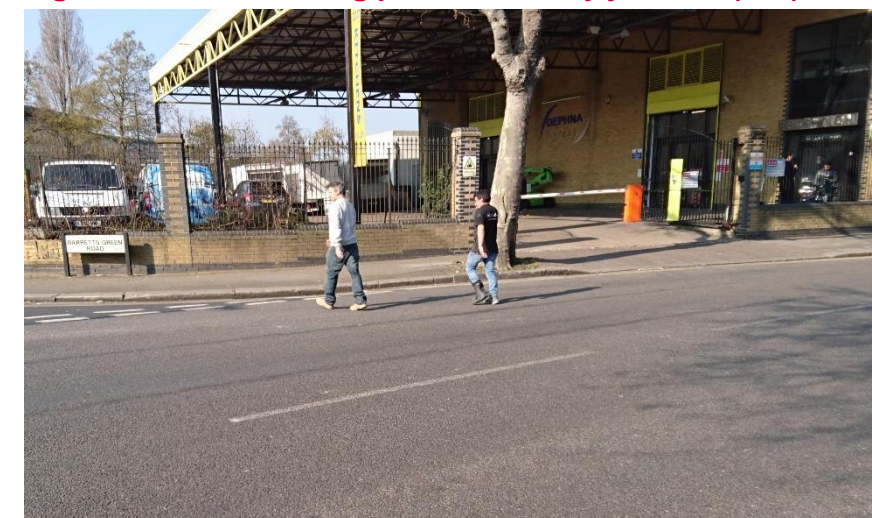
observed to cross on desire lines with poor visibility and fast vehicle speeds. Other links have long stretches with no crossing assistance at all where informal crossing is rendered difficult by high speeds and poor visibility due to parked vehicles (L32 and L31).

**Figure 4-13: No crossing provision at key junction (L27)**

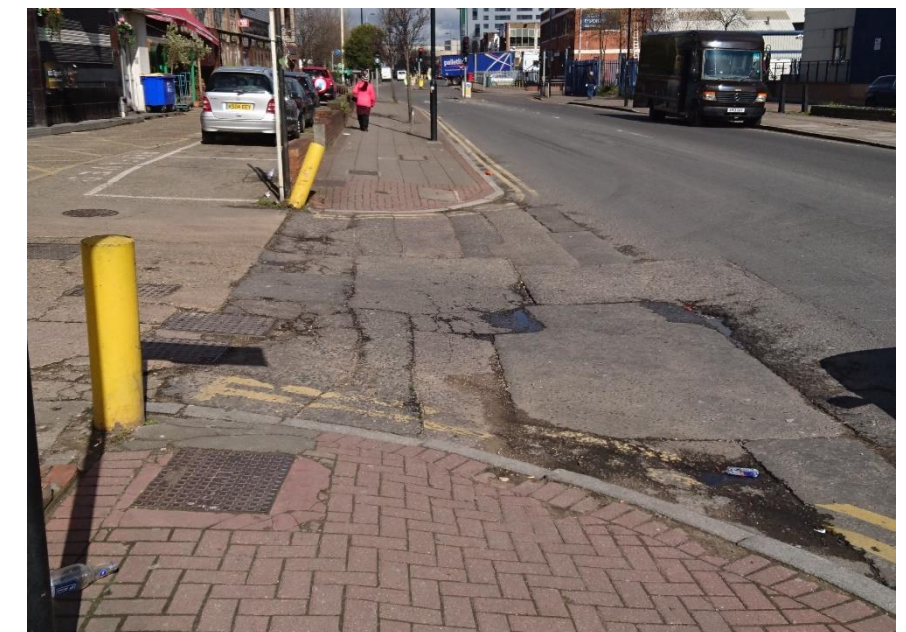
- 4.2.25 The footpaths and shared path links in the study area are generally characterised by decent surface quality. On the streets with industrial frontages, the presence of HGVs parking, servicing and turning into premises at vehicle crossovers makes the maintenance of the footway surface challenging.
- 4.2.26 A number of links scored very poorly for surface quality (L20, L23 and L26). Typical evidence of HGV damage includes dislodged kerbstones, surface rutting, cracked paving, cracked or splintering carriageway surfaces on vehicle crossovers. These factors can result in significant trip hazards for pedestrians.

Figure 4-18: Poor surface quality at vehicle crossover (L23)

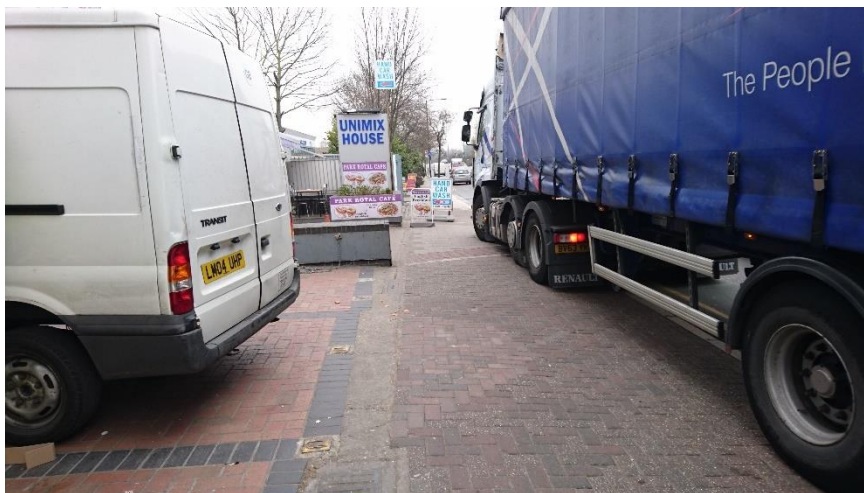
**Figure 4-20: Lorry parking on footway (L35)**

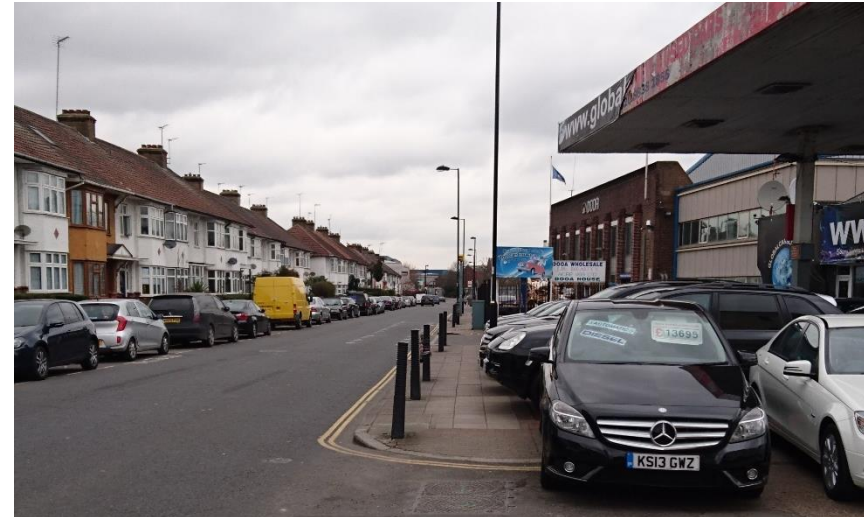
**Figure 4-21: Garage overspill into footway (L24)**

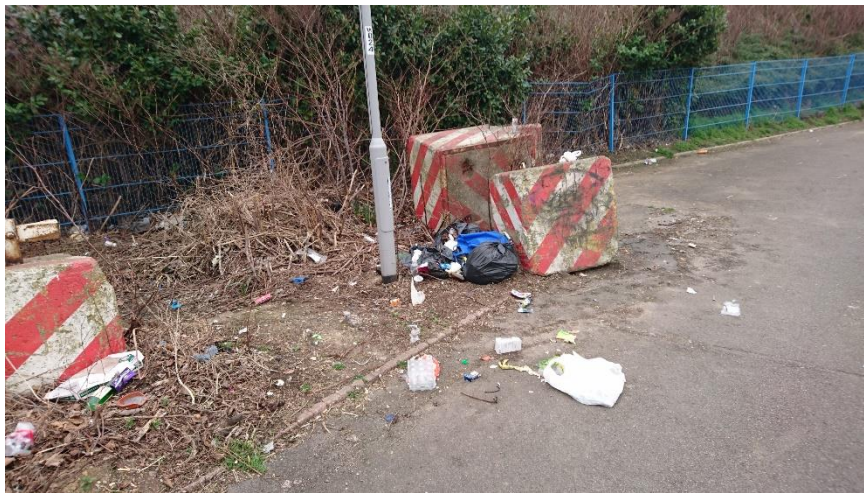
- 4.2.35 A number of both positive and negative scores were allocated to links in the study area for maintenance.
- 4.2.36 The presence of HGVs carrying aggregates through the area means that some streets are frequently exposed to dust, grit and debris. The ability of the footways to be cleaned then depends greatly on the surface quality and the presence of obstruction such as excess guardrail where dirt and grit tends to build up.
- 4.2.37 One observed effect of HGV damage on footways was a tendency for puddling in wet conditions.
- 4.2.38 In terms of general litter, some links were observed to be generally clean with bins generally provided at bus stops. But at the other end of the extreme were links with excessive litter and fly tipping.

**Figure 4-25: Fly tipping and litter (L9)**

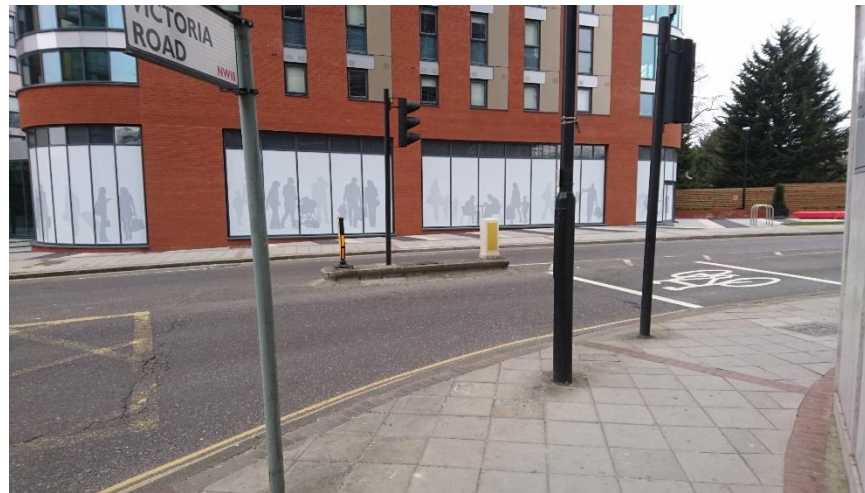
**Figure 4-28: No crossing on desire line (C17)**

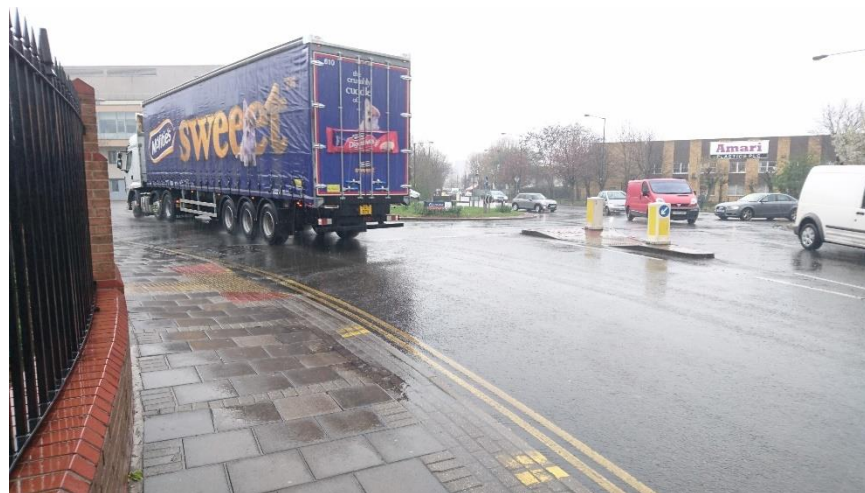
4.3.5 There are several large roundabouts in the study area, one at the entry to Coronation Road (C13 and C40) and two on Abbey Road (C50-C52 and C57-C59). The provision of dropped kerbs is all that denotes a crossing alignment on dual carriageway approaches to these major roundabouts. With wide turning radii, traffic is observed to enter and exit the roundabout at considerable speed.

**Figure 4-29: Crossing at large roundabout (C52)**

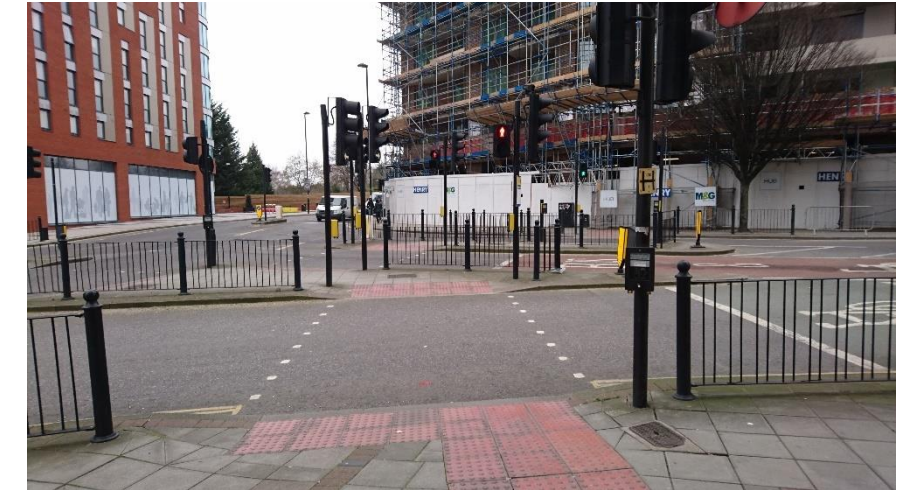
**Figure 4-32: Triple staggered crossing (C18)**

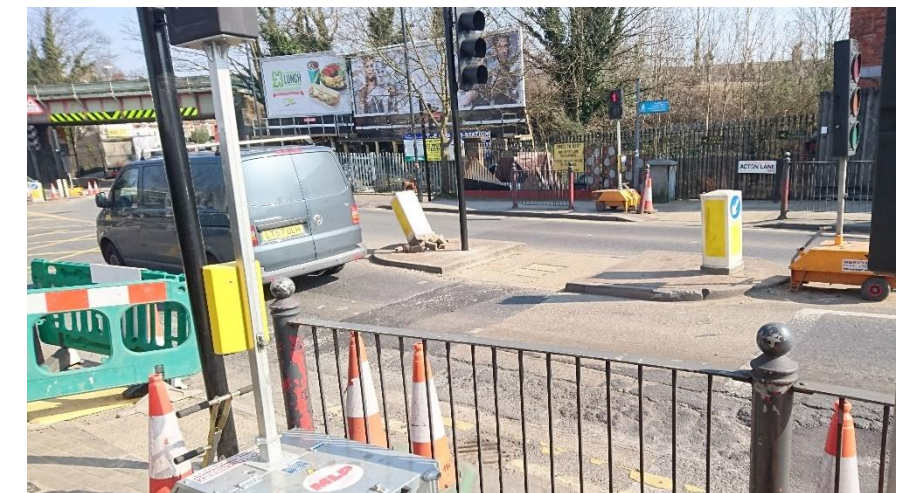
**Figure 4-33: Narrow crossing at Harlesden station (C8)**

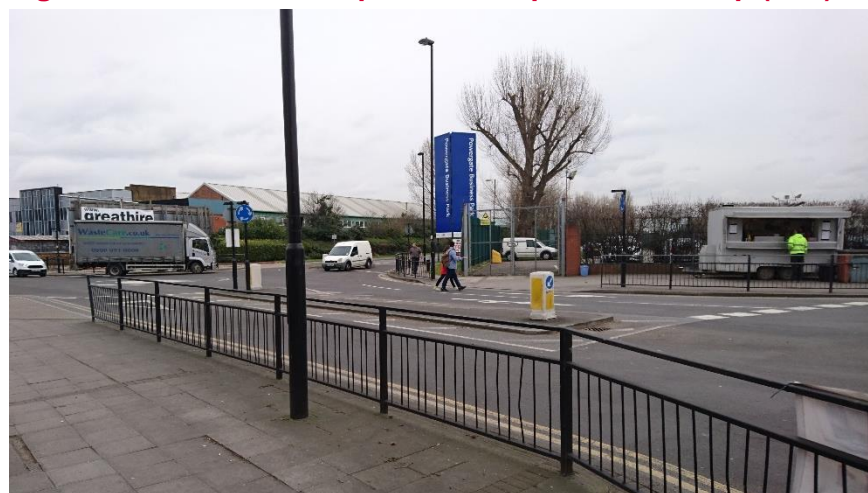
- 4.3.14 The majority of the signalised and zebra crossings in the study area were assessed to have a reasonable delineation of the crossing space, clearly identifiable stop lines and generally good visibility for drivers and pedestrians.
- 4.3.15 The roundabouts do not perform as well in terms of the delineation of pedestrian crossing space and sightlines between drivers and pedestrians. In many cases there is simply very little sense of pedestrian ownership of the space. The double roundabout arrangement on Chase Road is one example of illegible crossings. Drivers are observed to approach at speed and negotiate between multiple vehicle movements while paying little attention to the presence of pedestrians.

**Figure 4-34: No sense of pedestrian space ownership (C23)**

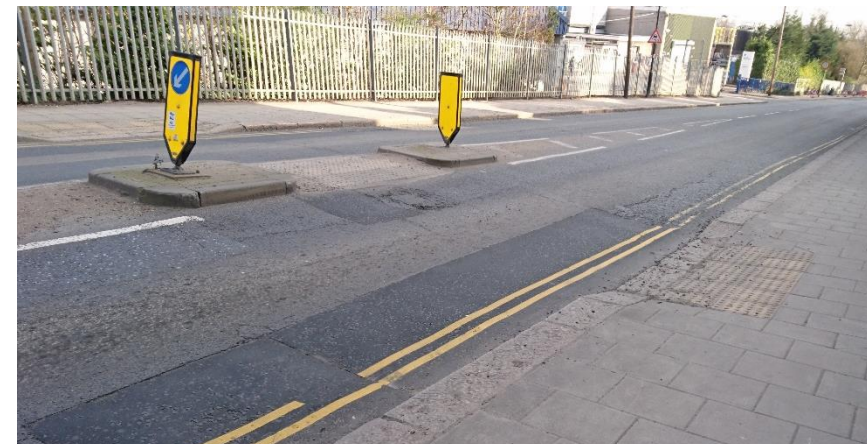
- 4.3.19 Surface quality issues occur at several points where the carriageway is uneven, rutted or broken up at the point where pedestrian cross the road (e.g. C20 and C22).

**Figure 4-35: Carriageway damage at crossing (C22)**

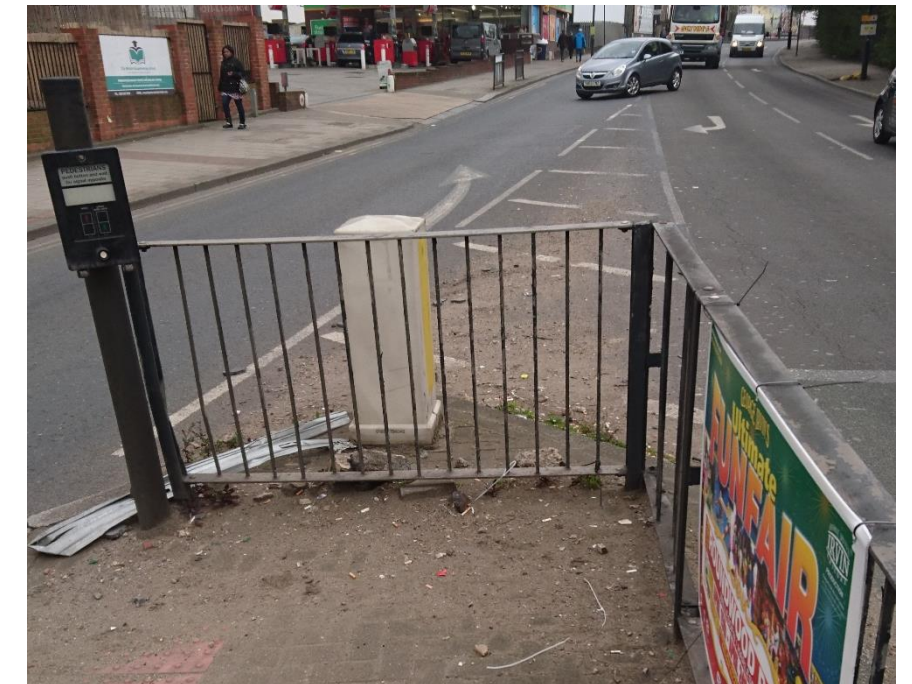
- 4.3.20 It was identified in the link audits that the presence of HGVs transporting aggregates results in grit and dust in the carriageway. This grit and debris tends to gather at dropped kerbs and crossing islands.

**Figure 4-36: Build-up of grit and debris at crossing island (C7)**

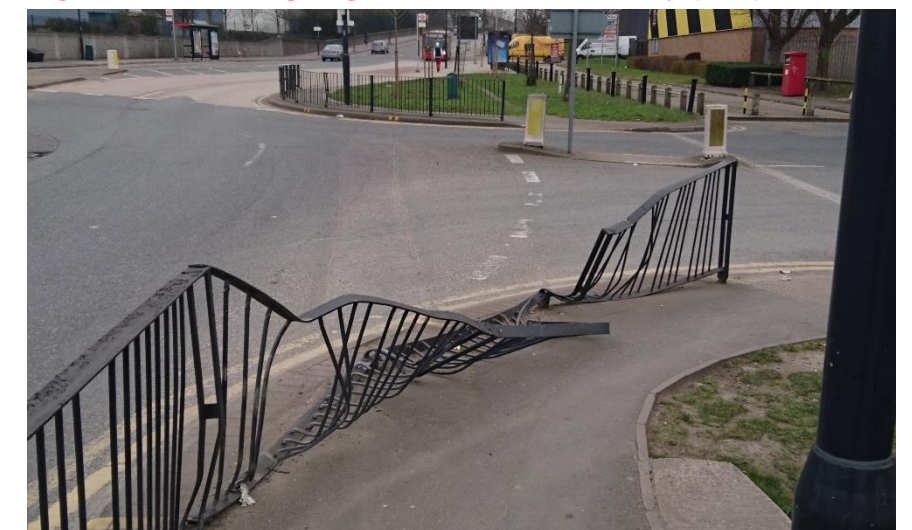
- 4.3.21 One specific issue noted in the study area is the frequent presence of guard rail and other street furniture that has been damaged by vehicles. This may be a consequence of the aggressive driving behaviour frequently observed in the area and it does reduce the effective pedestrian width available in several places (C13 and C58).

**Figure 4-37: Damaged guard rail in the footway (C58)**
