### Asbestos Survey Report & Register

Survey Type:	Asbestos Demolition Survey
Site:	Garages - Beech Avenue, Adjacent to 48 Beech Avenue, Brentwood, TW8 8NH
Surveyor:	Liam Bates
Contract:	S-10564
Survey Date:	04 November 2019
Report Date:	13 November 2019
Client:	Arcadis LLP PO Box 307, Manchester, M60 3NT

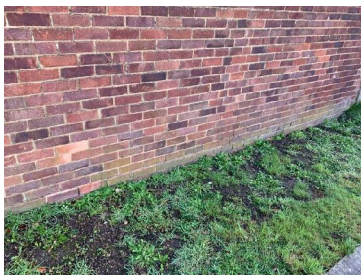
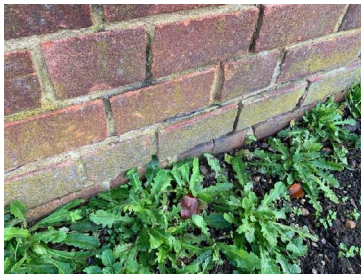
<b>Floor:</b>	Ground Floor		
<b>Room Area:</b>	Garages 001 - 006		
<b>Description:</b>	Damp Proof Course		
<b>Quantity:</b>	40lm

<b>Accessibility:</b>	Difficult		
<b>Product Type:</b>	1 - Bituminous Product		
<b>Damage Extent:</b>	1 - Low Damage		
<b>Surface Treatment:</b>	0 - Composite	<b>Re-inspection Due:</b>	N/A
<b>Asbestos Type:</b>	No Asbestos Detected	<b>Sample Ref:</b>	S01
<b>Material Assessment:</b>		<b>No Asbestos Detected</b>	
<b>Comments:</b> - The damp proof course was found to the low level wall around the perimeter of the garages.			
<b>Recommendations:</b> No action required

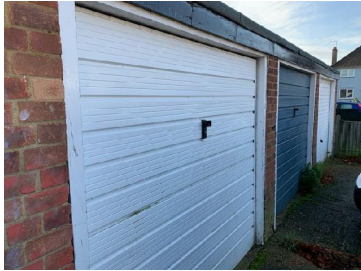
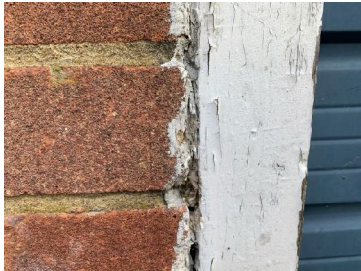
<b>Floor:</b>	Ground Floor		
<b>Room Area:</b>	Garages 001 - 006		
<b>Description:</b>	Putty to Garage Door Joints		
<b>Quantity:</b>	24lm

<b>Accessibility:</b>	Medium		
<b>Product Type:</b>	1 - Putty		
<b>Damage Extent:</b>	2 - Medium		
<b>Surface Treatment:</b>	0 - Composite	<b>Re-inspection Due:</b>	N/A
<b>Asbestos Type:</b>	No Asbestos Detected	<b>Sample Ref:</b>	S02
<b>Material Assessment:</b>		<b>No Asbestos Detected</b>	
<b>Comments:</b> - The putty was to the door joints to all garage doors. A composite sample from multiple locations was taken.			
<b>Recommendations:</b> No action required

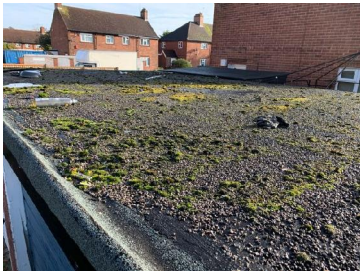
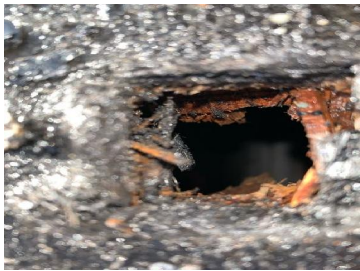
<b>Floor:</b>	Ground Floor		
<b>Room Area:</b>	Garages 001 - 006		
<b>Description:</b>	Roofing Felt		
<b>Quantity:</b>	75m <sup>2</sup>

<b>Accessibility:</b>	Medium		
<b>Product Type:</b>	1 - Bituminous Product		
<b>Damage Extent:</b>	2 - Medium		
<b>Surface Treatment:</b>	0 - Composite	<b>Re-inspection Due:</b>	N/A
<b>Asbestos Type:</b>	No Asbestos Detected	<b>Sample Ref:</b>	S03
<b>Material Assessment:</b>		<b>No Asbestos Detected</b>	
<b>Comments:</b> - The roof felt was uniform throughout the roofing area. A core hole was bored to establish that the felt was applied onto timber below. A sample of the felt was taken and the hole was patch repaired.

<b>Recommendations:</b> No action required
