### Asbestos Survey Report & Register

Survey Type:	Asbestos Demolition Survey
Site:	Garages - Beaconsfield Close, Beaconsfield Close, Chiswick, W4 4EL
Surveyor:	Liam Bates
Contract:	S-10566
Survey Date:	04 November 2019
Report Date:	12 November 2019
Re-Inspection Due:	04 November 2020
Client:	Arcadis LLP PO Box 307, Manchester, M60 3NT

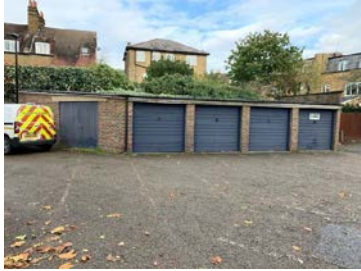
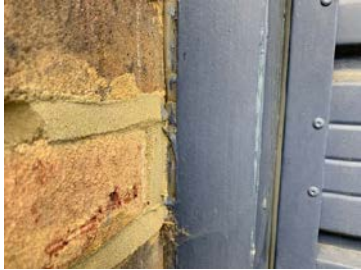
<b>Contract No:</b> S-10566	<b>Client:</b> Arcadis LLP	<b>ID Number:</b> 201038	
<b>Site:</b> Garages - Beaconsfield Close, Beaconsfield Close, Chiswick, W4 3EL		<b>Survey Date:</b> 04 November 2019	
<b>Building:</b>	Garages - Beaconsfield Close

<b>Floor:</b>	Ground Floor		
<b>Room Area:</b>	Garages 4-7 as 001		
<b>Description:</b>	Putty to Door Joints		
<b>Quantity:</b>	20lm

<b>Accessibility:</b>	Medium		
<b>Product Type:</b>	1 - Putty		
<b>Damage Extent:</b>	2 - Medium		
<b>Surface Treatment:</b>	0 - Composite	<b>Re-inspection Due:</b>	N/A
<b>Asbestos Type:</b>	No Asbestos Detected	<b>Sample Ref:</b>	S01
<b>Material Assessment:</b>		<b>No Asbestos Detected</b>	
<b>Comments:</b> - Putty was present to all timber framework joints.			
<b>Recommendations:</b> No action required

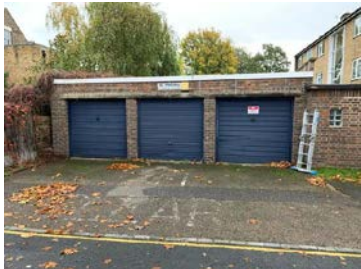
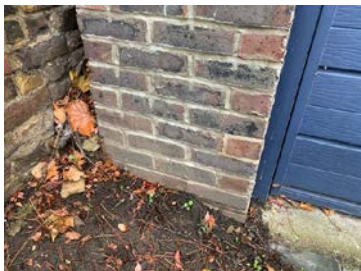
<b>Contract No:</b> S-10566	<b>Client:</b> Arcadis LLP	<b>ID Number:</b> 201034	
<b>Site:</b> Garages - Beaconsfield Close, Beaconsfield Close, Chiswick, W4 3EL		<b>Survey Date:</b> 04 November 2019	
<b>Building:</b>	Garages - Beaconsfield Close

<b>Floor:</b>	Ground Floor		
<b>Room Area:</b>	Garages 1-3 as 002		
<b>Description:</b>	Bitumen Damp Proof Course		
<b>Quantity:</b>	26lm

<b>Accessibility:</b>	Difficult		
<b>Product Type:</b>	1 - Bituminous Product		
<b>Damage Extent:</b>	1 - Low Damage		
<b>Surface Treatment:</b>	0 - Composite	<b>Re-inspection Due:</b>	04/11/2020
<b>Asbestos Type:</b>	1 - Chrysotile	<b>Sample Ref:</b>	S02
<b>Material Assessment:</b>		<b>Risk Score = 3</b> <b>Very Low</b>	
<b>Comments:</b> - The damp proof course ran the perimeter and was to the low level wall.			
<b>Recommendations:</b> Remove The asbestos containing material should be removed and disposed of in full accordance with current and relevant legislation prior to the demolition of the building.

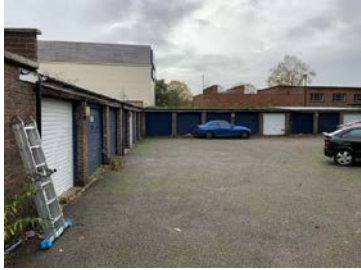
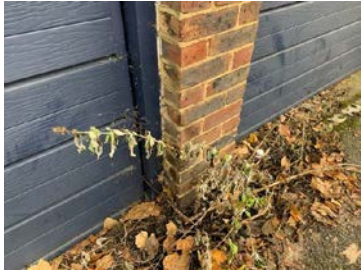
<b>Contract No:</b> S-10566	<b>Client:</b> Arcadis LLP	<b>ID Number:</b> 201030	
<b>Site:</b> Garages - Beaconsfield Close, Beaconsfield Close, Chiswick, W4 3EL		<b>Survey Date:</b> 04 November 2019	
<b>Building:</b>	Garages - Beaconsfield Close

<b>Floor:</b>	Ground Floor		
<b>Room Area:</b>	Garages 11-27 as 003		
<b>Description:</b>	Bitumen Damp Proof Course		
<b>Quantity:</b>	100lm

<b>Accessibility:</b>	Difficult		
<b>Product Type:</b>	1 - Bituminous Product		
<b>Damage Extent:</b>	1 - Low Damage		
<b>Surface Treatment:</b>	0 - Composite	<b>Re-inspection Due:</b>	N/A
<b>Asbestos Type:</b>	No Asbestos Detected	<b>Sample Ref:</b>	S04
<b>Material Assessment:</b>		<b>No Asbestos Detected</b>	
<b>Comments:</b> - The damp proof course ran the perimeter and was to the low level wall.			
<b>Recommendations:</b> No action required

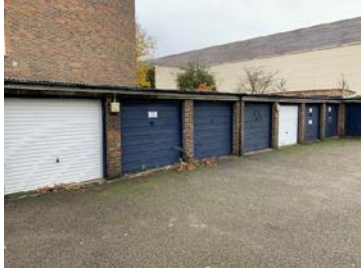
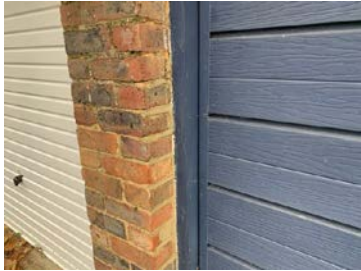
<b>Contract No:</b> S-10566	<b>Client:</b> Arcadis LLP	<b>ID Number:</b> 201051	
<b>Site:</b> Garages - Beaconsfield Close, Beaconsfield Close, Chiswick, W4 3EL		<b>Survey Date:</b> 04 November 2019	
<b>Building:</b>	Garages - Beaconsfield Close

<b>Floor:</b>	Ground Floor		
<b>Room Area:</b>	Garages 11-27 as 003		
<b>Description:</b>	Putty to Door Joints		
<b>Quantity:</b>	68lm

<b>Accessibility:</b>	Medium		
<b>Product Type:</b>	1 - Putty		
<b>Damage Extent:</b>	2 - Medium		
<b>Surface Treatment:</b>	0 - Composite	<b>Re-inspection Due:</b>	N/A
<b>Asbestos Type:</b>	No Asbestos Detected	<b>Sample Ref:</b>	S05
<b>Material Assessment:</b>		<b>No Asbestos Detected</b>	
<b>Comments:</b> - Putty was present to all timber framework joints.			
<b>Recommendations:</b> No action required

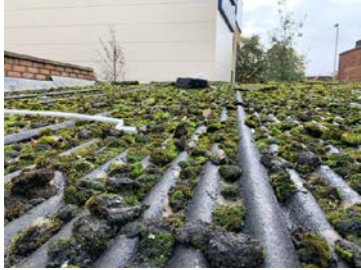
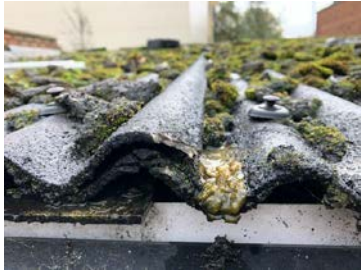
<b>Contract No:</b> S-10566	<b>Client:</b> Arcadis LLP	<b>ID Number:</b> 201031	
<b>Site:</b> Garages - Beaconsfield Close, Beaconsfield Close, Chiswick, W4 3EL		<b>Survey Date:</b> 04 November 2019	
<b>Building:</b>	Garages - Beaconsfield Close

<b>Floor:</b>	Ground Floor		
<b>Room Area:</b>	Garages 11-27 as 003		
<b>Description:</b>	Cement Roof Sheets		
<b>Quantity:</b>	60m <sup>2</sup>

<b>Accessibility:</b>	Medium		
<b>Product Type:</b>	1 - Cement Product		
<b>Damage Extent:</b>	2 - Medium		
<b>Surface Treatment:</b>	1 - Unsealed	<b>Re-inspection Due:</b>	04/11/2020
<b>Asbestos Type:</b>	1 - Chrysotile	<b>Sample Ref:</b>	S06
<b>Material Assessment:</b>		<b>Risk Score = 5</b> <b>Low</b>	
<b>Comments:</b> - The cement roof sheets were present above garages 18-22 & 26. A composite sample from multiple locations was taken.			
<b>Recommendations:</b> Remove The asbestos containing material should be removed and disposed of in full accordance with current and relevant legislation prior to the demolition of the building.

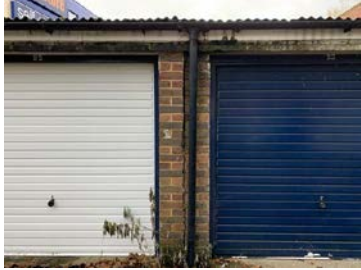
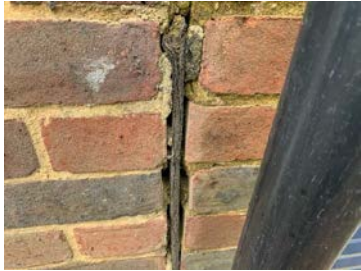
<b>Contract No:</b> S-10566	<b>Client:</b> Arcadis LLP	<b>ID Number:</b> 201036	
<b>Site:</b> Garages - Beaconsfield Close, Beaconsfield Close, Chiswick, W4 3EL		<b>Survey Date:</b> 04 November 2019	
<b>Building:</b>	Garages - Beaconsfield Close

<b>Floor:</b>	Ground Floor		
<b>Room Area:</b>	Garages 11-27 as 003		
<b>Description:</b>	Bitumen Packer		
<b>Quantity:</b>	2lm

<b>Accessibility:</b>	Difficult		
<b>Product Type:</b>	1 - Bituminous Product		
<b>Damage Extent:</b>	2 - Medium		
<b>Surface Treatment:</b>	0 - Composite	<b>Re-inspection Due:</b>	N/A
<b>Asbestos Type:</b>	No Asbestos Detected	<b>Sample Ref:</b>	S07
<b>Material Assessment:</b>		<b>No Asbestos Detected</b>	
<b>Comments:</b> - The bitumen packer layer ran vertically between garages 22 & 23.			
<b>Recommendations:</b> No action required

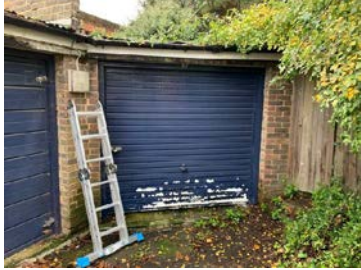
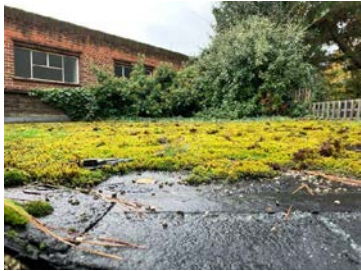
<b>Contract No:</b> S-10566	<b>Client:</b> Arcadis LLP	<b>ID Number:</b> 201054	
<b>Site:</b> Garages - Beaconsfield Close, Beaconsfield Close, Chiswick, W4 3EL		<b>Survey Date:</b> 04 November 2019	
<b>Building:</b>	Garages - Beaconsfield Close

<b>Floor:</b>	Ground Floor		
<b>Room Area:</b>	Garages 11-27 as 003		
<b>Description:</b>	Roof Felt		
<b>Quantity:</b>	25m <sup>2</sup>

<b>Accessibility:</b>	Medium		
<b>Product Type:</b>	1 - Bituminous Product		
<b>Damage Extent:</b>	2 - Medium		
<b>Surface Treatment:</b>	0 - Composite	<b>Re-inspection Due:</b>	N/A
<b>Asbestos Type:</b>	No Asbestos Detected	<b>Sample Ref:</b>	S08
<b>Material Assessment:</b>		<b>No Asbestos Detected</b>	
<b>Comments:</b> - The roof felt was only present above garage 27.			
<b>Recommendations:</b> No action required
