**London Borough of Hounslow Surveys
Site 20**

**Utility Mapping Survey
Site Report
Project No. 1716**

Prepared by:
Piotr Wegiel
40SEVEN Limited

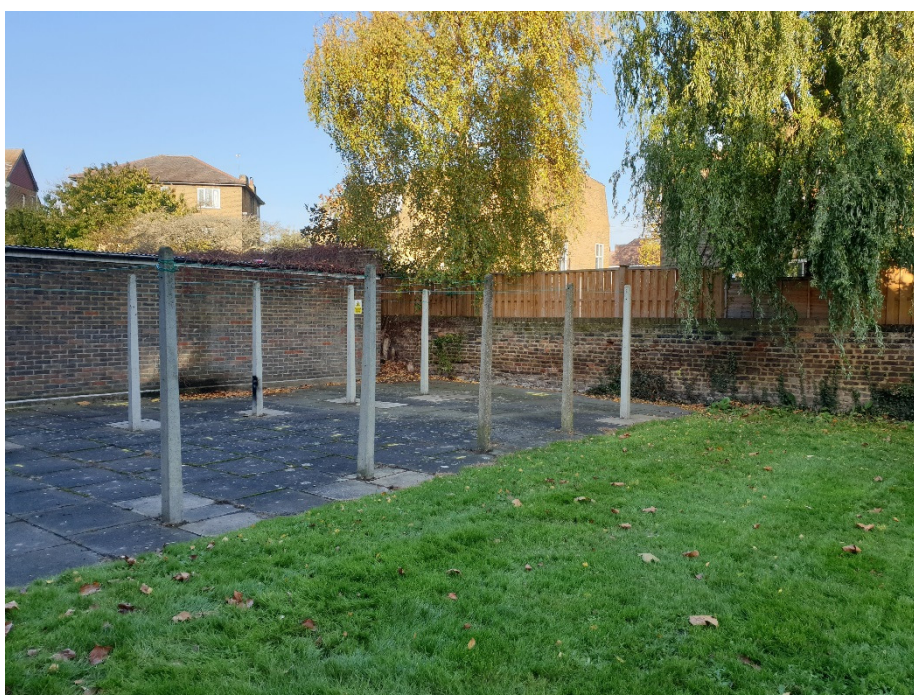
Photo 1

Description: General view of survey extents – Site 20A

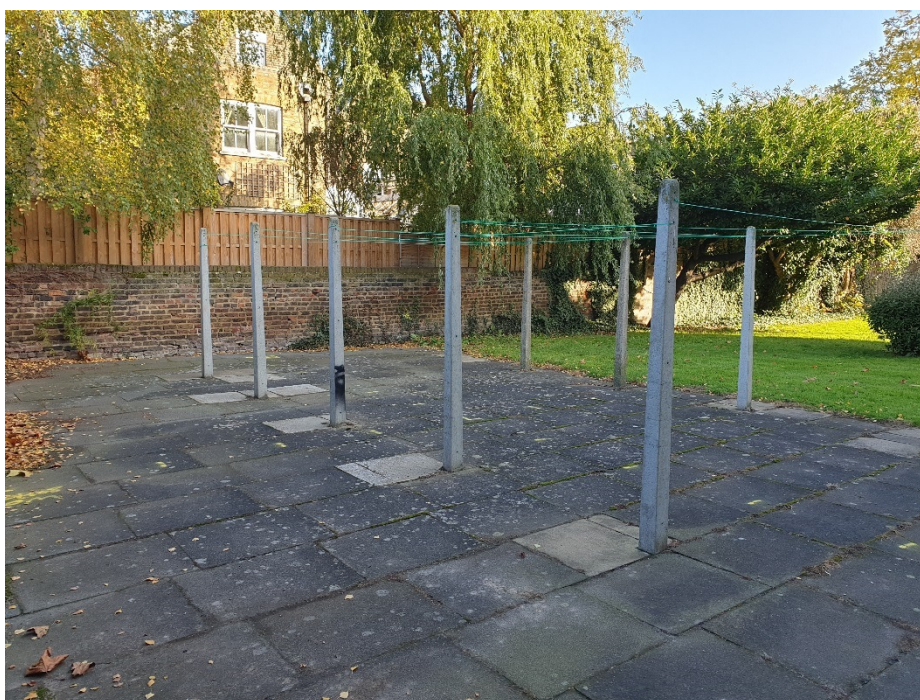
Photo 2

Description: General view of survey extents – Site 20A

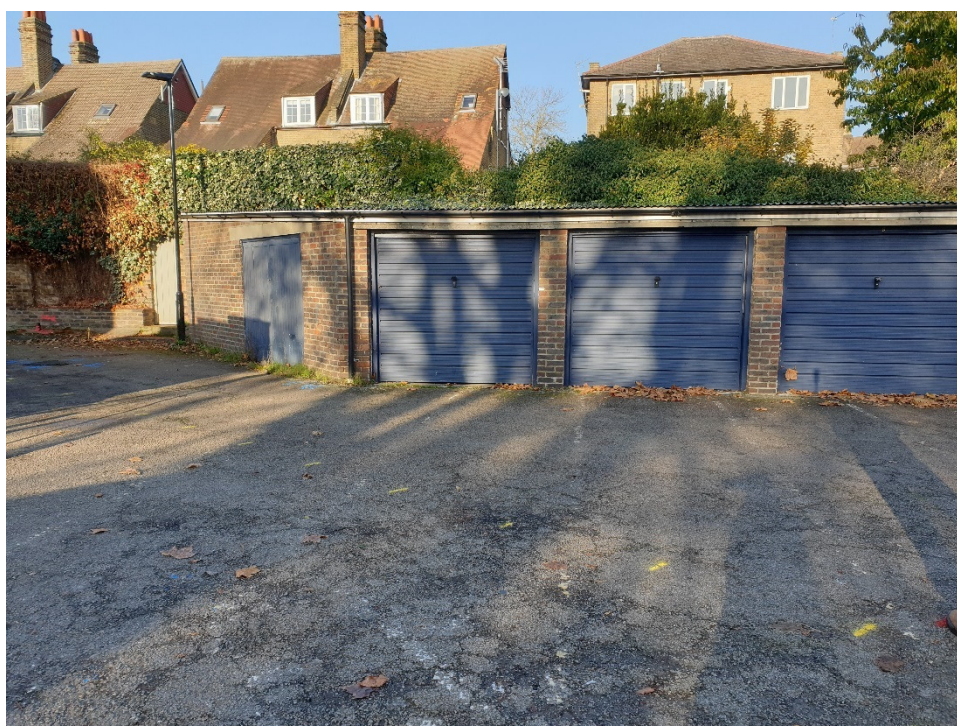
Photo 3

Description: General view of survey extents – Site 20B

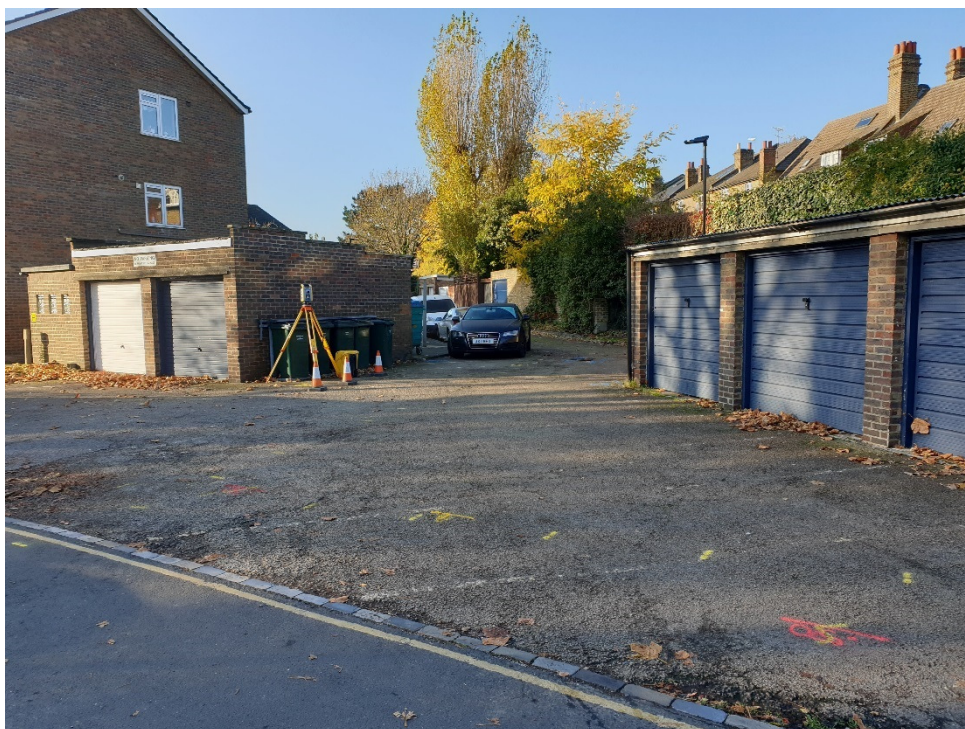
Photo 4

Description: General view of survey extents – Site 20B

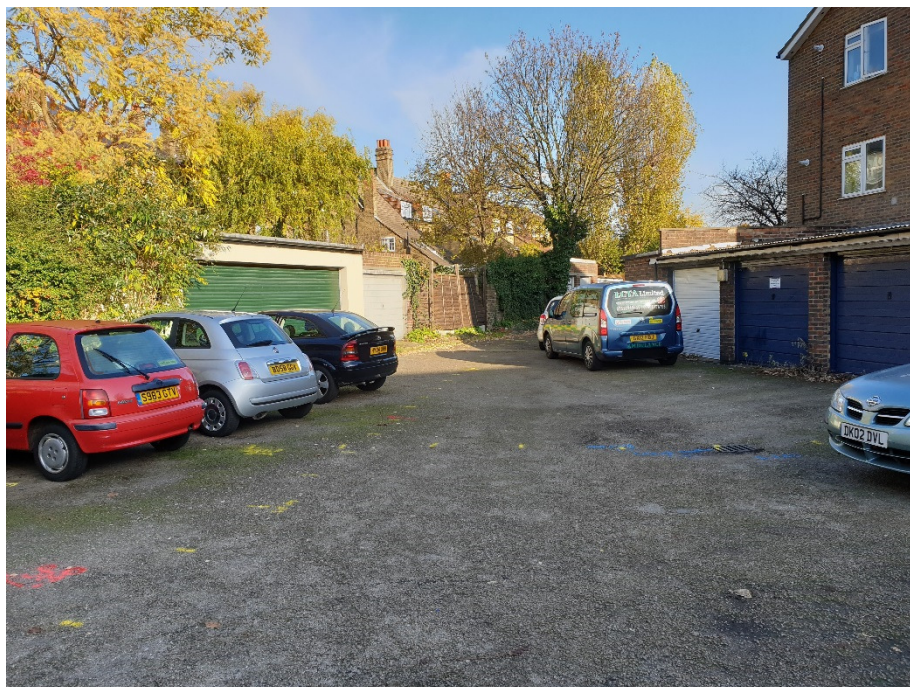
Photo 5

Description: General view of survey extents – Site 20C

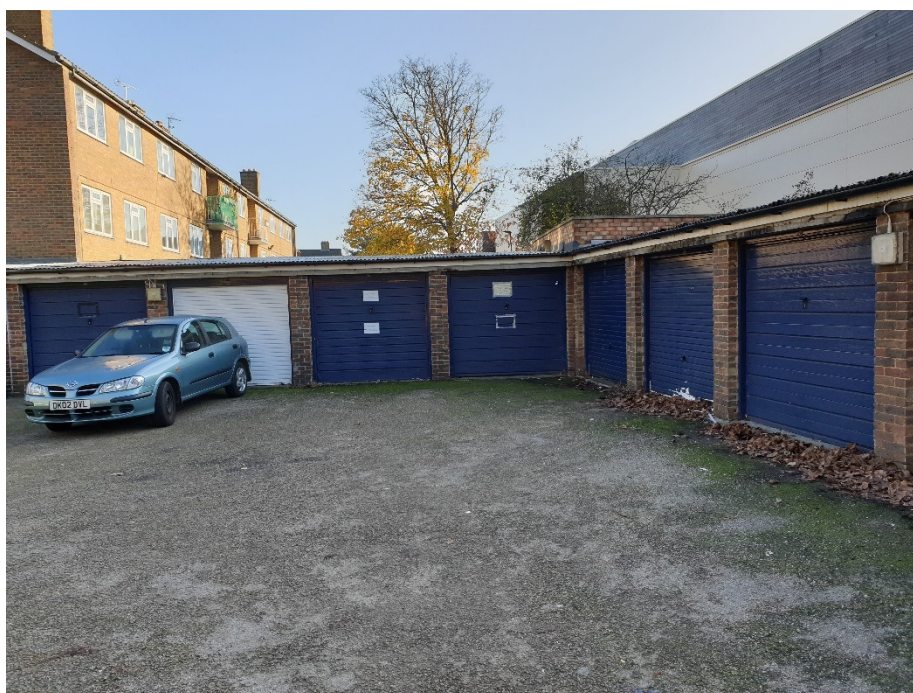
Photo 6

Description: General view of survey extents – Site 20C

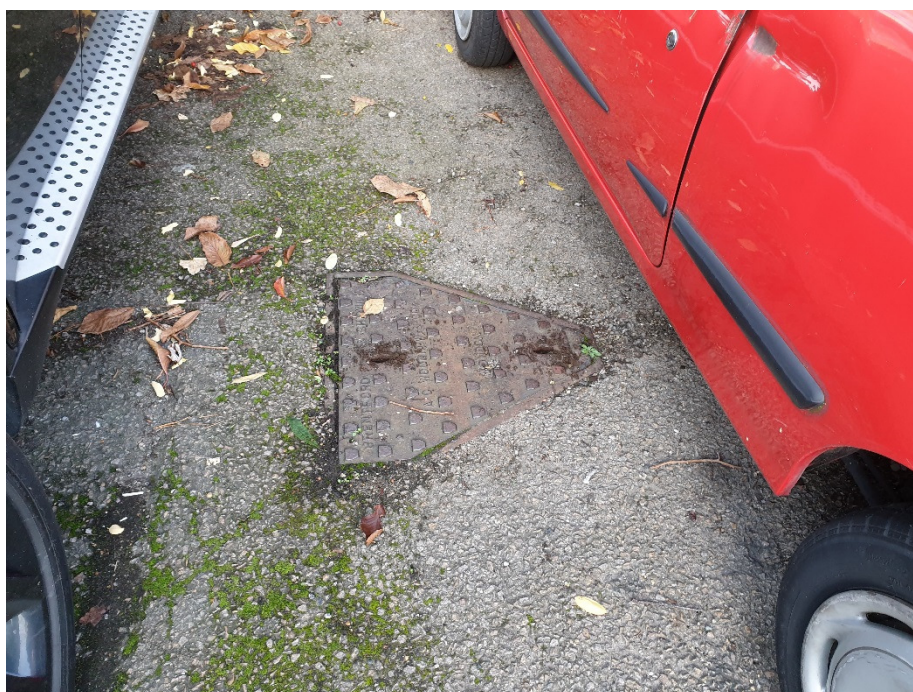
Photo 7

Service	Comment Number	Successes / Problems Differences between survey & "Stats"
Drainage	1	The surface and foul water drainage were identified outside survey area and routes traced by sonding and sounding.
	2	Unable to lift possible surface water cover on stie 20c due to parked vehicles. Routes presented on the map as assumed. See photo 7.
	3	Unable to survey gully on stie 20C due to parked vehicle. Routes presented on the drawing as assumed. See photo 8.
	4	No statutory record information available at time of survey.
Electric	1	Electric routes located and traced by direct connection to lampposts.
	2	A full passive power sweep was performed utilizing radio frequency equipment.
	3	Statutory record information available at time of survey provided by 40Seven.
CATV	1	Inspection chamber identified outside survey area in the footpath on Beaconsfield Close. Unable to generate radio frequency response due to fibre optic cables. Routes traced by flexi tracing the cable ducts.

Description: Possible surface water cover – unable to lift and survey.

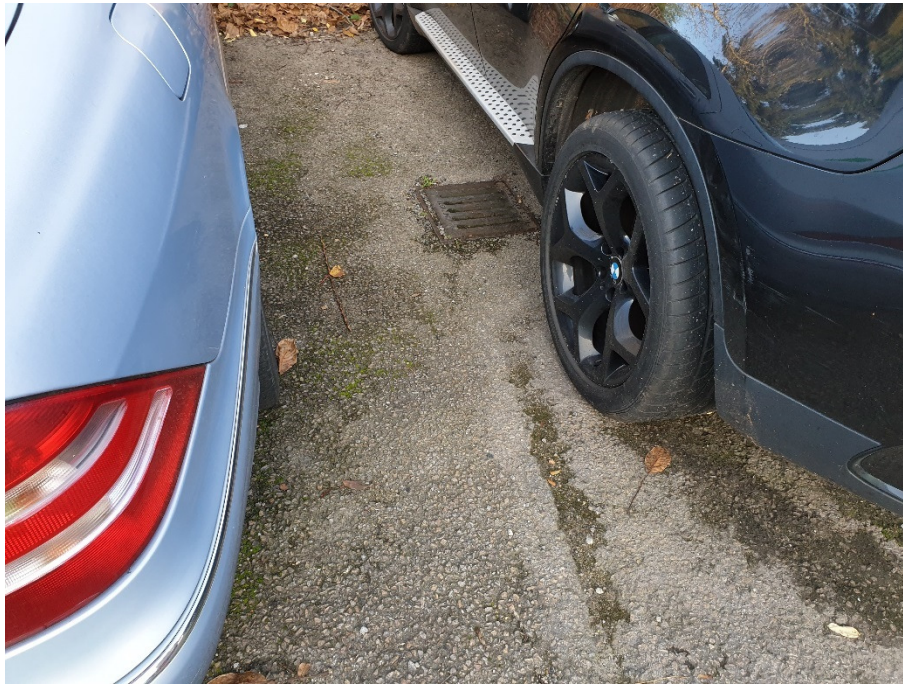
Photo 8

Description: Gully - unable to survey.

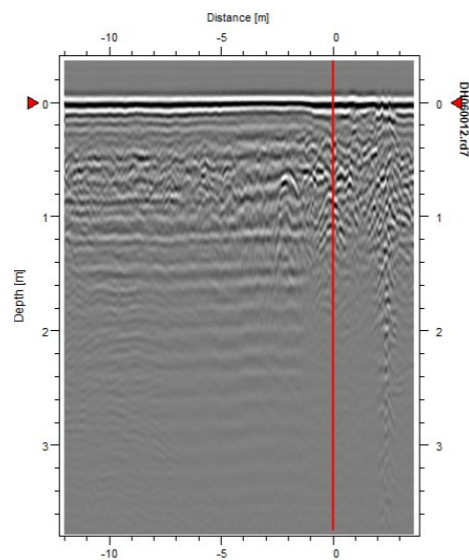
GPR 1

Description: Ground Penetrating Radar Scan 1.

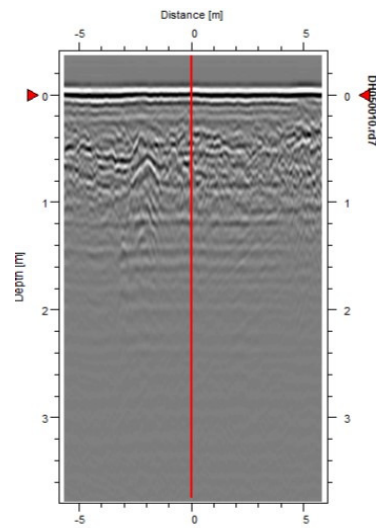
GPR 2

Description: Ground Penetrating Radar Scan 2.
