## Asbestos Demolition Survey

**Eaton Close  
Stanmore  
HA7 3BT**

**London Borough of Harrow**

Project Number:	Survey Date:	Issue Date:
N-20743	18 March 2020	23 March 2020

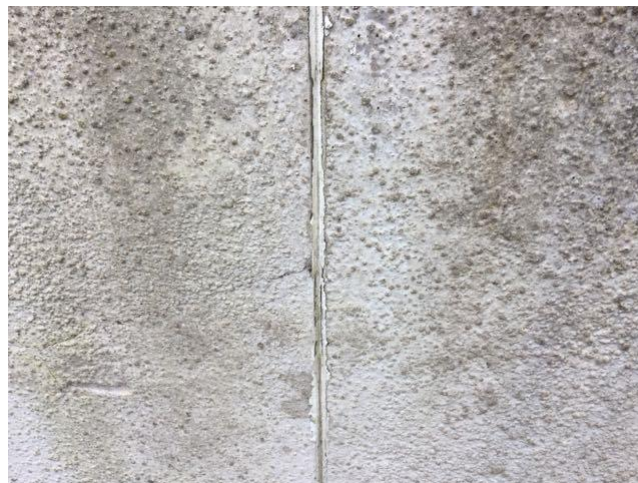
<b>Building</b>	Eaton Close
<b>Floor</b>	External
<b>Room</b>	99 - Block 2-6
<b>Description</b>	Expansion joint to concrete panelled walls
<b>Sample Reference</b>	S001
<b>Quantity</b>	40 Lin M
<b>Accessibility</b>	Easy

<b>Analysis Result</b>	No Asbestos Detected	0
<b>Product Type</b>	Putty	1
<b>Condition</b>	Low Damage	1
<b>Surface Treatment</b>	Composite (Self Sealed)	0

<b>Material Risk Assessment Score</b>
<b>0</b>
<b>Risk Assessment Description</b>
<b>No ACMs Detected</b>

<b>Comments</b>
N/A
<b>Recommendations</b>
No asbestos was detected within the sample collected and as such no further action is required.

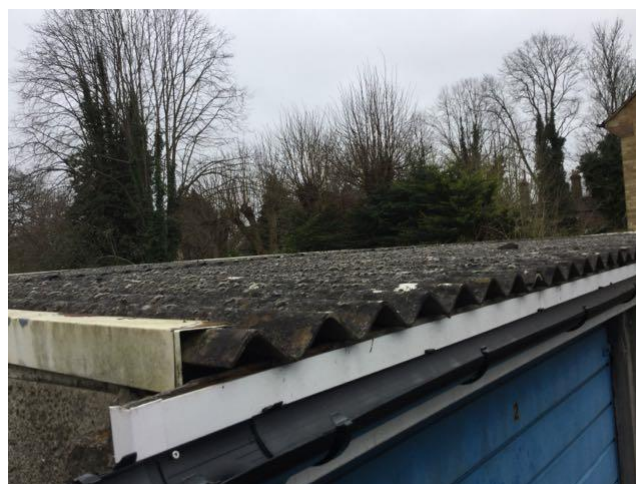
<b>Building</b>	Eaton Close
<b>Floor</b>	External
<b>Room</b>	99 - Block 2-6
<b>Description</b>	Cement profiled roofs
<b>Sample Reference</b>	S002
<b>Quantity</b>	50 m <sup>2</sup>
<b>Accessibility</b>	Medium

<b>Analysis Result</b>	Chrysotile	1
<b>Product Type</b>	Cement	1
<b>Condition</b>	Low Damage	1
<b>Surface Treatment</b>	Unsealed Cement	1

<b>Material Risk Assessment Score</b>
<b>4</b>
<b>Risk Assessment Description</b>
<b>Very Low Risk</b>

Cracked edges and damaged corners

The asbestos containing material should be removed and disposed of in full accordance with current and relevant legislation.

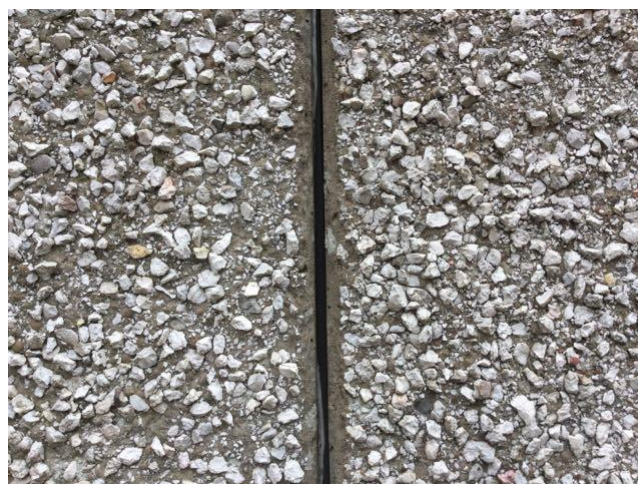
<b>Building</b>	Eaton Close
<b>Floor</b>	External
<b>Room</b>	99 - Block 7-12
<b>Description</b>	Expansion joint to concrete panelled walls
<b>Sample Reference</b>	S003
<b>Quantity</b>	40 Lin M
<b>Accessibility</b>	Easy

<b>Analysis Result</b>	Chrysotile	1
<b>Product Type</b>	Putty	1
<b>Condition</b>	Low Damage	1
<b>Surface Treatment</b>	Composite (Self Sealed)	0

<b>Material Risk Assessment Score</b>
<b>3</b>
<b>Risk Assessment Description</b>
<b>Very Low Risk</b>

The asbestos containing material should be removed and disposed of in full accordance with current and relevant legislation.

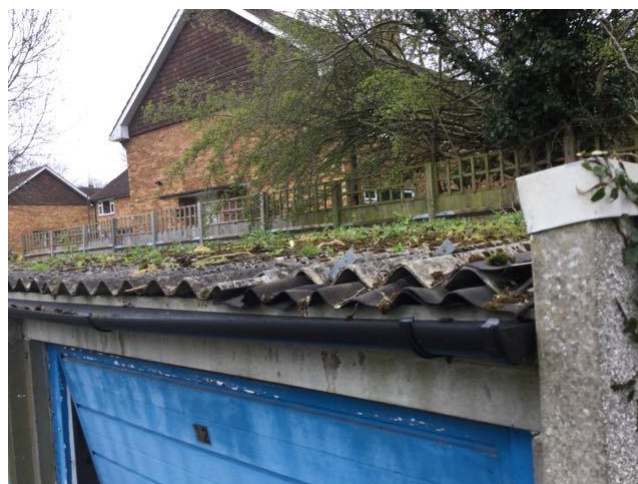
Building	Eaton Close
Floor	External
Room	99 - Block 7-12
Description	Cement profiled roofs
Sample Reference	S004
Quantity	50 m <sup>2</sup>
Accessibility	Medium

Analysis Result	Chrysotile	1
Product Type	Cement	1
Condition	Low Damage	1
Surface Treatment	Unsealed Cement	1

Material Risk Assessment Score
<b>4</b>
Risk Assessment Description
<b>Very Low Risk</b>

Cracked edges and damaged corners

The asbestos containing material should be removed and disposed of in full accordance with current and relevant legislation.

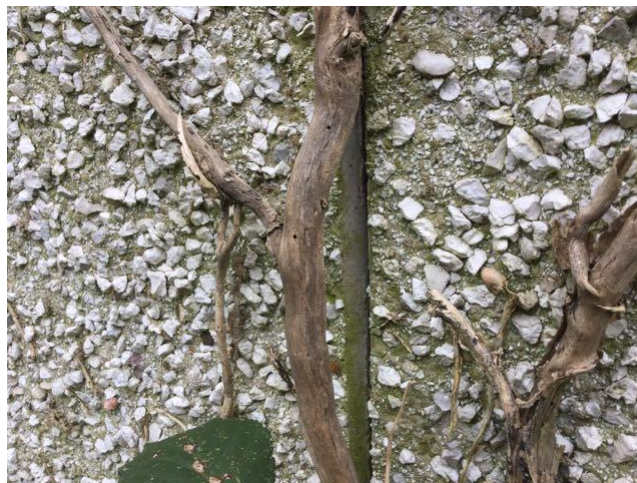
<b>Building</b>	Eaton Close
<b>Floor</b>	External
<b>Room</b>	99 - Block 13-17
<b>Description</b>	Expansion joint to concrete panelled walls
<b>Sample Reference</b>	S005
<b>Quantity</b>	40 Lin M
<b>Accessibility</b>	Easy

<b>Analysis Result</b>	Chrysotile	1
<b>Product Type</b>	Putty	1
<b>Condition</b>	Low Damage	1
<b>Surface Treatment</b>	Composite (Self Sealed)	0

<b>Material Risk Assessment Score</b>
<b>3</b>
<b>Risk Assessment Description</b>
<b>Very Low Risk</b>

The asbestos containing material should be removed and disposed of in full accordance with current and relevant legislation.

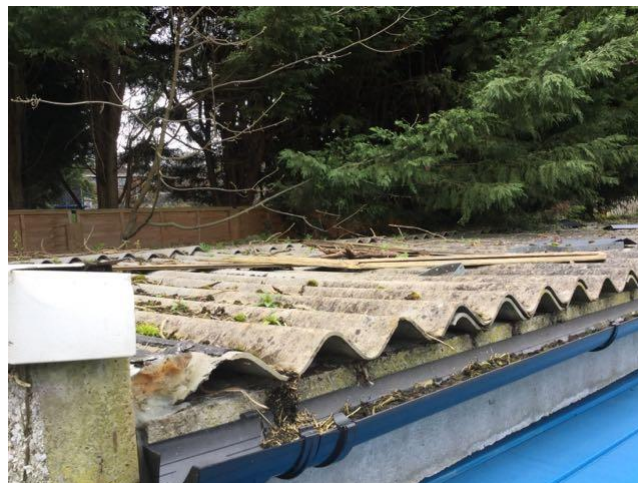
<b>Building</b>	Eaton Close
<b>Floor</b>	External
<b>Room</b>	99 - Block 13-17
<b>Description</b>	Cement profiled roofs
<b>Sample Reference</b>	S006
<b>Quantity</b>	50 m <sup>2</sup>
<b>Accessibility</b>	Medium

<b>Analysis Result</b>	Chrysotile	1
<b>Product Type</b>	Cement	1
<b>Condition</b>	Low Damage	1
<b>Surface Treatment</b>	Unsealed Cement	1

<b>Material Risk Assessment Score</b>
<b>4</b>
<b>Risk Assessment Description</b>
<b>Very Low Risk</b>

Cracked edges and damaged corners

The asbestos containing material should be removed and disposed of in full accordance with current and relevant legislation.

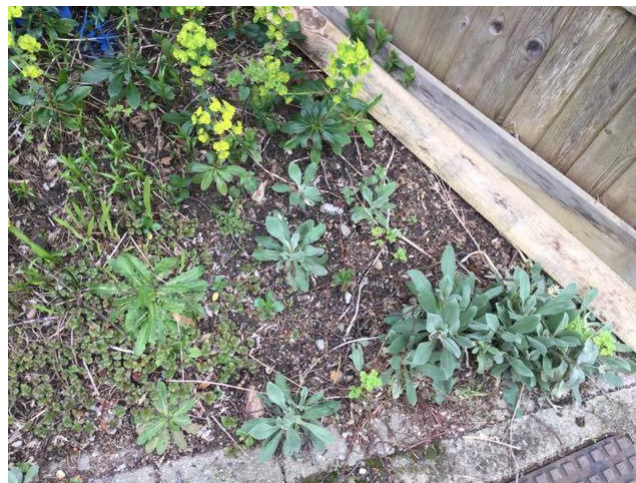
<b>Building</b>	Eaton Close
<b>Floor</b>	External
<b>Room</b>	99 - Car park area
<b>Description</b>	Debris to the floor of car park area
<b>Sample Reference</b>	S007
<b>Quantity</b>	1 m <sup>2</sup>
<b>Accessibility</b>	Easy

<b>Analysis Result</b>	Chrysotile	1
<b>Product Type</b>	Cement	1
<b>Condition</b>	High Damage	3
<b>Surface Treatment</b>	Unsealed Cement	1

<b>Material Risk Assessment Score</b>
<b>6</b>
<b>Risk Assessment Description</b>
<b>Low Risk</b>

1 m<sup>2</sup> spread over the 100m<sup>2</sup> area

The asbestos containing material should be removed and disposed of in full accordance with current and relevant legislation.
