### Asbestos Survey Report & Register

Survey Type:	Asbestos Demolition Survey
Site:	Garages - Florence Gardens, Florence Gardens, Chiswick, W4 3JX
Surveyor:	Liam Bates
Contract:	S-10567
Survey Date:	04 November 2019
Report Date:	12 November 2019
Client:	Arcadis LLP PO Box 307, Manchester, M60 3NT

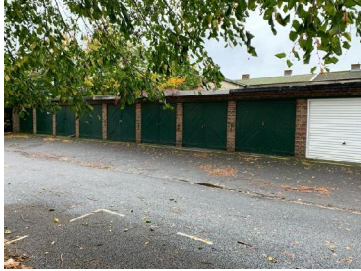
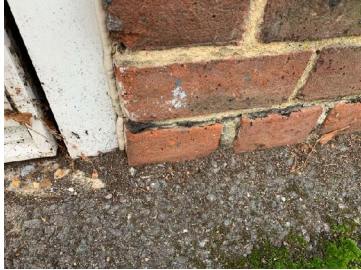
<b>Floor:</b>	Ground Floor		
<b>Room Area:</b>	Garages 1 - 13		
<b>Description:</b>	Damp Proof Course		
<b>Quantity:</b>	88lm

<b>Accessibility:</b>	Difficult		
<b>Product Type:</b>	1 - Bituminous Product		
<b>Damage Extent:</b>	1 - Low Damage		
<b>Surface Treatment:</b>	0 - Composite	<b>Re-inspection Due:</b>	N/A
<b>Asbestos Type:</b>	No Asbestos Detected	<b>Sample Ref:</b>	S01
<b>Material Assessment:</b>		<b>No Asbestos Detected</b>	
<b>Comments:</b> - The damp proof course was found to the low level.			
<b>Recommendations:</b> No action required

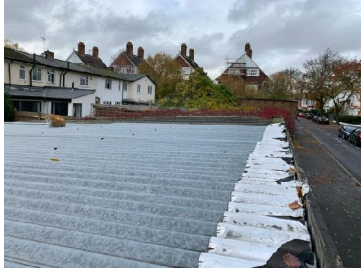
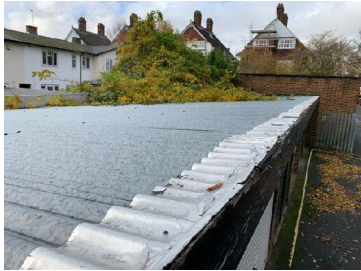
<b>Floor:</b>	Ground Floor		
<b>Room Area:</b>	Garages 1-13		
<b>Description:</b>	Roof Felt		
<b>Quantity:</b>	26lm

<b>Accessibility:</b>	Medium		
<b>Product Type:</b>	1 - Bituminous Product		
<b>Damage Extent:</b>	1 - Low Damage		
<b>Surface Treatment:</b>	0 - Composite	<b>Re-inspection Due:</b>	N/A
<b>Asbestos Type:</b>	No Asbestos Detected	<b>Sample Ref:</b>	S03
<b>Material Assessment:</b>		<b>No Asbestos Detected</b>	
<b>Comments:</b> - The roof felt fillet ran the front of the garages, apart from the middle section.			
<b>Recommendations:</b> No action required

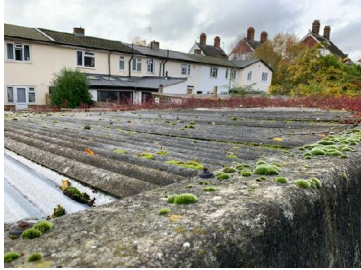
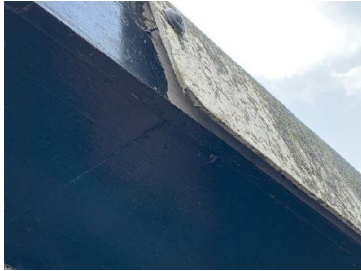
<b>Floor:</b>	Ground Floor		
<b>Room Area:</b>	Garages 1-13		
<b>Description:</b>	Cement Roof & Fascia		
<b>Quantity:</b>	40m <sup>2</sup>

<b>Accessibility:</b>	Difficult		
<b>Product Type:</b>	1 - Cement Product		
<b>Damage Extent:</b>	2 - Medium		
<b>Surface Treatment:</b>	1 - Unsealed	<b>Re-inspection Due:</b>	N/A
<b>Asbestos Type:</b>	No Asbestos Detected	<b>Sample Ref:</b>	S04
<b>Material Assessment:</b>		<b>No Asbestos Detected</b>	
<b>Comments:</b> - The cement panels were to the middle section of the garages only. Also included a cement fascia panel to front elevation.			
<b>Recommendations:</b> No action required
