Asbestos Survey Report & Register

Survey Type:	Asbestos Demolition Survey
Site:	Garage Site 5, Garage Block at Garth Court, Chiswick, W4 4QL
Surveyor:	Aaron Galyer
Contract:	S-07993
Survey Date:	04 April 2019
Report Date:	09 April 2019
Client:	Arcadis LLP PO Box 307, Manchester, M60 3NT

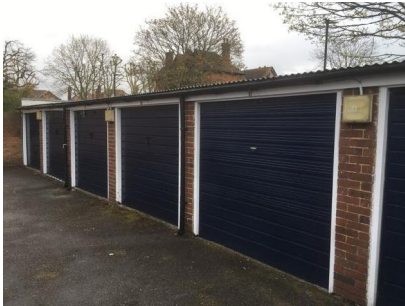
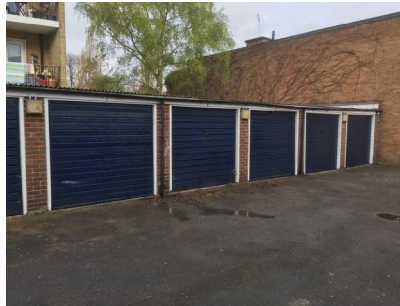
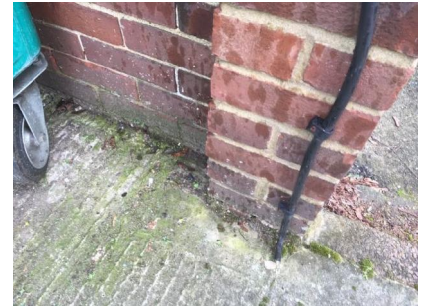
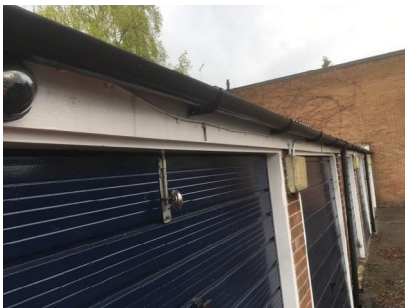
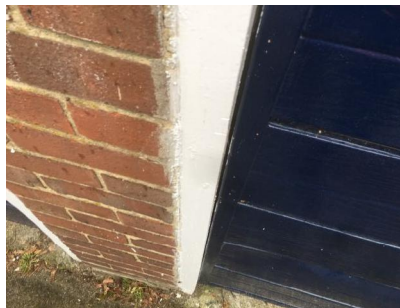
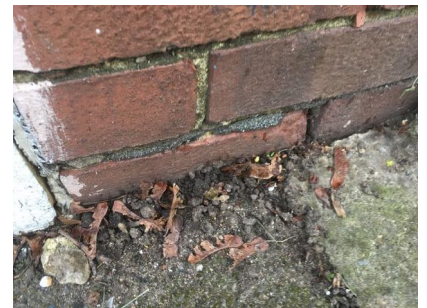
Photos:

Area:	Garages (Site 5) - All Accessible Areas - All Floors
Floors:	The floors comprised of bare concrete. (Only one garage could be accessed)
Walls:	The walls comprised of exposed brick work. (Only one garage could be accessed)
Ceilings:	The ceilings comprised of exposed metal primary. (Only one garage could be accessed)
External:	The external comprised of exposed brick, metal roof sheets, fibreglass capping to edges straight to brickwork, bitumen damp proof course, timber fascia panels painted white, timber surrounds to metal garage doors, metal and plastic rain water goods

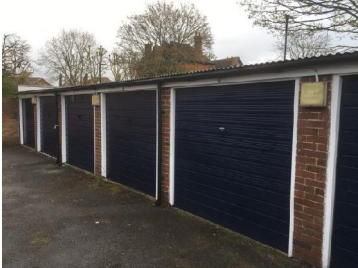
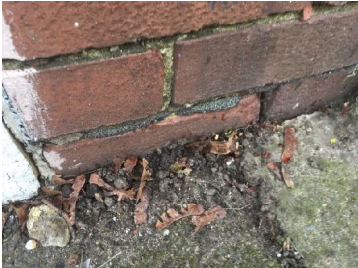
Contract No: S-07993	Client: Arcadis LLP	Location Ref OSL: OSL001	
Site: Garage Site 5, Garage Block at Garth Court, Chiswick, W4 4QL		Survey Date: 03 April 2019	
Building:	Garage Site 5

Floor:	Ground Floor		
Room Area:	Block 1 - Garages 001		
Description:	Bitumen Damp Proof Course		
Quantity:	34lm

Accessibility:	Easy		
Product Type:	1 - Bituminous Product		
Damage Extent:	1 - Low Damage		
Surface Treatment:	0 - Composite	Re-inspection Due:	N/A
Asbestos Type:	No Asbestos Detected	Sample Ref:	S01
Material Assessment:		No Asbestos Detected	
Comments: - Found to low level brickwork. The bitumen damp proof course ran around the entire perimeter of the garages. A composite sample was taken from various areas from the block of garages.			
Recommendations: No action required

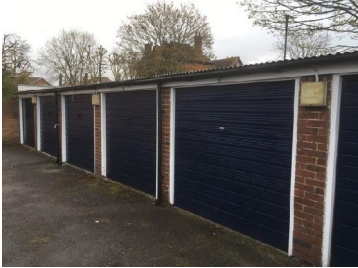
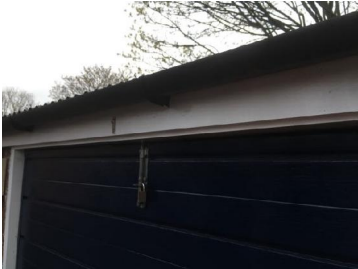
Contract No: S-07993	Client: Arcadis LLP	Location Ref OSL: OSL002	
Site: Garage Site 5, Garage Block at Garth Court, Chiswick, W4 4QL		Survey Date: 03 April 2019	
Building:	Garage Site 5

Floor:	Ground Floor		
Room Area:	Block 2 - Garages 001		
Description:	Insulating Board Fascia Panels		
Quantity:	12lm

Accessibility:	Medium		
Product Type:	2 - Insulating Board		
Damage Extent:	1 - Low Damage		
Surface Treatment:	2 - Unsealed	Re-inspection Due:	N/A
Asbestos Type:	No Asbestos Detected	Sample Ref:	S02
Material Assessment:		No Asbestos Detected	
Comments: - The fascia panels were painted timber however have been sampled to prove they are non-asbestos containing for when the works commence. The timber fascia panel was applied to a timber panel. The paint was flaking at various areas.			
Recommendations: No action required

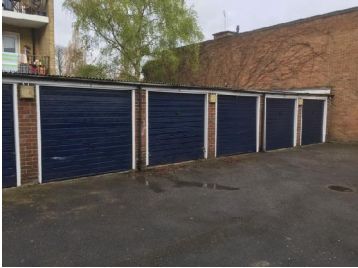
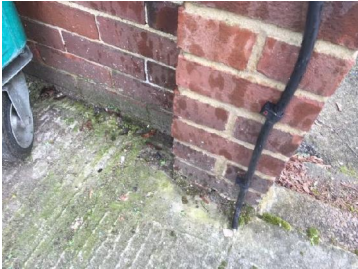
Contract No: S-07993	Client: Arcadis LLP	Location Ref OSL: OSL003	
Site: Garage Site 5, Garage Block at Garth Court, Chiswick, W4 4QL		Survey Date: 03 April 2019	
Building:	Garage Site 5

Floor:	Ground Floor		
Room Area:	Block 2- Garages 002		
Description:	Bitumen Damp Proof Course		
Quantity:	34lm

Accessibility:	Easy		
Product Type:	1 - Bituminous Product		
Damage Extent:	1 - Low Damage		
Surface Treatment:	0 - Composite	Re-inspection Due:	N/A
Asbestos Type:	No Asbestos Detected	Sample Ref:	S03
Material Assessment:		No Asbestos Detected	
Comments: - Found to low level brickwork. The bitumen damp proof course ran around the entire perimeter of the garages. A composite sample was taken from various areas from the block of garages.			
Recommendations: No action required

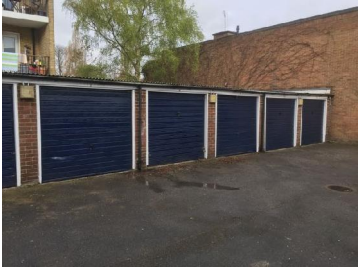
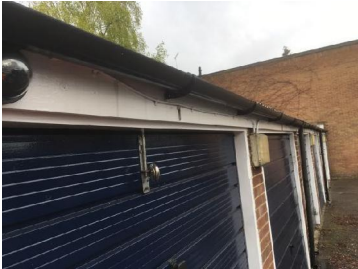
Contract No: S-07993	Client: Arcadis LLP	Location Ref OSL: OSL004	
Site: Garage Site 5, Garage Block at Garth Court, Chiswick, W4 4QL		Survey Date: 03 April 2019	
Building:	Garage Site 5

Floor:	Ground Floor		
Room Area:	Block 2- Garages 002		
Description:	Insulating Board Fascia Panels		
Quantity:	12lm

Accessibility:	Medium		
Product Type:	2 - Insulating Board		
Damage Extent:	1 - Low Damage		
Surface Treatment:	2 - Unsealed	Re-inspection Due:	N/A
Asbestos Type:	No Asbestos Detected	Sample Ref:	S04
Material Assessment:		No Asbestos Detected	
Comments: - The fascia panels were painted timber however have been sampled to prove they are non-asbestos containing for when the works commence. The timber fascia panel was applied to a timber panel. The paint was flaking at various areas.			
Recommendations: No action required

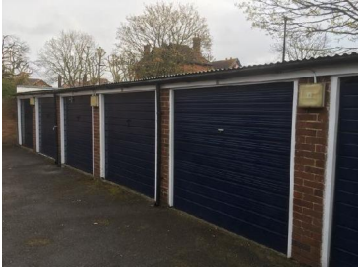
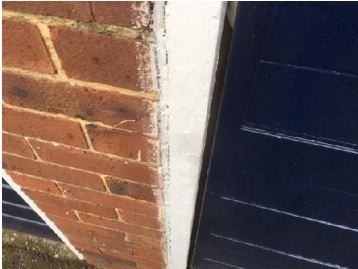
Contract No: S-07993	Client: Arcadis LLP	Location Ref OSL: OSL005	
Site: Garage Site 5, Garage Block at Garth Court, Chiswick, W4 4QL		Survey Date: 04 April 2019	
Building:	Garage Site 5

Floor:	Ground Floor		
Room Area:	Block 1 - Garages 001		
Description:	Putty Seals to Timber Framework		
Quantity:	24lm

Accessibility:	Easy		
Product Type:	1 - Putty		
Damage Extent:	1 - Low Damage		
Surface Treatment:	0 - Composite	Re-inspection Due:	N/A
Asbestos Type:	No Asbestos Detected	Sample Ref:	S05
Material Assessment:		No Asbestos Detected	
Comments: - Found to the timber framework around metal garage doors. The putty ran up each side of the garage door. Approx. 4lm per door.			
Recommendations: No action required

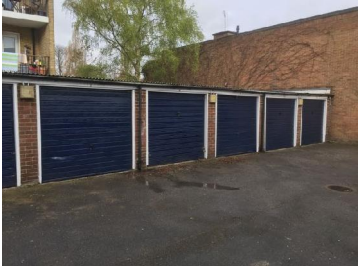
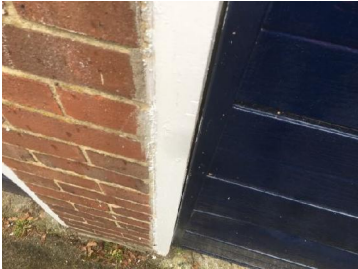
Contract No: S-07993	Client: Arcadis LLP	Location Ref OSL: OSL006	
Site: Garage Site 5, Garage Block at Garth Court, Chiswick, W4 4QL		Survey Date: 04 April 2019	
Building:	Garage Site 5

Floor:	Ground Floor		
Room Area:	Block 2 - Garages 002		
Description:	Putty Seals to Timber Framework		
Quantity:	24lm

Accessibility:	Easy		
Product Type:	1 - Putty		
Damage Extent:	1 - Low Damage		
Surface Treatment:	0 - Composite	Re-inspection Due:	N/A
Asbestos Type:	No Asbestos Detected	Sample Ref:	S06
Material Assessment:		No Asbestos Detected	
Comments: - Found to the timber framework around metal garage doors. The putty ran up each side of the garage door. Approx. 4lm per door.			
Recommendations: No action required
