Asbestos Survey Report & Register

Survey Type:	Asbestos Demolition Survey
Site:	Garage Site 9, Garage Blocks at Gunnersbury Close, Chiswick, W4 4EQ
Surveyor:	Jason Pack
Contract:	S-07995
Survey Date:	03 April 2019
Report Date:	12 April 2019
Client:	Arcadis LLP PO Box 307, Manchester, M60 3NT

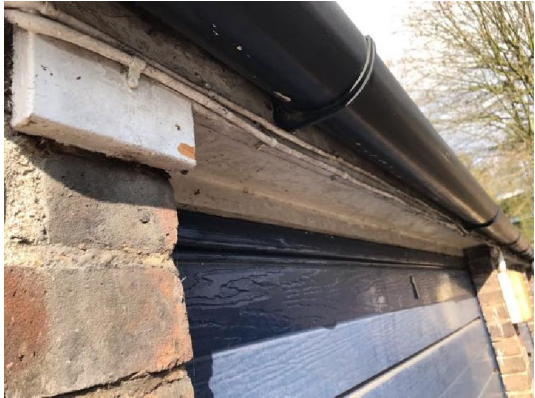
Contract No: S-07995	Client: Arcadis LLP	Location Ref OSL: OSL001	
Site: Garage Site 9, Garage Blocks at Gunnersbury Close, Chiswick, W4 4EQ		Survey Date: 03 April 2019	
Building:	Block 1-6

Floor:	Ground Floor		
Room Area:	099 External 001		
Description:	Insulating Board Soffit		
Quantity:	12lm		
Accessibility:	Easy		
Product Type:	2 - Insulating Board		
Damage Extent:	1 - Low Damage		
Surface Treatment:	1 - Sealed	Re-inspection Due:	N/A
Asbestos Type:	No Asbestos Detected	Sample Ref:	S01
Material Assessment:		No Asbestos Detected	
Comments: - Insulating board soffits to all garages.			
Recommendations: No action required

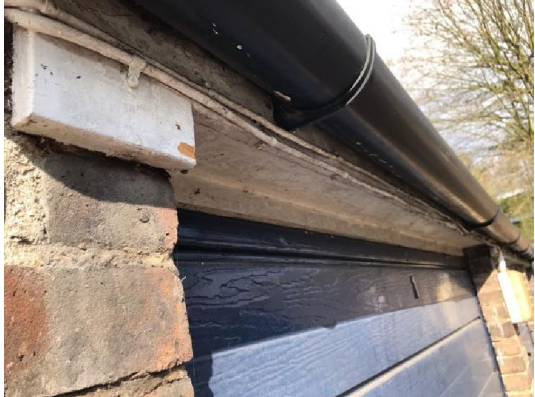
Contract No: S-07995	Client: Arcadis LLP	Location Ref OSL: OSL002	
Site: Garage Site 9, Garage Blocks at Gunnersbury Close, Chiswick, W4 4EQ		Survey Date: 03 April 2019	
Building:	Block 7 - 16

Floor:	External		
Room Area:	External 001		
Description:	Insulating Board Soffit		
Quantity:	12lm		
Accessibility:	Easy		
Product Type:	2 - Insulating Board		
Damage Extent:	1 - Low Damage		
Surface Treatment:	1 - Sealed	Re-inspection Due:	N/A
Asbestos Type:	No Asbestos Detected	Sample Ref:	S02
Material Assessment:		No Asbestos Detected	
Comments: - Insulating board soffits to all garages.			
Recommendations: No action required

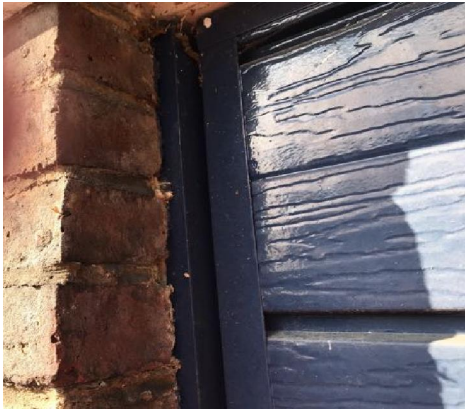
Contract No: S-07995	Client: Arcadis LLP	Location Ref OSL: OSL003	
Site: Garage Site 9, Garage Blocks at Gunnersbury Close, Chiswick, W4 4EQ		Survey Date: 03 April 2019	
Building:	Block 1-6

Floor:	Ground Floor		
Room Area:	099 External 001		
Description:	Insulating Board Door Frame		
Quantity:	20lm		
Accessibility:	Easy		
Product Type:	2 - Insulating Board		
Damage Extent:	1 - Low Damage		
Surface Treatment:	1 - Sealed	Re-inspection Due:	N/A
Asbestos Type:	No Asbestos Detected	Sample Ref:	S03
Material Assessment:		No Asbestos Detected	
Comments: - Insulating board door frames to entire garage block			
Recommendations: No action required

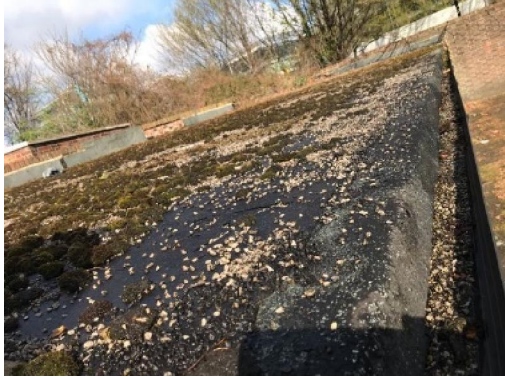
Contract No: S-07995	Client: Arcadis LLP	Location Ref OSL: OSL004	
Site: Garage Site 9, Garage Blocks at Gunnersbury Close, Chiswick, W4 4EQ		Survey Date: 03 April 2019	
Building:	Block 1-6

Floor:	Ground Floor		
Room Area:	099 External 001		
Description:	Felt to Roof		
Quantity:	120m ²		
Accessibility:	Medium		
Product Type:	1 - Bituminous Product		
Damage Extent:	1 - Low Damage		
Surface Treatment:	0 - Composite	Re-inspection Due:	N/A
Asbestos Type:	No Asbestos Detected	Sample Ref:	S04
Material Assessment:		No Asbestos Detected	
Comments: - Roofing felt to entire garage block			
Recommendations: No action required

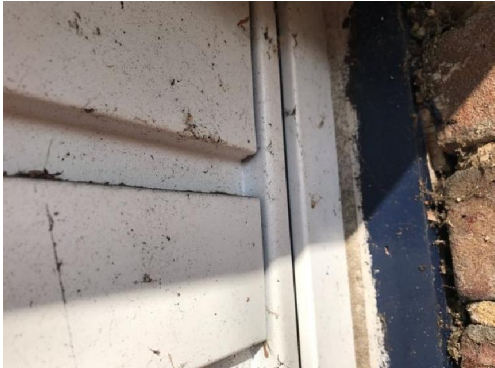
Contract No: S-07995	Client: Arcadis LLP	Location Ref OSL: OSL005	
Site: Garage Site 9, Garage Blocks at Gunnersbury Close, Chiswick, W4 4EQ		Survey Date: 03 April 2019	
Building:	Block 1-6

Floor:	Ground Floor		
Room Area:	099 External 001		
Description:	Mastic Seal to Door Frame		
Quantity:	4lm		
Accessibility:	Medium		
Product Type:	1 - Bituminous Product		
Damage Extent:	1 - Low Damage		
Surface Treatment:	0 - Composite	Re-inspection Due:	N/A
Asbestos Type:	No Asbestos Detected	Sample Ref:	S05
Material Assessment:		No Asbestos Detected	
Comments: - Mastic sealant to garage No.6			
Recommendations: No action required

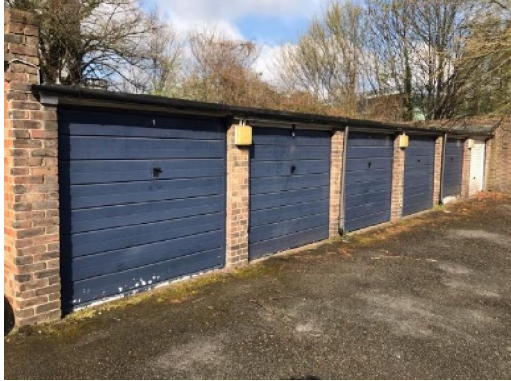
Contract No: S-07995	Client: Arcadis LLP	Location Ref OSL: OSL006	
Site: Garage Site 9, Garage Blocks at Gunnersbury Close, Chiswick, W4 4EQ		Survey Date: 03 April 2019	
Building:	Block 1-6

Floor:	Ground Floor		
Room Area:	099 External 001		
Description:	Paint to Garage Door		
Quantity:	24m ²		
Accessibility:	Medium		
Product Type:	1 - Painted Surface		
Damage Extent:	1 - Low Damage		
Surface Treatment:	0 - Composite	Re-inspection Due:	N/A
Asbestos Type:	No Asbestos Detected	Sample Ref:	S06
Material Assessment:		No Asbestos Detected	
Comments: - Paint to all garage doors			
Recommendations: No action required

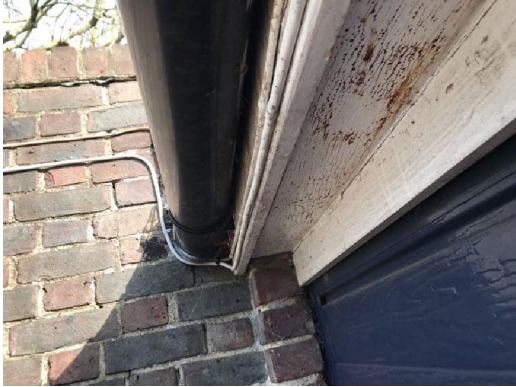
Contract No: S-07995	Client: Arcadis LLP	Location Ref OSL: OSL007	
Site: Garage Site 9, Garage Blocks at Gunnersbury Close, Chiswick, W4 4EQ		Survey Date: 03 April 2019	
Building:	Block 7 - 16

Floor:	Ground Floor		
Room Area:	099 External 001		
Description:	Insulating Board Soffit		
Quantity:	20lm		
Accessibility:	Medium		
Product Type:	2 - Insulating Board		
Damage Extent:	1 - Low Damage		
Surface Treatment:	1 - Sealed	Re-inspection Due:	N/A
Asbestos Type:	No Asbestos Detected	Sample Ref:	S07
Material Assessment:		No Asbestos Detected	
Comments: - Soffit to entire garage block			
Recommendations: No action required

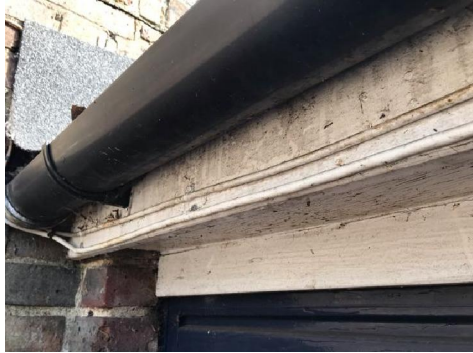
Contract No: S-07995	Client: Arcadis LLP	Location Ref OSL: OSL008	
Site: Garage Site 9, Garage Blocks at Gunnersbury Close, Chiswick, W4 4EQ		Survey Date: 03 April 2019	
Building:	Block 7 - 16

Floor:	Ground Floor		
Room Area:	099 External 001		
Description:	Insulating Board Fascia		
Quantity:	20lm		
Accessibility:	Medium		
Product Type:	2 - Insulating Board		
Damage Extent:	1 - Low Damage		
Surface Treatment:	1 - Sealed	Re-inspection Due:	N/A
Asbestos Type:	No Asbestos Detected	Sample Ref:	S08
Material Assessment:		No Asbestos Detected	
Comments: - Fascia to entire garage block			
Recommendations: No action required

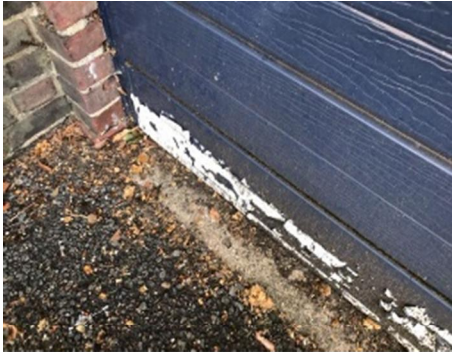
Contract No: S-07995	Client: Arcadis LLP	Location Ref OSL: OSL009	
Site: Garage Site 9, Garage Blocks at Gunnersbury Close, Chiswick, W4 4EQ		Survey Date: 03 April 2019	
Building:	Block 7 - 16

Floor:	Ground Floor		
Room Area:	099 External 001		
Description:	Paint to Garage Doors		
Quantity:	32m ²		
Accessibility:	Easy		
Product Type:	1 - Painted Surface		
Damage Extent:	1 - Low Damage		
Surface Treatment:	0 - Composite	Re-inspection Due:	N/A
Asbestos Type:	No Asbestos Detected	Sample Ref:	S09
Material Assessment:		No Asbestos Detected	
Comments: - Paint to all garage doors			
Recommendations: No action required

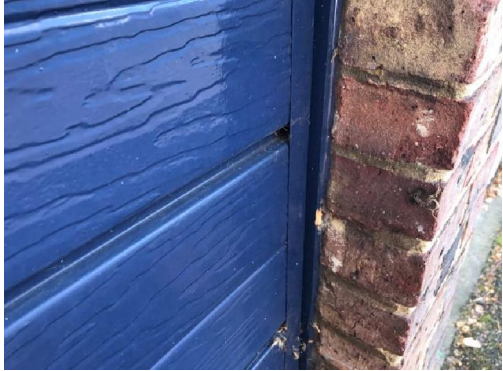
Contract No: S-07995	Client: Arcadis LLP	Location Ref OSL: OSL010	
Site: Garage Site 9, Garage Blocks at Gunnersbury Close, Chiswick, W4 4EQ		Survey Date: 03 April 2019	
Building:	Block 7 - 16

Floor:	Ground Floor		
Room Area:	099 External 001		
Description:	Insulating Board Door Frame		
Quantity:	20lm		
Accessibility:	Easy		
Product Type:	2 - Insulating Board		
Damage Extent:	1 - Low Damage		
Surface Treatment:	1 - Sealed	Re-inspection Due:	N/A
Asbestos Type:	No Asbestos Detected	Sample Ref:	S10
Material Assessment:		No Asbestos Detected	
Comments: - Door frames to entire garage block			
Recommendations: No action required

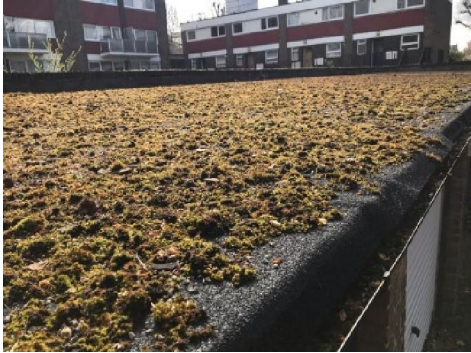
Contract No: S-07995	Client: Arcadis LLP	Location Ref OSL: OSL011	
Site: Garage Site 9, Garage Blocks at Gunnersbury Close, Chiswick, W4 4EQ		Survey Date: 03 April 2019	
Building:	Block 7 - 16

Floor:	Ground Floor		
Room Area:	099 External 001		
Description:	Felt Roof		
Quantity:	60m ²		
Accessibility:	Medium		
Product Type:	1 - Bituminous Product		
Damage Extent:	1 - Low Damage		
Surface Treatment:	0 - Composite	Re-inspection Due:	N/A
Asbestos Type:	No Asbestos Detected	Sample Ref:	S11
Material Assessment:		No Asbestos Detected	
Comments: - Roofing felt to entire garage block			
Recommendations: No action required

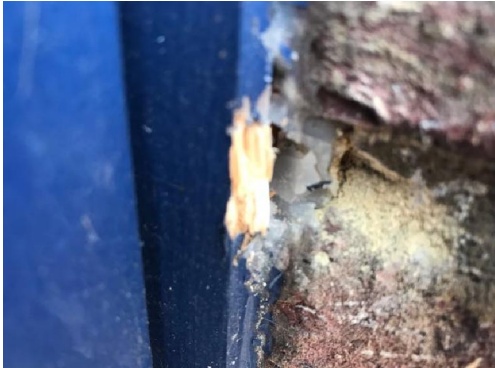
Contract No: S-07995	Client: Arcadis LLP	Location Ref OSL: OSL012	
Site: Garage Site 9, Garage Blocks at Gunnersbury Close, Chiswick, W4 4EQ		Survey Date: 03 April 2019	
Building:	Block 1-6

Floor:	Ground Floor		
Room Area:	099 External 001		
Description:	Mastic Seal to Door Frame		
Quantity:	4lm		
Accessibility:	Medium		
Product Type:	1 - Putty		
Damage Extent:	1 - Low Damage		
Surface Treatment:	0 - Composite	Re-inspection Due:	N/A
Asbestos Type:	No Asbestos Detected	Sample Ref:	S12
Material Assessment:		No Asbestos Detected	
Comments: - Mastic sealant to garage door No.1			
Recommendations: No action required

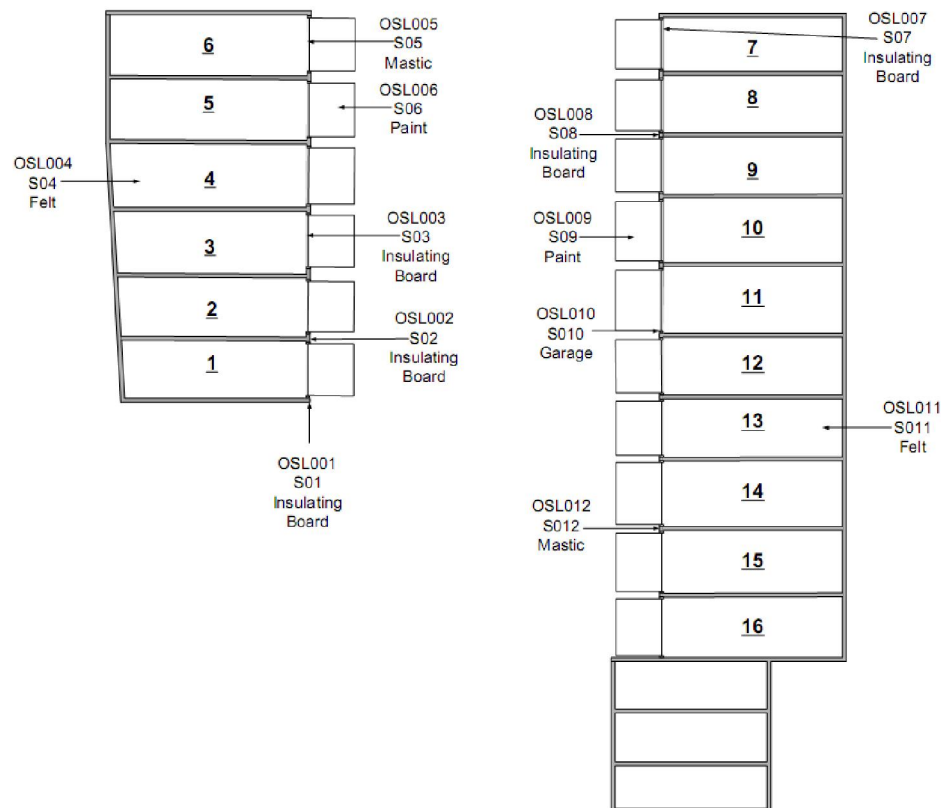
Garage Site 9			
No:	Room / Area:	No access and restriction details:	Photo
1.	Ground Floor / All Internal Areas 100	No access into any garages due to them all being locked shut and having no keys at the time of the survey. Some garages even had extra padlocks to secure them.
