Asbestos Survey Report & Register

Survey Type:	Asbestos Demolition Survey
Site:	Garages at Hartland Road Site A, South West Side of North Road and North side of Hartland Road, Isleworth, TW7 6RH
Surveyor(s):	Aaron Galyer & Liam Bates
Contract:	S-10025
Survey Date:	04 September 2019
Report Date:	10 September 2019
Client:	Arcadis LLP PO Box 307, Manchester, M60 3NT

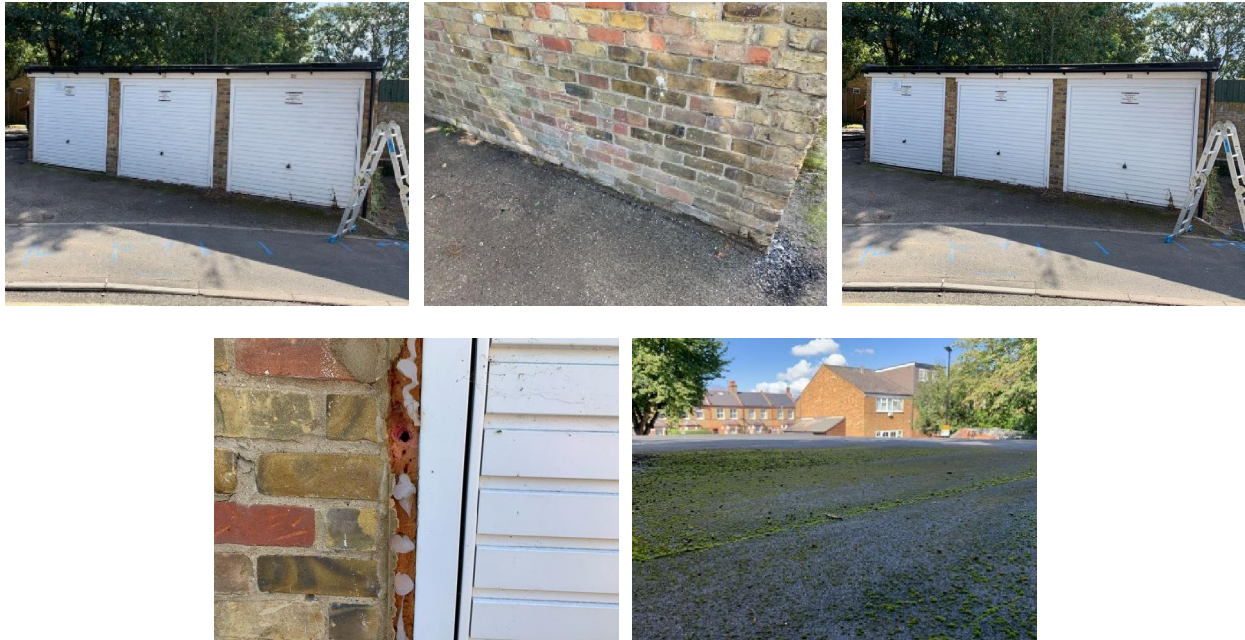
Area:	Garages - all areas - ground floor.
Floors:	The floors comprised of concrete. Only the external was accessed, internally could not be accessed as garages were locked.
Walls:	The walls comprised of brick.
Ceilings:	The ceilings comprised of felt lining to roof with timber beneath felt.
External:	The external areas comprised of UPVC & timber fascias, plastic gutters and downpipes, damp proof course, metal garage doors with metal/UPVC framework.

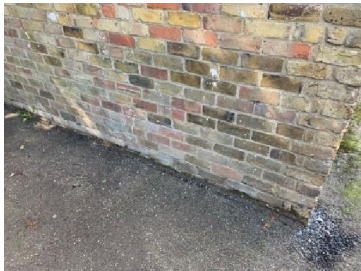
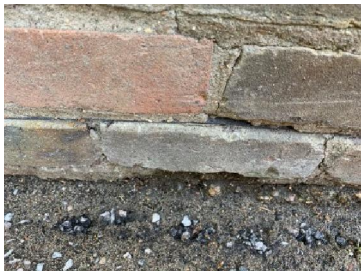
Floor:	Ground Floor		
Room Area:	External 099		
Description:	Bitumen Damp Proof Course		
Quantity:	30lm

Accessibility:	Easy		
Product Type:	1 - Bituminous Product		
Damage Extent:	1 - Low Damage		
Surface Treatment:	0 - Composite	Re-inspection Due:	N/A
Asbestos Type:	No Asbestos Detected	Sample Ref:	S01
Material Assessment:		No Asbestos Detected	
Comments: - Found to low level brickwork.			
Recommendations: No action required

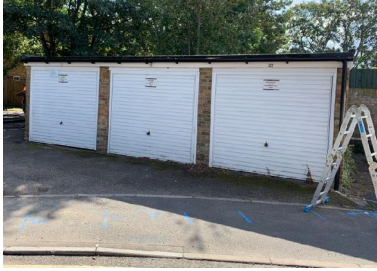
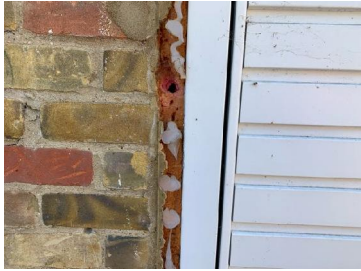
Floor:	Ground Floor		
Room Area:	External 099		
Description:	Putty Seals to Garage Doors		
Quantity:	12lm

Accessibility:	Easy		
Product Type:	1 - Putty		
Damage Extent:	1 - Low Damage		
Surface Treatment:	0 - Composite	Re-inspection Due:	N/A
Asbestos Type:	No Asbestos Detected	Sample Ref:	S02
Material Assessment:		No Asbestos Detected	
Comments: - Found to the perimeter of each garage door.			
Recommendations: No action required

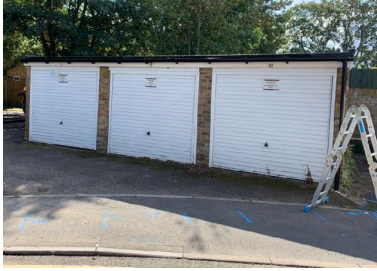
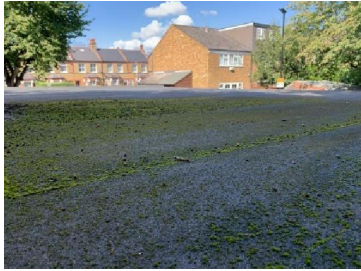
Floor:	Ground Floor		
Room Area:	External 099		
Description:	Felt Lining to Roof		
Quantity:	45m ²

Accessibility:	Medium		
Product Type:	1 - Bituminous Product		
Damage Extent:	1 - Low Damage		
Surface Treatment:	0 - Composite	Re-inspection Due:	N/A
Asbestos Type:	No Asbestos Detected	Sample Ref:	S03
Material Assessment:		No Asbestos Detected	
Comments: - Felt lining was found to entire roof. The felt was applied to timber.			
Recommendations: No action required
