### Asbestos Survey Report & Register

Survey Type:	Asbestos Demolition Survey
Site:	Garage Site 7, Garage Block at Oxford Court, Chiswick, W4 4DJ
Surveyor:	Jason Pack
Contract:	S-07996
Survey Date:	03 April 2019
Report Date:	12 April 2019
Client:	Arcadis LLP PO Box 307, Manchester, M60 3NT

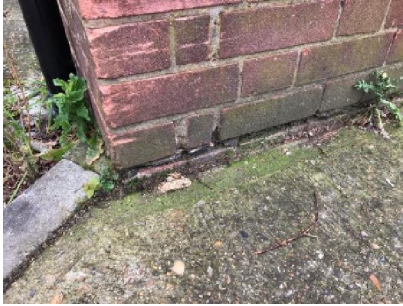
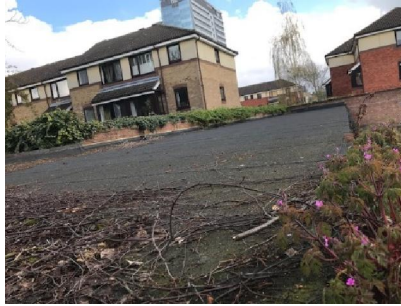
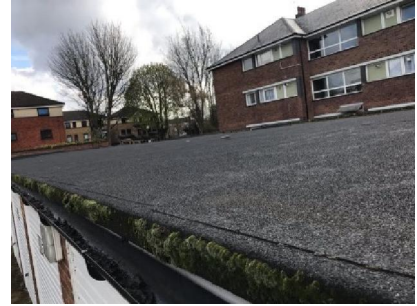
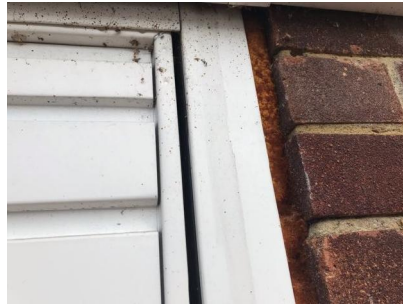
Area:	All Areas
Floors:	The floors could not be inspected as the garages were locked at the time of the survey.
Walls:	The walls are comprised of brick
Ceilings:	The ceilings could not be inspected as the garages were locked at the time of the survey.
External:	The garage blocks consist of brick walls with plastic gutters and down pipes along with uPVC infill strips around the metal garage doors and frames. The plastic fascia's are fixed to timber batons. There are no soffits present on either block.

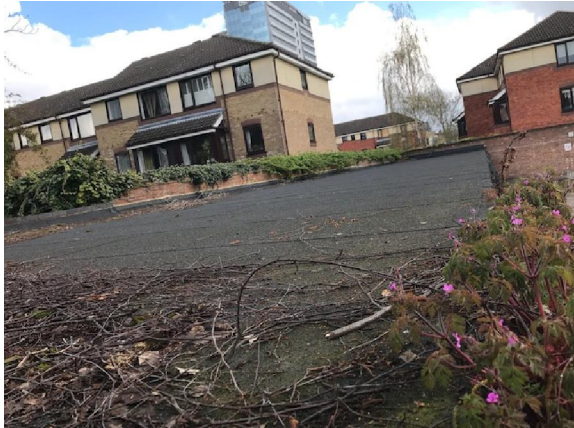
<b>Contract No:</b> S-07996	<b>Client:</b> Arcadis LLP	<b>Location Ref OSL:</b> OSL001	
<b>Site:</b> Garage Site 7, Garage Block at Oxford Court, Chiswick, W4 4DJ		<b>Survey Date:</b> 03 April 2019	
<b>Building:</b>	Block 1- 12

<b>Floor:</b>	Ground Floor		
<b>Room Area:</b>	099 External 001		
<b>Description:</b>	Felt to Roof		
<b>Quantity:</b>	90m <sup>2</sup>		
<b>Accessibility:</b>	Medium		
<b>Product Type:</b>	1 - Bituminous Product		
<b>Damage Extent:</b>	1 - Low Damage		
<b>Surface Treatment:</b>	0 - Composite	<b>Re-inspection Due:</b>	N/A
<b>Asbestos Type:</b>	No Asbestos Detected	<b>Sample Ref:</b>	S01
<b>Material Assessment:</b>		<b>No Asbestos Detected</b>	
<b>Comments:</b> - Roofing felt to entire block			
<b>Recommendations:</b> No action required

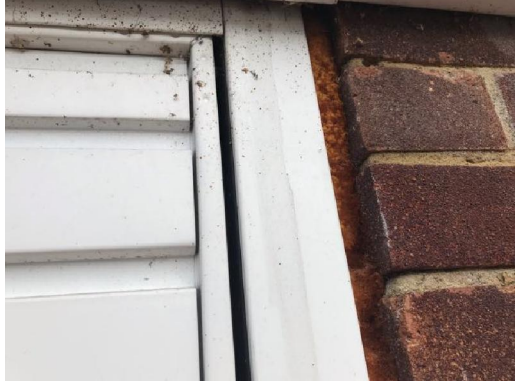
<b>Contract No:</b> S-07996	<b>Client:</b> Arcadis LLP	<b>Location Ref OSL:</b> OSL002	
<b>Site:</b> Garage Site 7, Garage Block at Oxford Court, Chiswick, W4 4DJ		<b>Survey Date:</b> 03 April 2019	
<b>Building:</b>	Block 1- 12

<b>Floor:</b>	Ground Floor		
<b>Room Area:</b>	099 External 001		
<b>Description:</b>	Foam Sealant		
<b>Quantity:</b>	24lm		
<b>Accessibility:</b>	Medium		
<b>Product Type:</b>	1 - Bituminous Product		
<b>Damage Extent:</b>	2 - Medium		
<b>Surface Treatment:</b>	0 - Composite	<b>Re-inspection Due:</b>	N/A
<b>Asbestos Type:</b>	No Asbestos Detected	<b>Sample Ref:</b>	S02
<b>Material Assessment:</b>		<b>No Asbestos Detected</b>	
<b>Comments:</b> - Foam sealant between garage units/doors			
<b>Recommendations:</b> No action required

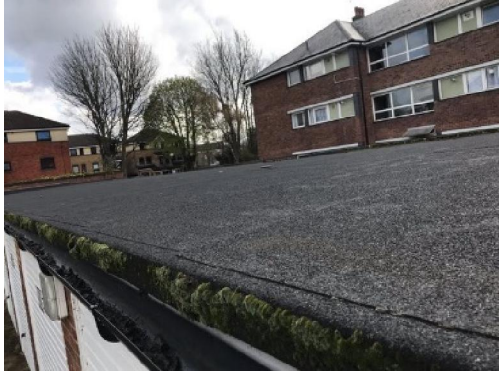
<b>Contract No:</b> S-07996	<b>Client:</b> Arcadis LLP	<b>Location Ref OSL:</b> OSL003	
<b>Site:</b> Garage Site 7, Garage Block at Oxford Court, Chiswick, W4 4DJ		<b>Survey Date:</b> 03 April 2019	
<b>Building:</b>	Block 1- 12

<b>Floor:</b>	Ground Floor		
<b>Room Area:</b>	099 External 001		
<b>Description:</b>	Felt to Roof		
<b>Quantity:</b>	90m <sup>2</sup>		
<b>Accessibility:</b>	Medium		
<b>Product Type:</b>	1 - Bituminous Product		
<b>Damage Extent:</b>	2 - Medium		
<b>Surface Treatment:</b>	0 - Composite	<b>Re-inspection Due:</b>	N/A
<b>Asbestos Type:</b>	No Asbestos Detected	<b>Sample Ref:</b>	S03
<b>Material Assessment:</b>		<b>No Asbestos Detected</b>	
<b>Comments:</b> - Roofing felt to entire garage block			
<b>Recommendations:</b> No action required

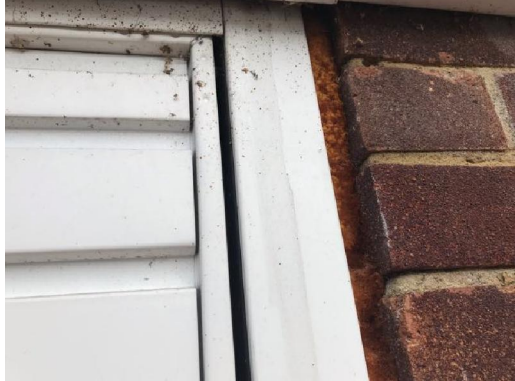
<b>Contract No:</b> S-07996	<b>Client:</b> Arcadis LLP	<b>Location Ref OSL:</b> OSL004	
<b>Site:</b> Garage Site 7, Garage Block at Oxford Court, Chiswick, W4 4DJ		<b>Survey Date:</b> 03 April 2019	
<b>Building:</b>	Block 13-23

<b>Floor:</b>	External		
<b>Room Area:</b>	External 001		
<b>Description:</b>	Foam Sealant		
<b>Quantity:</b>	24lm		
<b>Accessibility:</b>	Easy		
<b>Product Type:</b>	1 - Bituminous Product		
<b>Damage Extent:</b>	2 - Medium		
<b>Surface Treatment:</b>	0 - Composite	<b>Re-inspection Due:</b>	N/A
<b>Asbestos Type:</b>	No Asbestos Detected	<b>Sample Ref:</b>	S04
<b>Material Assessment:</b>		<b>No Asbestos Detected</b>	
<b>Comments:</b> - Foam sealant between garage units/doors			
<b>Recommendations:</b> No action required

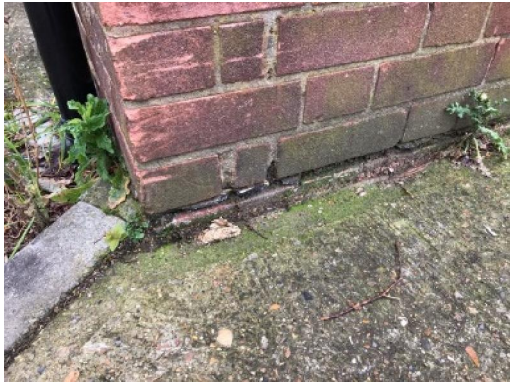
<b>Contract No:</b> S-07996	<b>Client:</b> Arcadis LLP	<b>Location Ref OSL:</b> OSL005	
<b>Site:</b> Garage Site 7, Garage Block at Oxford Court, Chiswick, W4 4DJ		<b>Survey Date:</b> 03 April 2019	
<b>Building:</b>	Block 13 - 23

<b>Floor:</b>	Ground Floor		
<b>Room Area:</b>	099 External 001		
<b>Description:</b>	Bitumen Damp proof course		
<b>Quantity:</b>	35lm		
<b>Accessibility:</b>	Difficult		
<b>Product Type:</b>	1 - Bituminous Product		
<b>Damage Extent:</b>	1 - Low Damage		
<b>Surface Treatment:</b>	0 - Composite	<b>Re-inspection Due:</b>	N/A
<b>Asbestos Type:</b>	No Asbestos Detected	<b>Sample Ref:</b>	S05
<b>Material Assessment:</b>		<b>No Asbestos Detected</b>	
<b>Comments:</b> - Presumed to be present to both blocks, only visible on block 13-23.			
<b>Recommendations:</b> No action required
