**London Borough of Hounslow
Garage Block at Oxford Court (Site 7)**

Utility Mapping Survey

Site Report

Project No. 1716

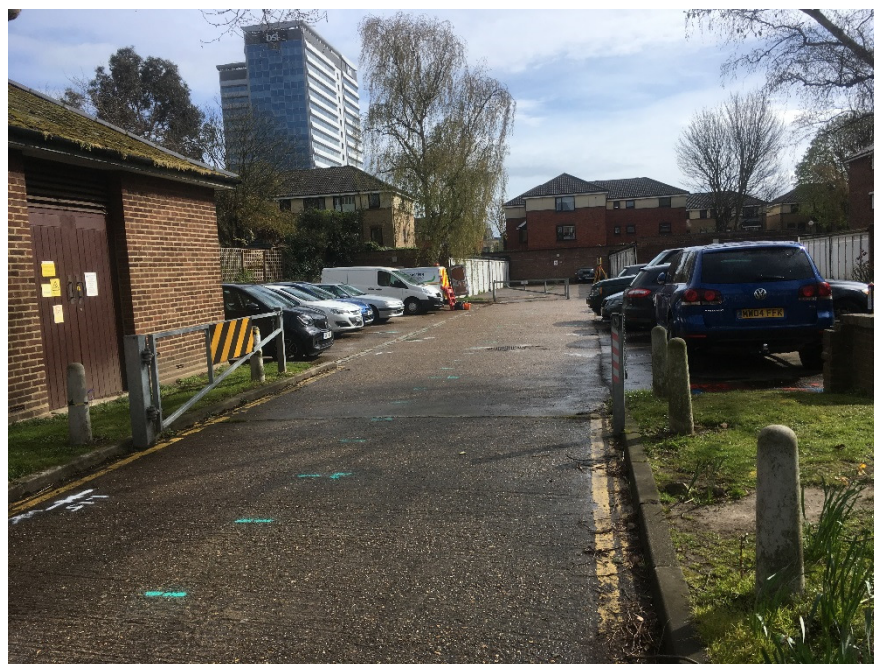
Photo 1

Description: General view of the survey extents.

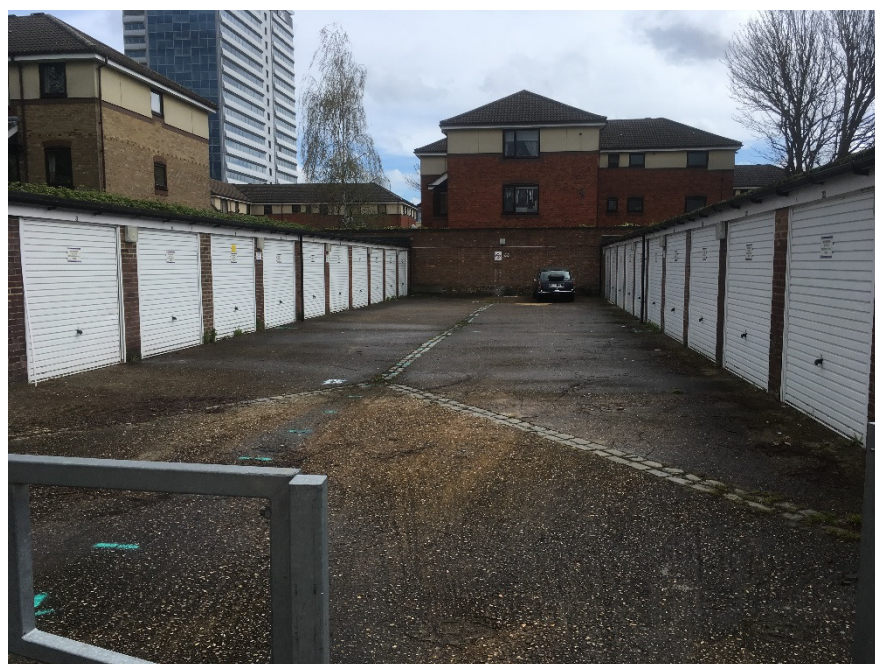
Photo 2

Description: General view of the survey extents.

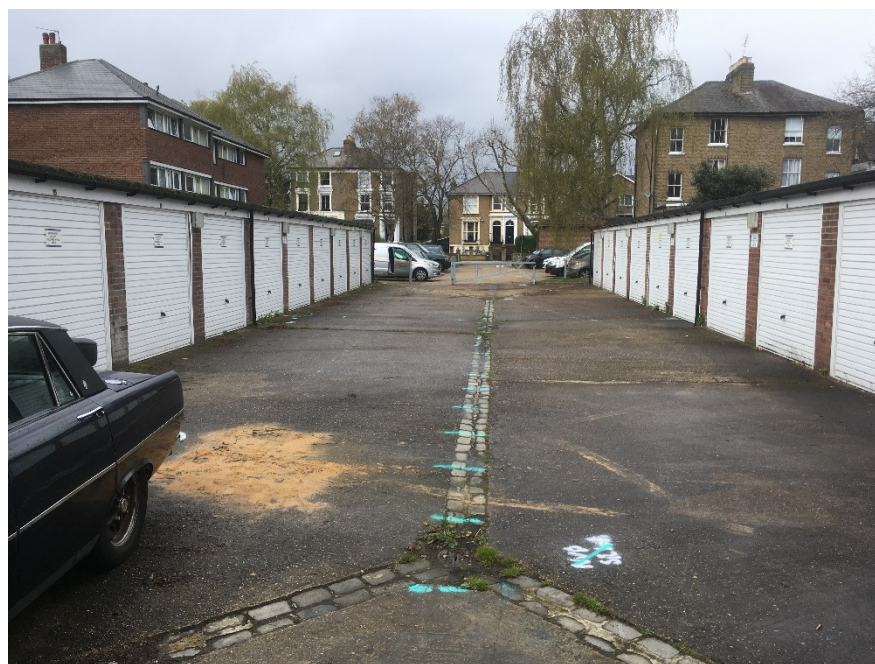
Photo 3

Description: General view of the survey extents.

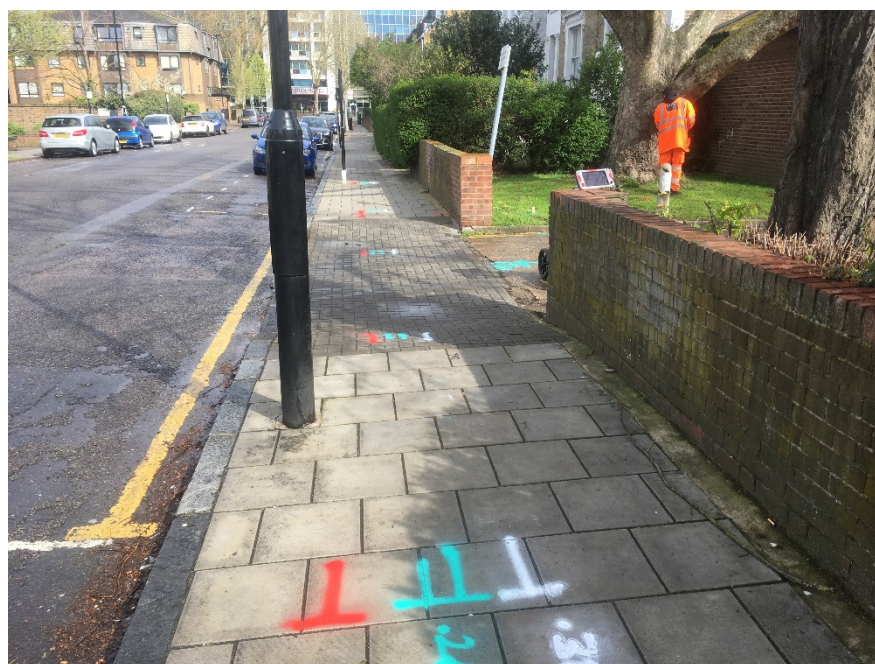
Photo 4

Description: General view of the survey extents.

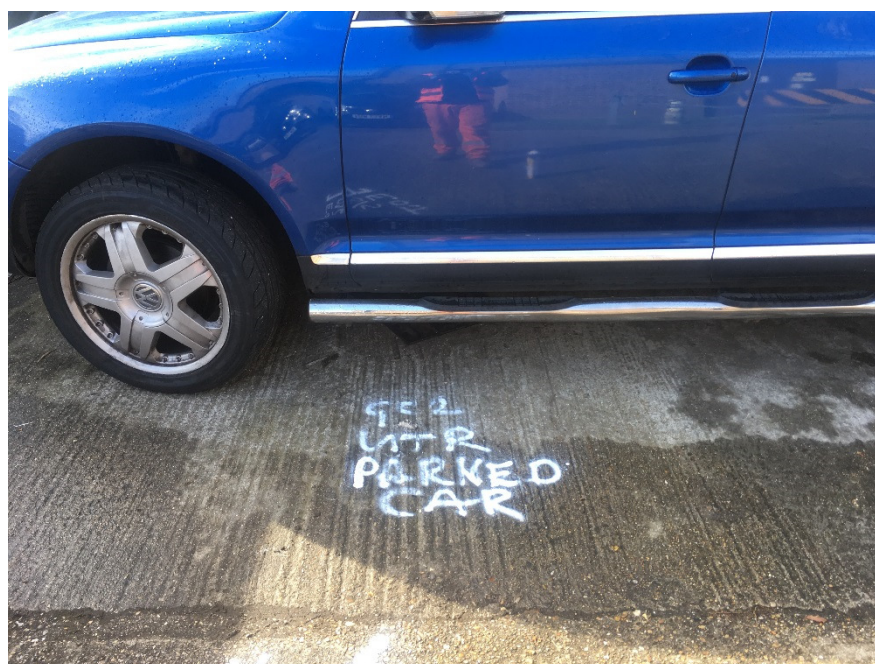
Photo 5

Description: Parked vehicle over inspection chamber GC02.

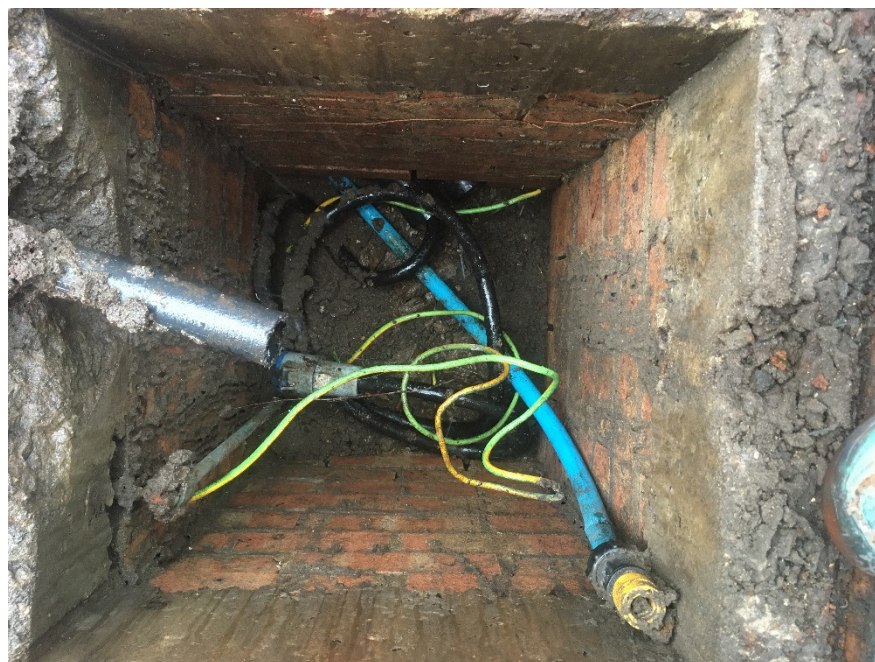
Photo 6

Service	Comment Number	Successes / Problems Differences between survey & "Stats"
	3	Inspection chamber GC03 with combined services of electric and water. Electric cables were connected to and traced by direct connection to the cables.
	4	A full passive power sweep was performed utilizing radio frequency equipment.
	5	No statutory record information available at time of survey.
Telecom	1	Telecommunication routes located within inspection covers in the footpath. Routes have been located and traced by direct connection to the cables inside the inspection cover and service providers added to the drawing where they were able to be identified.
	2	Routes that could not be completed / proven have been transferred from records where necessary.
Ducting Routes	1	Several empty ducting routes located throughout the survey areas. All available routes have been traced by inserting a locating device into the empty ducting route.

CATV	1	CATV routes located in the survey extents. These routes have been located and traced by direct connection to the cables inside the inspection covers.
	2	No statutory record information available at time of survey.
Water	1	Polyethene water pipe located inside inspection chamber GC03 with electric cables also inside the inspection chamber. Unable to locate water route due to pipe being polyethene.
	2	No statutory record information available at time of survey.
Gas	1	No gas located inside the survey extents at time of survey.
	2	Routes that could not be completed / proven have been transferred from records where necessary.
Other	1	One unknown route located and traced by active induction. Unable to associate any fittings or features in the vicinity to help establish utility types.
GPR Scans	1	The radar reflects changes in the electrical properties of materials in the sub-surface. The data prevents definition of unknown targets.

Description: combined services inside inspection chamber. Inspection chamber GC03.

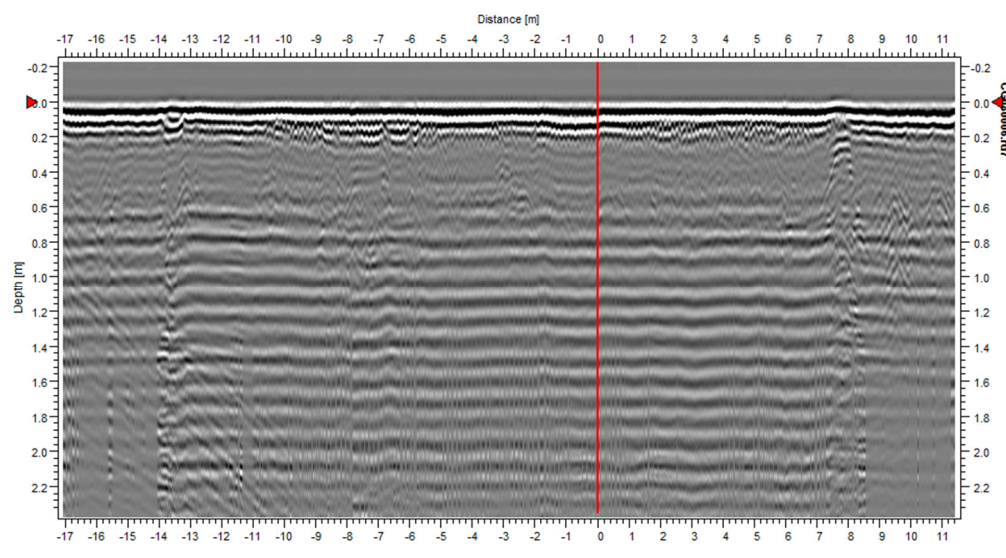
GPR 1

Description: Ground Penetrating Radar Image

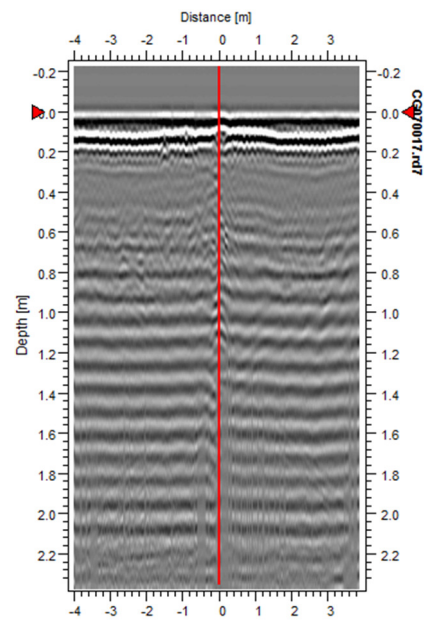
GPR 2

Description: Ground Penetrating Radar Image
