## Asbestos Demolition Survey

**Pinewood Close  
Pinner  
HA5 4BW**

**London Borough of Harrow**

Project Number:	Survey Date:	Issue Date:
N-20738	17 March 2020	20 March 2020

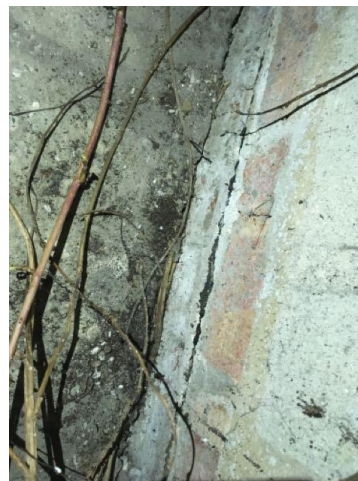
<b>Building</b>	Pinewood Close
<b>Floor</b>	External
<b>Room</b>	99 - Garages
<b>Description</b>	Bitumen damp proof course to the walls
<b>Sample Reference</b>	S001
<b>Quantity</b>	100 Lin M
<b>Accessibility</b>	Medium

<b>Analysis Result</b>	No Asbestos Detected	0
<b>Product Type</b>	Bitumen	1
<b>Condition</b>	Low Damage	1
<b>Surface Treatment</b>	Composite (Self Sealed)	0

<b>Material Risk Assessment Score</b>
<b>0</b>
<b>Risk Assessment Description</b>
<b>No ACMs Detected</b>

No asbestos was detected within the sample collected and as such no further action is required.

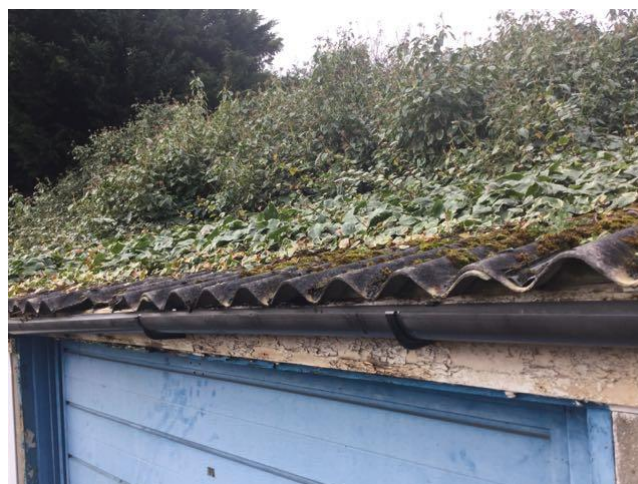
<b>Building</b>	Pinewood Close
<b>Floor</b>	External
<b>Room</b>	99 - Garages
<b>Description</b>	Cement roof to the garages
<b>Sample Reference</b>	S002
<b>Quantity</b>	180 m <sup>2</sup>
<b>Accessibility</b>	Medium

<b>Analysis Result</b>	Chrysotile	1
<b>Product Type</b>	Cement	1
<b>Condition</b>	Medium Damage	2
<b>Surface Treatment</b>	Unsealed Cement	1

<b>Material Risk Assessment Score</b>
<b>5</b>
<b>Risk Assessment Description</b>
<b>Low Risk</b>

Some areas were damaged and corners missing, large amounts of moss to the roofs.

The asbestos containing material should be removed and disposed of in full accordance with current and relevant legislation.

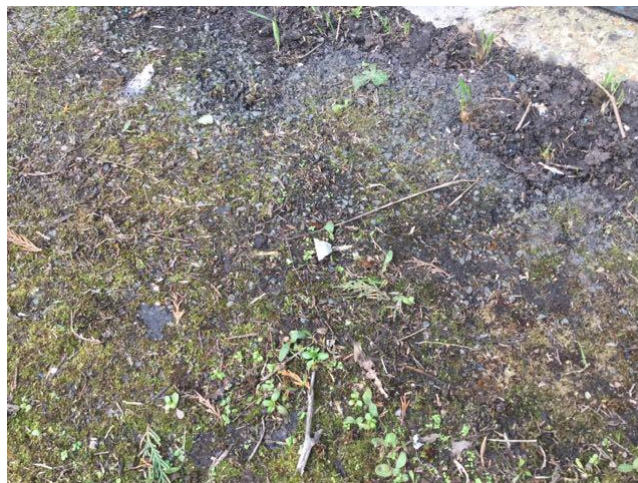
<b>Building</b>	Pinewood Close
<b>Floor</b>	External
<b>Room</b>	99 - Car park
<b>Description</b>	Debris to the floor of the car park
<b>Sample Reference</b>	S003
<b>Quantity</b>	2 m <sup>2</sup>
<b>Accessibility</b>	Easy

<b>Analysis Result</b>	Chrysotile	1
<b>Product Type</b>	Cement	1
<b>Condition</b>	High Damage	3
<b>Surface Treatment</b>	Unsealed Cement	1

<b>Material Risk Assessment Score</b>
<b>6</b>
<b>Risk Assessment Description</b>
<b>Low Risk</b>

Small pieces spread over an area of 100m<sup>2</sup>

The asbestos containing material should be removed and disposed of in full accordance with current and relevant legislation.
