Asbestos Survey Report & Register

Survey Type:	Asbestos Demolition Survey
Site:	Garage block at 60 Magdala Road, Isleworth, TW7 7DD
Surveyor(s):	Aaron Galyer & Liam Bates
Contract:	S-10024
Survey Date:	04 September 2019
Report Date:	10 September 2019
Re-Inspection Due:	04 September 2020
Client:	Arcadis LLP PO Box 307, Manchester, M60 3NT

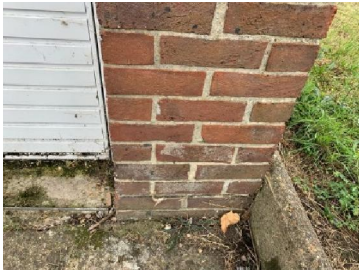
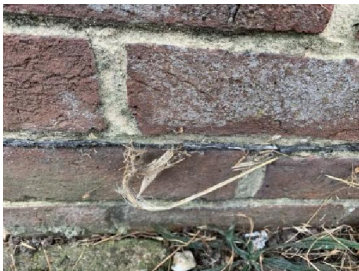
Contract No: S-10024	Client: Arcadis LLP	Location Ref OSL: OSL001	
Site: Garage block at 60 Magdala Road, Isleworth, TW7 7DD		Survey Date: 04 September 2019	
Building:	Garage block at 60 Magdala Road

Floor:	Ground Floor		
Room Area:	External 099		
Description:	Bitumen Damp Proof Course		
Quantity:	35lm

Accessibility:	Difficult		
Product Type:	1 - Bituminous Product		
Damage Extent:	1 - Low Damage		
Surface Treatment:	0 - Composite	Re-inspection Due:	N/A
Asbestos Type:	No Asbestos Detected	Sample Ref:	S01
Material Assessment:		No Asbestos Detected	
Comments: - Bitumen damp proof course found to low level wall. Ran entire perimeter of brick wall.			
Recommendations: No action required

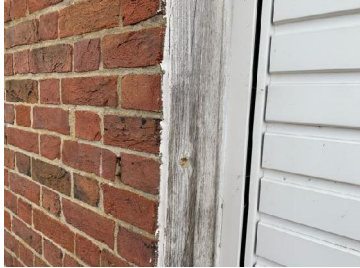
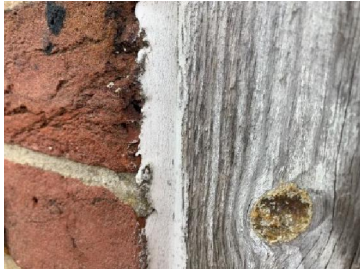
Contract No: S-10024	Client: Arcadis LLP	Location Ref OSL: OSL002	
Site: Garage block at 60 Magdala Road, Isleworth, TW7 7DD		Survey Date: 04 September 2019	
Building:	Garage block at 60 Magdala Road

Floor:	Ground Floor		
Room Area:	External 099		
Description:	Putty to Doors		
Quantity:	16lm

Accessibility:	Medium		
Product Type:	1 - Putty		
Damage Extent:	1 - Low Damage		
Surface Treatment:	0 - Composite	Re-inspection Due:	N/A
Asbestos Type:	No Asbestos Detected	Sample Ref:	S02
Material Assessment:		No Asbestos Detected	
Comments: - Putty was to door joints to all door frames.			
Recommendations: No action required

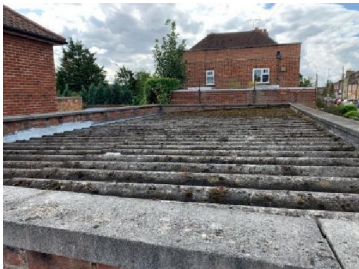
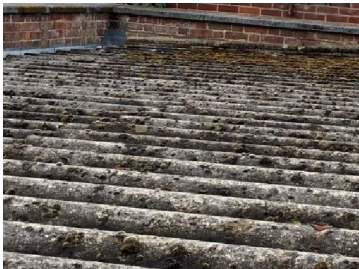
Contract No: S-10024	Client: Arcadis LLP	Location Ref OSL: OSL003	
Site: Garage block at 60 Magdala Road, Isleworth, TW7 7DD		Survey Date: 04 September 2019	
Building:	Garage block at 60 Magdala Road

Garage block at 60 Magdala Road					
OSL No/ Sample Ref	Risk:	Room / Area:	Product Type:	Asbestos Type:	Extent:
OSL003/S03	Very Low	Ground Floor / External 099	Cement Roof sheet - Cement Product	Chrysotile	75m ²

Floor:	Ground Floor		
Room Area:	External 099		
Description:	Cement Roof sheet		
Quantity:	75m ²

Accessibility:	Difficult		
Product Type:	1 - Cement Product		
Damage Extent:	1 - Low Damage		
Surface Treatment:	1 - Unsealed	Re-inspection Due:	04/09/2020
Asbestos Type:	1 - Chrysotile	Sample Ref:	S03
Material Assessment:		Risk Score = 4 Very Low	
Comments: - Cement roof sheets covering all roof areas.			
Recommendations: Remove The asbestos containing material should be removed and disposed of in full accordance with current and relevant legislation prior to the demolition of the building.

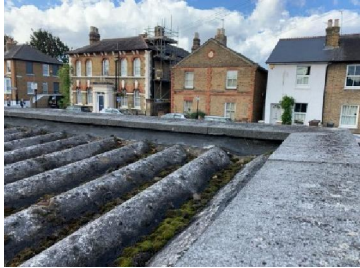
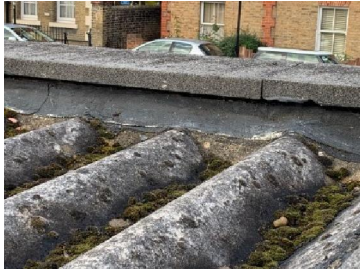
Contract No: S-10024	Client: Arcadis LLP	Location Ref OSL: OSL004	
Site: Garage block at 60 Magdala Road, Isleworth, TW7 7DD		Survey Date: 04 September 2019	
Building:	Garage block at 60 Magdala Road

Floor:	Ground Floor		
Room Area:	External 099		
Description:	Felt to roof		
Quantity:	35lm

Accessibility:	Difficult		
Product Type:	1 - Bituminous Product		
Damage Extent:	1 - Low Damage		
Surface Treatment:	0 - Composite	Re-inspection Due:	N/A
Asbestos Type:	No Asbestos Detected	Sample Ref:	S04
Material Assessment:		No Asbestos Detected	
Comments: - Felt to all joints of cement garage roof to wall.			
Recommendations: No action required

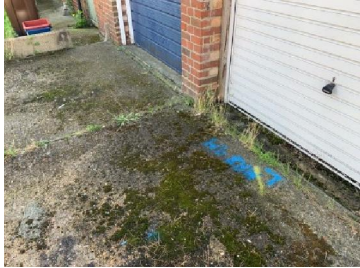
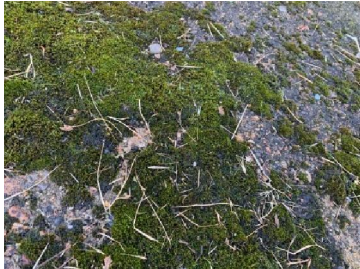
Contract No: S-10024	Client: Arcadis LLP	Location Ref OSL: OSL005	
Site: Garage block at 60 Magdala Road, Isleworth, TW7 7DD		Survey Date: 04 September 2019	
Building:	Garage block at 60 Magdala Road

Floor:	Ground Floor		
Room Area:	External 099		
Description:	Cement debris		
Quantity:	unquantifiable

Accessibility:	Easy		
Product Type:	1 - Cement Product		
Damage Extent:	3 - High		
Surface Treatment:	1 - Unsealed	Re-inspection Due:	N/A
Asbestos Type:	No Asbestos Detected	Sample Ref:	S05
Material Assessment:		No Asbestos Detected	
Comments: - Cement debris found to moss on the floor surrounding garages. The moss was in situ to the garage roof and was presumed to have fallen onto the floor below.			
Recommendations: No action required
