TfL Small Sites
Wadham Road
Utility Mapping Survey
Site Report
Project No. 1178

Date of Survey: January 2020

Type of Survey: Underground Utility Location & Mapping Survey.

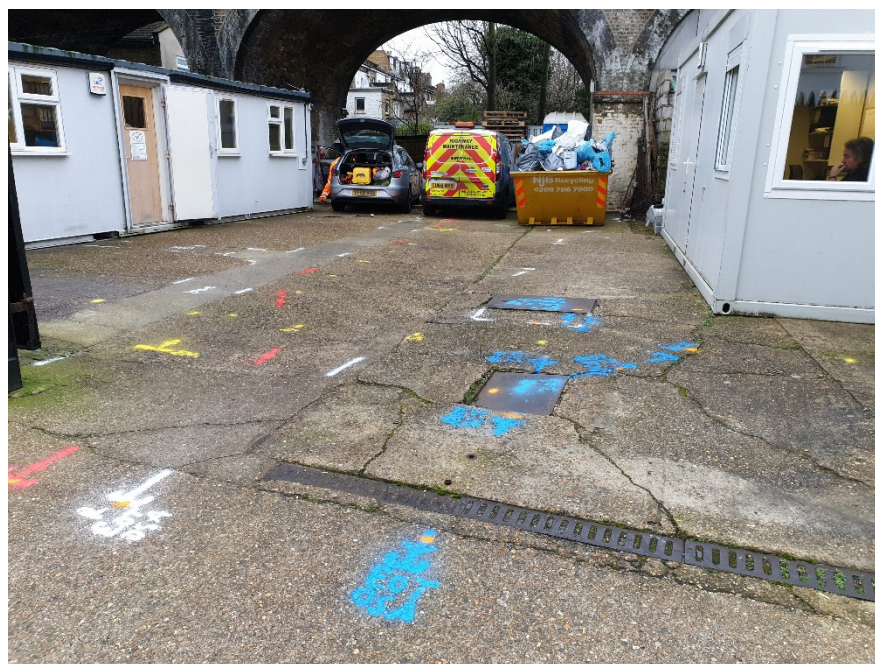
Photo 1

Description: General view of the survey extents.

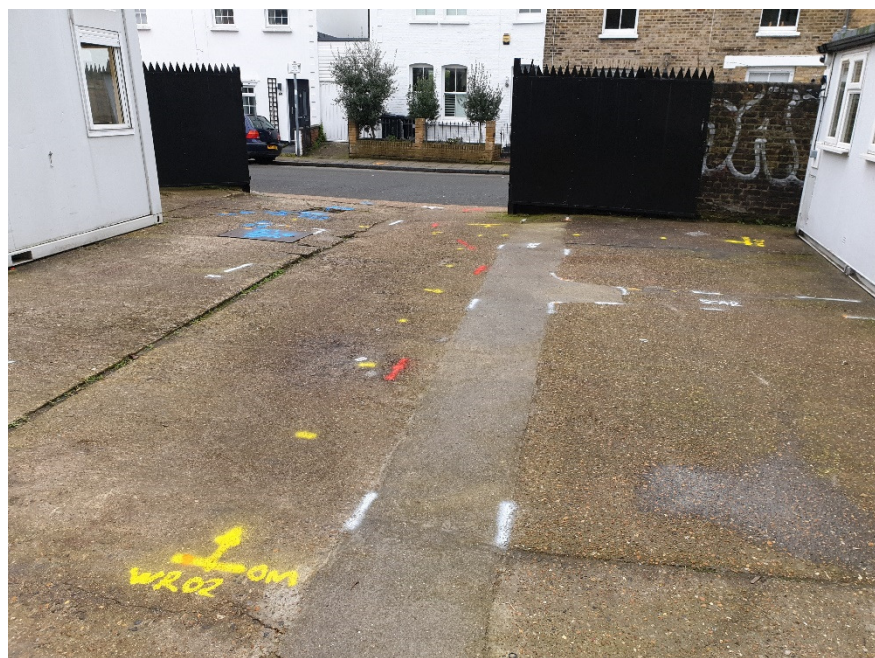
Photo 2

Description: General view of the survey extents.

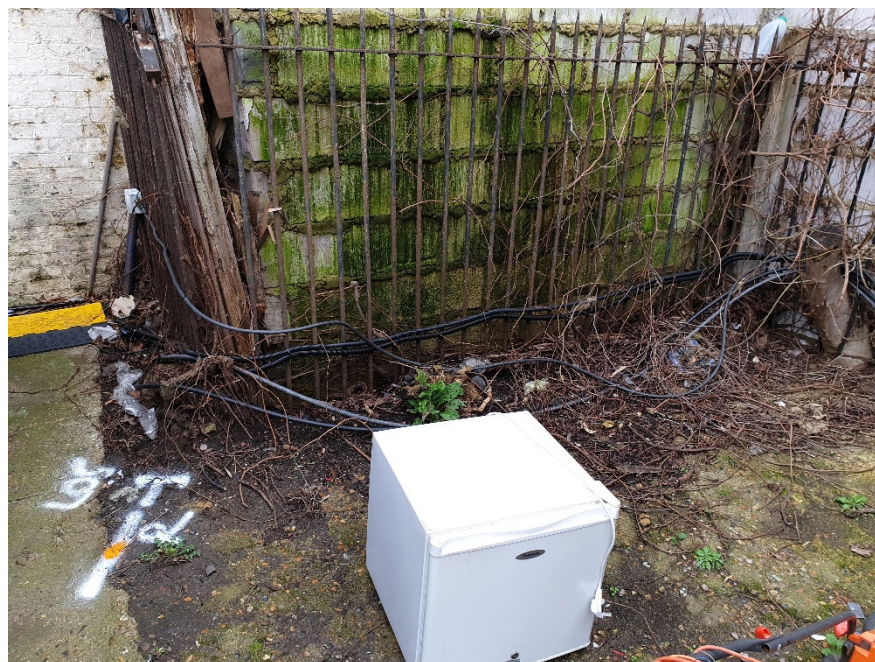
Photo 3

Description: General view of the survey extents.

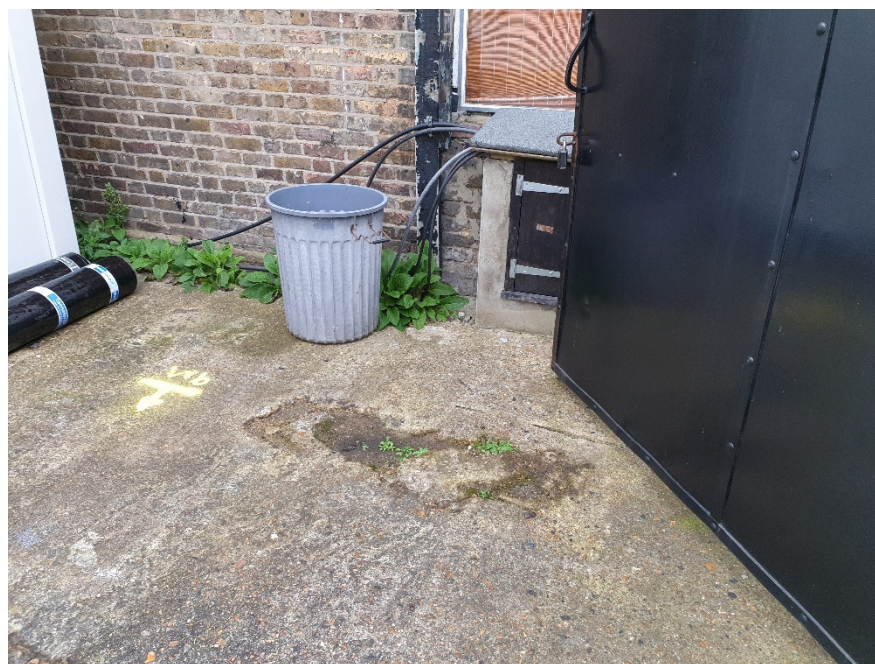
Photo 4

Description: General view of the survey extents.

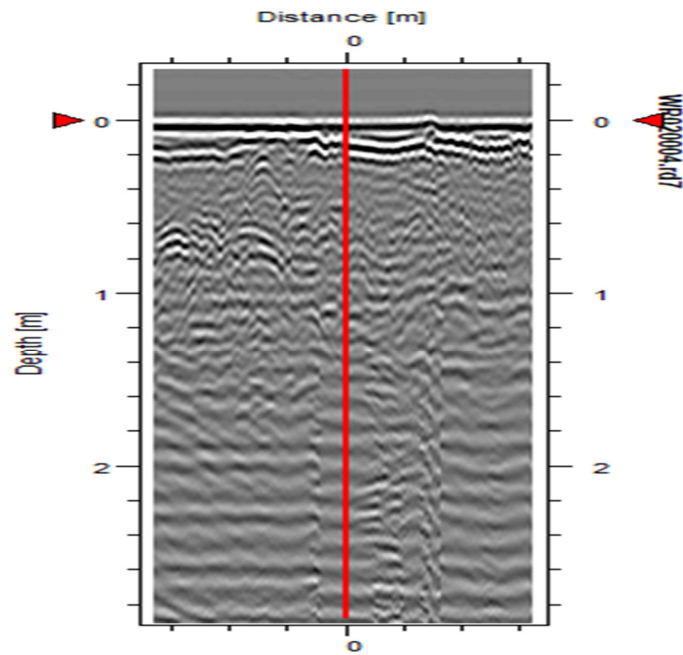
GPR 1

Description: Ground Penetrating Radar Image

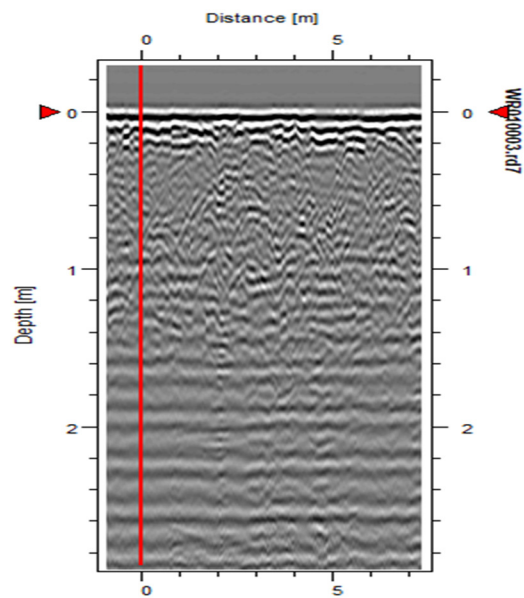
GPR 2

Description: Ground Penetrating Radar Image
