TFL_PSF_9131 SITE INVESTIGATIONS: SMALL SITES INITIATIVE LAND AT BEECHWOOD AVENUE, BARNET, N3 3BB

Site Ref: 439

Arboricultural Constraints Assessment Report

OCTOBER 2017

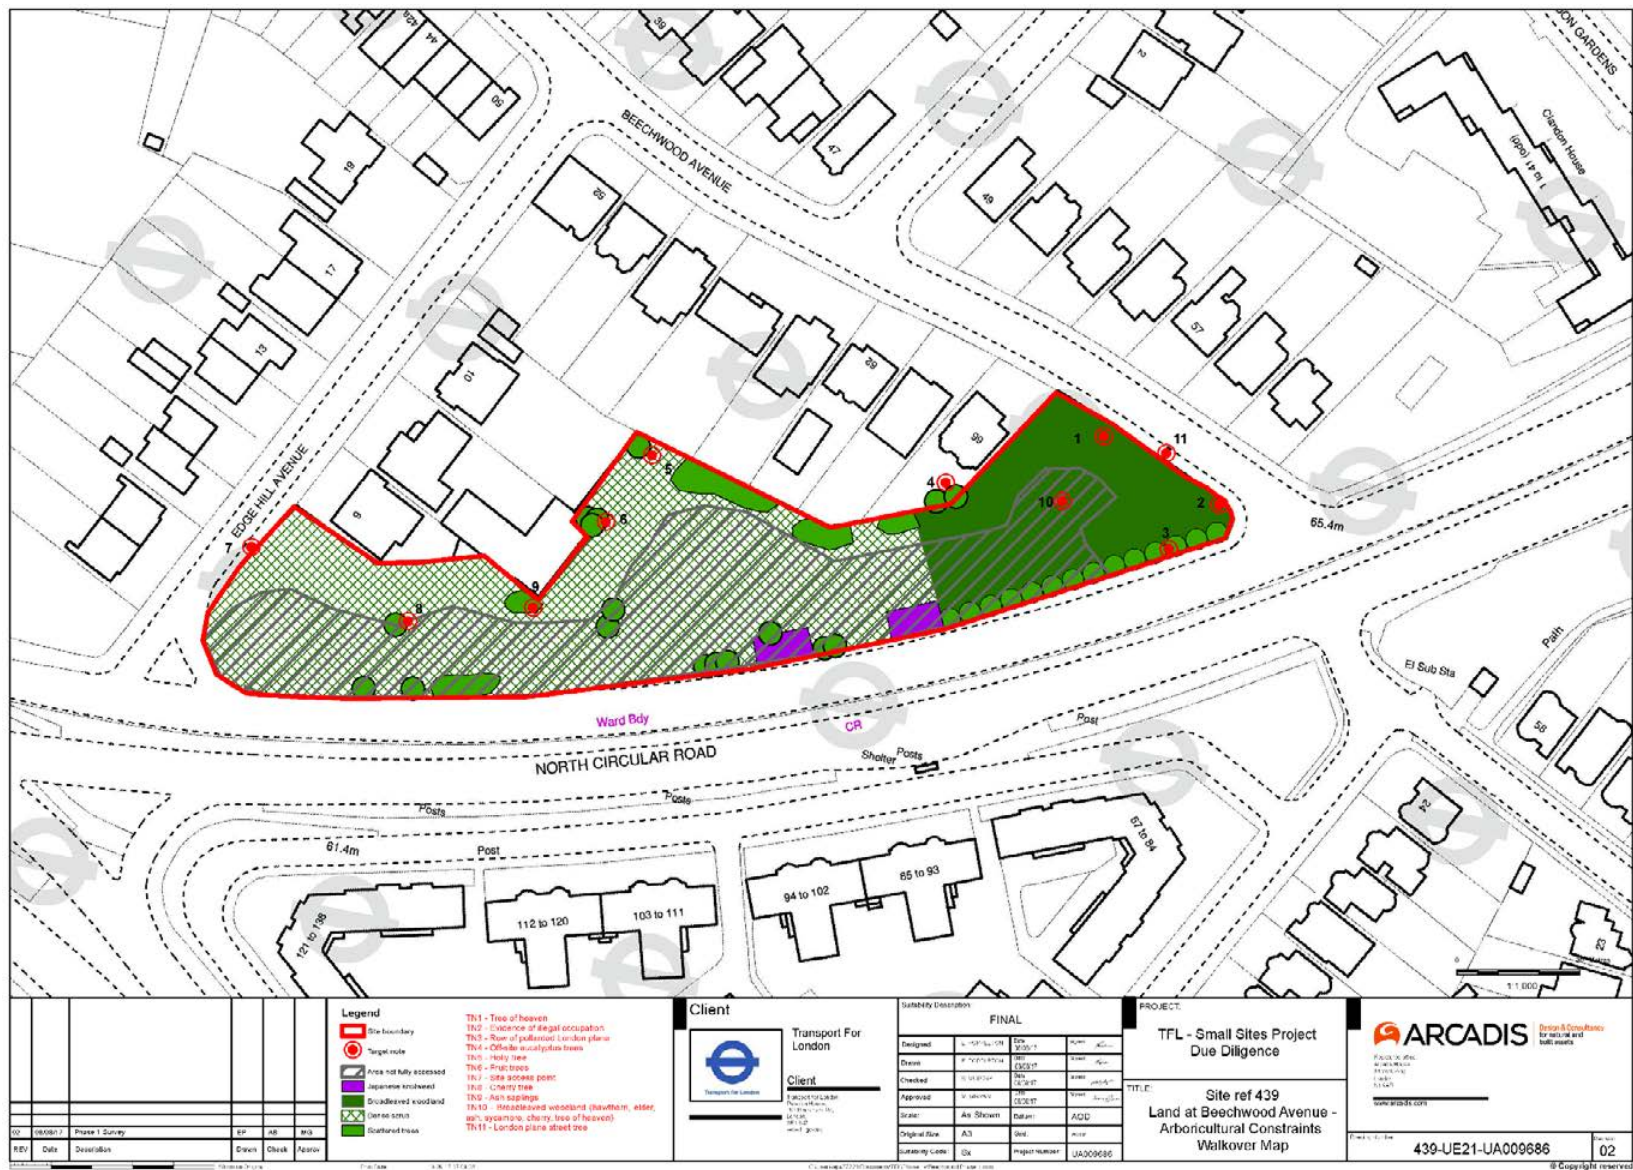
FIGURE 1. Arboricultural Constraints Walkover Map

The arboricultural constraints walkover found the study area to be covered in dense scrub with a scattering of young individual trees, the majority of which were less than 20 years old although some trees are likely have been planted and these may be in excess of 40 years old. Due to lack of positive management the trees were generally in poor condition. Figure 1 the Arboricultural Constraints Walkover Map shows the most significant trees identified. Photographs are presented in Appendix C.

The majority of the trees are not likely to be a significant issue for development from an individual arboricultural amenity point of view. The larger trees are likely to be Category C (these have been identified on Figure 1) and the majority of the trees on Site are young, unmanaged and arising from natural regeneration. However, the Site as a whole if considered as a group is visible from all sides and currently provides screening from the A406 North Circular Road to the residential properties on Edge Hill Avenue and Beechwood Avenue.

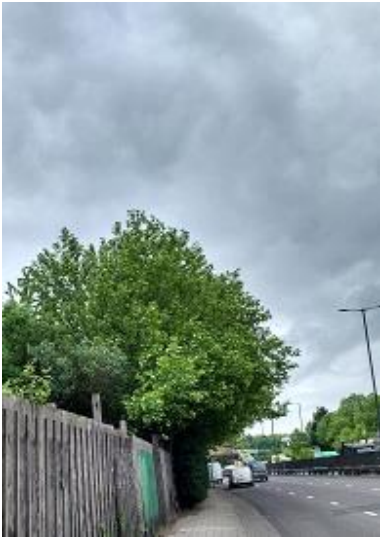
To the eastern end on the southern boundary of the Site adjacent to the A406 there is a row of heavily managed London plane trees (evidence of heavy pollarding, likely conducted to allow clearance for vehicles) that are older than the other specimens on the site, and have the potential to be in excess of 40 years old (TN 3). There are also several leylandii (*Cupressus × leylandii*) on the eastern boundary and a single large tree of heaven (TN 1).

The most significant trees are likely to be the row of heavily managed London Plane trees at the eastern end of the southern boundary of the Site adjacent to the A406 and any development should seek to retain these where possible. There are also several leylandii (*Cupressus × leylandii*) and a large tree of heaven on the eastern boundary, however these are unlikely to pose a constraint to the development.

Target Note	Description	Photograph
TN3	Row of pollarded London plane trees

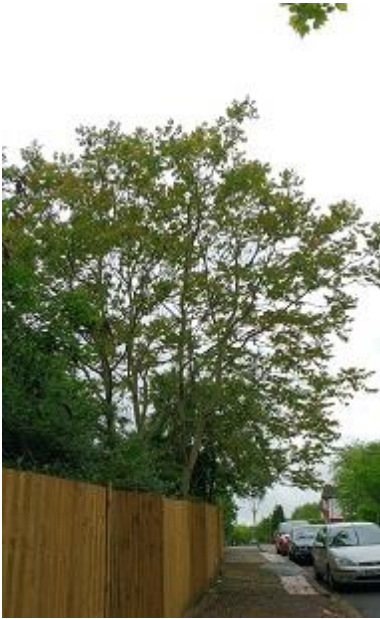
TN1	Tree of Heaven

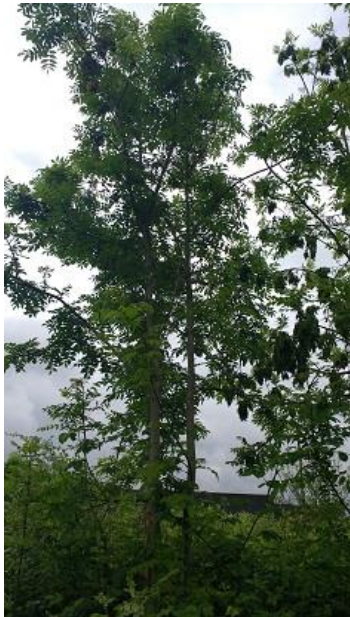
Target Note	Description	Photograph
N/A	Young ash tree

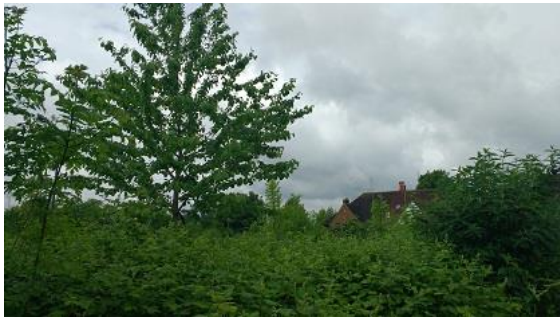
N/A	Cherry species sapling

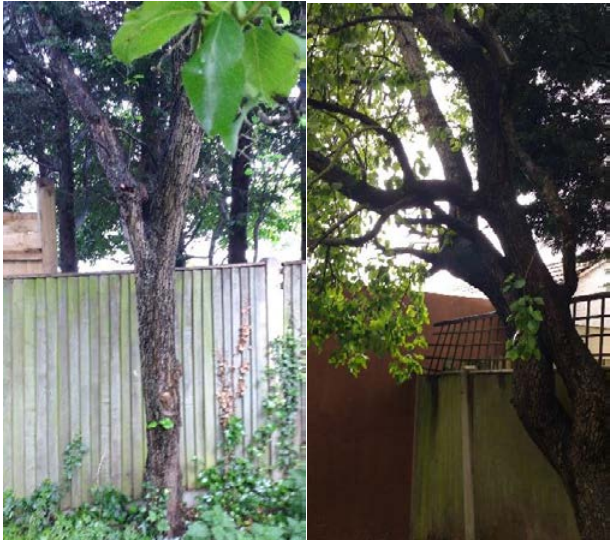
TN6	Fruit Trees
