TOWNSCAPE AND LVMF CONSIDERATIONS

140 - 150 London Wall [planning] | LVMF 17B.1 | Golden Jubilee/Hungerford Footbridges: downstream - crossing the Westminster bank | Telephoto - Existing

SUSTAINABILITY / CIRCULAR ECONOMY (SUMMARY)

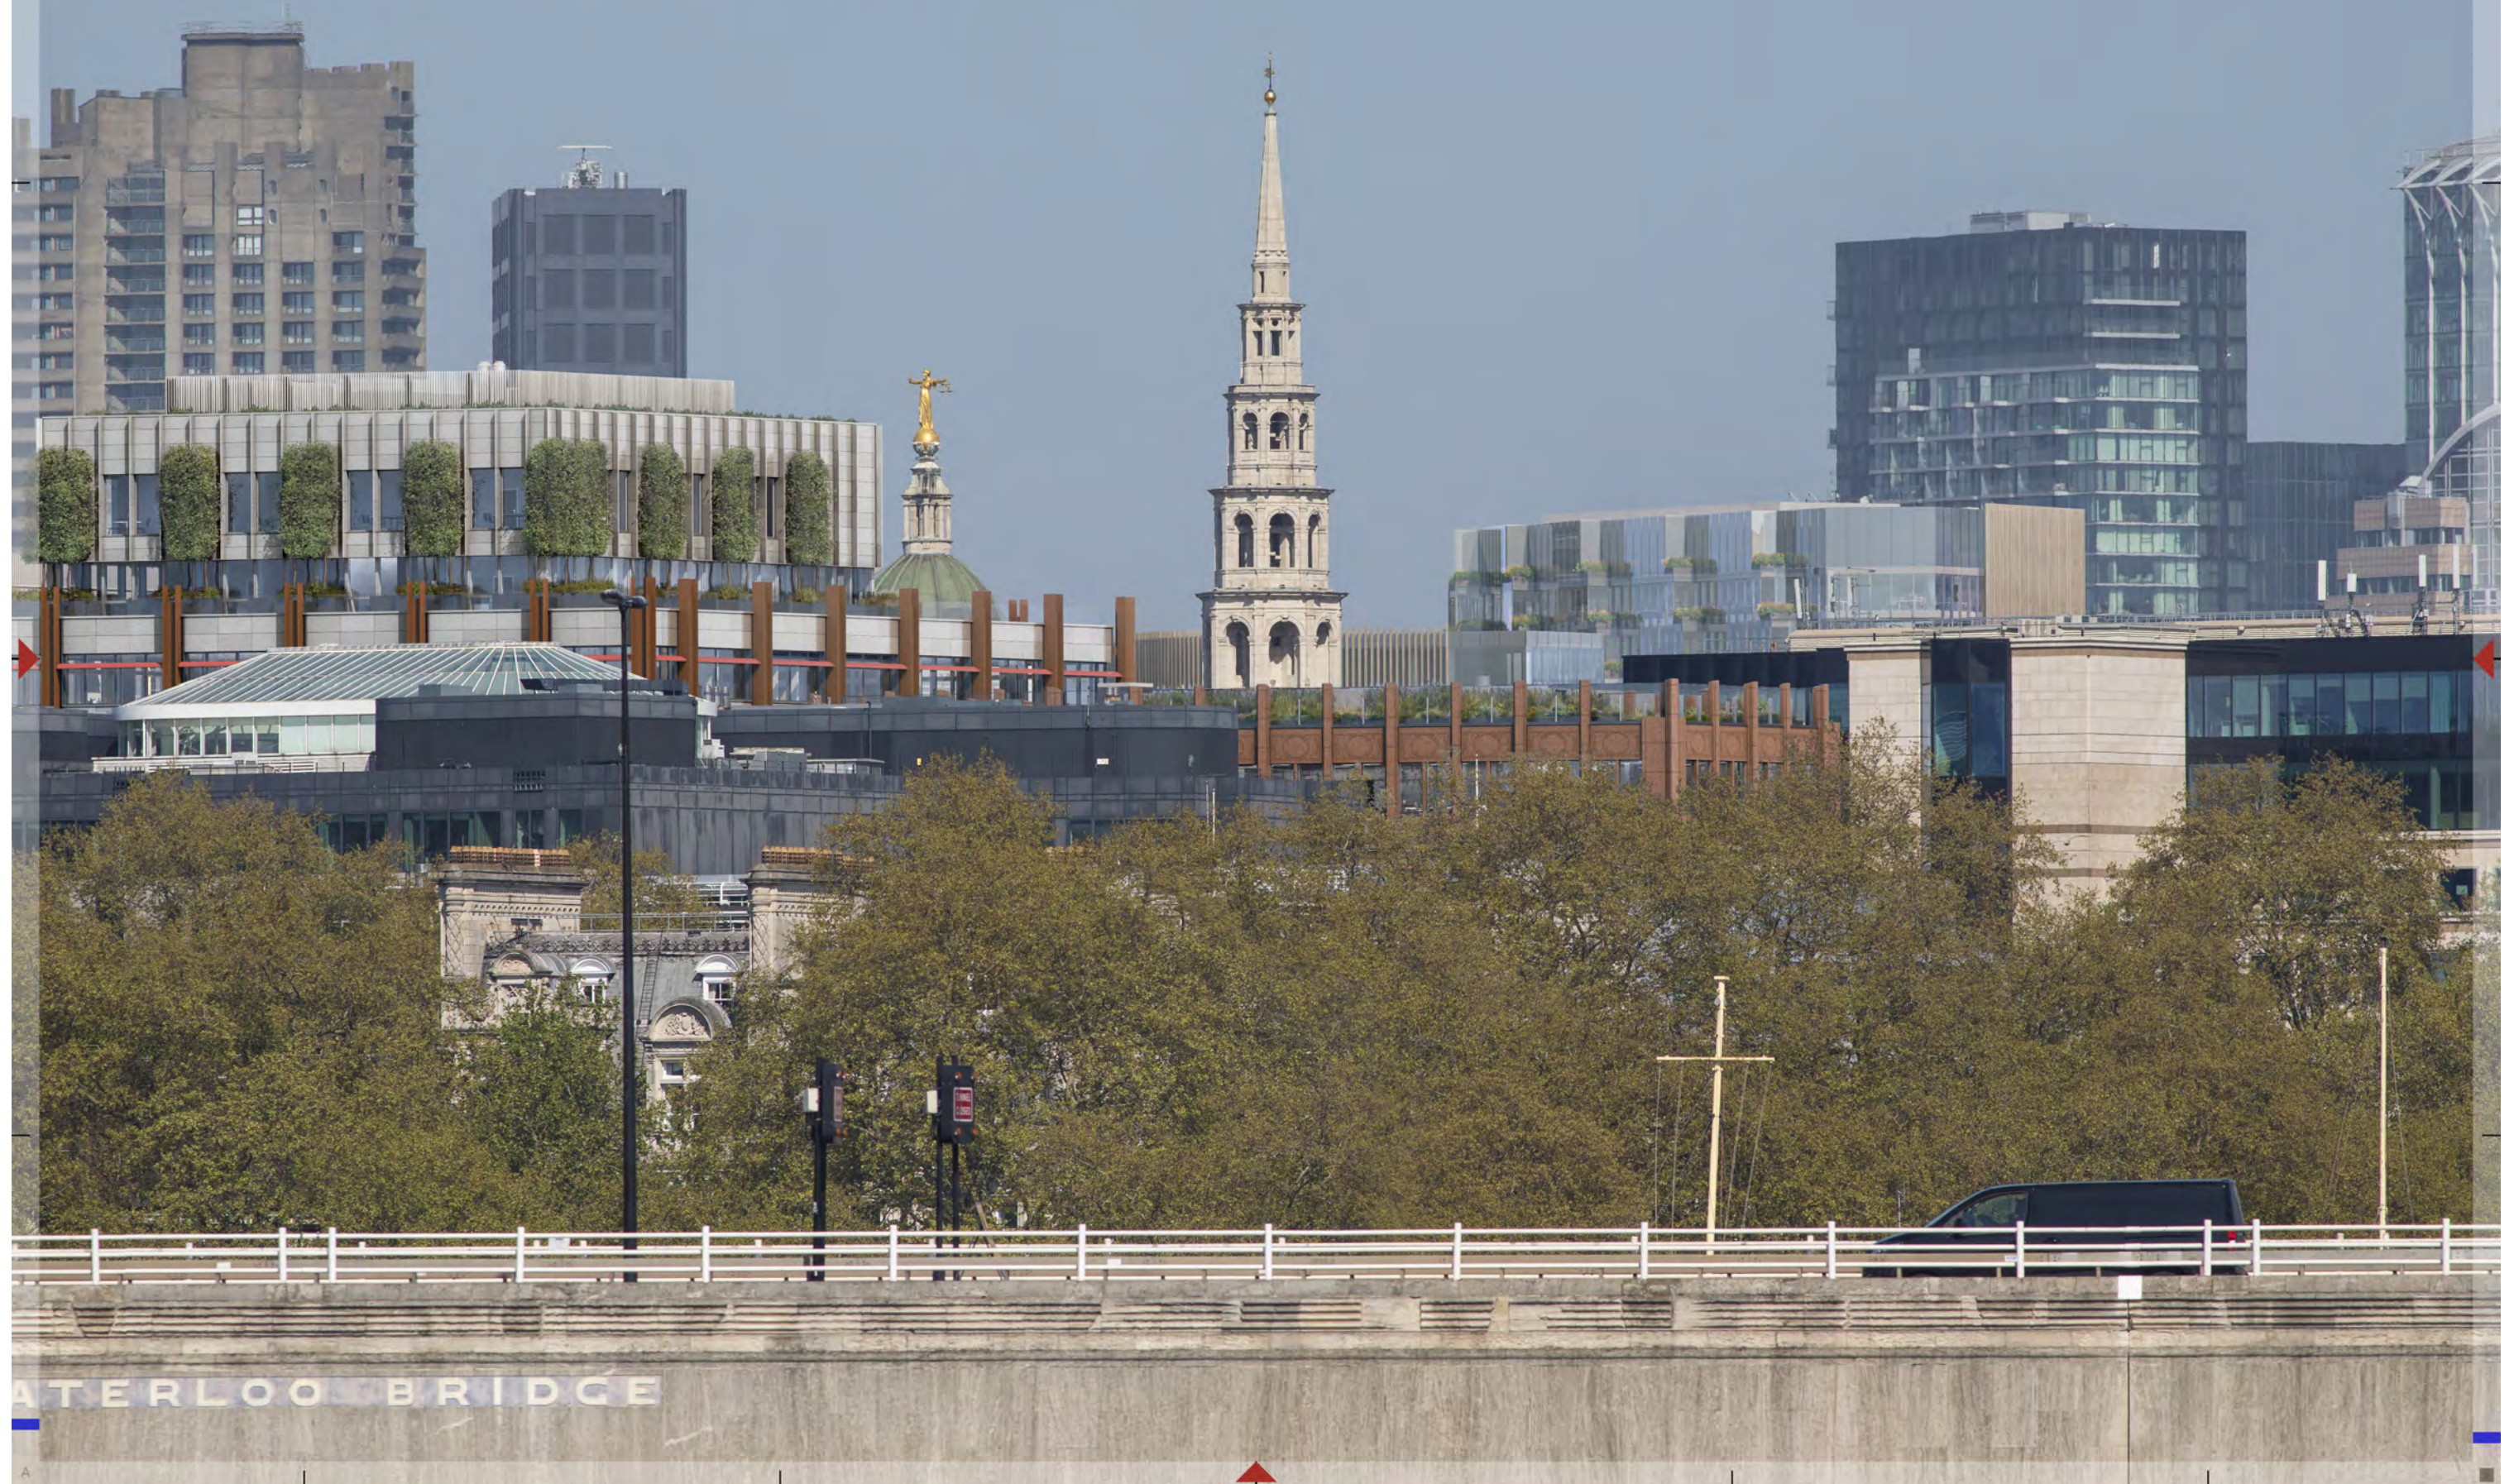
4563_1225 version 211129

140 - 150 London Wall [planning] | LVMF 17B.1 | Golden Jubilee/Hungerford Footbridges: downstream - crossing the Westminster bank | Telephoto - Proposed

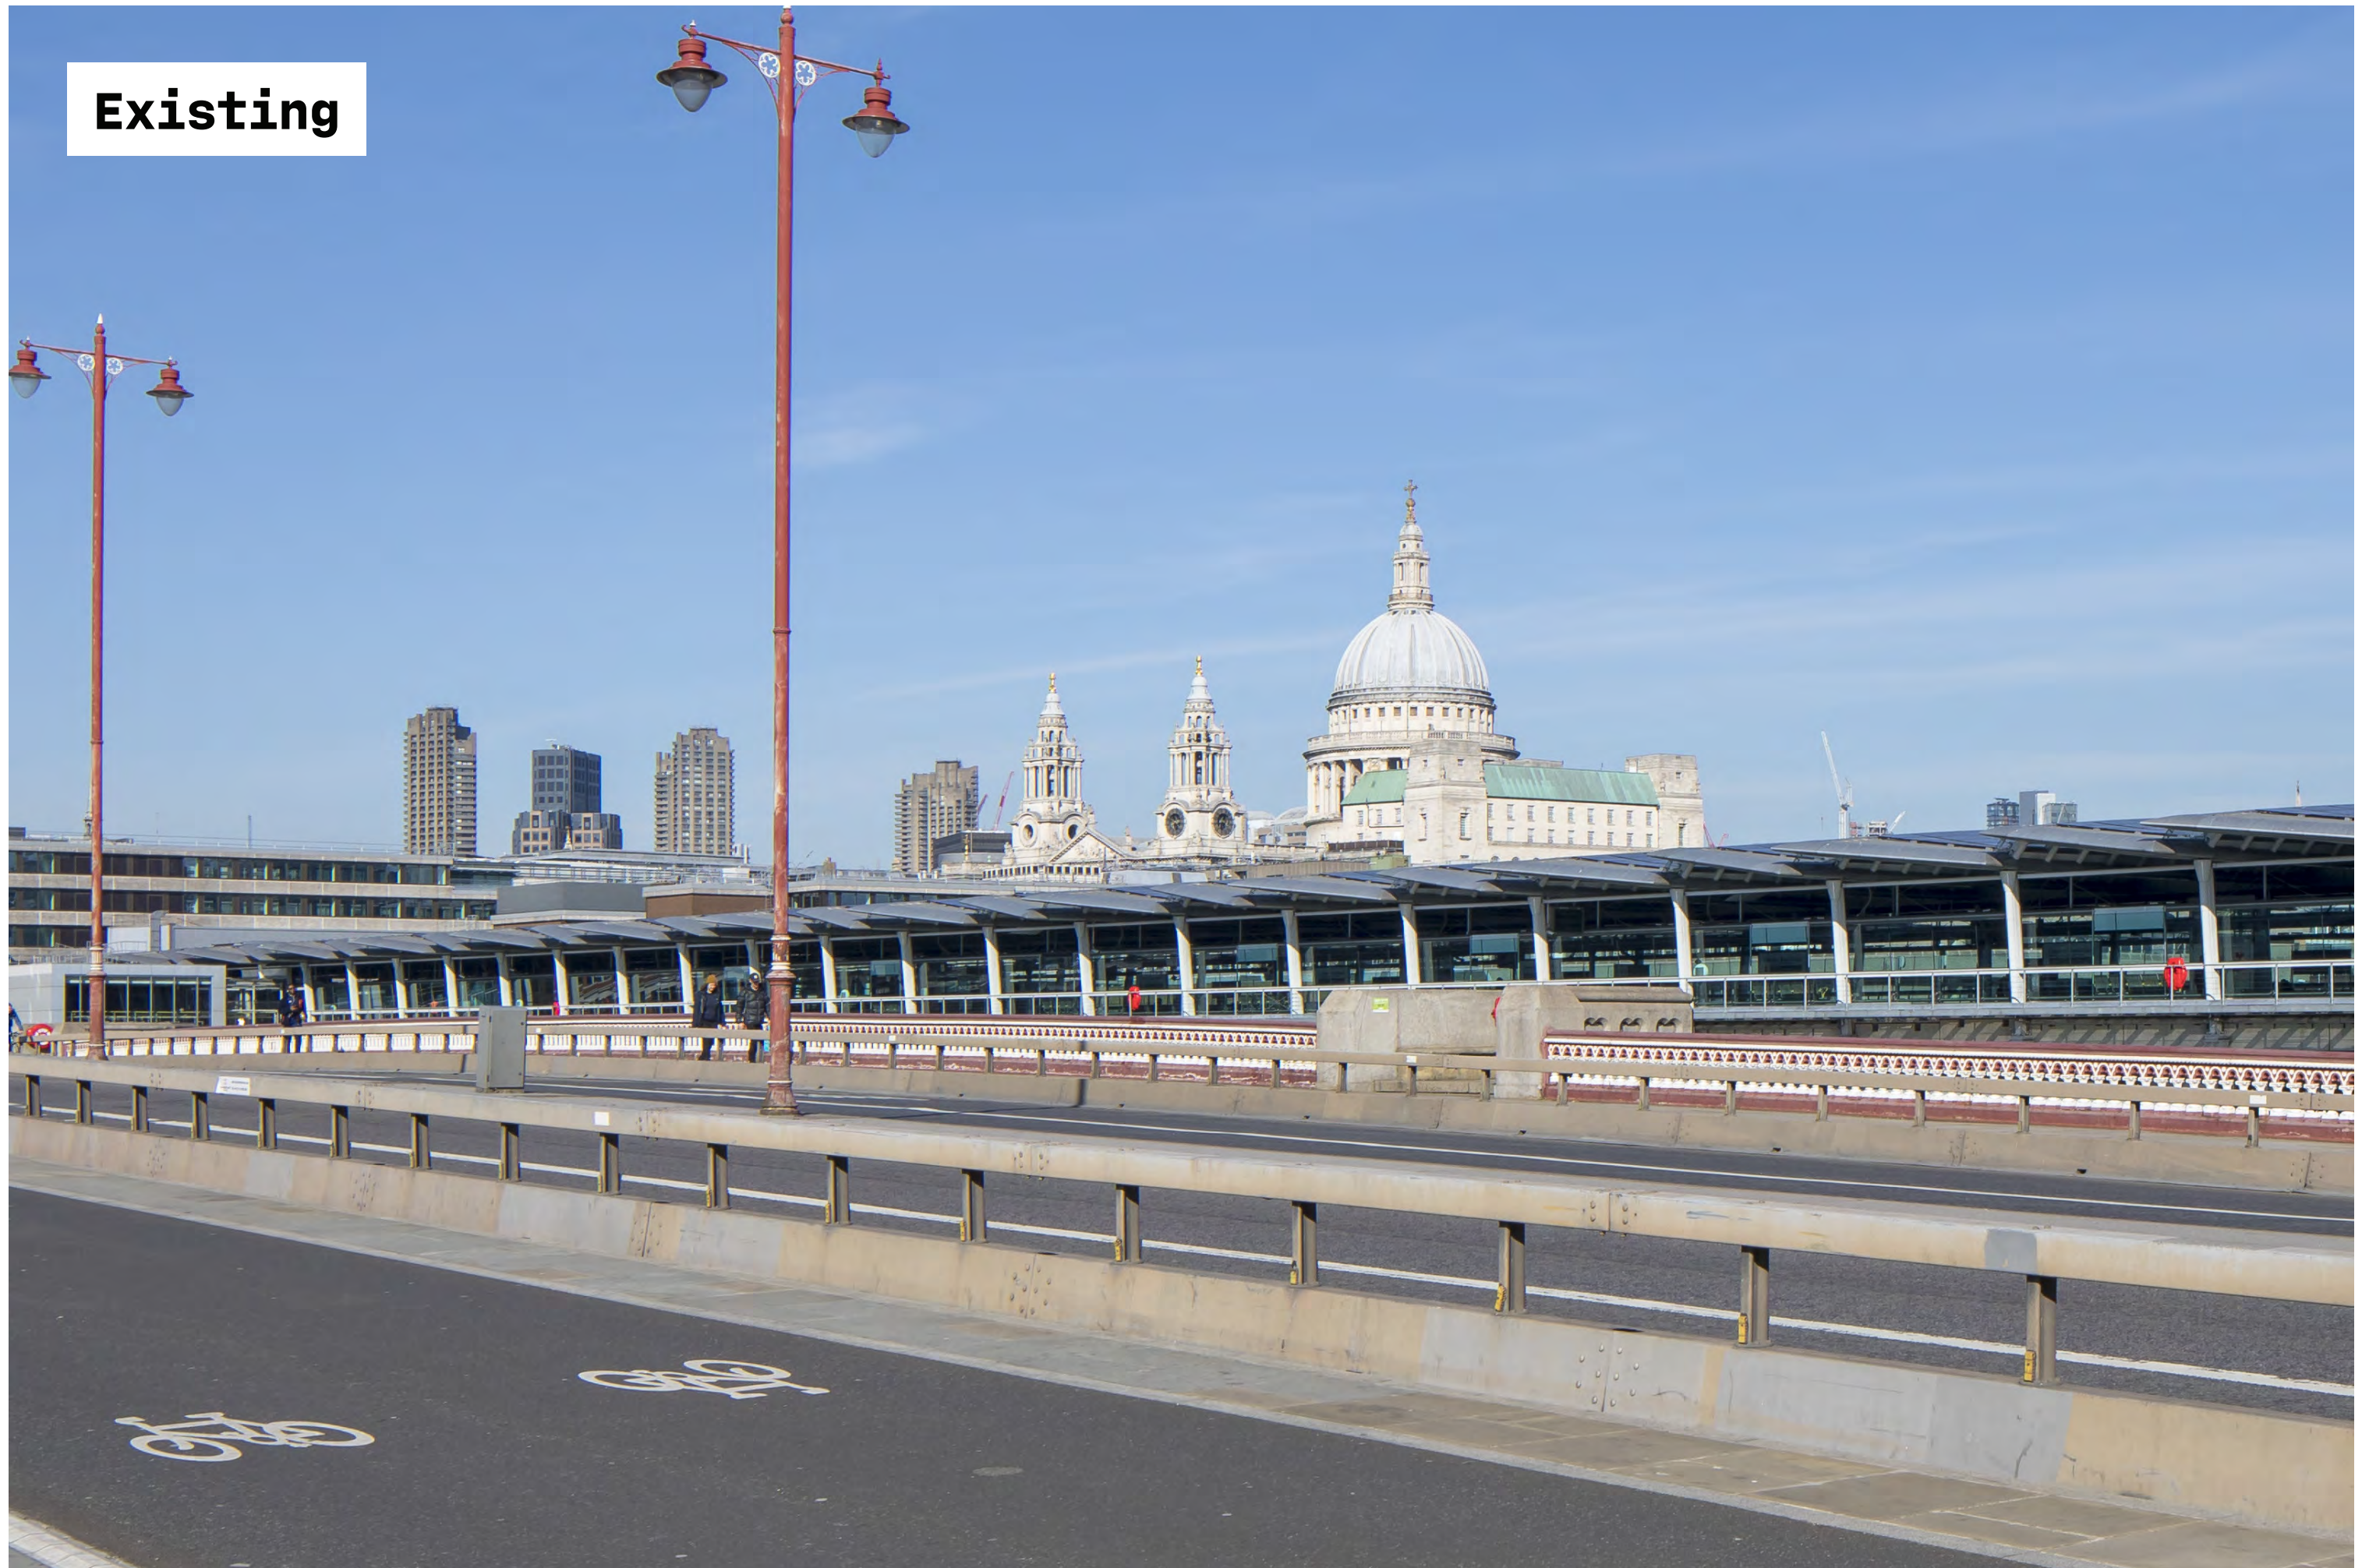
4563_7001 version 211116

140 - 150 London Wall [planning] | Blackfriars Bridge: between third and fourth Bastions - Existing

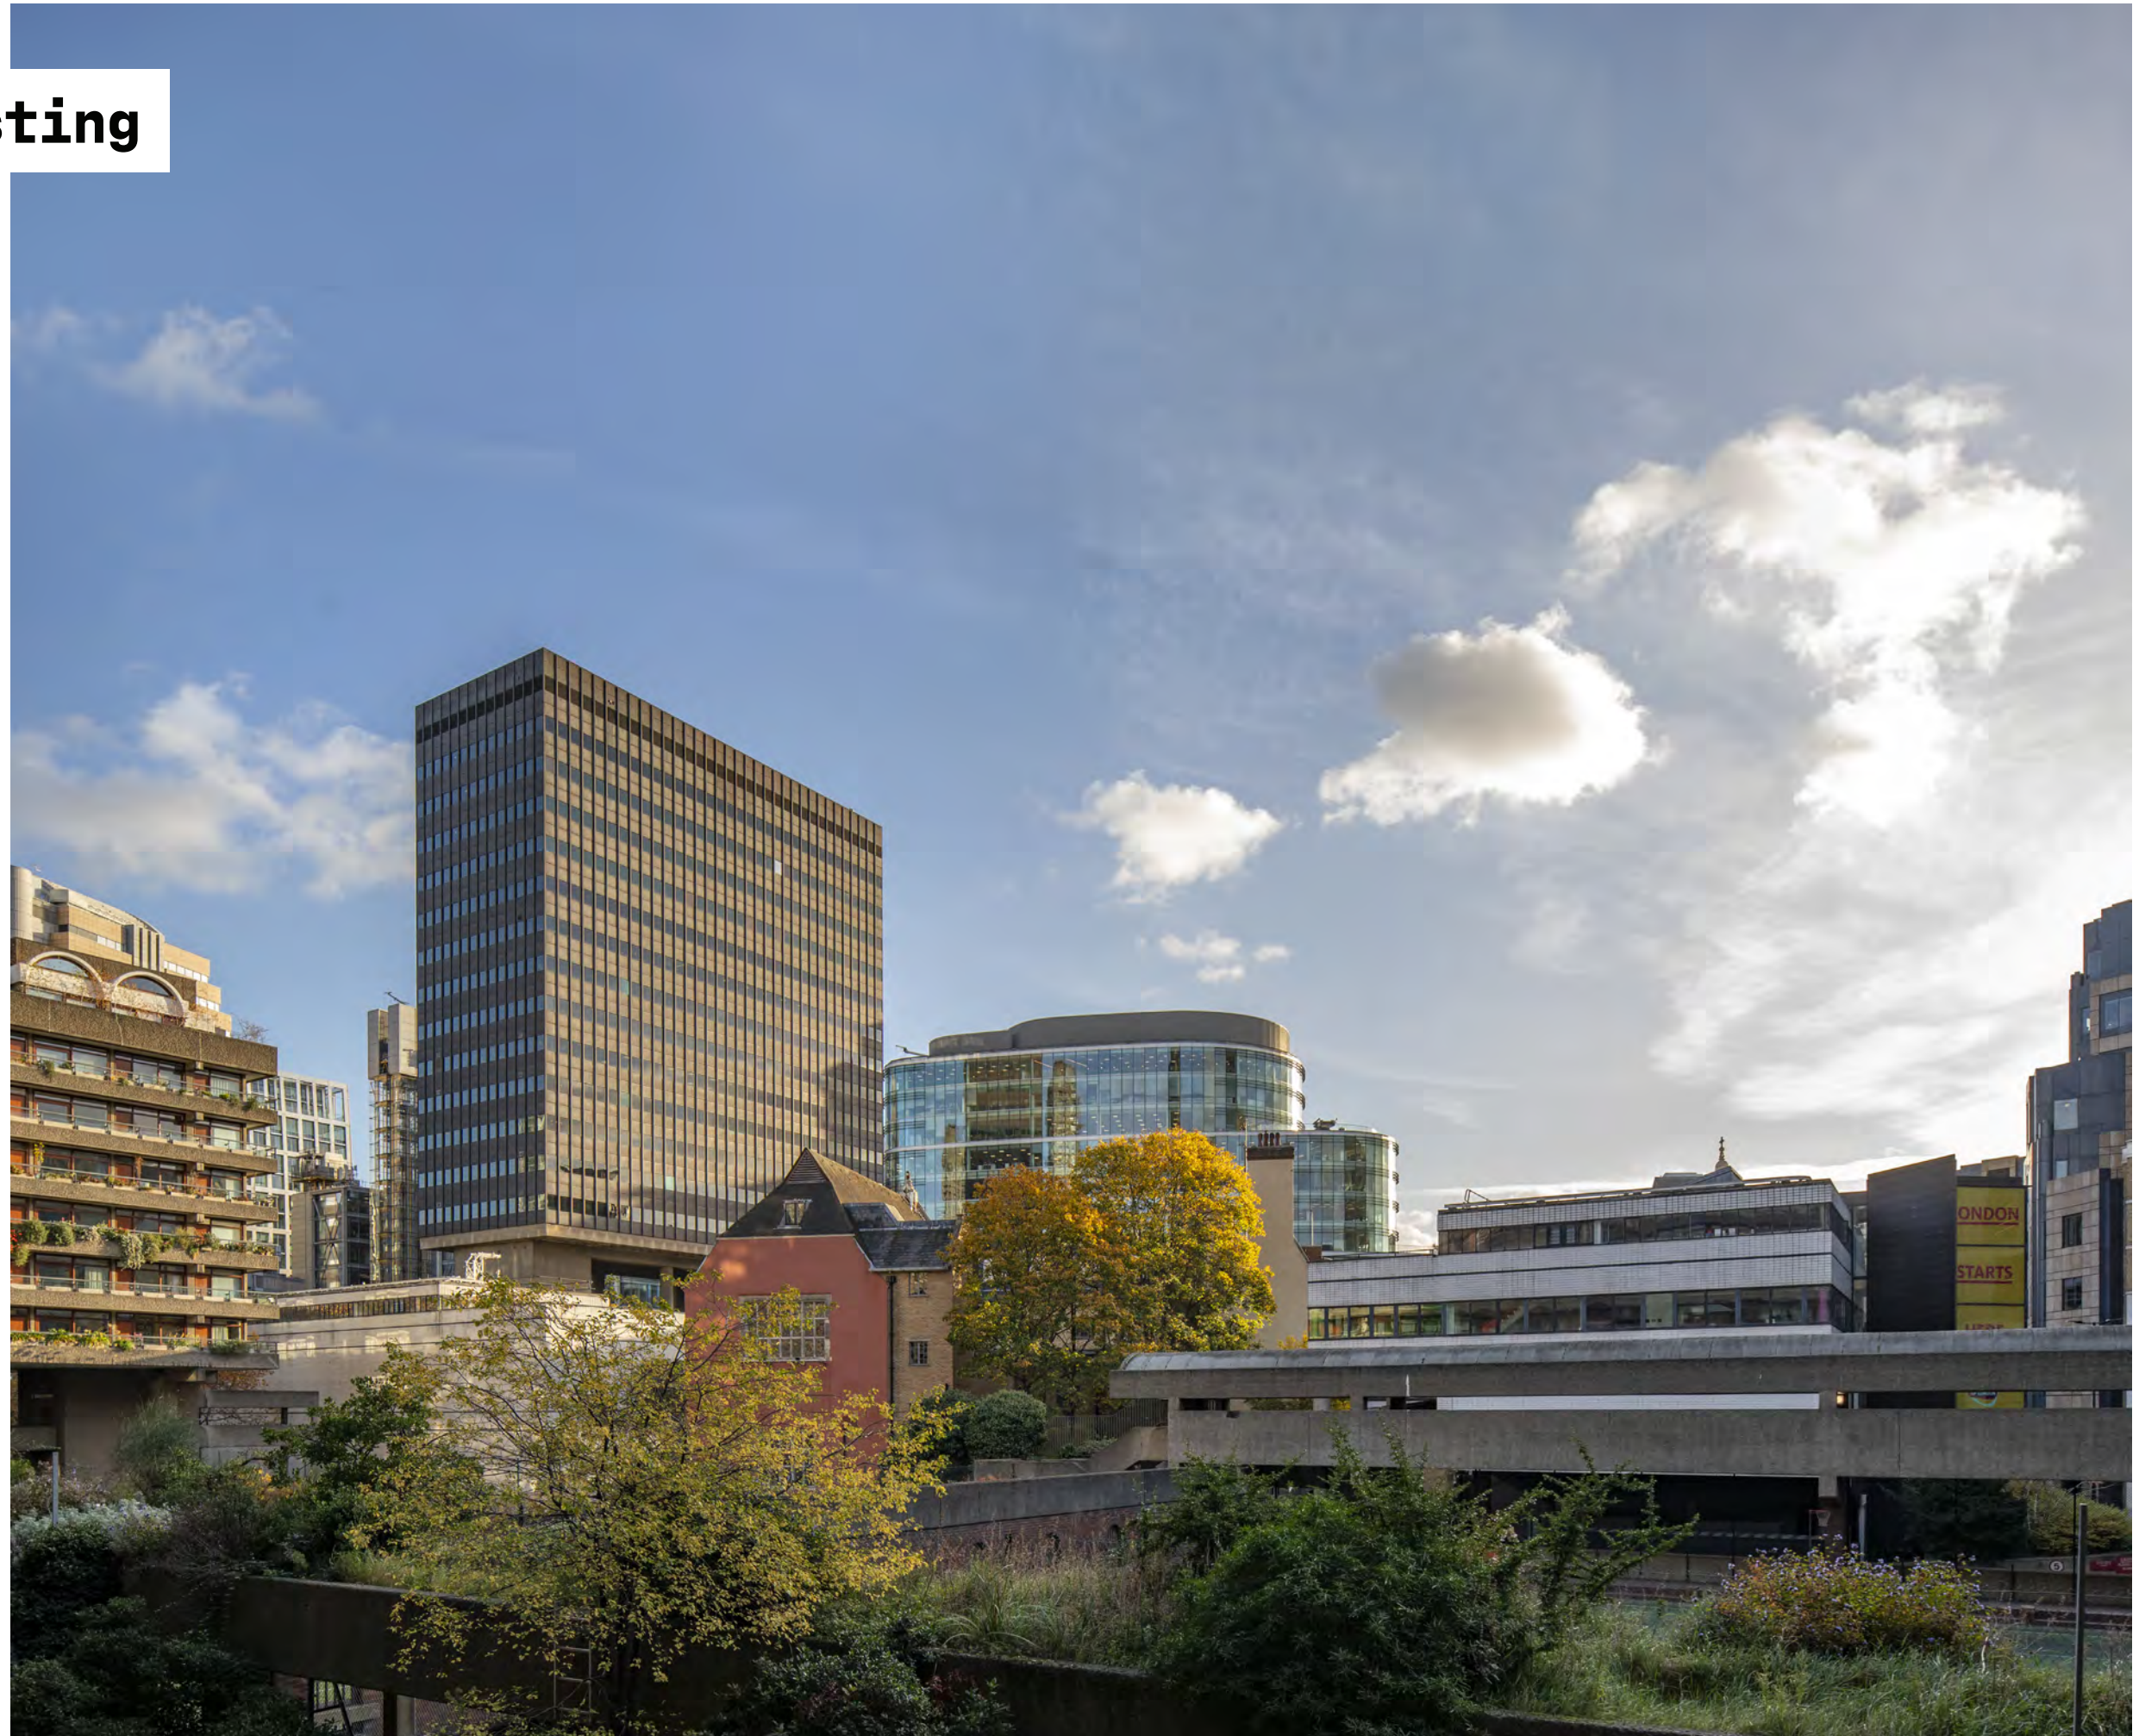
4563_7101 version 211130

140 - 150 London Wall [planning] | Barbican Estate: Thomas More Highwalk terrace, overlooking tennis courts - Existing

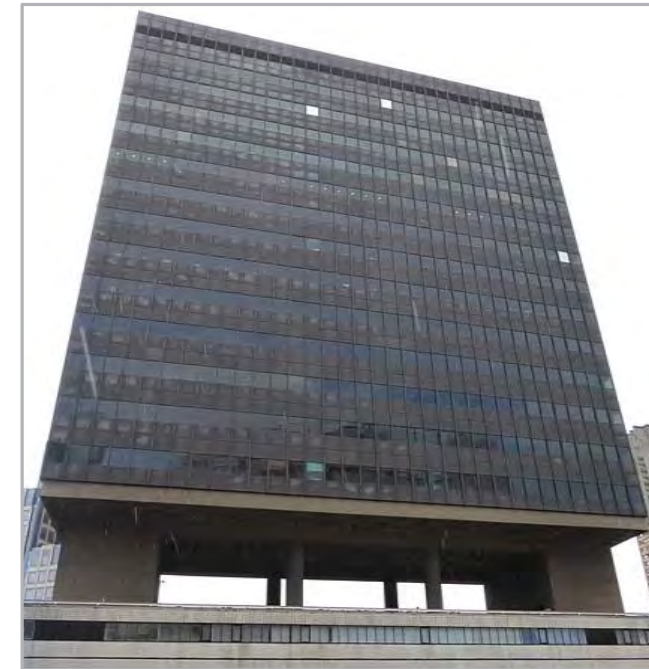
Bastion House - Structural Issues Identified

- The existing building was designed and built without consideration of the risks of disproportionate collapse
- Create major voids to allow services and lifts to meet modern standards would further compromise the structural integrity of the building
- The existing reinforced concrete frame does not meet current fire safety standards
- The building fabric is approaching the end of its design
- Remediation is at best complex and expensive
- Remediation might extend the life of a building for perhaps 20 years

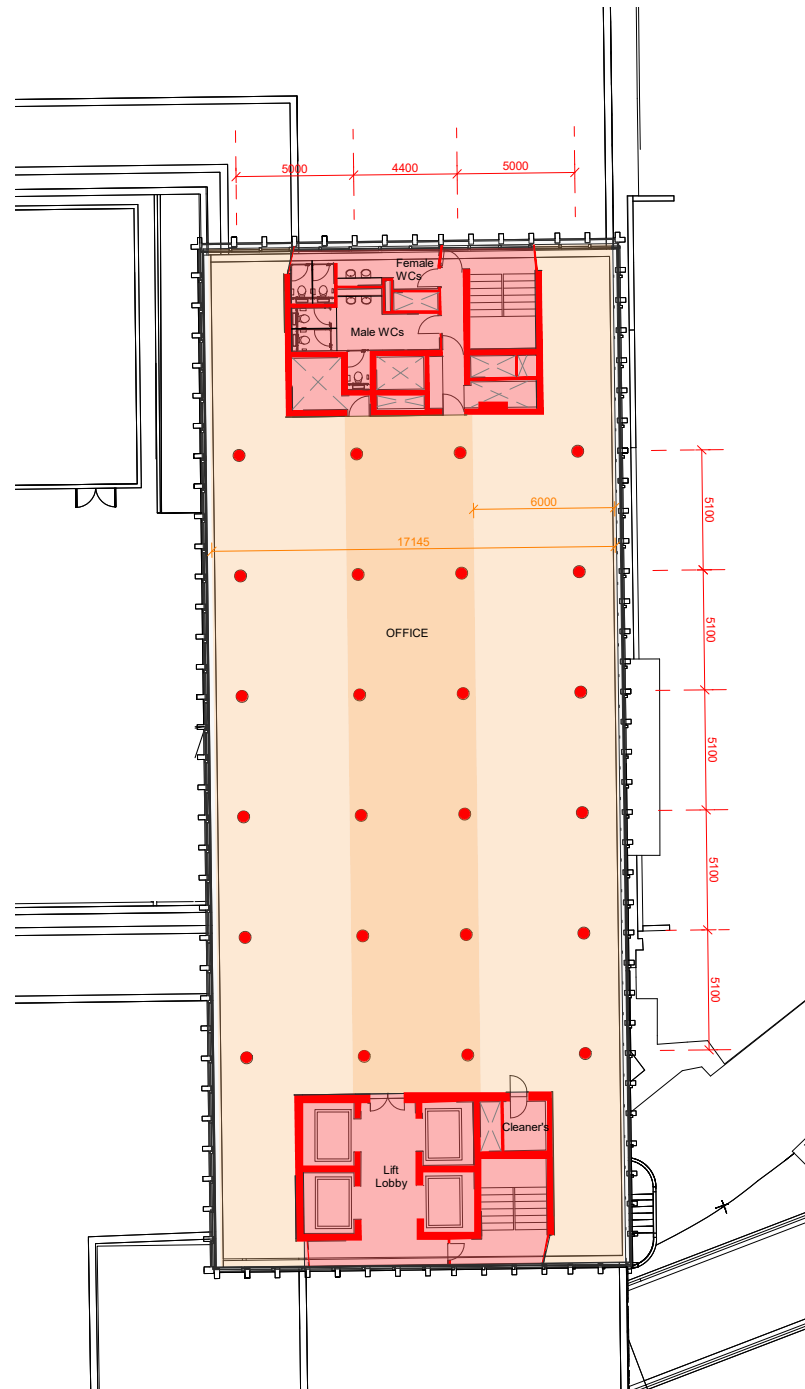
Bastion House - Spatial & Performance Issues Identified

- Restrictive floor to floor heights and column grids are not flexible, and provide sub-par conditions
- Significant upgrades would be required for fire-fighting and evacuation to meet regulations
- Cladding would have to be entirely replaced

- for energy performance and upgraded fire rating
- WC fixture counts would have to be increased and accessible WCs added
- Additional lifts would have to be added to meet recommended wait times
- Additional risers would have to be added to meet required air quality standards

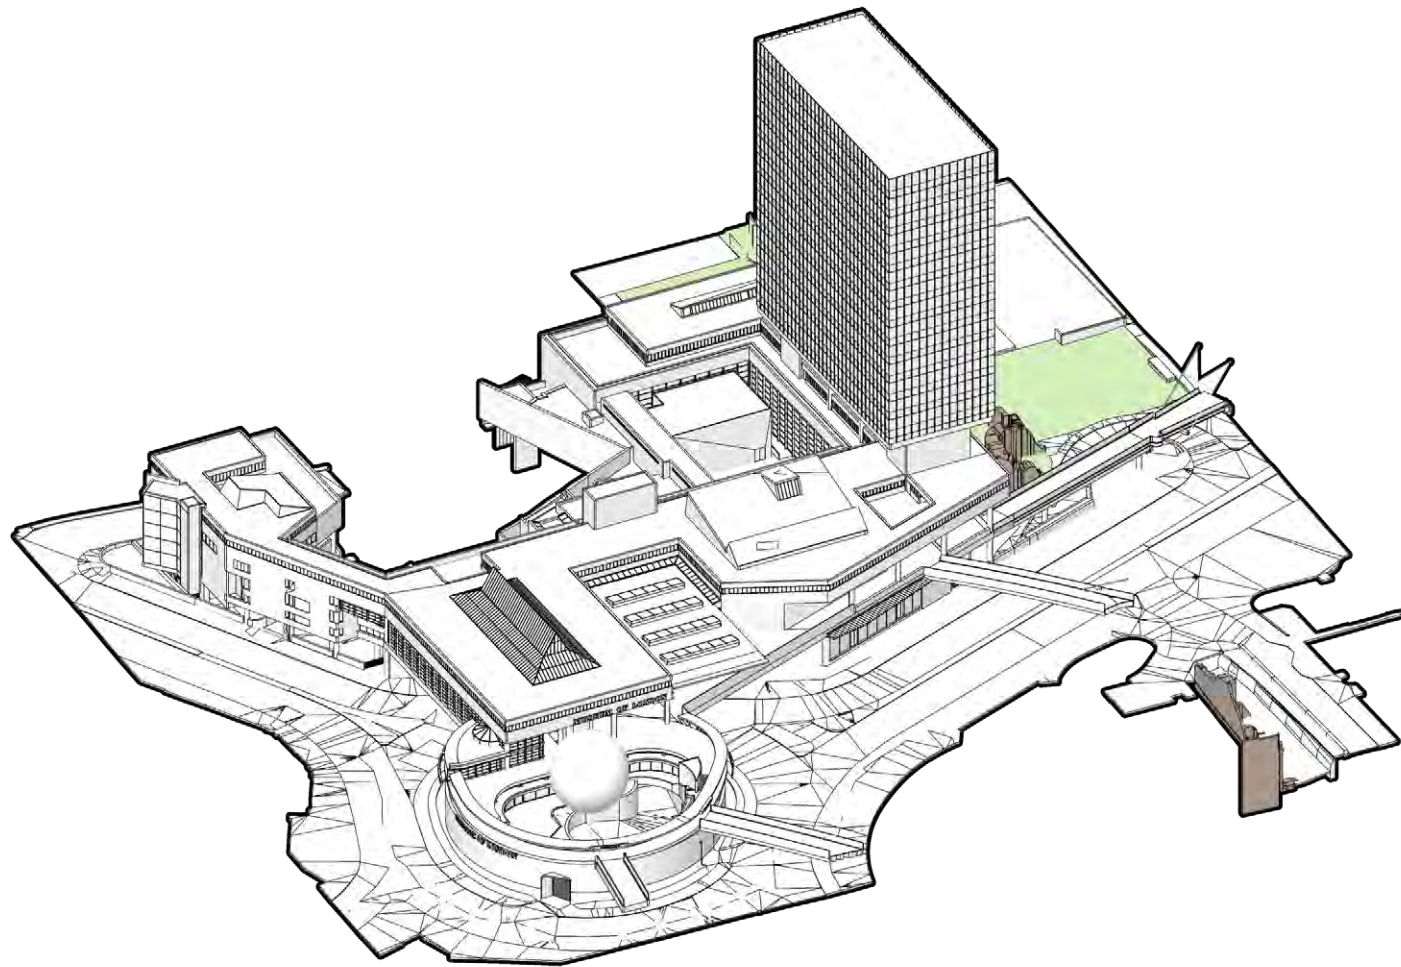
Potential for Refurbishment (No extension)

Conclusions:

- The buildings are near the end of their design lives
- Bastion House is no longer fit for purpose
- Bastion House has inherent structural liabilities
- Light refurbishment with no change of use will only extend life-span for 10-15 years before full redevelopment is necessary
- Low level of investment for a 'stop-gap' solution will result in poorly performing buildings
- Short-term re-use of museum spaces is challenging
- A high level of investment without an increase in yield will not be financially viable.

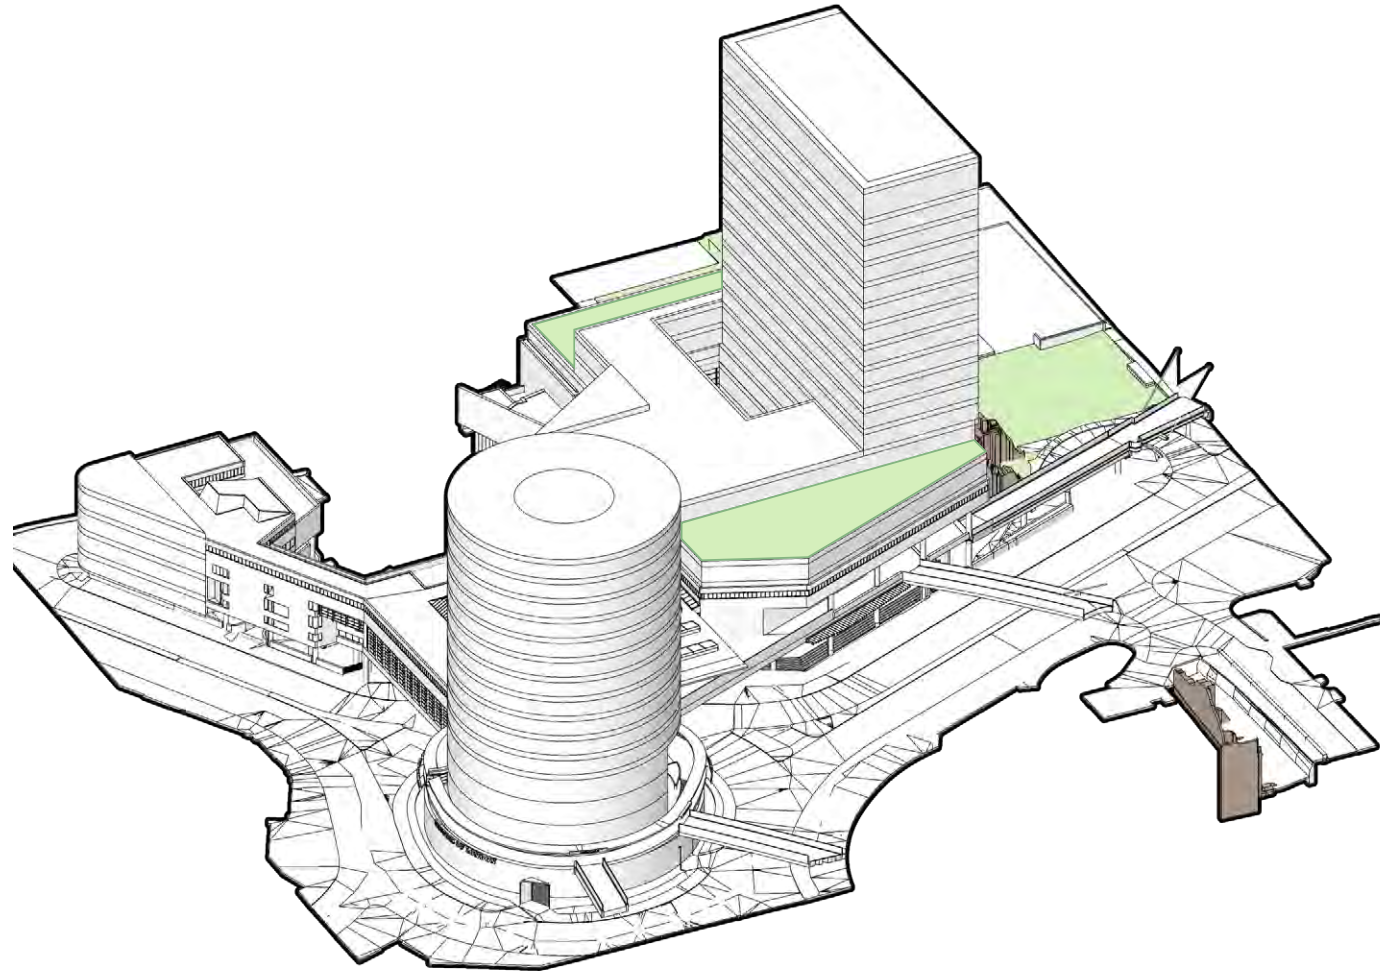
Potential for Extensive Renovation and Extension

- KEEP / RE-USE ALL EXISTING FOUNDATIONS / BASEMENT SUB-STRUCTURE
- RETAIN MAJORITY OF MOL / MINIMAL DEMOLITION
- KEEP EXISTING ROAD NETWORK
- REMOVAL OF BASTION HOUSE DUE TO STRUCTURAL SAFETY CONCERNS
- ADDITIONAL DEMOLISHED ELEMENTS TO FACILITATE MEANINGFUL EXTENSIONS
- UPGRADING OF FIRE PROTECTION TO STRUCTURE, CLADDING OF FACADE, NEW MEP & LIFTS
- ACTIVATED GROUND FLOOR / MODIFIED ENTRANCE TO ACCOMMODATE LEVEL CHANGE
- 1 & 2 STOREY EXTENSIONS TO MOL STRUCTURE
- ADDITIONAL MASSING TO MUSEUM OF LONDON NORTH WING - SIDE EXTENSION / NEW GROUND PLANE
- NEW BASTION HOUSE TOWER (11 STOREY) WITH MODERN FLOOR TO FLOOR HEIGHTS. RE-USING EXISTING FOUNDATIONS WOULD REQUIRE THE FOOTPRINT TO BE BROADLY SIMILAR TO THE EXISTING BUILDING.
- 14 STOREY EXTENSION TO EXISTING ROTUNDA SITE (HOTEL/POTENTIAL FOR OFFICE)

- Bastion House would have to be entirely re-built to ensure future robustness and 60+ year design life
- Extensive modifications and extensions to remaining existing structures
- Full new cladding required to meet modern performance criteria
- No significant improvement of public realm or public open space possible (reduction due to infill at Rotunda)
- The amount of work is nearly as extensive as a re-development scenario without the associated benefits.

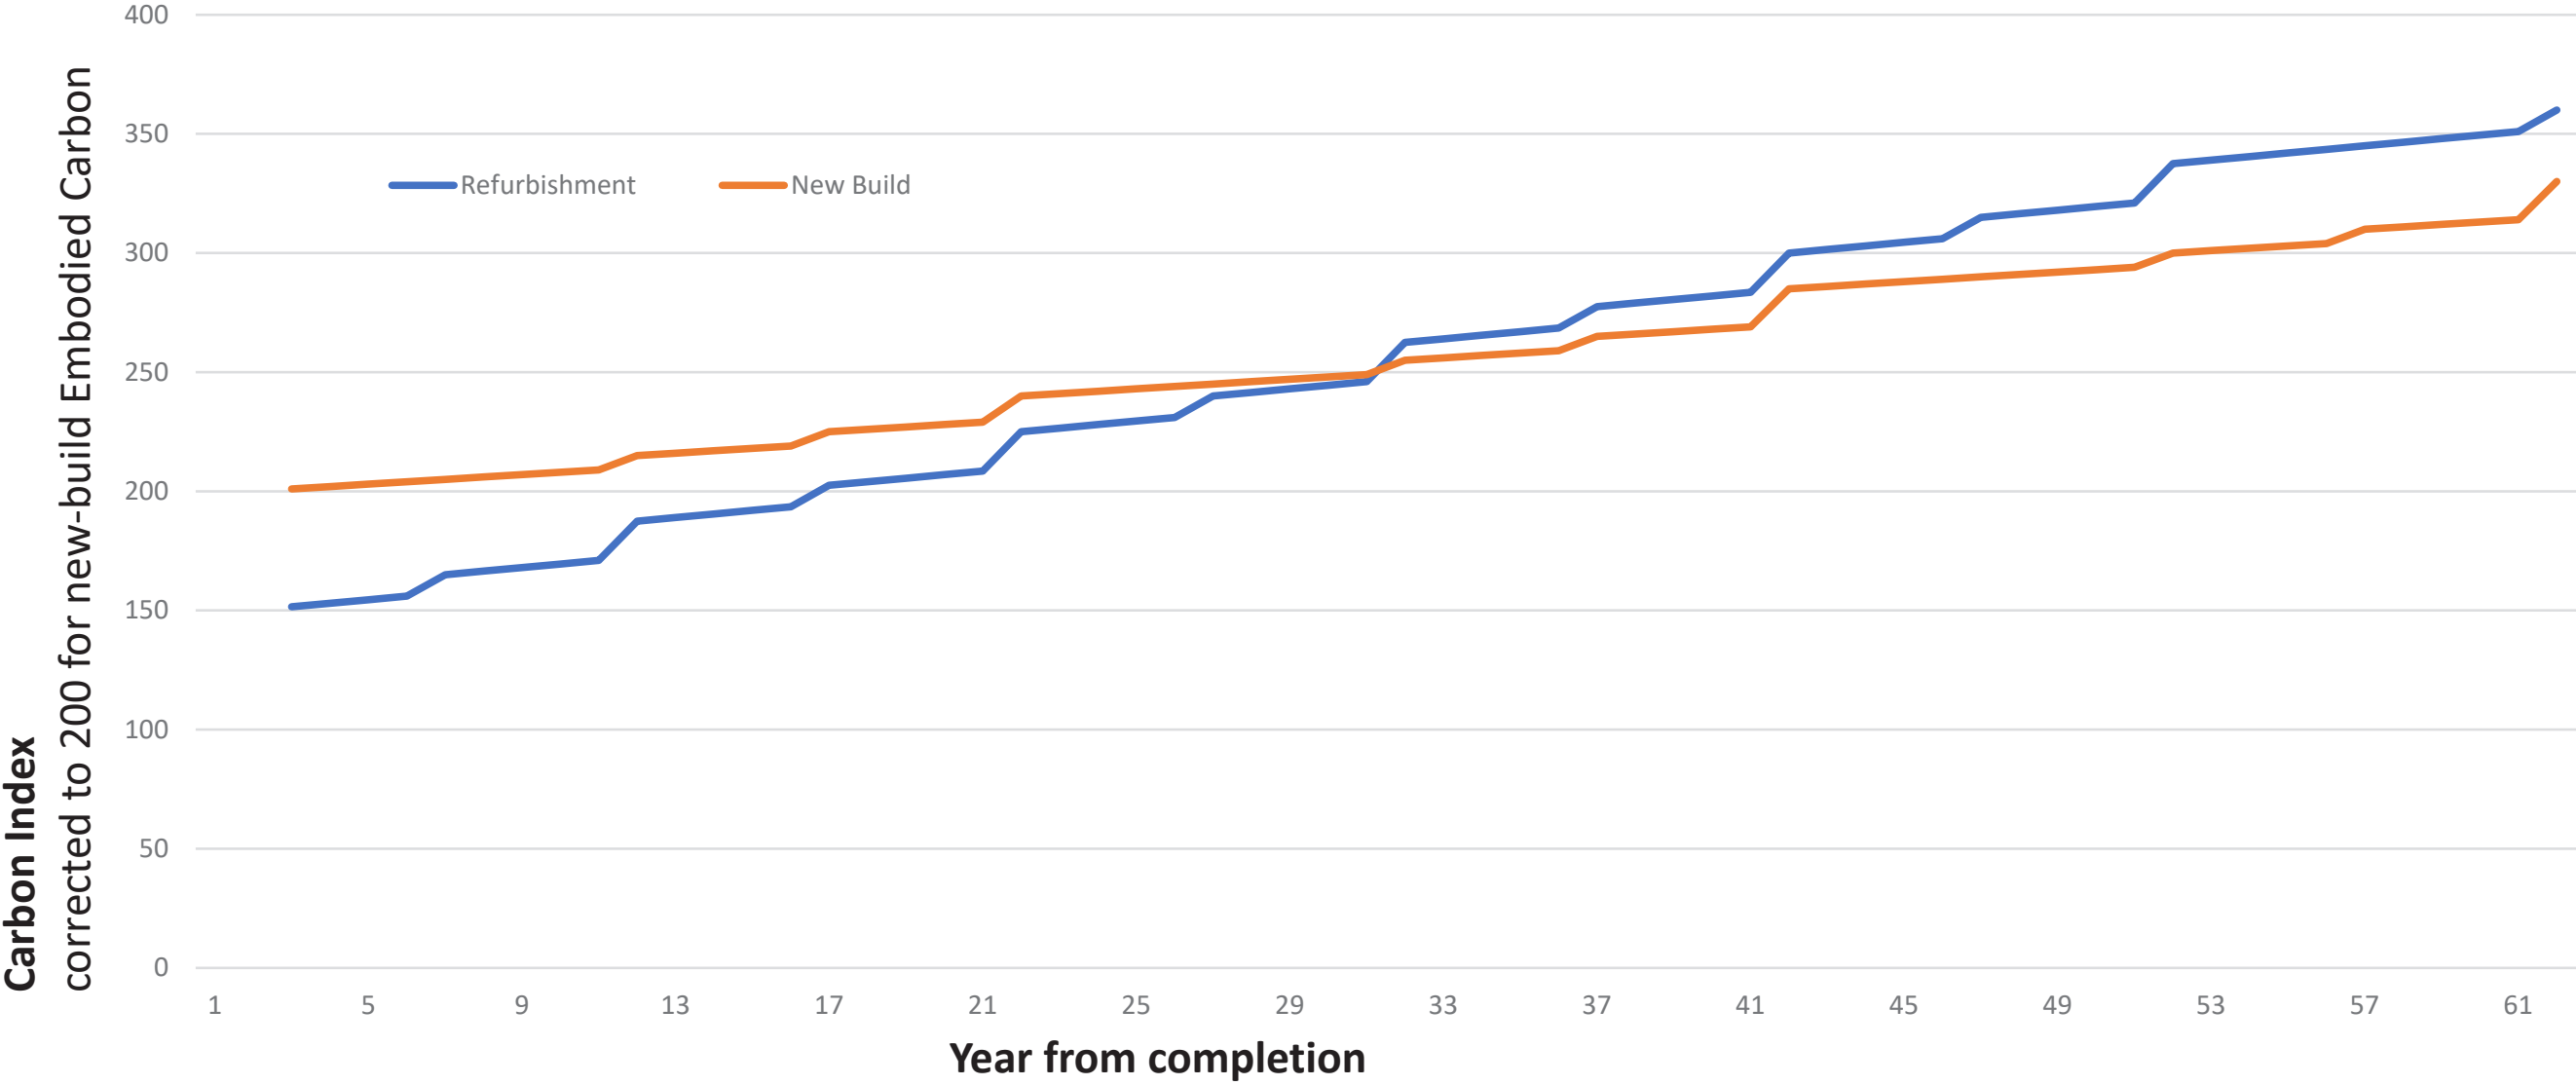
Carbon Emissions over Building Lifetime

- The scope of a comprehensive assessment of whole lifecycle carbon for a re-use and extension case versus redevelopment has been agreed with the City of London planning authority
- Our analysis of the carbon is only at a preliminary stage
- We are working with the design team to minimise the embodied carbon and operational carbon of the proposal to ensure that the carbon investment is responsible
