Detailed UXO Risk Assessment

FIL Reference: 2663R

Project: Goresbrook Road

Site Location: Goresbrook Road, Dagenham, RM9 6XS

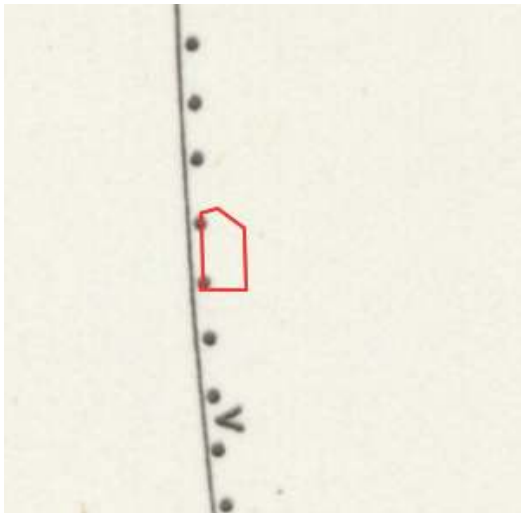
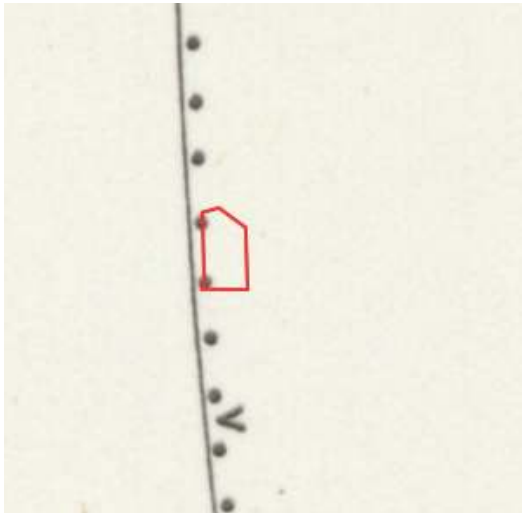
Showing a section of 1921 OS mapping. The site occupies a section of open ground.	Showing a section of the 1933 revision of OS mapping, the site continues to occupy a section of open ground.

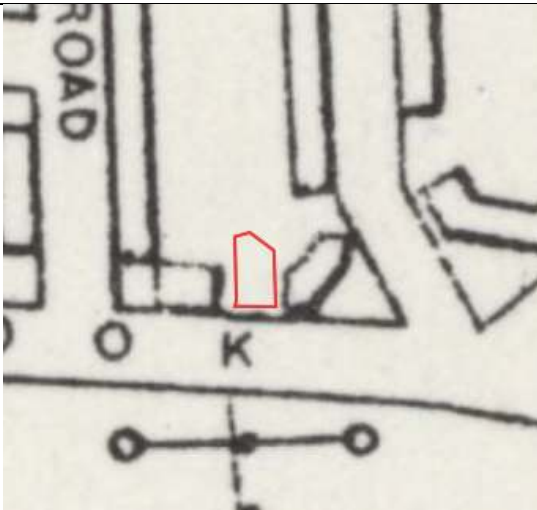
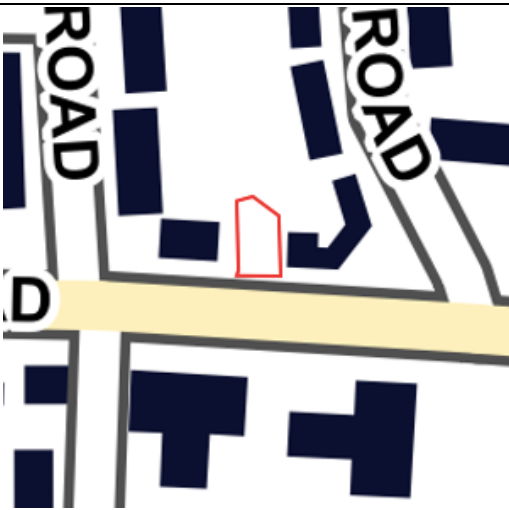
Showing a section of 1946 revision of OS mapping, detailing the sites wartime composition. With the surrounding area having been built up in the late 1930s. With open ground visible to the south of the site.	Showing a section of the 2020 revision of OS mapping. Post war development is visible detailing the location of the site. Little post-war development is obvious in the surrounding area.

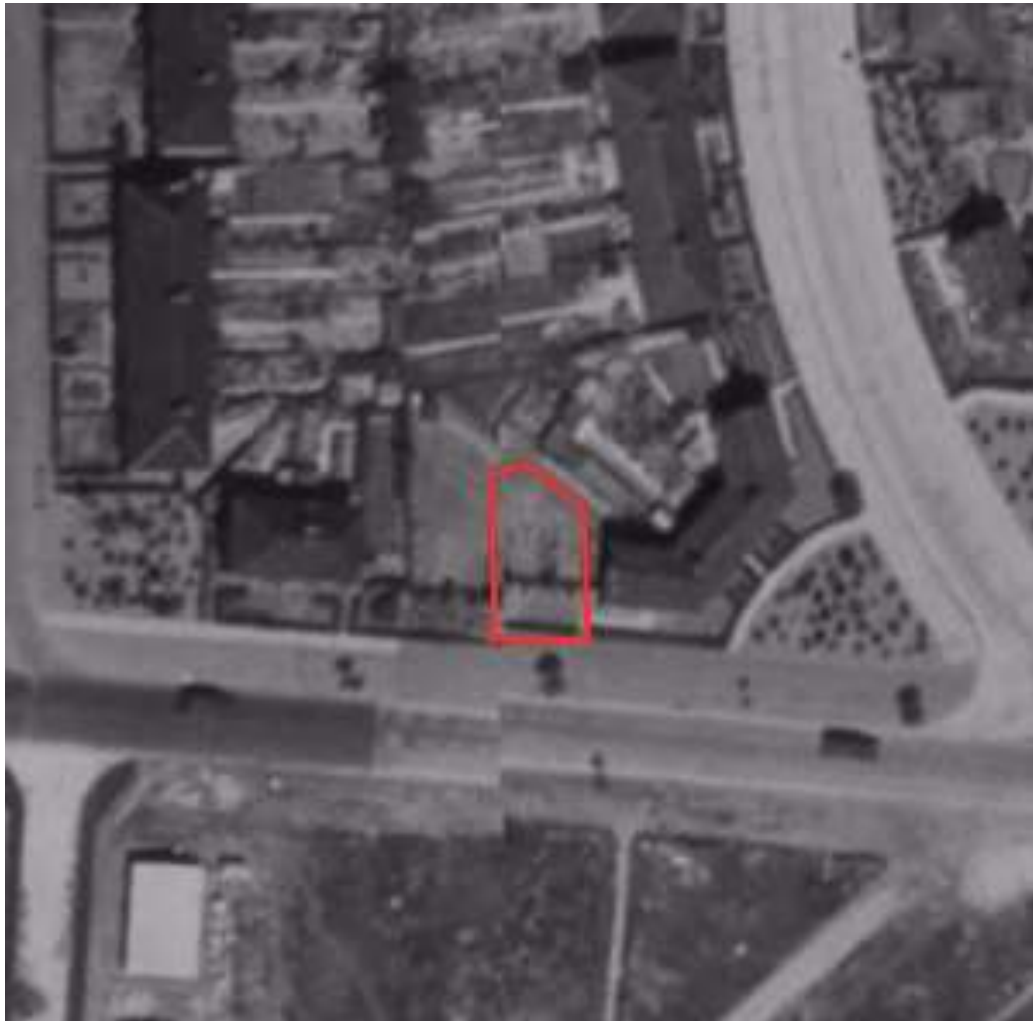
Figure 4. Royal Air Force aerial photography showing site as undeveloped ground c.1948. [Historic England]

During the Second World War, the site comprised of mostly undeveloped ground surrounded by gardens at the rear of the houses located around the site.

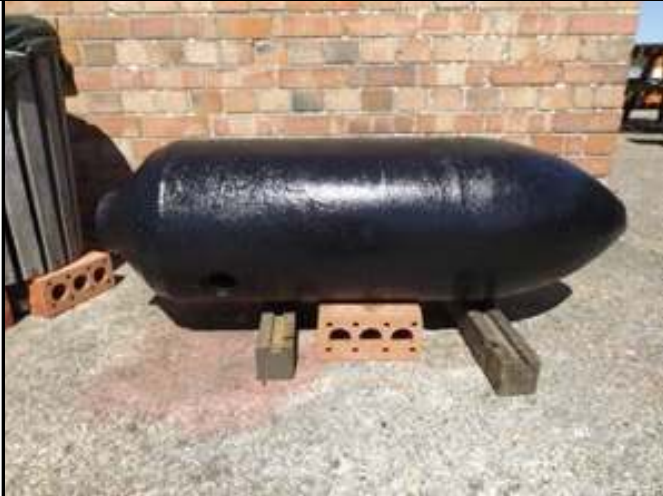
The SC series of HE Bombs were a thin cased general-purpose bomb used as general demolition bombs.
	German SC250 (recovered casing)	Most bombs were 50kg, 250kg or 500kg, although larger bombs of up to 1,800kg were also used. About half the weight of these HE bombs comprised of explosive fill.

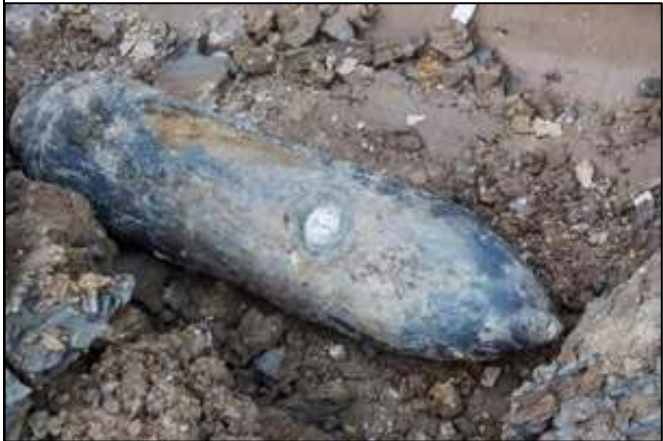
The SC50 had a one-piece drawn steel body and its total weight was 48 to 55 kg.[1] It was dropped on targets across the UK.
	German SC50 (London 2015)	The SD series of bombs were thicker cased, with a lower charge weight used against hardened targets.

When bombs strike but do not detonate, they can easily remain undetected. Note that the entry hole of an SC50 (the most commonly deployed German HE bomb) could have been as small as 20cm in diameter and therefore easily obscured within dense crops, or unmaintained vegetation, rough soil or rubble from previous damage.

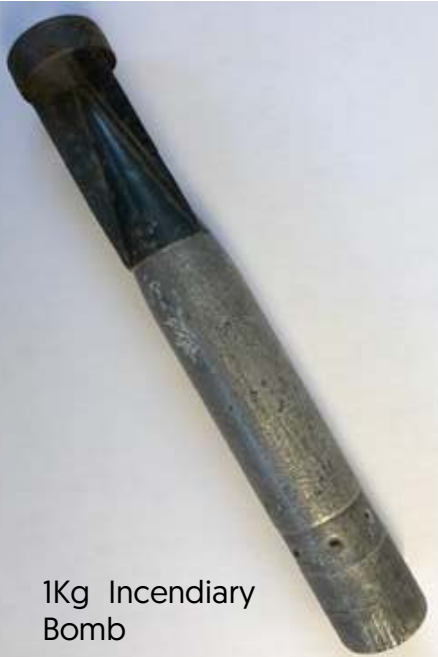
<p>1Kg Incendiary Bomb</p>	<p>The 1 kg B1E incendiary bomb consisted of a cylinder of magnesium alloy, with an incendiary filling of thermite. Rivetted to the body was a steel tail with three fins. These bombs did not explode but were ignited by a small percussion charge, fired upon impact. They were dropped in a variety of containers. Later an explosive head was incorporated into the IB.</p>

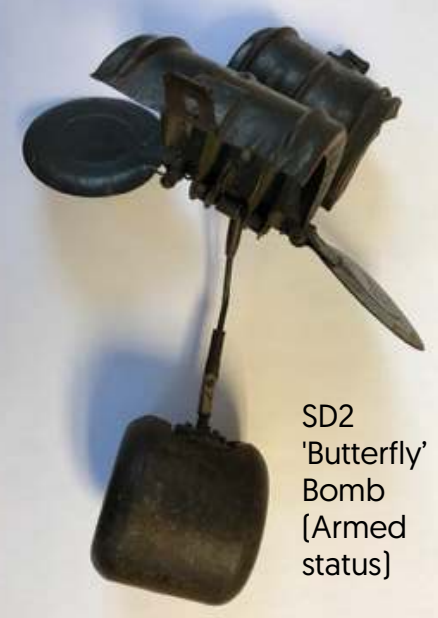
<p>SD2 'Butterfly' Bomb [Armed status]</p>	<p>A Butterfly Bomb (or <i>Sprengbombe Dickwandig</i> 2kg or SD2) was a German 2-kilogram anti-personnel sub munition used by the Luftwaffe during the Second World War. It was so named because the thin cylindrical metal outer shell which hinged open when the bomblet deployed gave it the superficial appearance of a large butterfly. The design was very distinctive and easy to recognise. SD2 bomblets were not dropped individually but were packed into containers holding between 6 and 108 sub munitions. These broke open in air and scattered the sub-munitions.</p>

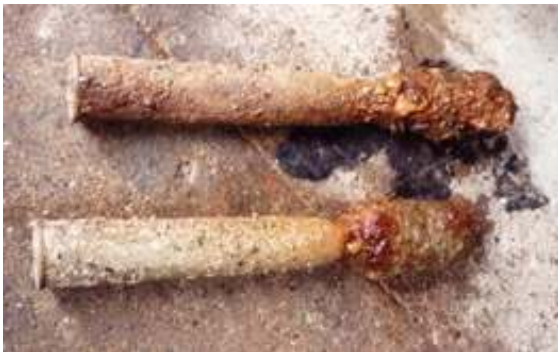
40mm AA Shells found at W Sussex site	Fixed [Heavy] Anti-Aircraft batteries were set up all around the country to defend potential targets from aerial attack. Size of guns and shells ranged from small, quick-firing 40mm Bofors guns to larger 3.7 or 4.5inch guns. 3.7 Inch = 12.7kg 94mm x 438mm 40mm = 0.9kg 40mm x 311mm 4.5 Inch = 24.7kg 114mm x 578mm

The smaller 40mm projectiles are similar in appearance and effect to SAA and, although still dangerous, present a lower hazard due to its decreased explosive content. Numerous unexploded AAA shells were recovered during and following WW2 and are still occasionally encountered on sites today.
