UXO Verification Assessment – The Observatory, Woolwich

Document Title UXO Verification Assessment
Document Ref. P10494-22-R11
Revision C
Project Location The Observatory, Woolwich
Client Sweco UK Ltd, on behalf of the Defence
Infrastructure Organisation
Date 23rd February 2023
Sweco Ref. 65201348-203_Woolwich_
UXO_Obs_VA_R2

UXO VERIFICATION ASSESSMENT

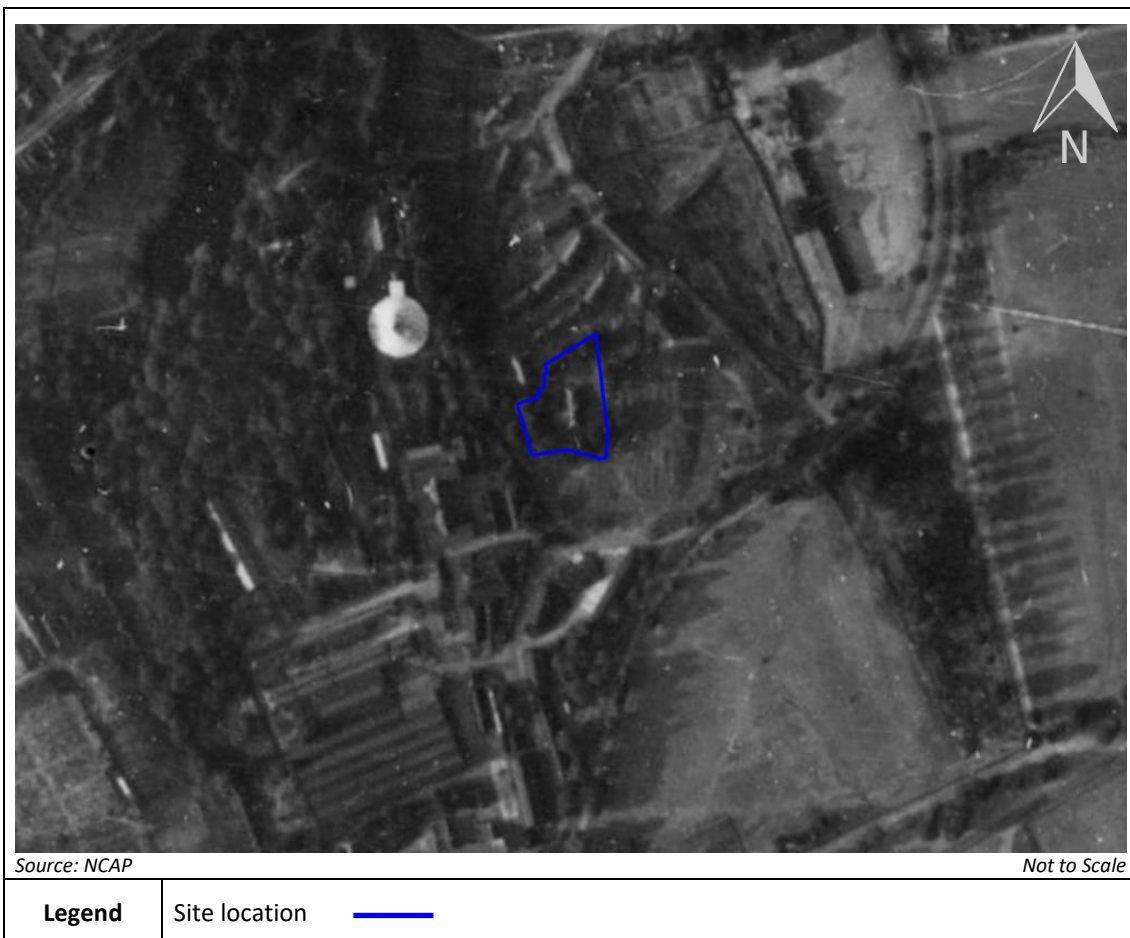
Plate 2 Aerial photograph, 27th September 1940

By WWII, rows of residential buildings had been constructed to the north of the Site. These can be seen in Plate 2, an aerial photograph dated the 27th September 1940. Records indicate that these were married quarters for RA officers.

This also shows that open ground to the east of the Site had been developed as allotment gardens.

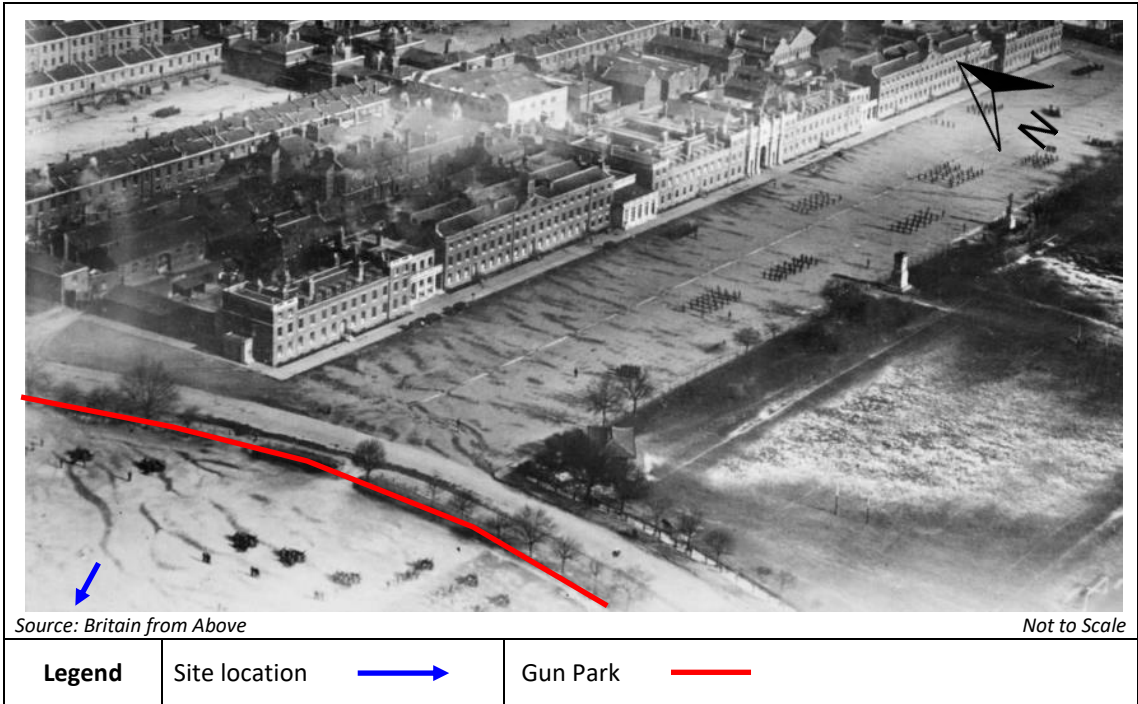
Plate 3 Oblique aerial photograph of the Woolwich drill ground, 1929

A drill ground was developed at the Gun Park for field-battery exercises. This continued in use into the early 20th century, as shown in Plate 3, an oblique aerial photograph dating from 1929.

This shows artillery units positioned in close proximity to the eastern boundary of the Site.

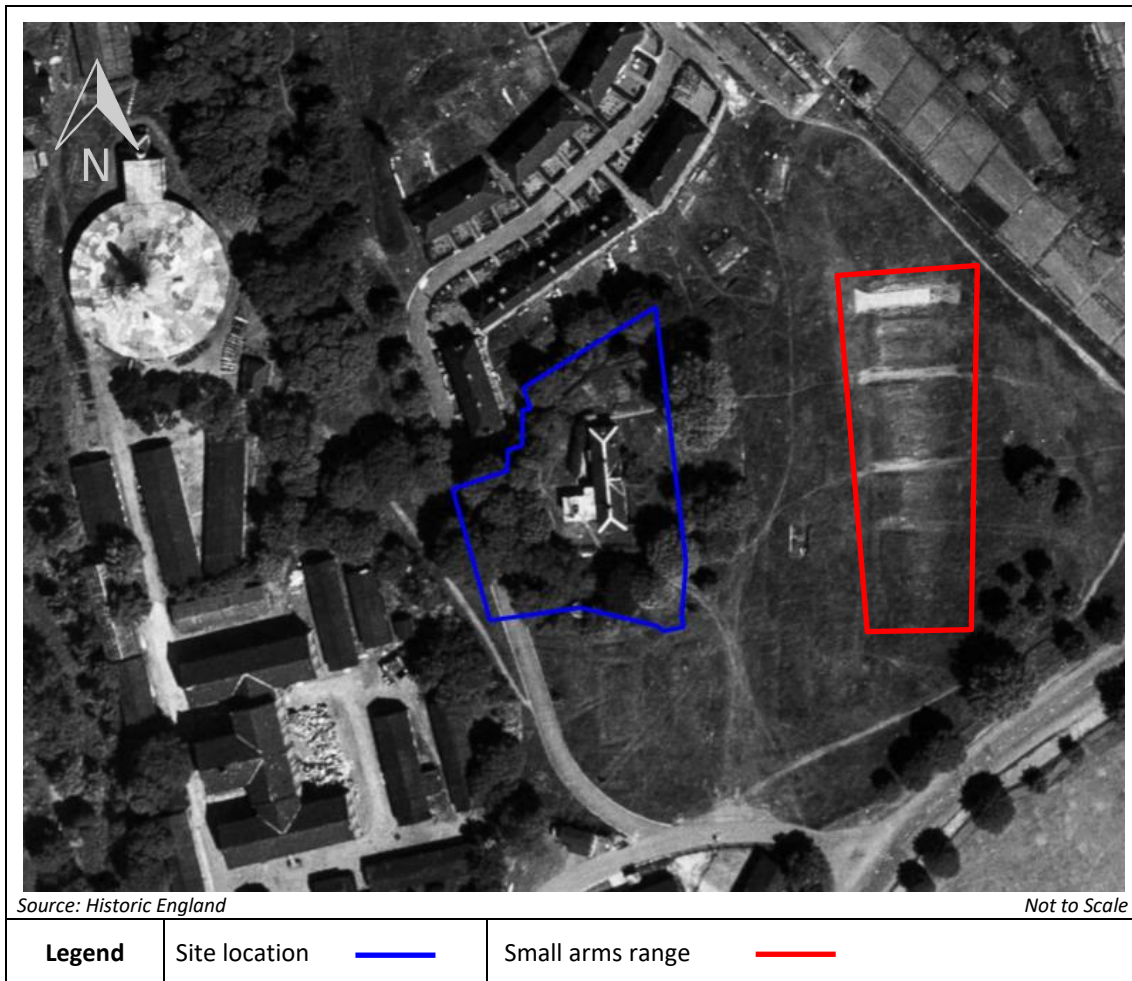
Plate 4 Aerial photograph of a temporary rifle range, 28th May 1947

Historic aerial photography indicates that a possible temporary small arms range was established in close proximity to the eastern boundary of the Site. This is visible in photographs dating from at least 1940.

Plate 4, an aerial photograph dated the 28th May 1947, shows the possible range oriented north to south, with fire directed away from the Site.

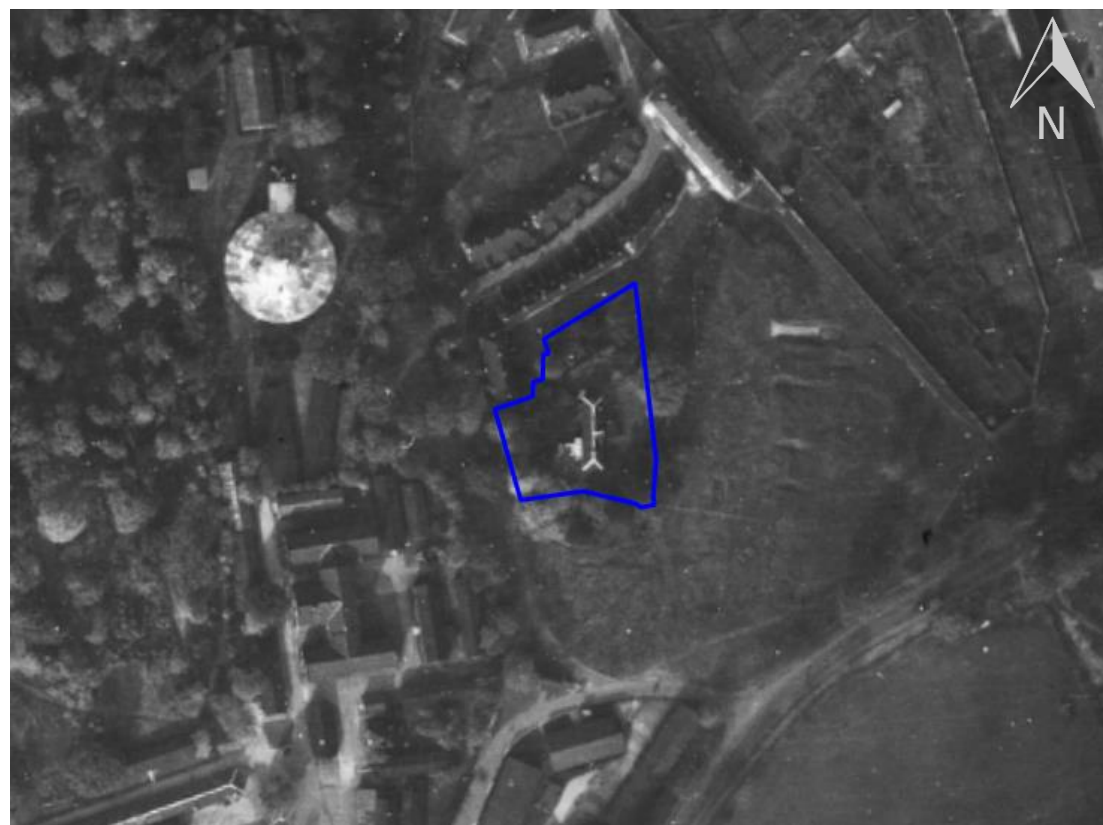
Plate 5 Aerial photograph, 25th October 1946

Plate 5 is an aerial photograph of the Site, dated the 25th October 1946. No evidence of bomb damage or cratering has been identified on the Site.

No records of bombing on the Site have been found and no evidence of bomb damage has been identified on the Site on historical aerial photography.

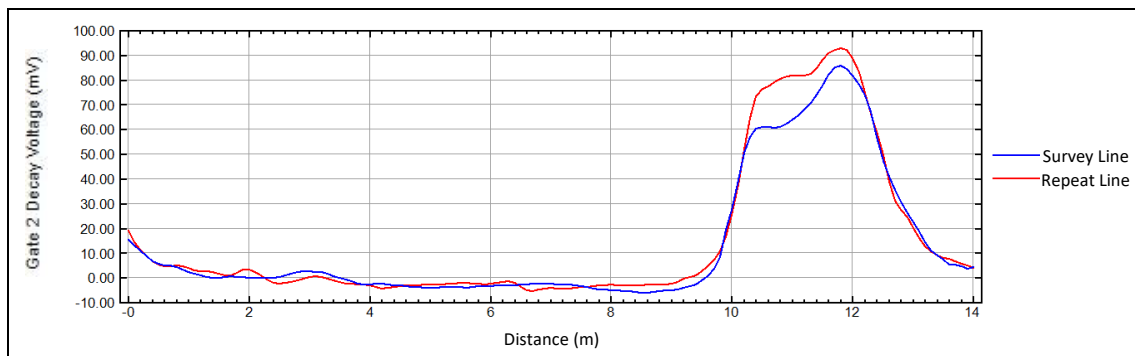
Figure 5 Repeatability assessment

Figure 5 shows an example of repeat profiles, which demonstrate good repeatability in terms of both positioning and amplitude of the anomalies.

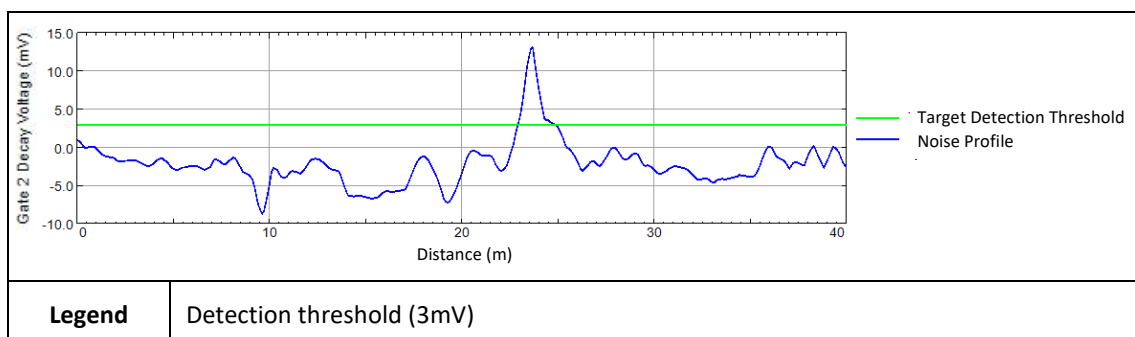
Figure 6 Target detection threshold (TDEM)

For target selection, a minimum threshold of detection had to be determined. This was calculated from analysis of the geophysical noise levels in the data with a value being chosen that was high enough to avoid false positive targets, and low enough to maximise the detection depth of the survey. Geophysical noise includes all measured signals that were not the target of the survey.

The noise threshold refers to the 2nd time gate, as it was the one used in the plots and primary interpretation for the reasons outlined in Sections 3.2.1 of this report.

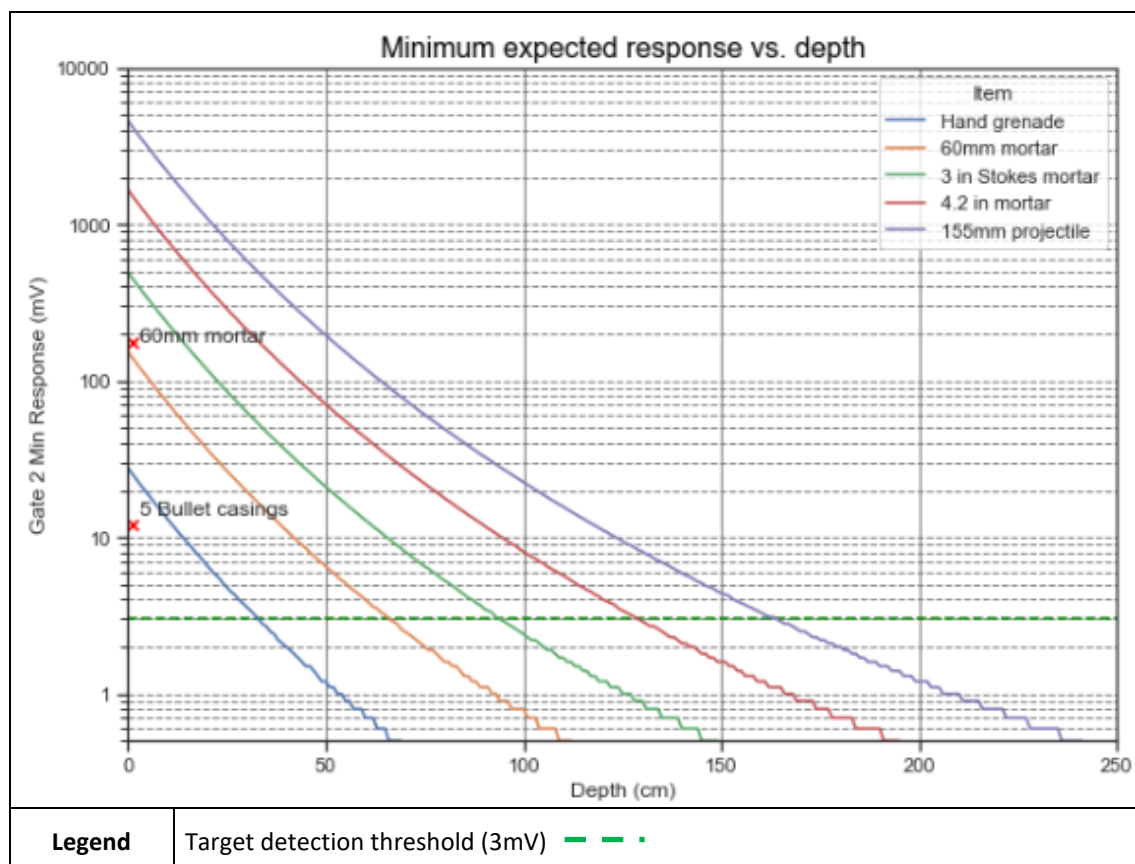
Figure 7 Modelled UXO detectability depths

It should be noted that smaller objects may also be detected if they are clustered together and/or very close to the surface. This is usually the case for bullet heads and cartridges for instance.

The depths of investigation are highly dependent on the target size and the burial setting. The depth of detectability of smaller diameter targets would be smaller than the depth of detectability of larger targets.
