Detailed Unexploded Ordnance (UXO) Threat & Risk Assessment

PROJECT NUMBER	8584_5	ORIGINATOR	D. Barrett
VERSION NUMBER	1.0	REVIEWED BY	B. Wilkinson (15 th March 2021)
CLIENT	Arcadis	RELEASED BY	L. Gregory (16 th March 2021)
STUDY SITE	Fambridge Road, RM8 1NS		
RATING	MEDIUM - This Study Site requires limited further action to reduce risk to ALARP during intrusive activities.

The Client has defined the Study Site as “Fambridge Road, RM8 1NS” and is centred on NGR 549138, 187415.

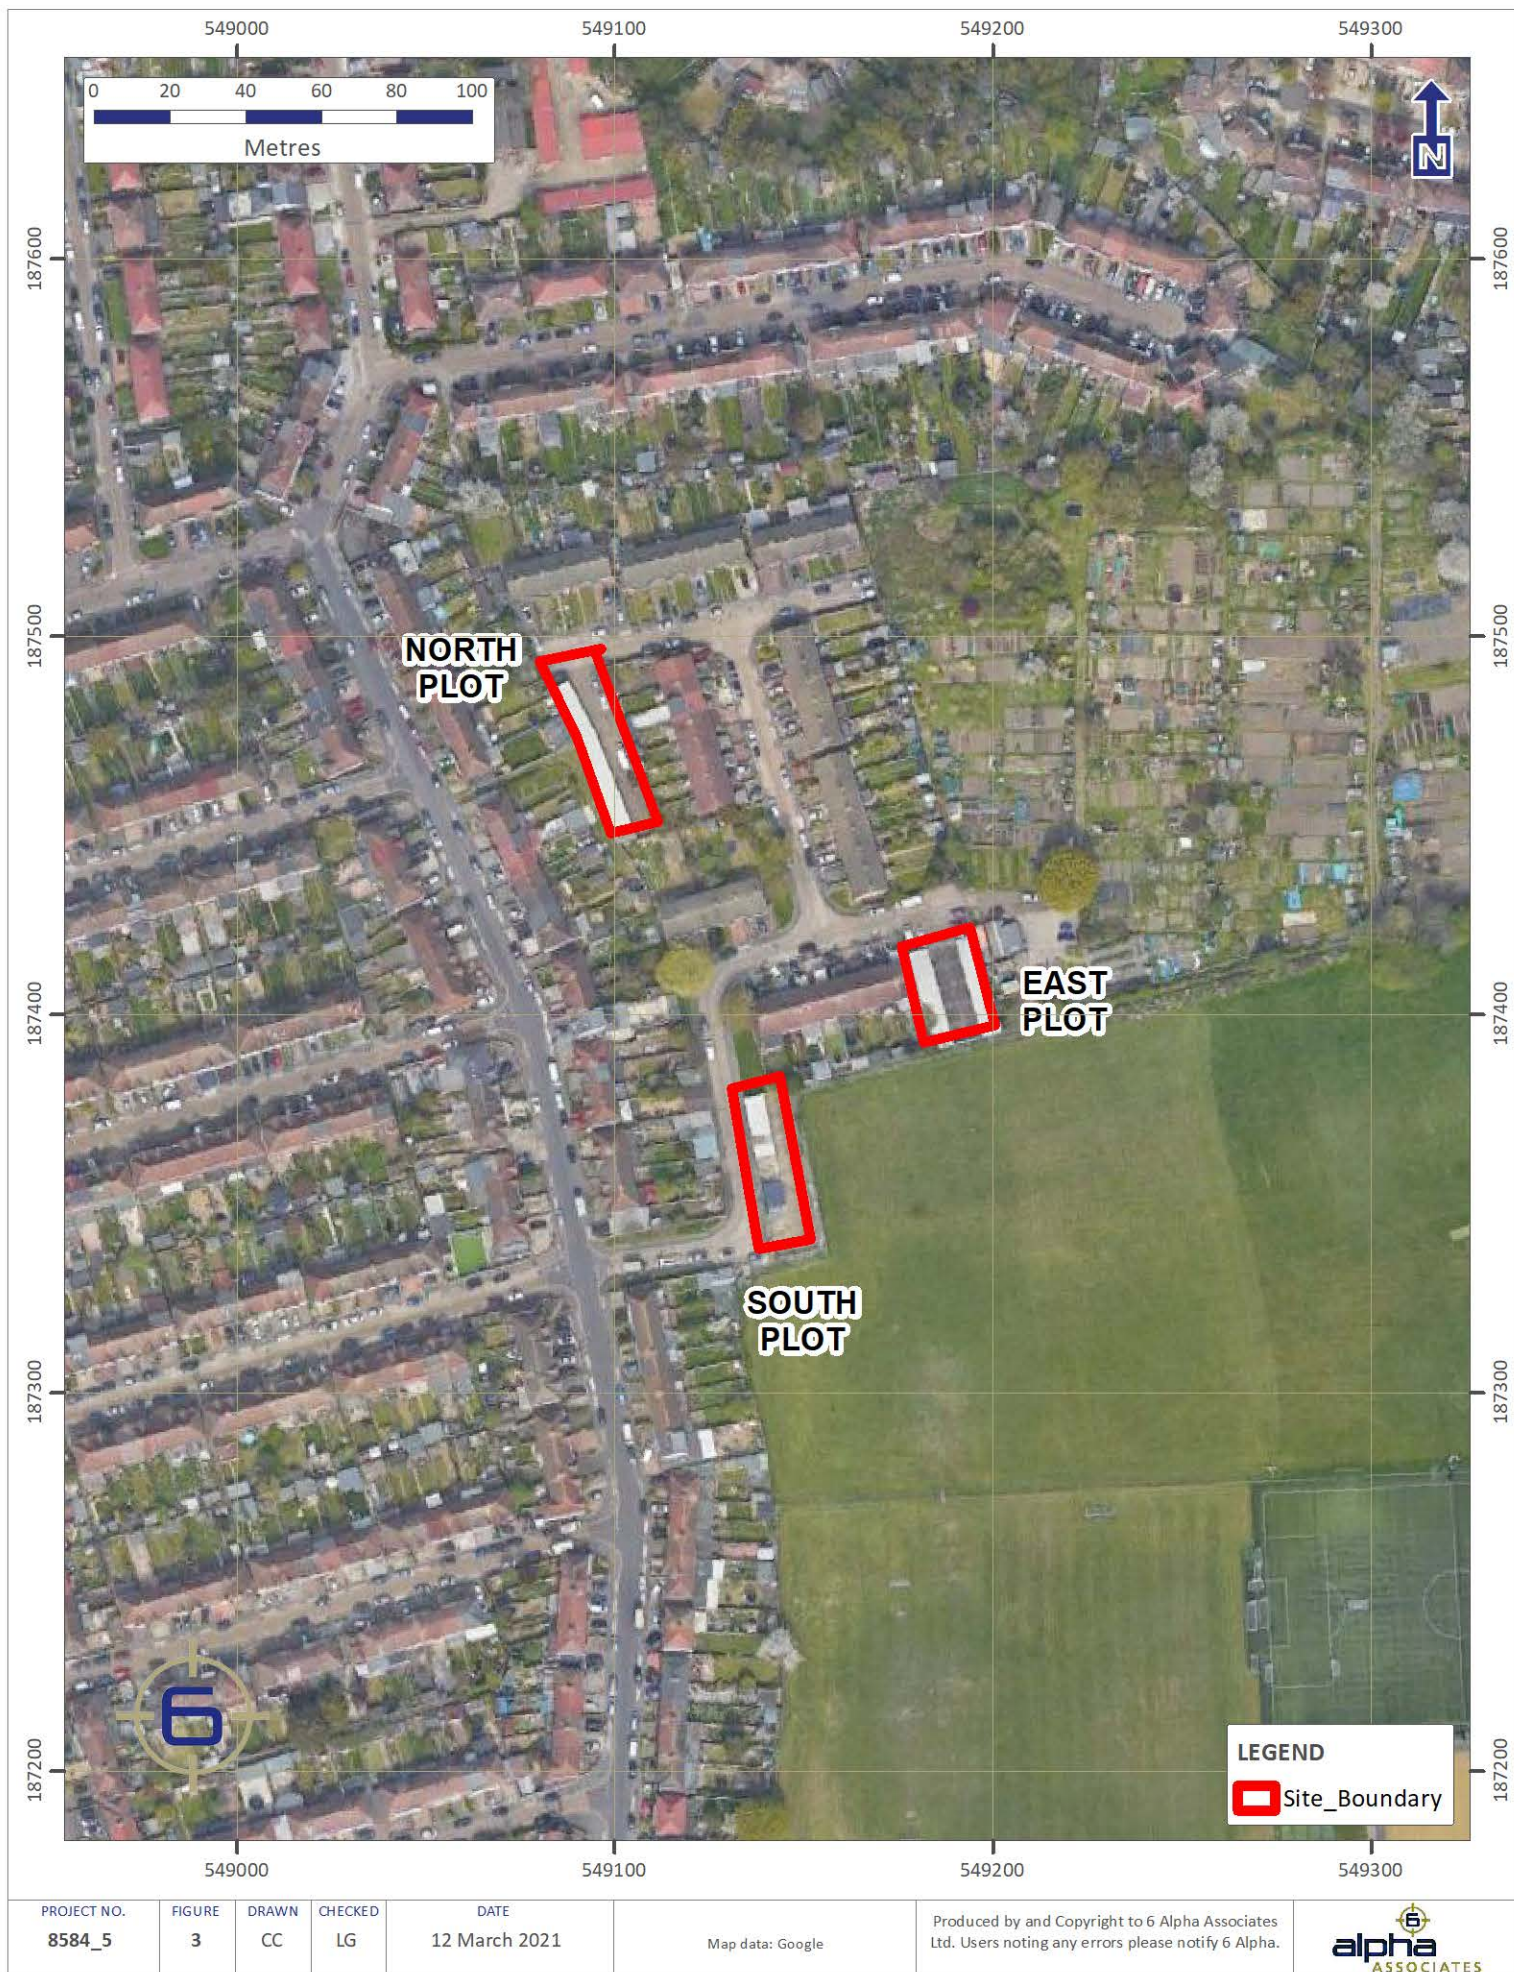
Figure Three - Aerial Photography (2020)

Current aerial photography corroborates the information above and shows that the Study Site is situated within a densely developed urban area. The Study Site itself consists of three plots, with each plot consisting of at least one structure and areas of hardstanding,

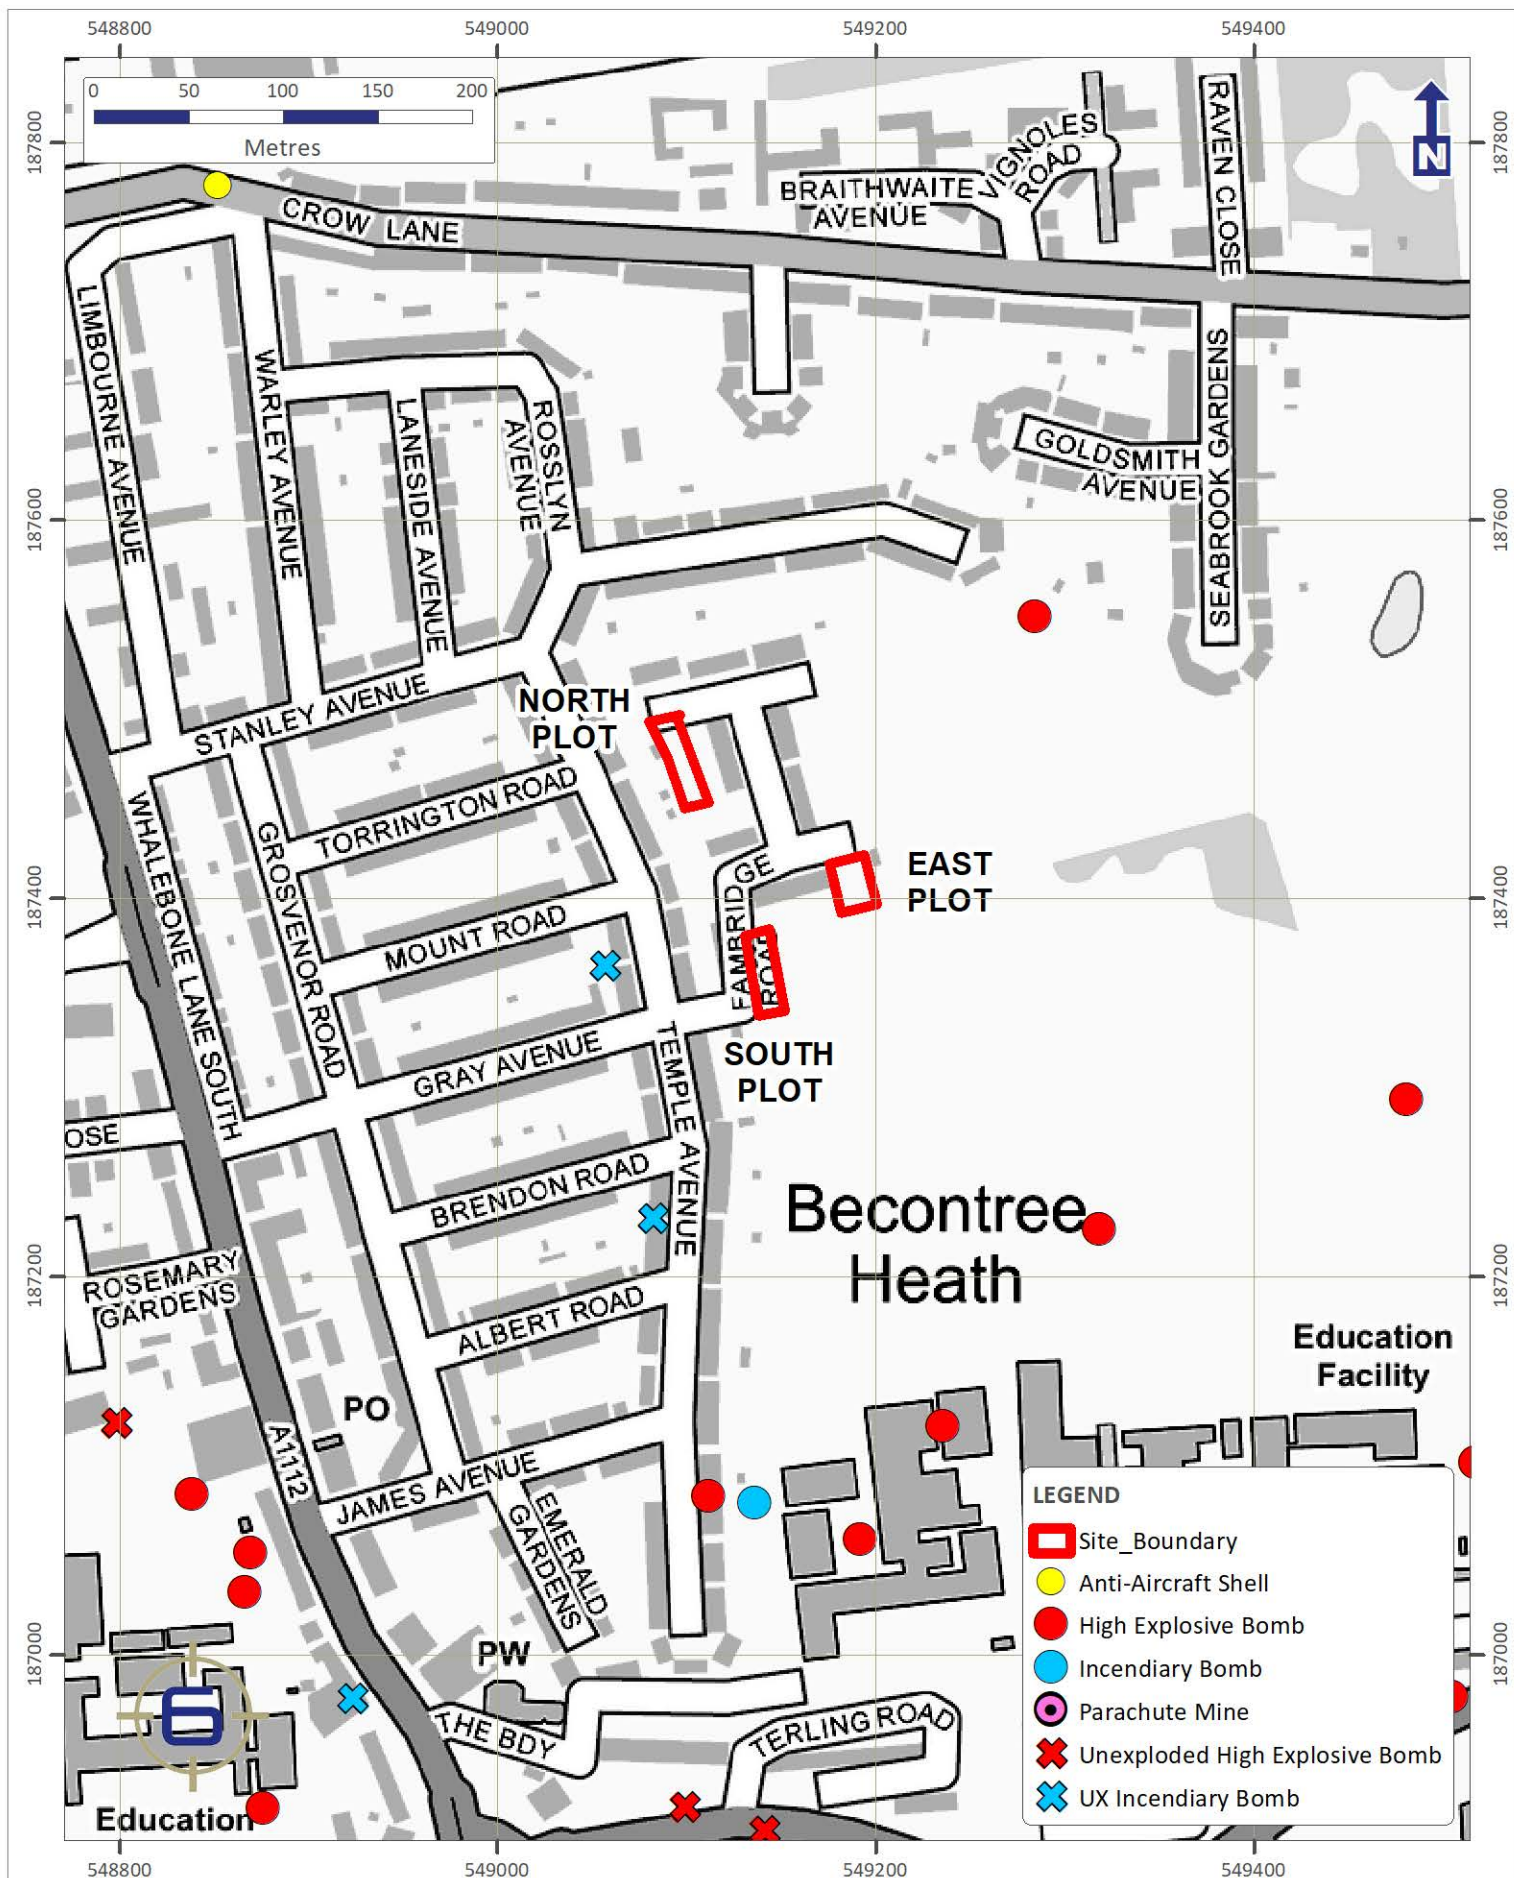
Figure Six - WWII Consolidated Bomb Strikes

During WWII, ARP wardens compiled detailed logs of bomb strikes across their respective districts. However, ARP records associated with the Study Site did not note any HE bomb strikes within it. Nonetheless, six were recorded in the wider area; 155m to the north-east, 200m to the south-east, 235m to the south-east, 255m to the south-south-west, 280m to the south-south-east and 300m to the east-south-east. Further research also identified an additional HE bomb strike on *Albert Road* 150m to the south-south-west.

Furthermore, whilst IBs may have fallen within the Study Site, they fell in such large numbers that accurate record keeping was either non-existent or perfunctory therefore, their prospective presence cannot be either corroborated or discounted. Nonetheless, IB strikes were noted 45m to the west, 255m to the south, 465m to the south and 815m to the south-west. In addition, five parachute mines were recorded impacting; 730m to the west, 775m to the north-north-west, 825m to the north-west, 825m to the north-west and 860m to the north-west. Finally, four AA shells were noted landing; 365m to the north-west, 430m to the north-west, 905m to the north-west and 990m to the west-south-west.

In addition to IBs and HE bomb strikes, during the latter part of the war when aerial bombing had significantly declined, the main threat came from V type weapons. The first recorded V1 strike on *London* was on the 13th June 1944, with the first recorded V2 strike on *London* on the 8th September 1944. V1 and V2 rockets were thin-skinned, unmanned and inaccurate weapons. One V1 rocket strike was recording landing 615m to the north-west, and two V2 rocket strikes 915m to the west and 990m to the north-west. Further research also identified an additional V2 rocket strike 190m to the east-north-east.
