# **BE FIRST REGENERATION LIMITED INNOVATIVE SITES PROGRAMME**

## **GARAGE BLOCK AT HIGHLAND AVENUE, DAGENHAM, RM10 7AS**

Phase 1 Desk Study and Preliminary Ground Investigation Report

10046791-AUK-XX-XX-RP-GE-0131-01

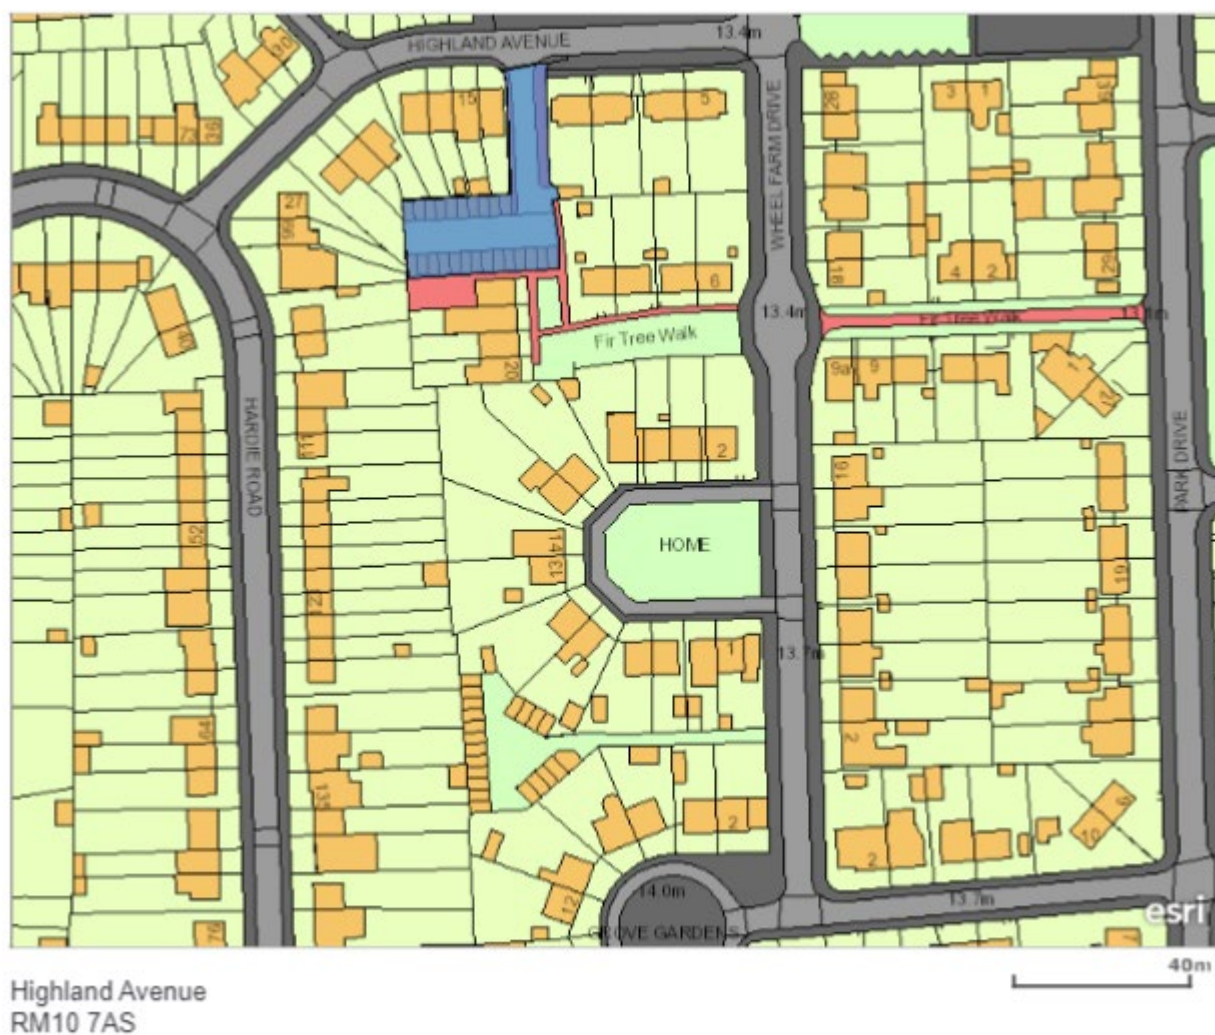
Figure 2: Highland Avenue Garages Site Plan (shown in blue) provided by the Client
