**DETAILED UXO
RISK ASSESSMENT**

STAGE 2 DETAILED UXO RISK ASSESSMENT

Client:	Lewisham Council		
Project Ref:	RENK01R		
Site Name:	Land Between 43 and 45 Camplin Street, Lewisham		
Report Ref:	DRA-25-1882-RENK01R-LandBetween43and45CamplinStreet,Lewisham		
Revision:	0		
Status:	Final		
Date:	26 th June 2025		
Author:	Megan Cherry	Project Researcher	megan.cherry@brimstoneuxo.com
Reviewed By:	Will Slack	Senior Project Researcher	will.slack@brimstoneuxo.com
Authorise By:	Aaron Florence	Managing Director

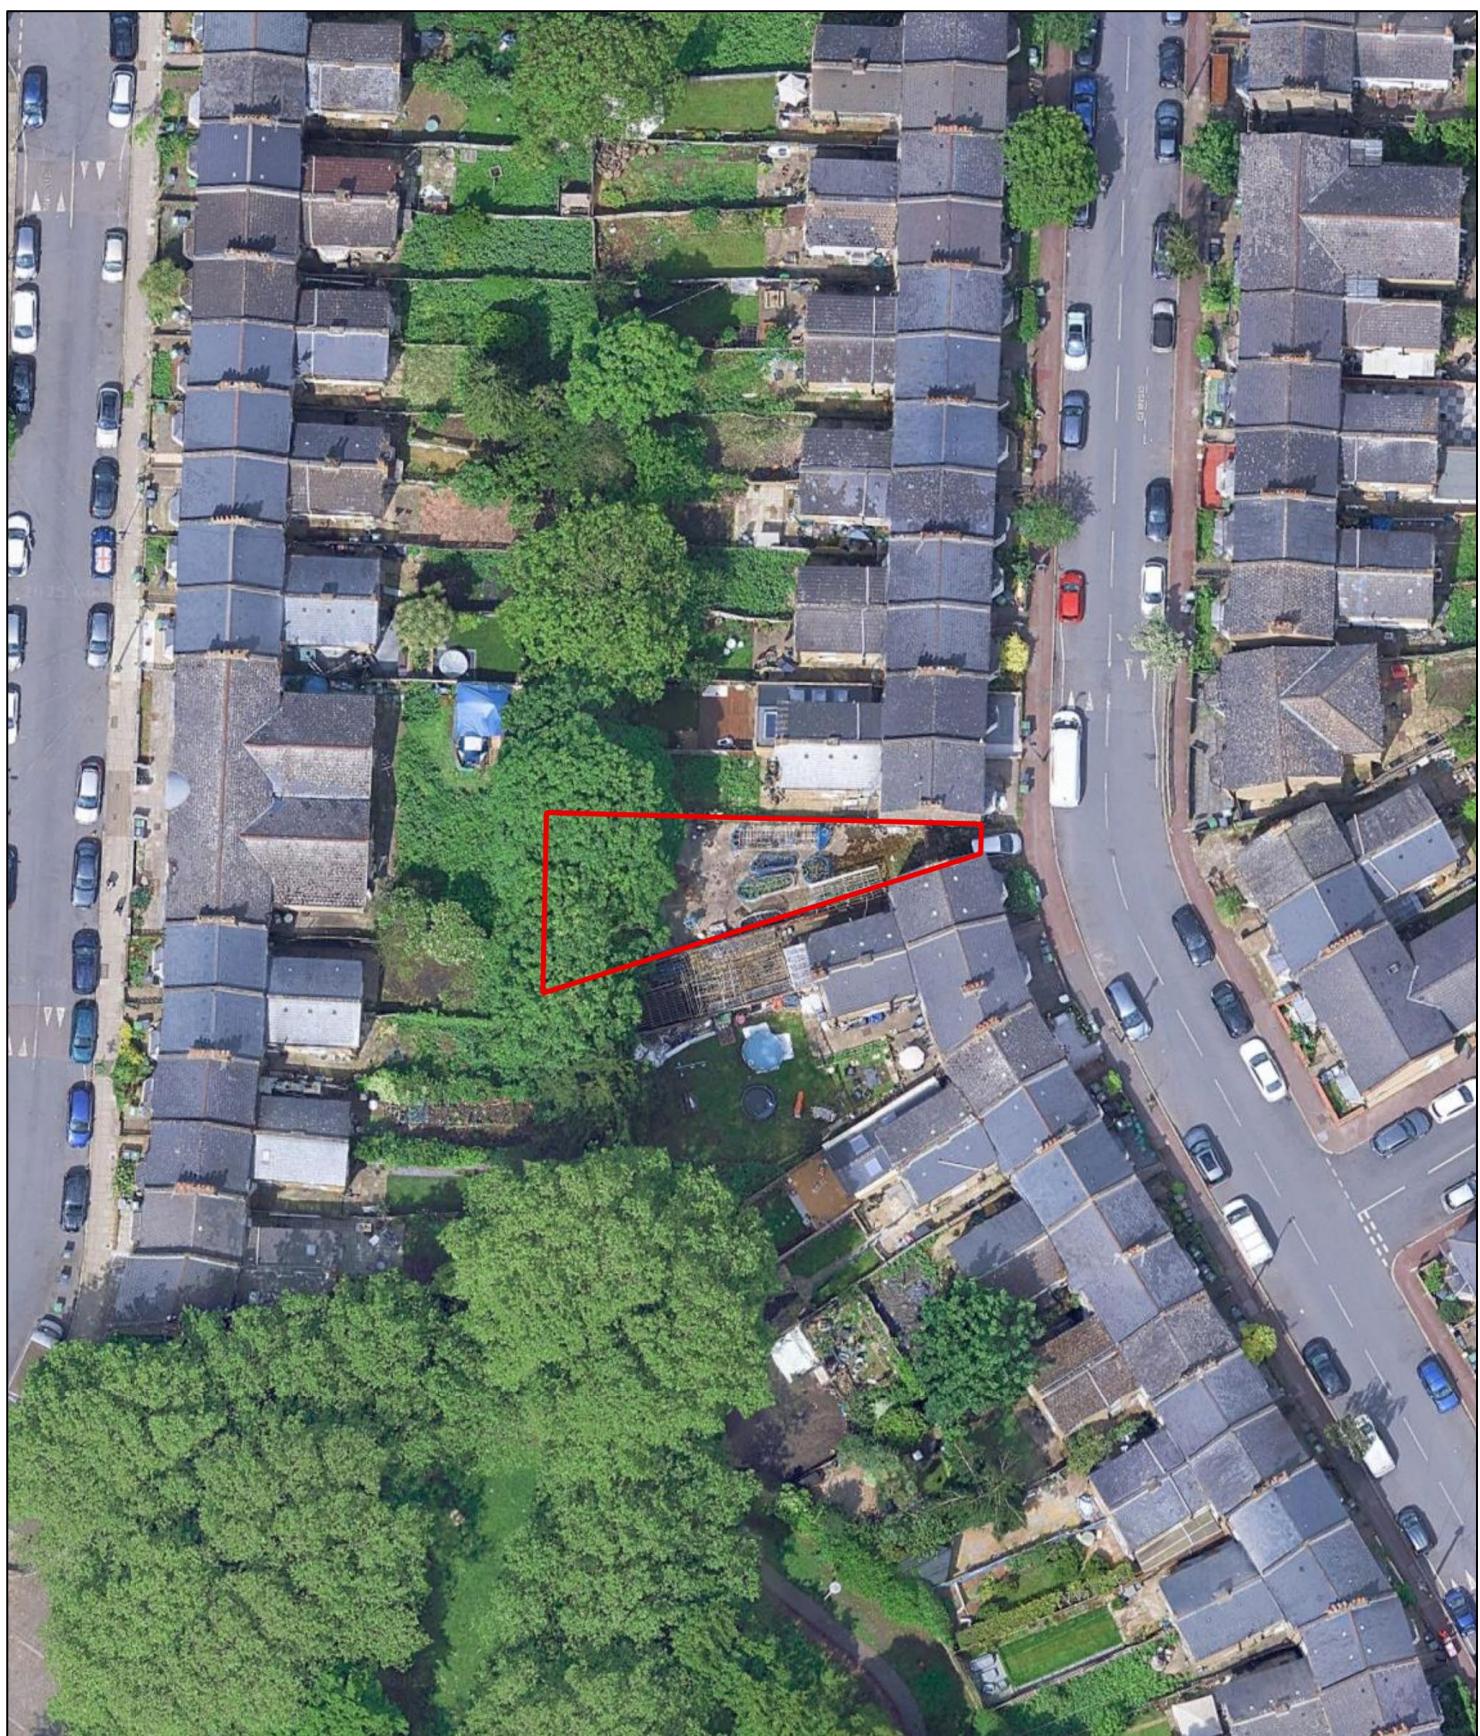
FIGURE: 2

Recent Satellite Imagery

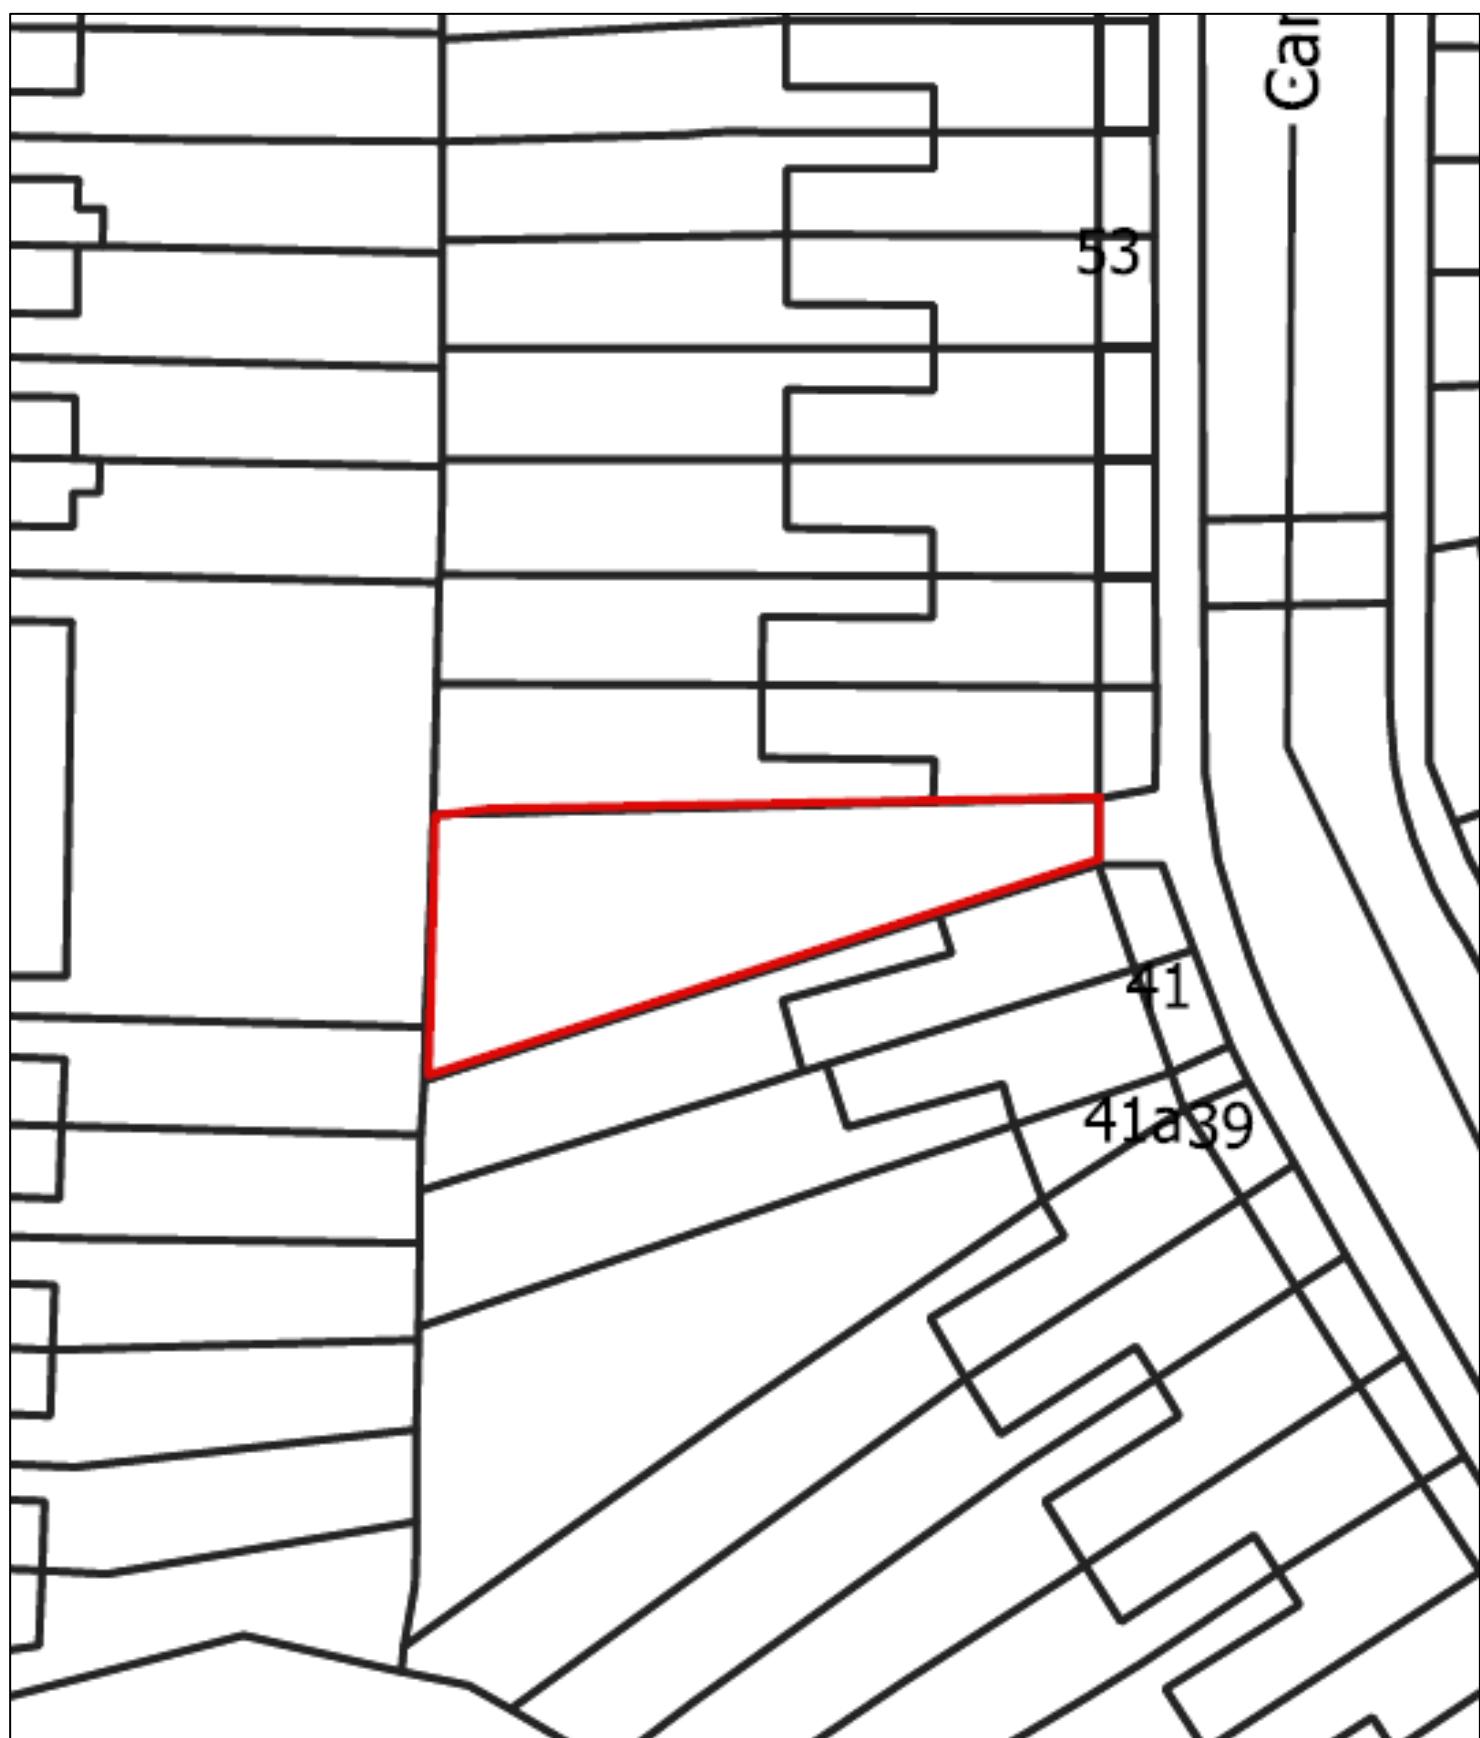
FIGURE: 3

Existing Site Plan

THE SITE: The Site is located within the London Borough of Lewisham, approximately 550m north-west of New Cross Gate railway station. The Site comprises hardstanding with mature vegetation at the western extent and multiple small allotment containers present intermittently.

The Site is bound to the north and south by residential structures, to the east by Camplin Street, and to the west by associated gardens of residential structures on Monson Road.

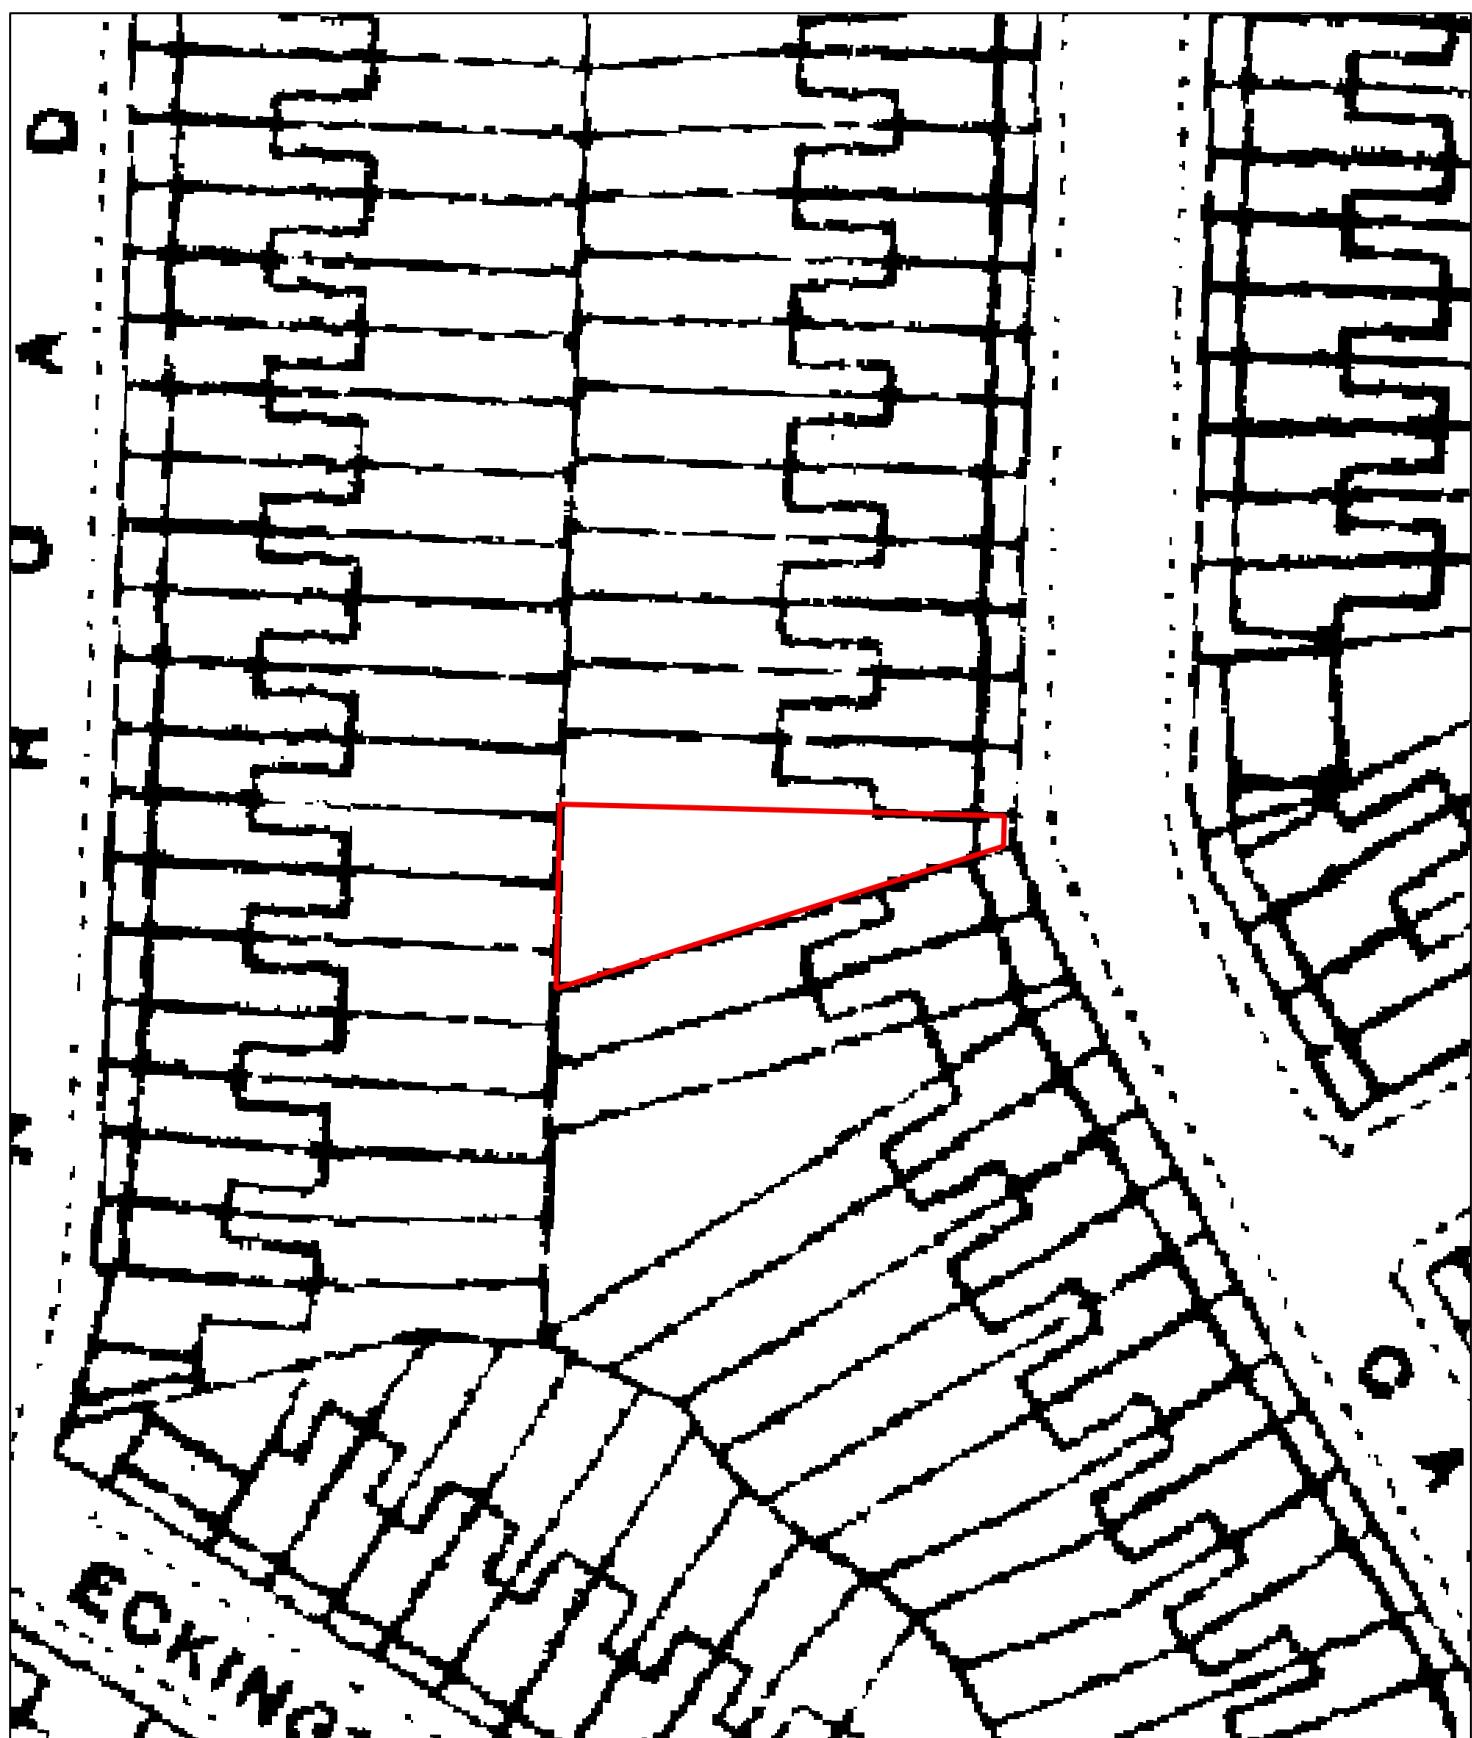
FIGURE: 4.1

Historical OS Mapping - 1916

Period	Map Date	Map Scale	Review
Pre- WWI	1894	1:2,500	<p>The Site entirely comprises open ground, bound to the north, south and west by residential properties and their associated gardens, and to the east by Camplin Street.</p> <p>All Saint's Church is present approximately 170m south-west of the Site.</p>
WWI	1916	1:2,500	<p>FIGURE 4.1: No significant changes have occurred on Site.</p> <p>An unnamed school, located approximately 110m north, has been expanded.</p>
Pre- WWII	1938	1:10,560	No significant changes have occurred on Site or in the surrounding area.
Post- WWII	1951- 1952	1:2,500	<p>FIGURE 4.2: A small extension to a residential structure has been built in the north-eastern extent of the Site.</p> <p>Multiple structural clearances are present within the study area (approximate 250m radius), located 15m west of the Site and approximately 195m north-west, 120m and 150m south, 245m south-east and 145m south-west of the Site. This is indicative of bomb damage.</p> <p>Two structures within the study area were labelled as 'ruins', situated approximately 45m north-east and 215m south-west.</p> <p>Multiple areas occupied by prefabricated properties have been identified within this mapping, located approximately 40m north-east, 145m north-west, 80m, 85m, 160m and 185m south-west. These were often constructed in areas of clearance resulting from bomb damage.</p>

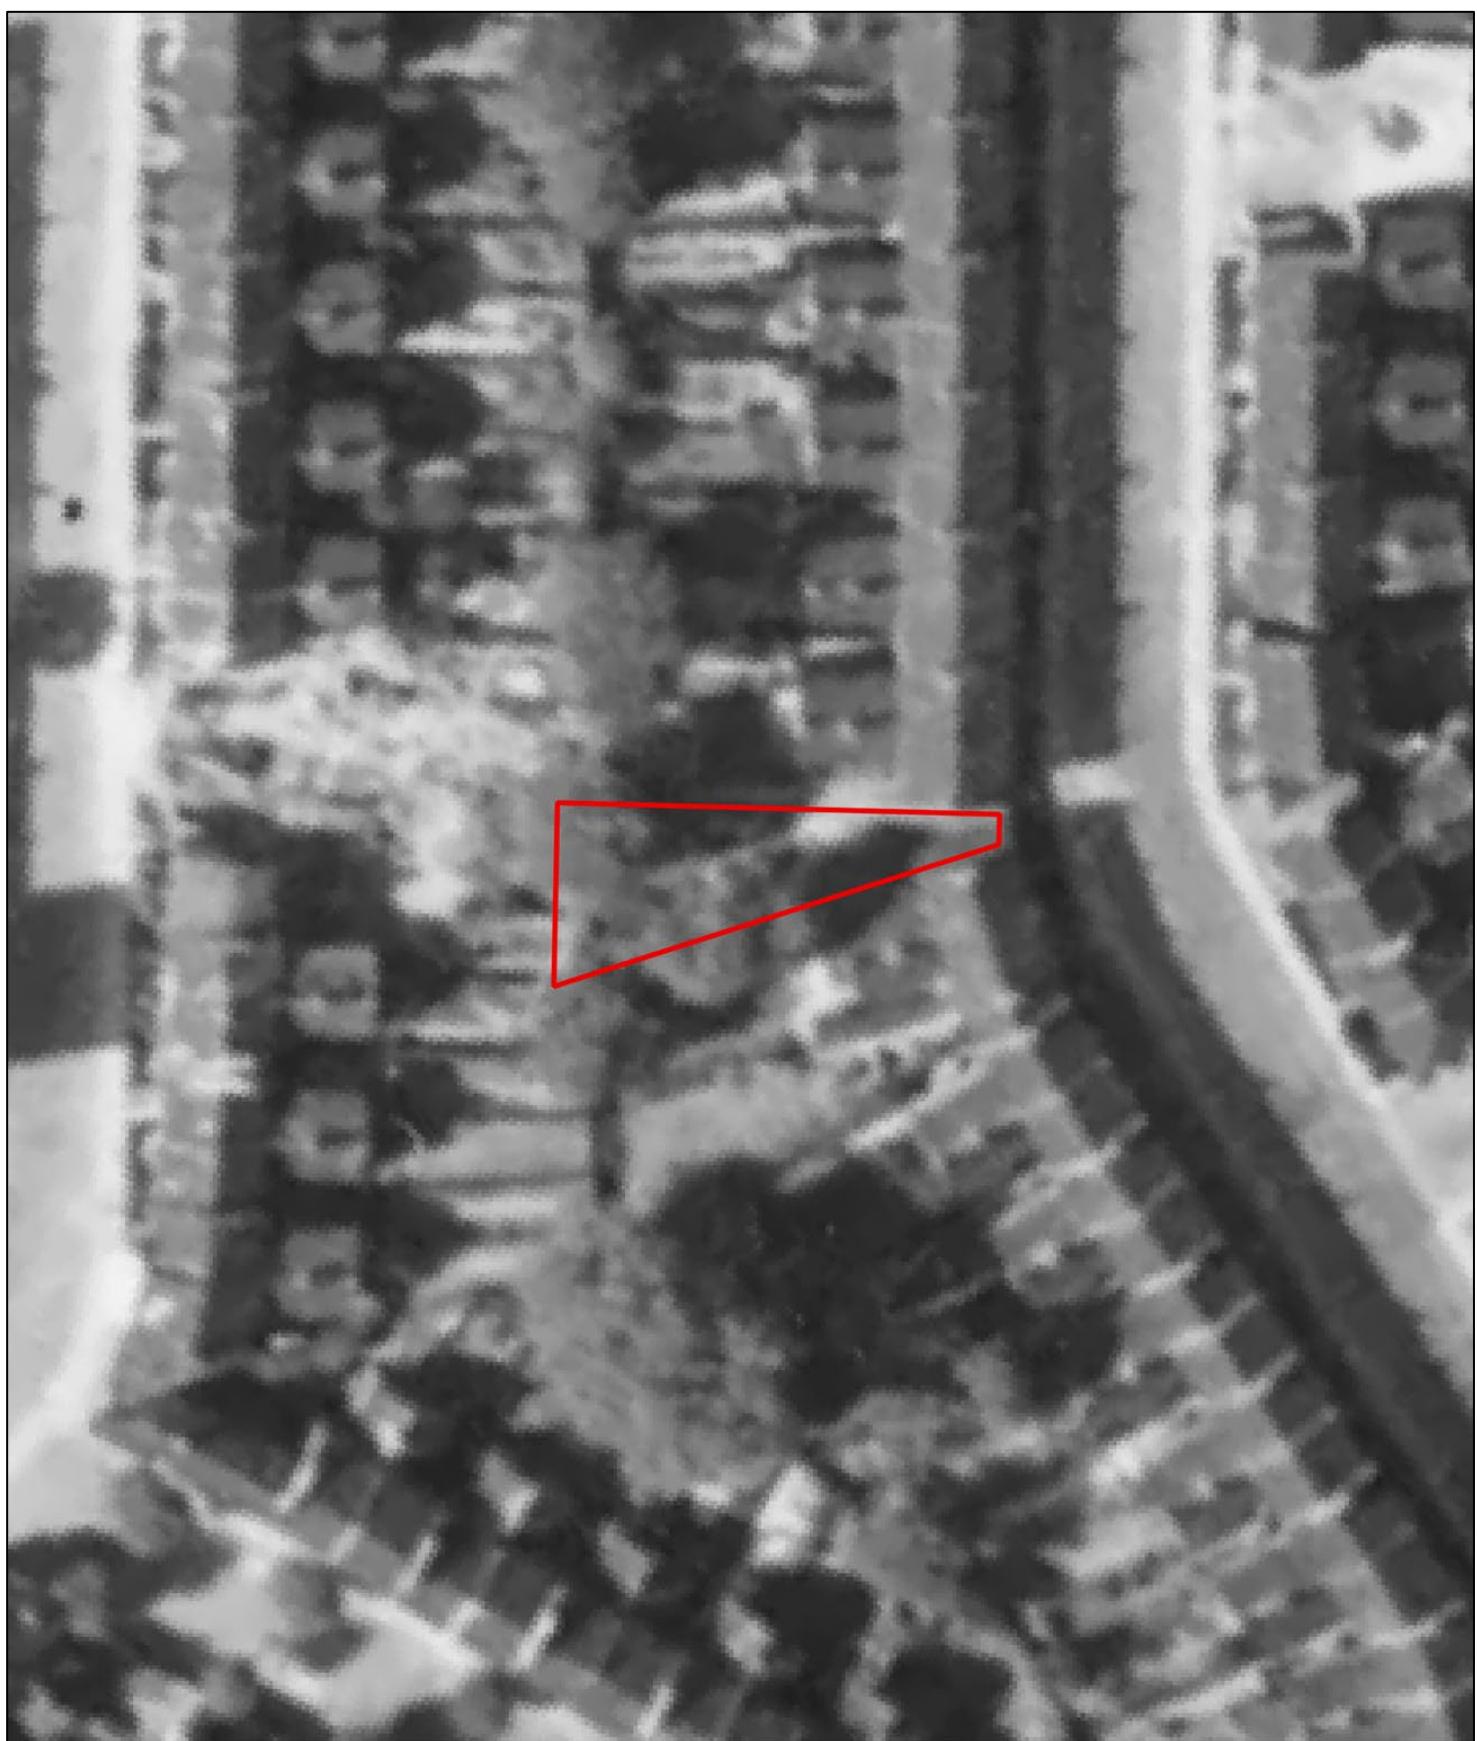
FIGURE: 5.1

Historical Aerial Photography – 18th June 1941

Period	Photo Date	Review
WWII	18 th June 1941	<p>FIGURES 5.1 & 5.2: This photograph was taken during the height of the Luftwaffe bombing campaign over London.</p> <p>The Site appears to comprise undeveloped, open ground bound by two residential properties to the north and south. Visibility of the Site is relatively poor as the western and south-western extent of the Site is obscured by trees and the south-eastern section is obscured by shadows from the surrounding structures. Consequently, accurate analysis of potential bomb damage within the Site area has been impeded.</p> <p>Areas of structural clearance are visible approximately 15m west of the Site and approximately 45m north-east.</p> <p>Roof repairs have been identified on residential properties located approximately 25m west of the Site.</p>
	7 th August 1944	<p>FIGURES 5.3 & 5.4: This low-resolution photograph was taken after the main period of bombing over Britain.</p> <p>The questionable quality of this photography and the previously mentioned obstructions to the visibility of the Site area means that analysis of the Site itself has been severely impeded.</p> <p>In the aforementioned area of structural clearance approximately 15m west of the Site, the ruined structure can be seen in its footprint.</p> <p>New areas of structural clearance are visible, located approximately 50m west, 80m and 105m south-east, and 155m south of the Site.</p> <p>Roof repairs have been identified on residential properties approximately 130m south-east of the Site.</p>

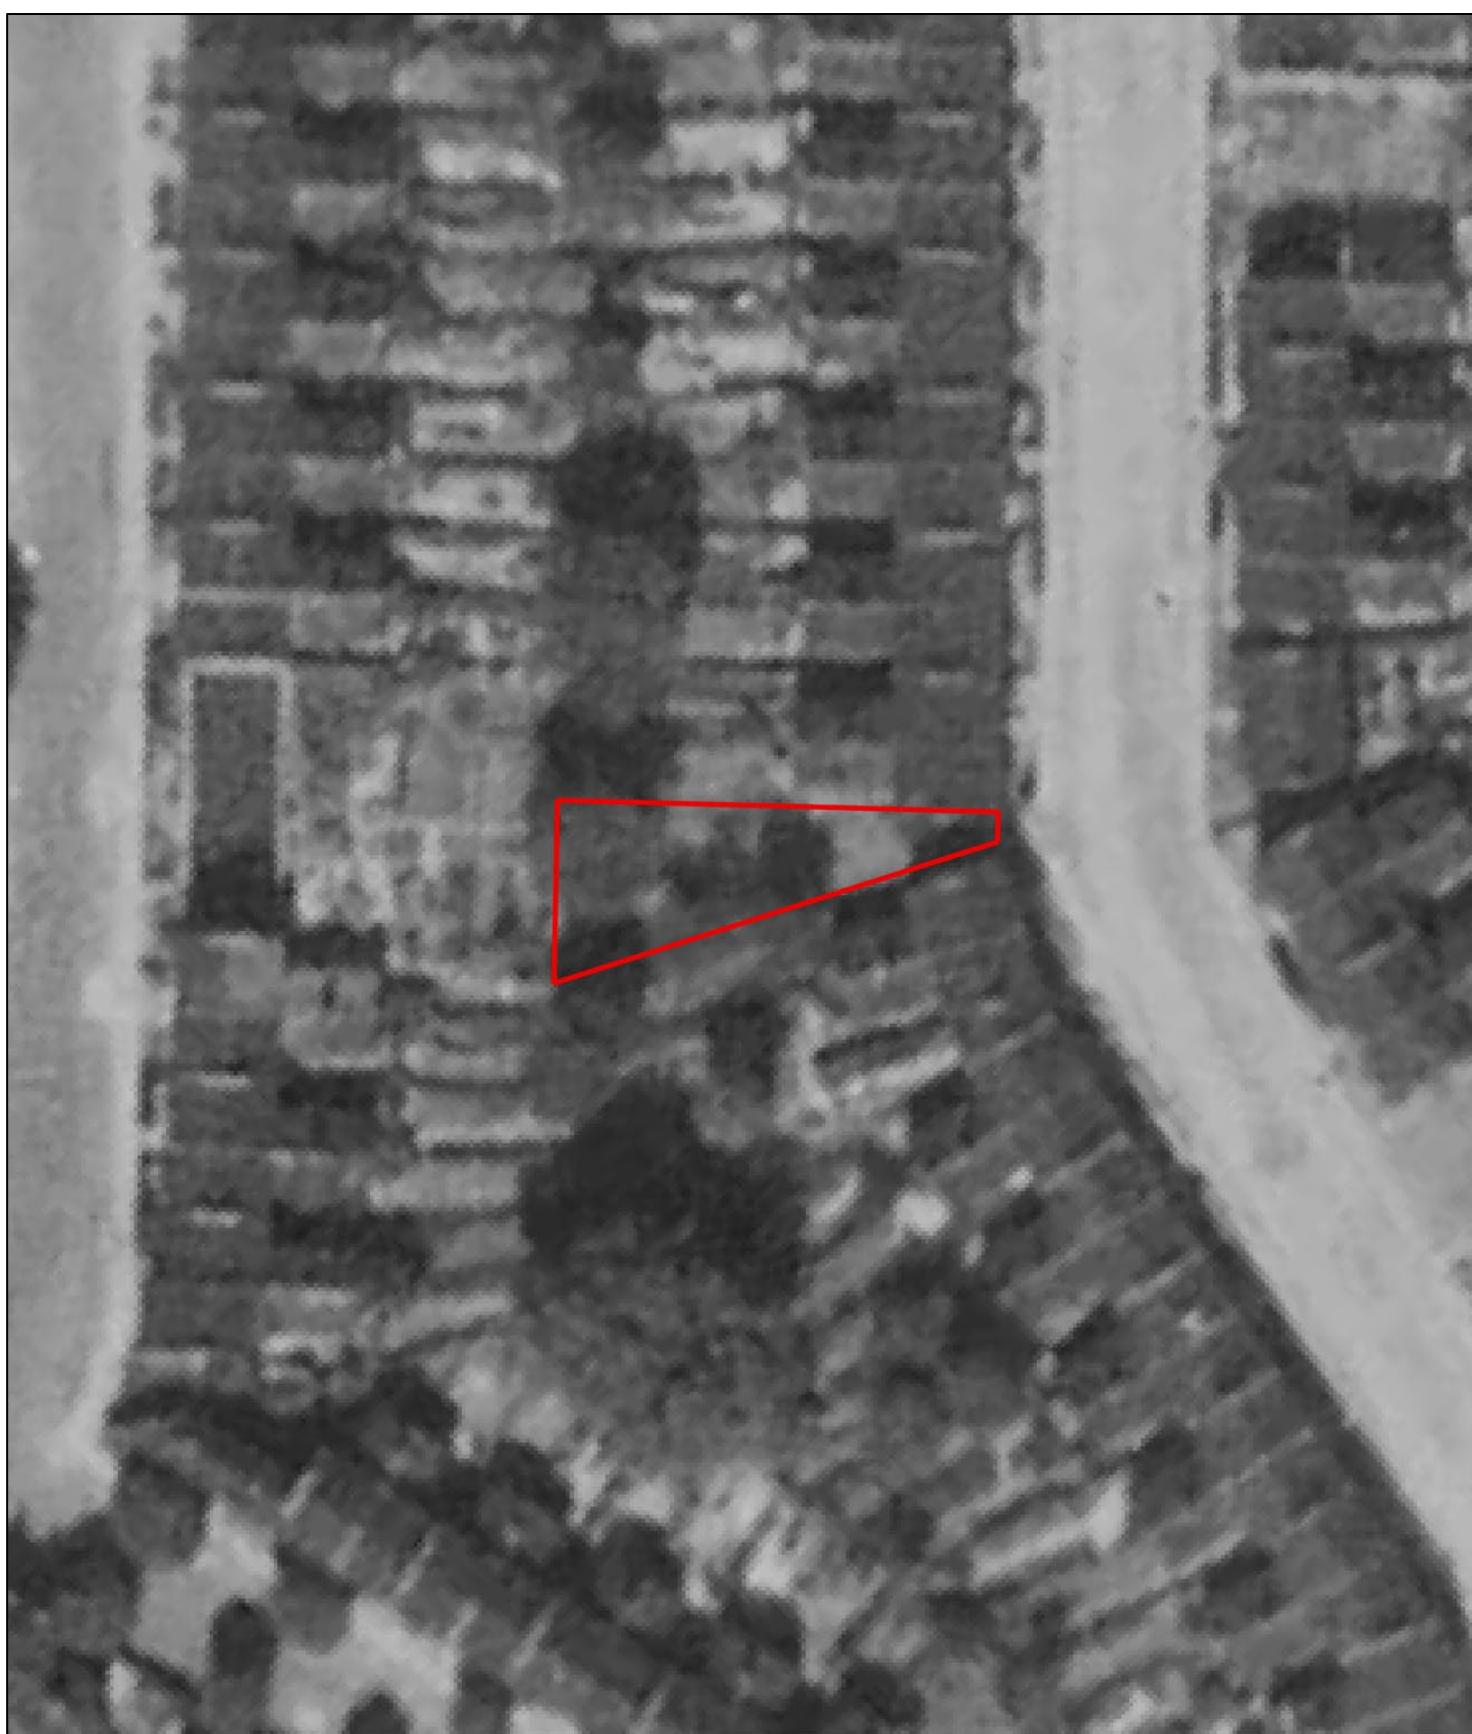
FIGURE: 5.3

Historical Aerial Photography - 7th August 1944

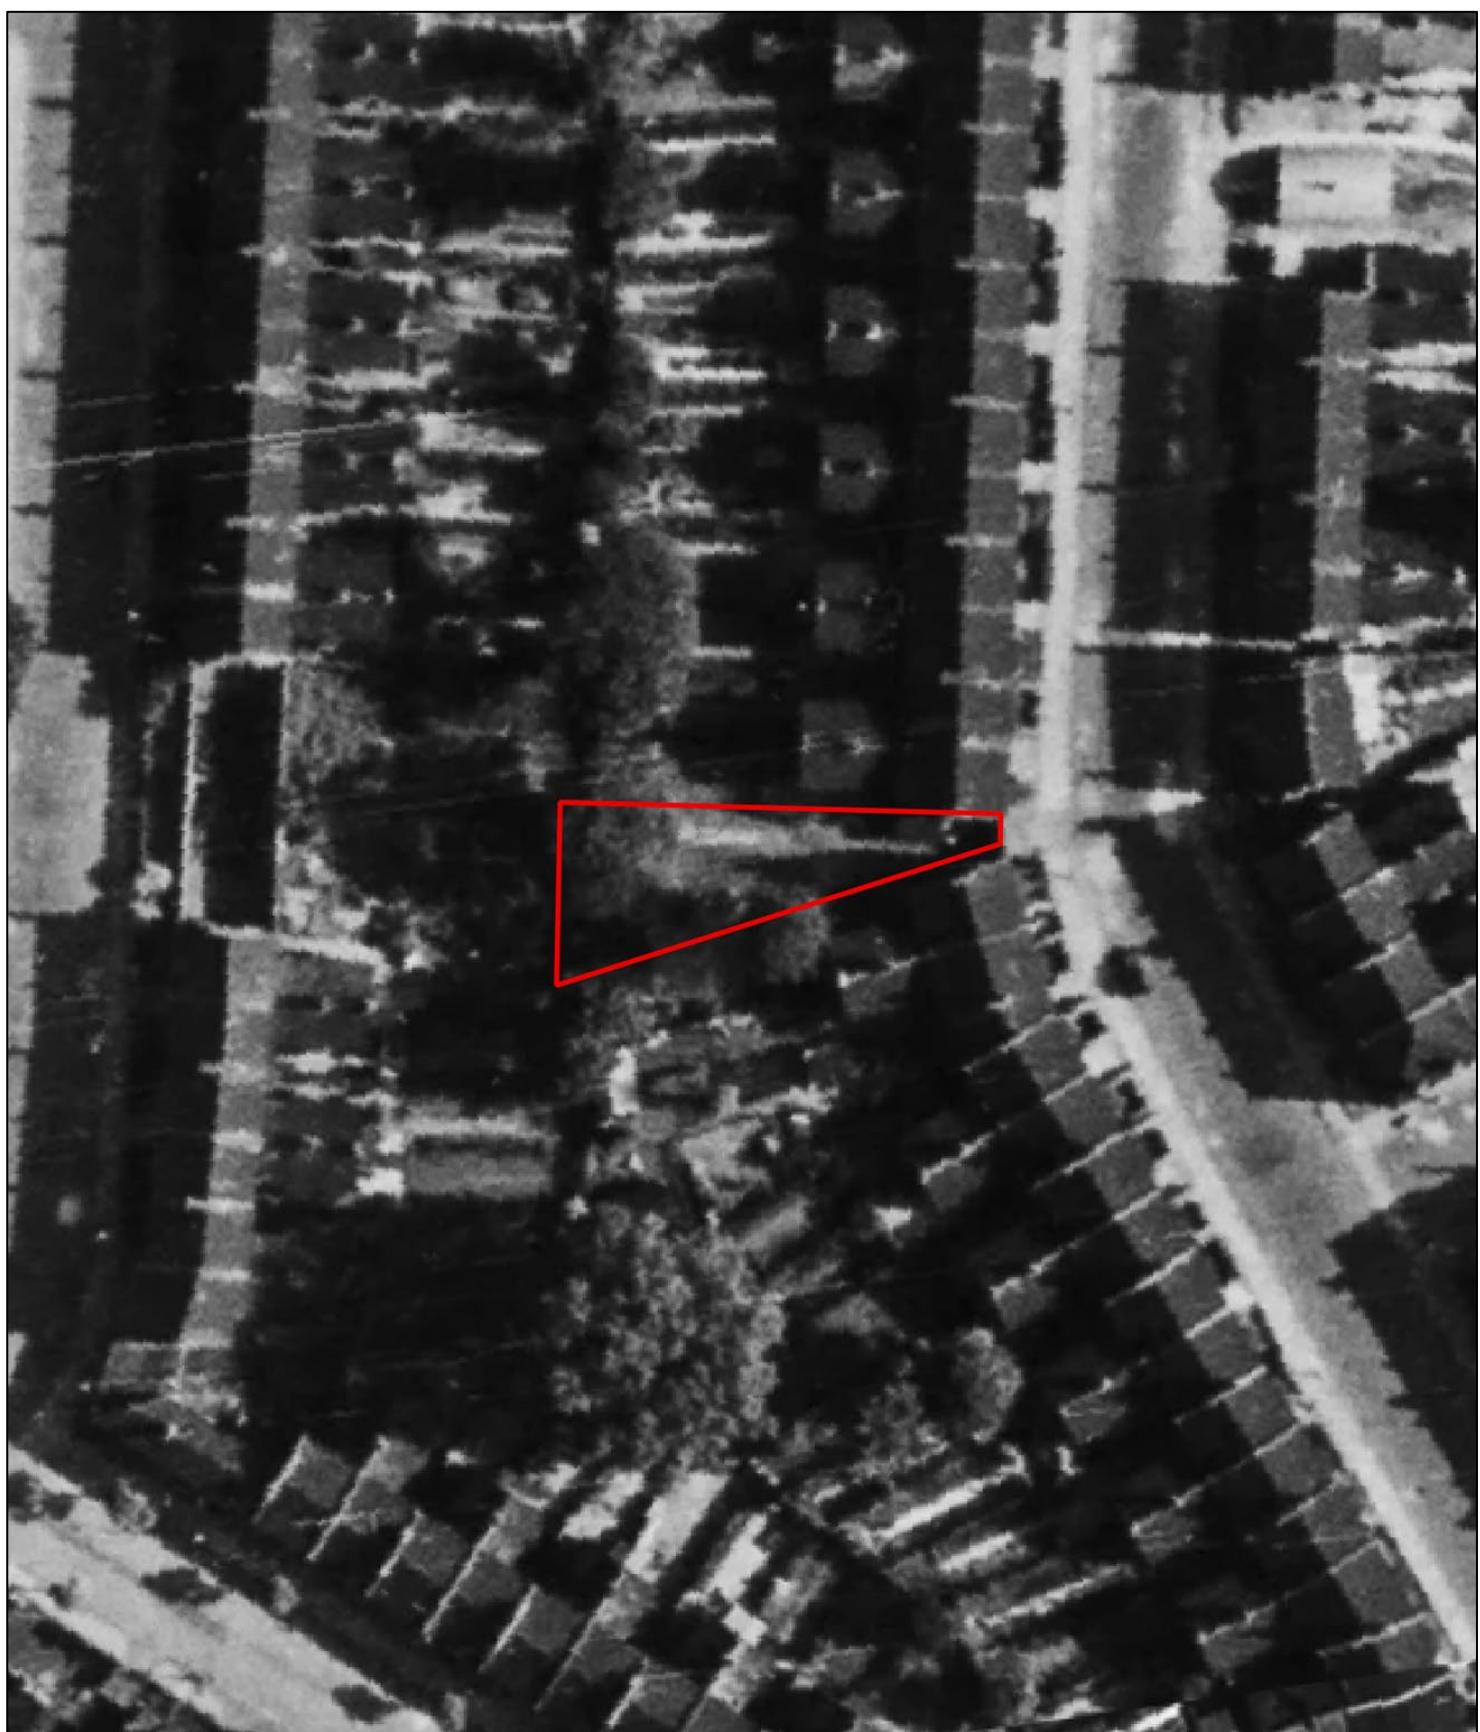
FIGURE: 5.5

Historical Aerial Photography – 9th July 1946

Post-WWII	9 th July 1946	<p>FIGURES 5.5 & 5.6: This high-resolution photograph was taken approximately 14 months after the end of WWII in Europe.</p> <p>The previously mentioned obstructions to the visibility of the Site area means that analysis of the Site itself has been severely impeded.</p> <p>The above-mentioned areas of structural clearance within the previous photograph are still visible in this image. The development works of a new structure in the clearance 15m west of the Site can be seen.</p> <p>A temporary prefabricated structure is now present in the footprint of the structural clearance located approximately 45m north-east of the Site.</p>
	28 th May 1947	<p>FIGURES 5.7 & 5.8: This high-resolution photograph was taken approximately two years after the end of WWII in Europe.</p> <p>The previously mentioned obstructions to the visibility of the Site area means that analysis of the Site itself has been severely impeded.</p> <p>Potential roof repairs are visible approximately 45m south-east of the Site.</p> <p>New structures can be seen approximately 50m west of the Site, in the footprint of a cleared structure from the image dated 1944.</p>

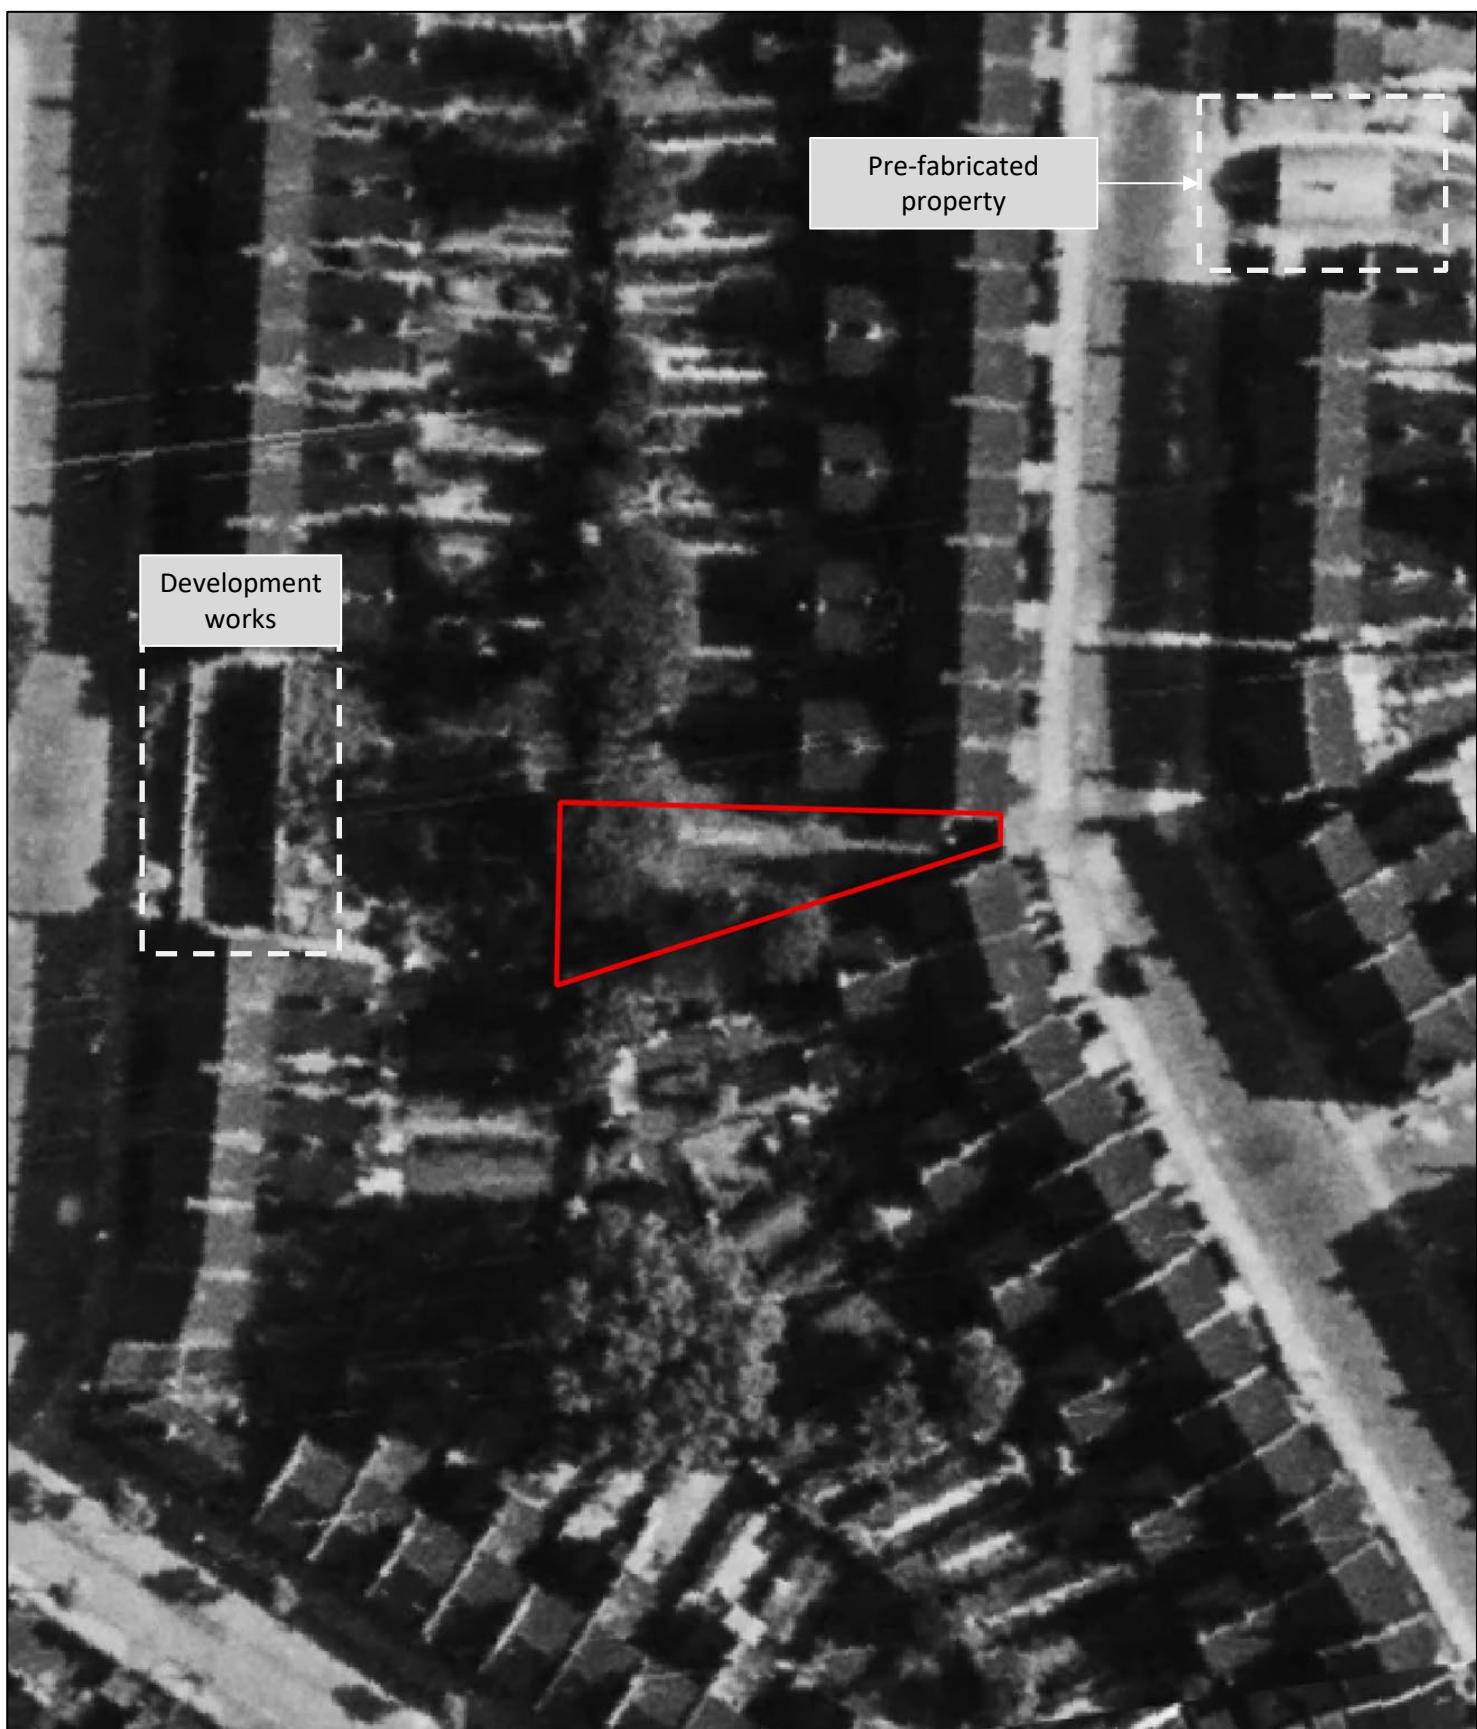
FIGURE: 5.6

Historical Aerial Photography – 9th July 1946

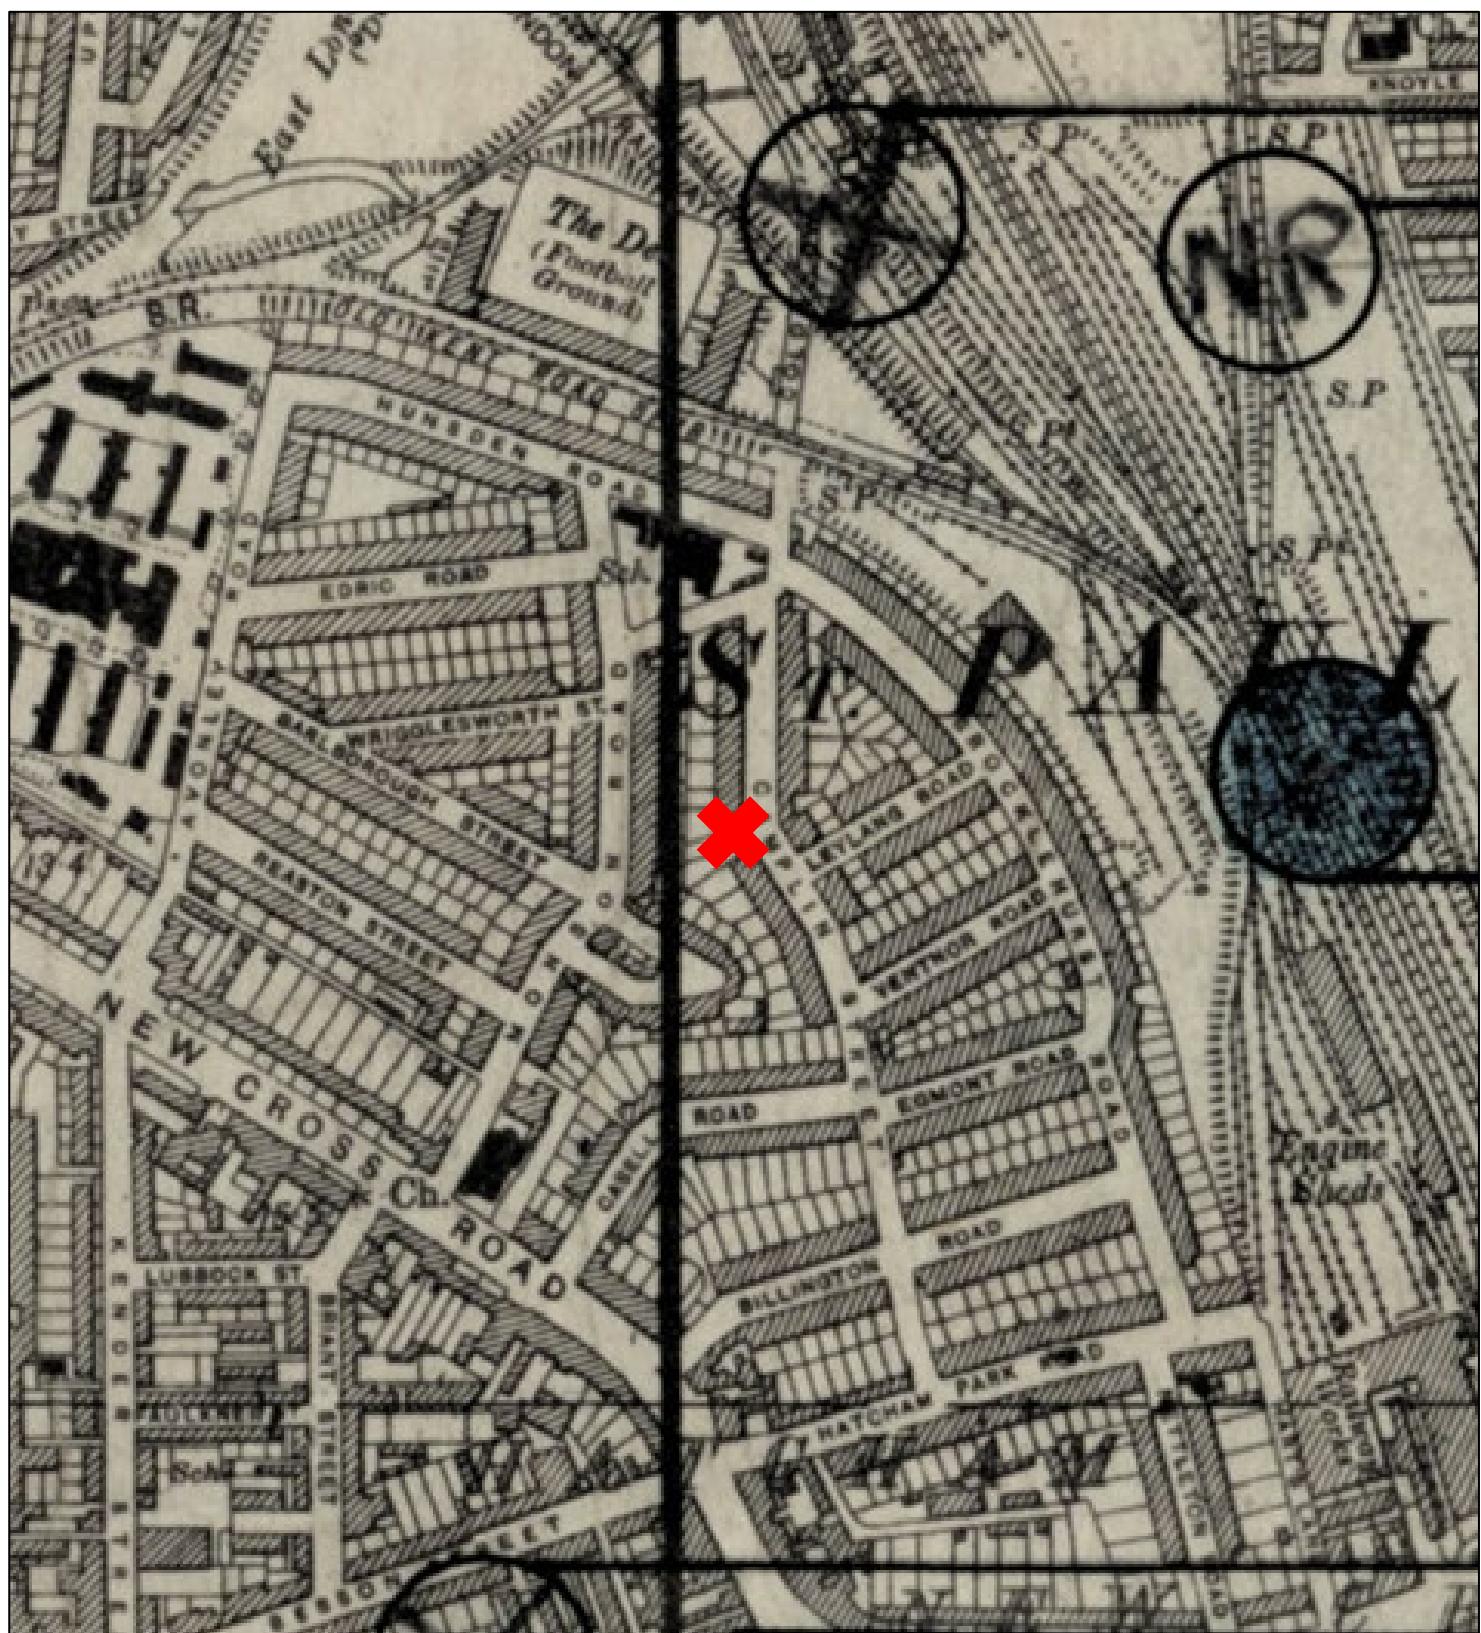
FIGURE: 7

V1 Bomb Census Mapping

V-1 flying bomb strike

No V1 or V2 strikes are plotted within or adjacent to the Site boundary. The closest V1 strike (7th July 1944) is plotted approximately 265m to the north-east, this can be seen at **FIGURE 7**. The closest V2 strike (25th November 1944) occurred 610m to the west.
