**DETAILED UXO
RISK ASSESSMENT**

STAGE 2 DETAILED UXO RISK ASSESSMENT

Client:	Lewisham Council		
Project Ref:	RENK01R		
Site Name:	Land Between 43 and 45 Camplin Street, Lewisham		
Report Ref:	DRA-25-1882-RENK01R-LandBetween43and45CamplinStreet,Lewisham		
Revision:	0		
Status:	Final		
Date:	26 th June 2025		
Author:	Megan Cherry	Project Researcher	megan.cherry@brimstoneuxo.com
Reviewed By:	Will Slack	Senior Project Researcher	will.slack@brimstoneuxo.com
Authorise By:	Aaron Florence	Managing Director

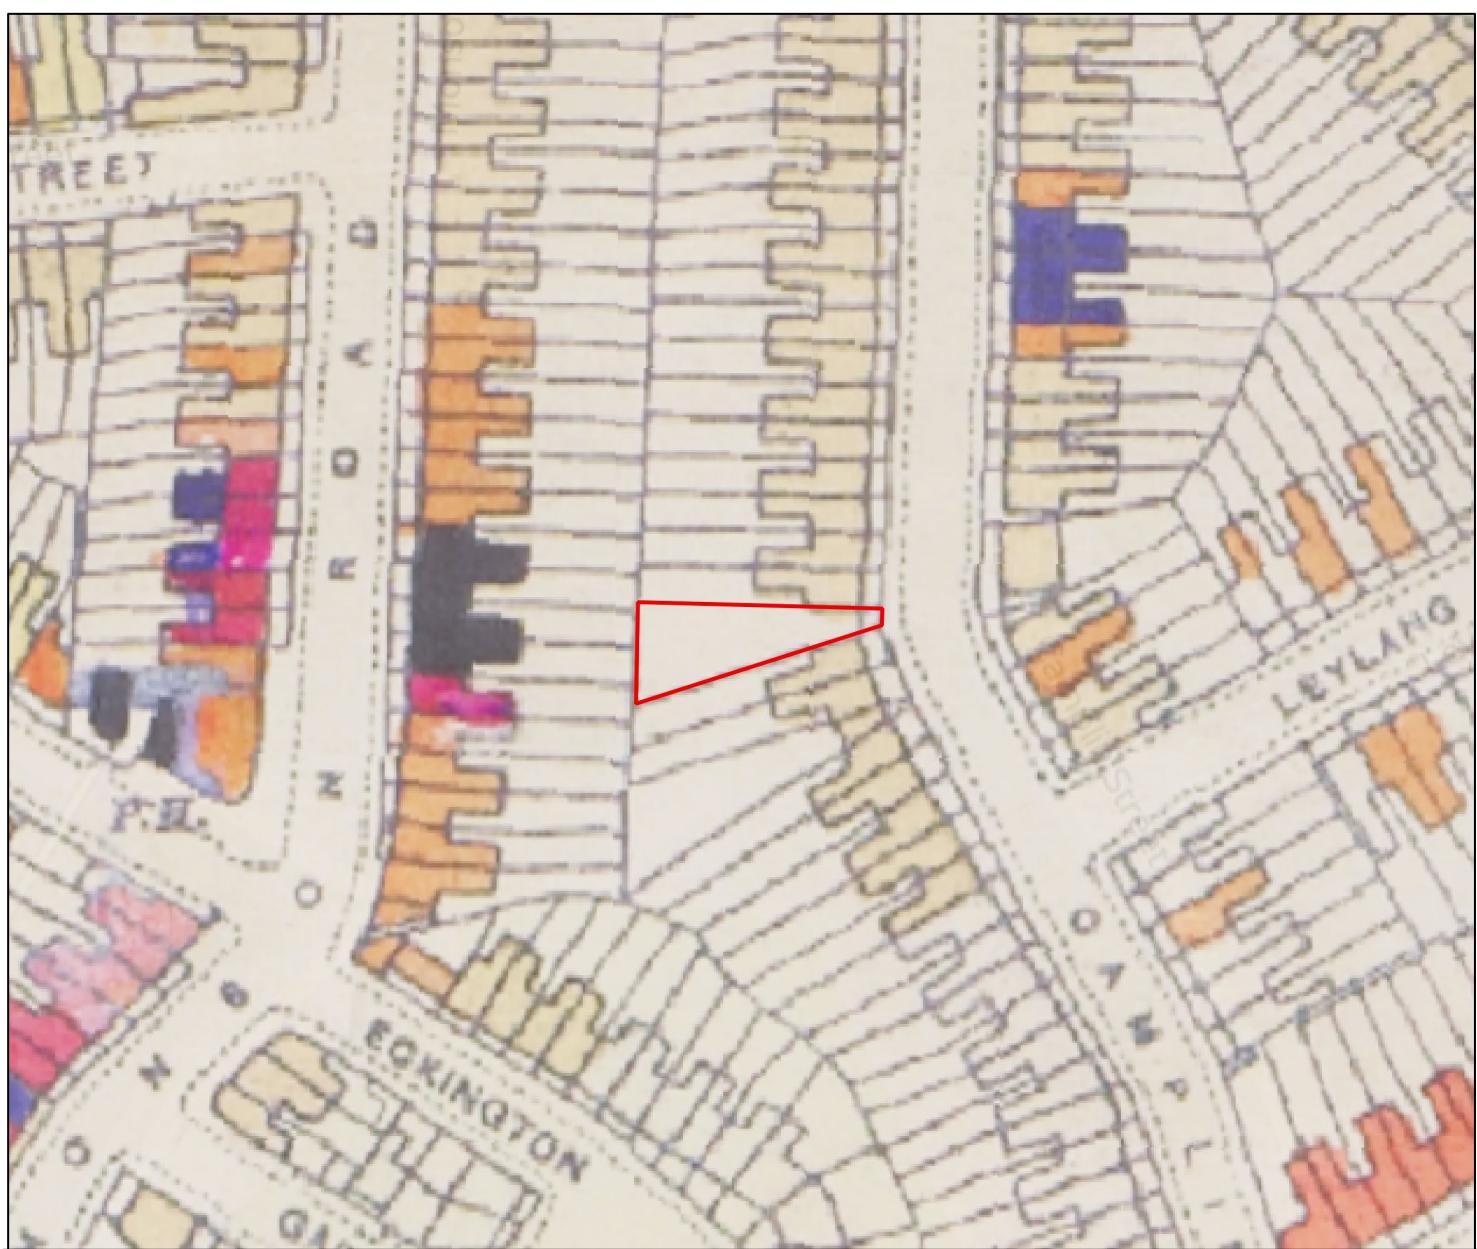
FIGURE: 8

London County Council Bomb Damage Map

Black: Total destruction		Yellow: Blast damage – minor in nature
	Purple: Damaged beyond repair		Light green: Clearance areas
	Dark red: Seriously damaged – doubtful if repairable		Small circle: V2 long-range rocket strike
	Light red/pink: Seriously damaged – repairable at cost		Large circle: V1 flying bomb strike
	Orange: General blast damage – not structural

Brimstone has reviewed an original war damage map covering the study area. The map was produced by the Engineer and Surveyors Department of the London County Council and was updated throughout the bombing campaign. A section of the map covering the study area is displayed at **FIGURE 8**.

- This source only records damage to structures, therefore as there were no structures on Site during WWII, any potential damage within the Site area would not be recorded.

- However, most of the structures within the study area (approximate 250m radius) are recorded as sustaining varying levels of damage.
 - The structures bordering the Site to the north and south were coloured yellow, indicative of 'blast damage – minor in nature' which corroborates post-WWII imagery that confirms these structures survived the war structurally intact.

- Overall, the damage recorded within the LCC damage map generally corroborates post-WWII aerial photography and OS mapping. Structural clearance is present in the areas within the latter two sources, where structures are recorded as sustaining more severe damage in the LCC damage map.

London County Council (LCC) Bomb Damage mapping records the structures which border the Site to the north and south as sustaining 'blast damage – minor in nature'. Most of the structures in the vicinity are recorded as sustaining varying levels of damage, including the structure 15m east of the Site as coloured black indicating it was totally destroyed. This is confirmed in the above-mentioned aerial imagery and post-war OS mapping.

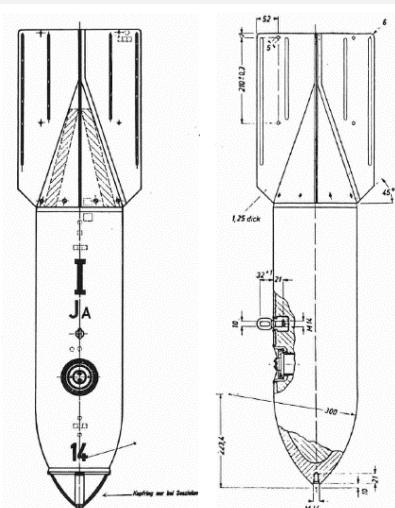
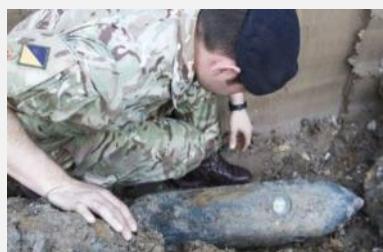
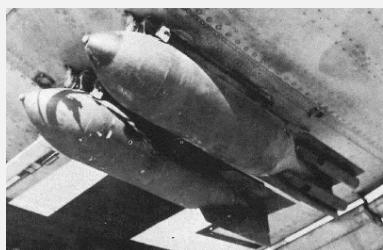
SC 50

Bomb Weight: 40-54kg (110-119lb)
Explosive Weight: 25kg (55lb)
Filling: TNT, Amatol or Trialen
Charge/Weight Ratio: 46%
Fuse Type: Electrical impact fuse or mechanical delayed action fuse
Body Dimensions: 1,100mm length x 200mm diameter
Appearance: Bomb body and tail painted grey/green with a yellow stripe on the tail unit. Steel construction.
Variants: 8 x variants. Additional fittings: Kopfring nose for limited penetration and Stabbo nose for dive-bombing.

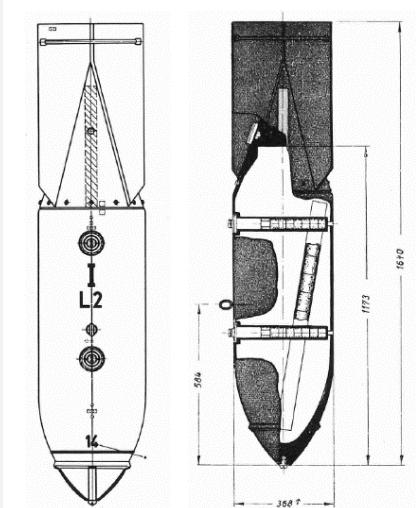
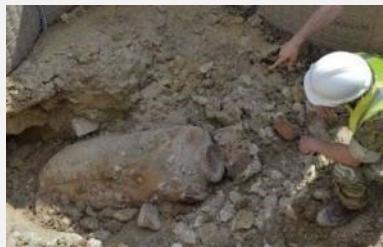
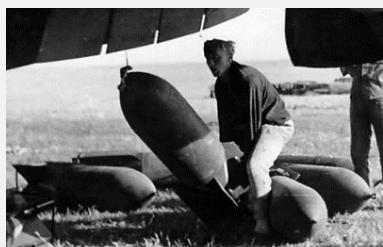
SC 250

Bomb Weight: 245-256kg (540-564lb)
Explosive Weight: 125-130kg (276-287lb)
Filling: TNT, Amatol and Trialen mix
Charge/Weight Ratio: 44%
Fuse Type: 1 or 2 electrical impact fuse(s) or mechanical delayed action fuse(s)
Body Dimensions: 1,173mm length x 368mm diameter
Appearance: Bomb body and tail painted grey/green with a yellow stripe on the tail unit. Steel construction.
Variants: 8 x variants. Kopfring nose for limited penetration. Stabbo nose for dive-bombing.

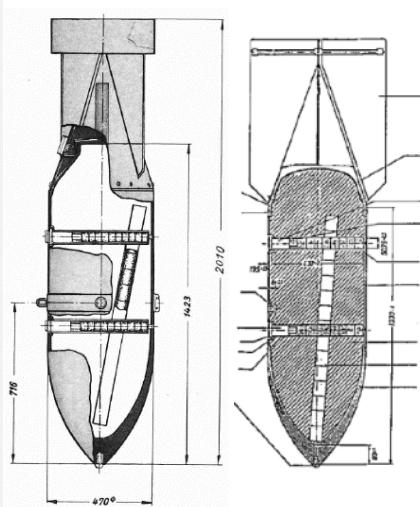
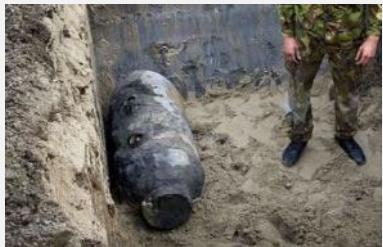
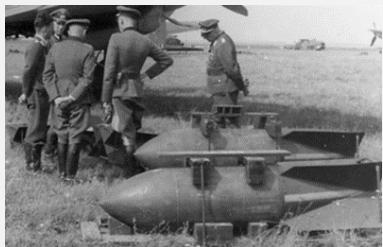
SC 500

Bomb Weight: 480-520kg (1,058-1,146lb)
Explosive Weight: 220kg (485lb)
Filling: TNT, Amatol and Trialen mix
Charge/Weight Ratio: 44%
Fuse Type: 2 electrical impact fuses or mechanical delayed action fuses
Body Dimensions: 1,423mm length x 470mm diameter
Appearance: Bomb body and tail painted grey/green or buff with a yellow stripe on the tail unit. Steel construction.
Variants: 3 x variants. Kopfring nose for limited penetration.

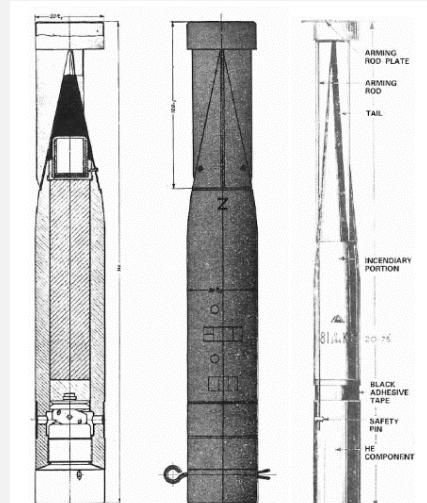
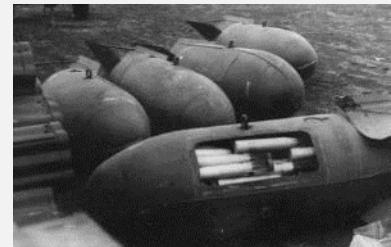
B-1E Sub-Munition

Bomb Weight:	1-1.3kg (2.2-2.87lb)
Incendiary Weight:	680g (1.4lb)
Filling:	Thermite
Fuse Type:	Simple impact fuse
Body Dimensions:	247mm length x 50mm diameter
Appearance:	Grey body and dark green painted tail unit. Magnesium alloy case.
Operation:	Small percussion charge ignites Thermite (>1,000°C burn).
Variants:	Most common variant: B 2EZ (2kg) included a small HE charge
Remarks:	Drop containers varied in size. The smallest cluster bomb held 36 x B-1Es and the largest 620 x B-1Es.

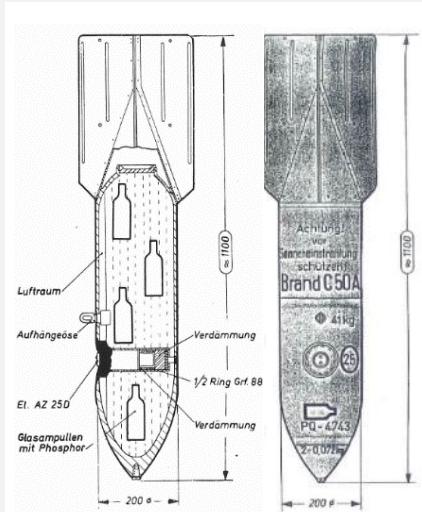
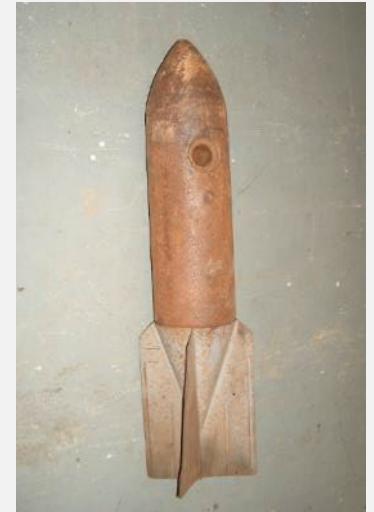
Brand C50

Bomb Weight:	41kg (90.4lb)
Incendiary Weight:	13kg (30lb)
Filling:	Main fill (86% Benzine, 10% Rubber) plus 4% Phosphorus in glass bottles
Fuse Type:	1 x electrical impact fuse
Bomb Dimensions:	762mm length x 203mm diameter
Appearance:	bomb body and tail painted grey or green with the rear of the bomb painted red and a red band around the centre of the body.
Variants:	C 50 B: 77% White Phos fill C 250 A: 87.7% Petroleum, 11.7% Polystyrene, 0.5% White Phos (185kg version)

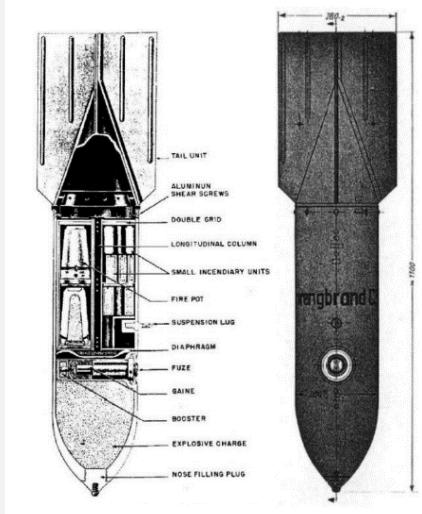
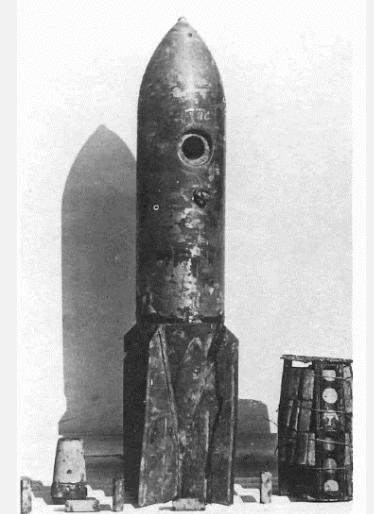
Spreng-Brand C50 - Fire Pot

Bomb Weight:	34kg (75lb)
Explosive Weight:	9kg (20lb)
Filling:	TNT burster charge, 6 x Thermite containers (fire pots) and 67 x small triangular incendiary elements.
Fuse Type:	1 x electrical impact fuses or aerial burst fuse
Bomb Dimensions:	711mm length x 203mm diameter
Appearance:	Bomb body and tail painted grey/green or pale blue with red base plug and red or green incendiary markings. Steel construction.
Operation:	A charge blows off the base plate, firing a plume of incendiary mixture 100 yds. Approx 1 second later the HE charge detonates.

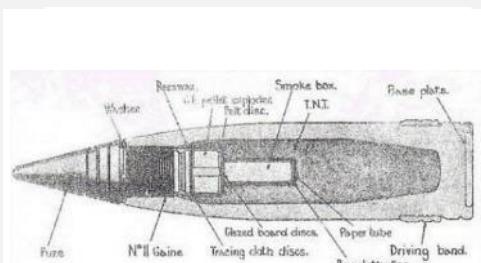
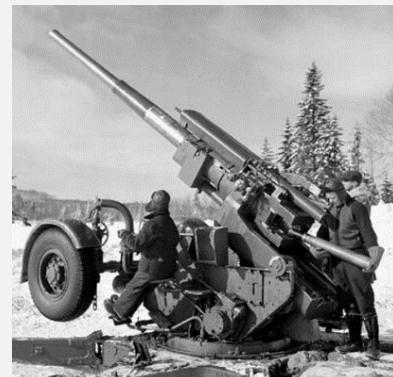
HAA Battery - 3.7" QF Shell

Shell Weight:	12.7kg
Shell Dimensions:	94mm x 438mm
Fill Weight:	1.1kg
Fill Type:	TNT
Fuse Type:	Mechanical Time Delay fuse
Appearance:	Grey body, copper driving bands, brass neck
Rate of Fire:	10 - 20 rpm
Ceiling:	9,000 - 18,000m
Variants:	HE or shrapnel shells. Note, the 4.5" gun was also used in an HAA role throughout the UK.

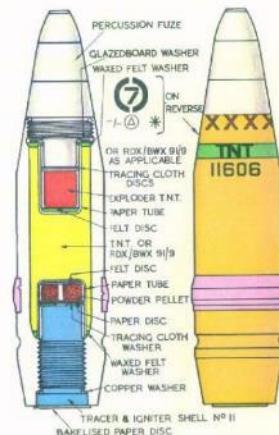
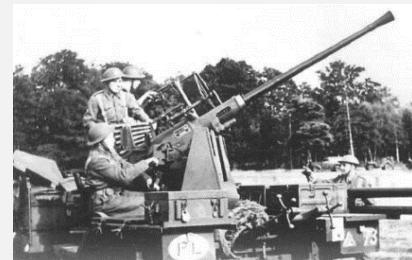
LAA Battery - 40mm Bofors Shell

Shell Weight:	0.84kg
Shell Dimensions:	40mm x 180mm
Fill Weight:	70g
Fill Type:	TNT
Fuse Type:	Impact fuse
Appearance:	Grey body, copper driving bands, brass neck
Rate of Fire:	120 rpm
Ceiling:	7,000m
Variants:	HE or AP shells. Both with rear tracer compartment

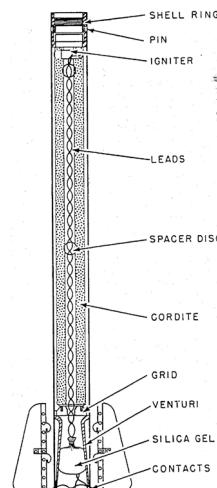
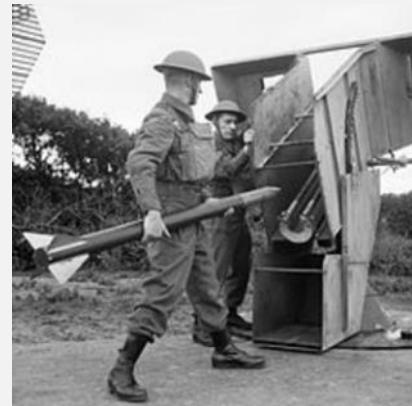
Z Battery - 3" U.P Rocket

Rocket Weight:	24.5kg
Warhead Weight:	1.94kg
Filling:	TNT warhead. Black Powder solid fuel rocket motor.
Fuse Type:	Mechanical Time Delay fuse
Rocket Dimensions:	1,930mm x 76mm
Ceiling:	6,770m
Operation:	Fired from single, tandem and (later) 36 x rail launchers (Z Batteries). Limited use throughout the UK.
