## SURVEY INFORMATION SHEET

| <b>Location of Survey</b><br>Cane Hill Hospital,<br>Cane Hill,<br>Coulsdon, Surrey,<br>CR5 3ES | <b>Position of Sample/Photo</b><br>Workshop Garages<br>External corrugated roof sheet | <b>Asbestos</b><br><br><b>Type</b> | Yes, Strongly Presumed<br><br>Chrysotile (White) |

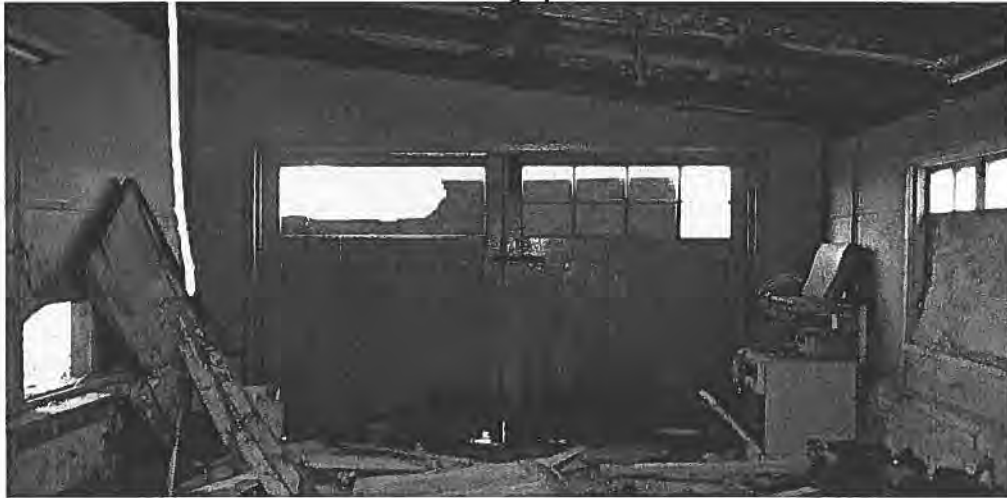
| <b>Location of Survey</b><br>Cane Hill Hospital,<br>Cane Hill,<br>Coulsdon, Surrey,<br>CR5 3ES | | <b>Position of Sample/Photo</b><br>Workshop Garages<br>Internal cladding panels | <b>Asbestos</b> Yes<br><br><b>Type</b> Chrysotile (White) |
| <b>Material Type</b> Cement | <b>Quantity</b> 50m <sup>2</sup> | <b>Sample No</b> 06/B/8026/129<br><br><b>Survey Date</b> 24.04 - 29.06.06<br><br><b>Date of Report</b> 18.08.06<br><br><b>Surveyor(s)</b> <span style="background-color: black; color: black;">XXXXXXXXXX</span> | |

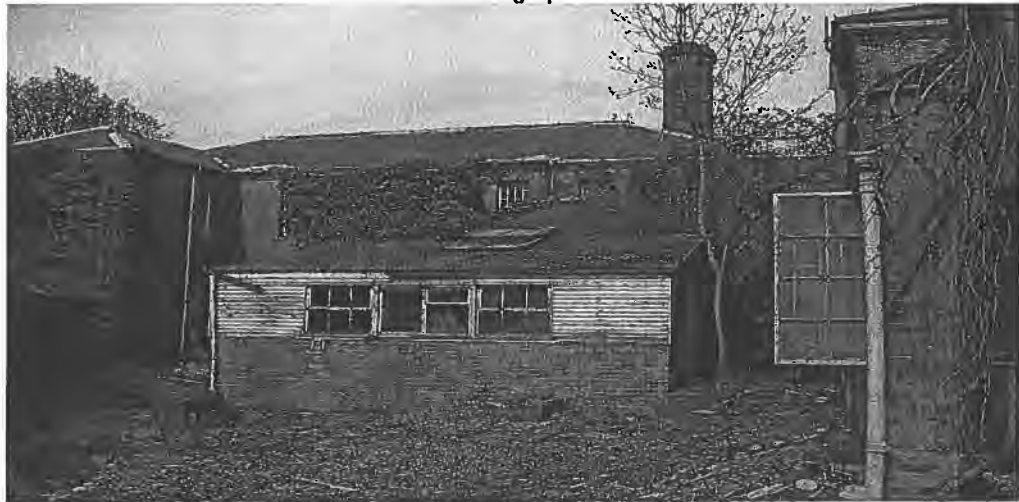
| <b>Location of Survey</b><br>Cane Hill Hospital,<br>Cane Hill,<br>Coulsdon, Surrey,<br>CR5 3ES | <b>Position of Sample/Photo</b><br>Maintenance workshop<br>External corrugated roof sheet | <b>Asbestos</b><br>Yes, Strongly Presumed | <b>Type</b><br>Chrysotile (White) |
| <b>Material Type</b><br>Cement | <b>Quantity</b><br>20m <sup>2</sup> | <b>Sample No</b><br>As 06/B/8026/126 | |

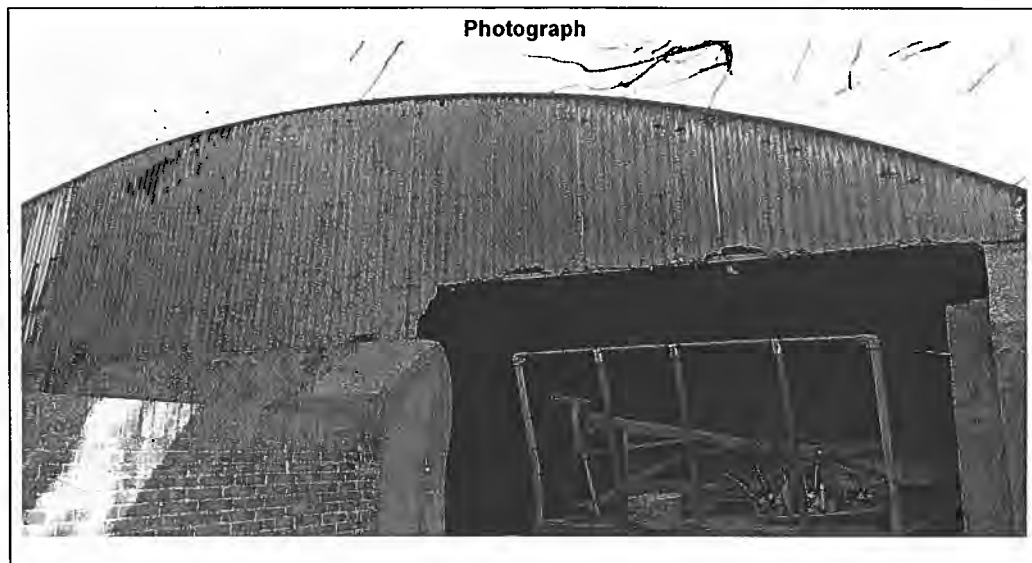
| <b>Location of Survey</b><br>Cane Hill Hospital,<br>Cane Hill,<br>Coulston, Surrey,<br>CR5 3ES | | <b>Position of Sample/Photo</b><br>Barn Roof<br>End Gable Upstand panels | | <b>Asbestos</b><br><br><b>Type</b> | Yes, Strongly<br>Presumed<br><br>Chrysotile (White) |
| <b>Material Type</b> | Cement | <b>Quantity</b> | 10m <sup>2</sup> | <b>Sample No</b> | As 06/B/8026/126 |

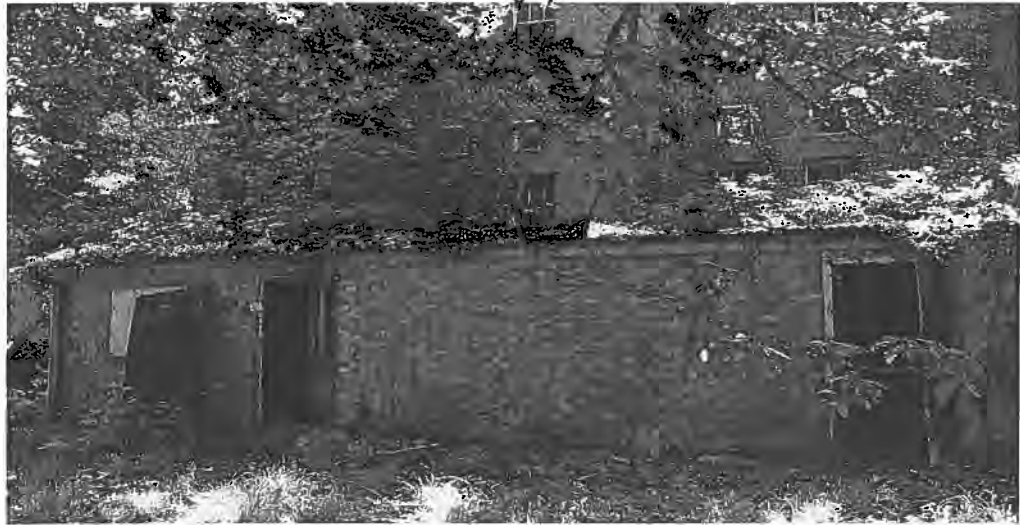
**Photograph**

| <b>Location of Survey</b><br>Cane Hill Hospital,<br>Cane Hill,<br>Coulston, Surrey,<br>CR5 3ES | | <b>Position of Sample/Photo</b><br>External Bin Stores adjacent<br>Zachary York Ward<br>Corrugated Roof sheet | | <b>Asbestos</b><br><br><b>Type</b> | Yes, Strongly<br>Presumed<br><br>Chrysotile (White) |
| <b>Material Type</b> | Cement | <b>Quantity</b> | 20m | <b>Sample No</b> | As 06/B/8026/126 |

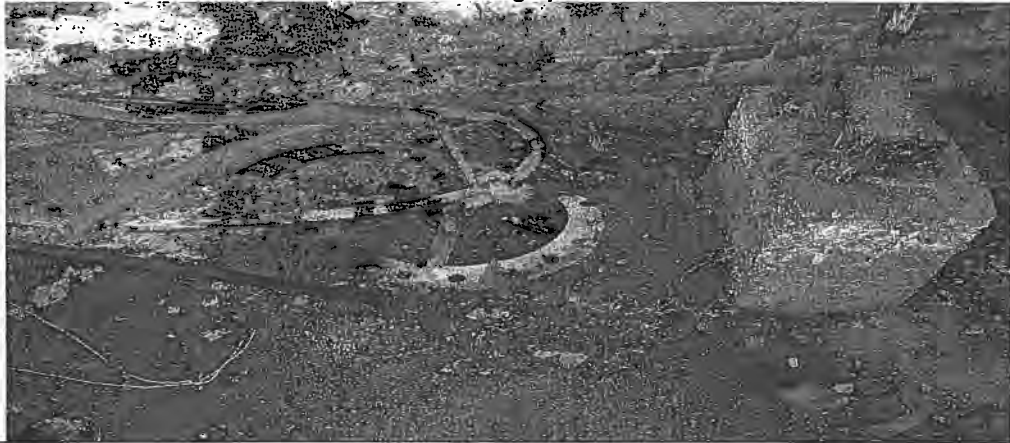
| <b>Location of Survey</b><br>Cane Hill Hospital,<br>Cane Hill,<br>Coulsdon, Surrey,<br>CR5 3ES | | <b>Position of Sample/Photo</b><br>External Bin Stores adjacent<br>Zachary York Ward<br>Gaskets | <b>Asbestos</b><br><br><b>Type</b> | Yes, Strongly<br>Presumed<br><br>Chrysotile (White) |
| <b>Material Type</b> | Gasket | <b>Quantity</b> | <1m <sup>2</sup> | <b>Sample No</b> As 06/B/8026/180<br><br><b>Survey Date</b> 24.04 - 29.06.06<br><br><b>Date of Report</b> 18.08.06<br><b>Surveyor(s)</b> <span style="background-color: black; color: black;">[REDACTED]</span> |

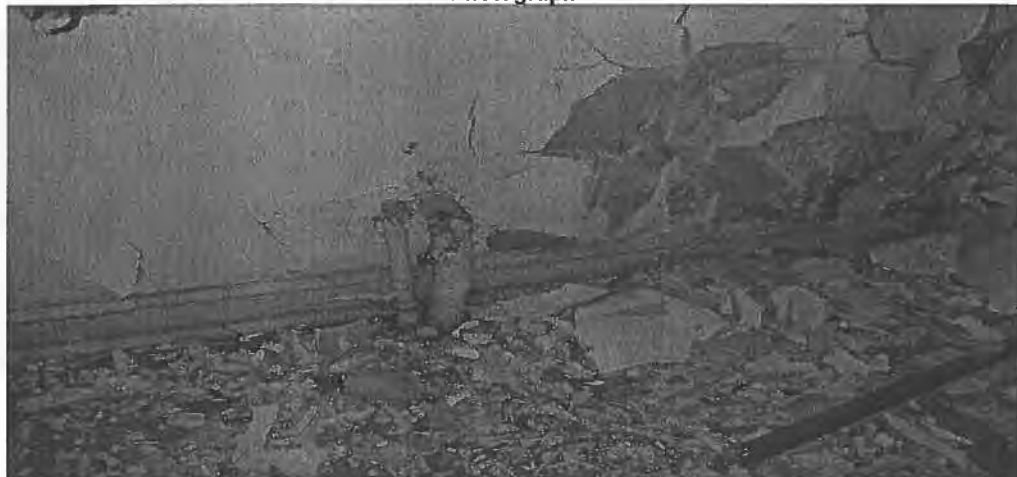
| <b>Location of Survey</b><br>Cane Hill Hospital,<br>Cane Hill,<br>Coulsdon, Surrey,<br>CR5 3ES | <b>Position of Sample/Photo</b><br>Nightingale Ward<br>Room adjacent corridor/lobby<br>Rope to low level pipes | <b>Asbestos</b><br><br><b>Type</b> | Yes, Strongly<br>Presumed<br><br>Chrysotile (White) |
| <b>Material Type</b> Rope | <b>Quantity</b> <1m | <b>Sample No</b><br><br><b>Survey Date</b><br><br><b>Date of Report</b><br><br><b>Surveyor(s)</b> | As 06/B/8026/58<br><br>24.04 - 29.06.06<br><br>18.08.06<br><br><div style="background-color: black; width: 100px; height: 40px;"></div> |

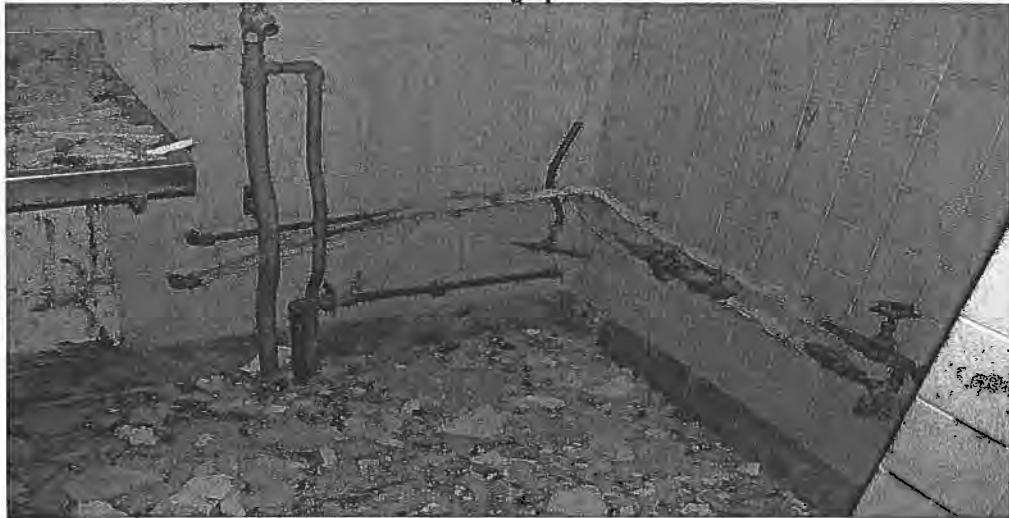
| <b>Location of Survey</b><br>Cane Hill Hospital,<br>Cane Hill,<br>Coulston, Surrey,<br>CR5 3ES | | <b>Position of Sample/Photo</b><br>Nightingale Ward<br>Kitchen<br>Rope to pipework | | <b>Asbestos</b><br><br><b>Type</b> | Yes, Strongly<br>Presumed<br><br>Chrysotile (White) |
| <b>Material Type</b> | Rope | <b>Quantity</b> | 1m | <b>Sample No</b> | As 06/B/8026/58 |

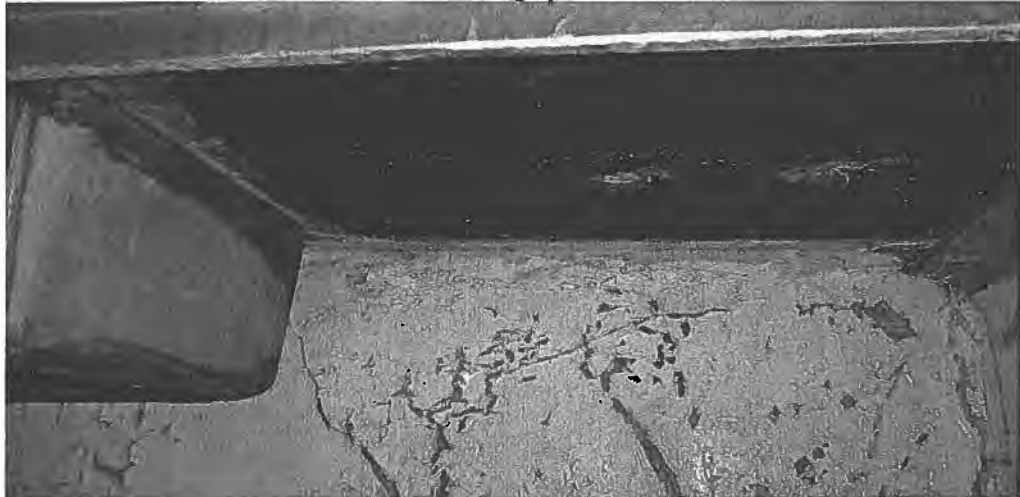
| <b>Location of Survey</b><br>Cane Hill Hospital,<br>Cane Hill,<br>Coulston, Surrey,<br>CR5 3ES | | <b>Position of Sample/Photo</b><br>Nightingale Ward<br>Kitchen<br>Sink paint | | <b>Asbestos</b><br><br><b>Type</b> | Yes, Strongly<br>Presumed<br><br>Chrysotile (White) |
| <b>Material Type</b><br>Bitumen | | <b>Quantity</b><br>1m <sup>2</sup> | | <b>Sample No</b> | As 06/B/8026/157 |

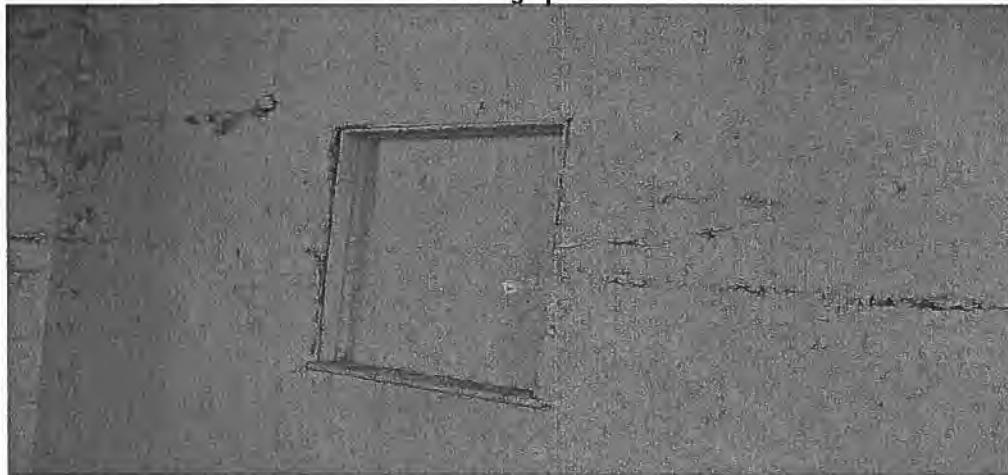
| <b>Location of Survey</b><br>Cane Hill Hospital,<br>Cane Hill,<br>Coulston, Surrey,<br>CR5 3ES | | <b>Position of Sample/Photo</b><br>Nightingale Ward<br>First floor window infill panels | <b>Asbestos</b> Yes |
| <b>Material Type</b> Board | | <b>Quantity</b> <1m <sup>2</sup> | <b>Type</b> Amosite (Brown)<br>Chrysotile (White) |

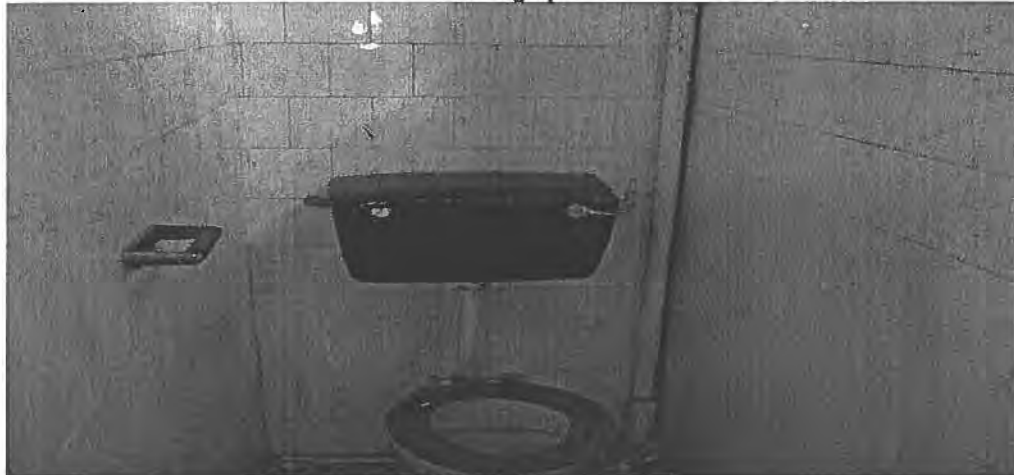
| <b>Location of Survey</b><br>Cane Hill Hospital,<br>Cane Hill,<br>Coulson, Surrey,<br>CR5 3ES | | <b>Position of Sample/Photo</b><br>Nightingale Ward<br>Cistern W.C (X6) | | <b>Asbestos</b> | Yes, Strongly<br>Presumed |
| <b>Material Type</b> Plastic | | <b>Quantity</b> 1m <sup>2</sup> | | <b>Type</b> | Amosite (Brown) |

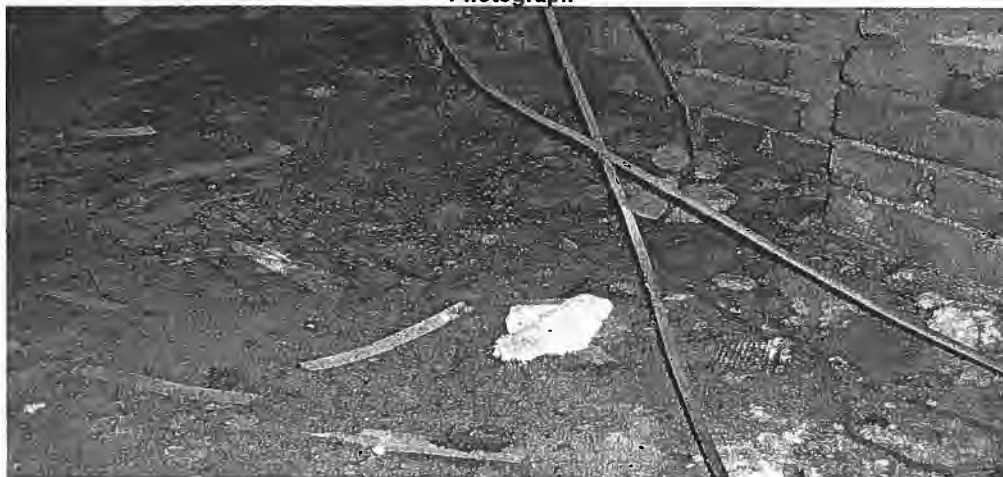
| <b>Location of Survey</b><br>Cane Hill Hospital,<br>Cane Hill,<br>Coulson, Surrey,<br>CR5 3ES | | <b>Position of Sample/Photo</b><br>Nightingale Ward<br>Undercroft Debris<br>(presumed throughout) | | <b>Asbestos</b><br><br><b>Type</b> | Yes<br><br>Crocidolite (Blue)<br>Amosite (Brown)<br>Chrysotile (White) |
| <b>Material Type</b> | Lagging | <b>Quantity</b> | <1m <sup>2</sup> | <b>Sample No</b> | 06/B/8026/131 |

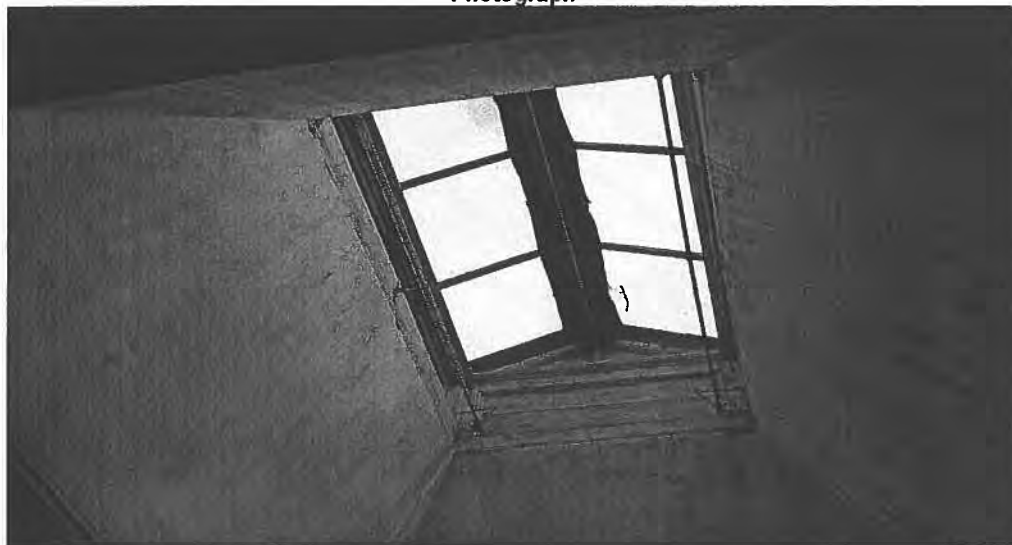
**Photograph**

| <b>Location of Survey</b><br>Cane Hill Hospital,<br>Cane Hill,<br>Coulston, Surrey,<br>CR5 3ES | | <b>Position of Sample/Photo</b><br>Hall adjacent Nightingale Ward<br>Skylight rope seal | | <b>Asbestos</b><br><br><b>Type</b> | Yes, Strongly<br>Presumed<br><br>Chrysotile (White) |
| <b>Material Type</b> | Rope | <b>Quantity</b> | 10m | <b>Sample No</b> | As 06/B/8026/31 |

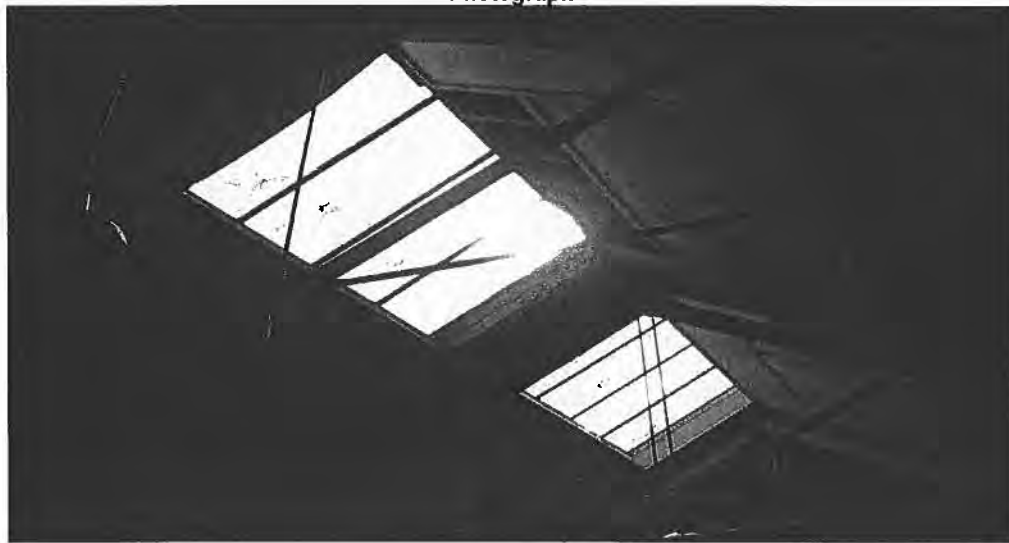
**Photograph**

| <b>Location of Survey</b><br>Cane Hill Hospital,<br>Cane Hill,<br>Coulsdon, Surrey,<br>CR5 3ES | | <b>Position of Sample/Photo</b><br>Hall adjacent Nightingale Ward<br>Skylight rope seal | | <b>Asbestos</b><br><br><b>Type</b> | Yes, Strongly<br>Presumed<br><br>Chrysotile (White) |
| <b>Material Type</b> | Rope | <b>Quantity</b> | 20m | <b>Sample No</b> | As 06/B/8026/31 |

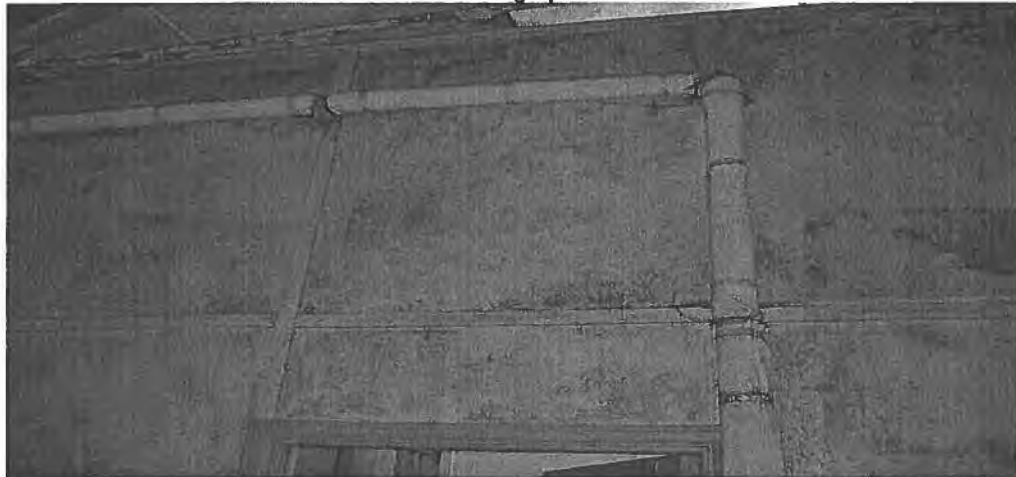
| <b>Location of Survey</b><br>Cane Hill Hospital,<br>Cane Hill,<br>Coulsdon, Surrey,<br>CR5 3ES | <b>Position of Sample/Photo</b><br>Workshop stores adjacent Hall<br>Pipe Lagging | <b>Asbestos</b> Yes | |
| | | <b>Type</b> Amosite (Brown) | |
| <b>Material Type</b> Lagging | <b>Quantity</b> 10m | <b>Sample No</b> 06/B/8026/132 | |

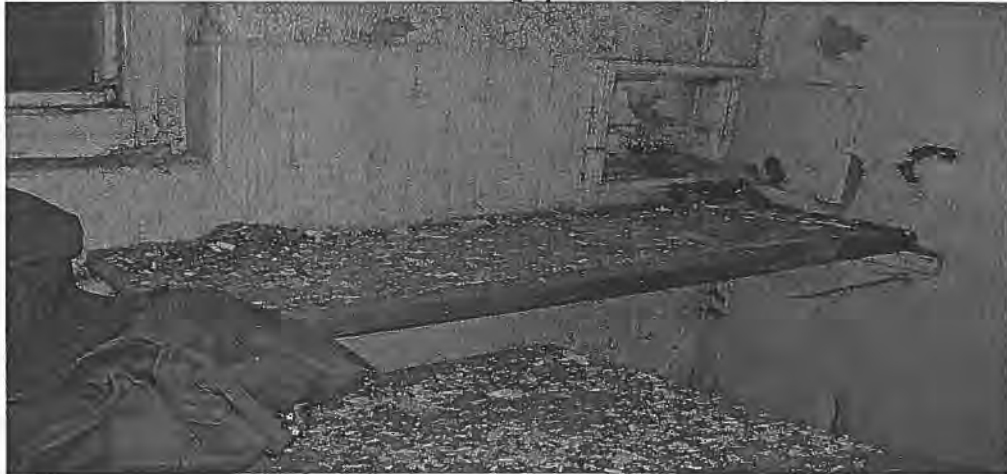
| <b>Location of Survey</b><br>Cane Hill Hospital,<br>Cane Hill,<br>Coulston, Surrey,<br>CR5 3ES | | <b>Position of Sample/Photo</b><br>Workshop stores adjacent Hall<br>Cement workbench (X2)<br>adjacent sink | <b>Asbestos</b><br><br><b>Type</b> | Yes, Strongly<br>Presumed<br><br>Chrysotile (White) |
| <b>Material Type</b> | Cement | <b>Quantity</b> | 2m <sup>2</sup> | <b>Sample No</b> As 06/B/8026/158 |

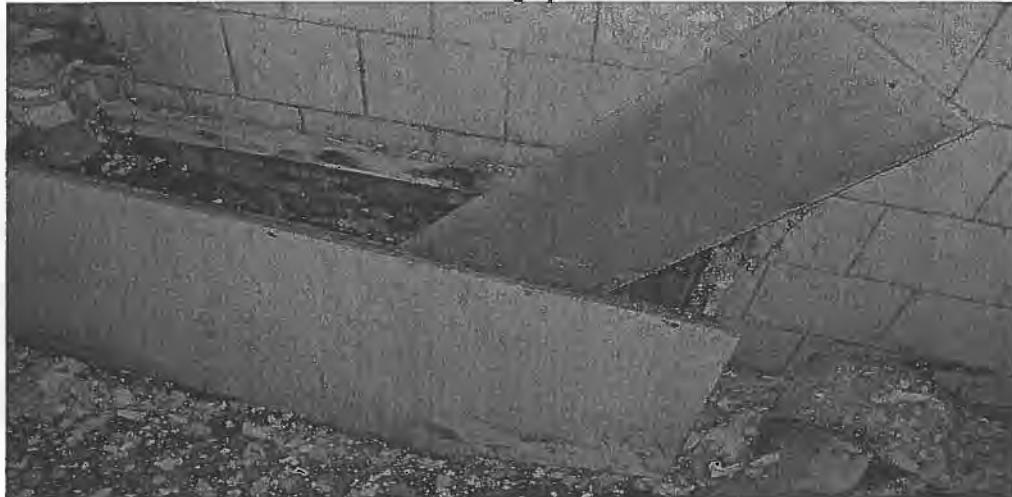
| <b>Location of Survey</b><br><br>Cane Hill Hospital,<br>Cane Hill,<br>Coulsdon, Surrey,<br>CR5 3ES | <b>Position of Sample/Photo</b><br><br>Workshop stores adjacent Hall<br>Low level boxing | <table style="width: 100%;"> <tr> <td style="width: 30%;"><b>Asbestos</b></td> <td>Yes, Strongly Presumed</td> </tr> <tr> <td><b>Type</b></td> <td>Chrysotile (White)</td> </tr> </table> | <b>Asbestos</b> | Yes, Strongly Presumed | <b>Type</b> | Chrysotile (White) | | | | | | | | |
| <table style="width: 100%;"> <tr> <td style="width: 30%;"><b>Material Type</b></td> <td>Cement</td> </tr> </table> | <b>Material Type</b> | Cement | <table style="width: 100%;"> <tr> <td style="width: 30%;"><b>Quantity</b></td> <td>1m<sup>2</sup></td> </tr> </table> | <b>Quantity</b> | 1m <sup>2</sup> | <table style="width: 100%;"> <tr> <td style="width: 30%;"><b>Sample No</b></td> <td>As 06/B/8026/78</td> </tr> <tr> <td><b>Survey Date</b></td> <td>24.04 - 29.06.06</td> </tr> <tr> <td><b>Date of Report</b></td> <td>18.08.06</td> </tr> <tr> <td><b>Surveyor(s)</b></td> <td style="background-color: black; color: black;">[REDACTED]</td> </tr> </table> | <b>Sample No</b> | As 06/B/8026/78 | <b>Survey Date</b> | 24.04 - 29.06.06 | <b>Date of Report</b> | 18.08.06 | <b>Surveyor(s)</b> | [REDACTED] |

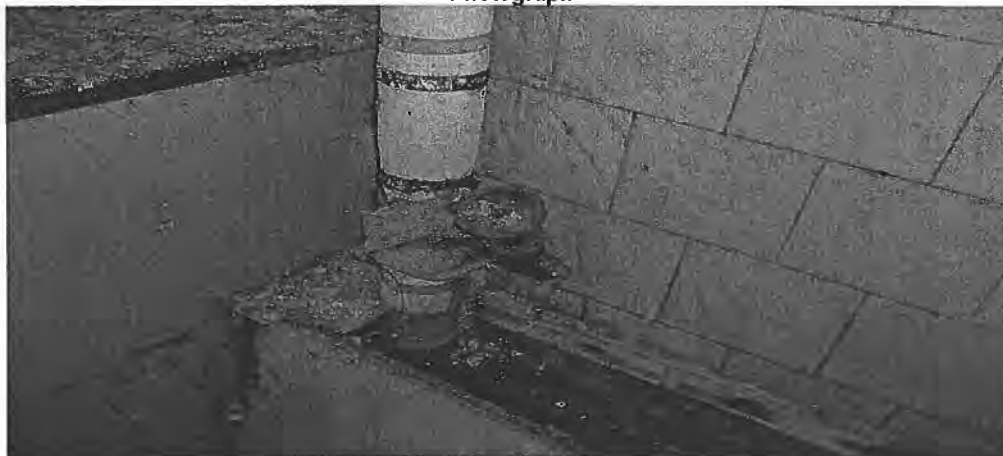
| <b>Location of Survey</b><br>Cane Hill Hospital,<br>Cane Hill,<br>Coulston, Surrey,<br>CR5 3ES | | <b>Position of Sample/Photo</b><br>Workshop stores adjacent Hall<br>Pipe Lagging | <b>Asbestos</b><br><br><b>Type</b> | Yes, Strongly<br>Presumed<br><br>Amosite (Brown) |
| <b>Material Type</b> | Lagging | <b>Quantity</b> | 10m | <b>Sample No</b> As 06/B/8026/132 |

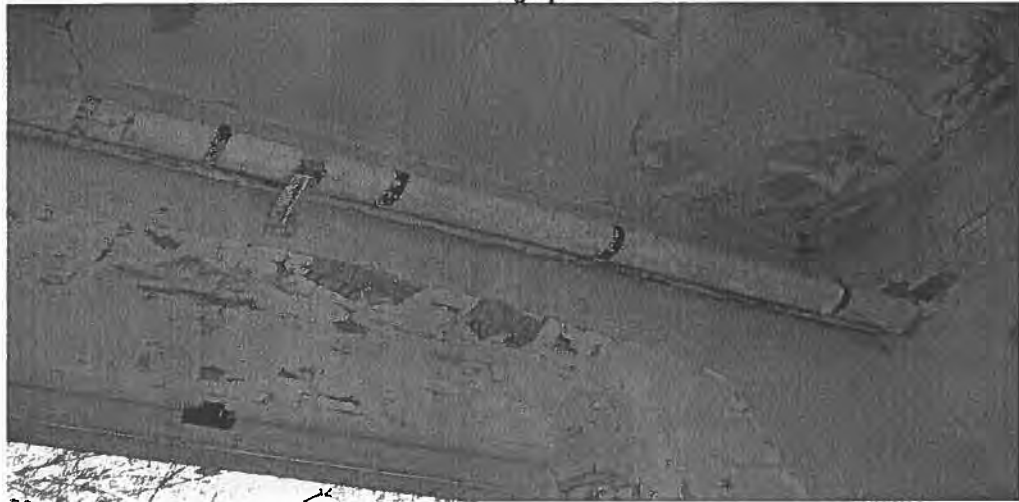
| <b>Location of Survey</b><br>Cane Hill Hospital,<br>Cane Hill,<br>Coulston, Surrey,<br>CR5 3ES | | <b>Position of Sample/Photo</b><br>Workshop stores adjacent Hall<br>Pipe Lagging | | <b>Asbestos</b><br><br><b>Type</b> | <b>Yes, Strongly<br/>Presumed</b><br><br>Amosite (Brown) |
| <b>Material<br/>Type</b> | Lagging | <b>Quantity</b> | 10m | <b>Sample No</b> | As 06/B/8026/132 |

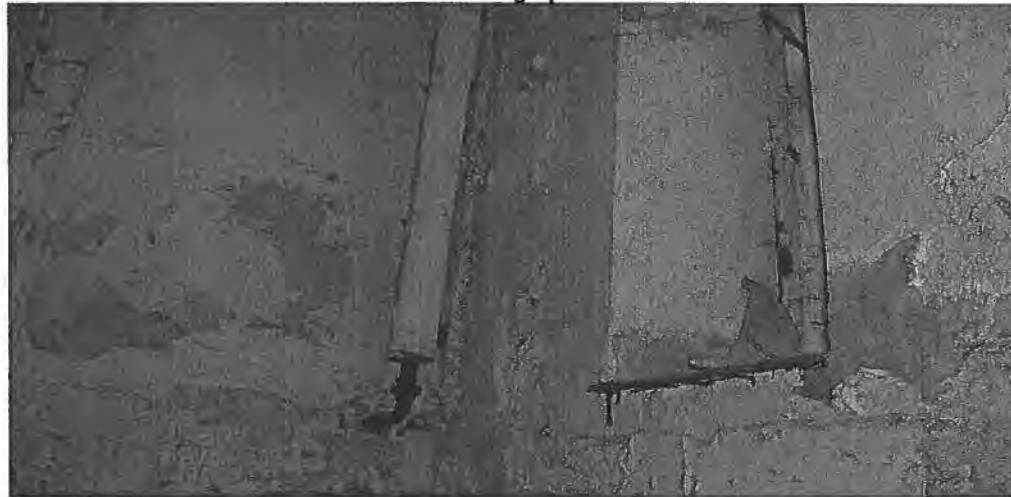
| <b>Location of Survey</b><br>Cane Hill Hospital,<br>Cane Hill,<br>Coulston, Surrey,<br>CR5 3ES | | <b>Position of Sample/Photo</b><br>Workshop stores adjacent Hall<br>Pipe Lagging | | <b>Asbestos</b><br><br><b>Type</b> | Yes, Strongly<br>presumed<br><br>Amosite (Brown) |
| <b>Material Type</b> | Lagging | <b>Quantity</b> | 10m | <b>Sample No</b> | As 06/B/8026/132 |

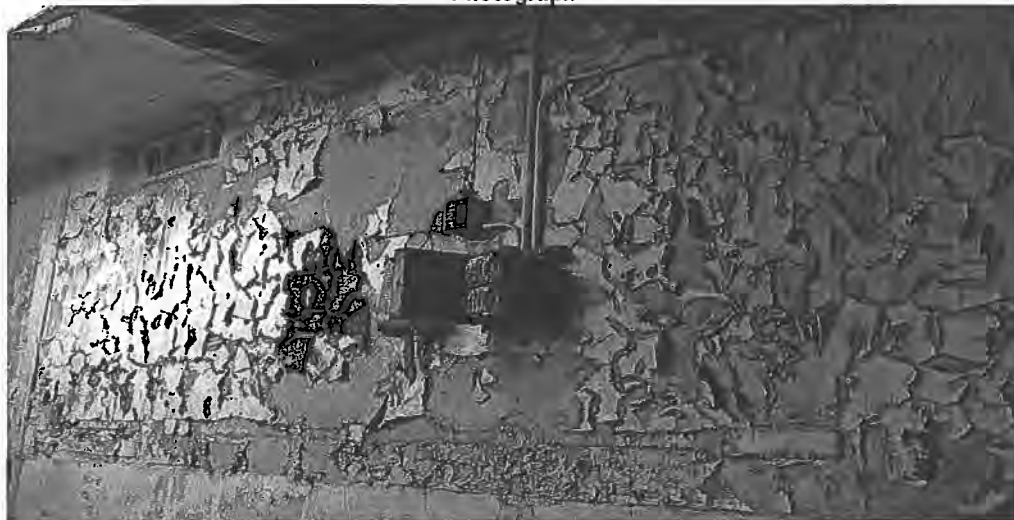
| <b>Location of Survey</b><br>Cane Hill Hospital,<br>Cane Hill,<br>Coulston, Surrey,<br>CR5 3ES | | <b>Position of Sample/Photo</b><br>Derelict Corridor adjacent<br>stores<br>Electrics | | <b>Asbestos</b><br><br><b>Type</b> | <b>Yes, Strongly<br/>Presumed</b><br><br>Chrysotile (White) |
| <b>Material<br/>Type</b> | Rope | <b>Quantity</b> | 1m <sup>2</sup> | <b>Sample No</b> | As 06/B/8026/22 |

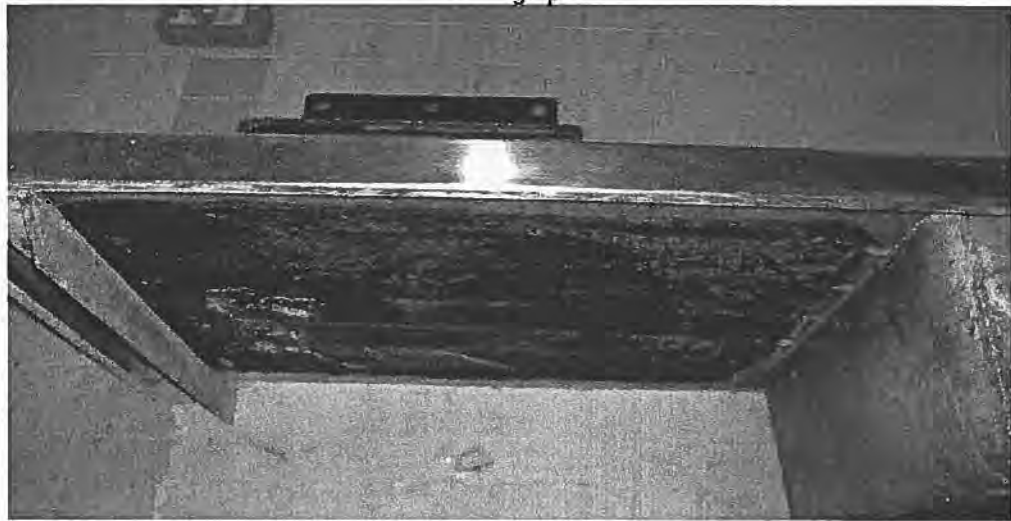
| <b>Location of Survey</b><br>Cane Hill Hospital,<br>Cane Hill,<br>Coulston, Surrey,<br>CR5 3ES | | <b>Position of Sample/Photo</b><br>Donne/Dickens Ward<br>Kitchen sink | | <b>Asbestos</b> | Yes, Strongly<br>Presumed |
| <b>Material Type</b> | Bitumen | <b>Quantity</b> | 1m <sup>2</sup> | <b>Sample No</b> | As 06/B/8026/157 |

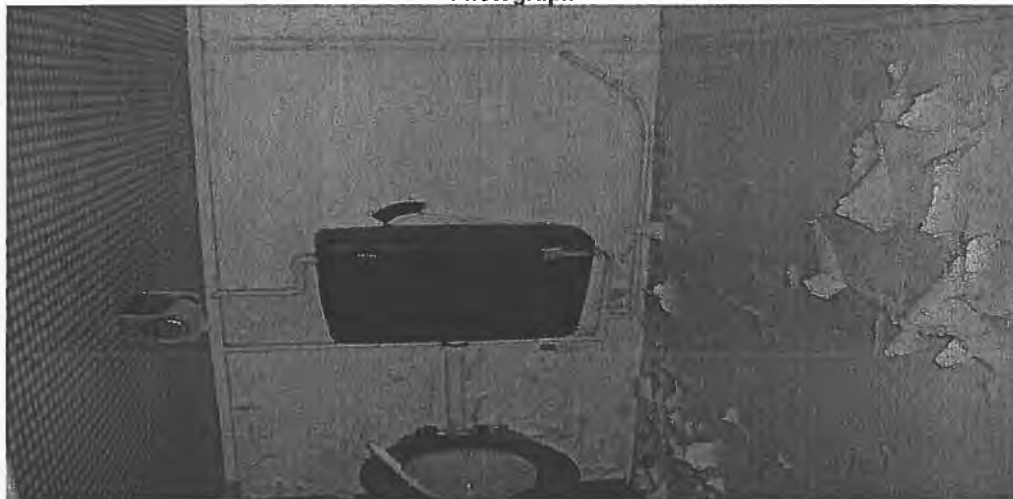
| <b>Location of Survey</b><br>Cane Hill Hospital,<br>Cane Hill,<br>Coulsdon, Surrey,<br>CR5 3ES | | <b>Position of Sample/Photo</b><br>Donne/Dickens Ward<br>Ground Floor<br>WC Cistern (X2) | | <b>Asbestos</b><br><br><b>Type</b> | Yes, Strongly<br>Presumed<br><br>Amosite (Brown) |
| <b>Material Type</b><br>Plastic | | <b>Quantity</b><br>1m <sup>2</sup> | | <b>Sample No</b><br><br><b>Survey Date</b><br><br><b>Date of Report</b><br><br><b>Surveyor(s)</b> | As 06/B/8026/5<br>24.04 - 29.06.06<br>18.08.06<br>[REDACTED] |

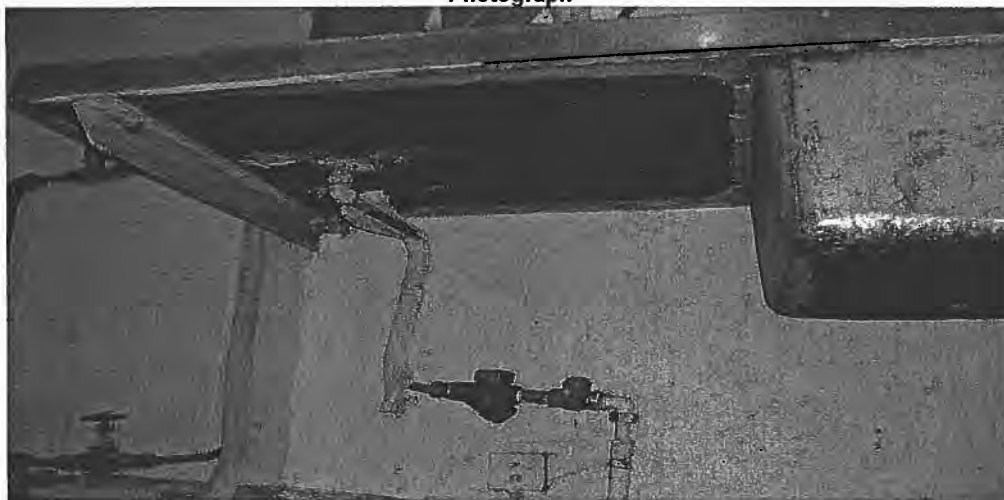
| <b>Location of Survey</b><br>Cane Hill Hospital,<br>Cane Hill,<br>Coulston, Surrey,<br>CR5 3ES | | <b>Position of Sample/Photo</b><br>Donne/Dickens Ward<br>Ground Floor Kitchen<br>Sink paint | | <b>Asbestos</b><br><br><b>Type</b> | Yes, Strongly<br>Presumed<br><br>Chrysotile (White) |
| <b>Material Type</b><br>Bitumen | | <b>Quantity</b><br>1m <sup>2</sup> | | <b>Sample No</b><br><br><b>Survey Date</b><br><br><b>Date of Report</b><br><br><b>Surveyor(s)</b> | As 06/B/8026/157<br>24.04 - 29.06.06<br>18.08.06<br>[REDACTED] |

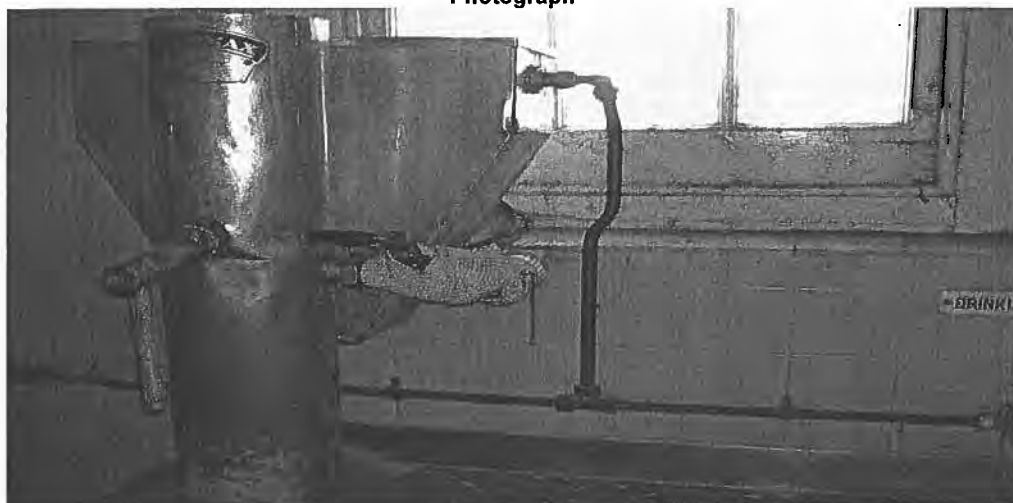
| <b>Location of Survey</b><br>Cane Hill Hospital,<br>Cane Hill,<br>Coulston, Surrey,<br>CR5 3ES | | <b>Position of Sample/Photo</b><br>Donne/Dickens Ward<br>First floor Kitchen<br>Rope to pipe | | <b>Asbestos</b><br><br>Yes, Strongly Presumed |
| <b>Material Type</b><br>Rope | | <b>Quantity</b><br><1m <sup>2</sup> | | <b>Type</b><br>Chrysotile (White) |

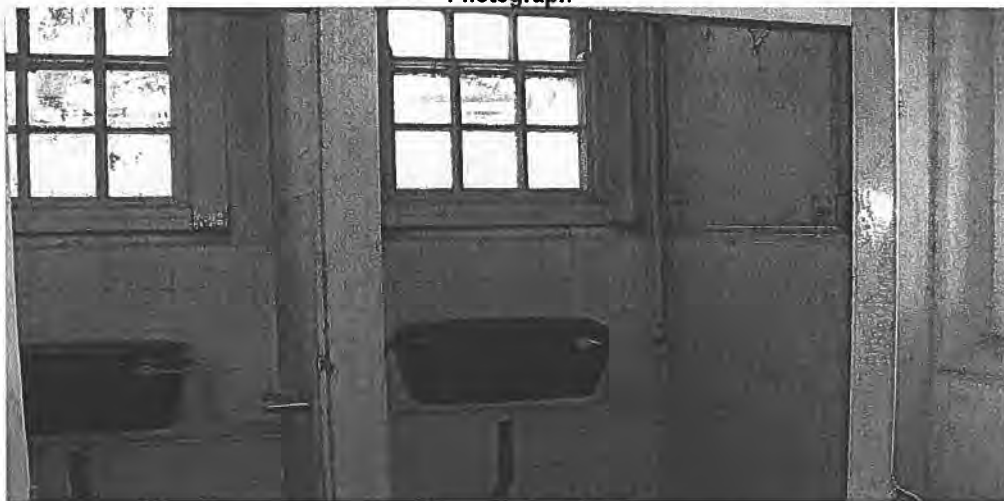
| <b>Location of Survey</b><br>Cane Hill Hospital,<br>Cane Hill,<br>Coulsdon, Surrey,<br>CR5 3ES | | <b>Position of Sample/Photo</b><br>Donne/Dickens Ward<br>First Floor<br>WC Cistern (X2) | <b>Asbestos</b><br><br><b>Type</b> | Yes, Strongly<br>Presumed<br><br>Amosite (Brown) |
| <b>Material Type</b> | Plastic | <b>Quantity</b> | 1m <sup>2</sup> | <b>Sample No</b> As 06/B/8026/5<br><br><b>Survey Date</b> 24.04 - 29.06.06<br><br><b>Date of Report</b> 18.08.06<br><br><b>Surveyor(s)</b> |

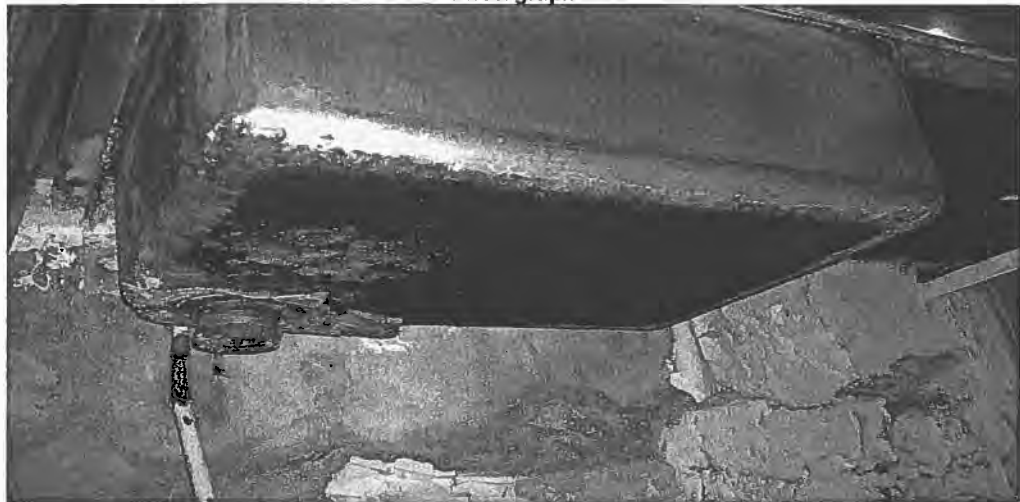
| <b>Location of Survey</b><br>Cane Hill Hospital,<br>Cane Hill,<br>Coulsdon, Surrey,<br>CR5 3ES | <b>Position of Sample/Photo</b><br>Donne/Dickens Ward<br>First Floor Kitchen<br>Sink paint | <b>Asbestos</b><br><br><b>Type</b> | Yes, Strongly<br>Presumed<br><br>Chrysotile (White) |
| <b>Material Type</b><br>Bitumen | <b>Quantity</b><br>1m <sup>2</sup> | <b>Sample No</b> As 06/B/8026/157<br><br><b>Survey Date</b> 24.04 - 29.06.06<br><br><b>Date of Report</b> 18.08.06<br><br><b>Surveyor(s)</b> <span style="background-color: black; color: black;">[REDACTED]</span> | |

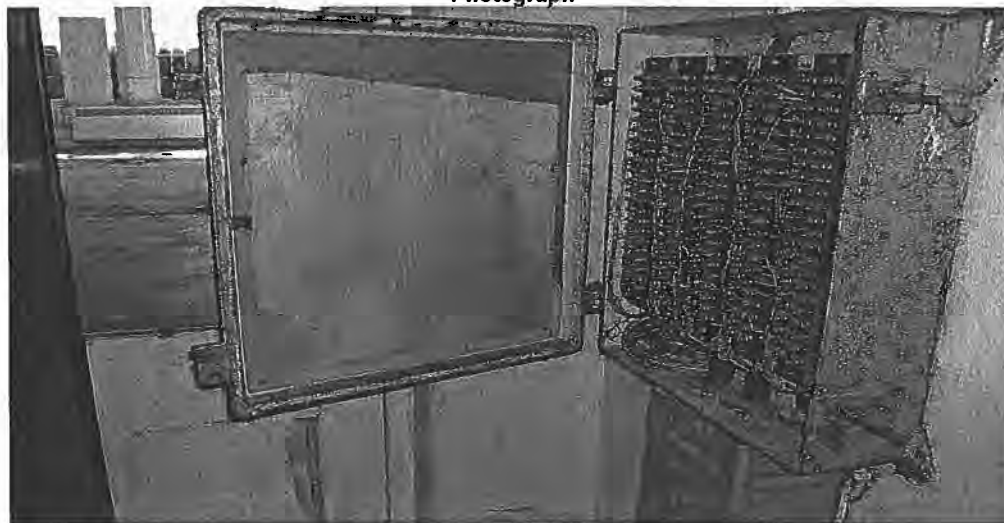
| <b>Location of Survey</b><br>Cane Hill Hospital,<br>Cane Hill,<br>Coulston, Surrey,<br>CR5 3ES | | <b>Position of Sample/Photo</b><br>Donne/Dickens Ward<br>Electrics (X2) rope seal | | <b>Asbestos</b><br><br><b>Type</b> | Yes, Strongly<br>Presumed<br><br>Chrysotile (White) |
| <b>Material Type</b> | Rope | <b>Quantity</b> | 1m | <b>Sample No</b> | As 06/B/8026/22 |

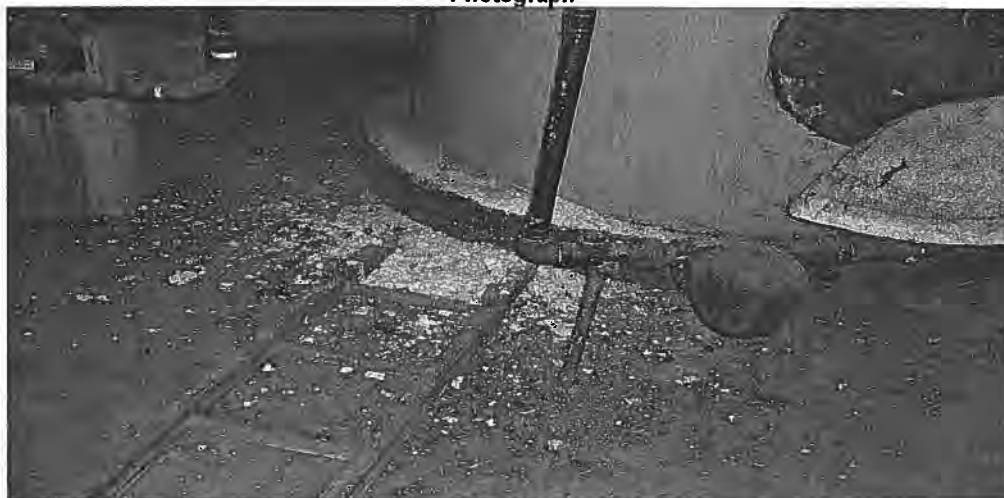
| <b>Location of Survey</b><br>Cane Hill Hospital,<br>Cane Hill,<br>Coulsdon, Surrey,<br>CR5 3ES | | <b>Position of Sample/Photo</b><br>Calorifier Room adjacent<br>Faraday Ward<br>Pipe Lagging<br>Debris | <b>Asbestos</b><br><br><b>Type</b> | Yes, Strongly<br>Presumed<br><br>Amosite (Brown)<br>Chrysotile (White) |
| <b>Material Type</b> | Lagging | <b>Quantity</b> | 1m <sup>2</sup> | <b>Sample No</b> As 06/B/8026/133<br><br><b>Survey Date</b> 24.04 - 29.06.06<br><br><b>Date of Report</b> 18.08.06<br><br><b>Surveyor(s)</b> <span style="background-color: black; color: black;">[REDACTED]</span> |

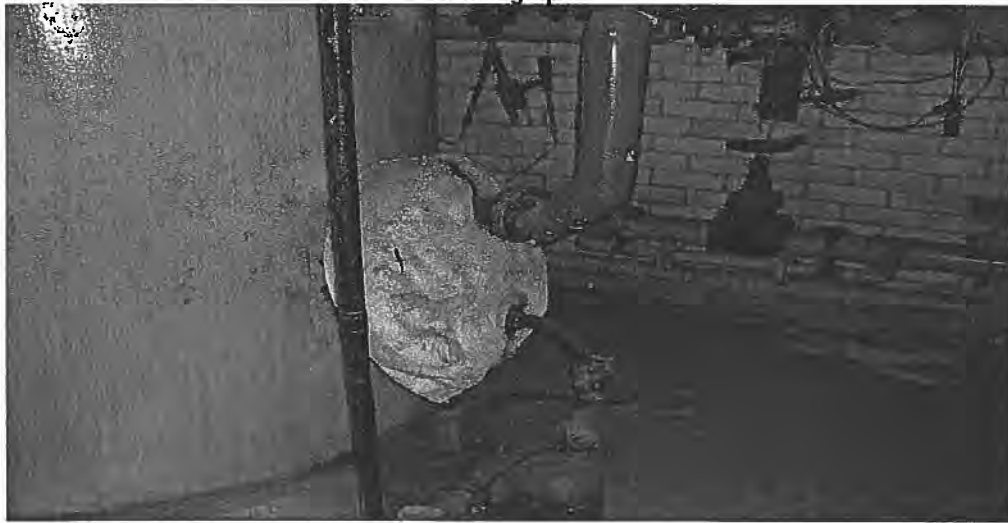
| <b>Location of Survey</b><br>Cane Hill Hospital,<br>Cane Hill,<br>Coulsdon, Surrey,<br>CR5 3ES | | <b>Position of Sample/Photo</b><br>Calorifier Room adjacent<br>Faraday Ward<br>Small Tank & Pipe Lagging | | <b>Asbestos</b><br><br><b>Type</b> | Yes, Strongly<br>Presumed<br><br>Amosite (Brown)<br>Chrysotile (White) |
| <b>Material Type</b> | Lagging | <b>Quantity</b> | 200m<br>In total | <b>Sample No</b> | As 06/B/8026/133 |

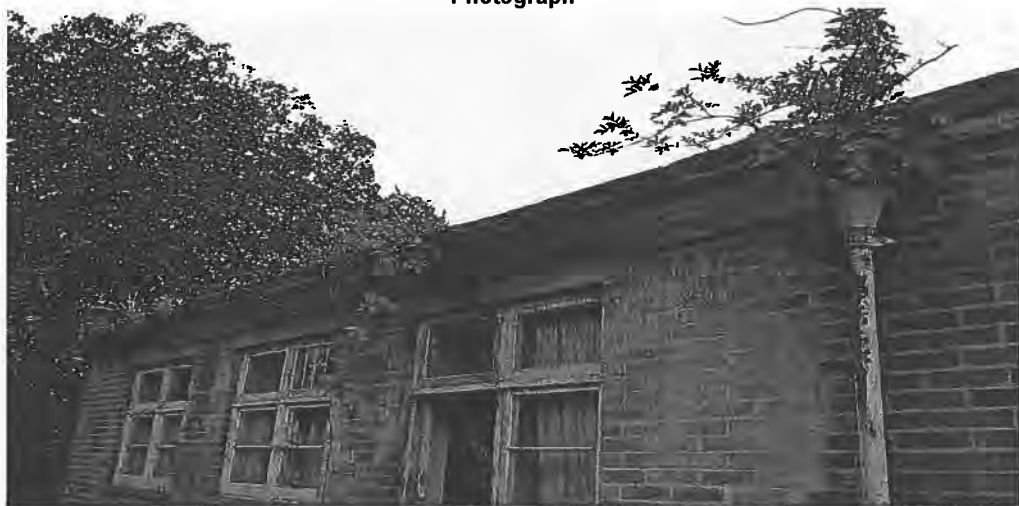
| <b>Location of Survey</b><br>Cane Hill Hospital,<br>Cane Hill,<br>Coulston, Surrey,<br>CR5 3ES | | <b>Position of Sample/Photo</b><br>Calorifier Room adjacent<br>Faraday Ward<br>External Roof Soffitt | | <b>Asbestos</b><br><br><b>Type</b> | <b>Yes, Strongly Presumed</b><br><br>Chrysotile (White) |

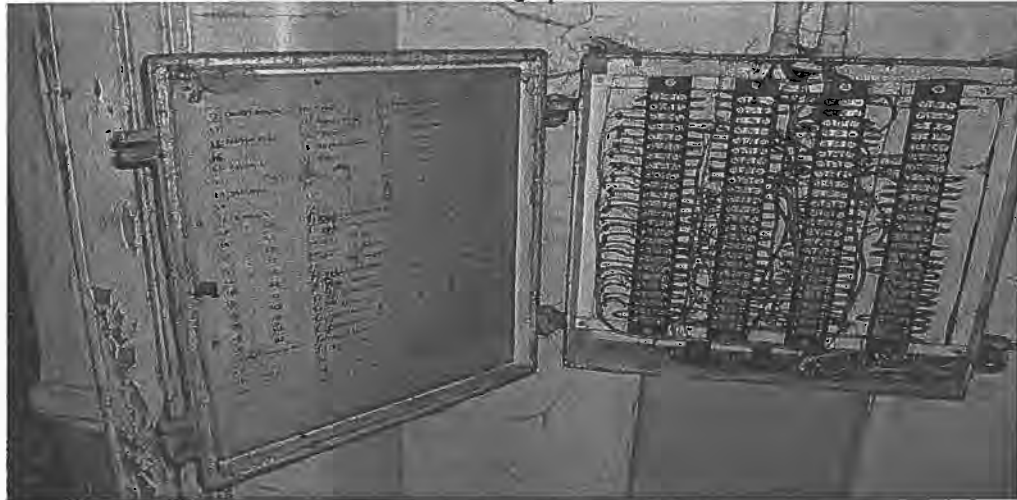
| <b>Material Type</b> Rope | <b>Quantity</b> 1m | <b>Sample No</b> As 06/B/8026/22<br><br><b>Survey Date</b> 24.04 - 29.06.06<br><br><b>Date of Report</b> 18.08.06<br><b>Surveyor(s)</b> <span style="background-color: black; color: black;">[REDACTED]</span> | |

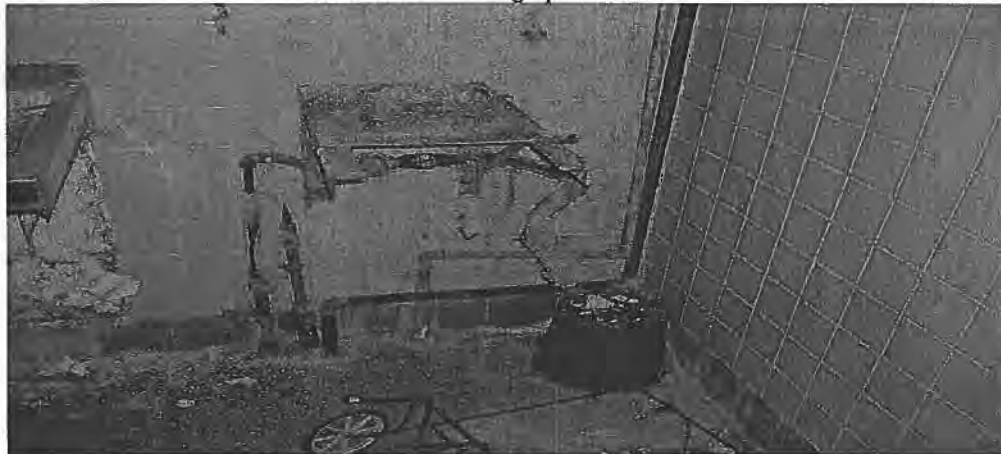
| <b>Location of Survey</b><br>Cane Hill Hospital,<br>Cane Hill,<br>Coulston, Surrey,<br>CR5 3ES | | <b>Position of Sample/Photo</b><br>Faraday Ward<br>Ground Floor Kitchen<br>Rope to pipework | | <b>Asbestos</b><br><br><b>Type</b> | Yes, Strongly<br>Presumed<br><br>Chrysotile (White) |
| <b>Material Type</b> | Rope | <b>Quantity</b> | 1m <sup>2</sup> | <b>Sample No</b> | As 06/B/8026/58 |

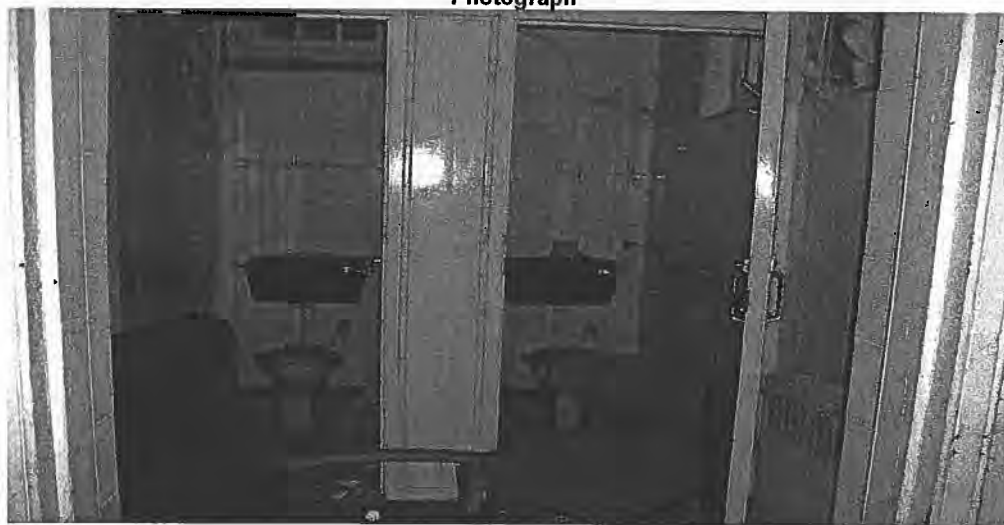
| <b>Location of Survey</b><br>Cane Hill Hospital,<br>Cane Hill,<br>Coulsdon, Surrey,<br>CR5 3ES | | <b>Position of Sample/Photo</b><br>Faraday Ward<br>Ground Floor<br>W.C. Cistern (X20) | <b>Asbestos</b><br><br><b>Type</b> | Yes, Strongly<br>Presumed<br><br>Amosite (Brown) |
| <b>Material Type</b> | Plastic | <b>Quantity</b> | 1m <sup>2</sup> each | <b>Sample No</b><br><br><b>Survey Date</b><br><br><b>Date of Report</b><br><br><b>Surveyor(s)</b> |

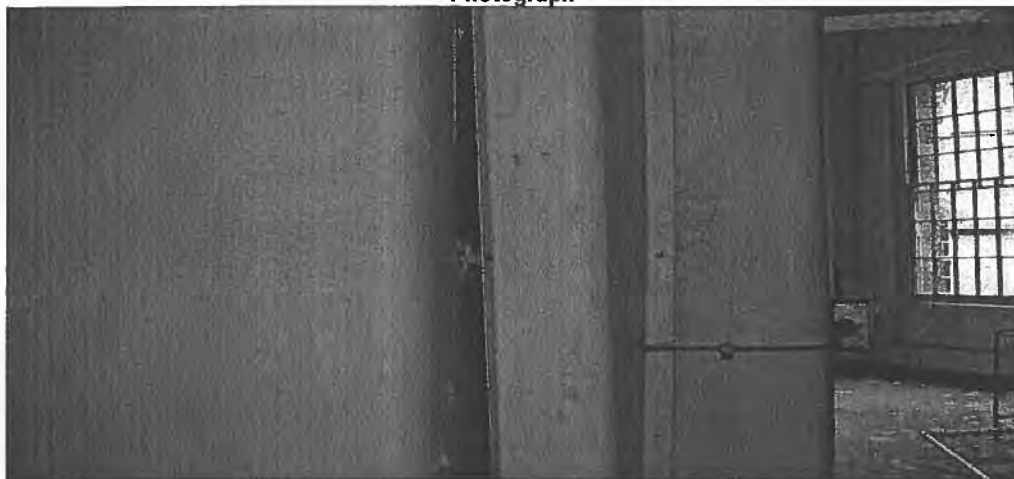
| <b>Location of Survey</b><br>Cane Hill Hospital,<br>Cane Hill,<br>Coulsdon, Surrey,<br>CR5 3ES | | <b>Position of Sample/Photo</b><br>Faraday Ward<br>Riser rawl plugs<br>(presumed throughout) | <b>Asbestos</b><br><br><b>Type</b> | Yes, Strongly<br>Presumed<br><br>Amosite (Brown) |
| <b>Material Type</b> | Board | <b>Quantity</b> | <1m | <b>Sample No</b> As 06/B/8026/65<br><br><b>Survey Date</b> 24.04 - 29.06.06<br><br><b>Date of Report</b> 18.08.06<br><br><b>Surveyor(s)</b> <span style="background-color: black; color: black;">[REDACTED]</span> |

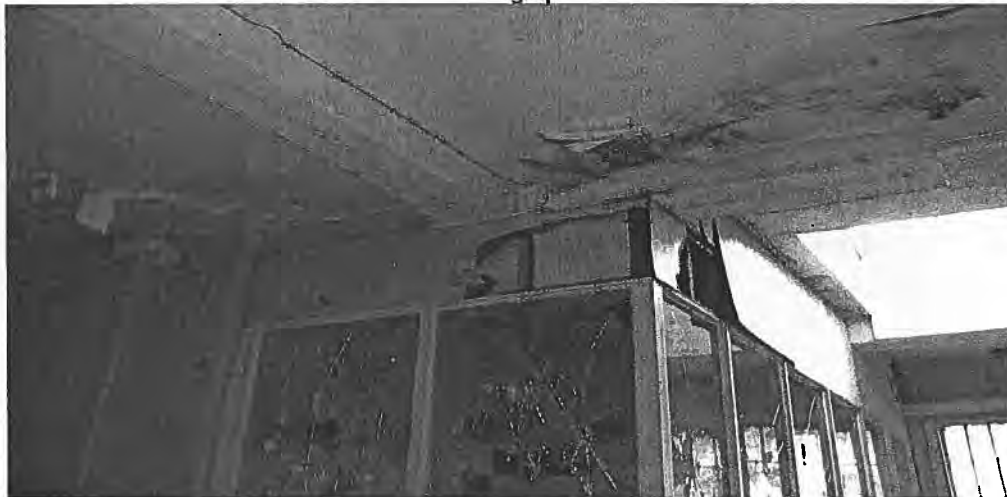
| <b>Location of Survey</b><br>Cane Hill Hospital,<br>Cane Hill,<br>Coulston, Surrey,<br>CR5 3ES | | <b>Position of Sample/Photo</b><br>Faraday Ward<br>Ground Floor<br>Nurses Station stud walls<br>Internal Sandwich Boards | <b>Asbestos</b><br><br><b>Type</b> | Yes, Strongly<br>Presumed<br><br>Amosite (Brown) |
| <b>Material Type</b> | Board | <b>Quantity</b> | 20m <sup>2</sup> | <b>Sample No</b><br><br><b>Survey Date</b><br><br><b>Date of Report</b><br><br><b>Surveyor(s)</b> |

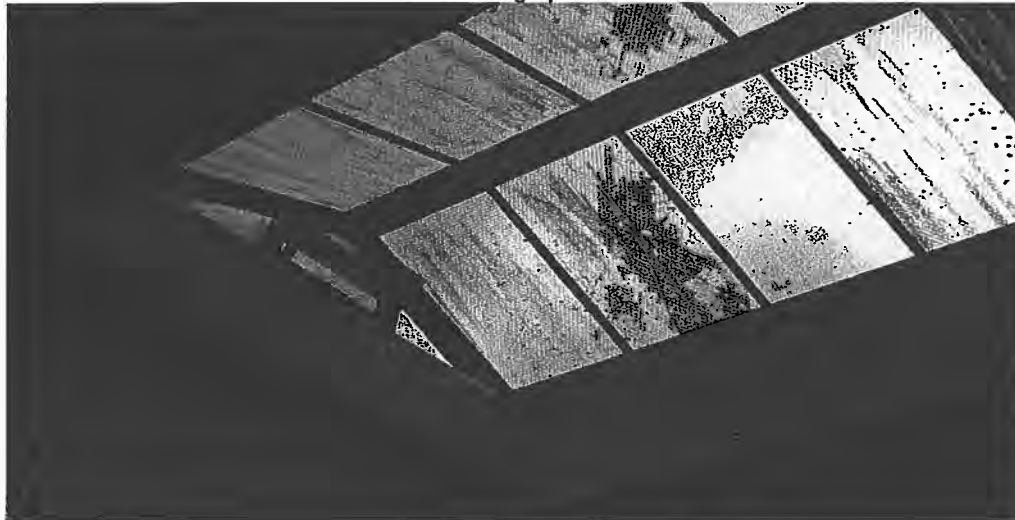
| <b>Location of Survey</b><br>Cane Hill Hospital,<br>Cane Hill,<br>Coulsdon, Surrey,<br>CR5 3ES | <b>Position of Sample/Photo</b><br>Faraday Ward<br>Skylight<br>Rope seal | <b>Asbestos</b><br><br><b>Type</b> | Yes, Strongly<br>Presumed<br><br>Chrysotile (White) |
| <b>Material Type</b> Rope | <b>Quantity</b> 20m | <b>Sample No</b> As 06/B/8026/31<br><br><b>Survey Date</b> 24.04 - 29.06.06<br><br><b>Date of Report</b> 18.08.06<br><br><b>Surveyor(s)</b> | <div style="background-color: black; width: 100px; height: 40px; margin-top: 10px;"></div> |
