## SURVEY INFORMATION SHEET

| <b>Location of Survey</b><br>Cane Hill Hospital,<br>Cane Hill,<br>Coulsdon, Surrey,<br>CR5 3ES | <b>Position of Sample/Photo</b><br>Workshop Garages<br>External corrugated roof sheet | <b>Asbestos</b><br><br><b>Type</b> | Yes, Strongly Presumed<br><br>Chrysotile (White) |

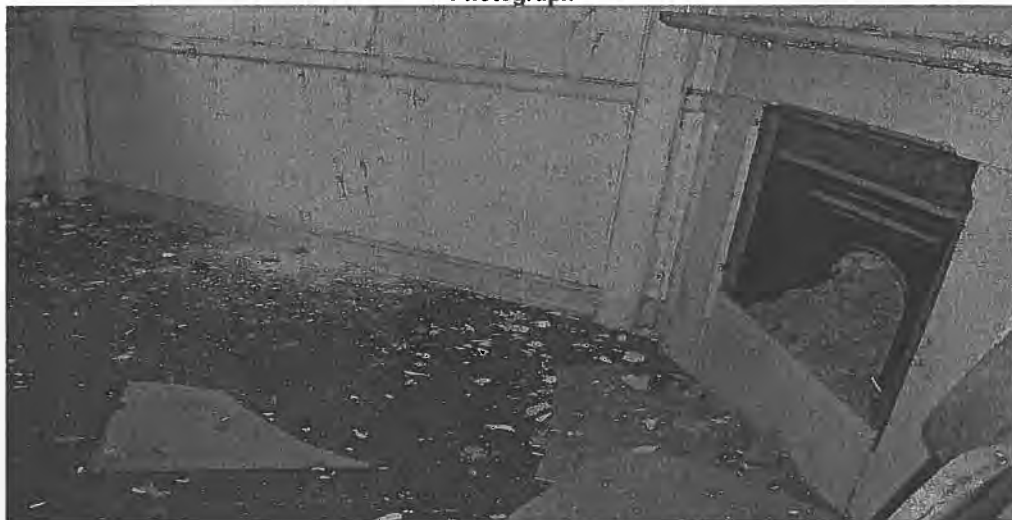
| <b>Location of Survey</b><br>Cane Hill Hospital,<br>Cane Hill,<br>Coulsdon, Surrey,<br>CR5 3ES | <b>Position of Sample/Photo</b><br>Faraday Ward<br>End Office<br>Fireplace panels & debris | <b>Asbestos</b><br><br><b>Type</b> | Yes, Strongly Presumed<br><br>Chrysotile (White) |
| <b>Material Type</b> Cement | <b>Quantity</b> 1m <sup>2</sup> | <b>Sample No</b> As 06/B/8026/19<br><br><b>Survey Date</b> 24.04 - 29.06.06<br><br><b>Date of Report</b> 18.08.06<br><br><b>Surveyor(s)</b> | |

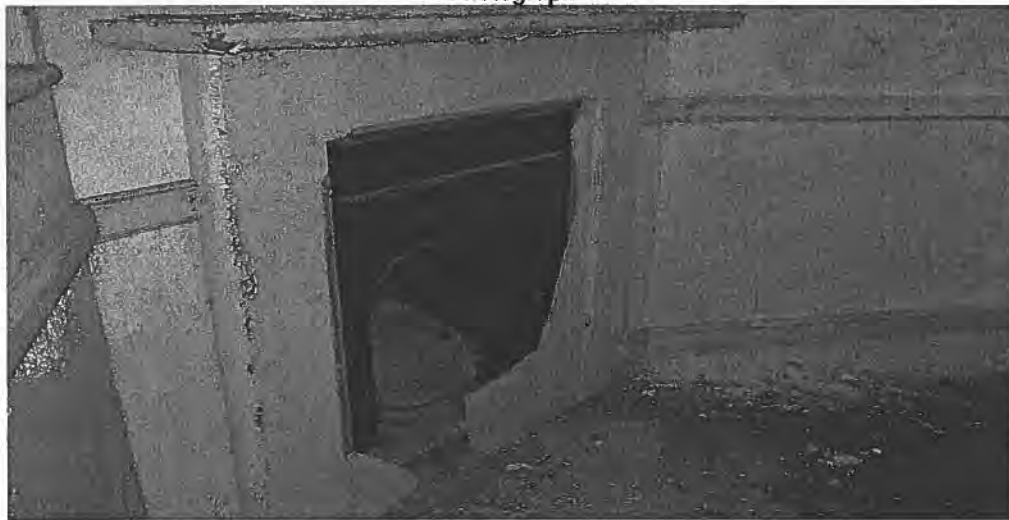
| <b>Location of Survey</b><br>Cane Hill Hospital,<br>Cane Hill,<br>Coulston, Surrey,<br>CR5 3ES | | <b>Position of Sample/Photo</b><br>Faraday Ward<br>Office<br>Fireplace panels & debris | | <b>Asbestos</b><br><br><b>Type</b> | Yes, Strongly<br>Presumed<br><br>Chrysotile (White) |
| <b>Material Type</b><br>Cement | | <b>Quantity</b><br>1m <sup>2</sup> | | <b>Sample No</b> | As 06/B/8026/19 |

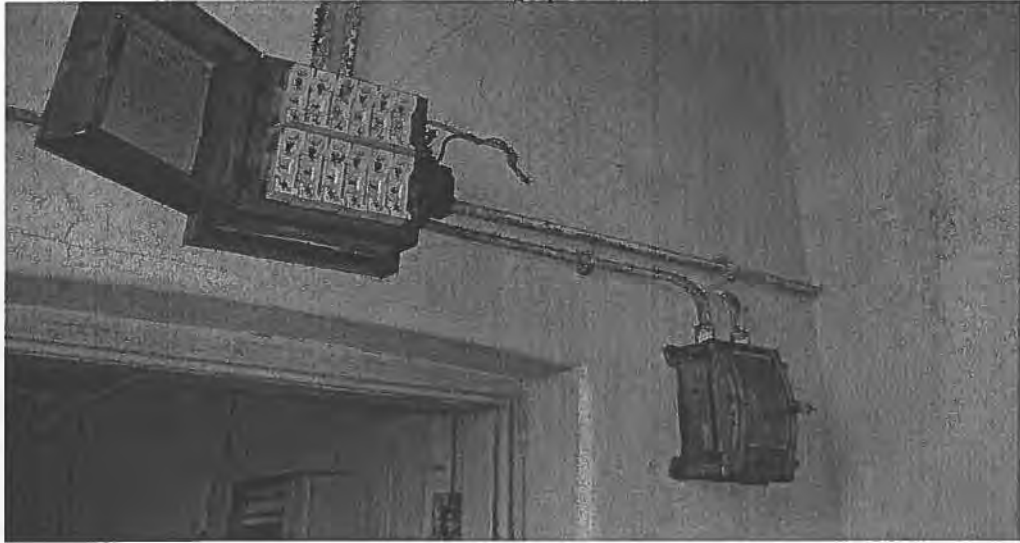
| <b>Location of Survey</b><br>Cane Hill Hospital,<br>Cane Hill,<br>Coulsdon, Surrey,<br>CR5 3ES | | <b>Position of Sample/Photo</b><br>Faraday Ward<br>Room adjacent Ward<br>Wall electrics | | <b>Asbestos</b><br><br><b>Type</b> | <b>Yes, Strongly Presumed</b><br><br>Chrysotile (White) |
| <b>Material Type</b> | Cement | <b>Quantity</b> | 100m | <b>Sample No</b> | As 06/B/8026/28 |

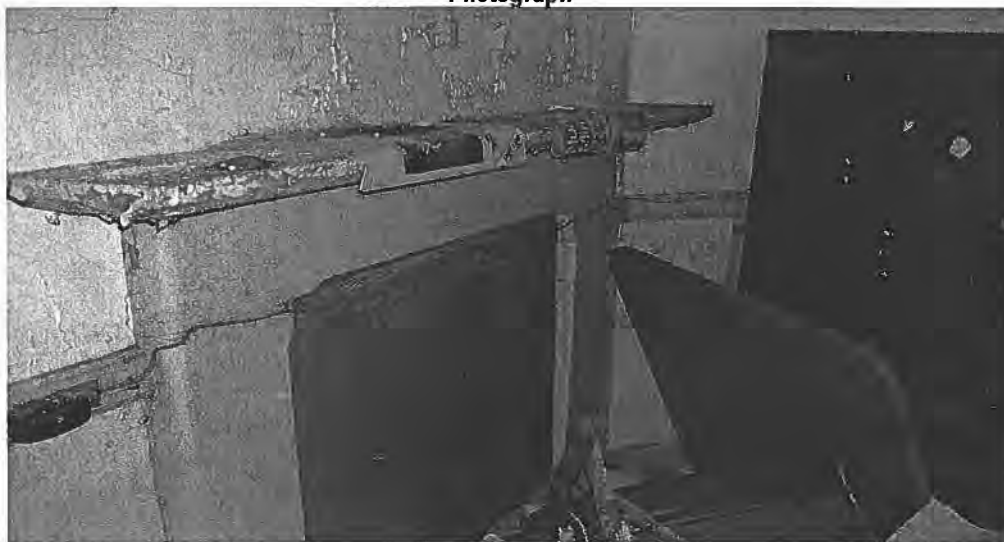
**Photograph**

| <b>Location of Survey</b><br>Cane Hill Hospital,<br>Cane Hill,<br>Coulson, Surrey,<br>CR5 3ES | | <b>Position of Sample/Photo</b><br>Faraday Ward<br>Office adjacent stairs<br>Fireplace panels | | <b>Asbestos</b><br><br><b>Type</b> | Yes, Strongly<br>Presumed<br><br>Chrysotile (White) |

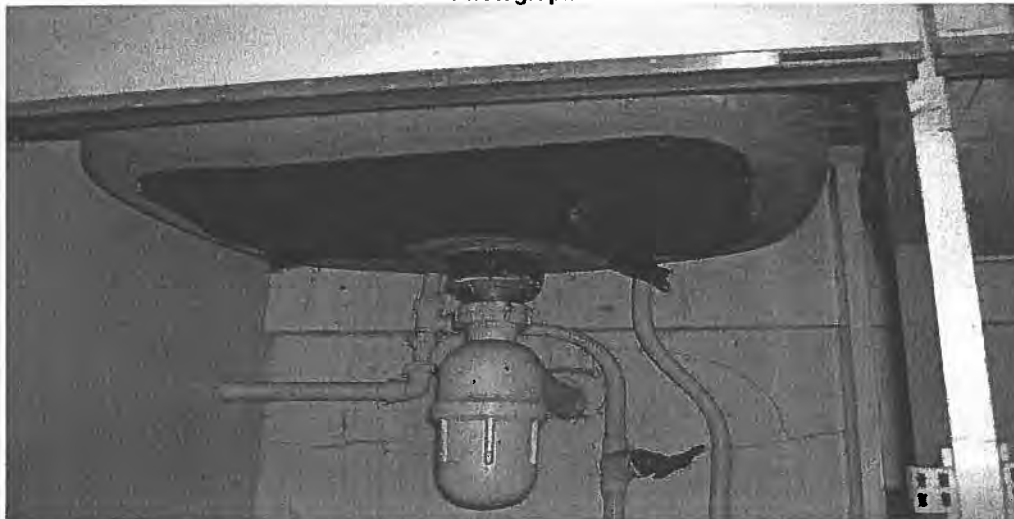
| <b>Location of Survey</b><br>Cane Hill Hospital,<br>Cane Hill,<br>Coulston, Surrey,<br>CR5 3ES | | <b>Position of Sample/Photo</b><br>Faraday Ward<br>Second Floor<br>Sink Pad | | <b>Asbestos</b> | Yes, Strongly<br>Presumed |
| | | | | <b>Type</b> | Chrysotile (White) |
| <b>Material Type</b> | Bitumen | <b>Quantity</b> | 1m <sup>2</sup> | <b>Sample No</b> | As 06/B/8026/64 |

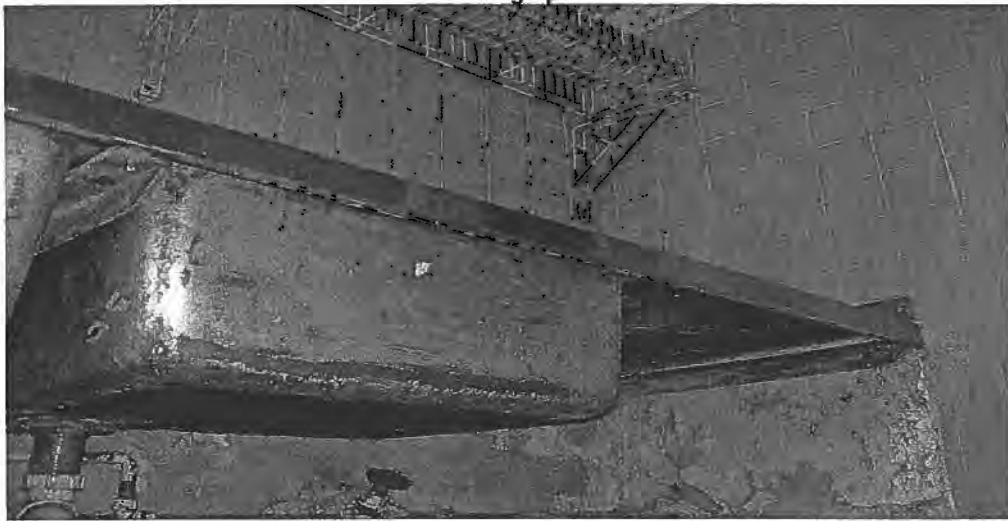
| <b>Location of Survey</b><br>Cane Hill Hospital,<br>Cane Hill,<br>Coulson, Surrey,<br>CR5 3ES | | <b>Position of Sample/Photo</b><br>Guy Ward<br>First Floor<br>Kitchen<br>Sink Paint | | <b>Asbestos</b><br><br><b>Type</b> | Yes, Strongly<br>Presumed<br><br>Chrysotile (White) |
| <b>Material Type</b><br>Bitumen | | <b>Quantity</b><br><1m <sup>2</sup> | | <b>Sample No</b><br><br><b>Survey Date</b><br><br><b>Date of Report</b><br><br><b>Surveyor(s)</b> | As 06/B/8026/157<br>24.04 – 29.06.06<br>18.08.06<br> |

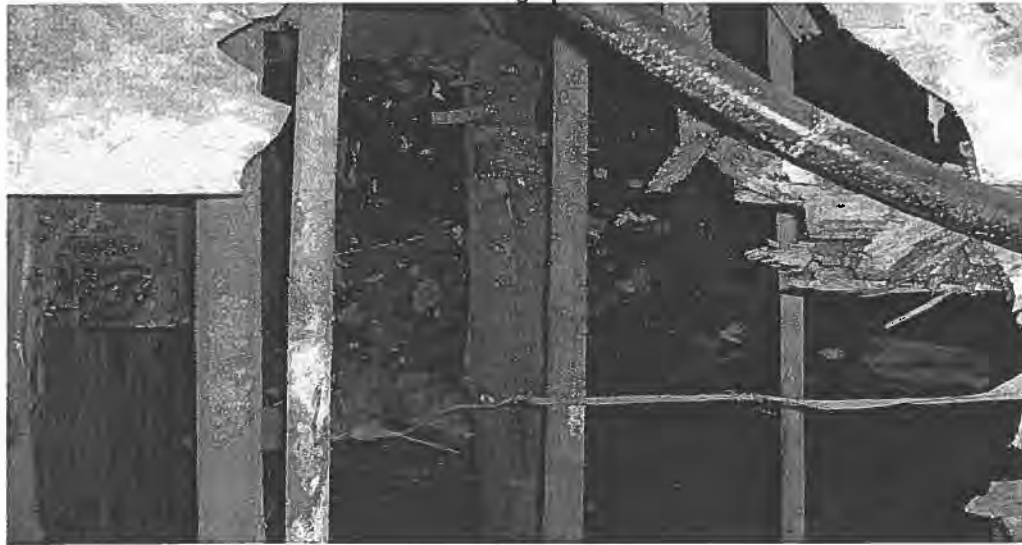
| Cane Hill Hospital,<br>Cane Hill,<br>Coulsdon, Surrey,<br>CR5 3ES | | Guy Ward<br>Undercroft<br>Lagging debris | | <b>Type</b> | Amosite (Brown) |
| <b>Material Type</b> | Lagging | <b>Quantity</b> | <1m | <b>Sample No</b> | 06/B/8026/136 |

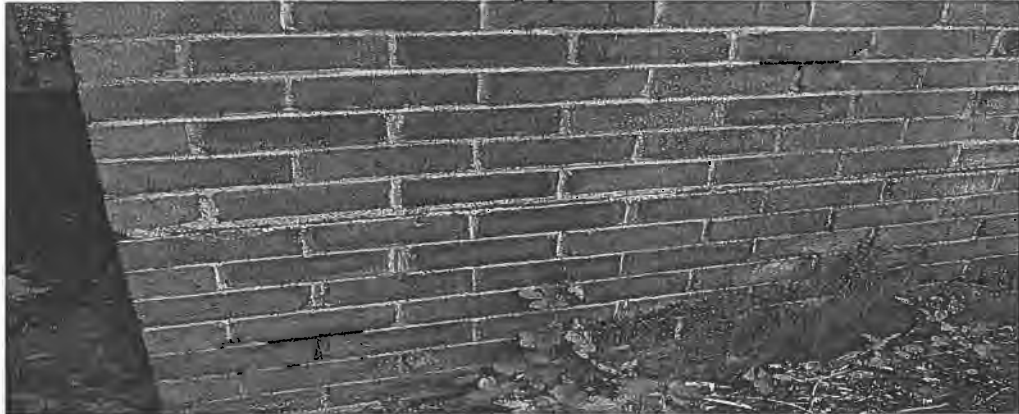
| <b>Location of Survey</b><br><br>Cane Hill Hospital,<br>Cane Hill,<br>Coulsdon, Surrey,<br>CR5 3ES | <b>Position of Sample/Photo</b><br><br>Damp course, outhouse adj to<br>Guy ward | <b>Asbestos</b> None Detected<br><br><b>Type</b> N/A |
| <b>Material Type</b> Bitumen | <b>Quantity</b> 10m | <b>Sample No</b> 06/B/8026/143<br><br><b>Survey Date</b> 24.04 - 29.06.06<br><br><b>Date of Report</b> 18.08.06<br><br><b>Surveyor(s)</b> <span style="background-color: black; color: black;">[REDACTED]</span> |

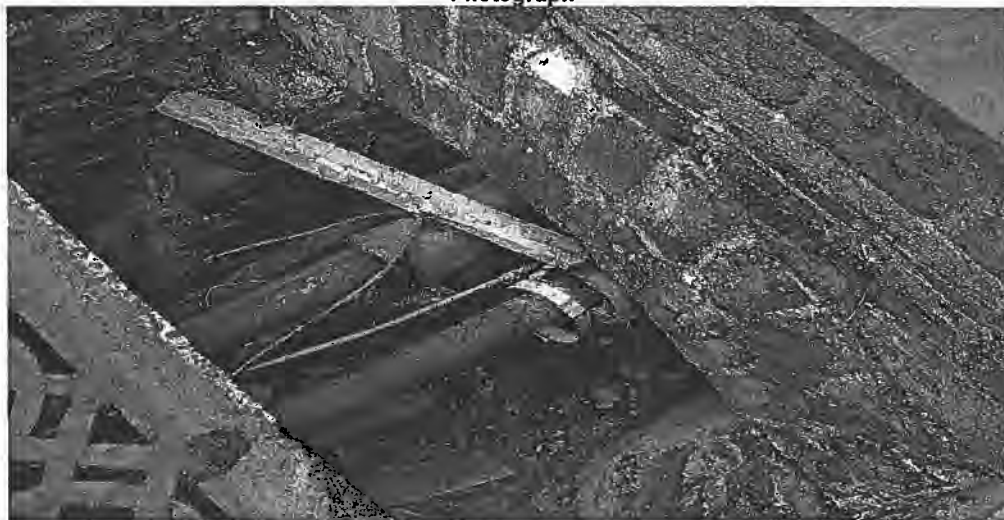
| Cane Hill Hospital,<br>Cane Hill,<br>Coulsdon, Surrey,<br>CR5 3ES | | Harvard Ward<br>Lagging to RH external pipe<br>leading to undercroft, | <b>Type</b> | N/A |
| <b>Material Type</b> | Lagging | <b>Quantity</b> 20m <sup>2</sup> | <b>Sample No</b> | 06/B/8026/137 |

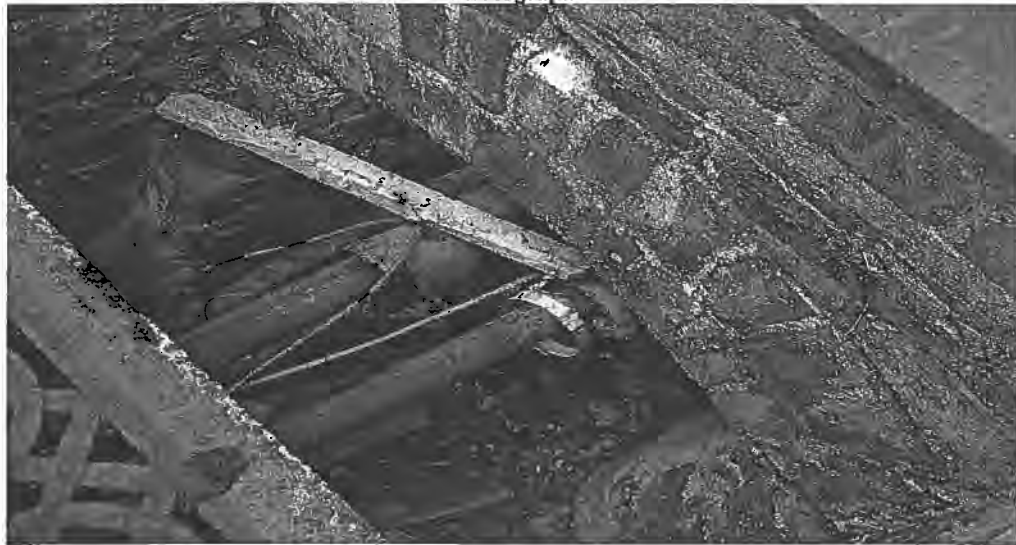
| <b>Location of Survey</b><br>Cane Hill Hospital,<br>Cane Hill,<br>Coulsdon, Surrey,<br>CR5 3ES | | <b>Position of Sample/Photo</b><br>Harvard Ward<br>Lagging to LH external pipe<br>leading to undercroft | <b>Asbestos</b><br><br><b>Type</b> | None Detected<br><br>N/A |
| <b>Material Type</b> | <b>Lagging</b> | <b>Quantity</b> | 10m <sup>2</sup> | <b>Sample No</b> 06/B/8026/138<br><br><b>Survey Date</b> 24.04 - 29.06.06<br><br><b>Date of Report</b> 18.08.06<br><br><b>Surveyor(s)</b> <span style="background-color: black; color: black;">[REDACTED]</span> |

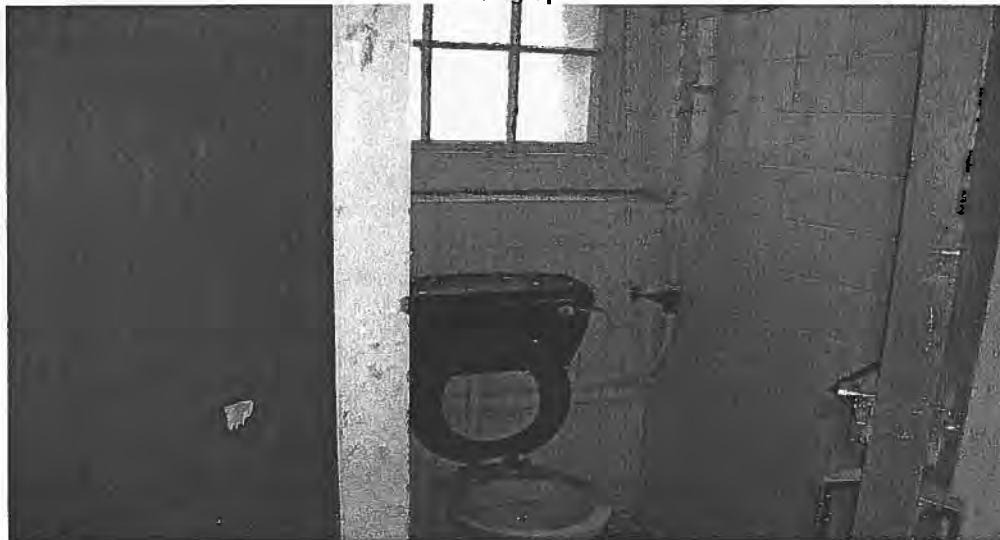
**Photograph**

| <b>Location of Survey</b><br>Cane Hill Hospital,<br>Cane Hill,<br>Coulston, Surrey,<br>CR5 3ES | | <b>Position of Sample/Photo</b><br>Harvard Ward<br>W.C. Cistern (X27) | | <b>Asbestos</b><br><br><b>Type</b> | Yes, Strongly<br>Presumed<br><br>Amosite (Brown) |

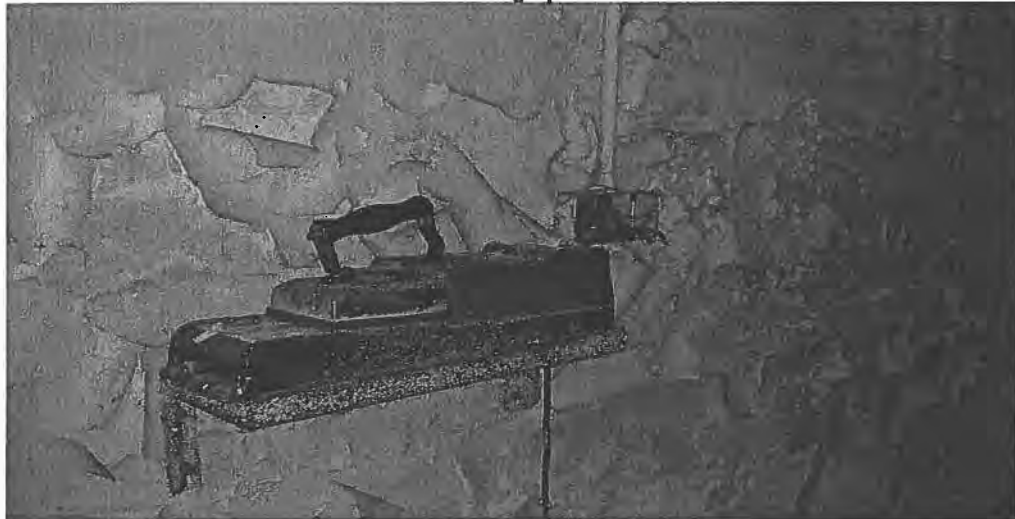
| <b>Location of Survey</b><br>Cane Hill Hospital,<br>Cane Hill,<br>Coulston, Surrey,<br>CR5 3ES | | <b>Position of Sample/Photo</b><br>Harvard Ward<br>Link corridor to W.C Block<br>Wall mounted iron pad | | <b>Asbestos</b><br><br><b>Type</b> | Yes, Strongly<br>Presumed<br><br>Chrysotile (White) |
| <b>Material Type</b> | Cement | <b>Quantity</b> | <1m <sup>2</sup> | <b>Sample No</b> | As 06/B/8026/20 |

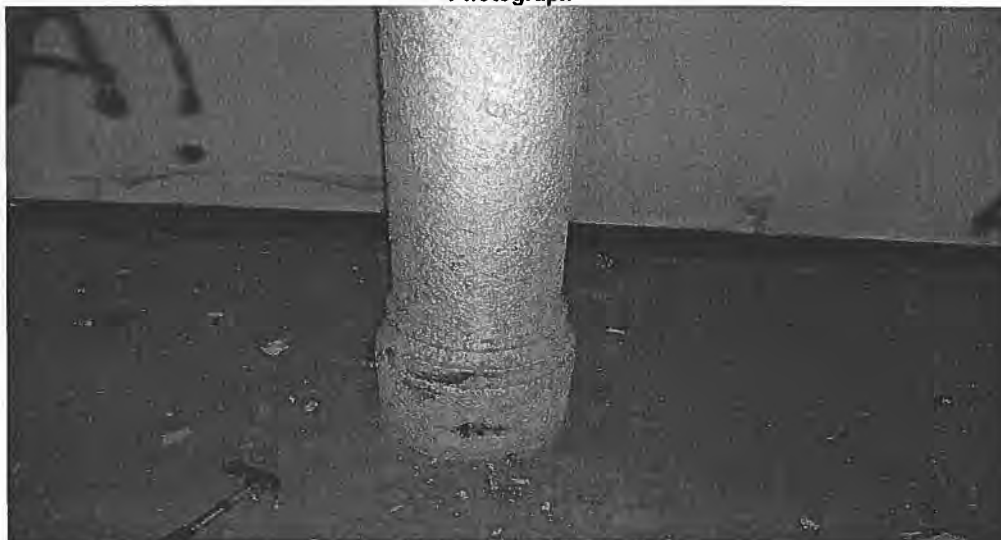
| <b>Location of Survey</b><br>Cane Hill Hospital,<br>Cane Hill,<br>Coulston, Surrey,<br>CR5 3ES | | <b>Position of Sample/Photo</b><br>Harvard ward<br>Textured coating to support<br>pillar | | <b>Asbestos</b><br><br><b>Type</b> | None Detected<br><br>N/A |
| <b>Material Type</b> | Textured<br>Coating | <b>Quantity</b> | 4m <sup>2</sup> | <b>Sample No</b> | 06/B/8026/139 |

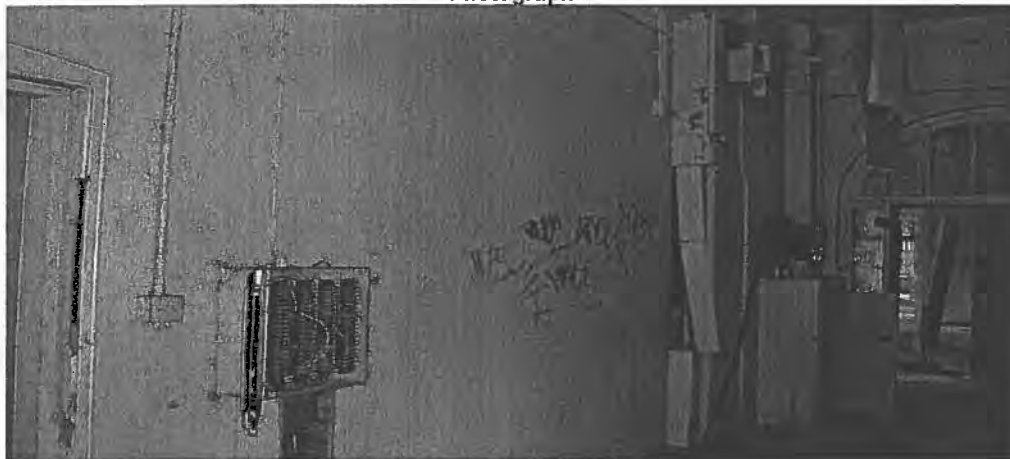
| <b>Location of Survey</b><br>Cane Hill Hospital,<br>Cane Hill,<br>Coulston, Surrey,<br>CR5 3ES | | <b>Position of Sample/Photo</b><br>Harvard Ward<br>Lobby<br>Wall electrics<br>Rope Seals | | <b>Asbestos</b><br><br><b>Type</b> | Yes, Strongly<br>Presumed<br><br>Chrysotile (White) |
| <b>Material Type</b> | Rope | <b>Quantity</b> | 1m | <b>Sample No</b> | As 06/B/8026/22 |

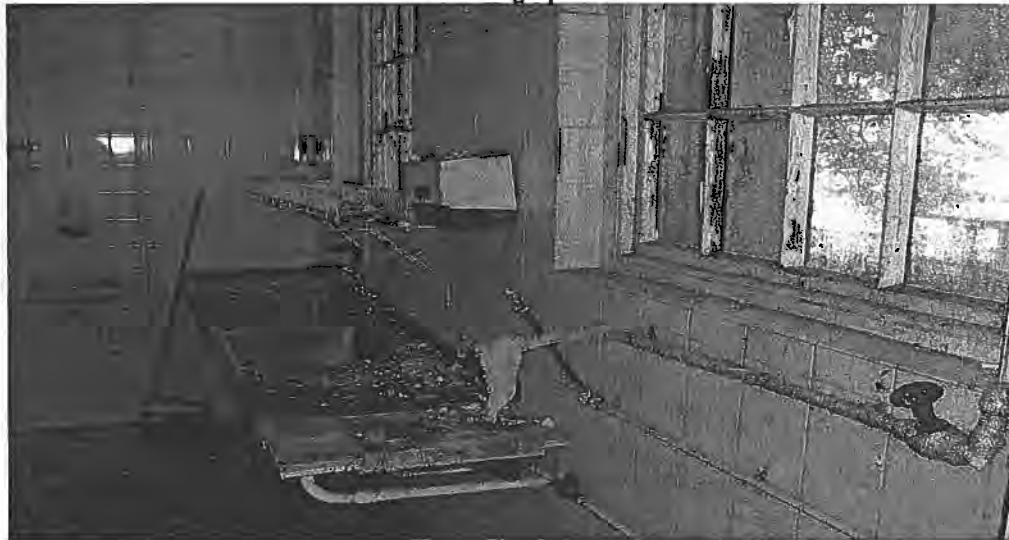
| <b>Location of Survey</b><br>Cane Hill Hospital,<br>Cane Hill,<br>Coulston, Surrey,<br>CR5 3ES | | <b>Position of Sample/Photo</b><br>Harvard Ward<br>Ground Floor Kitchen<br>Rope to pipework | | <b>Asbestos</b><br><br><b>Type</b> | Yes., Strongly<br>Presumed<br><br>Chrysotile (White) |
| <b>Material Type</b><br>Rope | | <b>Quantity</b><br>1m <sup>2</sup> | | <b>Sample No</b> | As 06/B/8026/58 |

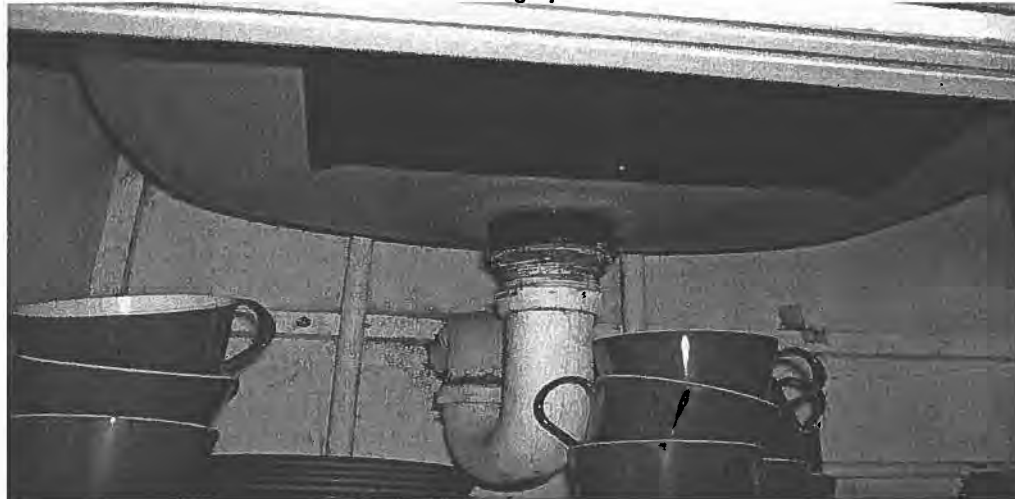
| <b>Location of Survey</b><br>Cane Hill Hospital,<br>Cane Hill,<br>Coulston, Surrey,<br>CR5 3ES | | <b>Position of Sample/Photo</b><br>Harvard Ward<br>Room opposite kitchen<br>Sink Pad | | <b>Asbestos</b><br><br><b>Type</b> | <b>Yes, Strongly Presumed</b><br><br>Chrysotile (White) |
| <b>Material Type</b> | Bitumen | <b>Quantity</b> | <1m <sup>2</sup> | <b>Sample No</b> | As 06/B/8026/64 |

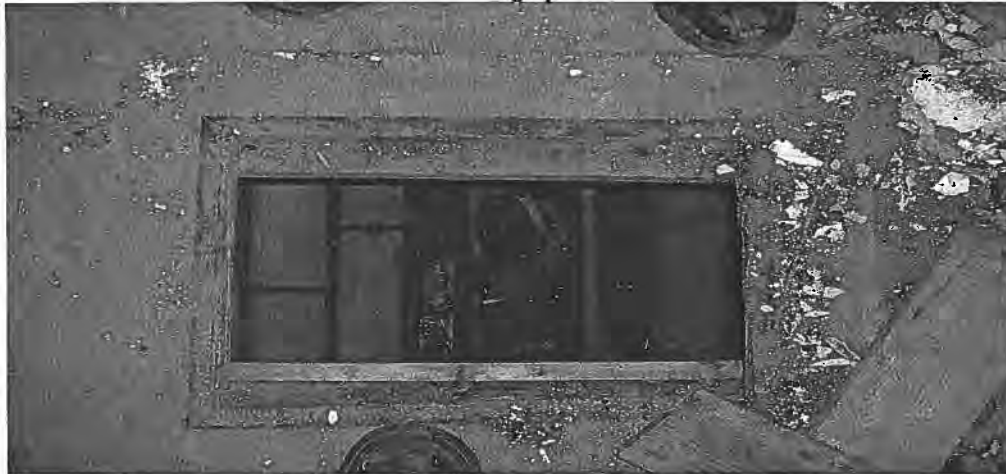
| <b>Location of Survey</b><br>Cane Hill Hospital,<br>Cane Hill,<br>Coulston, Surrey,<br>CR5 3ES | | <b>Position of Sample/Photo</b><br>Harvard ward<br>Pipe residue, corridor<br>undercroft | | <b>Asbestos</b><br><br><b>Type</b> | None Detected<br><br>N/A |
| <b>Material Type</b><br>Lagging | | <b>Quantity</b><br>10m | <b>Sample No</b><br>06/B/8026/140 | | |

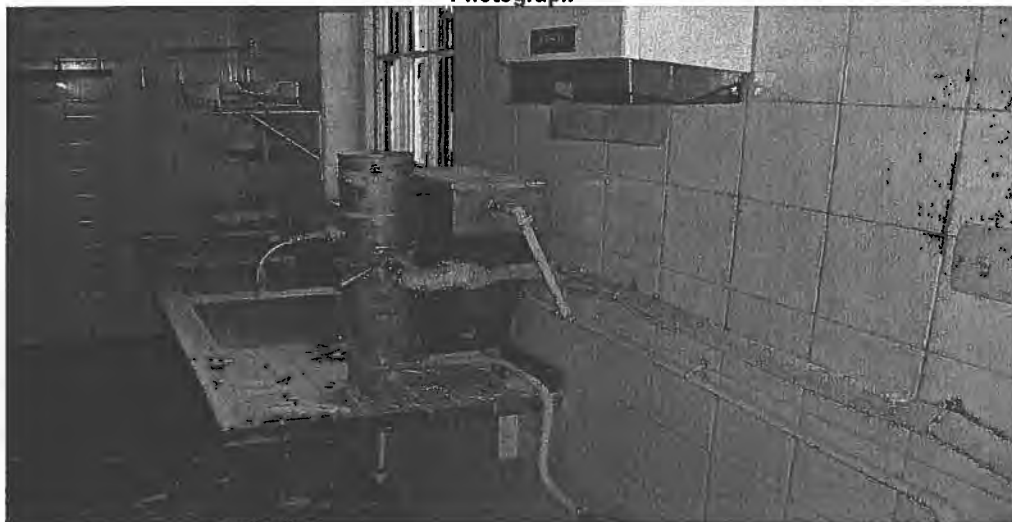
| <b>Location of Survey</b><br>Cane Hill Hospital,<br>Cane Hill,<br>Coulston, Surrey,<br>CR5 3ES | | <b>Position of Sample/Photo</b><br>Harvard Ward<br>First Floor<br>Kitchen<br>Rope to pipe work | | <b>Asbestos</b> | Yes, Strongly<br>Presumed |
| <b>Material Type</b> | | <b>Quantity</b> | | <b>Type</b> | Chrysotile (White) |
| Rope | | 1m | | <b>Sample No</b> | As 06/B/8026/58 |

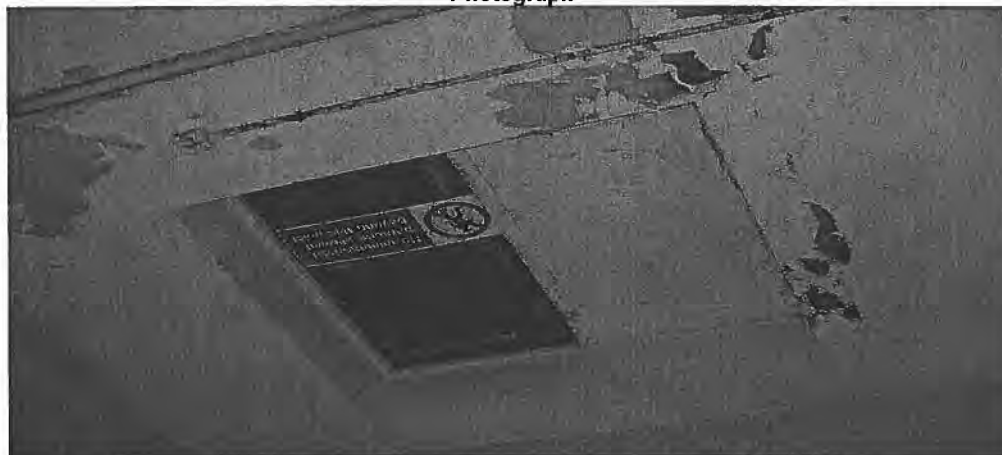
| <b>Location of Survey</b><br>Cane Hill Hospital,<br>Cane Hill,<br>Coulston, Surrey,<br>CR5 3ES | | <b>Position of Sample/Photo</b><br>Harvard ward<br>Lift motor room<br>Panel to hatch | <b>Asbestos</b> Yes |
| <b>Material Type</b> Board | | <b>Quantity</b> 1m <sup>2</sup> | <b>Type</b> Amosite (Brown)<br>Chrysotile (White) |

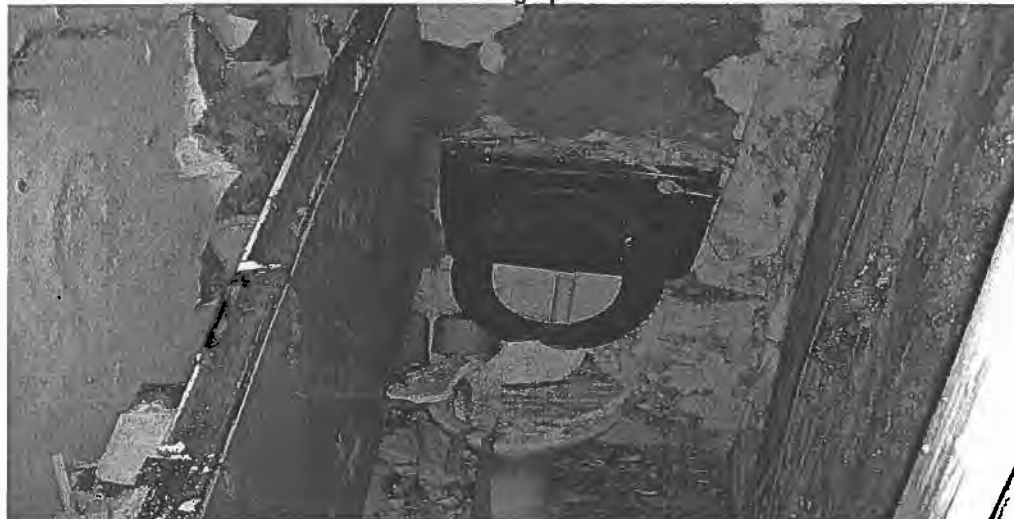
| <b>Location of Survey</b><br>Cane Hill Hospital,<br>Cane Hill,<br>Coulsdon, Surrey,<br>CR5 3ES | | <b>Position of Sample/Photo</b><br>Rooms adjacent link corridor &<br>Harvard Ward<br>W.C. Cistern | | <b>Asbestos</b><br><br><b>Type</b> | Yes, Strongly<br>Presumed<br><br>Amosite (Brown) |
| <b>Material Type</b><br>Plastic | | <b>Quantity</b><br>1m | | <b>Sample No</b><br><br><b>Survey Date</b><br><br><b>Date of Report</b><br><br><b>Surveyor(s)</b> | As 06/B/8026/5<br>24.04 - 29.06.06<br>18.08.06<br> |

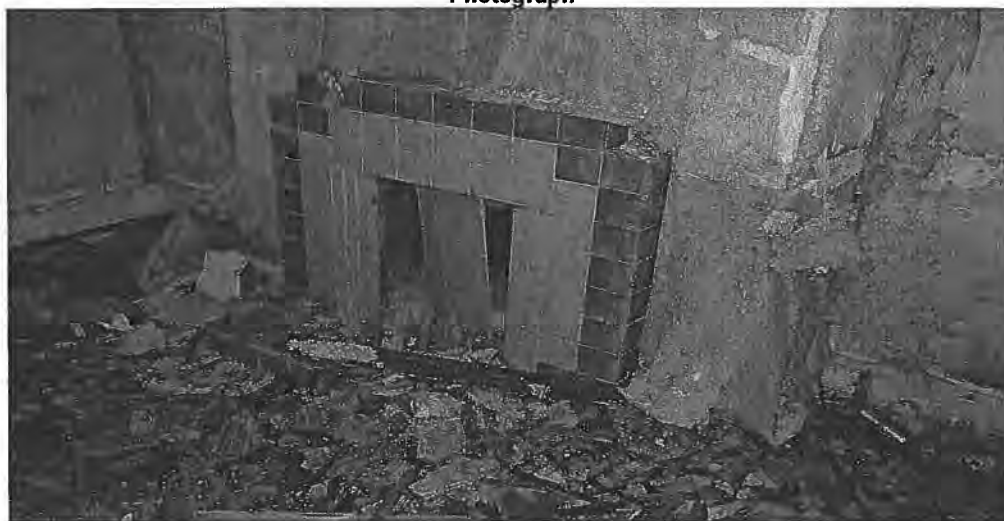
| <b>Location of Survey</b><br>Cane Hill Hospital,<br>Cane Hill,<br>Coulston, Surrey,<br>CR5 3ES | | <b>Position of Sample/Photo</b><br>Rooms adjacent link corridor &<br>Harvard Ward<br>Fireplace panel | <b>Asbestos</b><br><br><b>Type</b> | Yes, Strongly<br>presumed<br><br>Chrysotile (White) |
| <b>Material Type</b> | Cement | <b>Quantity</b> | 1m | <b>Sample No</b><br>As 06/B/8026/19 |

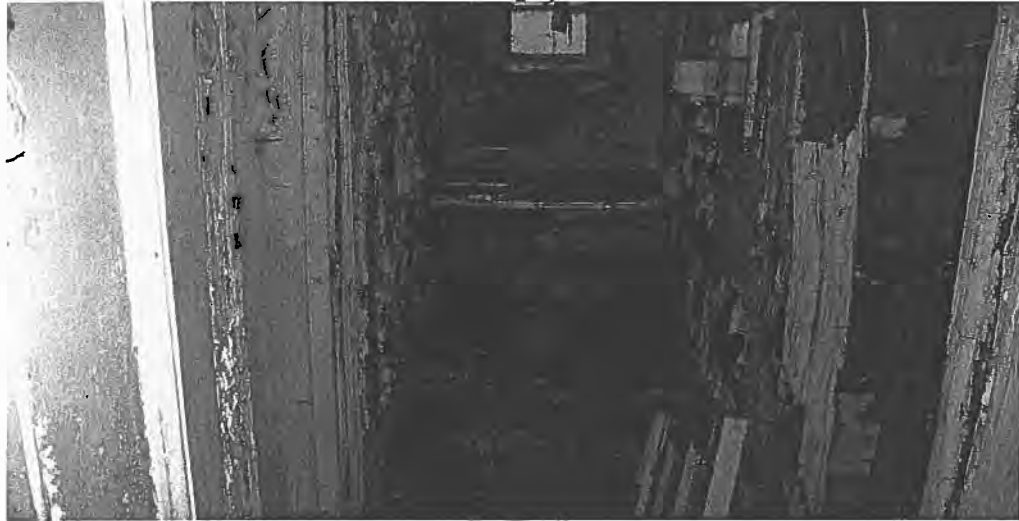
| <b>Location of Survey</b><br>Cane Hill Hospital,<br>Cane Hill,<br>Coulsdon, Surrey,<br>CR5 3ES | | <b>Position of Sample/Photo</b><br>Rooms adjacent link corridor &<br>Harvard Ward<br>Sink Pad | | <b>Asbestos</b> | Yes, Strongly<br>Presumed |
| | | | | <b>Type</b> | Chrysotile (White) |

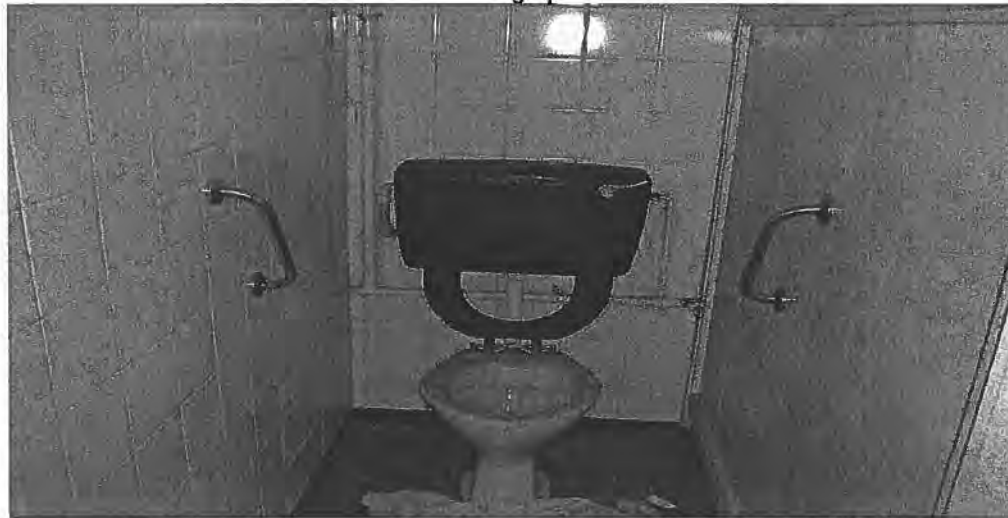
| <b>Material Type</b> Plastic | <b>Quantity</b> 1m <sup>2</sup> Each | <b>Sample No</b> As 06/B/8026/5<br><br><b>Survey Date</b> 24.04 - 29.06.06<br><br><b>Date of Report</b> 18.08.06<br><br><b>Surveyor(s)</b> <span style="background-color: black; color: black;">[REDACTED]</span> |

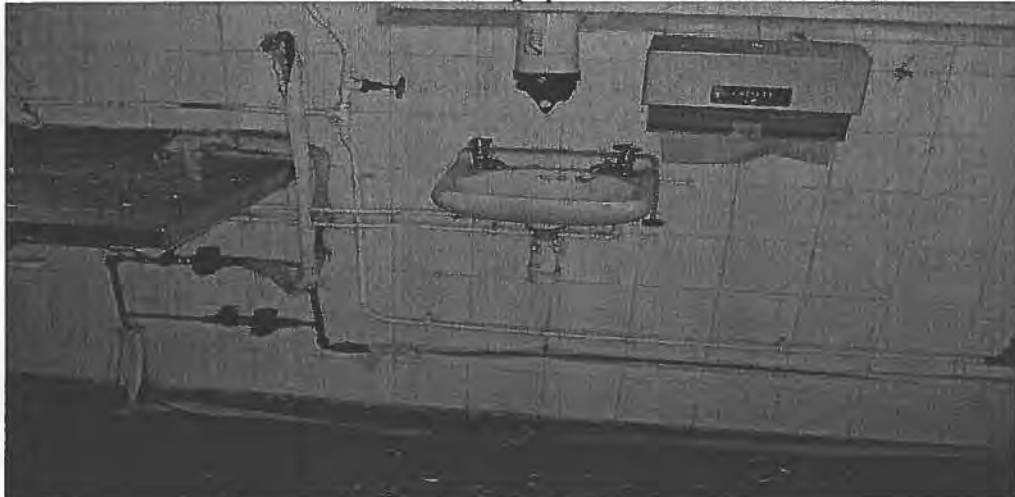
| <b>Location of Survey</b><br>Cane Hill Hospital,<br>Cane Hill,<br>Coulston, Surrey,<br>CR5 3ES | | <b>Position of Sample/Photo</b><br>Kings Keats Ward<br>Kitchen<br>Rope to pipework | | <b>Asbestos</b><br><br><b>Type</b> | Yes, Strongly<br>Presumed<br><br>Chrysotile (White) |

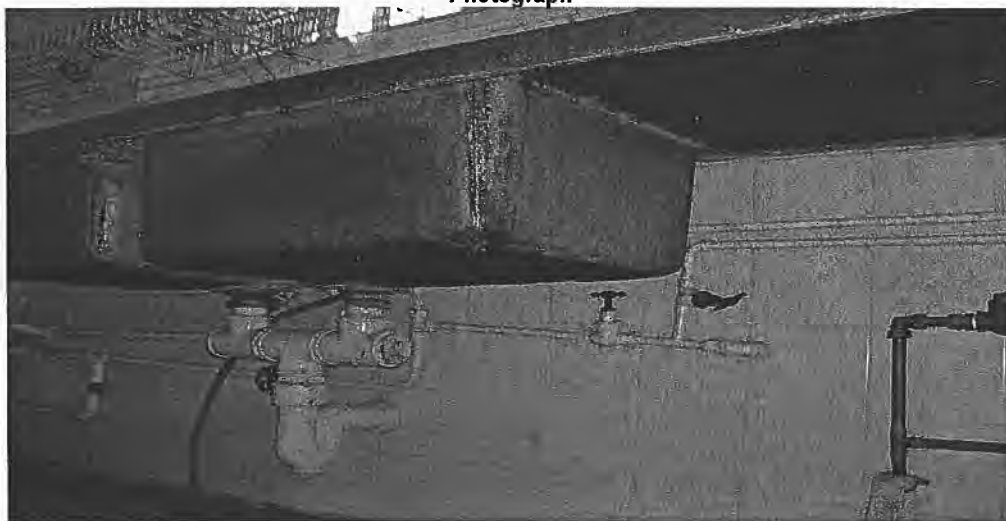
| <b>Location of Survey</b><br>Cane Hill Hospital,<br>Cane Hill,<br>Coulsdon, Surrey,<br>CR5 3ES | | <b>Position of Sample/Photo</b><br>Kings Keats Ward<br>Sink Paint | | <b>Asbestos</b> | Yes, Strongly<br>Presumed |

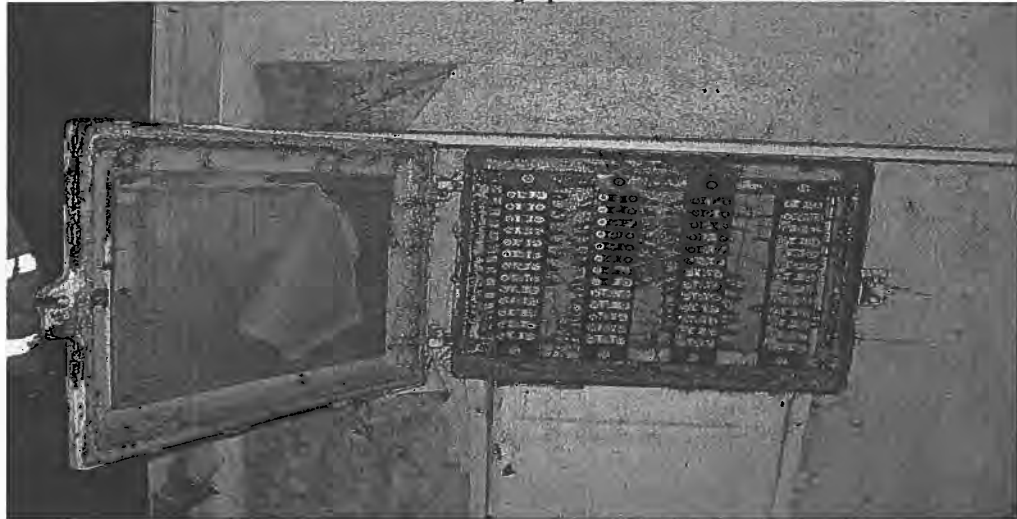
| <b>Location of Survey</b><br>Cane Hill Hospital,<br>Cane Hill,<br>Coulston, Surrey,<br>CR5 3ES | | <b>Position of Sample/Photo</b><br>Kings Keats Ward<br>Wall Electrics<br>Rope seals | | <b>Asbestos</b><br><br><b>Type</b> | Yes, Strongly<br>Presumed<br><br>Chrysotile (White) |

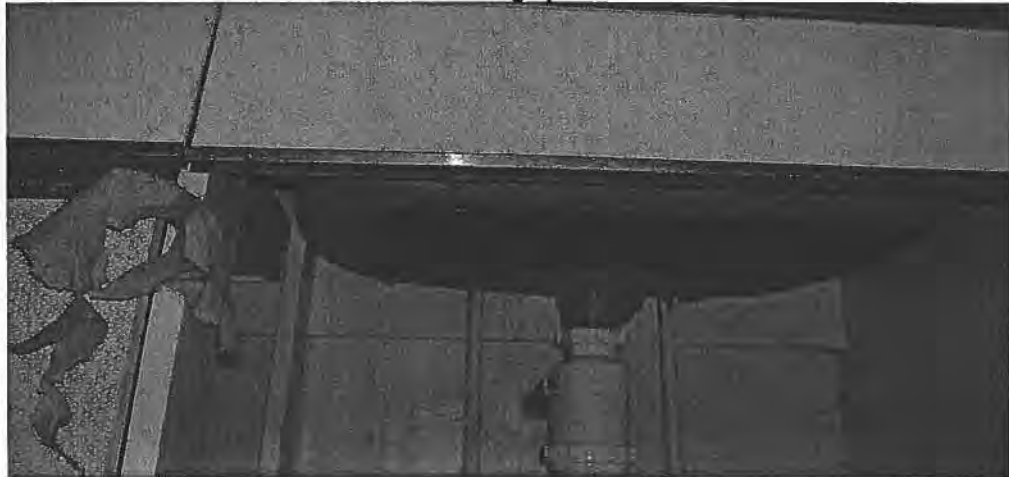
| <b>Location of Survey</b><br>Cane Hill Hospital,<br>Cane Hill,<br>Coulsdon, Surrey,<br>CR5 3ES | | <b>Position of Sample/Photo</b><br>Kings Keats Ward<br>Sink Pad | | <b>Asbestos</b> Yes, Strongly<br>Presumed |

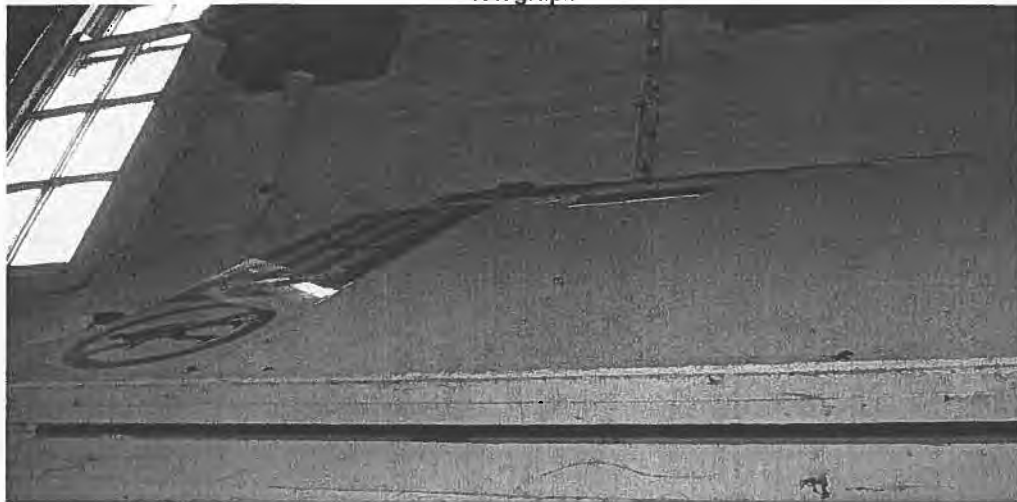
| <b>Location of Survey</b><br>Cane Hill Hospital,<br>Cane Hill,<br>Coulston, Surrey,<br>CR5 3ES | | <b>Position of Sample/Photo</b><br>Panel to hatch, lift motor room,<br>King Keats ward | | <b>Asbestos</b><br><br><b>Type</b> | None Detected<br><br>N/A |

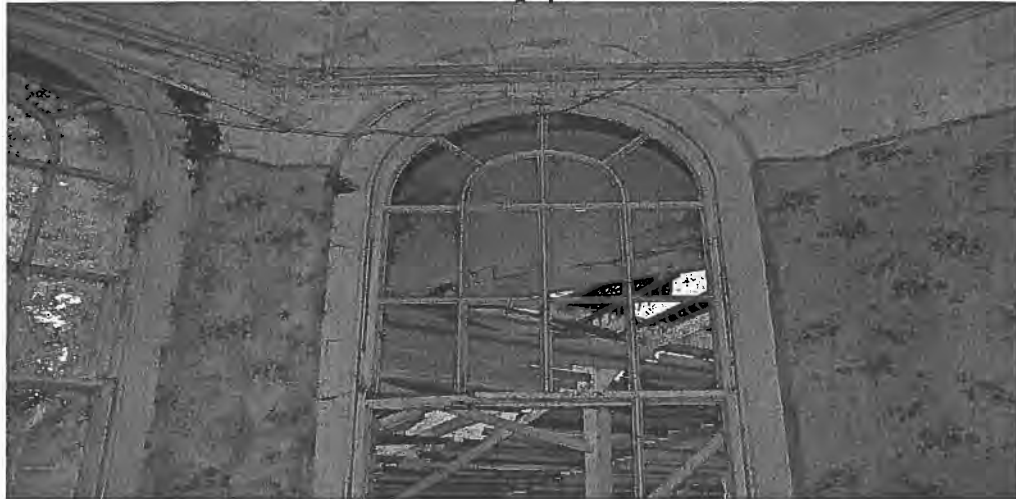
**Photograph**

| <b>Location of Survey</b><br>Cane Hill Hospital,<br>Cane Hill,<br>Coulsdon, Surrey,<br>CR5 3ES | <b>Position of Sample/Photo</b><br>Johnson/Jenner Ward<br>Ground Floor<br>Upstand to skylight roof in sun<br>room | <b>Asbestos</b> Yes<br><br><b>Type</b> Chrysotile (White) |
| <b>Material Type</b> Cement | <b>Quantity</b> 1m | <b>Sample No</b> 06/B/8026/147<br><br><b>Survey Date</b> 24.04 - 29.06.06<br><br><b>Date of Report</b> 18.08.06<br><br><b>Surveyor(s)</b> <span style="background-color: black; color: black;">[REDACTED]</span> |

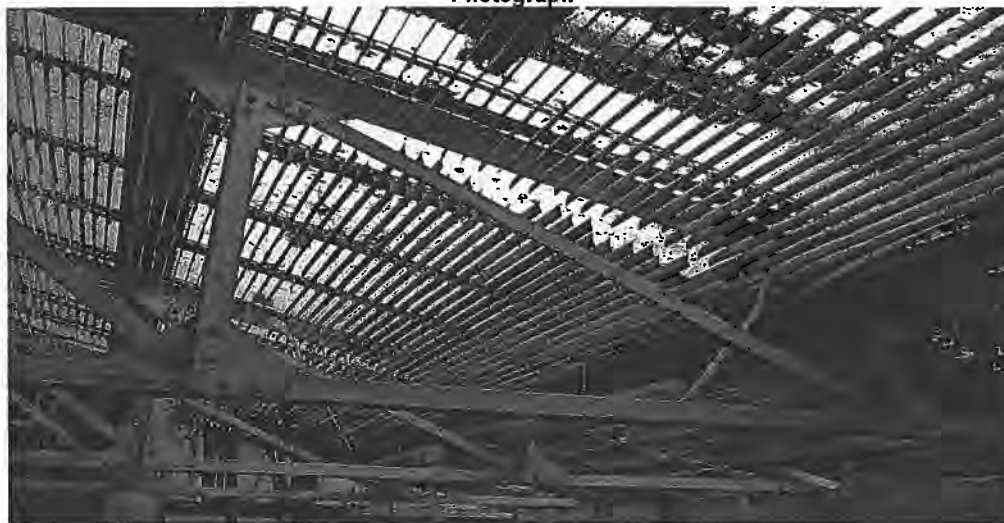
**Photograph**

| <b>Location of Survey</b><br>Cane Hill Hospital,<br>Cane Hill,<br>Coulston, Surrey,<br>CR5 3ES | | <b>Position of Sample/Photo</b><br>Johnson/Jenner Ward<br>Sun Room Skylight<br>Rope Seal | <b>Asbestos</b><br><br><b>Type</b> | Yes, Strongly<br>Presumed<br><br>Chrysotile (White) |
| <b>Material Type</b> | Rope | <b>Quantity</b> | 200m | <b>Sample No</b> As 06/B/8026/31<br><br><b>Survey Date</b> 24.04 - 29.06.06<br><br><b>Date of Report</b> 18.08.06<br><br><b>Surveyor(s)</b> <span style="background-color: black; color: black;">[REDACTED]</span> |

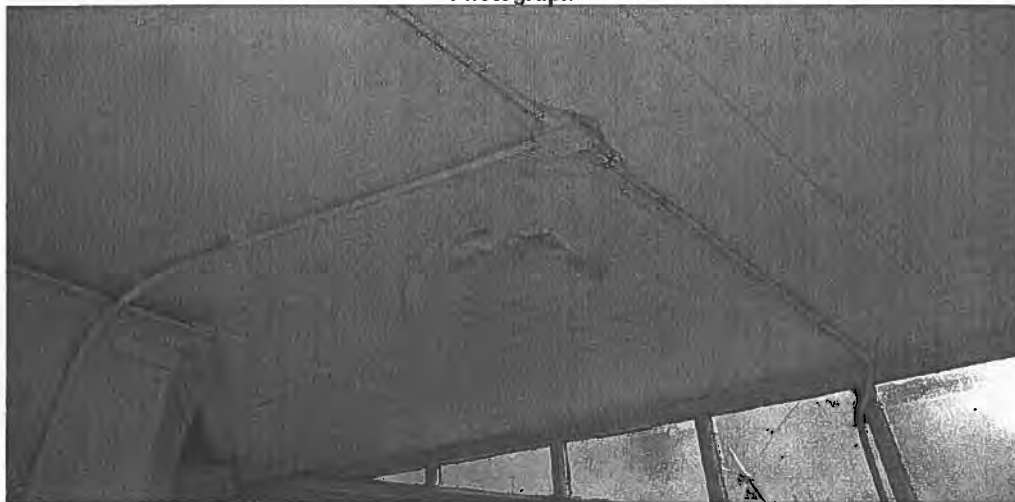
**Photograph**

| <b>Location of Survey</b><br>Cane Hill Hospital,<br>Cane Hill,<br>Coulsdon, Surrey,<br>CR5 3ES | <b>Position of Sample/Photo</b><br>Johnson/Jenner Ward<br>Ceiling panels to sun room, | <b>Asbestos</b> Yes<br><br><b>Type</b> Chrysotile (White) |
| <b>Material Type</b> Cement | <b>Quantity</b> 10m <sup>2</sup> | <b>Sample No</b> 06/B/8026/148<br><br><b>Survey Date</b> 24.04 - 29.06.06<br><br><b>Date of Report</b> 18.08.06<br><b>Surveyor(s)</b> <span style="background-color: black; color: black;">[REDACTED]</span> |

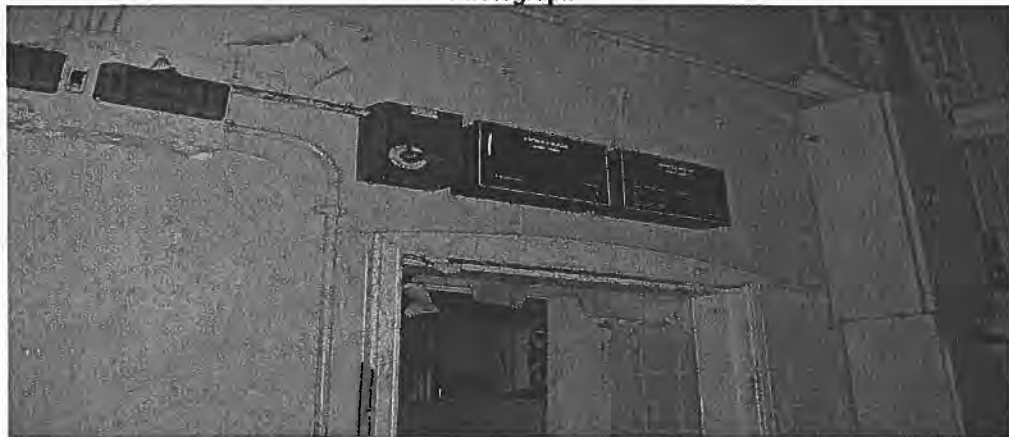
**Photograph**

| <b>Location of Survey</b><br>Cane Hill Hospital,<br>Cane Hill,<br>Coulston, Surrey,<br>CR5 3ES | | <b>Position of Sample/Photo</b><br>Johnson/Jenner Ward<br>Wall Electrics | | <b>Asbestos</b><br><br><b>Type</b> | Yes, Strongly<br>Presumed<br><br>Chrysotile (White) |
| <b>Material Type</b> | Rope | <b>Quantity</b> | 1m | <b>Sample No</b> | As 06/B/8026/9 |

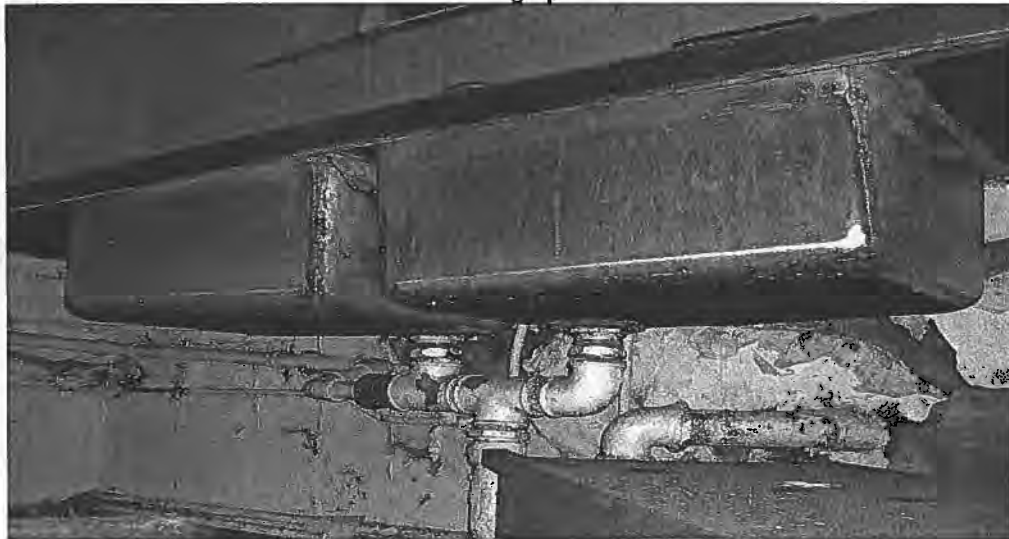
**Photograph**

| <b>Location of Survey</b><br>Cane Hill Hospital,<br>Cane Hill,<br>Coulsdon, Surrey,<br>CR5 3ES | | <b>Position of Sample/Photo</b><br>Johnson/Jenner Ward<br>First Floor<br>Sink Paint | | <b>Asbestos</b> | Yes, Strongly<br>Presumed |
| <b>Material Type</b> | Bitumen | <b>Quantity</b> | 1m | <b>Sample No</b> | As 06/B/8026/157 |

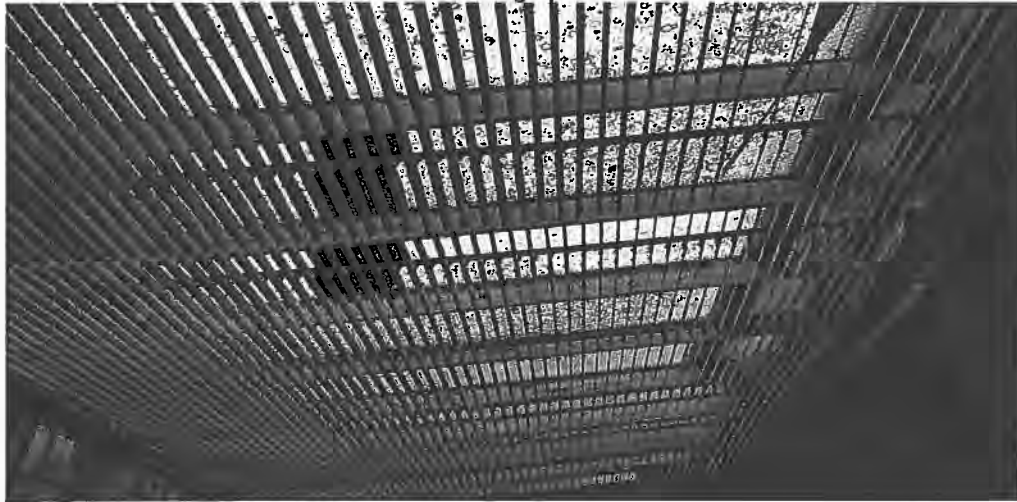
**Photograph**

| <b>Location of Survey</b><br>Cane Hill Hospital,<br>Cane Hill,<br>Coulston, Surrey,<br>CR5 3ES | | <b>Position of Sample/Photo</b><br>Johnson/Jenner Ward<br>First Floor<br>Sun Room Skylight<br>Rope Seal | | <b>Asbestos</b><br><br><b>Type</b> | Yes, Strongly<br>Presumed<br><br>Chrysotile (White) |
| <b>Material Type</b> | Rope | <b>Quantity</b> | 100m | <b>Sample No</b> | As 06/B/8026/31 |

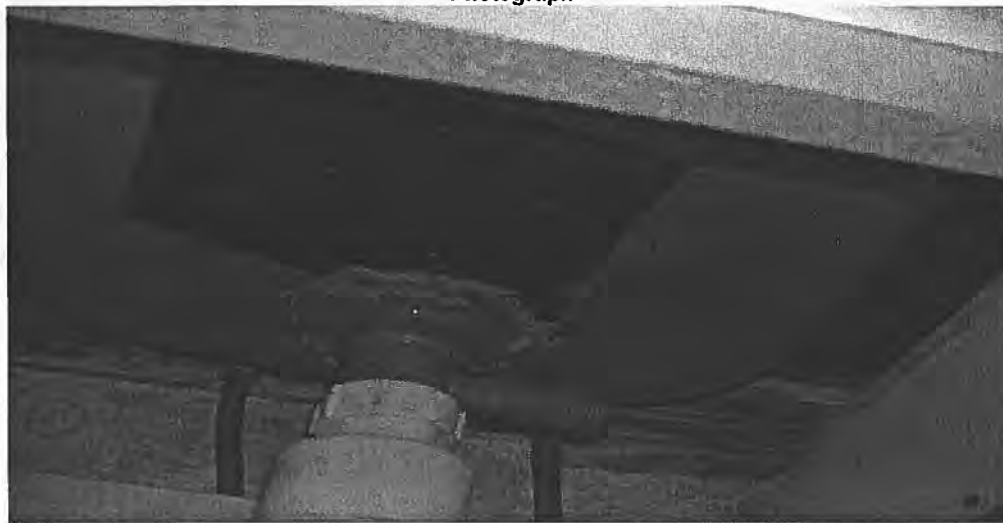
**Photograph**

| <b>Location of Survey</b><br>Cane Hill Hospital,<br>Cane Hill,<br>Coulsdon, Surrey,<br>CR5 3ES | | <b>Position of Sample/Photo</b><br>Johnson/Jenner Ward<br>First Floor<br>Sink Pad | | <b>Asbestos</b> | Yes, Strongly<br>Presumed |
| <b>Material Type</b> Bitumen | | <b>Quantity</b> 1m <sup>2</sup> | | <b>Type</b> | Chrysotile (White) |

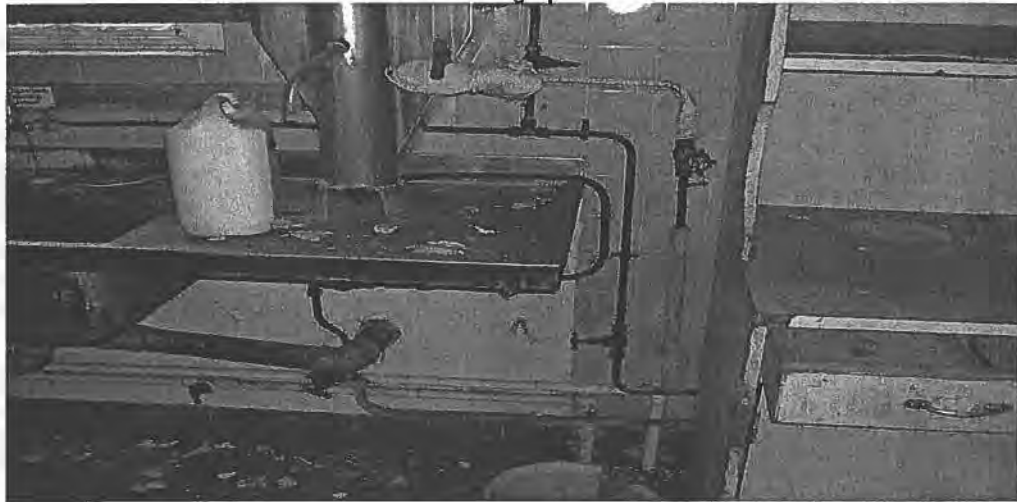
**Photograph**

| <b>Location of Survey</b><br>Cane Hill Hospital,<br>Cane Hill,<br>Coulsdon, Surrey,<br>CR5 3ES | | <b>Position of Sample/Photo</b><br>Johnson/Jenner Ward<br>First Floor Kitchen<br>Rope to pipe work | | <b>Asbestos</b><br><br><b>Type</b> | Yes, Strongly<br>Presumed<br><br>Chrysotile (White) |
| <b>Material Type</b> | Rope | <b>Quantity</b> | 1m | <b>Sample No</b> | As 06/B/8026/58 |
