## SURVEY INFORMATION SHEET

| <b>Location of Survey</b><br>Cane Hill Hospital,<br>Cane Hill,<br>Coulsdon, Surrey,<br>CR5 3ES | <b>Position of Sample/Photo</b><br>Workshop Garages<br>External corrugated roof sheet | <b>Asbestos</b><br><br><b>Type</b> | Yes, Strongly Presumed<br><br>Chrysotile (White) |

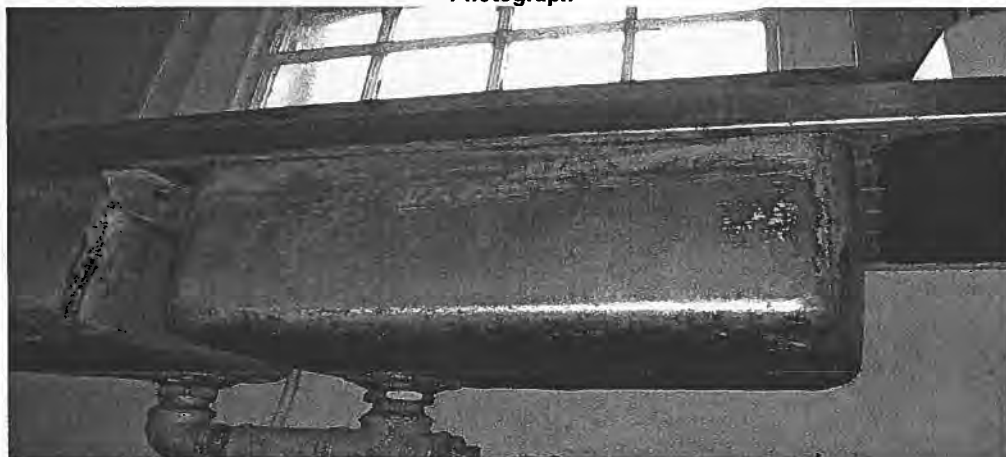
**Photograph**

| <b>Location of Survey</b><br>Cane Hill Hospital,<br>Cane Hill,<br>Coulsdon, Surrey,<br>CR5 3ES | | <b>Position of Sample/Photo</b><br>Johnson/Jenner Ward<br>First Floor<br>Kitchen Sink Paint | | <b>Asbestos</b> | Yes, Strongly<br>Presumed |
| <b>Material Type</b> Bitumen | | <b>Quantity</b> 1m | | <b>Sample No</b> | As 06/B/8026/157 |

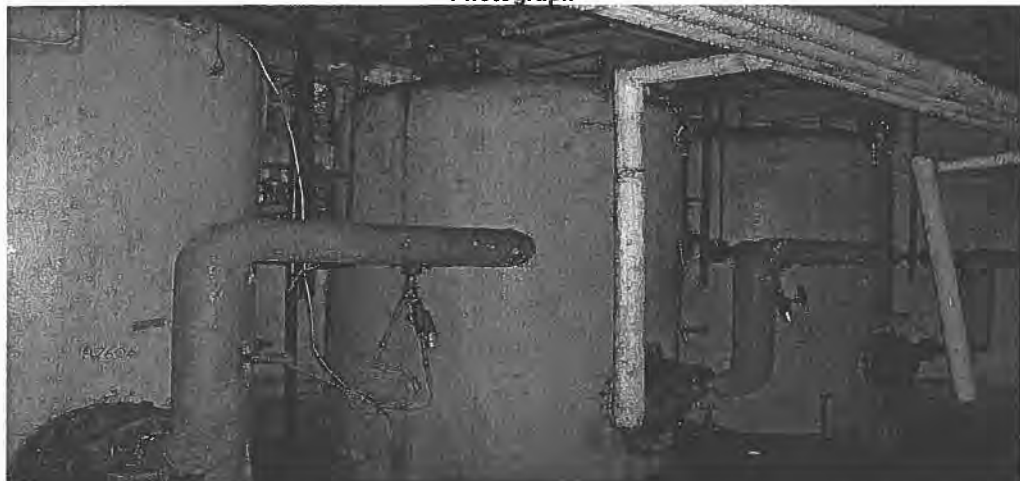
**Photograph**

| <b>Location of Survey</b><br>Cane Hill Hospital,<br>Cane Hill,<br>Coulston, Surrey,<br>CR5 3ES | | <b>Position of Sample/Photo</b><br>Boiler House adjacent to<br>Johnson/Jenner Ward<br>Large Tank (X3) Lagging | | <b>Asbestos</b><br><br><b>Type</b> | Yes, Strongly<br>Presumed<br><br>Amosite (Brown)<br>Chrysotile (White) |
| <b>Material Type</b> | Lagging | <b>Quantity</b> | 120m <sup>2</sup> | <b>Sample No</b> | As 06/B/8026/150 |

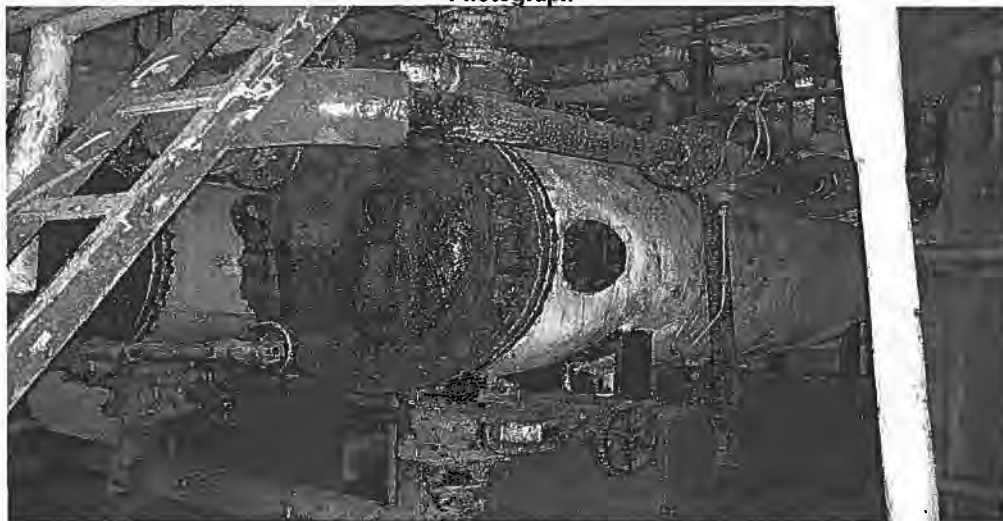
**Photograph**

| <b>Location of Survey</b><br>Cane Hill Hospital,<br>Cane Hill,<br>Coulston, Surrey,<br>CR5 3ES | | <b>Position of Sample/Photo</b><br>Boiler House adjacent to<br>Johnson/Jenner Ward<br>Small Tank Lagging | | <b>Asbestos</b><br><br><b>Type</b> | Yes, Strongly<br>Presumed<br><br>Amosite (Brown)<br>Chrysotile (White) |
| <b>Material Type</b> | Lagging | <b>Quantity</b> | 60m <sup>2</sup> | <b>Sample No</b> | As 06/B/8026/150 |

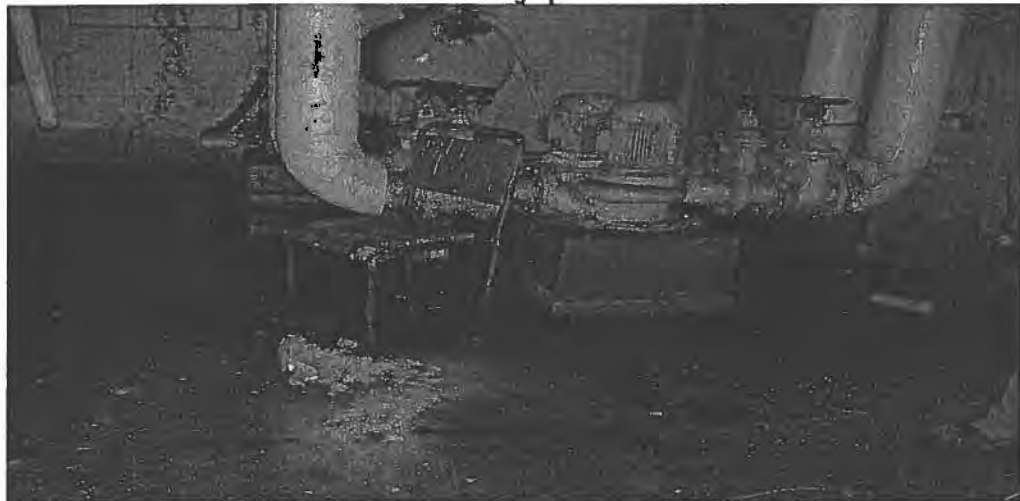
**Photograph**

| <b>Location of Survey</b><br>Cane Hill Hospital,<br>Cane Hill,<br>Coulsdon, Surrey,<br>CR5 3ES | <b>Position of Sample/Photo</b><br>Boiler House adjacent to<br>Johnson/Jenner Ward<br>Lagging debris on floor | <b>Asbestos</b> Yes<br><br><b>Type</b> Amosite (Brown)<br>Chrysotile (White) |
| <b>Material</b> Lagging<br><b>Type</b> | <b>Quantity</b> Debris | <b>Sample No</b> 06/B/8026/150<br><br><b>Survey Date</b> 24.04 - 29.06.06<br><br><b>Date of Report</b> 18.08.06<br><br><b>Surveyor(s)</b> <span style="background-color: black; color: black;">[REDACTED]</span> |

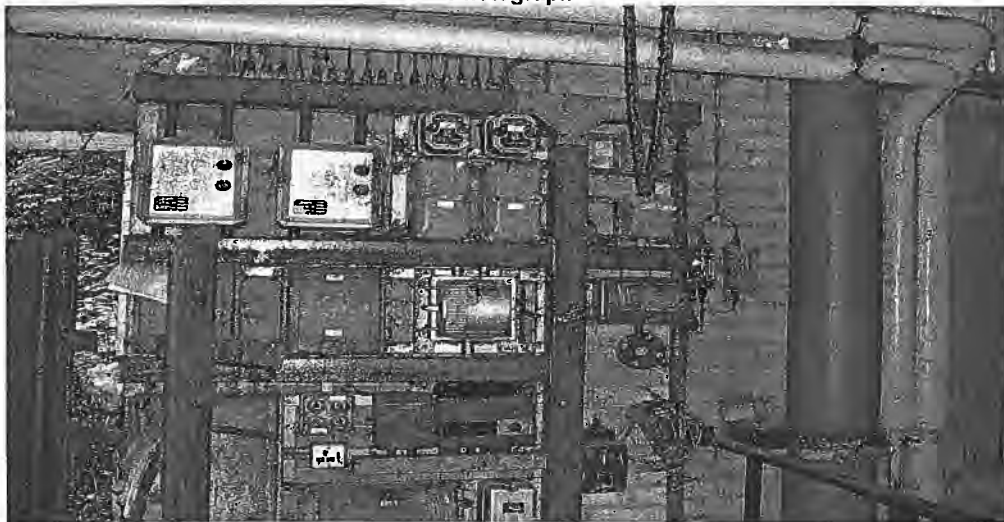
**Photograph**

| <b>Location of Survey</b><br>Cane Hill Hospital,<br>Cane Hill,<br>Coulston, Surrey,<br>CR5 3ES | | <b>Position of Sample/Photo</b><br>Boiler House adjacent to<br>Johnson /Jenner Ward<br>Electrics | <b>Asbestos</b><br><br><b>Type</b> | Yes, Strongly<br>Presumed<br><br>Chrysotile (White) |
| <b>Material Type</b> | Rope &<br>Cement | <b>Quantity</b> | 2m | <b>Sample No</b> As 06/B/8026/9<br>& 22 & 28<br><br><b>Survey Date</b> 24.04 - 29.06.06<br><br><b>Date of Report</b> 18.08.06<br><br><b>Surveyor(s)</b> <span style="background-color: black; color: black;">[REDACTED]</span> |

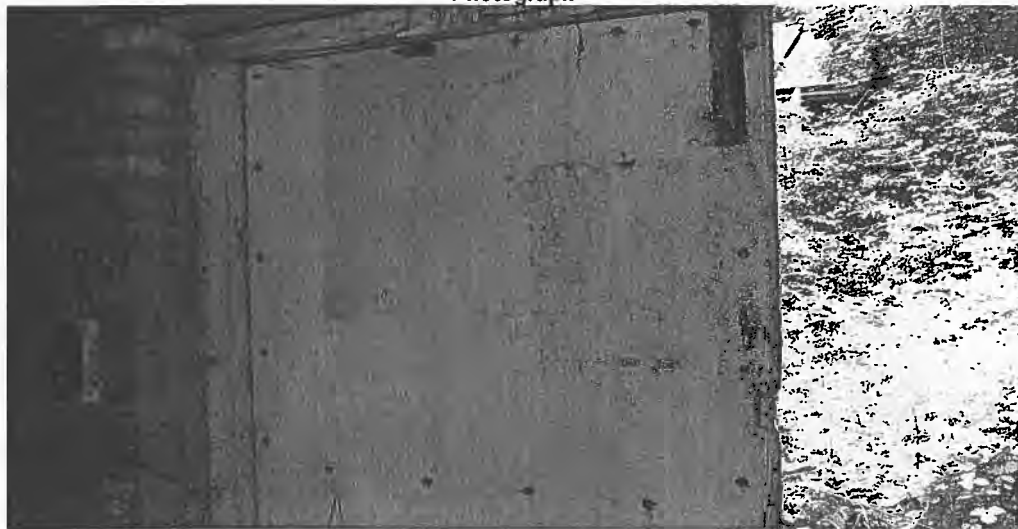
**Photograph**

| <b>Location of Survey</b><br><br>Cane Hill Hospital,<br>Cane Hill,<br>Coulsdon, Surrey,<br>CR5 3ES | <b>Position of Sample/Photo</b><br><br>Boiler block adjacent<br>Johnson/Jenner Ward<br>Door Panel | <table style="width: 100%;"> <tr> <td style="width: 50%;"><b>Asbestos</b></td> <td>Yes</td> </tr> <tr> <td><b>Type</b></td> <td>Amosite (Brown)<br/>Chrysotile (White)</td> </tr> </table> | <b>Asbestos</b> | Yes | <b>Type</b> | Amosite (Brown)<br>Chrysotile (White) | | | | |
| <b>Material Type</b> Board | <b>Quantity</b> 4m <sup>2</sup> | <table style="width: 100%;"> <tr> <td style="width: 50%;"><b>Sample No</b></td> <td>06/B/8026/151</td> </tr> <tr> <td><b>Survey Date</b></td> <td>24.04 - 29.06.06</td> </tr> <tr> <td><b>Date of Report</b></td> <td>18.08.06</td> </tr> <tr> <td><b>Surveyor(s)</b></td> <td style="background-color: black; color: black;">[REDACTED]</td> </tr> </table> | <b>Sample No</b> | 06/B/8026/151 | <b>Survey Date</b> | 24.04 - 29.06.06 | <b>Date of Report</b> | 18.08.06 | <b>Surveyor(s)</b> | [REDACTED] |

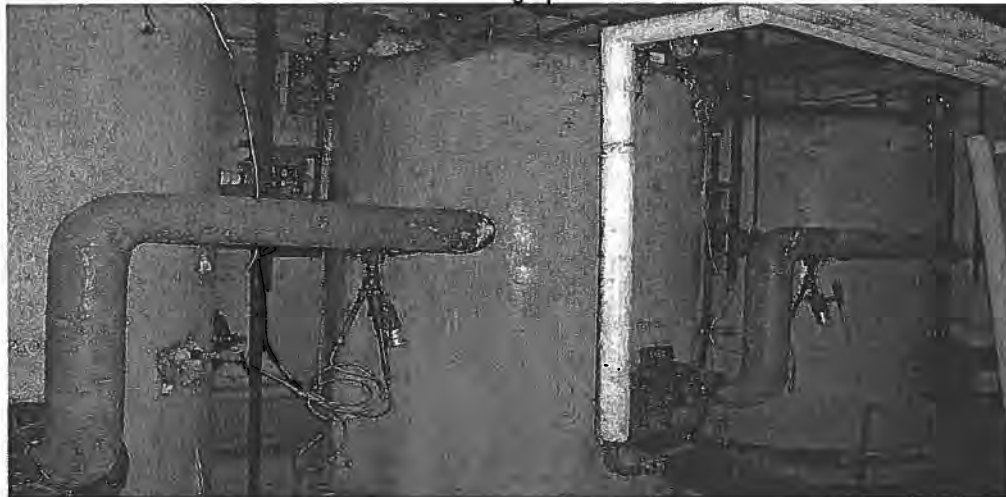
**Photograph**

| <b>Location of Survey</b><br>Cane Hill Hospital,<br>Cane Hill,<br>Coulsdon, Surrey,<br>CR5 3ES | <b>Position of Sample/Photo</b><br>Boiler Block adjacent<br>Johnson/Jenner Ward<br>Red Pipe lagging | <b>Asbestos</b> Yes, Strongly Presumed<br><br><b>Type</b> Amosite (Brown) |
| <b>Material Type</b> Lagging | <b>Quantity</b> 100m | <b>Sample No</b> 06/B/8026/152<br><br><b>Survey Date</b> 24.04 - 29.06.06<br><br><b>Date of Report</b> 18.08.06<br><br><b>Surveyor(s)</b> <span style="background-color: black; color: black;">[REDACTED]</span> |

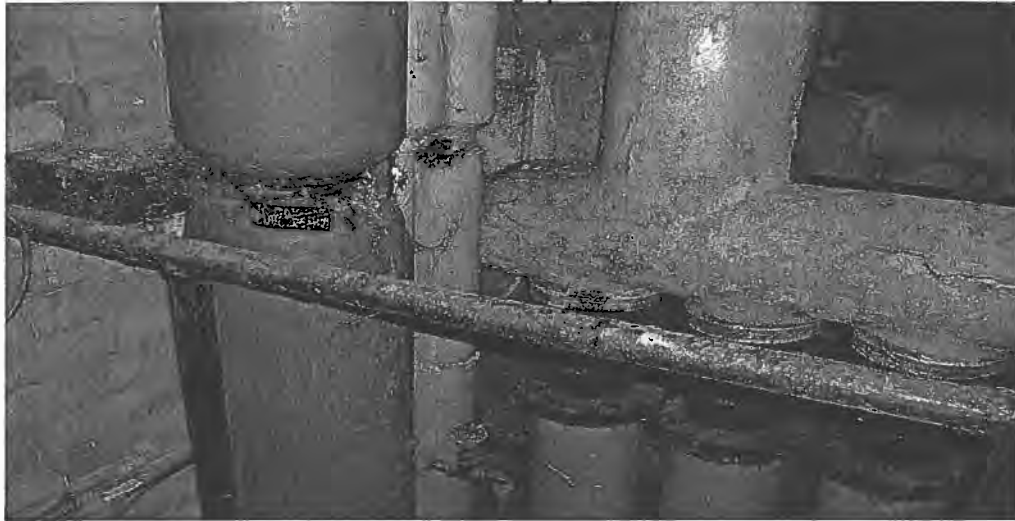
**Photograph**

| <b>Location of Survey</b><br>Cane Hill Hospital,<br>Cane Hill,<br>Coulsdon, Surrey,<br>CR5 3ES | <b>Position of Sample/Photo</b><br>Boiler Block adjacent<br>Johnson/Jenner Ward<br>Pipes entering duct | <b>Asbestos</b><br><br><b>Type</b> | Yes, Strongly<br>Presumed<br><br>Amosite (Brown) |
| <b>Material Type</b><br>Lagging | <b>Quantity</b><br>10m | <b>Sample No</b><br><br><b>Survey Date</b><br><br><b>Date of Report</b><br><br><b>Surveyor(s)</b> | As 06/B/8026/152<br><br>24.04 – 29.06.06<br><br>18.08.06<br><div style="background-color: black; width: 100px; height: 40px; margin-top: 5px;"></div> |

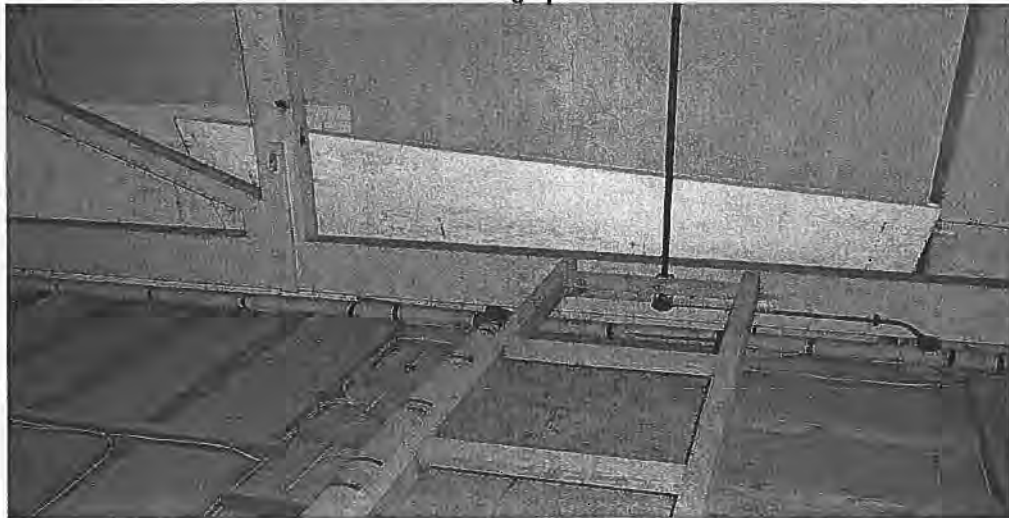
### Photograph

| <b>Location of Survey</b><br>Cane Hill Hospital,<br>Cane Hill,<br>Coulsdon, Surrey,<br>CR5 3ES | <b>Position of Sample/Photo</b><br>Nurses Block adjacent<br>King/Keats Ward<br>Panels in loft(x12) | <b>Asbestos</b> Yes<br><br><b>Type</b> Amosite (Brown) |
| <b>Material Type</b> Board | <b>Quantity</b> 60m <sup>2</sup> | <b>Sample No</b> 06/B/8026/153<br><br><b>Survey Date</b> 24.04 - 29.06.06<br><br><b>Date of Report</b> 18.08.06<br><br><b>Surveyor(s)</b> <span style="background-color: black; color: black;">[REDACTED]</span> |

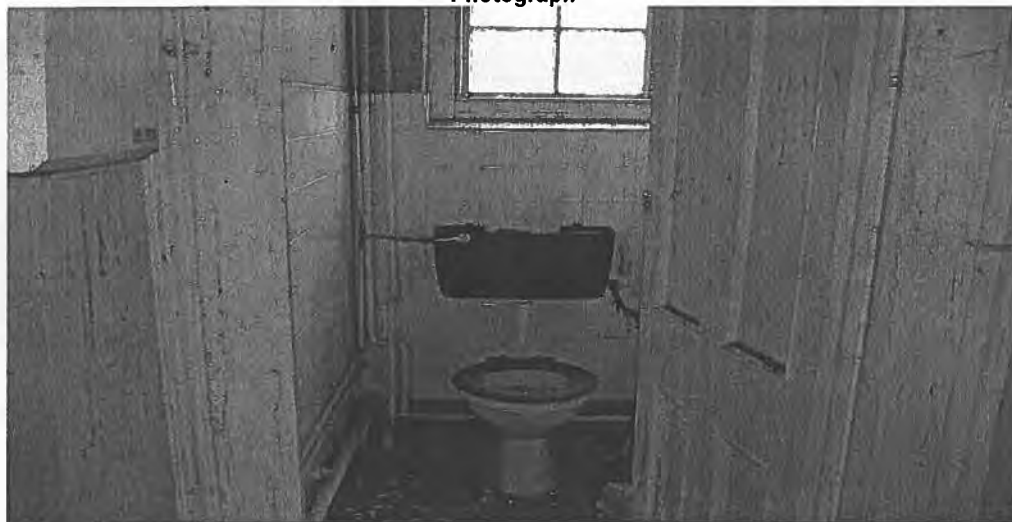
**Photograph**

| <b>Location of Survey</b><br>Cane Hill Hospital,<br>Cane Hill,<br>Coulson, Surrey,<br>CR5 3ES | | <b>Position of Sample/Photo</b><br>Nurse Block Staff Wing<br>W.C. Cistern (X11) | | <b>Asbestos</b> | Yes, Strongly<br>Presumed |
| <b>Material Type</b> Plastic | | <b>Quantity</b> 1m <sup>2</sup> each | | <b>Type</b> | Amosite (Brown) |

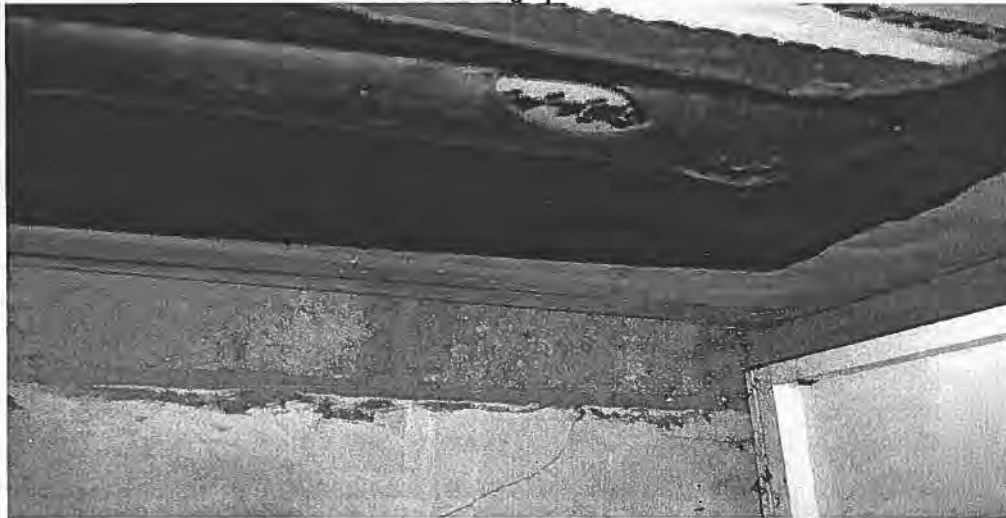
**Photograph**

| <b>Location of Survey</b><br>Cane Hill Hospital,<br>Cane Hill,<br>Coulston, Surrey,<br>CR5 3ES | | <b>Position of Sample/Photo</b><br>Nurse Block<br>Sink Pad (X6) | <b>Asbestos</b><br><br><b>Type</b> | Yes, Strongly<br>Presumed<br><br>Chrysotile (White) |
| <b>Material Type</b> | Bitumen | <b>Quantity</b> | <1m <sup>2</sup> | <b>Sample No</b><br>As 06/B/8026/64<br><br><b>Survey Date</b><br>24.04 - 29.06.06<br><br><b>Date of Report</b><br>18.08.06<br><br><b>Surveyor(s)</b> |

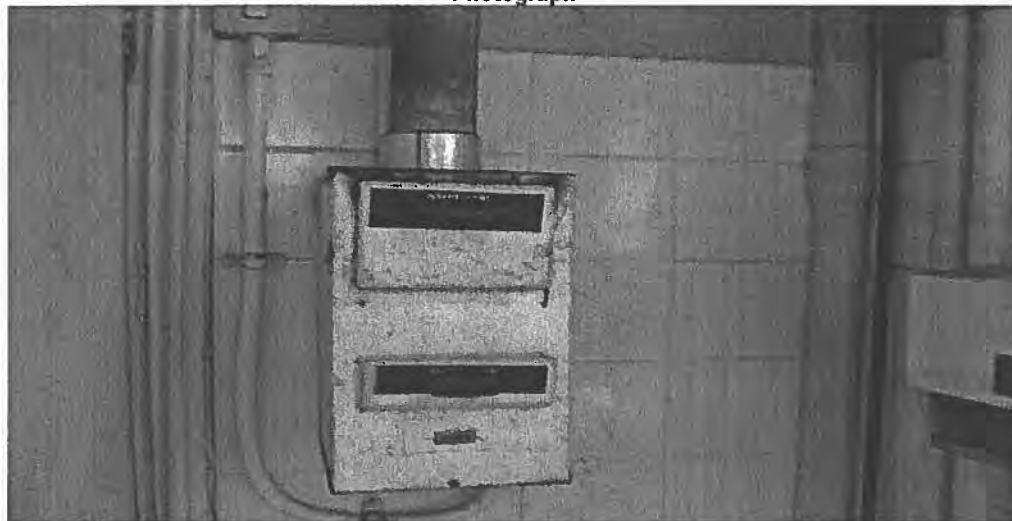
**Photograph**

| <b>Location of Survey</b><br>Cane Hill Hospital,<br>Cane Hill,<br>Coulsdon, Surrey,<br>CR5 3ES | | <b>Position of Sample/Photo</b><br>Nurses Block adjacent King/<br>Keats Ward<br>Flue pipe & Cement sheet in<br>bunny boiler, ( to all floors X3) | | <b>Asbestos</b><br><br><b>Type</b> | <b>Yes</b><br><br>Chrysotile (White) |
| <b>Material Type</b> | Cement | <b>Quantity</b> | 2m <sup>2</sup> (X3) | <b>Sample No</b> | 06/B/8026/154 |

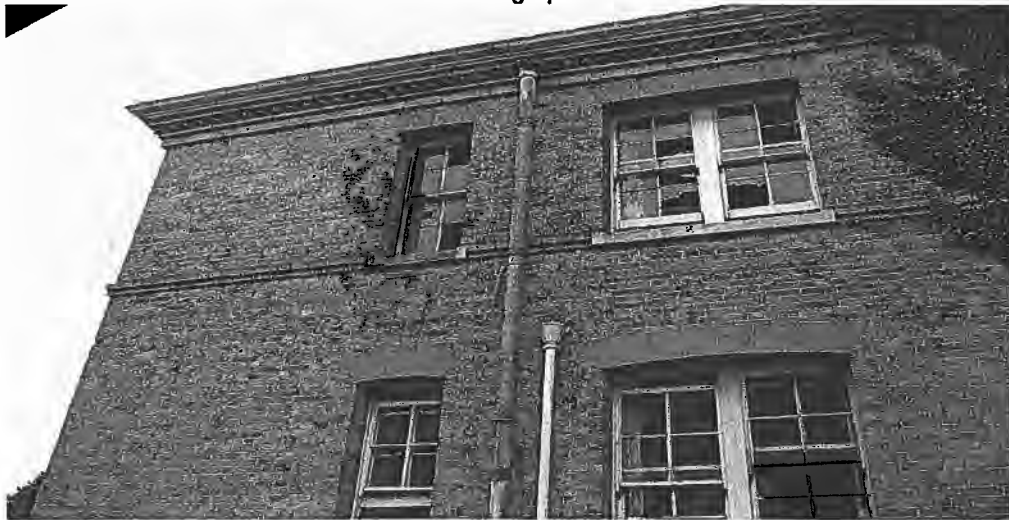
**Photograph**

| <b>Location of Survey</b><br>Cane Hill Hospital,<br>Cane Hill,<br>Coulston, Surrey,<br>CR5 3ES | | <b>Position of Sample/Photo</b><br>Nurses Block<br>External Flue pipe | <b>Asbestos</b><br><br><b>Type</b> | Yes, Strongly<br>Presumed<br><br>Chrysotile (White) |
| <b>Material Type</b> | Cement | <b>Quantity</b> | 8m | <b>Sample No</b> As 06/B/8026/154<br><b>Survey Date</b> 24.04 - 29.06.06<br><b>Date of Report</b> 18.08.06<br><b>Surveyor(s)</b> <span style="background-color: black; color: black;">[REDACTED]</span> |

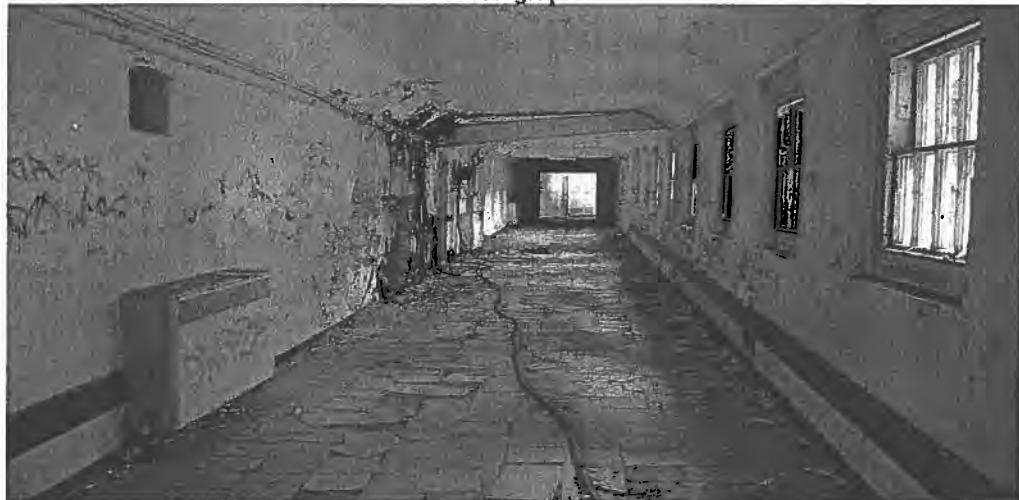
**Photograph**

| <b>Location of Survey</b><br>Cane Hill Hospital,<br>Cane Hill,<br>Coulsdon, Surrey,<br>CR5 3ES | | <b>Position of Sample/Photo</b><br>Kings/Keats Link Corridor<br>Floor Tiles | | <b>Asbestos</b><br><br><b>Type</b> | Yes, Strongly<br>presumed<br><br>Chrysotile (White) |
| <b>Material Type</b> | Vinyl | <b>Quantity</b> | 120m | <b>Sample No</b> | As 06/B/8026/99 |

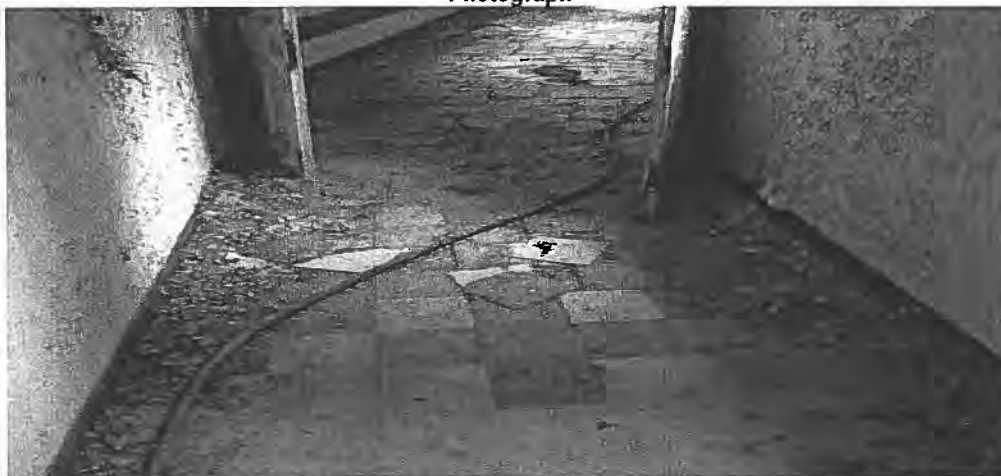
**Photograph**

| <b>Location of Survey</b><br>Cane Hill Hospital,<br>Cane Hill,<br>Coulsdon, Surrey,<br>CR5 3ES | <b>Position of Sample/Photo</b><br>Nurses Wing Link Corridor<br>Floor Tiles | <b>Asbestos</b> Yes, Strongly<br>presumed<br><br><b>Type</b> Chrysotile (White) |
| <b>Material Type</b> Vinyl | <b>Quantity</b> 60m <sup>2</sup> | <b>Sample No</b> As 06/B/8026/100<br><br><b>Survey Date</b> 24.04 – 29.06.06<br><br><b>Date of Report</b> 18.08.06<br><br><b>Surveyor(s)</b> <span style="background-color: black; color: black;">[REDACTED]</span> |

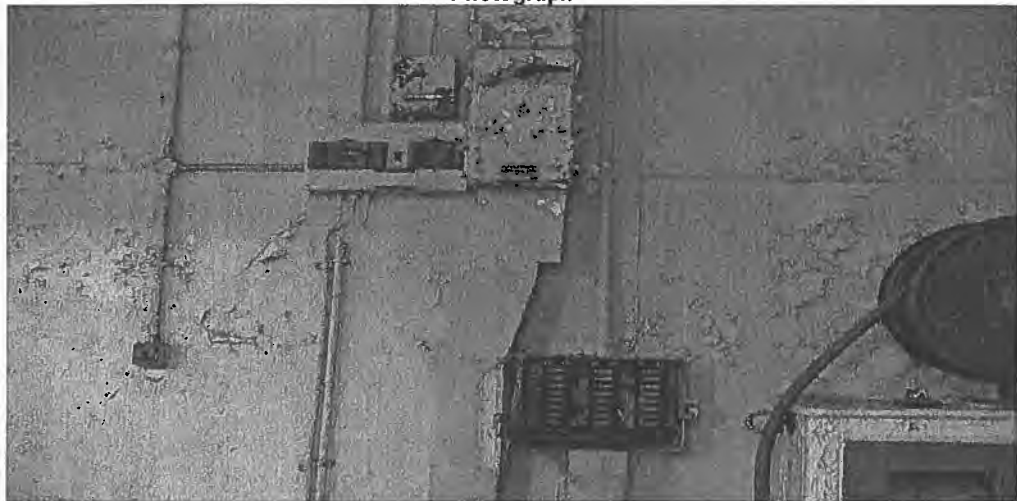
**Photograph**

| <b>Location of Survey</b><br>Cane Hill Hospital,<br>Cane Hill,<br>Coulsdon, Surrey,<br>CR5 3ES | | <b>Position of Sample/Photo</b><br>Lidgett/Lettsom Ward<br>Electrics | | <b>Asbestos</b><br><br><b>Type</b> | Yes, Strongly<br>presumed<br><br>Chrysotile (White) |
| <b>Material Type</b><br>Rope | | <b>Quantity</b><br>1m <sup>2</sup> | | <b>Sample No</b> | As 06/B/8026/22 |

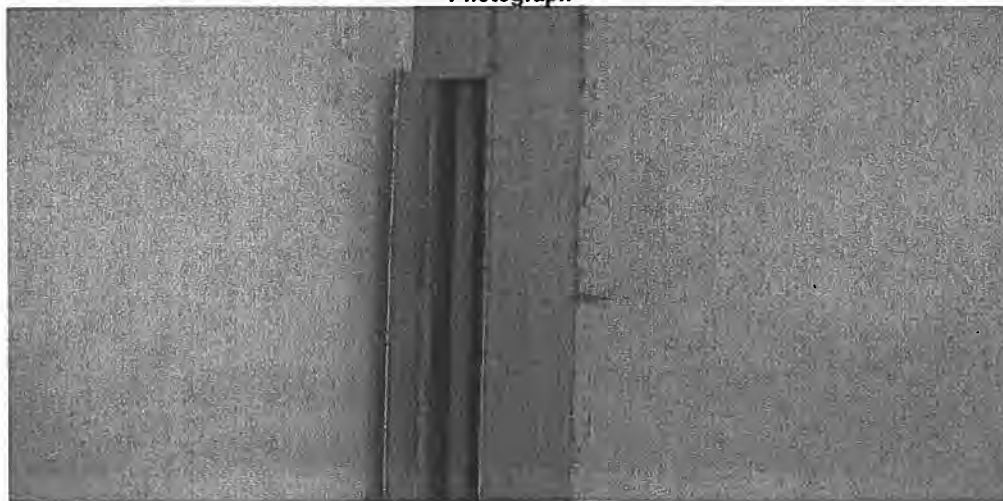
**Photograph**

| <b>Location of Survey</b><br>Cane Hill Hospital,<br>Cane Hill,<br>Coulston, Surrey,<br>CR5 3ES | | <b>Position of Sample/Photo</b><br>Lidgett/Lettsom Ward<br>Riser<br>Rope lagging to pipe | | <b>Asbestos</b><br><br><b>Type</b> | Yes, Strongly<br>Presumed<br><br>Chrysotile (White) |
| <b>Material Type</b><br>Rope | | <b>Quantity</b><br>4m | | <b>Sample No</b> | As 06/B/8026/58 |

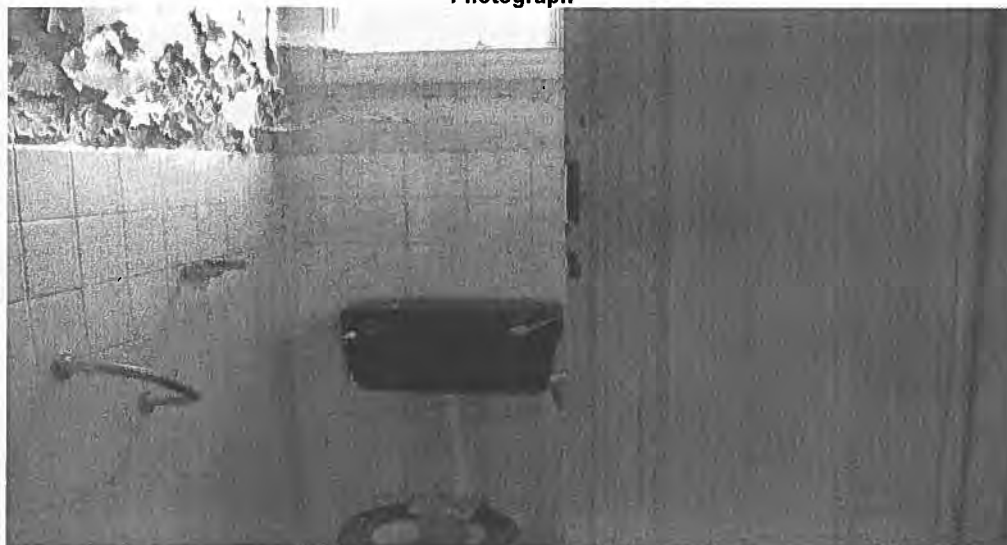
**Photograph**

| <b>Location of Survey</b><br>Cane Hill Hospital,<br>Cane Hill,<br>Coulston, Surrey,<br>CR5 3ES | | <b>Position of Sample/Photo</b><br>Lidgett/Lettsom Ward<br>W.C. Cistern | | <b>Asbestos</b><br><br><b>Type</b> | Yes, Strongly<br>Presumed<br><br>Amosite (Brown) |
| <b>Material Type</b> | Plastic | <b>Quantity</b> | 1m <sup>2</sup> | <b>Sample No</b> | As 06/B/8026/5 |

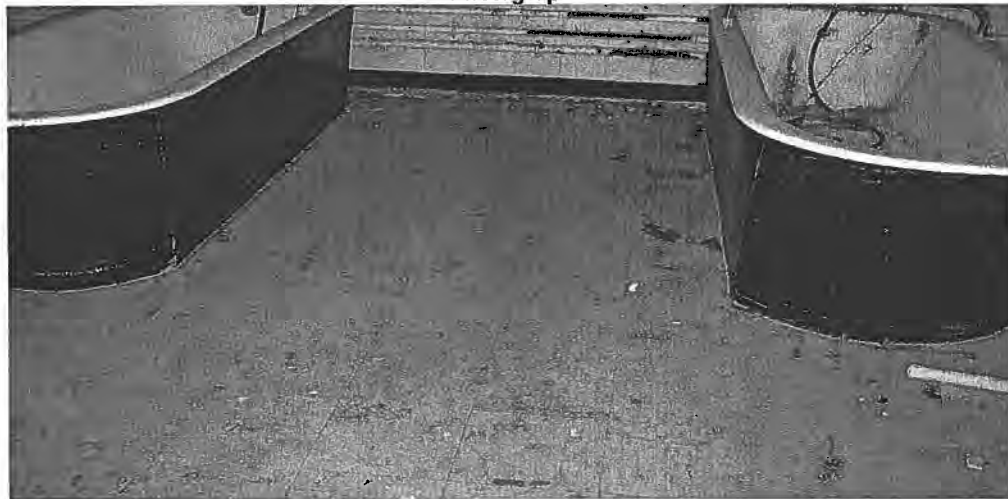
**Photograph**

| <b>Location of Survey</b><br>Cane Hill Hospital,<br>Cane Hill,<br>Coulsdon, Surrey,<br>CR5 3ES | <b>Position of Sample/Photo</b><br>Lidgett/Lettsom Ward<br>Bathroom Floor Tile | <b>Asbestos</b> Yes, Strongly presumed<br><br><b>Type</b> Chrysotile (White) |
| <b>Material Type</b> Vinyl | <b>Quantity</b> 24m | <b>Sample No</b> As 06/B/8026/63<br><br><b>Survey Date</b> 24.04 - 29.06.06<br><br><b>Date of Report</b> 18.08.06<br><br><b>Surveyor(s)</b> <span style="background-color: black; color: black;">[REDACTED]</span> |

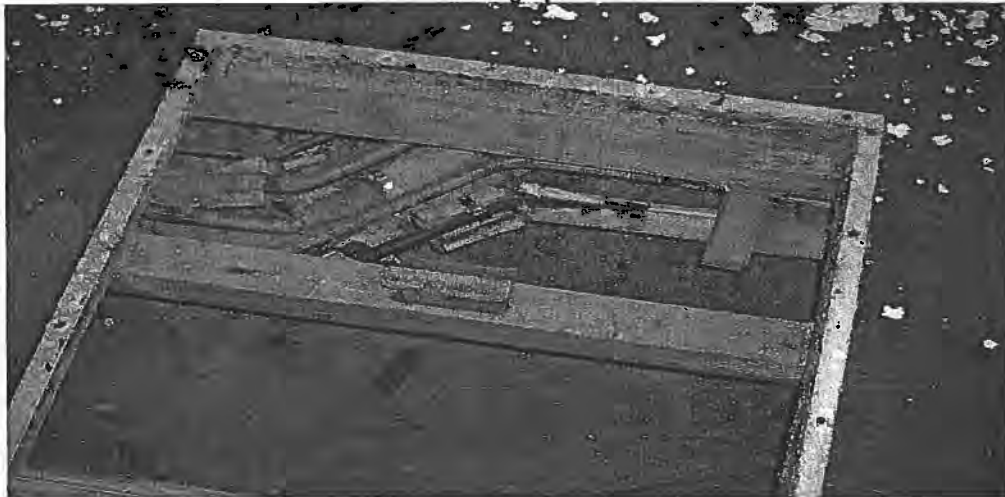
| <b>Location of Survey</b><br>Cane Hill Hospital,<br>Cane Hill,<br>Coulston, Surrey,<br>CR5 3ES | | <b>Position of Sample/Photo</b><br>Lidgett/Lettsom Ward<br>Paper insert to pipe lagging,<br>undercroft (presumed<br>throughout) | | <b>Asbestos</b> Yes |
| <b>Material Type</b> Paper | | <b>Quantity</b> 1m <sup>2</sup> | | <b>Type</b> Chrysotile (White) |
| | | | | <b>Sample No</b> 06/B/8026/155 |

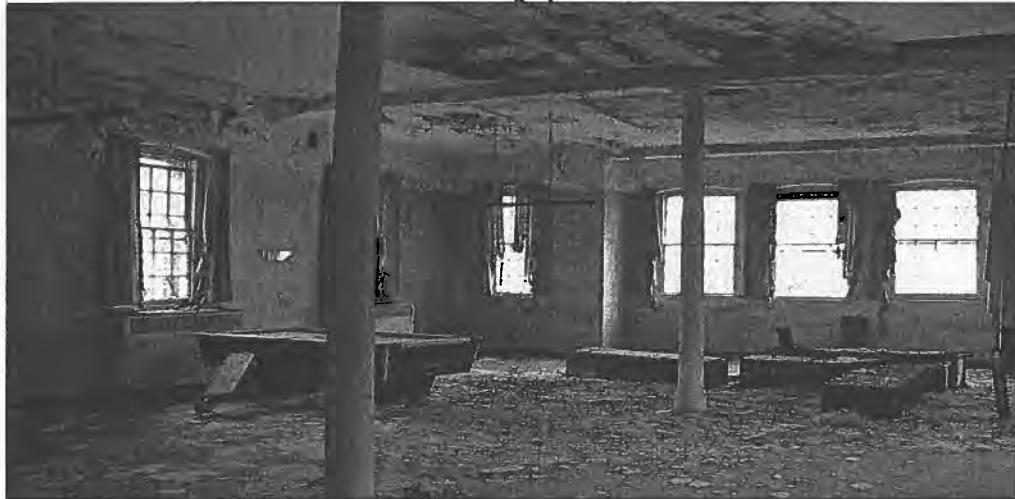
| <b>Location of Survey</b><br>Cane Hill Hospital,<br>Cane Hill,<br>Coulsdon, Surrey,<br>CR5 3ES | | <b>Position of Sample/Photo</b><br>Ledgitt/Lettsom Ward<br>Textured coating to pillars, 1 <sup>st</sup><br>floor, | <b>Asbestos</b><br><br><b>Type</b> | None Detected<br><br>N/A |
| <b>Material Type</b> | Textured coating | <b>Quantity</b> | 1m <sup>2</sup> | <b>Sample No</b> 06/B/8026/156<br><br><b>Survey Date</b> 24.04 - 29.06.06<br><br><b>Date of Report</b> 18.08.06<br><br><b>Surveyor(s)</b> <span style="background-color: black; color: black;">[REDACTED]</span> |

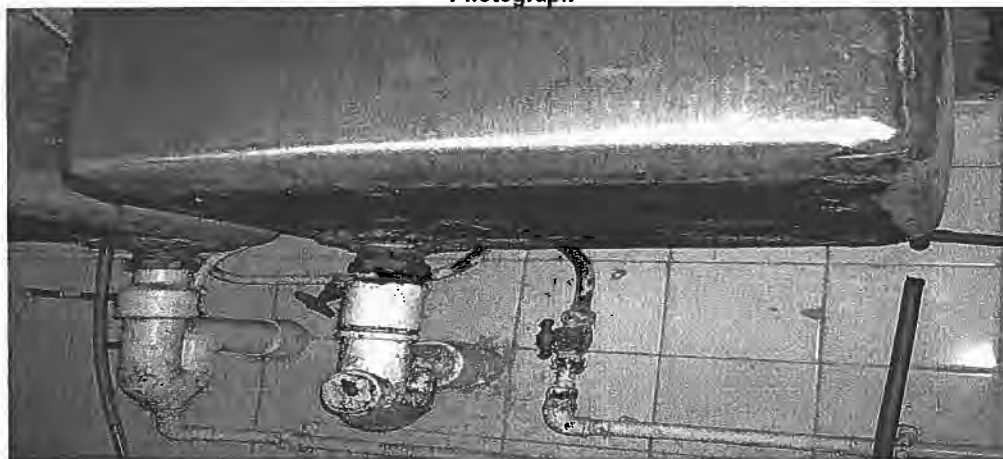
| <b>Location of Survey</b><br>Cane Hill Hospital,<br>Cane Hill,<br>Coulsdon, Surrey,<br>CR5 3ES | | <b>Position of Sample/Photo</b><br>Lidgett/Lettsom Ward<br>Kitchen Sink Paint | <b>Asbestos</b> Yes |
| | | | <b>Type</b> Chrysotile (White) |
| <b>Material Type</b> Bitumen | <b>Quantity</b> 1m <sup>2</sup> | <b>Sample No</b> 06/B/8026/157 | |

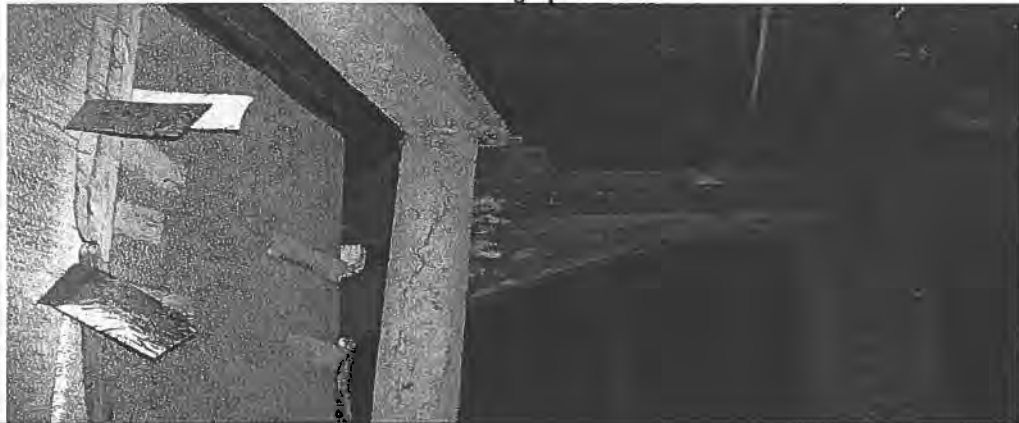
| <b>Location of Survey</b><br>Cane Hill Hospital,<br>Cane Hill,<br>Coulsdon, Surrey,<br>CR5 3ES | <b>Position of Sample/Photo</b><br>Lidgitt/Lettsom Ward<br>Loft,<br>Pipe lagging adjacent tank | <b>Asbestos</b> Yes<br><br><b>Type</b> Chrysotile (White)<br>Crocidolite (Blue) | |
| <b>Material Type</b> Lagging | <b>Quantity</b> 1m <sup>2</sup> | <b>Sample No</b> 06/B/8026/226<br><br><b>Survey Date</b> 24.04 - 29.06.06<br><br><b>Date of Report</b> 18.08.06<br><br><b>Surveyor(s)</b> <span style="background-color: black; color: black;">[REDACTED]</span> | |

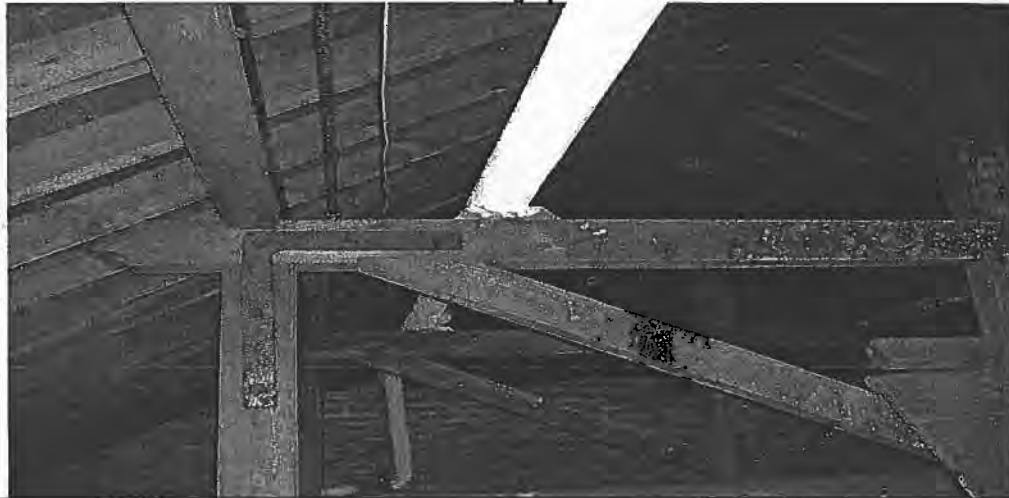
| <b>Location of Survey</b><br>Cane Hill Hospital,<br>Cane Hill,<br>Coulson, Surrey,<br>CR5 3ES | | <b>Position of Sample/Photo</b><br>Lidgitt/Lettsom Ward,<br>Loft, Pipe lagging | <b>Asbestos</b><br><br><b>Type</b> | Yes, Strongly<br>Presumed<br><br>Chrysotile (White)<br>Crocidolite (Blue) |
| <b>Material Type</b> | Lagging | <b>Quantity</b> | 100m | <b>Sample No</b> As 06/B/8026/226<br><br><b>Survey Date</b> 24.04 - 29.06.06<br><br><b>Date of Report</b> 18.08.06<br><br><b>Surveyor(s)</b> <span style="background-color: black; color: black;">[REDACTED]</span> |

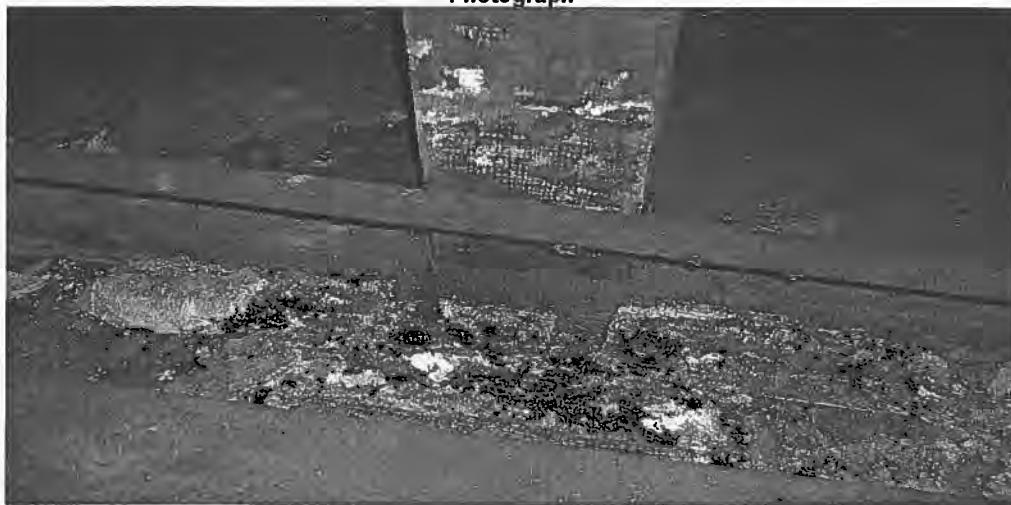
| <b>Location of Survey</b><br>Cane Hill Hospital,<br>Cane Hill,<br>Coulston, Surrey,<br>CR5 3ES | | <b>Position of Sample/Photo</b><br>Lidgitt/Lettsom Ward<br>Loft, Pipe lagging debris | | <b>Asbestos</b><br><br><b>Type</b> | Yes, Strongly<br>Presumed<br><br>Chrysotile (White)<br>Crocidolite (Blue) |
| <b>Material Type</b> | Lagging | <b>Quantity</b> | <1m | <b>Sample No</b> | As 06/B/8026/226 |

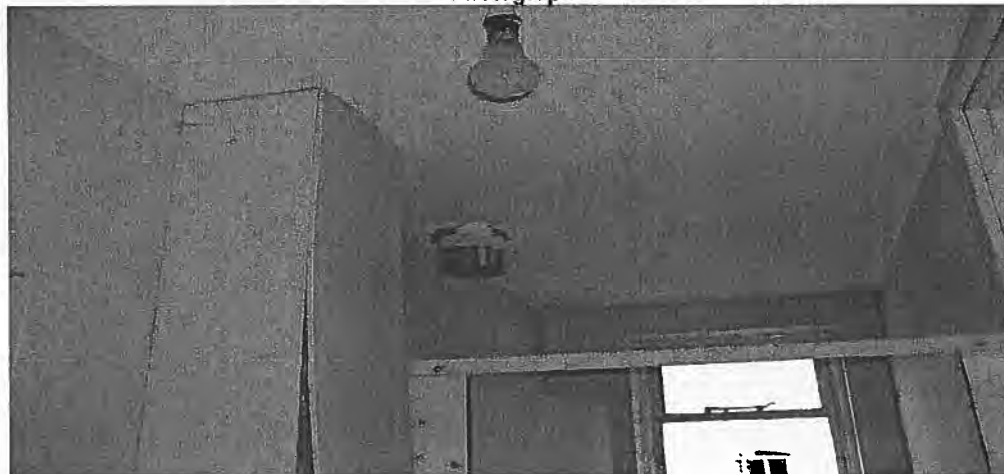
| <b>Location of Survey</b><br>Cane Hill Hospital,<br>Cane Hill,<br>Coulson, Surrey,<br>CR5 3ES | <b>Position of Sample/Photo</b><br>Art Therapy<br>Flue pipe adjacent boxing | <b>Asbestos</b> Yes, Strongly presumed<br><br><b>Type</b> Chrysotile (White) |
| <b>Material Type</b> Cement | <b>Quantity</b> 2m | <b>Sample No</b> As 06/B/8026/154<br><br><b>Survey Date</b> 24.04 - 29.06.06<br><br><b>Date of Report</b> 18.08.06<br><b>Surveyor(s)</b> <span style="background-color: black; color: black;">[REDACTED]</span> |

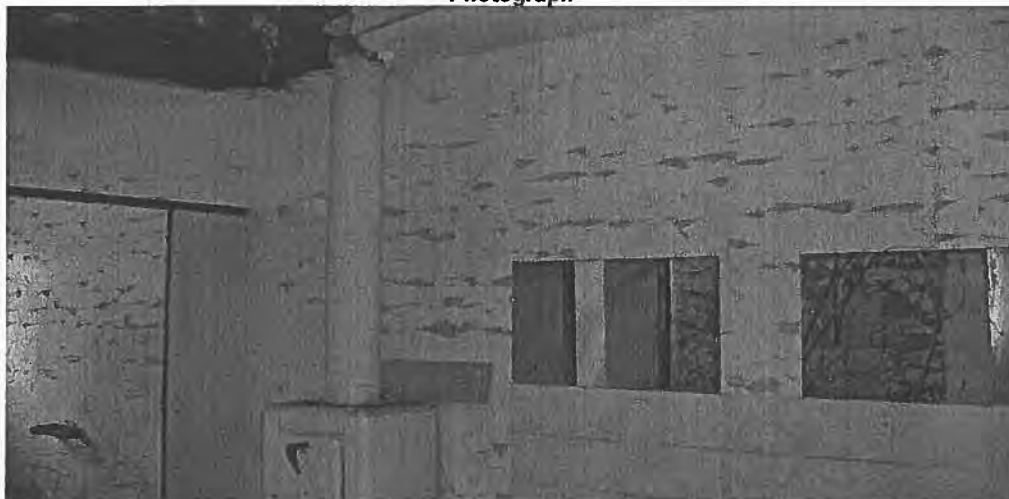
| <b>Location of Survey</b><br>Cane Hill Hospital,<br>Cane Hill,<br>Coulston, Surrey,<br>CR5 3ES | | <b>Position of Sample/Photo</b><br>Art Therapy<br>WC adjacent Corridor<br>Bunny Boiler & Flue pipe | | <b>Asbestos</b><br><br><b>Type</b> | Yes, Strongly<br>Presumed<br><br>Chrysotile (White) |
| <b>Material Type</b> | Cement | <b>Quantity</b> | 1m | <b>Sample No</b> | As 06/B/8026/154 |

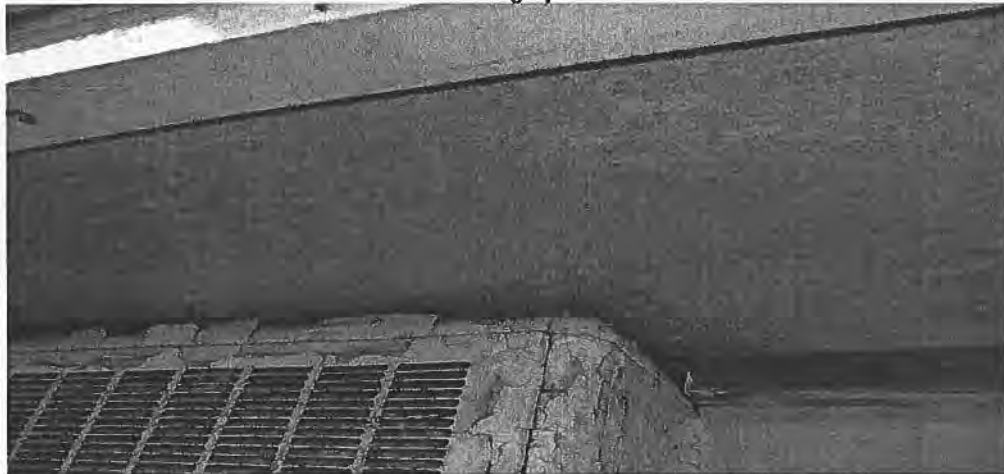
| <b>Location of Survey</b><br>Cane Hill Hospital,<br>Cane Hill,<br>Coulsdon, Surrey,<br>CR5 3ES | <b>Position of Sample/Photo</b><br>Art Therapy<br>Kitchen<br>Cement panel under sideboard | <b>Asbestos</b> Yes<br><br><b>Type</b> Chrysotile (White) |
| <b>Material Type</b> Cement | <b>Quantity</b> 2m | <b>Sample No</b> 06/B/8026/158<br><br><b>Survey Date</b> 24.04 - 29.06.06<br><br><b>Date of Report</b> 18.08.06<br><br><b>Surveyor(s)</b> <span style="background-color: black; color: black;">[REDACTED]</span> |

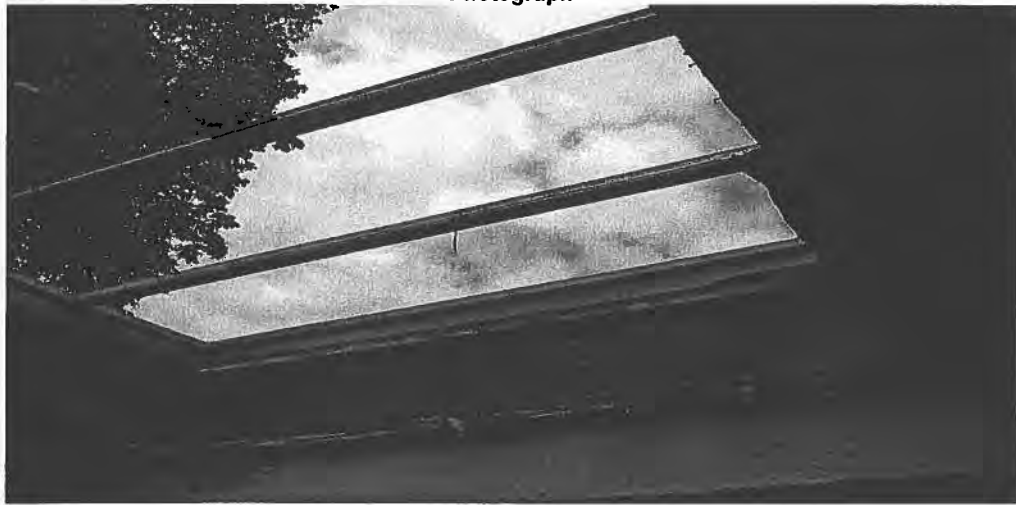
| <b>Location of Survey</b><br>Cane Hill Hospital,<br>Cane Hill,<br>Coulston, Surrey,<br>CR5 3ES | | <b>Position of Sample/Photo</b><br>Art Therapy<br>Skylight (X4)<br>Rope seal | | <b>Asbestos</b><br><br><b>Type</b> | <b>Yes, Strongly Presumed</b><br><br>Chrysotile (White) |
| <b>Material Type</b> | Rope | <b>Quantity</b> | 40m | <b>Sample No</b> | As 06/B/8026/31 |

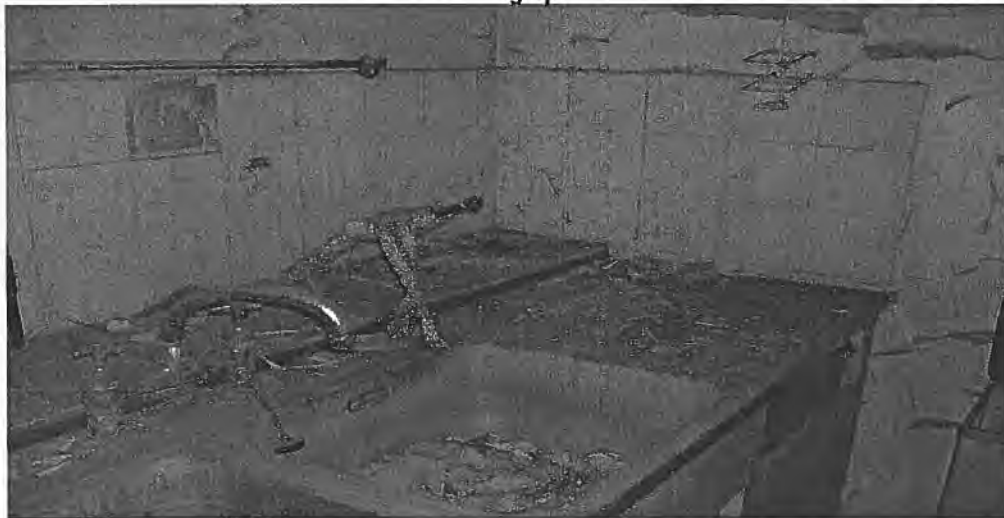
| <b>Location of Survey</b><br>Cane Hill Hospital,<br>Cane Hill,<br>Coulsdon, Surrey,<br>CR5 3ES | | <b>Position of Sample/Photo</b><br>Art Therapy<br>Kitchen<br>Rope to Pipe | | <b>Asbestos</b><br><br><b>Type</b> | Yes, Strongly<br>Presumed<br><br>Chrysotile (White) |
| <b>Material Type</b><br>Rope | | <b>Quantity</b><br><1m | | <b>Sample No</b> | As 06/B/8026/58 |

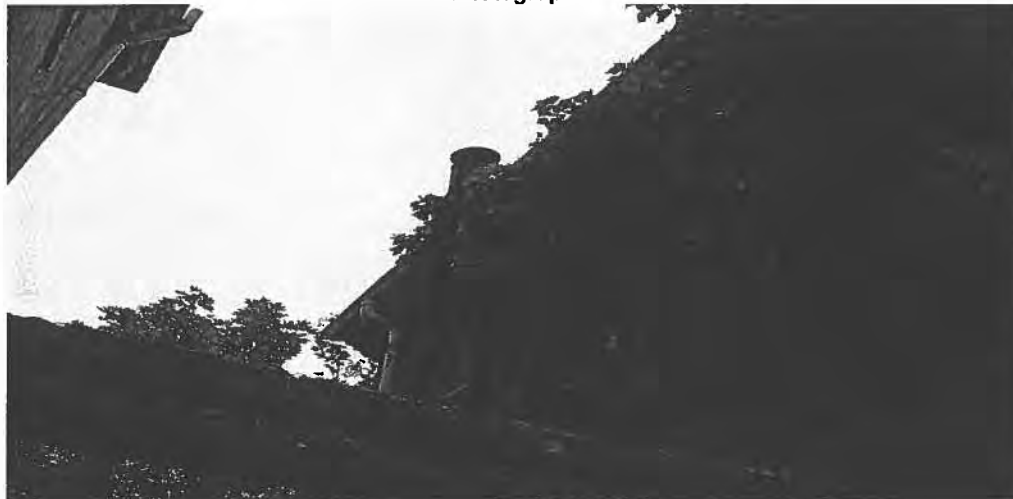
| <b>Location of Survey</b><br>Cane Hill Hospital,<br>Cane Hill,<br>Coulston, Surrey,<br>CR5 3ES | | <b>Position of Sample/Photo</b><br>Art Therapy<br>External flue pipe | <b>Asbestos</b><br><br><b>Type</b> | <b>Yes, Strongly Presumed</b><br><br>Chrysotile (White) |
| <b>Material Type</b> | Cement | <b>Quantity</b> | <1m <sup>2</sup> | <b>Sample No</b> As 06/B/8026/154<br><br><b>Survey Date</b> 24.04 - 29.06.06<br><br><b>Date of Report</b> 18.08.06<br><br><b>Surveyor(s)</b> <span style="background-color: black; color: black;">[REDACTED]</span> |

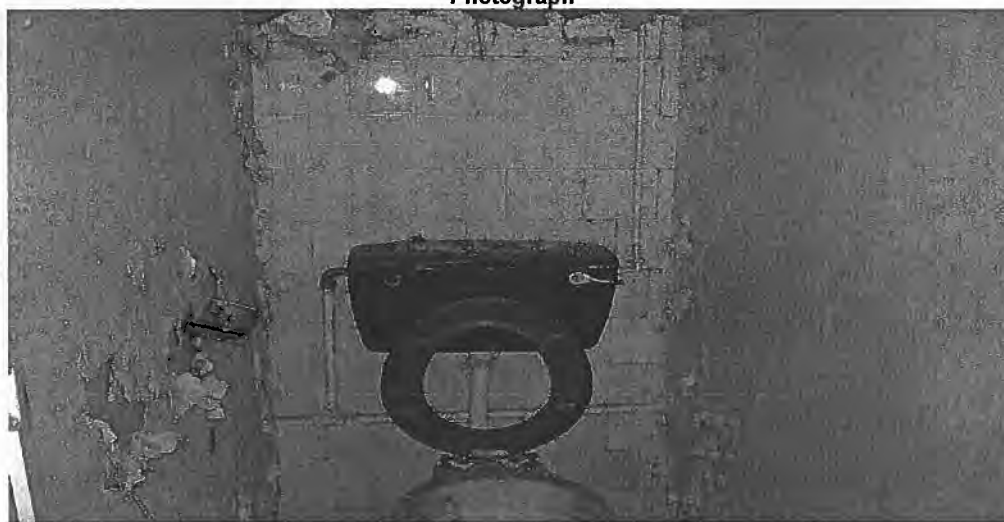
| <b>Location of Survey</b><br>Cane Hill Hospital,<br>Cane Hill,<br>Coulsdon, Surrey,<br>CR5 3ES | | <b>Position of Sample/Photo</b><br>Art Therapy<br>W.C. Cistern (X3) | <b>Asbestos</b><br><br><b>Type</b> | Yes, Strongly<br>Presumed<br><br>Amosite (Brown) |
| <b>Material Type</b> | Plastic | <b>Quantity</b> | 1m | <b>Sample No</b> As 06/B/8026/5<br><b>Survey Date</b> 24.04 - 29.06.06<br><b>Date of Report</b> 18.08.06<br><b>Surveyor(s)</b> <span style="background-color: black; color: black;">[REDACTED]</span> |

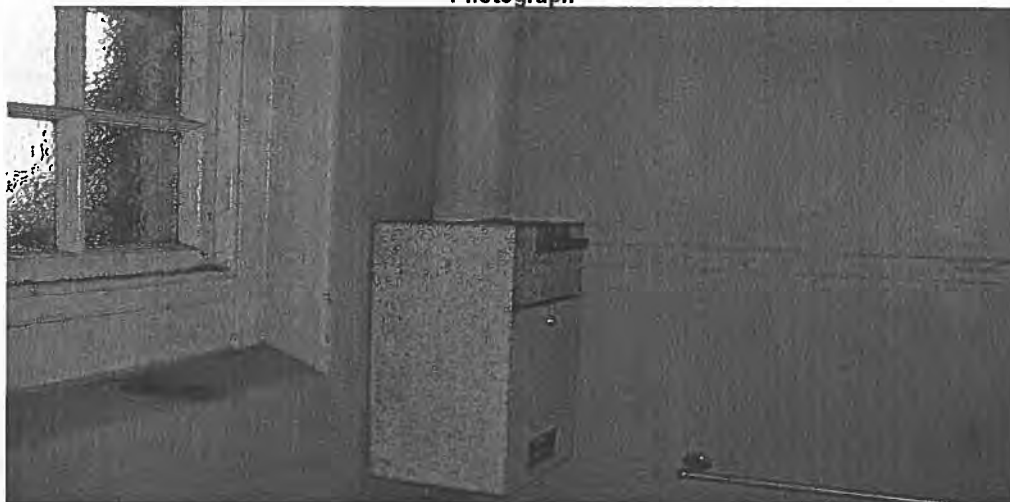
| <b>Location of Survey</b><br>Cane Hill Hospital,<br>Cane Hill,<br>Coulston, Surrey,<br>CR5 3ES | | <b>Position of Sample/Photo</b><br>Art Therapy<br>First Floor end of Corridor<br>Bathroom<br>Bunny Boiler & Flue pipe | | <b>Asbestos</b> | Yes, Strongly Presumed |
| | | | | <b>Type</b> | Chrysotile (White) |
| <b>Material Type</b> | Cement | <b>Quantity</b> | 1m | <b>Sample No</b> | As 06/B/8026/154 |

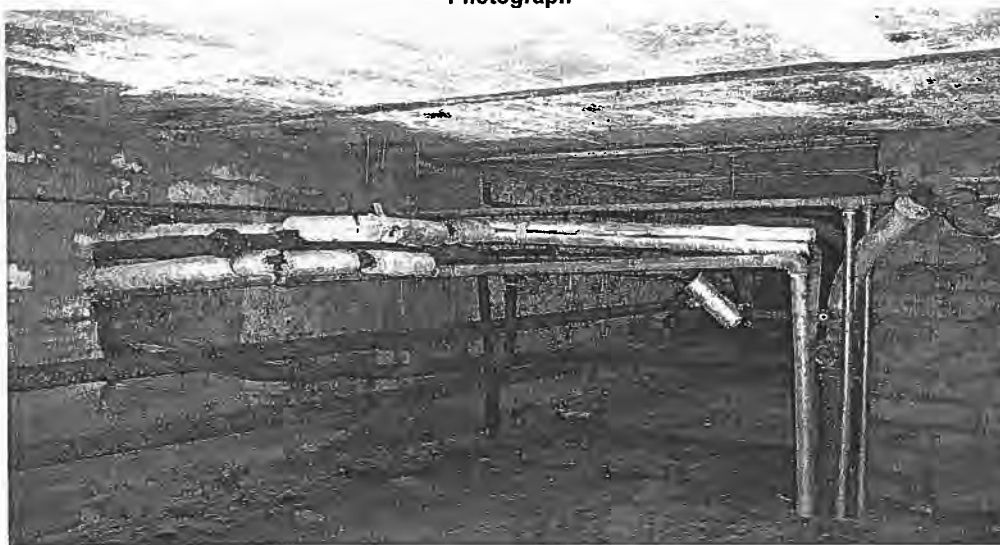
| <b>Location of Survey</b><br>Cane Hill Hospital,<br>Cane Hill,<br>Coulson, Surrey,<br>CR5 3ES | | <b>Position of Sample/Photo</b><br>Canteen<br>Undercroft<br>Foil paper lagging, | | <b>Asbestos</b> Yes |
| <b>Material Type</b> Paper | | <b>Quantity</b> 3m | | <b>Type</b> Chrysotile (White) |
| | | <b>Sample No</b> 06/B/8026/159 | | |

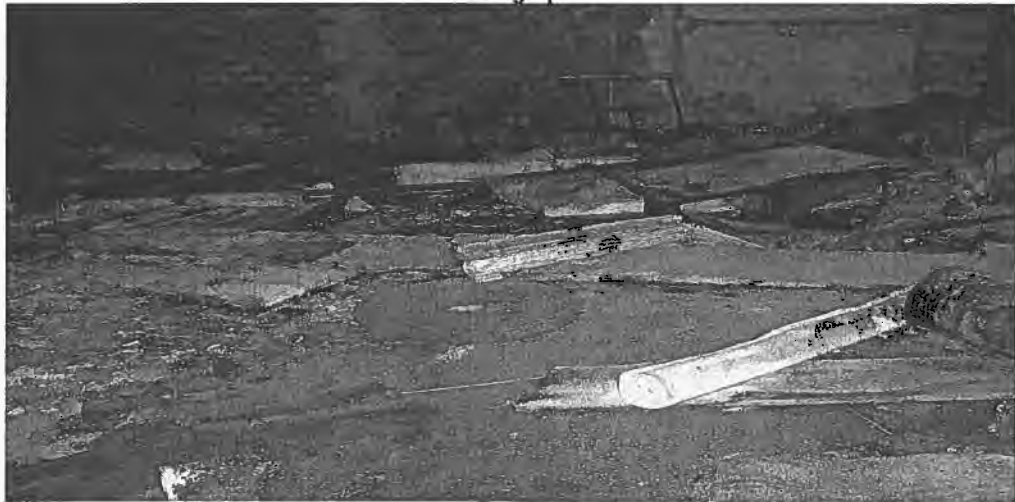
| <b>Location of Survey</b><br>Cane Hill Hospital,<br>Cane Hill,<br>Coulston, Surrey,<br>CR5 3ES | | <b>Position of Sample/Photo</b><br>Canteen<br>Undercroft<br>Foil paper lagging debris | | <b>Asbestos</b><br><br><b>Type</b> | Yes, Strongly<br>presumed<br><br>Chrysotile (White) |
| <b>Material Type</b> | Paper | <b>Quantity</b> | <1m | <b>Sample No</b> | As 06/B/8026/159 |
