## SURVEY INFORMATION SHEET

| <b>Location of Survey</b><br>Cane Hill Hospital,<br>Cane Hill,<br>Coulsdon, Surrey,<br>CR5 3ES | <b>Position of Sample/Photo</b><br>Workshop Garages<br>External corrugated roof sheet | <b>Asbestos</b><br><br><b>Type</b> | Yes, Strongly Presumed<br><br>Chrysotile (White) |

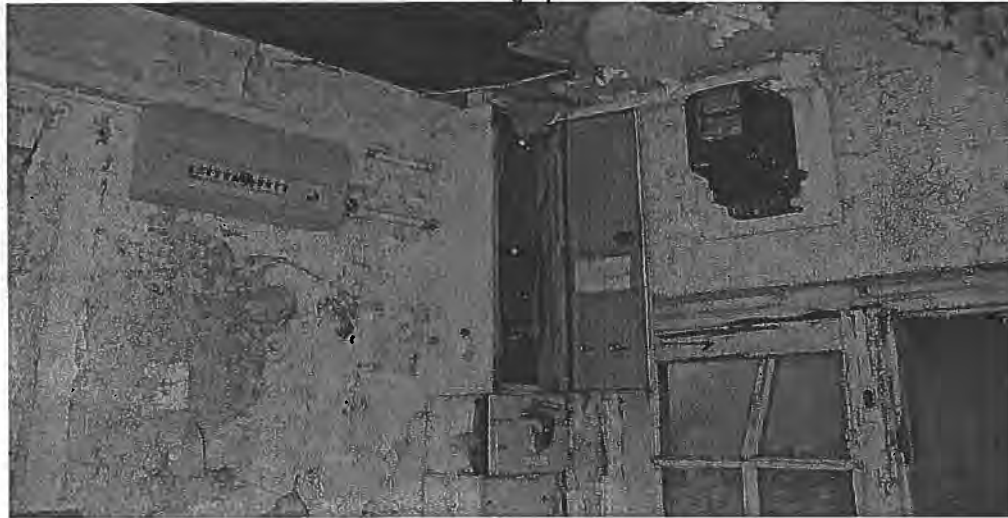
| <b>Location of Survey</b><br>Cane Hill Hospital,<br>Cane Hill,<br>Coulsdon, Surrey,<br>CR5 3ES | | <b>Position of Sample/Photo</b><br>Canteen<br>Electrics | | <b>Asbestos</b><br><br><b>Type</b> | Yes, Strongly<br>Presumed<br><br>Chrysotile (White) |
| <b>Material Type</b><br>Rope | | <b>Quantity</b><br>1m <sup>2</sup> | | <b>Sample No</b> | As 06/B/8026/9 |

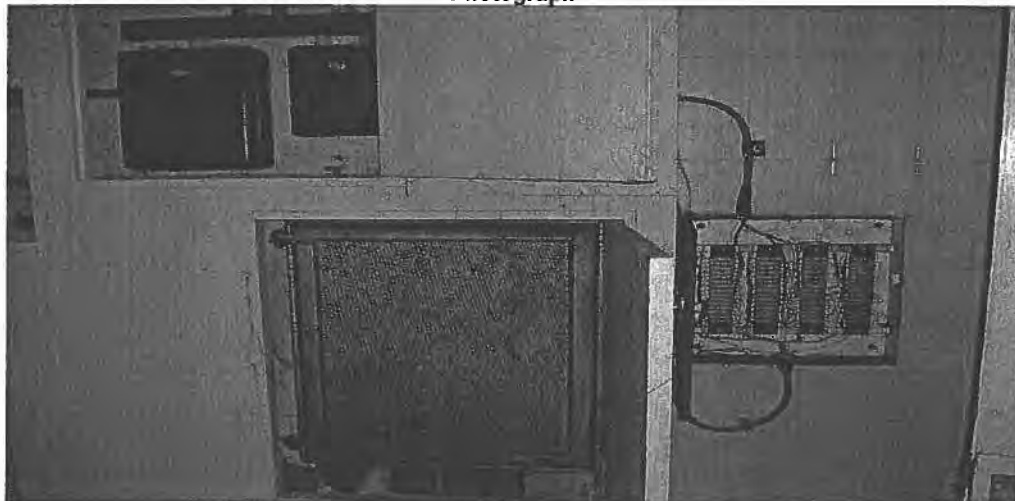
| <b>Location of Survey</b><br>Cane Hill Hospital,<br>Cane Hill,<br>Coulston, Surrey,<br>CR5 3ES | | <b>Position of Sample/Photo</b><br>Canteen<br>Wall electrics | <b>Asbestos</b><br><br><b>Type</b> | Yes, Strongly<br>Presumed<br><br>Chrysotile (White) |
| <b>Material Type</b><br>Rope | <b>Quantity</b><br><1m <sup>2</sup> | <b>Sample No</b> As 06/B/8026/22<br><br><b>Survey Date</b> 24.04 - 29.06.06<br><br><b>Date of Report</b> 18.08.06<br><br><b>Surveyor(s)</b> <span style="background-color: black; color: black;">[REDACTED]</span> | | |

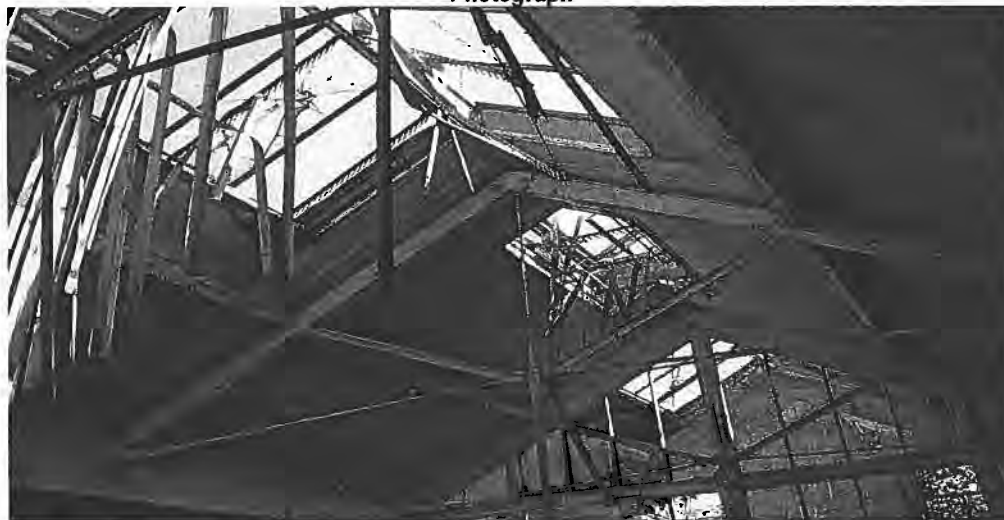
| <b>Location of Survey</b><br>Cane Hill Hospital,<br>Cane Hill,<br>Coulston, Surrey,<br>CR5 3ES | | <b>Position of Sample/Photo</b><br>Hall adjacent Canteen<br>Skylight rope seal | | <b>Asbestos</b> | Yes, Strongly<br>Presumed |
| <b>Material Type</b> Rope | | <b>Quantity</b> 40m | | <b>Type</b> | Chrysotile (White) |
| | | | | <b>Sample No</b> | As 06/B/8026/31 |

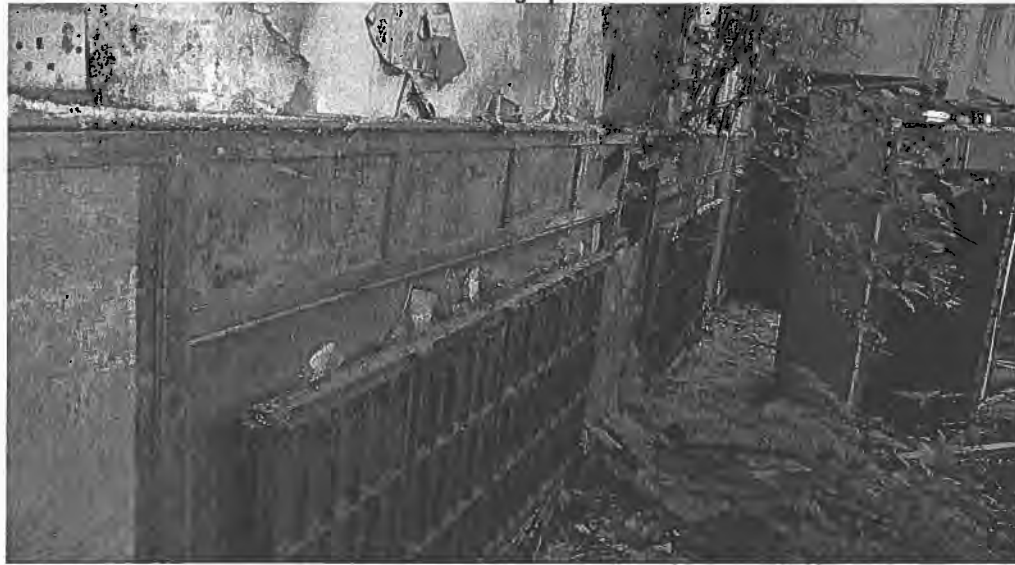
| <b>Location of Survey</b><br>Cane Hill Hospital,<br>Cane Hill,<br>Coulston, Surrey,<br>CR5 3ES | | <b>Position of Sample/Photo</b><br>Canteen,<br>Catering Hall<br>Radiator panel (X6) | <b>Asbestos</b> Yes |
| <b>Material Type</b> Cement | | <b>Quantity</b> 6m <sup>2</sup> | <b>Type</b> Chrysotile (White) |
| | | | <b>Sample No</b> 06/B/8026/160 |

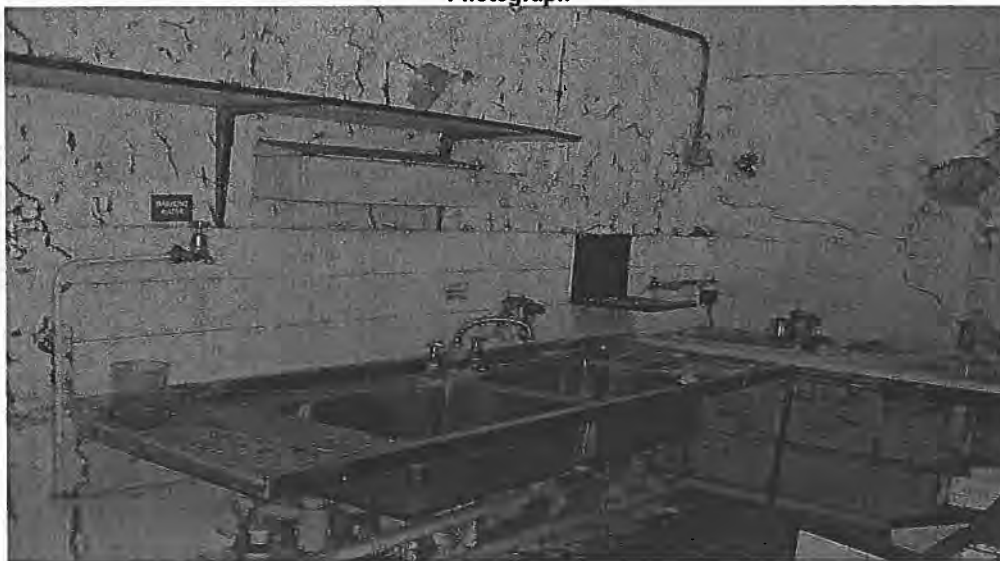
**Photograph**

| <b>Location of Survey</b><br>Cane Hill Hospital,<br>Cane Hill,<br>Coulston, Surrey,<br>CR5 3ES | | <b>Position of Sample/Photo</b><br>Kitchen adjacent Catering Hall<br>Sink paint | <b>Asbestos</b><br><br><b>Type</b> | Yes, Strongly<br>Presumed<br><br>Chrysotile (White) |

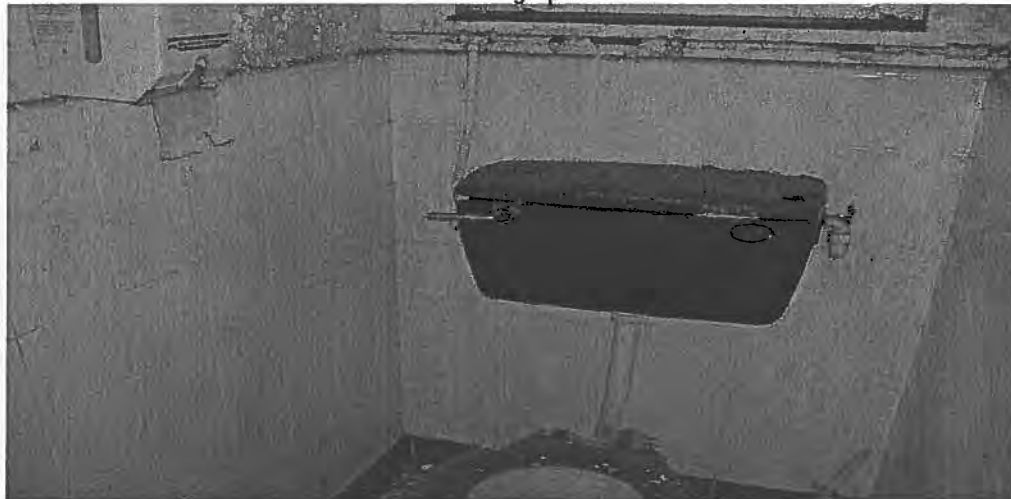
| <b>Location of Survey</b><br>Cane Hill Hospital,<br>Cane Hill,<br>Coulston, Surrey,<br>CR5 3ES | | <b>Position of Sample/Photo</b><br>Catering department<br>W.C. Cistern | | <b>Asbestos</b><br><br><b>Type</b> | Yes, Strongly<br>Presumed<br><br>Amosite (Brown) |
| <b>Material Type</b> | Plastic | <b>Quantity</b> | 1m <sup>2</sup> | <b>Sample No</b> | As 06/B/8026/5 |

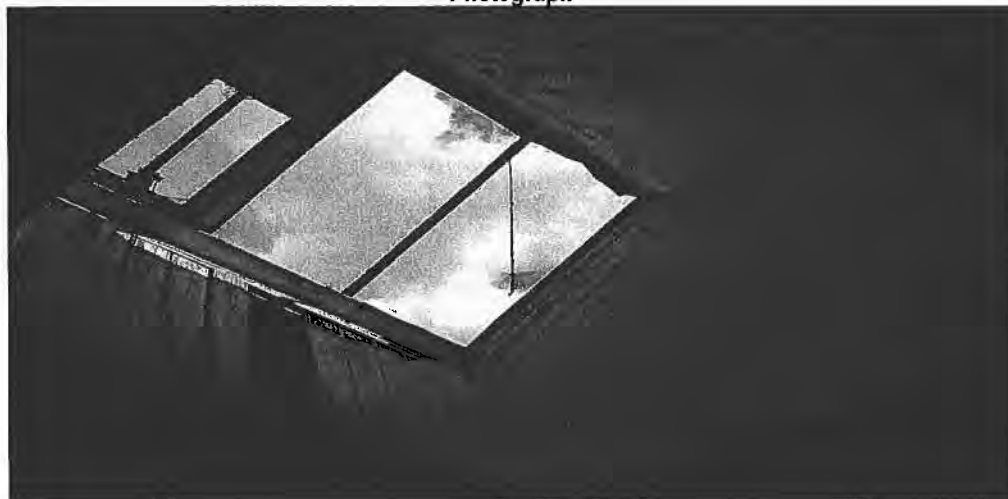
| <b>Location of Survey</b><br>Cane Hill Hospital,<br>Cane Hill,<br>Coulston, Surrey,<br>CR5 3ES | | <b>Position of Sample/Photo</b><br>Catering Hall<br>Skylight rope seal | | <b>Asbestos</b><br><br><b>Type</b> | Yes, Strongly<br>Presumed<br><br>Chrysotile (White) |
| <b>Material Type</b><br>Rope | | <b>Quantity</b><br>30m | | <b>Sample No</b> | As 06/B/8026/31 |

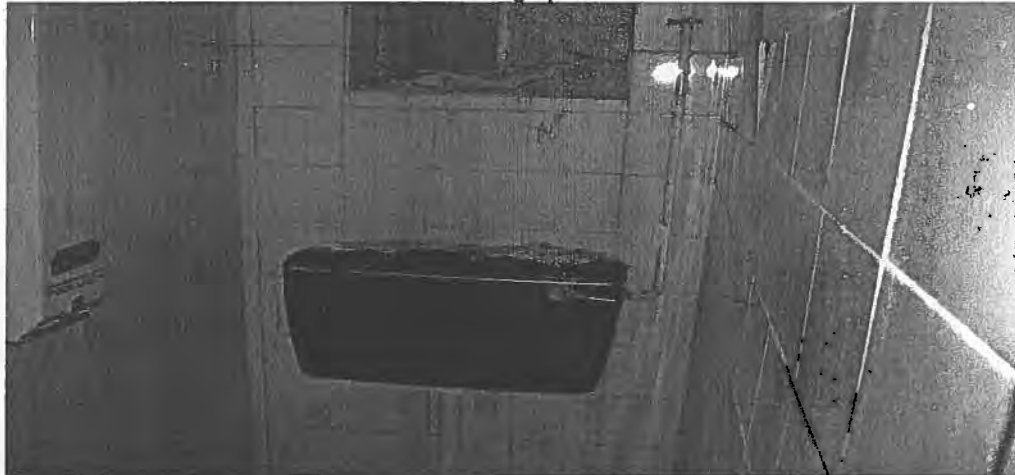
| <b>Location of Survey</b><br>Cane Hill Hospital,<br>Cane Hill,<br>Coulston, Surrey,<br>CR5 3ES | | <b>Position of Sample/Photo</b><br>Understairs WC adjacent Main<br>Hall<br>W.C. Cistern | | <b>Asbestos</b><br><br><b>Type</b> | <b>Yes, Strongly<br/>Presumed</b><br><br>Amosite (Brown) |
| <b>Material<br/>Type</b> | Plastic | <b>Quantity</b> | 1m <sup>2</sup> | <b>Sample No</b> As 06/B/8026/5<br><br><b>Survey Date</b> 24.04 - 29.06.06<br><br><b>Date of Report</b> 18.08.06<br><br><b>Surveyor(s)</b> <span style="background-color: black; color: black;">[REDACTED]</span> | |

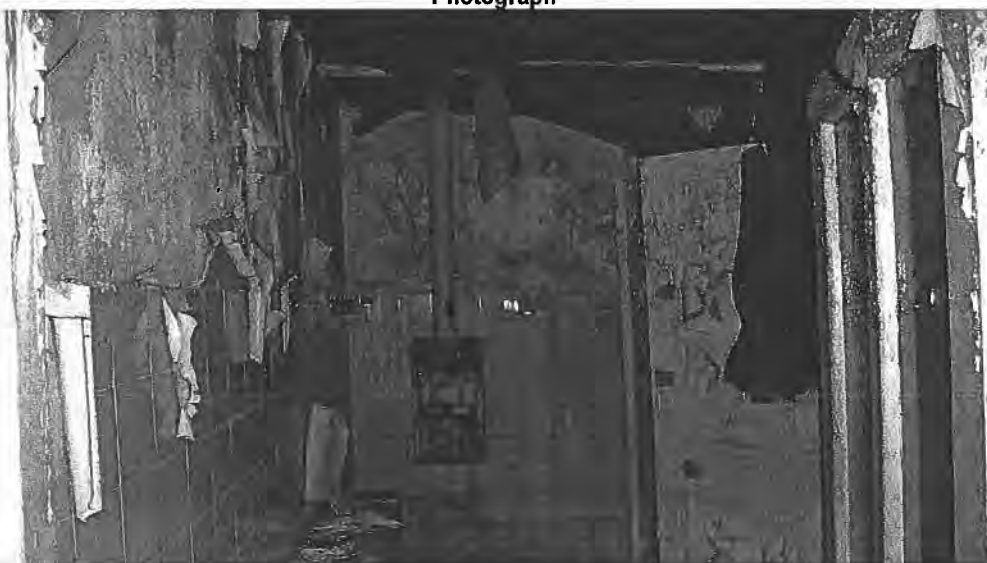
| <b>Location of Survey</b><br>Cane Hill Hospital,<br>Cane Hill,<br>Coulston, Surrey,<br>CR5 3ES | | <b>Position of Sample/Photo</b><br>Understairs WC adjacent Main<br>Hall<br>Bunny Boiler & Flue pipe | | <b>Asbestos</b><br><br><b>Type</b> | Yes, Strongly<br>Presumed<br><br>Chrysotile (White) |
| <b>Material Type</b><br>Cement | | <b>Quantity</b><br>2m | | <b>Sample No</b> | As 06/B/8026/154 |

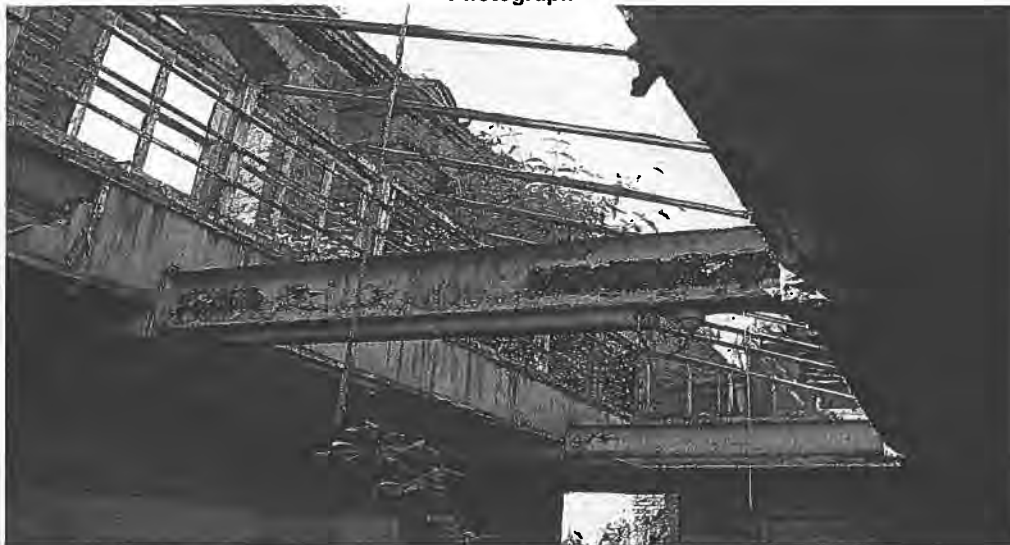
**Photograph**

| <b>Location of Survey</b><br>Cane Hill Hospital,<br>Cane Hill,<br>Coulston, Surrey,<br>CR5 3ES | | <b>Position of Sample/Photo</b><br>Kitchen<br>Skylight<br>Rope Seals | <b>Asbestos</b><br><br><b>Type</b> | <b>Yes, Strongly Presumed</b><br><br>Chrysotile (White) |

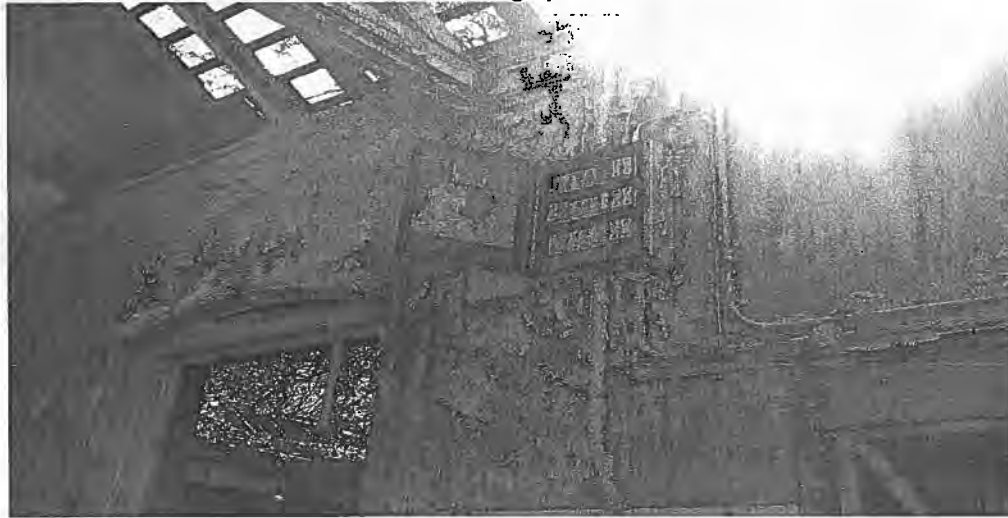
| <b>Location of Survey</b><br>Cane Hill Hospital,<br>Cane Hill,<br>Coulsdon, Surrey,<br>CR5 3ES | | <b>Position of Sample/Photo</b><br>Kitchen<br>Electrics<br>Rope Seals | | <b>Asbestos</b><br><br><b>Type</b> | Yes, Strongly<br>presumed<br><br>Chrysotile (White) |
| <b>Material Type</b><br>Rope | | <b>Quantity</b><br>1m <sup>2</sup> | | <b>Sample No</b> | As 06/B/8026/22 |

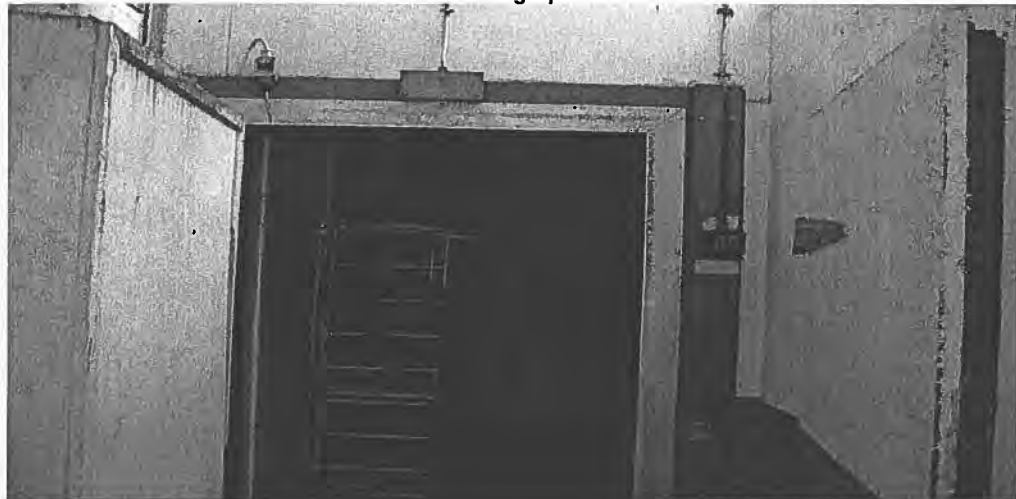
| <b>Location of Survey</b><br>Cane Hill Hospital,<br>Cane Hill,<br>Coulston, Surrey,<br>CR5 3ES | | <b>Position of Sample/Photo</b><br>Kitchen<br>Cement to fridge wall | | <b>Asbestos</b> Yes |
| <b>Material Type</b> Cement | | <b>Quantity</b> 40m <sup>2</sup> | <b>Type</b> Chrysotile (White) | |
| | | <b>Sample No</b> 06/B/8026/161 | | |

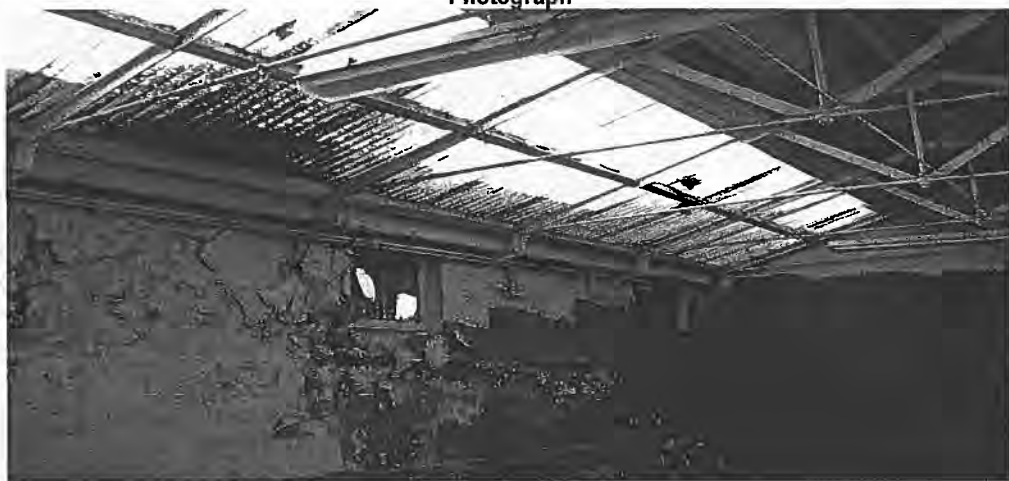
| <b>Location of Survey</b><br>Cane Hill Hospital,<br>Cane Hill,<br>Coulston, Surrey,<br>CR5 3ES | | <b>Position of Sample/Photo</b><br>Kitchen Hall<br>Roof guttering | | <b>Asbestos</b> Yes |
| <b>Material Type</b> Cement | | <b>Quantity</b> 20m <sup>2</sup> | | <b>Type</b> Chrysotile (White) |
| | | | | <b>Sample No</b> 06/B/8026/162 |

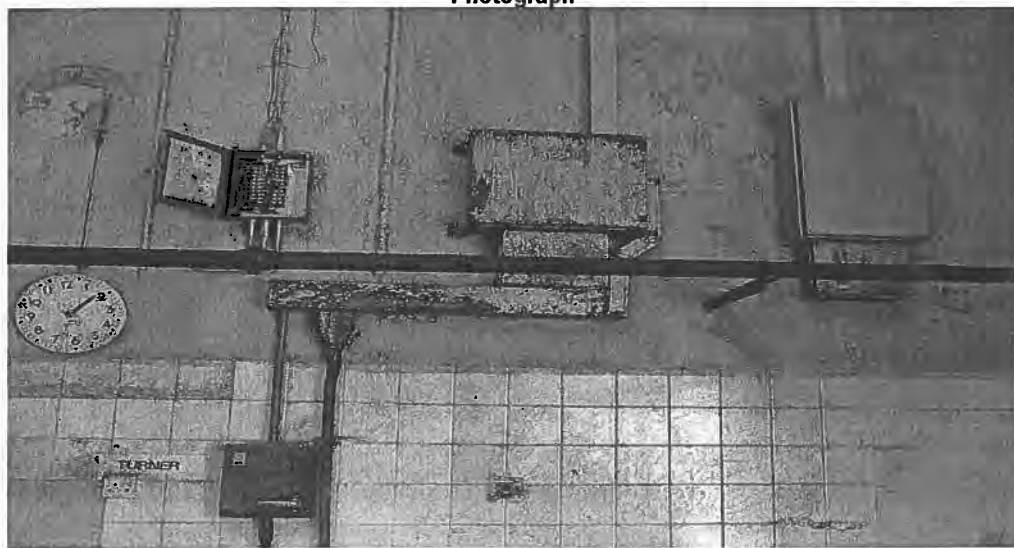
| <b>Location of Survey</b><br>Cane Hill Hospital,<br>Cane Hill,<br>Coulsdon, Surrey,<br>CR5 3ES | <b>Position of Sample/Photo</b><br>Kitchen<br>Electrics<br>Rope Seals | <b>Asbestos</b><br><br><b>Type</b> | Yes, Strongly<br>Presumed<br><br>Chrysotile (White) |
| <b>Material Type</b> Rope | <b>Quantity</b> <1m | <b>Sample No</b> As 06/B/8026/22<br><br><b>Survey Date</b> 24.04 - 29.06.06<br><br><b>Date of Report</b> 18.08.06<br><br><b>Surveyor(s)</b> <span style="background-color: black; color: black;">[REDACTED]</span> | |

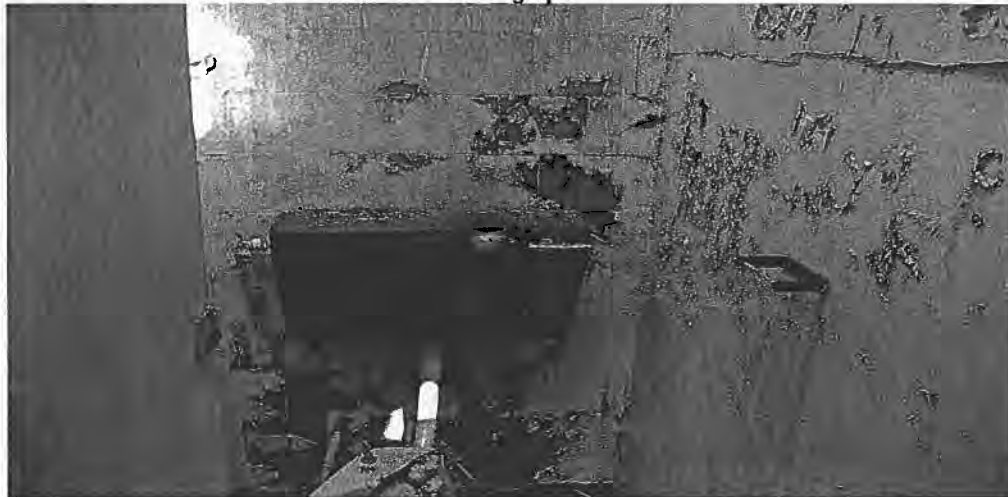
| <b>Location of Survey</b><br>Cane Hill Hospital,<br>Cane Hill,<br>Coulson, Surrey,<br>CR5 3ES | | <b>Position of Sample/Photo</b><br>Kitchen<br>W.C Cistern | | <b>Asbestos</b><br><br><b>Type</b> | Yes, Strongly<br>Presumed<br><br>Chrysotile (White) |
| <b>Material Type</b> | Plastic | <b>Quantity</b> | 1m <sup>2</sup> | <b>Sample No</b> | As 06/B/8026/5 |

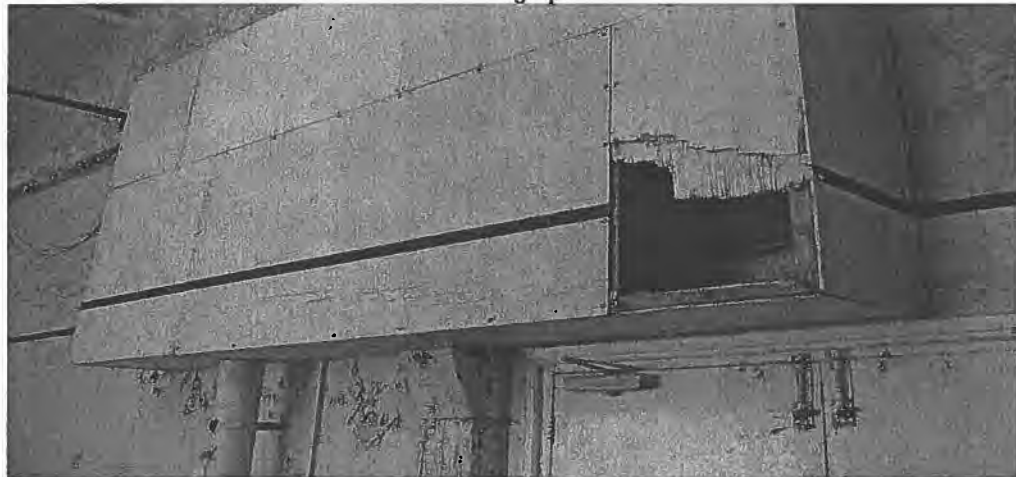
| <b>Location of Survey</b><br>Cane Hill Hospital,<br>Cane Hill,<br>Coulston, Surrey,<br>CR5 3ES | | <b>Position of Sample/Photo</b><br>Kitchen<br>Electrics in wood boxing | | <b>Asbestos</b><br><br><b>Type</b> | <b>Yes, Strongly Presumed</b><br><br>Chrysotile (White) |
| <b>Material Type</b> | Rope | <b>Quantity</b> | 1m | <b>Sample No</b> | As 06/B/8026/9 |

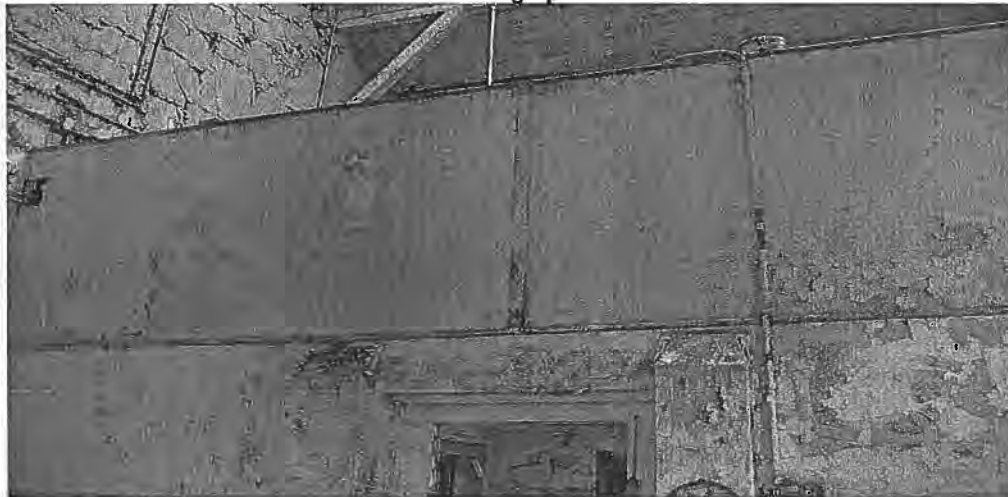
| <b>Material Type</b><br>Cement | <b>Quantity</b><br>20m <sup>2</sup> | <b>Sample No</b><br>As 06/B/8026/126 | |

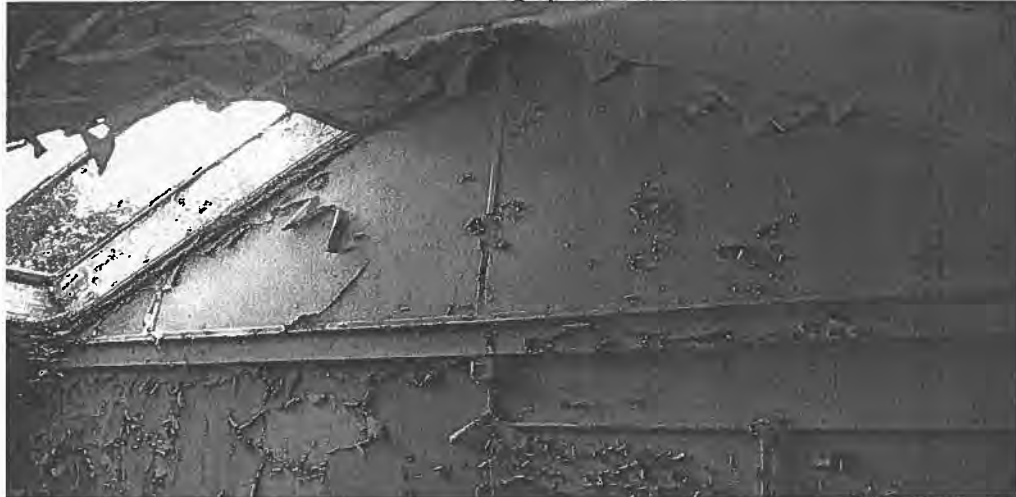
| <b>Location of Survey</b><br>Cane Hill Hospital,<br>Cane Hill,<br>Coulston, Surrey,<br>CR5 3ES | | <b>Position of Sample/Photo</b><br>Laundry office<br>Panel partition to store | | <b>Asbestos</b><br><br><b>Type</b> | Yes, Strongly<br>Presumed<br><br>Chrysotile (White) |
| <b>Material Type</b><br>Cement | | <b>Quantity</b><br>4m <sup>2</sup> | | <b>Sample No</b> | As 06/B/8026/163 |

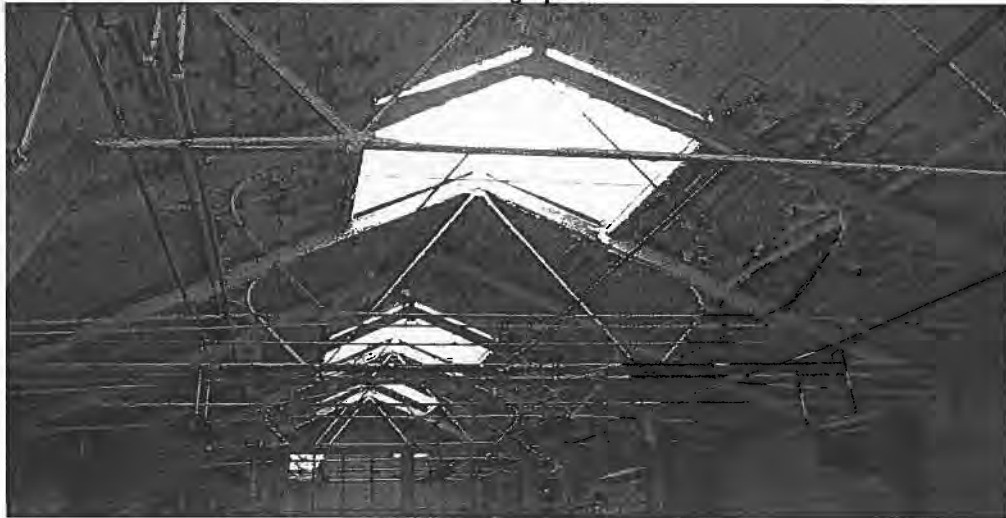
| <b>Location of Survey</b><br>Cane Hill Hospital,<br>Cane Hill,<br>Coulsdon, Surrey,<br>CR5 3ES | <b>Position of Sample/Photo</b><br>Laundry<br>Skylight rope seals | <b>Asbestos</b> Yes, Strongly Presumed<br><br><b>Type</b> Chrysotile (White) |
| <b>Material Type</b> Rope | <b>Quantity</b> 80m | <b>Sample No</b> As 06/B/8026/31<br><br><b>Survey Date</b> 24.04 - 29.06.06<br><br><b>Date of Report</b> 18.08.06<br><br><b>Surveyor(s)</b> <span style="background-color: black; color: black;">[REDACTED]</span> |

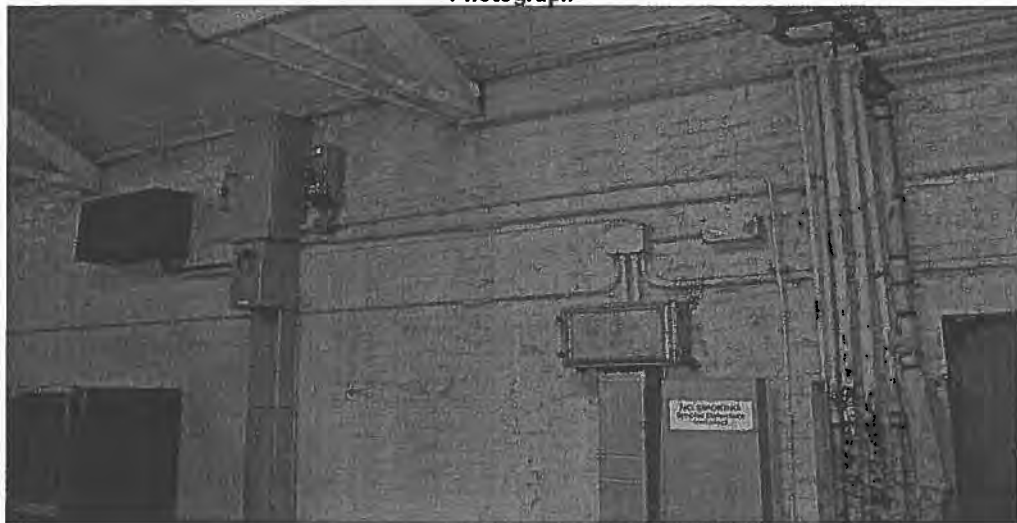
| <b>Location of Survey</b><br>Cane Hill Hospital,<br>Cane Hill,<br>Coulsdon, Surrey,<br>CR5 3ES | | <b>Position of Sample/Photo</b><br>Laundry<br>Electrics | | <b>Asbestos</b><br><br><b>Type</b> | Yes, Strongly<br>Presumed<br><br>Chrysotile (White) |
| <b>Material Type</b> | Rope | <b>Quantity</b> | 1m <sup>2</sup> | <b>Sample No</b> | As 06/B/8026/22 |

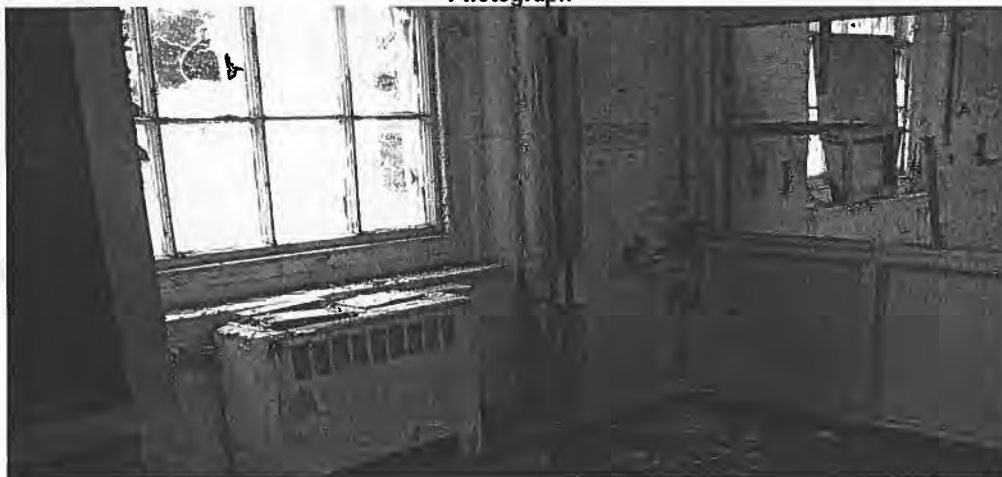
| <b>Location of Survey</b><br>Cane Hill Hospital,<br>Cane Hill,<br>Coulsdon, Surrey,<br>CR5 3ES | <b>Position of Sample/Photo</b><br>Laundry<br>Small Office in Main Room<br>Foil paper lagging | <b>Asbestos</b> Yes<br><br><b>Type</b> Chrysotile (White) |
| <b>Material Type</b> Paper | <b>Quantity</b> 8m | <b>Sample No</b> 06/B/8026/164<br><br><b>Survey Date</b> 24.04 - 29.06.06<br><br><b>Date of Report</b> 18.08.06<br><b>Surveyor(s)</b> <span style="background-color: black; color: black;">[REDACTED]</span> |

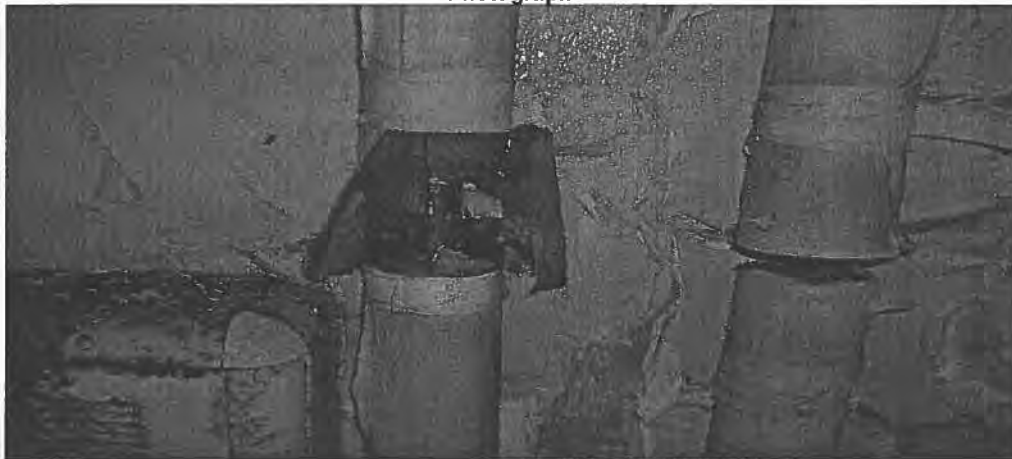
| <b>Location of Survey</b><br>Cane Hill Hospital,<br>Cane Hill,<br>Coulsdon, Surrey,<br>CR5 3ES | <b>Position of Sample/Photo</b><br>Laundry<br>Toilets<br>Paper under MMMF lagging<br>(presumed throughout) | <b>Asbestos</b><br><br><b>Type</b> | <b>Yes</b><br><br>Chrysotile (White) |
| <b>Material Type</b><br>Paper | <b>Quantity</b><br>1000m <sup>2</sup> | <b>Sample No</b> | 06/B/8026/165 |

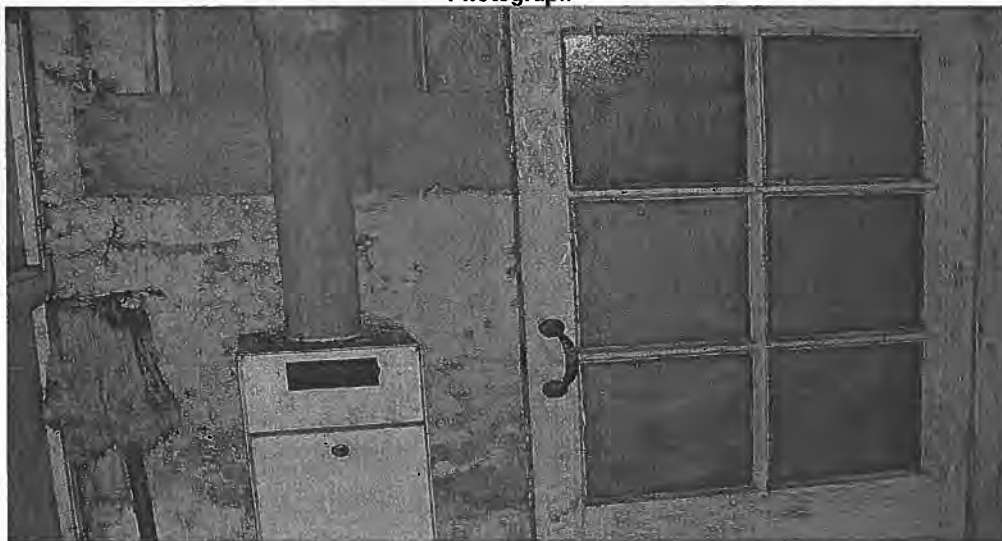
| <b>Location of Survey</b><br>Cane Hill Hospital,<br>Cane Hill,<br>Coulston, Surrey,<br>CR5 3ES | | <b>Position of Sample/Photo</b><br>Laundry<br>Toilets<br>Bunny boiler & Flue pipe | | <b>Asbestos</b><br><br><b>Type</b> | Yes, Strongly<br>presumed<br><br>Chrysotile (White) |
| <b>Material Type</b><br>Cement | | <b>Quantity</b><br>1m <sup>2</sup> | <b>Sample No</b><br>As 06/B/8026/154 | | |

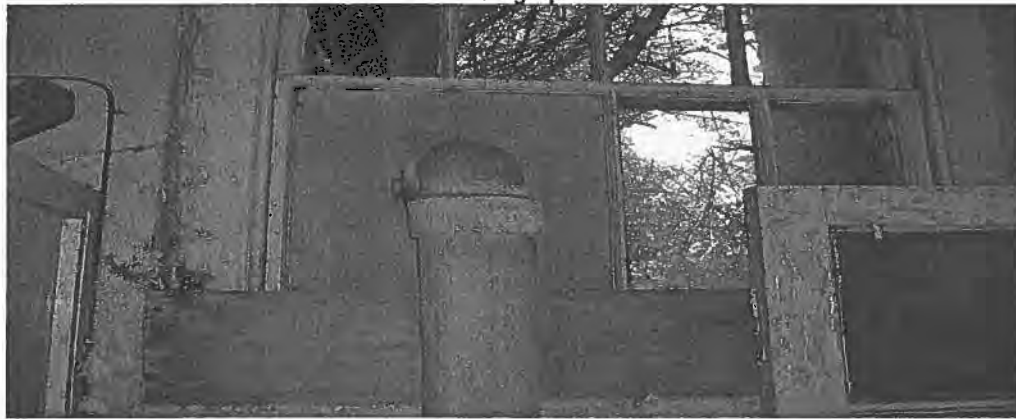
| <b>Location of Survey</b><br>Cane Hill Hospital,<br>Cane Hill,<br>Coulsdon, Surrey,<br>CR5 3ES | <b>Position of Sample/Photo</b><br>Laundry<br>WC, Window infill panel above<br>boiler | <b>Asbestos</b> Yes<br><br><b>Type</b> Amosite (Brown) | |
| <b>Material Type</b> Board | <b>Quantity</b> <1m | <b>Sample No</b> 06/B/8026/166<br><br><b>Survey Date</b> 24.04 - 29.06.06<br><br><b>Date of Report</b> 18.08.06<br><br><b>Surveyor(s)</b> <span style="background-color: black; color: black;">[REDACTED]</span> | |

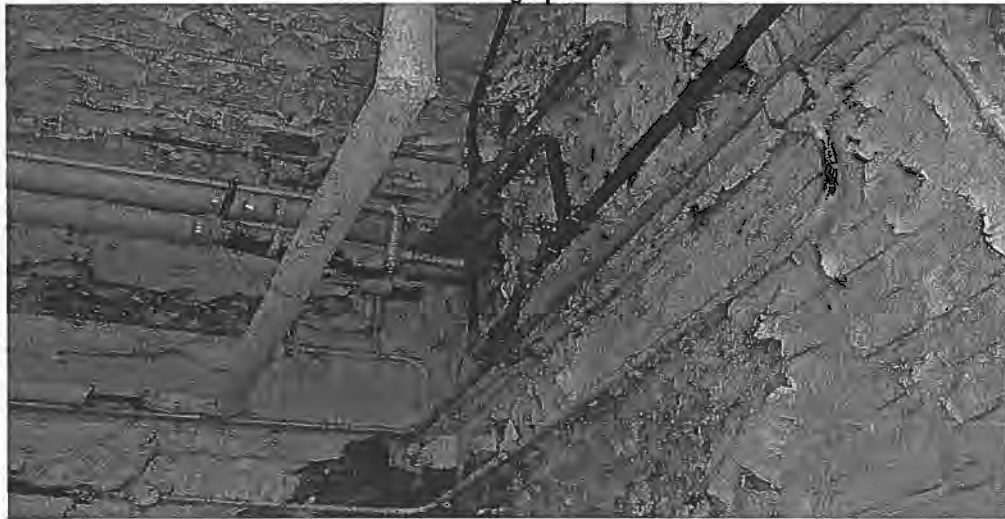
| <b>Location of Survey</b><br>Cane Hill Hospital,<br>Cane Hill,<br>Coulston, Surrey,<br>CR5 3ES | | <b>Position of Sample/Photo</b><br>Laundry<br>Main Room<br>Red pipe lagging | | <b>Asbestos</b> Yes |
| <b>Material Type</b> Lagging | | <b>Quantity</b> 2m | | <b>Type</b> Chrysotile (White)<br>Amosite (Brown) |

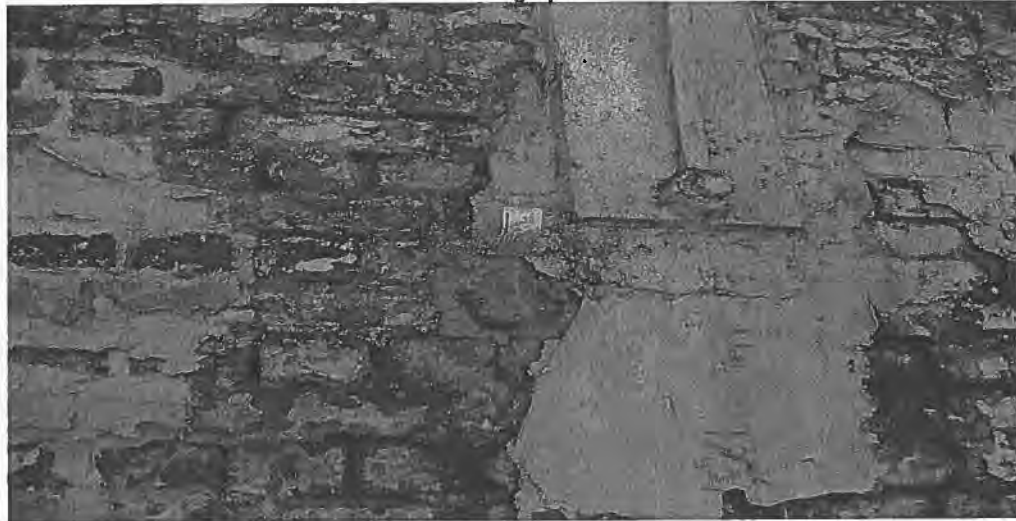
| <b>Location of Survey</b><br><br>Cane Hill Hospital,<br>Cane Hill,<br>Coulsdon, Surrey,<br>CR5 3ES | <b>Position of Sample/Photo</b><br><br>Laundry<br>Main Room<br>Wall debris | <b>Asbestos</b> Yes<br><br><b>Type</b> Chrysotile (White) |
| <b>Material Type</b> Lagging | <b>Quantity</b> <1m <sup>2</sup> | <b>Sample No</b> 06/B/8026/168<br><br><b>Survey Date</b> 24.04 - 29.06.06<br><br><b>Date of Report</b> 18.08.06<br><br><b>Surveyor(s)</b> <span style="background-color: black; color: black;">[REDACTED]</span> |

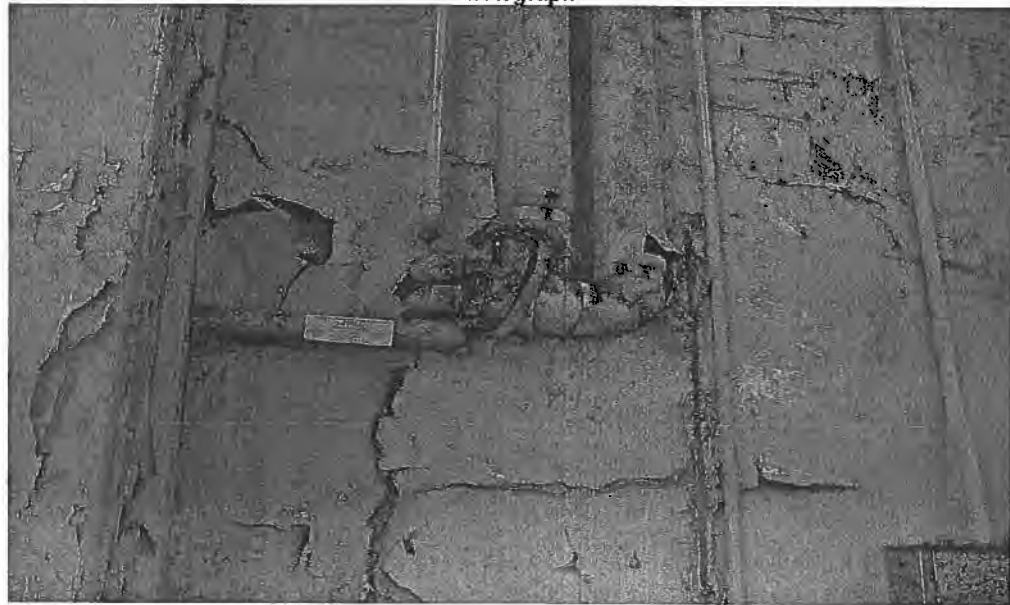
**Photograph**

| <b>Location of Survey</b><br>Cane Hill Hospital,<br>Cane Hill,<br>Coulsdon, Surrey,<br>CR5 3ES | | <b>Position of Sample/Photo</b><br>Laundry<br>Main Room<br>Pipe debris | <b>Asbestos</b> Yes<br><br><b>Type</b> Chrysotile (White) |

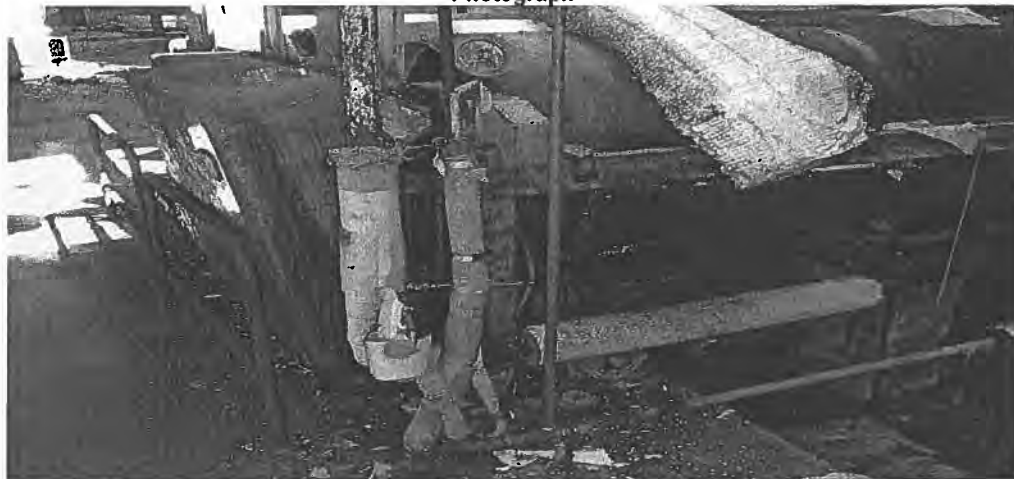
| <b>Location of Survey</b><br>Cane Hill Hospital,<br>Cane Hill,<br>Coulsdon, Surrey,<br>CR5 3ES | <b>Position of Sample/Photo</b><br>Laundry<br>Rope to laundry equipment | <b>Asbestos</b><br><br><b>Type</b> | Yes, Strongly<br>Presumed<br><br>Chrysotile (White) |
| <b>Material Type</b> Rope | <b>Quantity</b> 2m | <b>Sample No</b> As 06/B/8026/58<br><br><b>Survey Date</b> 24.04 - 29.06.06<br><br><b>Date of Report</b> 18.08.06<br><br><b>Surveyor(s)</b> <span style="background-color: black; color: black;">[REDACTED]</span> | |

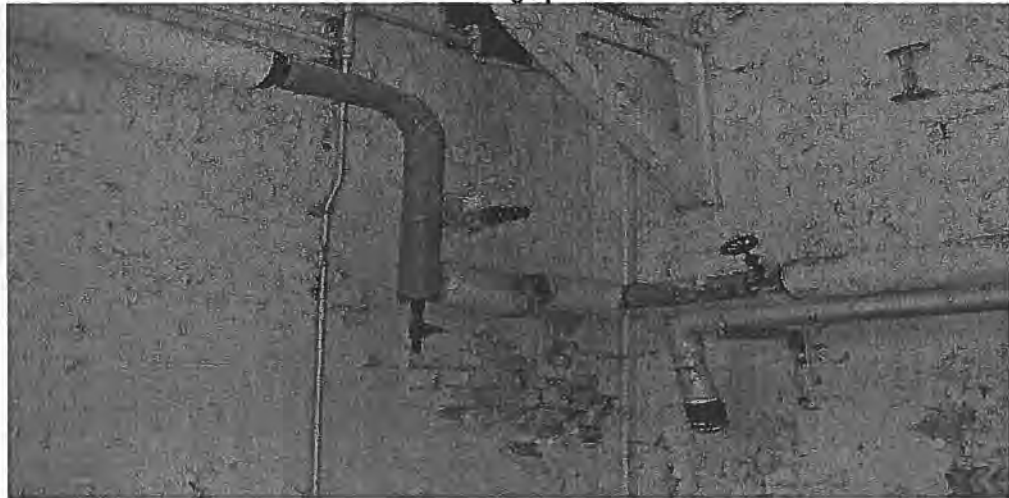
| <b>Location of Survey</b><br>Cane Hill Hospital,<br>Cane Hill,<br>Coulston, Surrey,<br>CR5 3ES | | <b>Position of Sample/Photo</b><br>Laundry<br>Red Pipe Lagging | <b>Asbestos</b><br><br><b>Type</b> | Yes, Strongly<br>presumed<br><br>Chrysotile (White)<br>Amosite (Brown) |
| <b>Material Type</b> | Lagging | <b>Quantity</b> | 3m | <b>Sample No</b> As 06/B/8026/167 |

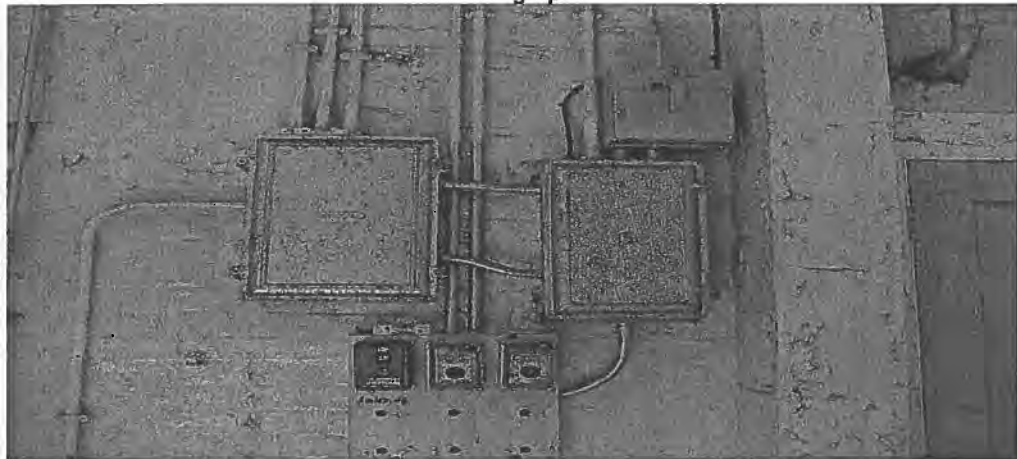
| <b>Location of Survey</b><br>Cane Hill Hospital,<br>Cane Hill,<br>Coulsdon, Surrey,<br>CR5 3ES | <b>Position of Sample/Photo</b><br>Laundry<br>Electrics | <b>Asbestos</b><br><br><b>Type</b> | Yes, Strongly<br>Presumed<br><br>Chrysotile (White) |
| <b>Material Type</b> Rope | <b>Quantity</b> 1m <sup>2</sup> | <b>Sample No</b> As 06/B/8026/22<br><br><b>Survey Date</b> 24.04 - 29.06.06<br><br><b>Date of Report</b> 18.08.06<br><br><b>Surveyor(s)</b> <span style="background-color: black; color: black;">[REDACTED]</span> | |

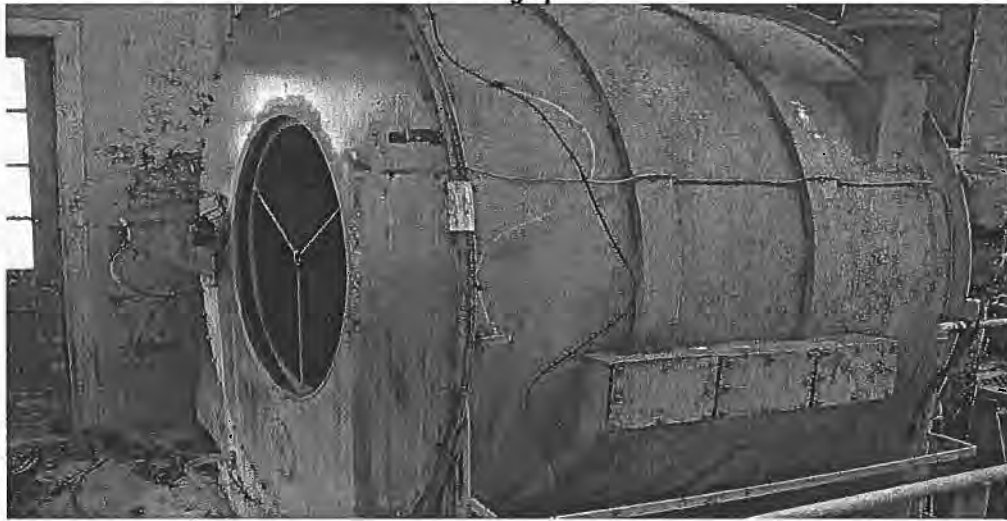
| <b>Location of Survey</b><br>Cane Hill Hospital,<br>Cane Hill,<br>Coulsdon, Surrey,<br>CR5 3ES | <b>Position of Sample/Photo</b><br>Laundry<br>Rope gasket to dryer | <b>Asbestos</b> Yes<br><br><b>Type</b> Chrysotile (White) |
| <b>Material Type</b> Rope | <b>Quantity</b> 4m | <b>Sample No</b> 06/B/8026/170<br><br><b>Survey Date</b> 24.04 - 29.06.06<br><br><b>Date of Report</b> 18.08.06<br><br><b>Surveyor(s)</b> [REDACTED] |

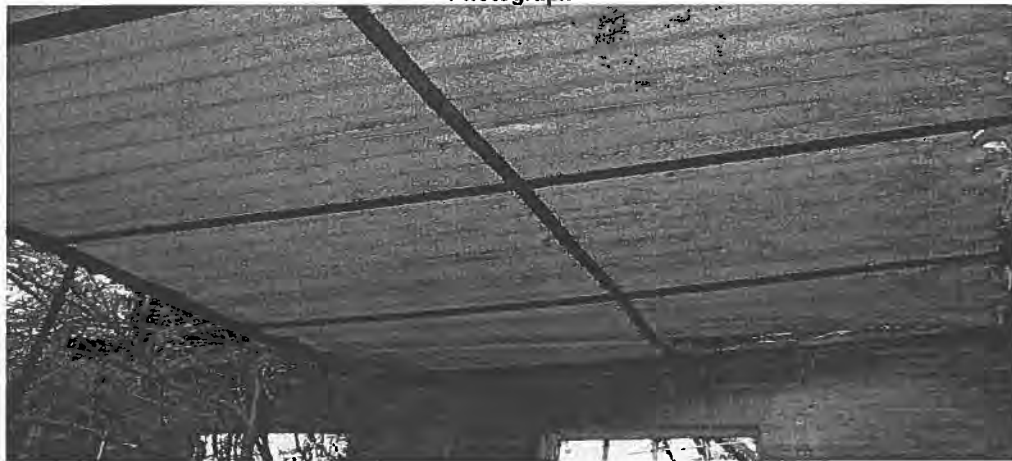
| <b>Location of Survey</b><br>Cane Hill Hospital,<br>Cane Hill,<br>Coulston, Surrey,<br>CR5 3ES | | <b>Position of Sample/Photo</b><br>Lightwell adjacent Laundry<br>Cement roof sheet | | <b>Asbestos</b><br><br><b>Type</b> | Yes, Strongly<br>Presumed<br><br>Chrysotile (White) |
| <b>Material Type</b> | Cement | <b>Quantity</b> | 10m <sup>2</sup> | <b>Sample No</b> | As 06/B/8026/126 |

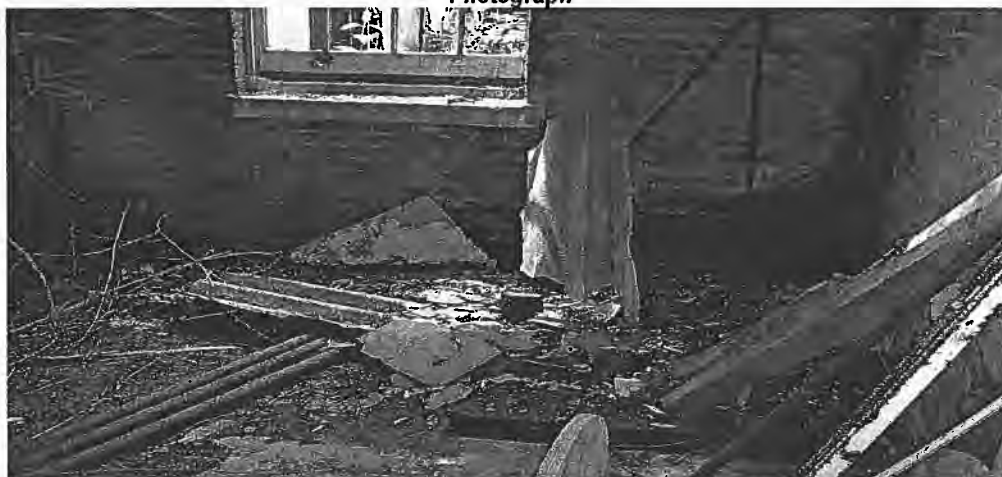
| <b>Location of Survey</b><br>Cane Hill Hospital,<br>Cane Hill,<br>Coulsdon, Surrey,<br>CR5 3ES | <b>Position of Sample/Photo</b><br>Lightwell adjacent Laundry<br>Cement roof sheet debris | <b>Asbestos</b> Yes, Strongly Presumed<br><br><b>Type</b> Chrysotile (White) |
| <b>Material Type</b> Cement | <b>Quantity</b> 1m <sup>2</sup> | <b>Sample No</b> 06/B/8026/126<br><br><b>Survey Date</b> 24.04 - 29.06.06<br><br><b>Date of Report</b> 18.08.06<br><b>Surveyor(s)</b> <span style="background-color: black; color: black;">[REDACTED]</span> |

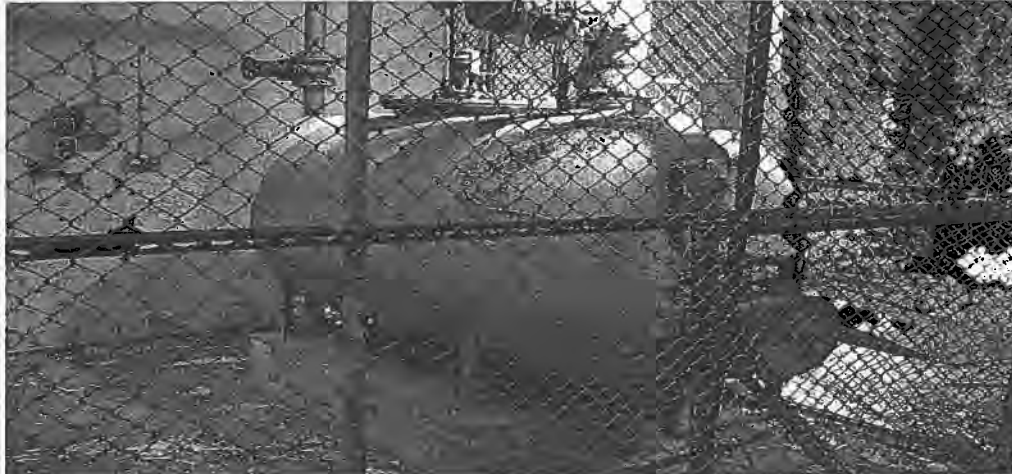
| <b>Location of Survey</b><br>Cane Hill Hospital,<br>Cane Hill,<br>Coulsdon, Surrey,<br>CR5 3ES | <b>Position of Sample/Photo</b><br>Laundry<br>Caged area<br>Tank insulation | <b>Asbestos</b> Yes<br><br><b>Type</b> Chrysotile (White)<br>Crocidolite (Blue) |
| <b>Material Type</b> Lagging | <b>Quantity</b> 20m | <b>Sample No</b> 06/B/8026/171<br><br><b>Survey Date</b> 24.04 - 29.06.06<br><br><b>Date of Report</b> 18.08.06<br><br><b>Surveyor(s)</b> <span style="background-color: black; color: black;">[REDACTED]</span> |

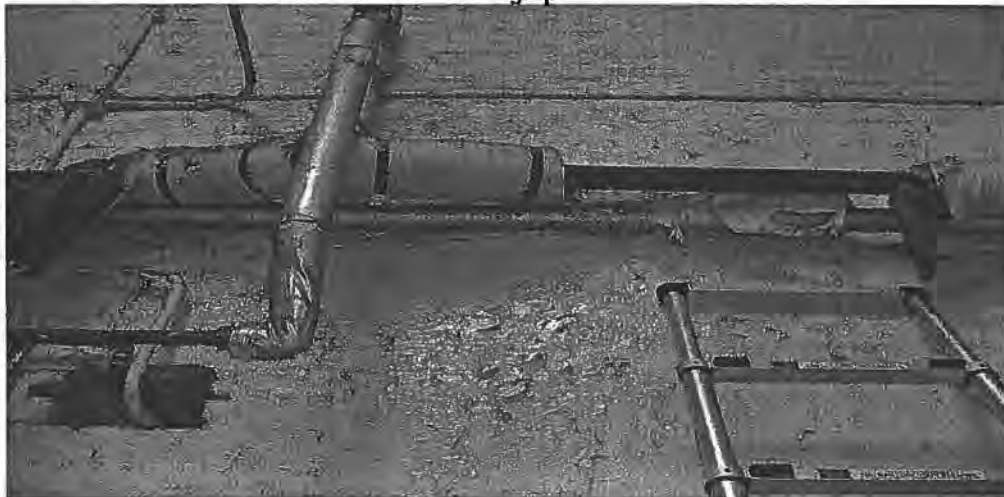
| <b>Location of Survey</b><br>Cane Hill Hospital,<br>Cane Hill,<br>Coulsdon, Surrey,<br>CR5 3ES | | <b>Position of Sample/Photo</b><br>Laundry<br>High level pipe<br>Pipe lagging debris behind<br>pipe | <b>Asbestos</b> Yes |
| <b>Material Type</b> Lagging | | <b>Quantity</b> 12m <sup>2</sup> | <b>Type</b> Amosite (Brown)<br>Chrysotile (White) |

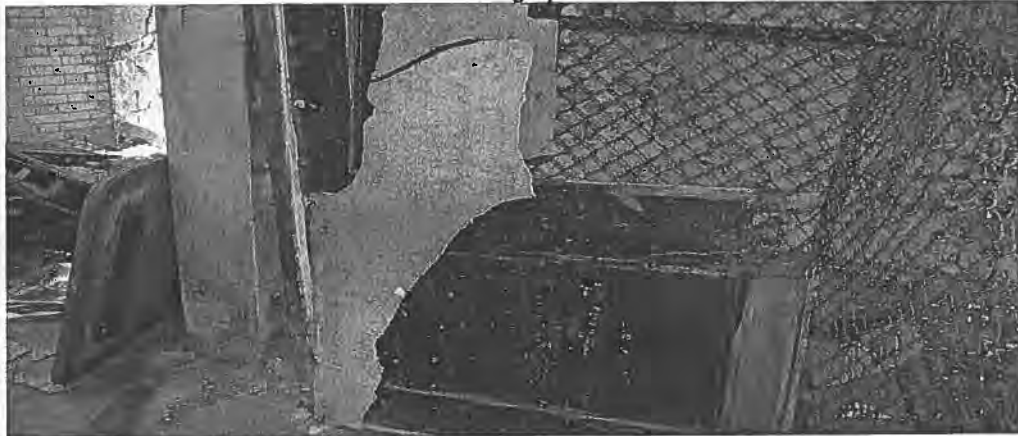
| <b>Location of Survey</b><br>Cane Hill Hospital,<br>Cane Hill,<br>Coulsdon, Surrey,<br>CR5 3ES | | <b>Position of Sample/Photo</b><br>Door panel to door between<br>Laundry & Laundry Store | | <b>Asbestos</b><br><br><b>Type</b> | <b>Yes</b><br><br>Chrysotile (White) |
| <b>Material Type</b> | Cement | <b>Quantity</b> | 1m <sup>2</sup> | <b>Sample No</b> | 06/B/8026/173 |
