## SURVEY INFORMATION SHEET

| <b>Location of Survey</b><br>Cane Hill Hospital,<br>Cane Hill,<br>Coulsdon, Surrey,<br>CR5 3ES | <b>Position of Sample/Photo</b><br>Workshop Garages<br>External corrugated roof sheet | <b>Asbestos</b><br><br><b>Type</b> | Yes, Strongly Presumed<br><br>Chrysotile (White) |

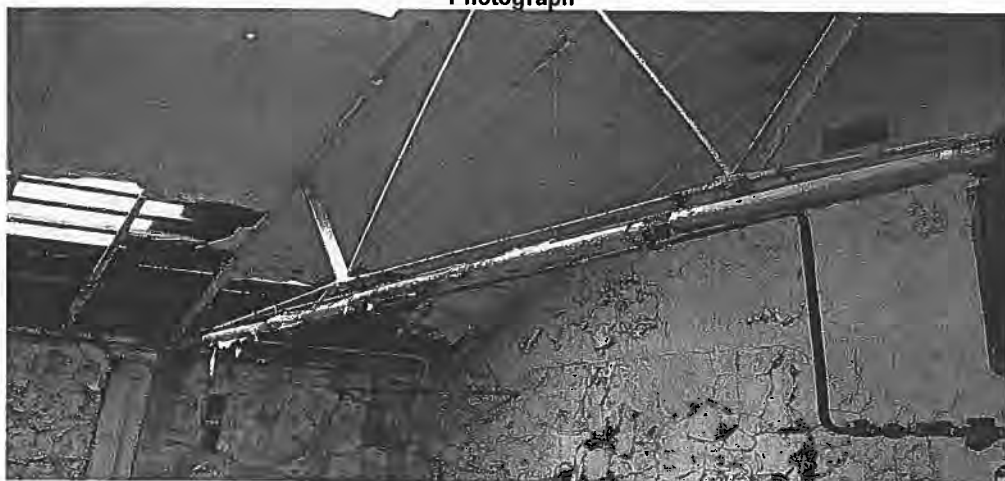
| <b>Location of Survey</b><br>Cane Hill Hospital,<br>Cane Hill,<br>Coulston, Surrey,<br>CR5 3ES | | <b>Position of Sample/Photo</b><br>Laundry<br>Foil corrugated paper pipe<br>lagging | | <b>Asbestos</b><br><br><b>Type</b> | Yes, Strongly<br>Presumed<br><br>Chrysotile (White) |
| <b>Material Type</b> | Paper | <b>Quantity</b> | 10m | <b>Sample No</b> | As 06/B/8026/50 |

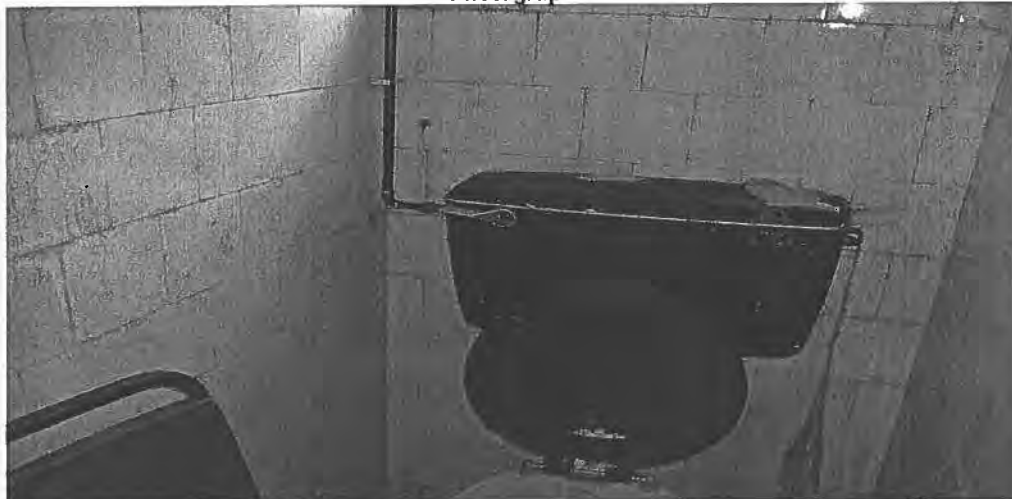
| <b>Location of Survey</b><br>Cane Hill Hospital,<br>Cane Hill,<br>Coulsdon, Surrey,<br>CR5 3ES | <b>Position of Sample/Photo</b><br>WC adjacent Laundry<br>Cistern | <b>Asbestos</b><br><br><b>Type</b> | Yes, Strongly<br>Presumed<br><br>Amosite (Brown) |
| <b>Material Type</b> Plastic | <b>Quantity</b> 1m <sup>2</sup> | <b>Sample No</b> As 06/B/8026/5<br><br><b>Survey Date</b> 24.04 - 29.06.06<br><br><b>Date of Report</b> 18.08.06<br><br><b>Surveyor(s)</b> <span style="background-color: black; color: black;">[REDACTED]</span> | |

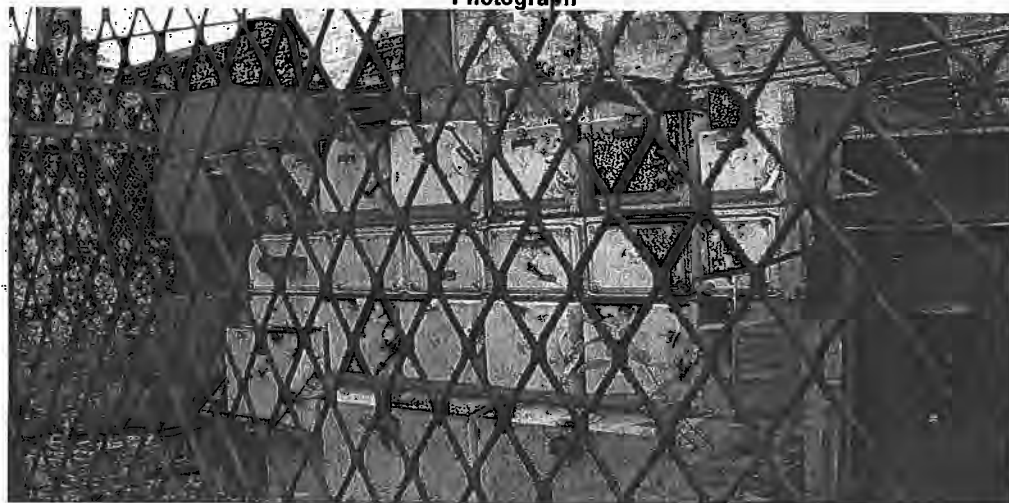
| <b>Location of Survey</b><br>Cane Hill Hospital,<br>Cane Hill,<br>Coulsdon, Surrey,<br>CR5 3ES | | <b>Position of Sample/Photo</b><br>External workshop electrics<br>within cage | <b>Asbestos</b><br><br><b>Type</b> | Yes, Strongly<br>Presumed<br><br>Chrysotile (White) |
| <b>Material Type</b> | Rope | <b>Quantity</b> | 1m <sup>2</sup> | <b>Sample No</b> As 06/B/8026/9<br>&22<br><br><b>Survey Date</b> 24.04 - 29.06.06<br><br><b>Date of Report</b> 18.08.06<br><br><b>Surveyor(s)</b> <span style="background-color: black; color: black;">[REDACTED]</span> |

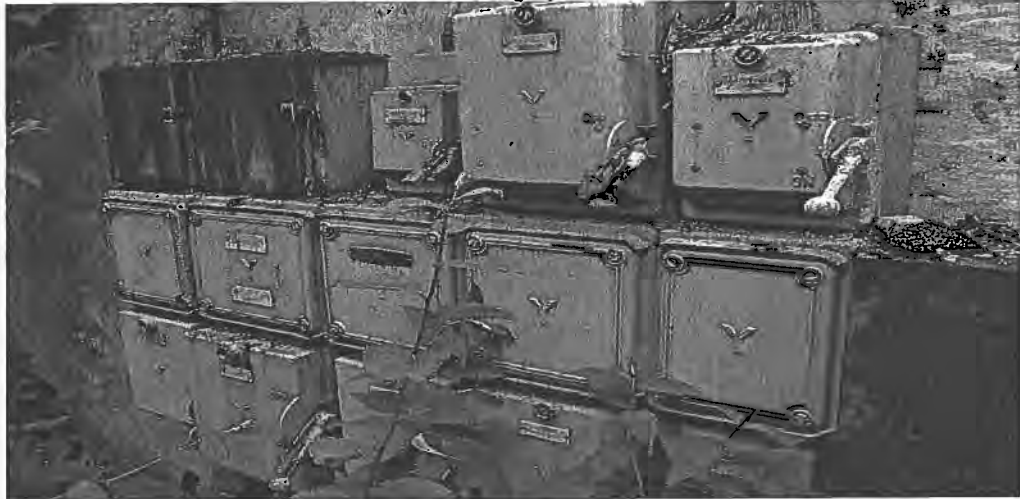
| <b>Location of Survey</b><br>Cane Hill Hospital,<br>Cane Hill,<br>Coulston, Surrey,<br>CR5 3ES | | <b>Position of Sample/Photo</b><br>External workshop electrics | | <b>Asbestos</b><br><br><b>Type</b> | Yes, Strongly<br>Presumed<br><br>Chrysotile (White) |
| <b>Material Type</b> | Rope | <b>Quantity</b> | 1m <sup>2</sup> | <b>Sample No</b> | As 06/B/8026/9<br>&22 |

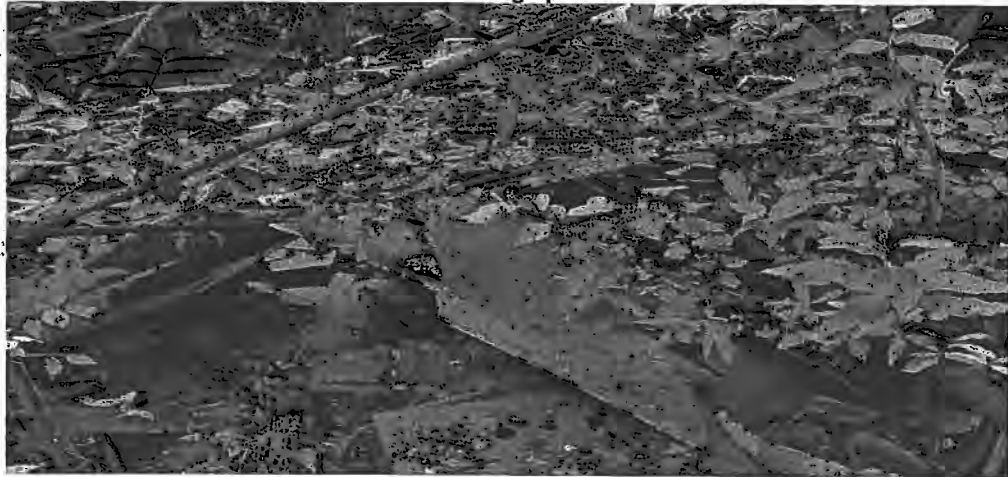
| <b>Location of Survey</b><br>Cane Hill Hospital,<br>Cane Hill,<br>Coulston, Surrey,<br>CR5 3ES | | <b>Position of Sample/Photo</b><br>External workshop cement<br>debris (throughout) | | <b>Asbestos</b><br><br><b>Type</b> | Yes, Strongly<br>Presumed<br><br>Chrysotile (White) |
| <b>Material Type</b> | Cement | <b>Quantity</b> | 10m <sup>2</sup> | <b>Sample No</b> | As 06/B/8026/126 |

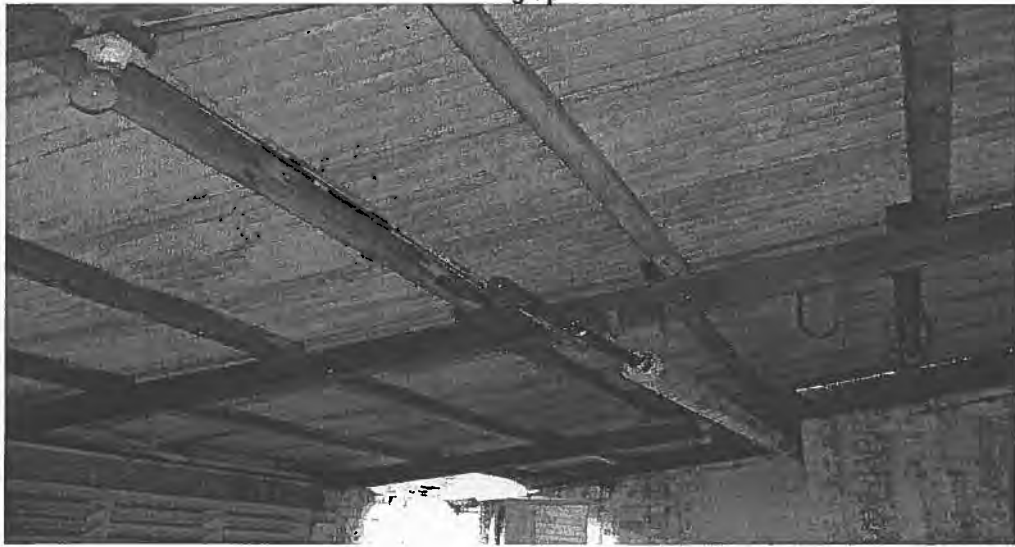
| <b>Location of Survey</b><br>Cane Hill Hospital,<br>Cane Hill,<br>Coulston, Surrey,<br>CR5 3ES | | <b>Position of Sample/Photo</b><br>Roof sheet in lean-to adjacent<br>Laundry Store & Incinerator | | <b>Asbestos</b><br><br><b>Type</b> | Yes, Strongly<br>Presumed<br><br>Chrysotile (White) |
| <b>Material Type</b> | Cement | <b>Quantity</b> | 40m <sup>2</sup> | <b>Sample No</b> | As 06/B/8026/126 |

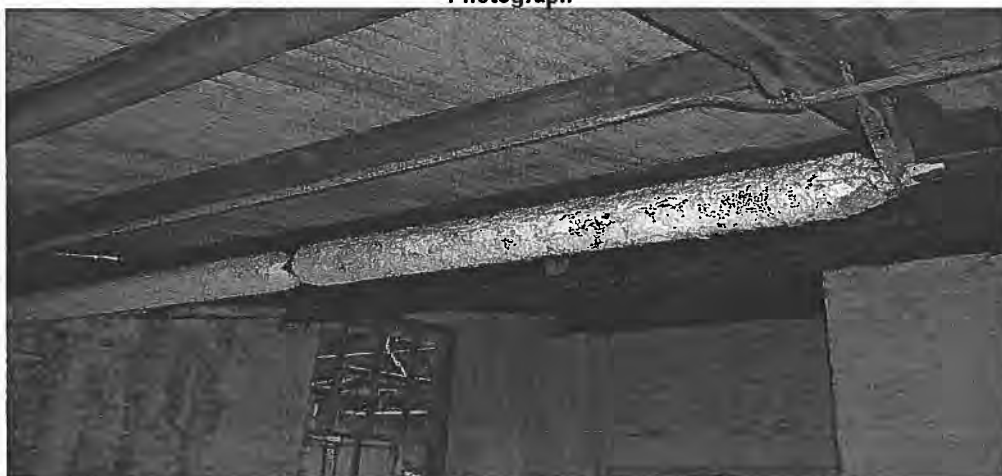
| <b>Location of Survey</b><br>Cane Hill Hospital,<br>Cane Hill,<br>Coulsdon, Surrey,<br>CR5 3ES | <b>Position of Sample/Photo</b><br>Pipe lagging in lean-to<br>adjacent Laundry Store &<br>Incinerator | <b>Asbestos</b> Yes<br><br><b>Type</b> Chrysotile (White)<br>Crocidolite (Blue) |
| <b>Material Type</b> Lagging | <b>Quantity</b> 10m | <b>Sample No</b> 06/B/8026/174<br><br><b>Survey Date</b> 24.04 - 29.06.06<br><br><b>Date of Report</b> 18.08.06<br><b>Surveyor(s)</b> [REDACTED] |

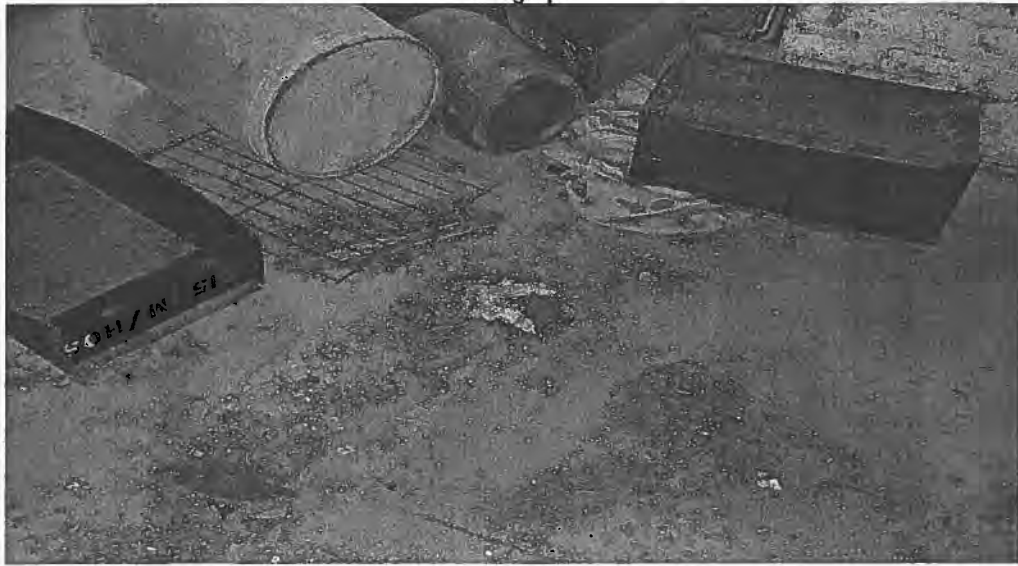
| <b>Location of Survey</b><br>Cane Hill Hospital,<br>Cane Hill,<br>Coulston, Surrey,<br>CR5 3ES | | <b>Position of Sample/Photo</b><br>Lagging debris in lean-to<br>adjacent Laundry Store &<br>Incinerator | | <b>Asbestos</b><br><br><b>Type</b> | Yes, Strongly<br>Presumed<br><br>Chrysotile (White)<br>Crocidolite (Blue) |
| <b>Material Type</b> | Lagging | <b>Quantity</b> | <1m | <b>Sample No</b> | As 06/B/8026/174 |

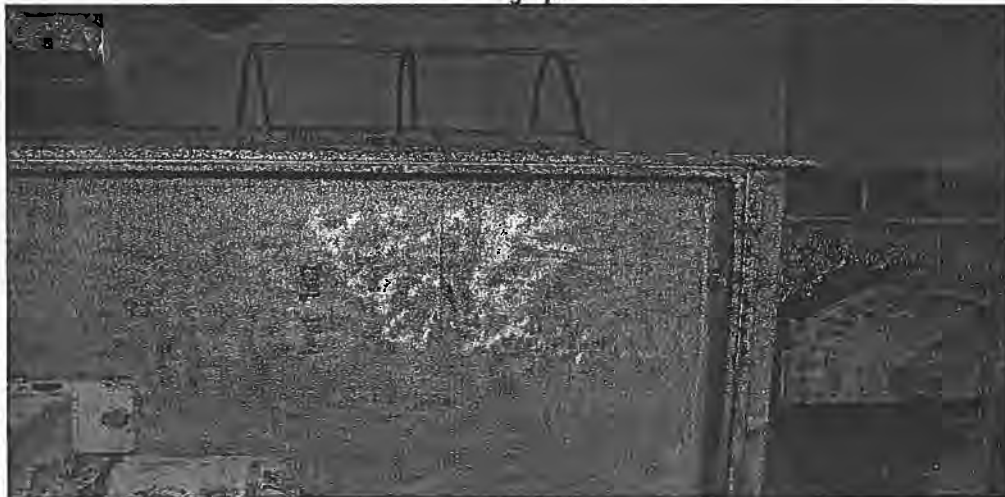
| <b>Location of Survey</b><br>Cane Hill Hospital,<br>Cane Hill,<br>Coulsdon, Surrey,<br>CR5 3ES | <b>Position of Sample/Photo</b><br>Incinerator<br>Rope seal | <b>Asbestos</b> Yes, Strongly Presumed<br><br><b>Type</b> Chrysotile (White) |
| <b>Material Type</b> Rope | <b>Quantity</b> 4m | <b>Sample No</b> As 06/B/8026/22<br><br><b>Survey Date</b> 24.04 - 29.06.06<br><br><b>Date of Report</b> 18.08.06<br><b>Surveyor(s)</b> [REDACTED] |

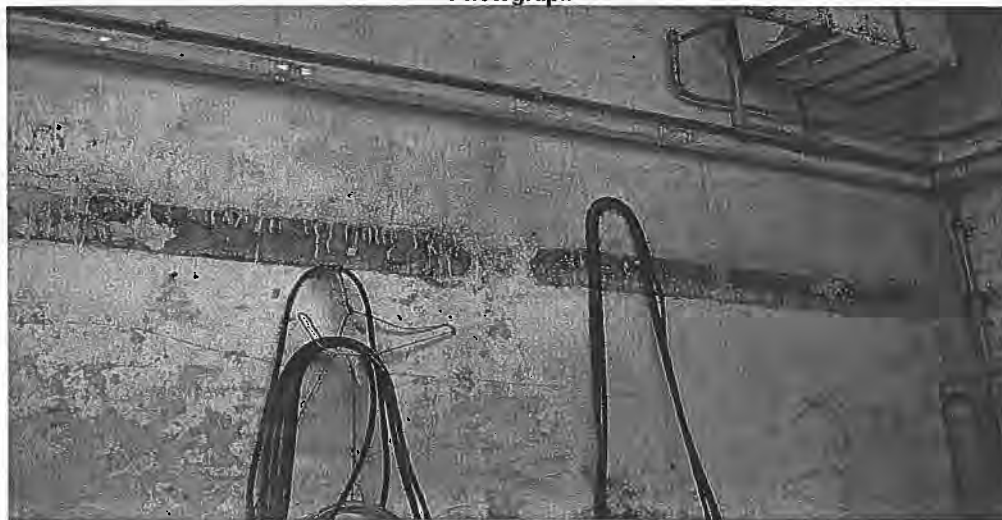
**Photograph**

| <b>Location of Survey</b><br>Cane Hill Hospital,<br>Cane Hill,<br>Coulston, Surrey,<br>CR5 3ES | | <b>Position of Sample/Photo</b><br>Laundry store<br>Wall debris | <b>Asbestos</b> Yes<br><br><b>Type</b> Chrysotile (White) |
| <b>Material Type</b> Lagging | <b>Quantity</b> <1m | <b>Sample No</b> 06/B/8026/175<br><br><b>Survey Date</b> 24.04 - 29.06.06<br><br><b>Date of Report</b> 18.08.06<br><br><b>Surveyor(s)</b> <span style="background-color: black; color: black;">[REDACTED]</span> | |

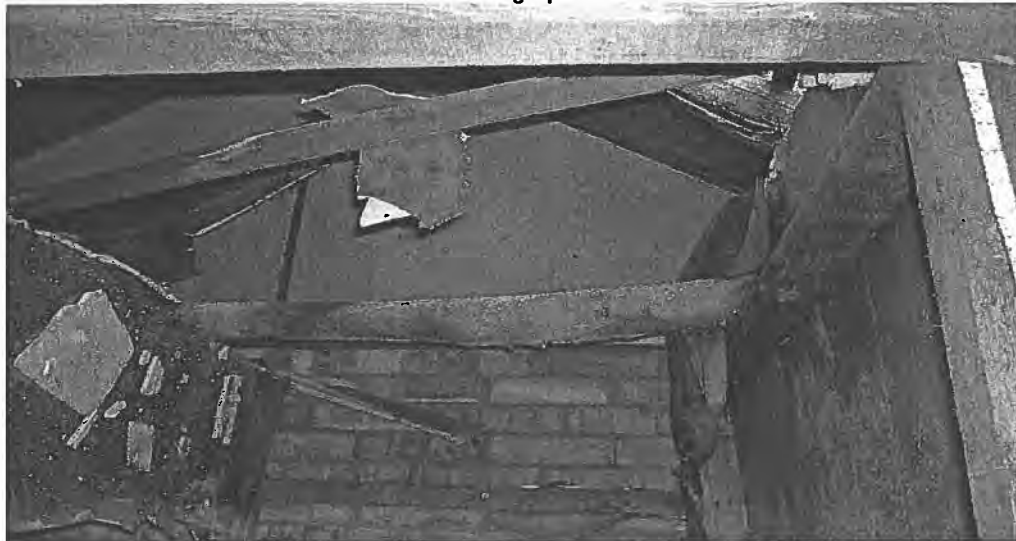
**Photograph**

| <b>Location of Survey</b><br>Cane Hill Hospital,<br>Cane Hill,<br>Coulston, Surrey,<br>CR5 3ES | | <b>Position of Sample/Photo</b><br>External Store adjacent<br>Laundry Office<br>Partition panel | | <b>Asbestos</b><br><br><b>Type</b> | <br>Yes, Strongly<br>Presumed<br><br>Chrysotile (White) |
| <b>Material Type</b><br>Cement | | <b>Quantity</b><br>4m <sup>2</sup> | | <b>Sample No</b> | As 06/B/8026/175 |

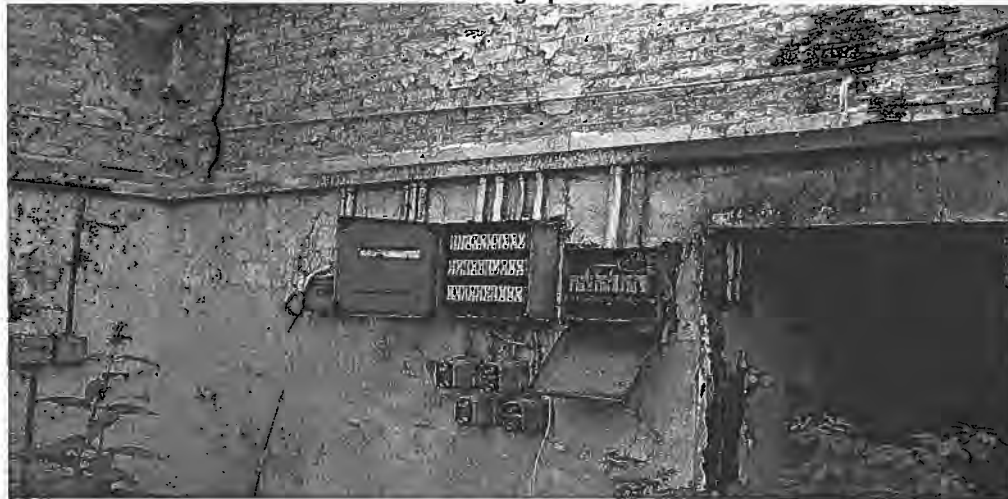
**Photograph**

| <b>Location of Survey</b><br>Cane Hill Hospital,<br>Cane Hill,<br>Coulston, Surrey,<br>CR5 3ES | | <b>Position of Sample/Photo</b><br>Workshop adjacent Laundry<br>Electrics | <b>Asbestos</b><br><br><b>Type</b> | Yes, Strongly<br>Presumed<br><br>Chrysotile (White) |
| <b>Material Type</b> | Rope | <b>Quantity</b> | 1m | <b>Sample No</b> As 06/B/8026/9<br>&22<br><b>Survey Date</b> 24.04 - 29.06.06<br><b>Date of Report</b> 18.08.06<br><b>Surveyor(s)</b> <span style="background-color: black; color: black;">[REDACTED]</span> |

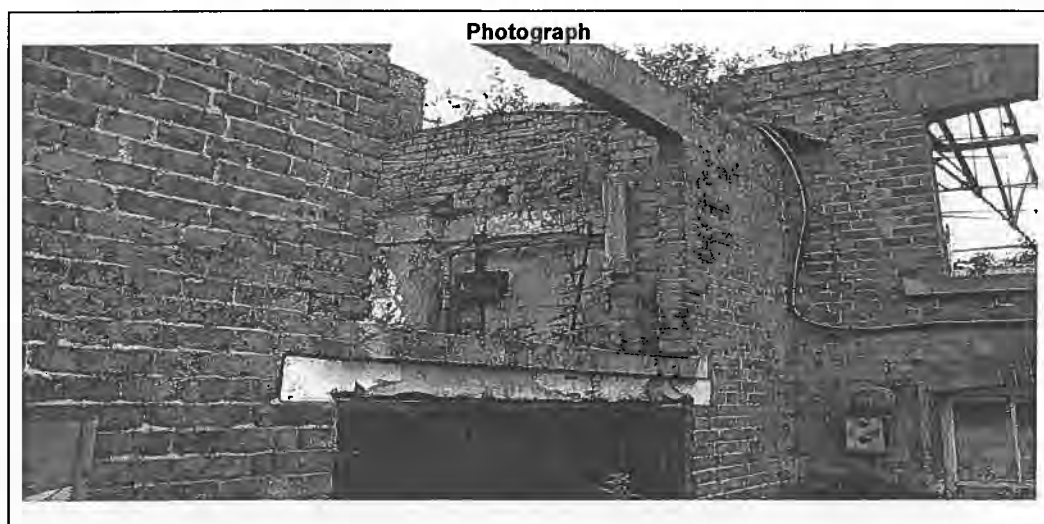
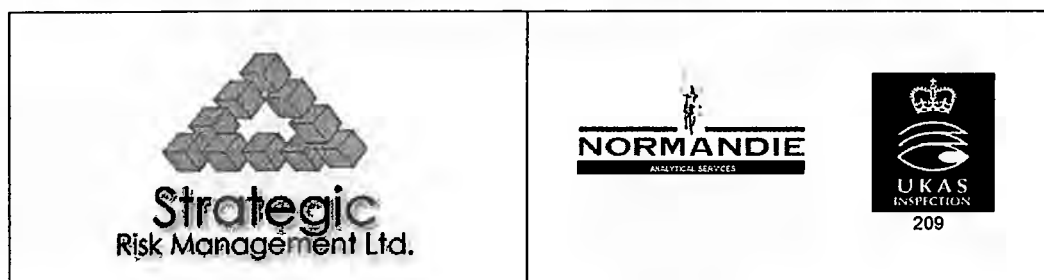
| <b>Location of Survey</b><br>Cane Hill Hospital,<br>Cane Hill,<br>Coulsdon, Surrey,<br>CR5 3ES | | <b>Position of Sample/Photo</b><br>Derelict building adjacent<br>Workshop<br>Rope to pipework | | <b>Asbestos</b><br><br><b>Type</b> | Yes, Strongly<br>Presumed<br><br>Chrysotile (White) |
| <b>Material Type</b> | Rope | <b>Quantity</b> | 1m | <b>Sample No</b> | As 06/B/8026/58 |

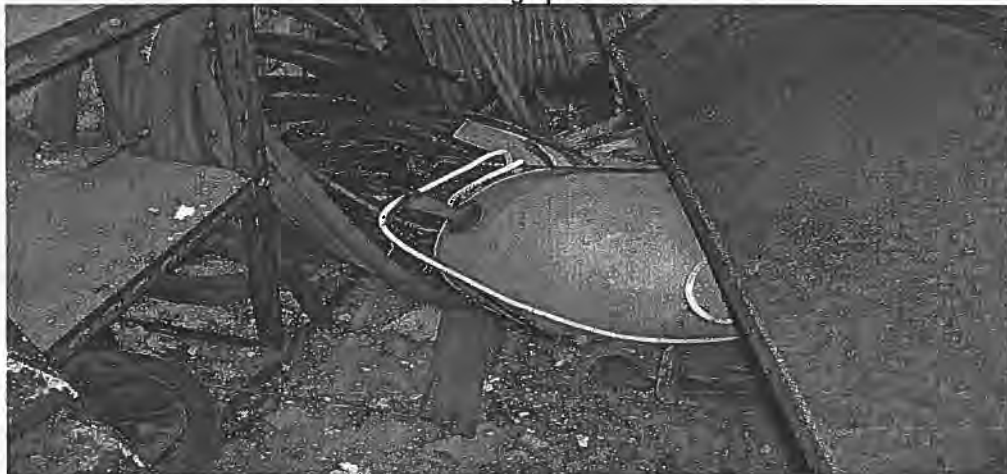
**Photograph**

| <b>Location of Survey</b><br>Cane Hill Hospital,<br>Cane Hill,<br>Coulston, Surrey,<br>CR5 3ES | | <b>Position of Sample/Photo</b><br>Store adjacent Generator<br>Cable wrap | <b>Asbestos</b><br><br><b>Type</b> | Yes, Strongly<br>Presumed<br><br>Chrysotile (White) |
| <b>Material Type</b> | Rope | <b>Quantity</b> | 2m | <b>Sample No</b> As 06/B/8026/43<br><br><b>Survey Date</b> 24.04 - 29.06.06<br><br><b>Date of Report</b> 18.08.06<br><br><b>Surveyor(s)</b> <span style="background-color: black; color: black;">[REDACTED]</span> |

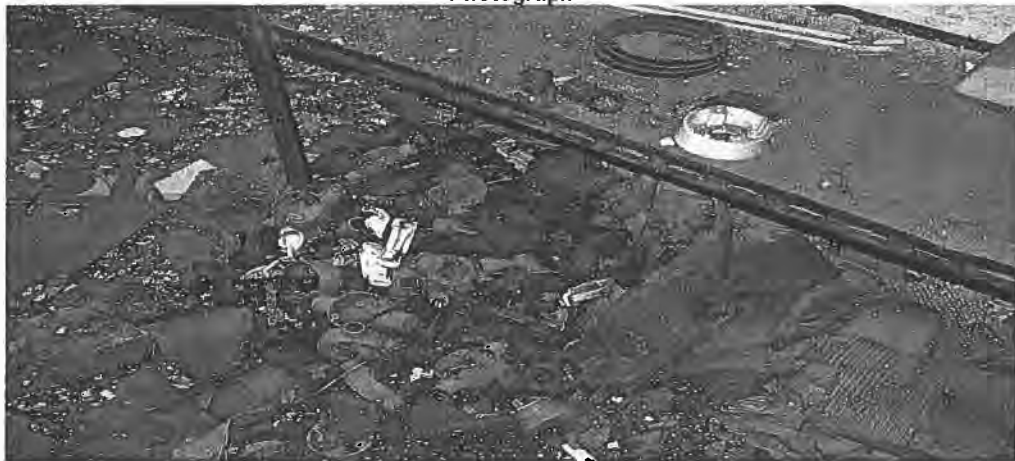
**Photograph**

| <b>Location of Survey</b><br>Cane Hill Hospital,<br>Cane Hill,<br>Coulston, Surrey,<br>CR5 3ES | | <b>Position of Sample/Photo</b><br>Store adjacent Generator<br>Redundant fuses | | <b>Asbestos</b><br><br><b>Type</b> | Yes, Strongly<br>Presumed<br><br>Chrysotile (White) |
| <b>Material Type</b> | Rope | <b>Quantity</b> | <1m | <b>Sample No</b> | As 06/B/8026/9 |

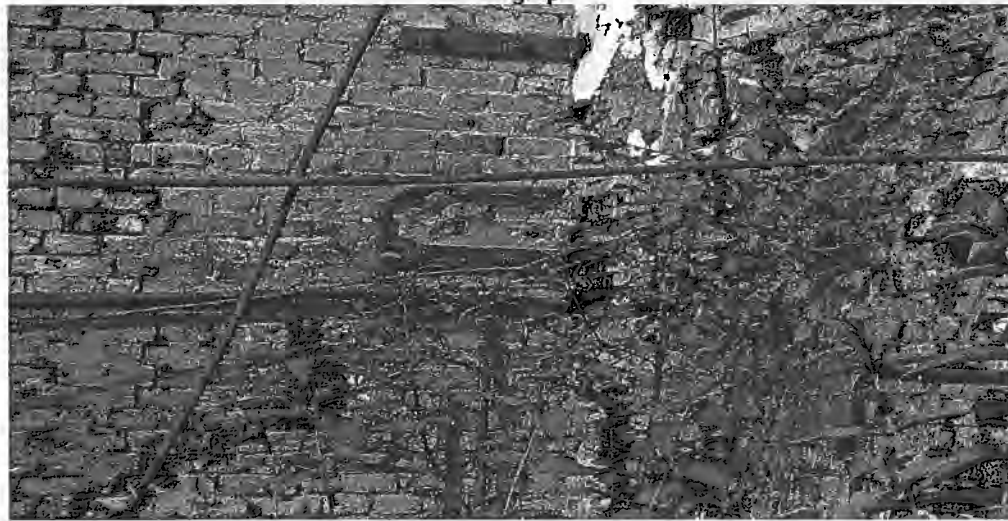
**Photograph**

| <b>Location of Survey</b><br>Cane Hill Hospital,<br>Cane Hill,<br>Coulston, Surrey,<br>CR5 3ES | | <b>Position of Sample/Photo</b><br>Derelict building adjacent<br>Workshop<br>Rope to pipework | <b>Asbestos</b><br><br><b>Type</b> | Yes, Strongly<br>Presumed<br><br>Chrysotile (White) |
| <b>Material Type</b> | Rope | <b>Quantity</b> | <1m <sup>2</sup> | <b>Sample No</b> As 06/B/8026/58<br><br><b>Survey Date</b> 24.04 - 29.06.06<br><br><b>Date of Report</b> 18.08.06<br><br><b>Surveyor(s)</b> <span style="background-color: black; color: black;">[REDACTED]</span> |

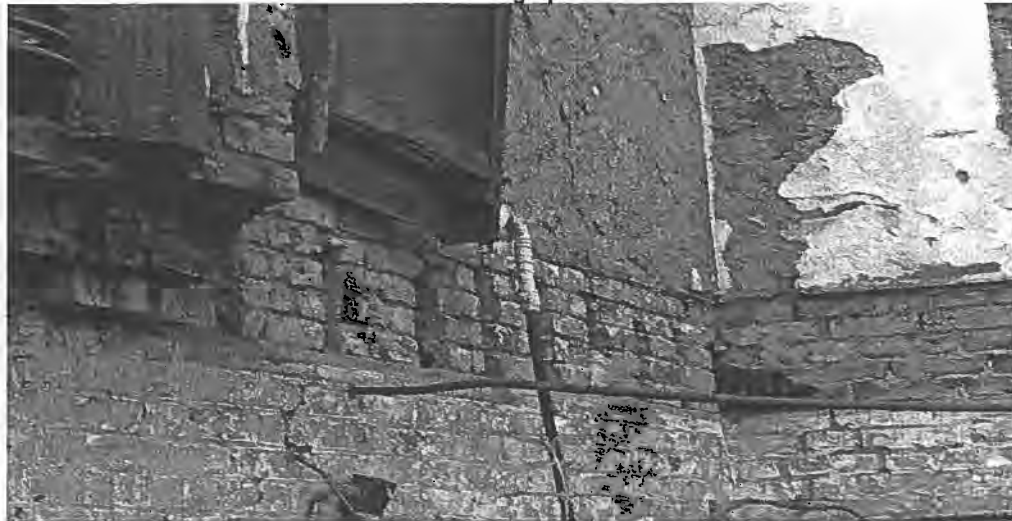
**Photograph**

| <b>Location of Survey</b><br>Cane Hill Hospital,<br>Cane Hill,<br>Coulston, Surrey,<br>CR5 3ES | | <b>Position of Sample/Photo</b><br>Derelict building adjacent<br>Workshop<br>Rope to pipework | | <b>Asbestos</b><br><br><b>Type</b> | <br>Yes, Strongly<br>Presumed<br><br>Chrysotile (White) |
| <b>Material Type</b> | Rope | <b>Quantity</b> | 1m | <b>Sample No</b> | As 06/B/8026/58 |

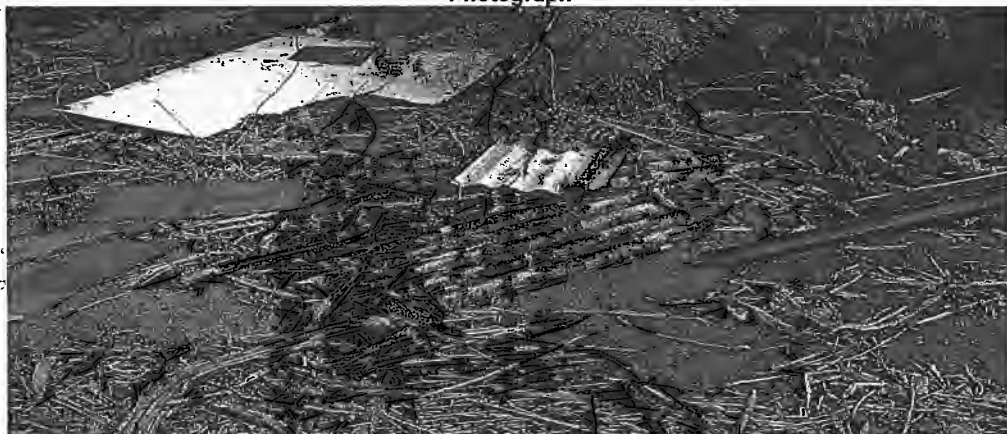
**Photograph**

| <b>Location of Survey</b><br>Cane Hill Hospital,<br>Cane Hill,<br>Coulston, Surrey,<br>CR5 3ES | | <b>Position of Sample/Photo</b><br>Workshop<br>External debris | | <b>Asbestos</b><br><br><b>Type</b> | Yes, Strongly<br>Presumed<br><br>Chrysotile (White) |
| <b>Material Type</b><br>Cement | | <b>Quantity</b><br>10m <sup>2</sup> | | <b>Sample No</b> | As 06/B/8026/126 |

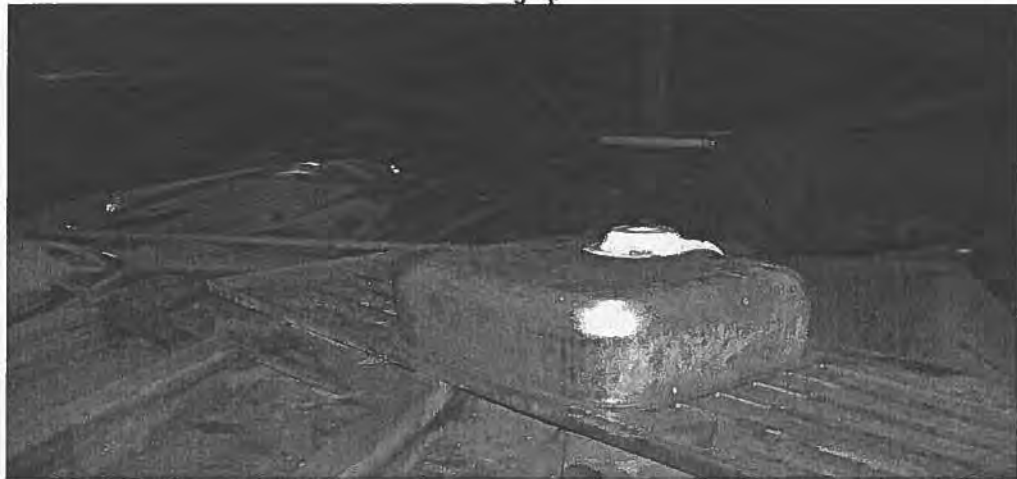
**Photograph**

| <b>Location of Survey</b><br>Cane Hill Hospital,<br>Cane Hill,<br>Coulston, Surrey,<br>CR5 3ES | | <b>Position of Sample/Photo</b><br>Workshop roof void<br>Redundant Sink Pad | | <b>Asbestos</b><br><br><b>Type</b> | Yes, Strongly<br>Presumed<br><br>Chrysotile (White) |
| <b>Material Type</b> | Bitumen | <b>Quantity</b> | 1m <sup>2</sup> | <b>Sample No</b> | As 06/B/8026/64 |

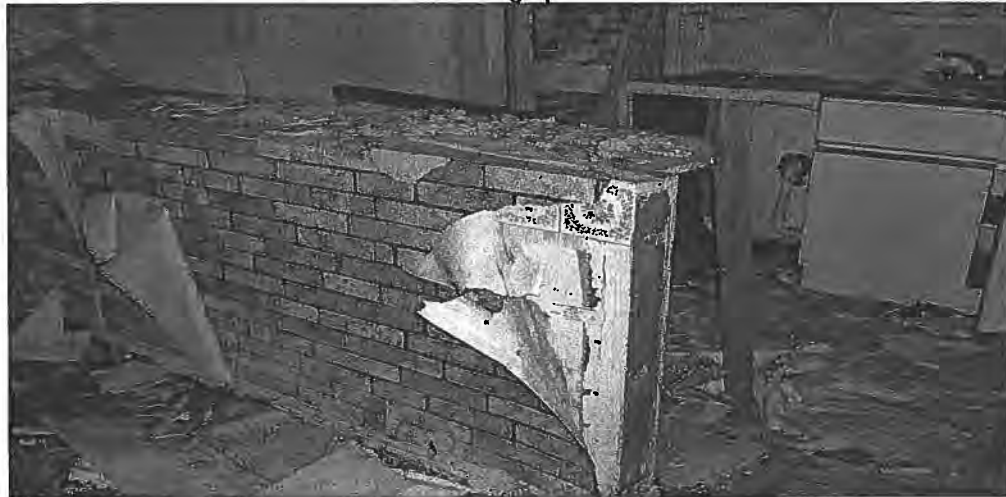
**Photograph**

| <b>Location of Survey</b><br>Cane Hill Hospital,<br>Cane Hill,<br>Coulsdon, Surrey,<br>CR5 3ES | <b>Position of Sample/Photo</b><br>Mortuary House, Kitchen,<br>Partition board to low level<br>breakfast bar | <b>Asbestos</b> Yes<br><br><b>Type</b> Amosite (Brown) |
| <b>Material Type</b> Board | <b>Quantity</b> 2m <sup>2</sup> | <b>Sample No</b> 06/B/8026/178<br><br><b>Survey Date</b> 24.04 - 29.06.06<br><br><b>Date of Report</b> 18.08.06<br><br><b>Surveyor(s)</b> [REDACTED] |

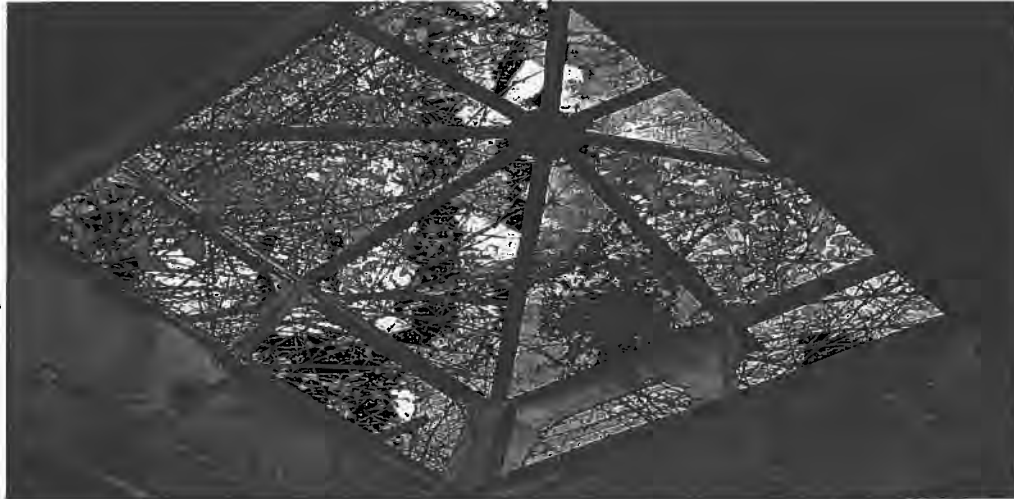
**Photograph**

| <b>Location of Survey</b><br>Cane Hill Hospital,<br>Cane Hill,<br>Coulston, Surrey,<br>CR5 3ES | | <b>Position of Sample/Photo</b><br>Mortuary House kitchen,<br>Skylight rope seal | | <b>Asbestos</b><br><br><b>Type</b> | Yes, Strongly<br>Presumed<br><br>Chrysotile (White) |
| <b>Material Type</b> | Rope | <b>Quantity</b> | 4m | <b>Sample No</b> | As 06/B/8026/31 |

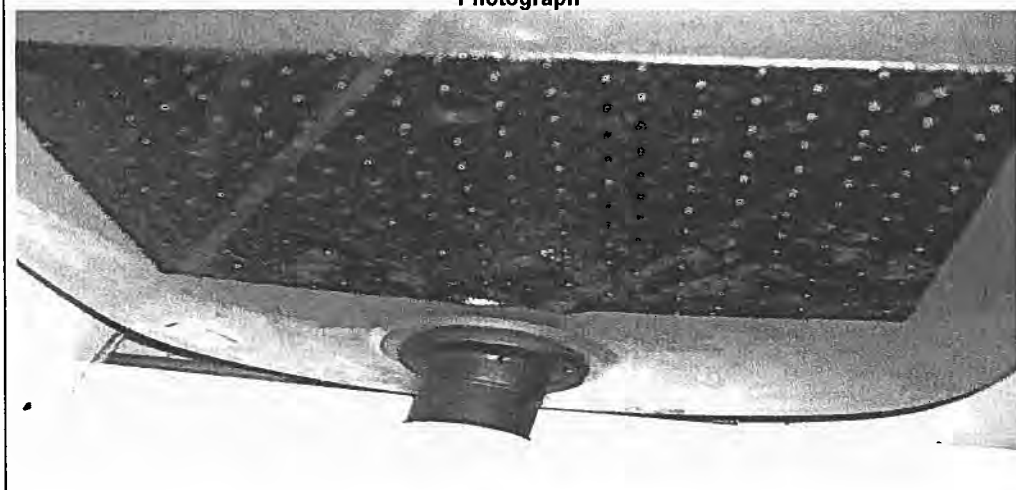
**Photograph**

| <b>Location of Survey</b><br>Cane Hill Hospital,<br>Cane Hill,<br>Coulston, Surrey,<br>CR5 3ES | | <b>Position of Sample/Photo</b><br>Mortuary House kitchen,<br>Sink Pad | <b>Asbestos</b><br><br><b>Type</b> | Yes, Strongly<br>Presumed<br><br>Chrysotile (White) |
| <b>Material Type</b> | Bitumen | <b>Quantity</b> | <1m | <b>Sample No</b> As 06/B/8026/64 |

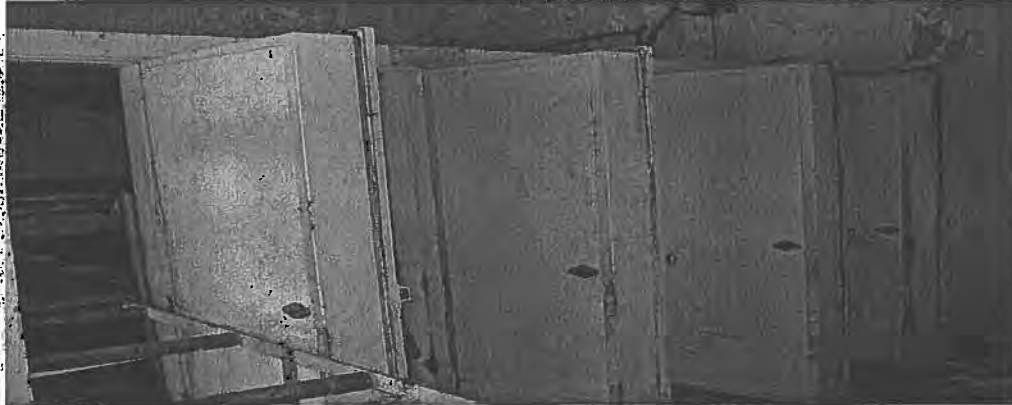
**Photograph**

| <b>Location of Survey</b><br>Cane Hill Hospital,<br>Cane Hill,<br>Coulsdon, Surrey,<br>CR5 3ES | <b>Position of Sample/Photo</b><br>Mortuary Fridge panels | <b>Asbestos</b> Yes, Strongly Presumed<br><br><b>Type</b> Chrysotile (White) |
| <b>Material Type</b> Cement | <b>Quantity</b> 80m <sup>2</sup> | <b>Sample No</b> As 06/B/8026/161<br><br><b>Survey Date</b> 24.04 - 29.06.06<br><br><b>Date of Report</b> 18.08.06<br><b>Surveyor(s)</b> <span style="background-color: black; color: black;">[REDACTED]</span> |

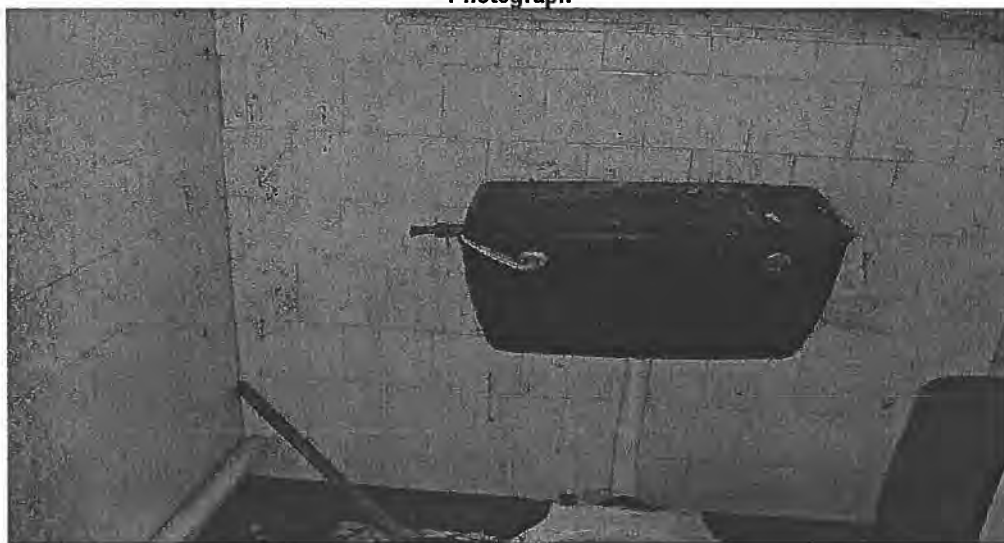
**Photograph**

| <b>Location of Survey</b><br>Cane Hill Hospital,<br>Cane Hill,<br>Coulsdon, Surrey,<br>CR5 3ES | <b>Position of Sample/Photo</b><br>Mortuary W.C.<br>Cistern | <b>Asbestos</b><br><br><b>Type</b> | Yes, Strongly<br>Presumed<br><br>Amosite (Brown) |
| <b>Material Type</b><br>Plastic | <b>Quantity</b><br>1m <sup>2</sup> | <b>Sample No</b><br><br><b>Survey Date</b><br><br><b>Date of Report</b><br><br><b>Surveyor(s)</b> | As 06/B/8026/5<br><br>24.04 - 29.06.06<br><br>18.08.06<br><br><div style="background-color: black; width: 100px; height: 40px;"></div> |

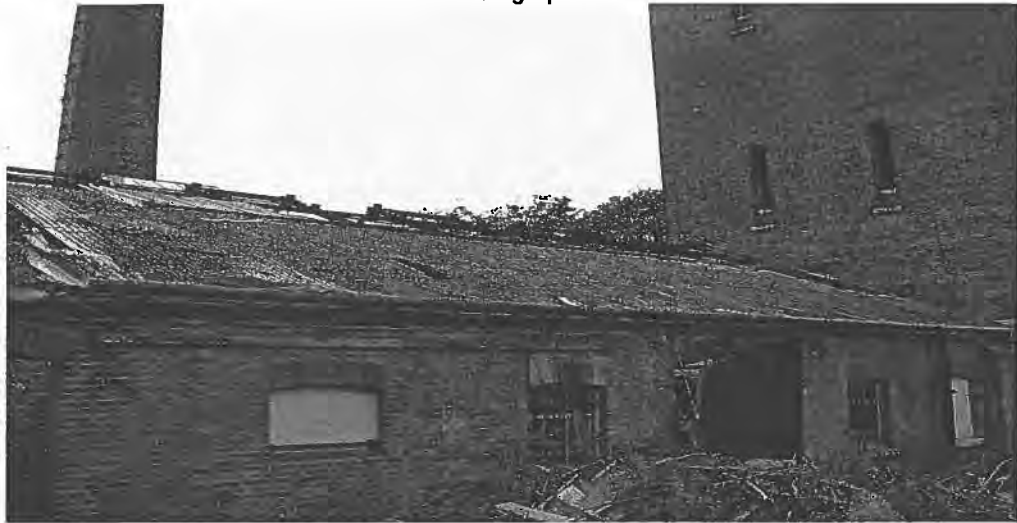
**Photograph**

| <b>Location of Survey</b><br><br>Cane Hill Hospital,<br>Cane Hill,<br>Coulsdon, Surrey,<br>CR5 3ES | <b>Position of Sample/Photo</b><br><br>Workshop adjacent Water<br>Tank Tower<br>Roof sheet | <b>Asbestos</b><br><br>Yes, Strongly<br>Presumed | <b>Type</b><br><br>Chrysotile (White) |
| <b>Material Type</b><br><br>Cement | <b>Quantity</b><br><br>100m <sup>2</sup> | <b>Sample No</b><br>As 06/B/8026/126<br><br><b>Survey Date</b><br>24.04 - 29.06.06<br><br><b>Date of Report</b><br>18.08.06<br><br><b>Surveyor(s)</b><br><div style="background-color: black; width: 100px; height: 40px; margin-top: 5px;"></div> | |

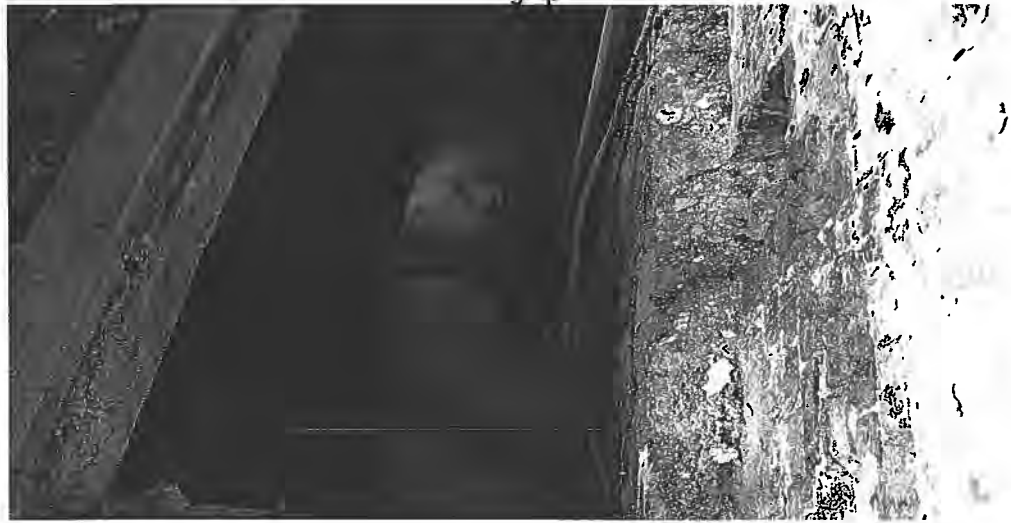
**Photograph**

| <b>Location of Survey</b><br>Cane Hill Hospital,<br>Cane Hill,<br>Coulston, Surrey,<br>CR5 3ES | <b>Position of Sample/Photo</b><br>Workshop adjacent Water<br>Tank Tower<br>Undercroft Pipe Lagging<br>(presumed throughout) | <b>Asbestos</b> Yes, Strongly<br>Presumed<br><br><b>Type</b> Chrysotile (White)<br>Crocidolite (Blue) |
| <b>Material</b> Lagging<br><b>Type</b> | <b>Quantity</b> >100m | <b>Sample No</b> As 06/B/8026/174<br><br><b>Survey Date</b> 24.04 - 29.06.06<br><br><b>Date of Report</b> 18.08.06<br><br><b>Surveyor(s)</b> <span style="background-color: black; color: black;">[REDACTED]</span> |

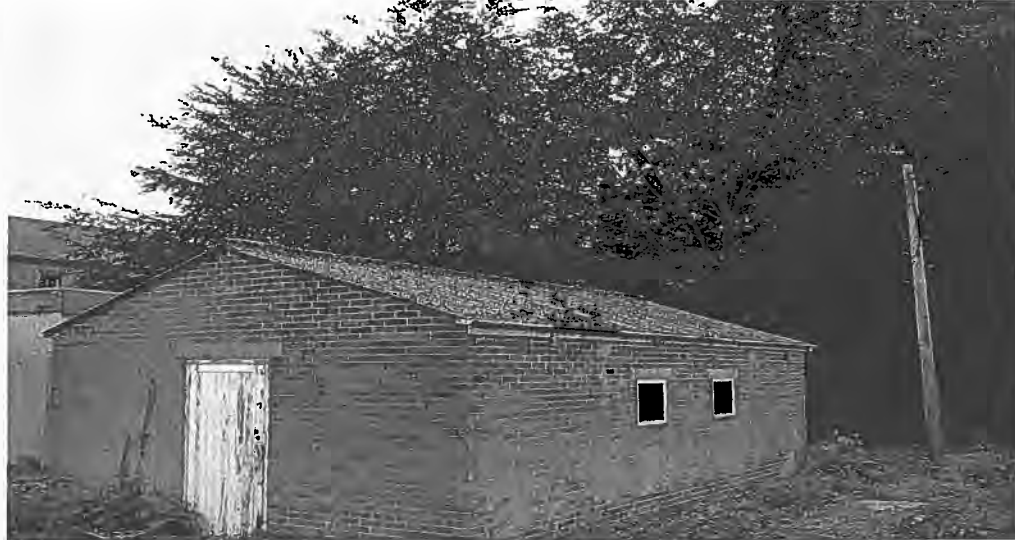
**Photograph**

| <b>Location of Survey</b><br>Cane Hill Hospital,<br>Cane Hill,<br>Coulston, Surrey,<br>CR5 3ES | | <b>Position of Sample/Photo</b><br>Remote store to rear of Water<br>Tank Tower<br>Roof Sheet | | <b>Asbestos</b><br><br><b>Type</b> | <b>Yes, Strongly<br/>Presumed</b><br><br>Chrysotile (White) |
| <b>Material<br/>Type</b> | Cement | <b>Quantity</b> | 40m <sup>2</sup> | <b>Sample No</b> | As 06/B/8026/126 |

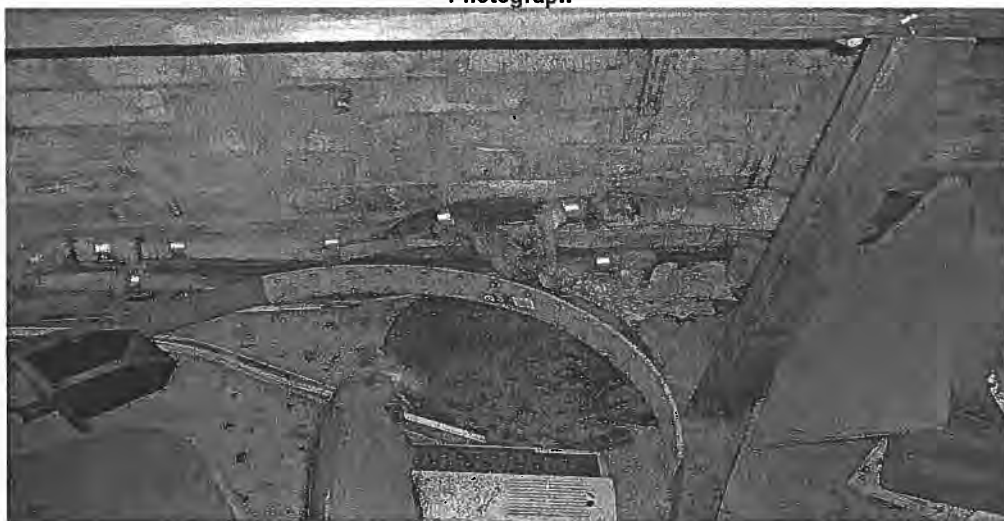
**Photograph**

| <b>Location of Survey</b><br>Cane Hill Hospital,<br>Cane Hill,<br>Coulston, Surrey,<br>CR5 3ES | | <b>Position of Sample/Photo</b><br>Remote store to rear of Water<br>Tank Tower<br>Gasket debris | <b>Asbestos</b><br><br><b>Type</b> | Yes, Strongly<br>Presumed<br><br>Chrysotile (White) |
| <b>Material Type</b> | Gasket | <b>Quantity</b> | <1m <sup>2</sup> | <b>Sample No</b> As 06/B/8026/180<br><br><b>Survey Date</b> 24.04 - 29.06.06<br><br><b>Date of Report</b> 18.08.06<br><b>Surveyor(s)</b> [REDACTED] |

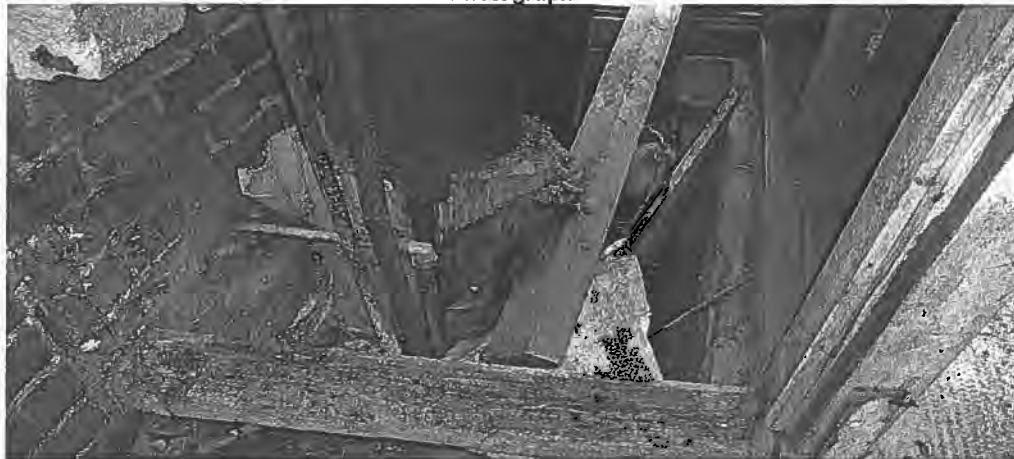
**Photograph**

| <b>Location of Survey</b><br>Cane Hill Hospital,<br>Cane Hill,<br>Coulsdon, Surrey,<br>CR5 3ES | | <b>Position of Sample/Photo</b><br>Water Tower<br>Corrugated lagging to Outtake<br>Pipes | | <b>Asbestos</b><br><br><b>Type</b> | Yes<br><br>Chrysotile (White) |
| <b>Material Type</b> | Paper | <b>Quantity</b> | 1m <sup>2</sup> | <b>Sample No</b> | 06/B/8026/176 |

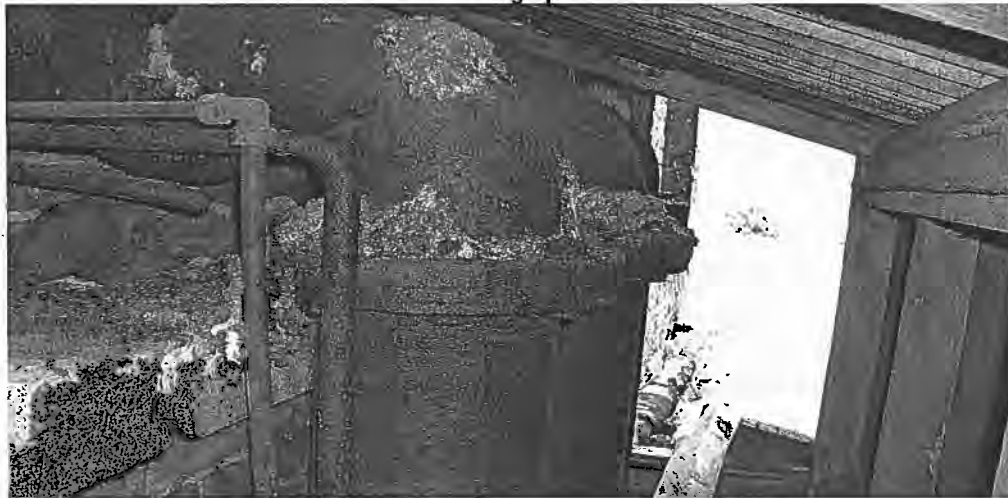
**Photograph**

| <b>Location of Survey</b><br>Cane Hill Hospital,<br>Cane Hill,<br>Coulsdon, Surrey,<br>CR5 3ES | <b>Position of Sample/Photo</b><br>Water Tower<br>Debris to Outtake Pipes | <b>Asbestos</b> Yes<br><br><b>Type</b> Chrysotile (White) | |
| <b>Material Type</b> Lagging | <b>Quantity</b> <1m <sup>2</sup> | <b>Sample No</b> 06/B/8026/177<br><br><b>Survey Date</b> 24.04 - 29.06.06<br><br><b>Date of Report</b> 18.08.06<br><b>Surveyor(s)</b> <span style="background-color: black; color: black;">[REDACTED]</span> | |

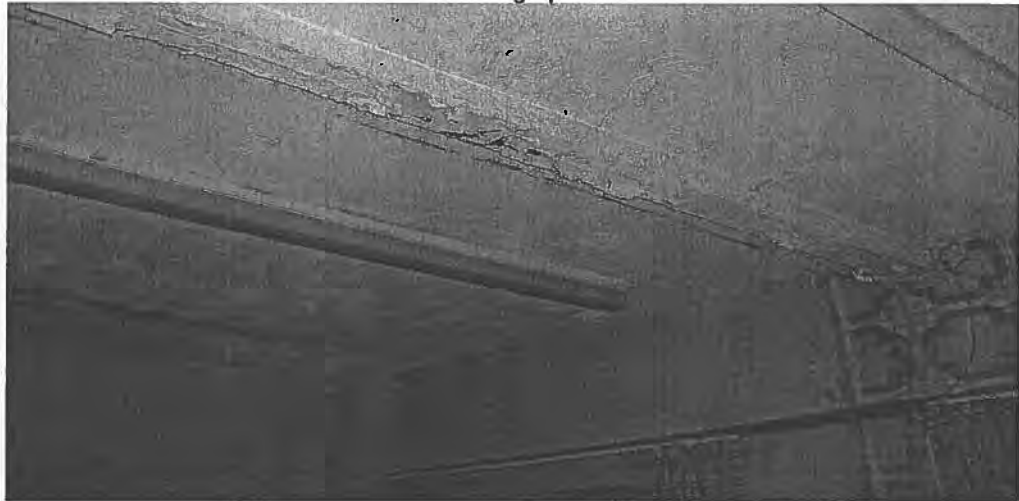
**Photograph**

| <b>Location of Survey</b><br>Cane Hill Hospital,<br>Cane Hill,<br>Coulston, Surrey,<br>CR5 3ES | | <b>Position of Sample/Photo</b><br>Water Tower Courtyard,<br>Foreman's Office<br>Textured coating to ceiling | | <b>Asbestos</b> Yes |
| <b>Material Type</b> Textured coating | | <b>Quantity</b> 10m <sup>2</sup> | <b>Type</b> Chrysotile (White) | |

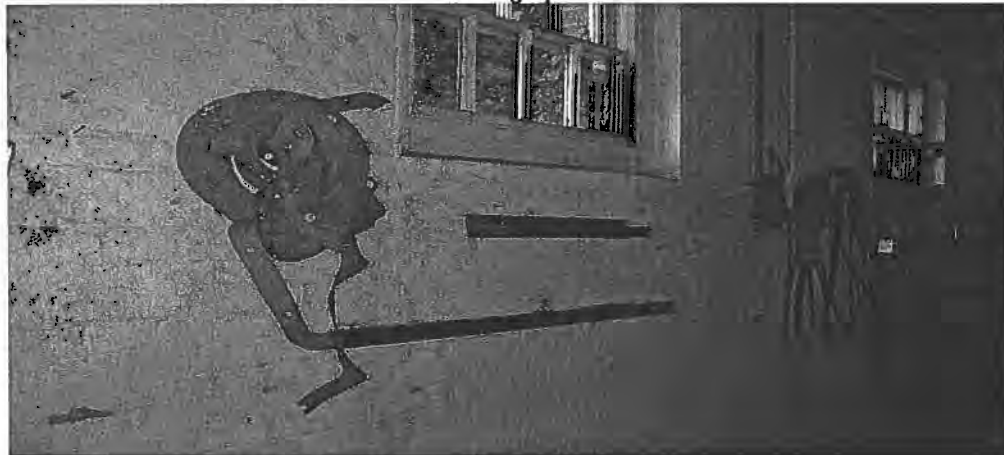
**Photograph**

| <b>Location of Survey</b><br>Cane Hill Hospital,<br>Cane Hill,<br>Coulson, Surrey,<br>CR5 3ES | | <b>Position of Sample/Photo</b><br>Water Tower Courtyard,<br>Workshops<br>Wall Gasket material | | <b>Asbestos</b> | Yes, Strongly<br>Presumed |
| <b>Material Type</b><br>Gasket | | <b>Quantity</b><br>1m <sup>2</sup> | | <b>Type</b> | Chrysotile (White) |

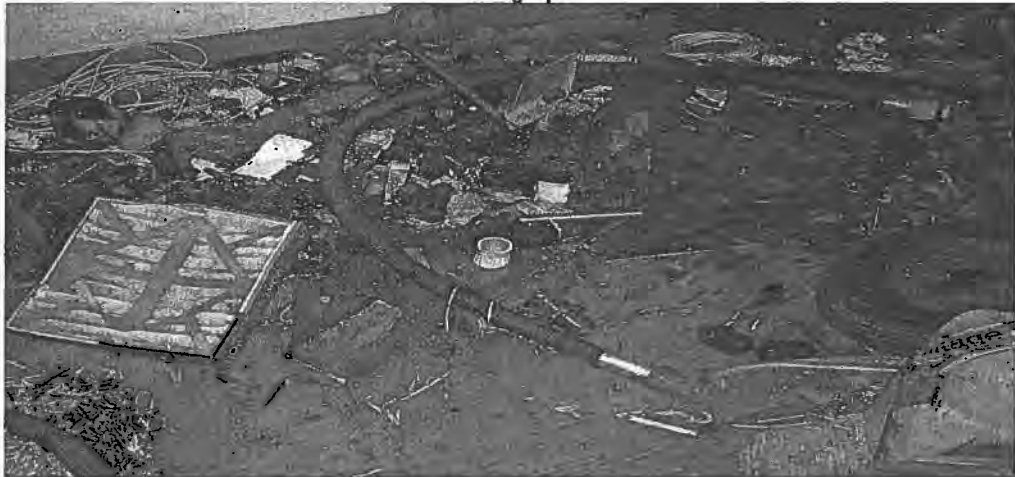
**Photograph**

| <b>Location of Survey</b><br>Cane Hill Hospital,<br>Cane Hill,<br>Coulsdon, Surrey,<br>CR5 3ES | | <b>Position of Sample/Photo</b><br>Water Tower Courtyard,<br>Workshops<br>Gasket material | | <b>Asbestos</b><br><br><b>Type</b> | Yes, Strongly<br>Presumed<br><br>Chrysotile (White) |
| <b>Material Type</b><br>Gasket | | <b>Quantity</b><br>4m <sup>2</sup> | | <b>Sample No</b> | As 06/B/8026/180 |

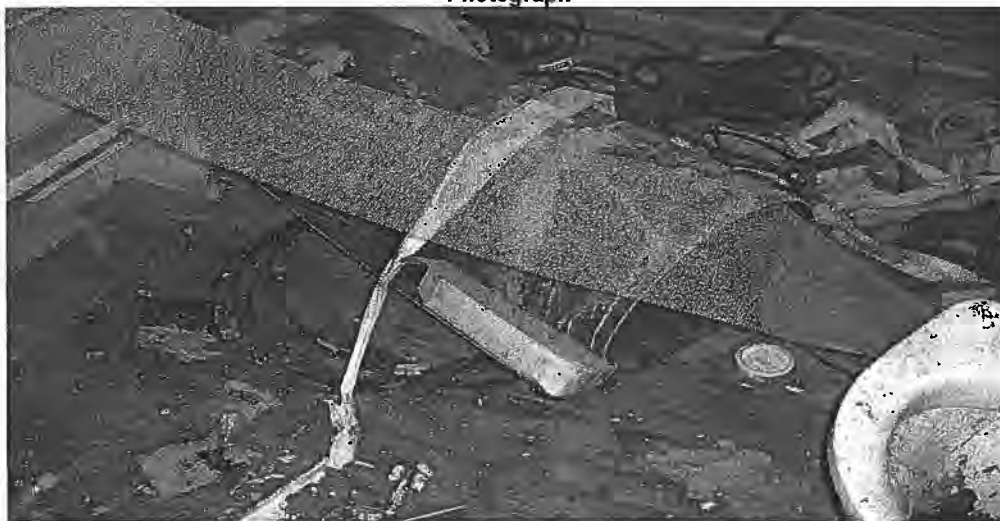
**Photograph**

| Cane Hill Hospital,<br>Cane Hill,<br>Coulston, Surrey,<br>CR5 3ES | | Water Tower Courtyard,<br>Workshops<br>Gasket material | | <b>Type</b> | Chrysotile (White) |
| <b>Material Type</b> | Gasket | <b>Quantity</b> | 4m <sup>2</sup> | <b>Sample No</b> | 06/B/8026/180 |

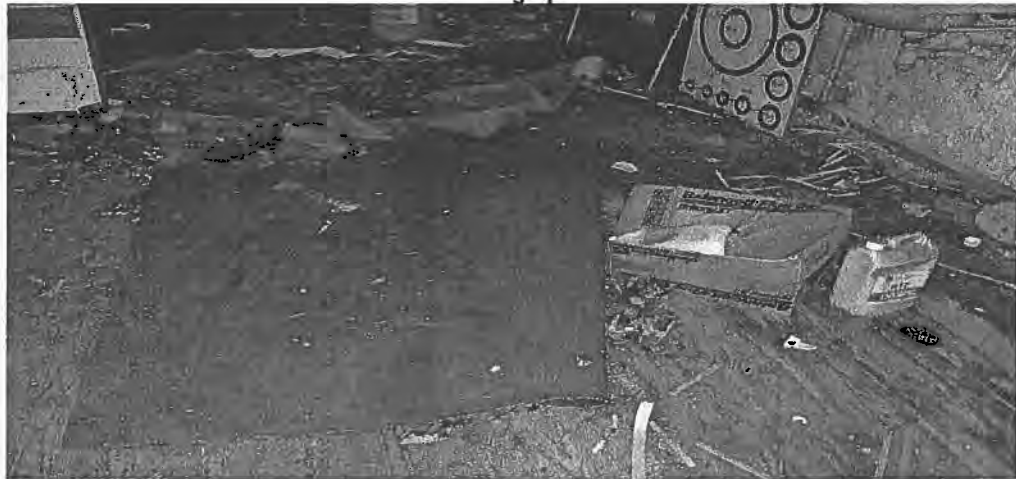
**Photograph**

| <b>Location of Survey</b><br>Cane Hill Hospital,<br>Cane Hill,<br>Coulsdon, Surrey,<br>CR5 3ES | | <b>Position of Sample/Photo</b><br>Water Tower Courtyard,<br>Workshops<br>Gasket material | | <b>Asbestos</b><br><br><b>Type</b> | <b>Yes, Strongly Presumed</b><br><br>Chrysotile (White) |
| <b>Material Type</b> | Gasket | <b>Quantity</b> | 1m <sup>2</sup> | <b>Sample No</b> | As 06/B/8026/180 |
