## SURVEY INFORMATION SHEET

| <b>Location of Survey</b><br>Cane Hill Hospital,<br>Cane Hill,<br>Coulsdon, Surrey,<br>CR5 3ES | <b>Position of Sample/Photo</b><br>Workshop Garages<br>External corrugated roof sheet | <b>Asbestos</b><br><br><b>Type</b> | Yes, Strongly Presumed<br><br>Chrysotile (White) |

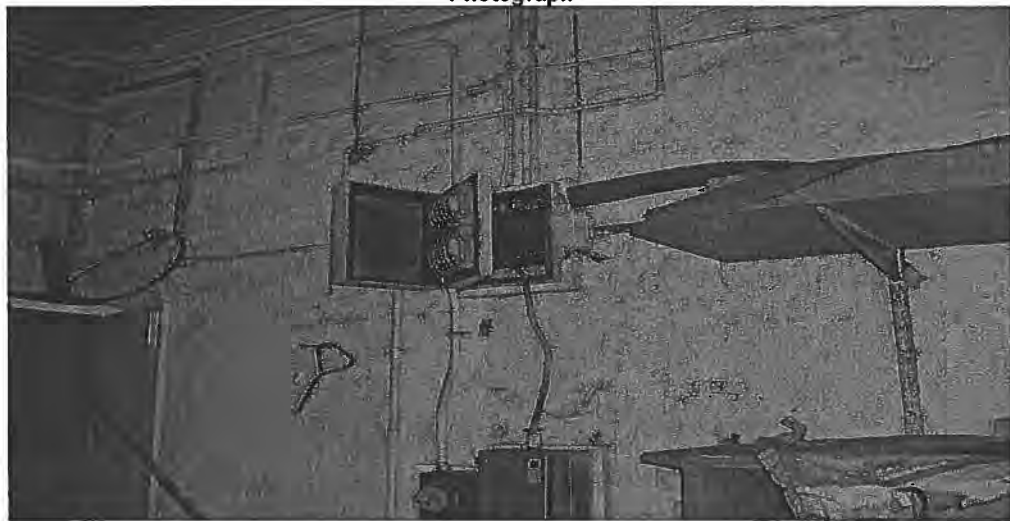
**Photograph**

| <b>Location of Survey</b><br>Cane Hill Hospital,<br>Cane Hill,<br>Coulston, Surrey,<br>CR5 3ES | | <b>Position of Sample/Photo</b><br>Water Tower Courtyard<br>Workshops,<br>Electrics | | <b>Asbestos</b><br><br><b>Type</b> | Yes, Strongly<br>Presumed<br><br>Chrysotile (White) |
| <b>Material Type</b> | Rope | <b>Quantity</b> | 1m <sup>2</sup> | <b>Sample No</b> | As 06/B/8026/22 |

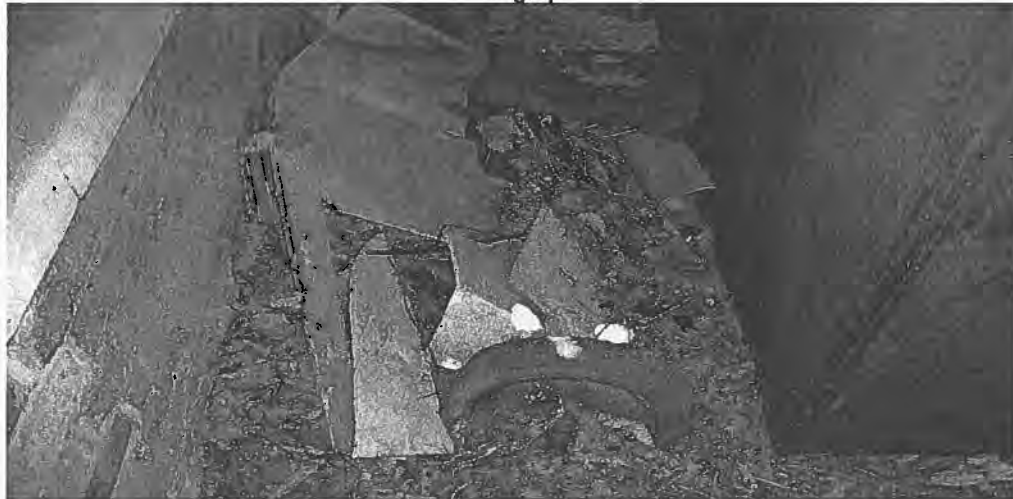
**Photograph**

| <b>Location of Survey</b><br><br>Cane Hill Hospital,<br>Cane Hill,<br>Coulsdon, Surrey,<br>CR5 3ES | <b>Position of Sample/Photo</b><br><br>Water Tower Courtyard<br>Board debris outside<br>workshops | <b>Asbestos</b> Yes<br><br><b>Type</b> Amosite (Brown) |
| <b>Material Type</b> Board | <b>Quantity</b> 1m | <b>Sample No</b> 06/B/8026/181<br><br><b>Survey Date</b> 24.04 - 29.06.06<br><br><b>Date of Report</b> 18.08.06<br><br><b>Surveyor(s)</b> <span style="background-color: black; color: black;">[REDACTED]</span> |

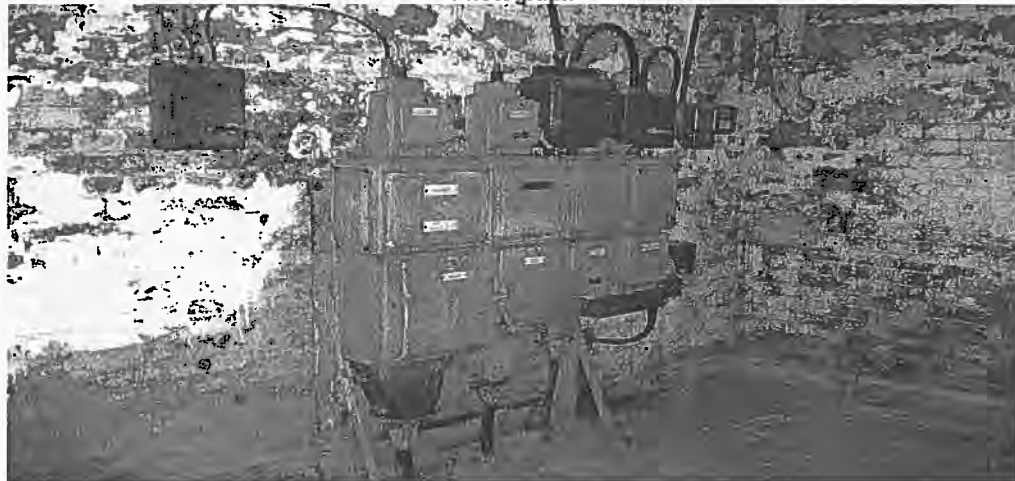
### Photograph

| <b>Location of Survey</b><br>Cane Hill Hospital,<br>Cane Hill,<br>Coulsdon, Surrey,<br>CR5 3ES | <b>Position of Sample/Photo</b><br>Water Tank Tower<br>Electrics | <b>Asbestos</b> Yes, Strongly Presumed<br><br><b>Type</b> Chrysotile (White) |
| <b>Material Type</b> Rope | <b>Quantity</b> 2m | <b>Sample No</b> As 06/B/8026/9<br><br><b>Survey Date</b> 24.04 - 29.06.06<br><br><b>Date of Report</b> 18.08.06<br><br><b>Surveyor(s)</b> <span style="background-color: black; color: black;">[REDACTED]</span> |

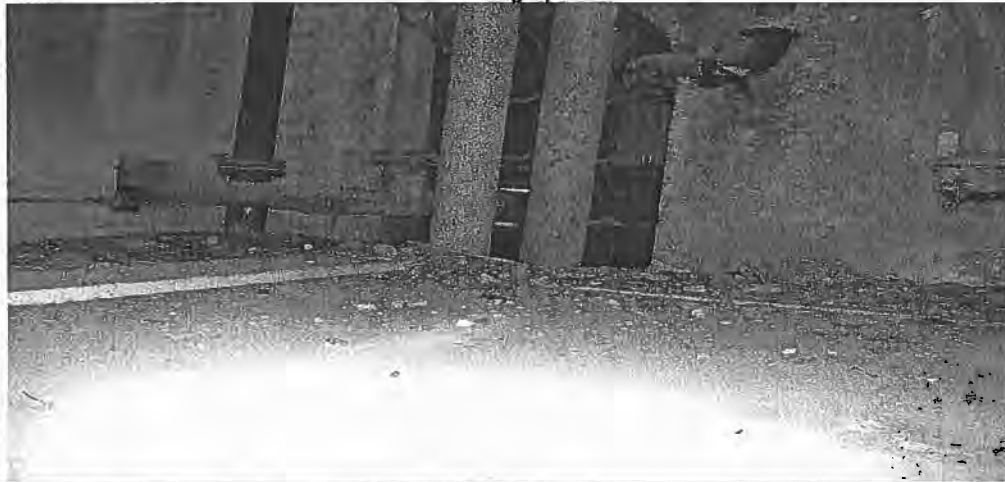
**Photograph**

| <b>Location of Survey</b><br>Cane Hill Hospital,<br>Cane Hill,<br>Coulsdon, Surrey,<br>CR5 3ES | <b>Position of Sample/Photo</b><br>Water Tank Tower<br>Office Ceiling | <b>Asbestos</b> Yes<br><br><b>Type</b> Amosite (Brown) |
| <b>Material Type</b> Board | <b>Quantity</b> 10m <sup>2</sup> | <b>Sample No</b> 06/B/8026/224<br><br><b>Survey Date</b> 24.04 - 29.06.06<br><br><b>Date of Report</b> 18.08.06<br><b>Surveyor(s)</b> [REDACTED] |

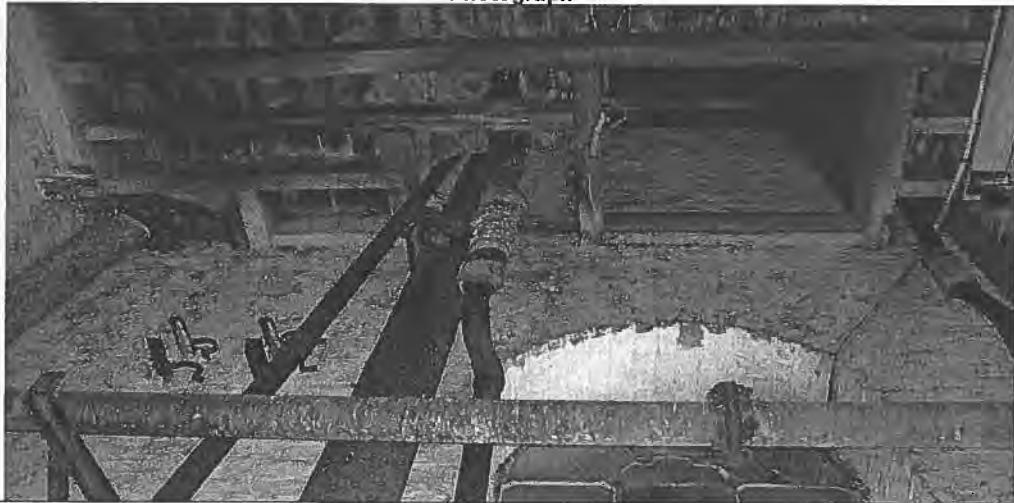
**Photograph**

| <b>Location of Survey</b><br>Cane Hill Hospital,<br>Cane Hill,<br>Coulsdon, Surrey,<br>CR5 3ES | | <b>Position of Sample/Photo</b><br>Water Tank Tower<br>Pipe Lagging<br>(presumed throughout) | | <b>Asbestos</b><br><br><b>Type</b> | Yes, Strongly<br>Presumed<br><br>Chrysotile (White)<br>Amosite (Brown) |
| <b>Material Type</b><br>Lagging | | <b>Quantity</b><br>1m <sup>2</sup> | | <b>Sample No</b> | As 06/B/8026/216 |

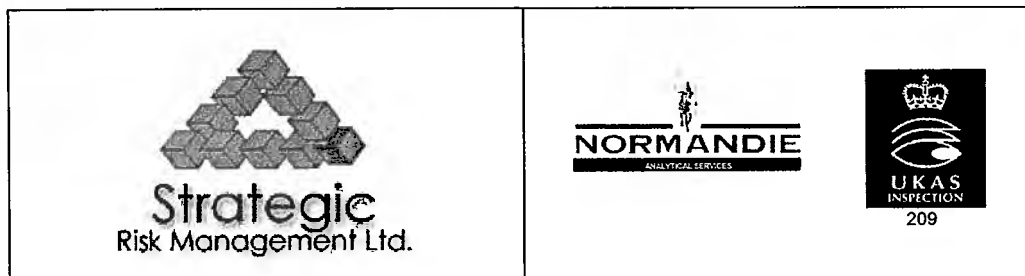
| <b>Location of Survey</b><br>Cane Hill Hospital,<br>Cane Hill,<br>Coulston, Surrey,<br>CR5 3ES | | <b>Position of Sample/Photo</b><br>Water Tank Tower<br>Undercroft<br>Lagging | | <b>Asbestos</b><br><br><b>Type</b> | Yes, Strongly<br>Presumed<br><br>Amosite (Brown)<br>Chrysotile (White) |
| <b>Material Type</b> | Lagging | <b>Quantity</b> | 1m <sup>2</sup> | <b>Sample No</b> | As 06/B/8026/216 |

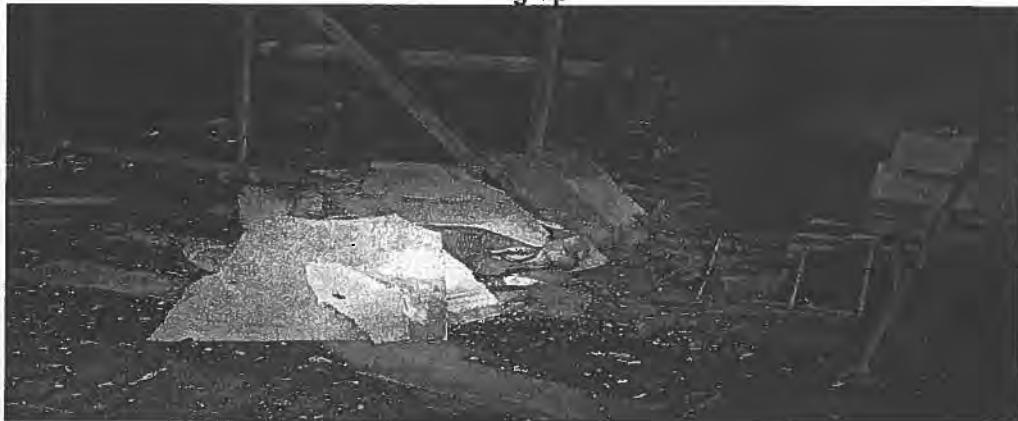
**Photograph**

| <b>Location of Survey</b><br>Cane Hill Hospital<br>Coulsdon<br>Surrey<br>CR5 3ES | | <b>Position of Sample/Photo</b><br>Bricked Up Garage adjacent<br>Water Tower<br>Debris to floor<br>(noted throughout area) | | <b>Asbestos</b><br><br><b>Type</b> | Yes, Strongly<br>Presumed<br><br>Amosite (brown)<br>Chrysotile (white) |

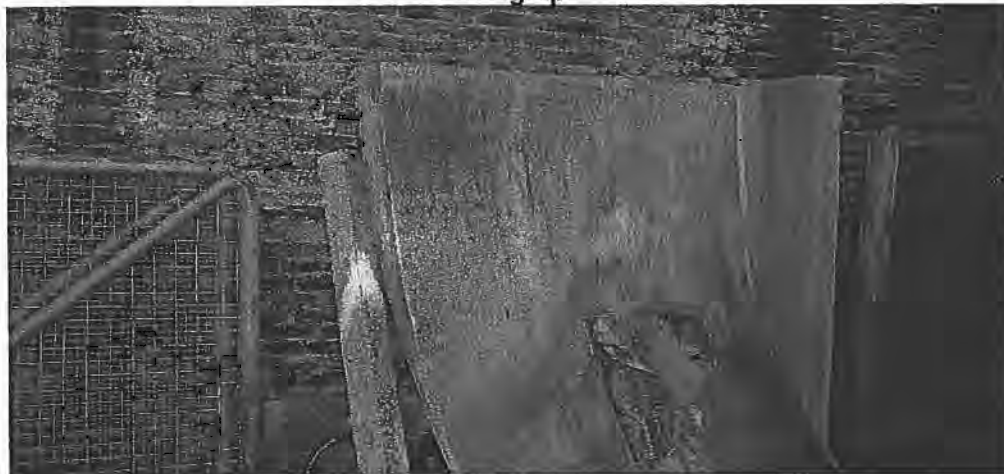
**Photograph**

| <b>Location of Survey</b><br>Cane Hill Hospital<br>Coulson<br>Surrey<br>CR5 3ES | | <b>Position of Sample/Photo</b><br>Bricked Up Garage adjacent<br>Water Tower<br>Redundant AIB Sheets<br>(noted throughout area) | | <b>Asbestos</b><br><br><b>Type</b> | Yes, Strongly<br>Presumed<br><br>Amosite (brown)<br>Chrysotile (white) |

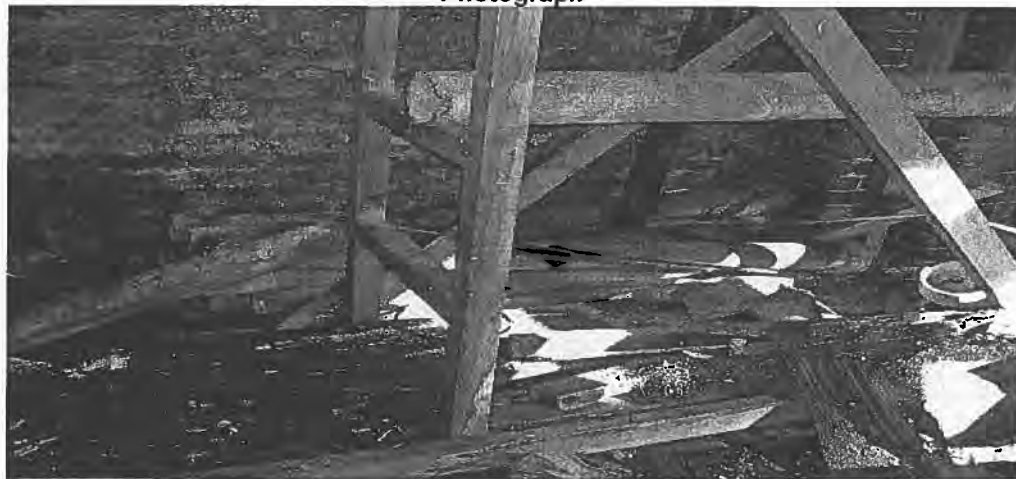
**Photograph**

| <b>Location of Survey</b><br>Cane Hill Hospital<br>Coulsdon<br>Surrey<br>CR5 3ES | | <b>Position of Sample/Photo</b><br>Bricked Up Garage adjacent<br>Water Tower<br>Redundant Flue Pipes<br>(noted throughout area) | | <b>Asbestos</b><br><br><b>Type</b> | <b>Yes, Strongly Presumed</b><br><br>Chrysotile (white) |
| <b>Material Type</b> | Cement | <b>Quantity</b> | 10m | <b>Sample No</b> | As 06/B/8026/20 |

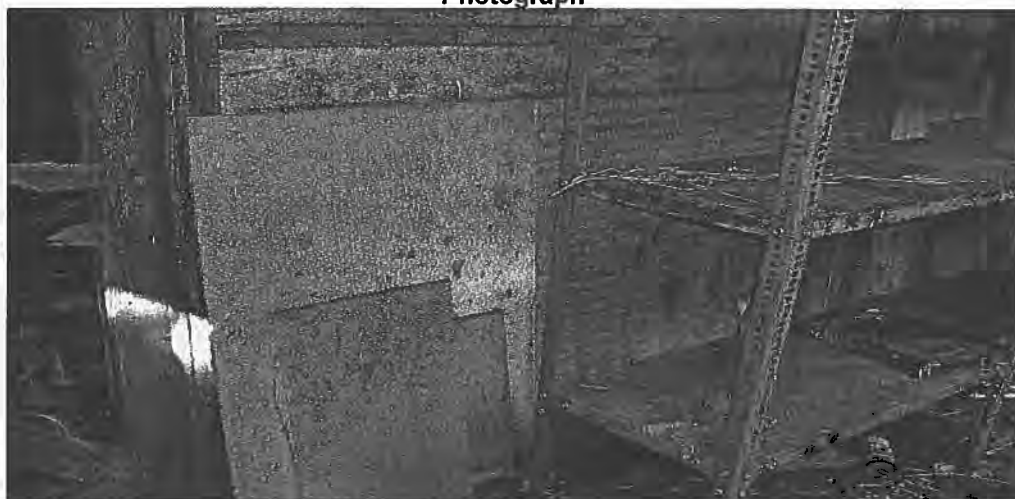
**Photograph**

| <b>Location of Survey</b><br>Cane Hill Hospital<br>Coulsdon<br>Surrey<br>CR5 3ES | | <b>Position of Sample/Photo</b><br>Bricked Up Garage adjacent<br>Water Tower<br>Store room<br>Redundant sheets<br>(noted throughout) | | <b>Asbestos</b><br><br><b>Type</b> | Yes, Strongly<br>Presumed<br><br>Chrysotile (white) |
| <b>Material Type</b> | Cement | <b>Quantity</b> | 4m <sup>2</sup> | <b>Sample No</b><br><br><b>Survey Date</b><br><br><b>Date of Report</b><br><br><b>Surveyor(s)</b> | As 06/B/8026/20<br><br>04/03/07<br><br>13/03/07<br><br><div style="background-color: black; width: 100px; height: 20px;"></div> |

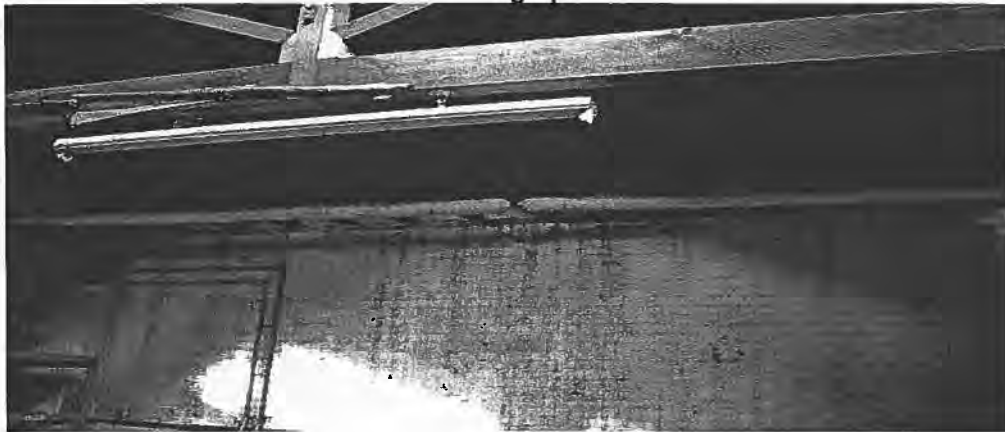
**Photograph**

| <b>Location of Survey</b><br>Cane Hill Hospital<br>Coulsdon<br>Surrey<br>CR5 3ES | | <b>Position of Sample/Photo</b><br>Bricked Up Garage adjacent<br>Water Tower<br>Store room adjacent corridor<br>High Level pipe lagging | | <b>Asbestos</b><br><br><b>Type</b> | Yes, Strongly<br>Presumed<br><br>Amosite (brown)<br>Chrysotile (white) |
| <b>Material Type</b> | Lagging | <b>Quantity</b> | 10m | <b>Sample No</b> | As 06/B/8026/219 |

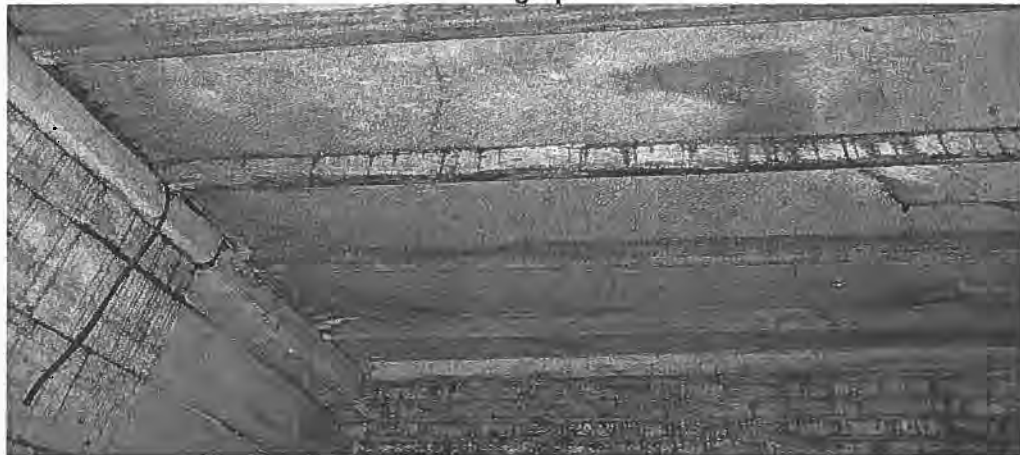
**Photograph**

| <b>Location of Survey</b><br>Cane Hill Hospital<br>Coulsdon<br>Surrey<br>CR5 3ES | | <b>Position of Sample/Photo</b><br>Bricked Up Garage adjacent<br>Water Tower<br>Ceiling to cupboard adjacent<br>door to corridor | | <b>Asbestos</b><br><br><b>Type</b> | <b>Yes, Strongly<br/>Presumed</b><br><br>Chrysotile (white) |
| <b>Material<br/>Type</b> | Cement | <b>Quantity</b> | 10m <sup>2</sup> | <b>Sample No</b> | As 06/B/8026/20 |

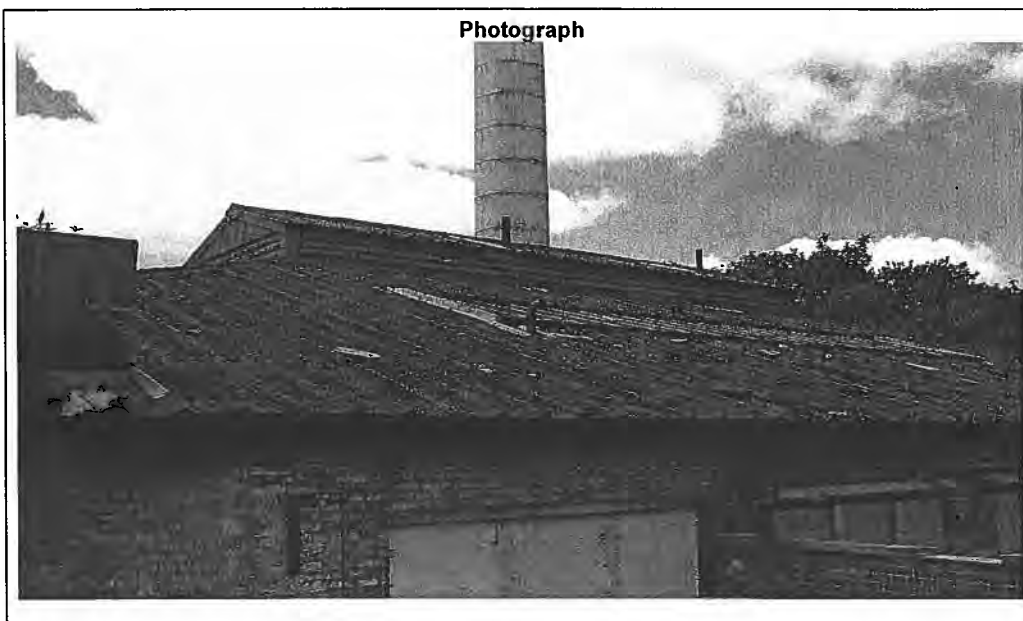
**Photograph**

| <b>Location of Survey</b><br>Cane Hill Hospital,<br>Cane Hill,<br>Coulston, Surrey,<br>CR5 3ES | | <b>Position of Sample/Photo</b><br>Boiler House<br>Profiled Roof Sheet | | <b>Asbestos</b><br><br><b>Type</b> | Yes, Strongly<br>Presumed<br><br>Chrysotile (White) |
| <b>Material Type</b><br>Cement | | <b>Quantity</b><br>400m <sup>2</sup> | | <b>Sample No</b> | As 06/B/8026/126 |

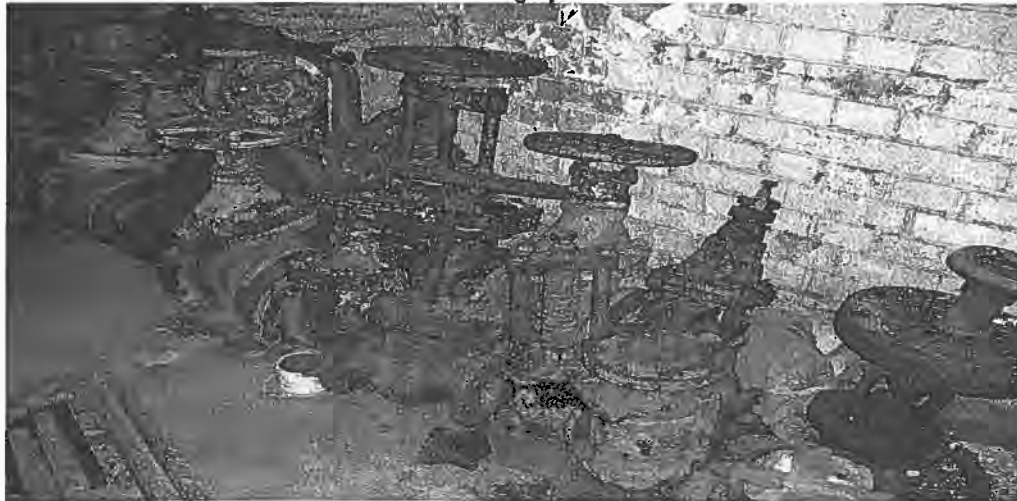
**Photograph**

| <b>Location of Survey</b><br>Cane Hill Hospital,<br>Cane Hill,<br>Coulsdon, Surrey,<br>CR5 3ES | <b>Position of Sample/Photo</b><br>Boiler House Store,<br>Redundant Crane valve | <b>Asbestos</b> Yes<br><br><b>Type</b> Chrysotile (White) |
| <b>Material Type</b> Gasket | <b>Quantity</b> <1m <sup>2</sup> | <b>Sample No</b> 06/B/8026/182<br><br><b>Survey Date</b> 24.04 - 29.06.06<br><br><b>Date of Report</b> 18.08.06<br><br><b>Surveyor(s)</b> <span style="background-color: black; color: black;">[REDACTED]</span> |

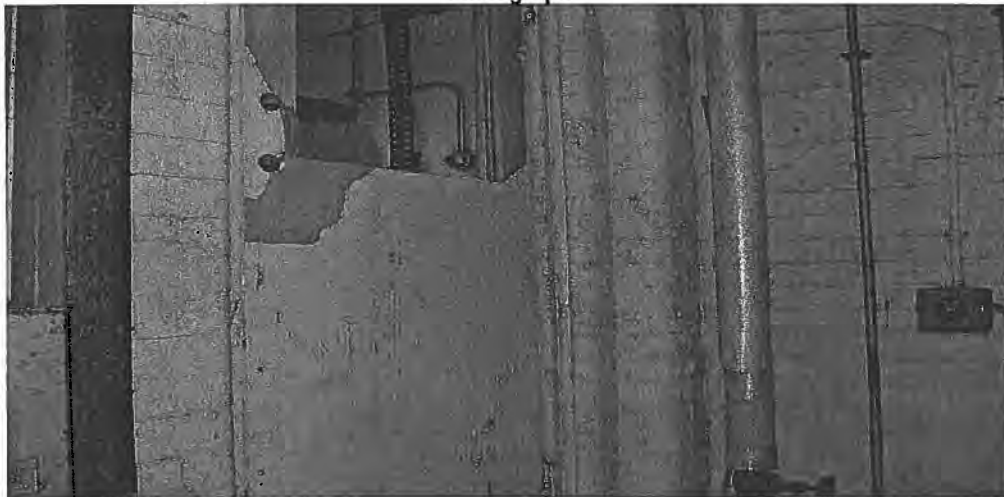
**Photograph**

| <b>Location of Survey</b><br>Cane Hill Hospital,<br>Cane Hill,<br>Coulston, Surrey,<br>CR5 3ES | | <b>Position of Sample/Photo</b><br>Boiler House<br>Door panel, | | <b>Asbestos</b> Yes |
| <b>Material Type</b> Board | | <b>Quantity</b> 1m <sup>2</sup> | | <b>Type</b> Amosite (Brown) |

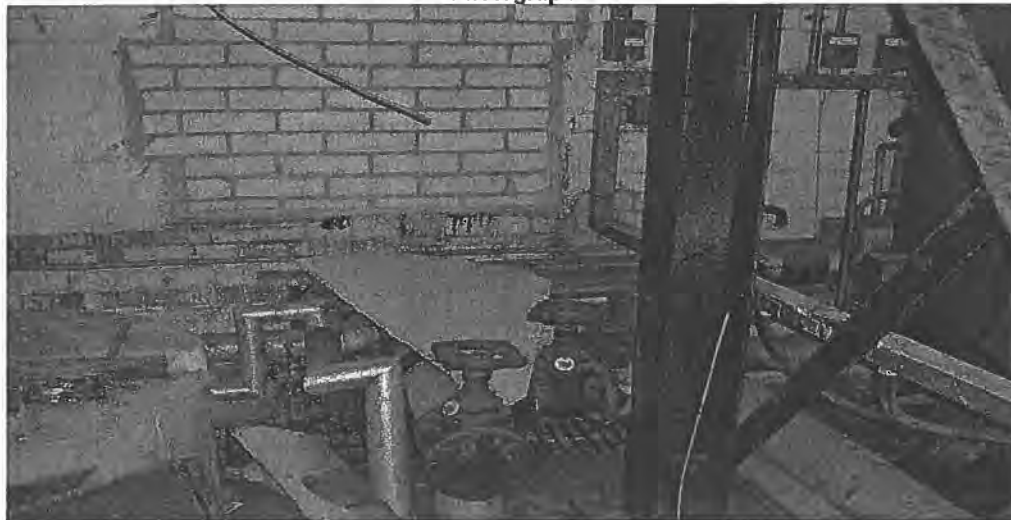
**Photograph**

| <b>Location of Survey</b><br>Cane Hill Hospital,<br>Cane Hill,<br>Coulsdon, Surrey,<br>CR5 3ES | | <b>Position of Sample/Photo</b><br>Boiler House<br>Door panel debris | | <b>Asbestos</b><br><br><b>Type</b> | <b>Yes, Strongly Presumed</b><br><br>Amosite (Brown) |
| <b>Material Type</b> | Board | <b>Quantity</b> | <1m | <b>Sample No</b> | As 06/B/8026/183 |

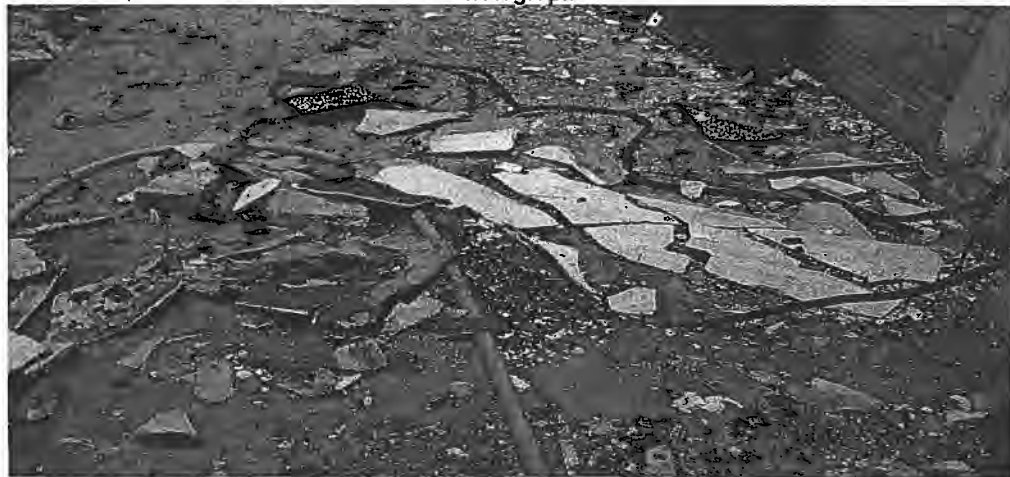
**Photograph**

| <b>Location of Survey</b><br>Cane Hill Hospital,<br>Cane Hill,<br>Coulsdon, Surrey,<br>CR5 3ES | <b>Position of Sample/Photo</b><br>Boiler House<br>Roof Debris | <b>Asbestos</b> Yes<br><br><b>Type</b> Chrysotile (White) |
| <b>Material Type</b> Cement | <b>Quantity</b> 1m <sup>2</sup> | <b>Sample No</b> 06/B/8026/184<br><br><b>Survey Date</b> 24.04 - 29.06.06<br><br><b>Date of Report</b> 18.08.06<br><b>Surveyor(s)</b> <span style="background-color: black; color: black;">[REDACTED]</span> |

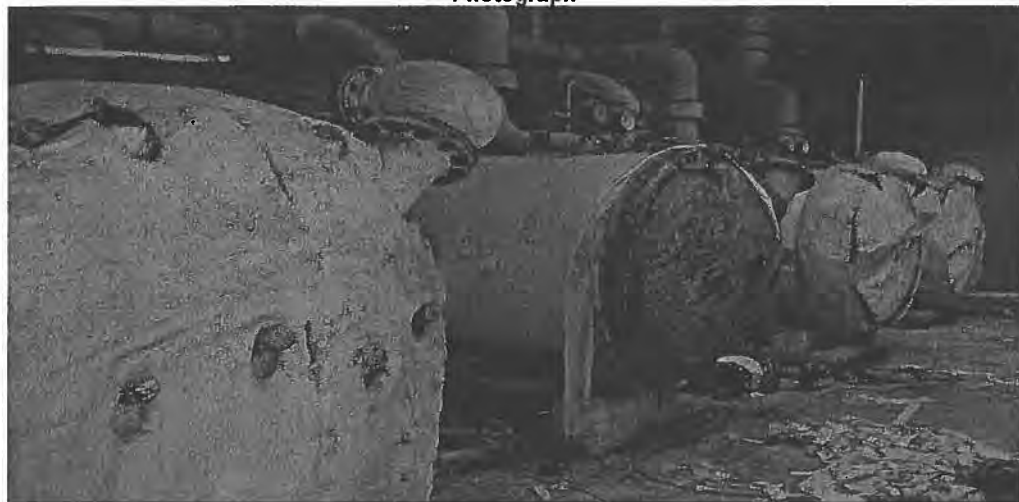
**Photograph**

| <b>Location of Survey</b><br>Cane Hill Hospital,<br>Cane Hill,<br>Coulston, Surrey,<br>CR5 3ES | | <b>Position of Sample/Photo</b><br>Boiler House<br>Tank Room,<br>Gaiter to tank (X4), | | <b>Asbestos</b> Yes |
| <b>Material Type</b> Rope | | <b>Quantity</b> 8m <sup>2</sup> | | <b>Type</b> Chrysotile (White) |

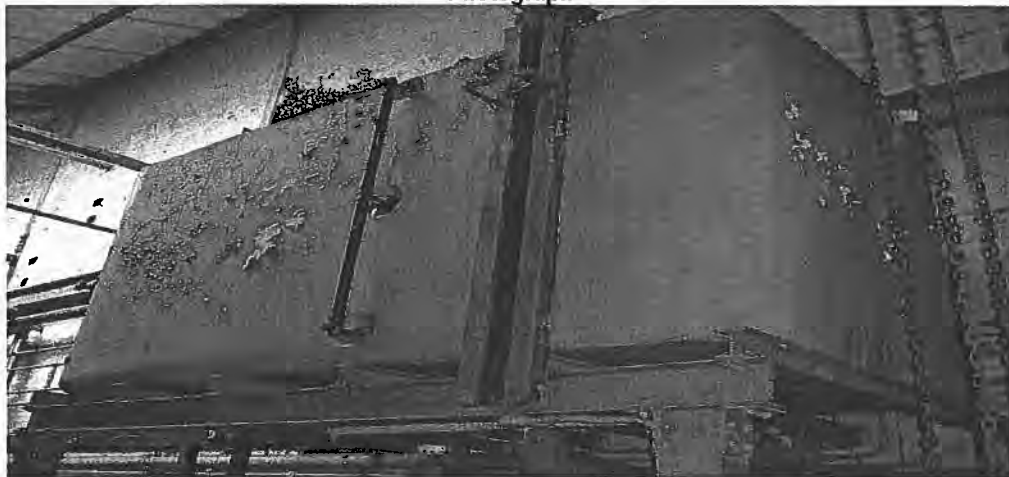
**Photograph**

| <b>Location of Survey</b><br>Cane Hill Hospital,<br>Cane Hill,<br>Coulston, Surrey,<br>CR5 3ES | | <b>Position of Sample/Photo</b><br>Boiler Room<br>Tank Room<br>Main Tank Lagging | | <b>Asbestos</b> | Yes |
| <b>Material Type</b> Lagging | | <b>Quantity</b> 100m <sup>2</sup> | | <b>Type</b> | Chrysotile (White)<br>Amosite (Brown) |

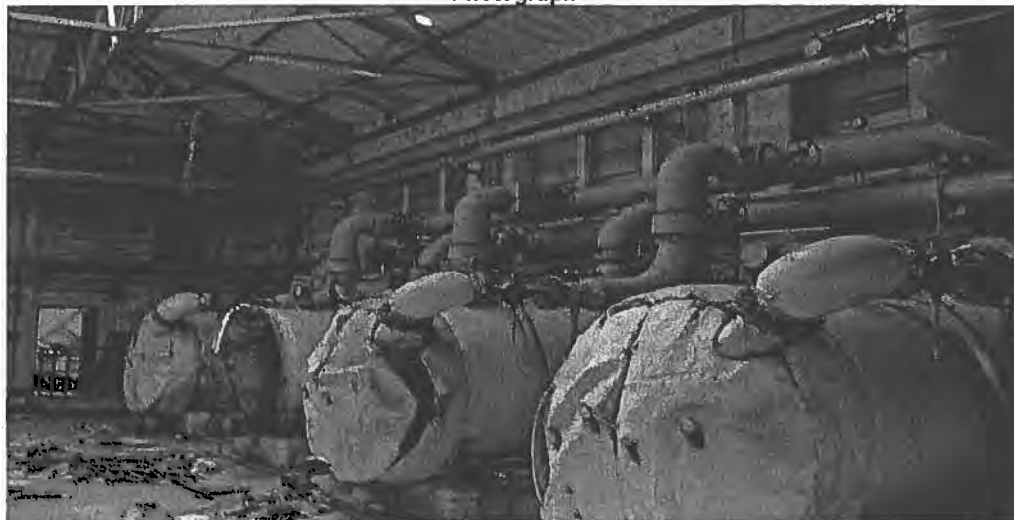
**Photograph**

| <b>Location of Survey</b><br>Cane Hill Hospital,<br>Cane Hill,<br>Coulsdon, Surrey,<br>CR5 3ES | | <b>Position of Sample/Photo</b><br>Boiler House<br>Tank Room,<br>Tank (X4) Lagging | | <b>Asbestos</b> Yes |
| <b>Material Type</b> Lagging | | <b>Quantity</b> 80m <sup>2</sup> | | <b>Type</b> Chrysotile (White) |

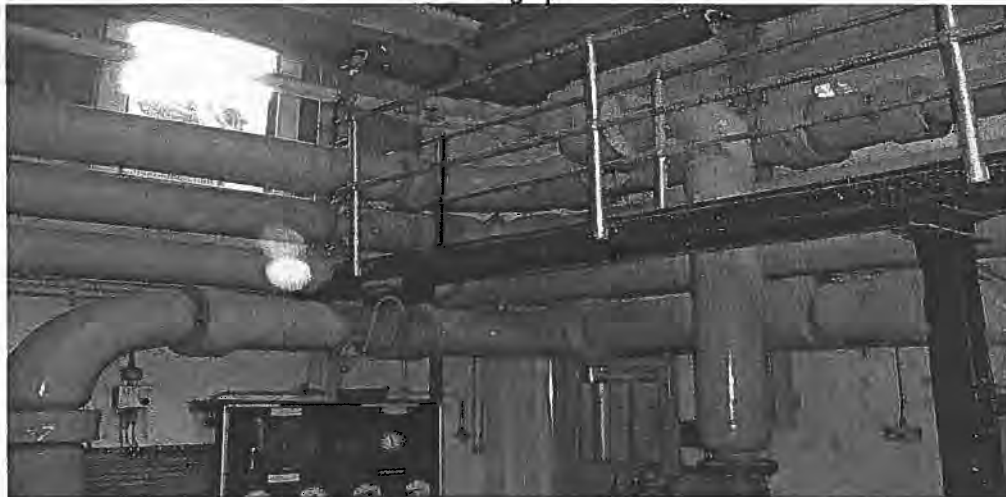
**Photograph**

| <b>Location of Survey</b><br>Cane Hill Hospital,<br>Cane Hill,<br>Coulston, Surrey,<br>CR5 3ES | | <b>Position of Sample/Photo</b><br>Boiler Room<br>Pipe Lagging | | <b>Asbestos</b> Yes |
| <b>Material Type</b> Lagging | | <b>Quantity</b> 400m | | <b>Type</b> Chrysotile (White)<br>Amosite (Brown) |

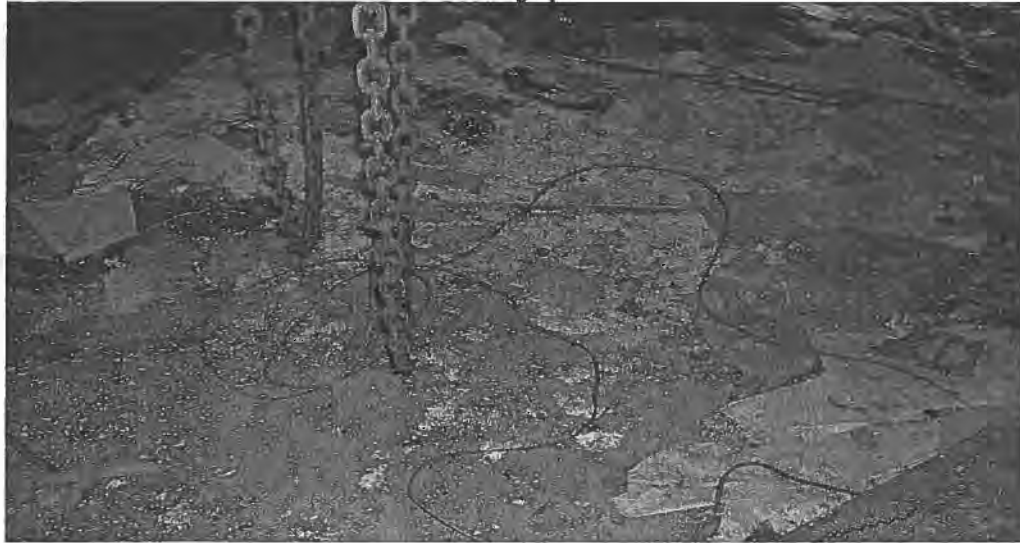
**Photograph**

| <b>Location of Survey</b><br>Cane Hill Hospital,<br>Cane Hill,<br>Coulsdon, Surrey,<br>CR5 3ES | | <b>Position of Sample/Photo</b><br>Boiler Room Tank Room<br>Floor beneath tank<br>Lagging debris<br>(presumed throughout) | | <b>Asbestos</b> Yes |
| <b>Material Type</b> Lagging | | <b>Quantity</b> 1m <sup>2</sup> | | <b>Type</b> Chrysotile (White)<br>Amosite (Brown) |

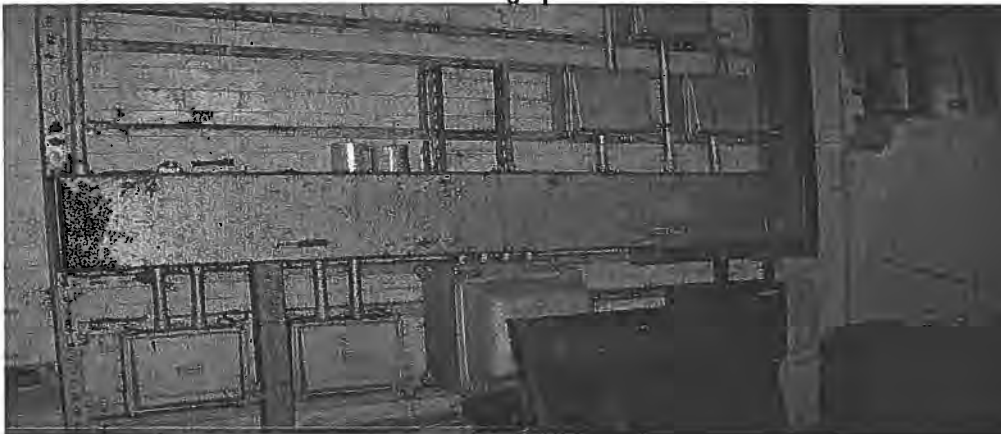
**Photograph**

| <b>Location of Survey</b><br>Cane Hill Hospital,<br>Cane Hill,<br>Coulsdon, Surrey,<br>CR5 3ES | | <b>Position of Sample/Photo</b><br>Boiler Room<br>Electrics | | <b>Asbestos</b><br><br><b>Type</b> | Yes, Strongly<br>Presumed<br><br>Chrysotile (White) |
| <b>Material Type</b> | Rope | <b>Quantity</b> | 1m <sup>2</sup> | <b>Sample No</b> | As 06/B/8026/22 |

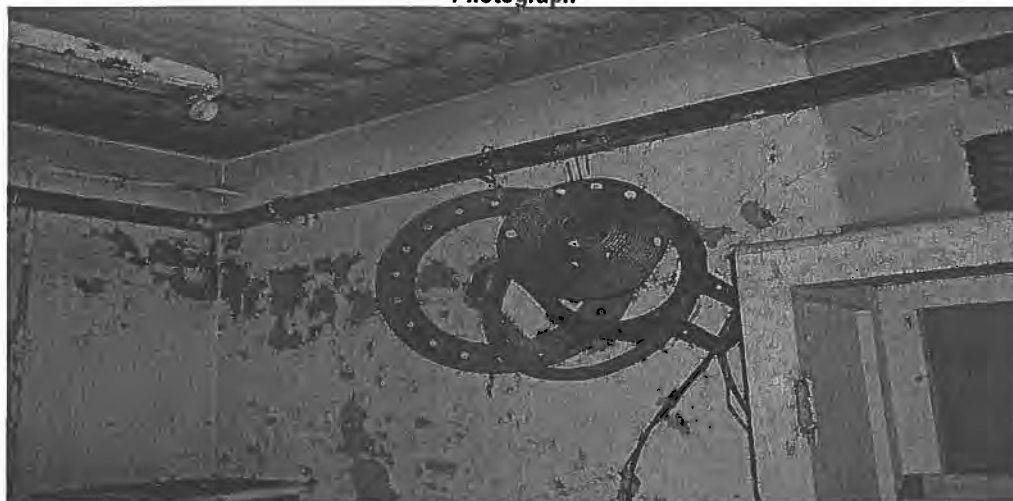
**Photograph**

| <b>Location of Survey</b><br>Cane Hill Hospital,<br>Cane Hill,<br>Coulsdon, Surrey,<br>CR5 3ES | | <b>Position of Sample/Photo</b><br>Boiler House<br>Redundant Gaskets | | <b>Asbestos</b><br><br><b>Type</b> | <b>Yes, Strongly Presumed</b><br><br>Chrysotile (White) |
| <b>Material Type</b> | Gasket | <b>Quantity</b> | 1m <sup>2</sup> | <b>Sample No</b> | As 06/B/8026/180 |

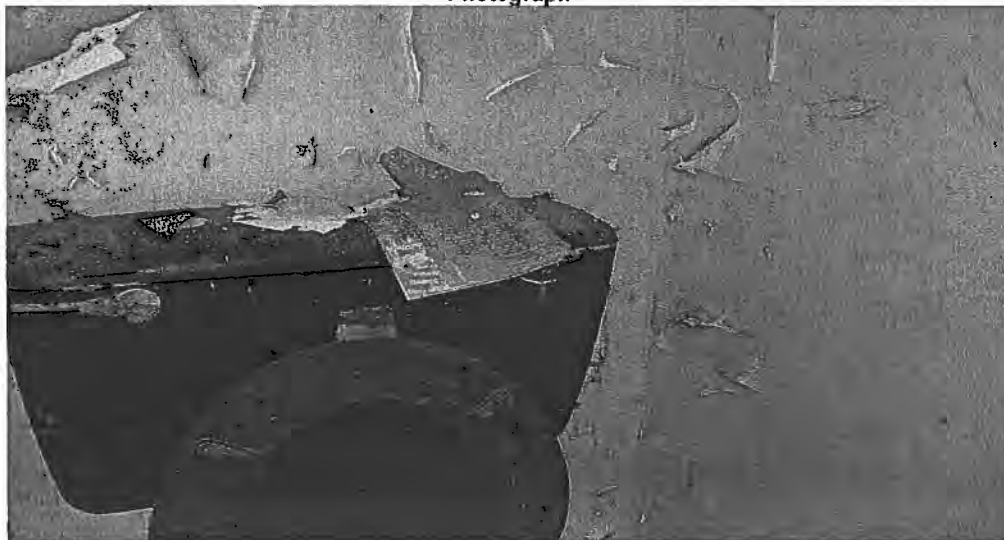
**Photograph**

| <b>Location of Survey</b><br>Cane Hill Hospital,<br>Cane Hill,<br>Coulston, Surrey,<br>CR5 3ES | | <b>Position of Sample/Photo</b><br>Boiler Room<br>W.C. Cistern | | <b>Asbestos</b><br><br><b>Type</b> | <b>Yes, Strongly Presumed</b><br><br>Amosite (Brown) |
| <b>Material Type</b> | Plastic | <b>Quantity</b> | 1m <sup>2</sup> | <b>Sample No</b> | As 06/B/8026/5 |

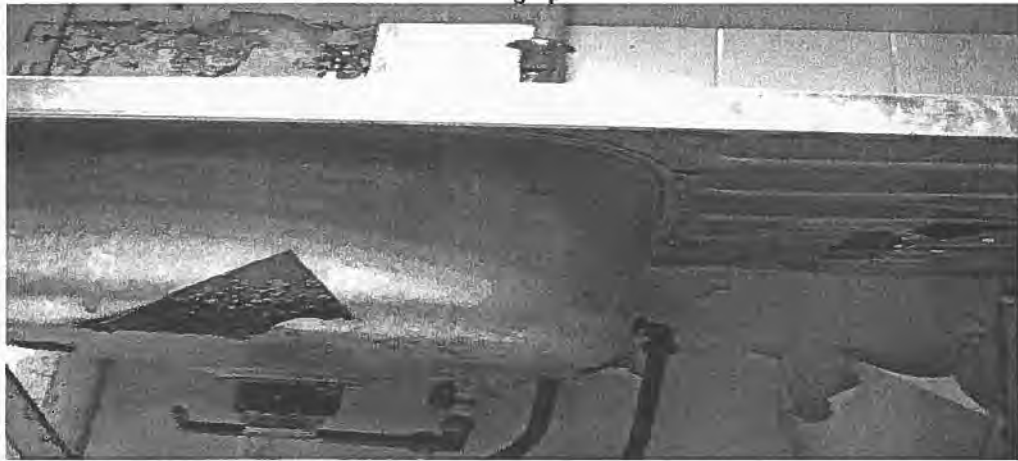
**Photograph**

| <b>Location of Survey</b><br>Cane Hill Hospital,<br>Cane Hill,<br>Coulston, Surrey,<br>CR5 3ES | | <b>Position of Sample/Photo</b><br>Boiler House<br>Sink Pad | | <b>Asbestos</b><br><br><b>Type</b> | Yes, Strongly<br>Presumed<br><br>Chrysotile (White) |
| <b>Material Type</b> | Bitumen | <b>Quantity</b> | <1m <sup>2</sup> | <b>Sample No</b> | As 06/B/8026/64 |

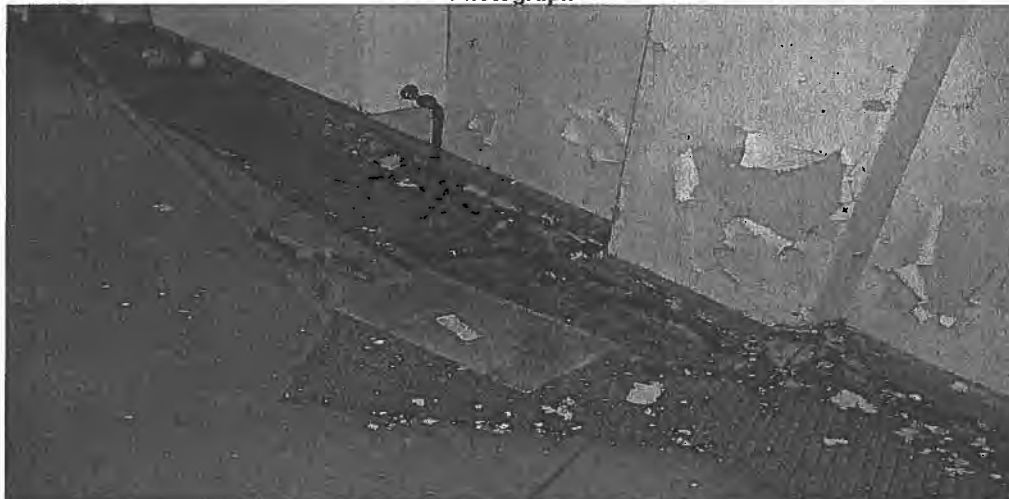
**Photograph**

| <b>Location of Survey</b><br><br>Cane Hill Hospital,<br>Cane Hill,<br>Coulsdon, Surrey,<br>CR5 3ES | <b>Position of Sample/Photo</b><br><br>John Hutchinson Centre<br>Cement under metal duct<br>cover | <b>Asbestos</b> Yes<br><br><b>Type</b> Chrysotile (White) |
| <b>Material Type</b> Cement | <b>Quantity</b> 10m <sup>2</sup> | <b>Sample No</b> 06/B/8026/191<br><br><b>Survey Date</b> 24.04 - 29.06.06<br><br><b>Date of Report</b> 18.08.06<br><br><b>Surveyor(s)</b> <span style="background-color: black; color: black;">[REDACTED]</span> |

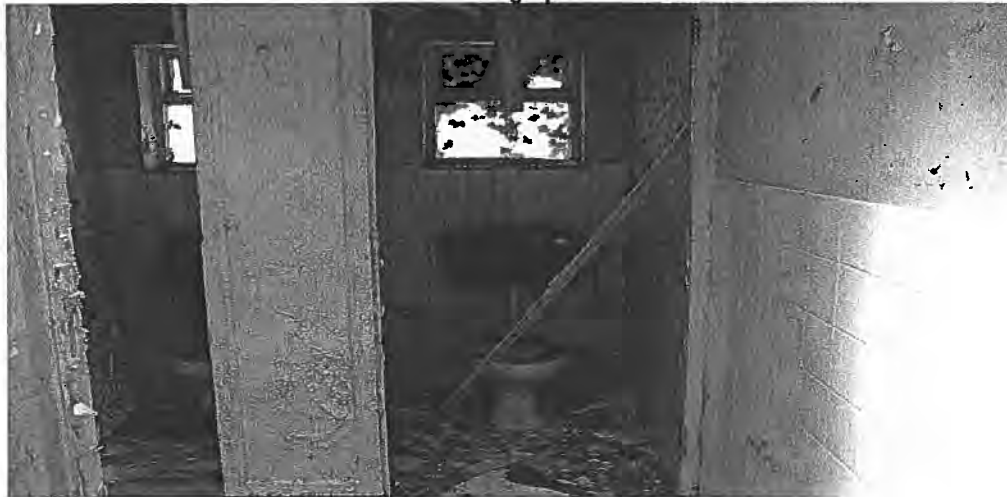
**Photograph**

| <b>Location of Survey</b><br>Cane Hill Hospital,<br>Cane Hill,<br>Coulston, Surrey,<br>CR5 3ES | | <b>Position of Sample/Photo</b><br>John Hutchinson Centre<br>W.C. Cistern | <b>Asbestos</b><br><br><b>Type</b> | <b>Yes, Strongly Presumed</b><br><br>Amosite (Brown) |
| <b>Material Type</b> | Plastic | <b>Quantity</b> | 1m | <b>Sample No</b> As 06/B/8026/5 |

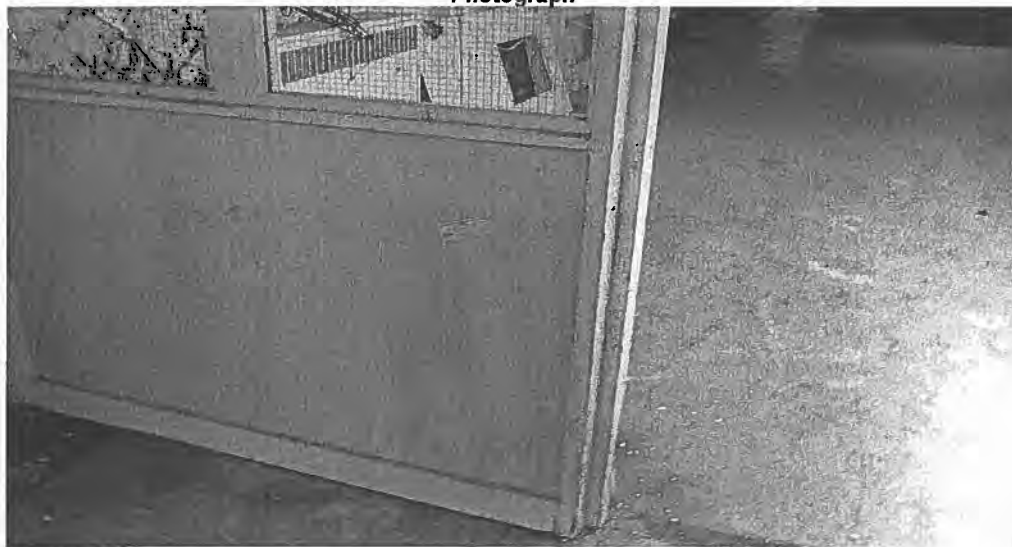
**Photograph**

| <b>Location of Survey</b><br><br>Cane Hill Hospital,<br>Cane Hill,<br>Coulsdon, Surrey,<br>CR5 3ES | <b>Position of Sample/Photo</b><br><br>John Hutchinson Centre<br>Partition wall panel | <b>Asbestos</b><br><br>None Detected | <b>Type</b><br><br>N/A |
| <b>Material Type</b><br><br>Plaster | <b>Quantity</b><br><br>1m <sup>2</sup> | <b>Sample No</b><br>06/B/8026/192<br><br><b>Survey Date</b><br>24.04 - 29.06.06<br><br><b>Date of Report</b><br>18.08.06<br><br><b>Surveyor(s)</b><br><div style="background-color: black; width: 100px; height: 30px; margin-top: 5px;"></div> | |

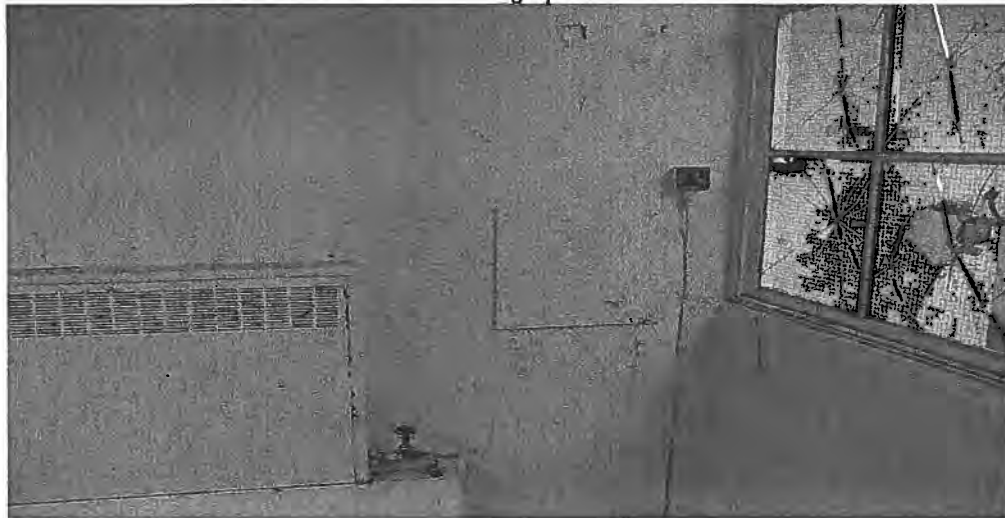
**Photograph**

| <b>Location of Survey</b><br>Cane Hill Hospital,<br>Cane Hill,<br>Coulsdon, Surrey,<br>CR5 3ES | <b>Position of Sample/Photo</b><br>John Hutchinson Centre<br>Office wall panel | <b>Asbestos</b> Yes, Strongly Presumed<br><br><b>Type</b> Chrysotile (White) |
| <b>Material Type</b> Cement | <b>Quantity</b> <1m <sup>2</sup> | <b>Sample No</b> As 06/B/8026/195<br><br><b>Survey Date</b> 24.04 - 29.06.06<br><br><b>Date of Report</b> 18.08.06<br><br><b>Surveyor(s)</b> <span style="background-color: black; color: black;">[REDACTED]</span> |

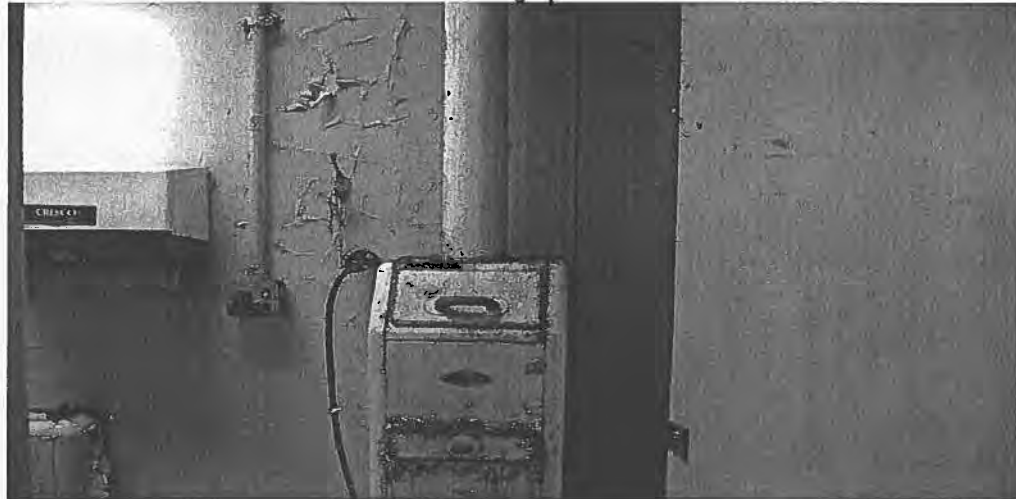
**Photograph**

| <b>Location of Survey</b><br>Cane Hill Hospital,<br>Cane Hill,<br>Coulston, Surrey,<br>CR5 3ES | | <b>Position of Sample/Photo</b><br>John Hutchinson Centre<br>Bunny Boiler & Flue pipe | | <b>Asbestos</b><br><br><b>Type</b> | Yes, Strongly<br>Presumed<br><br>Chrysotile (White) |
| <b>Material Type</b> | Cement | <b>Quantity</b> | 1m | <b>Sample No</b> | As 06/B/8026/154 |

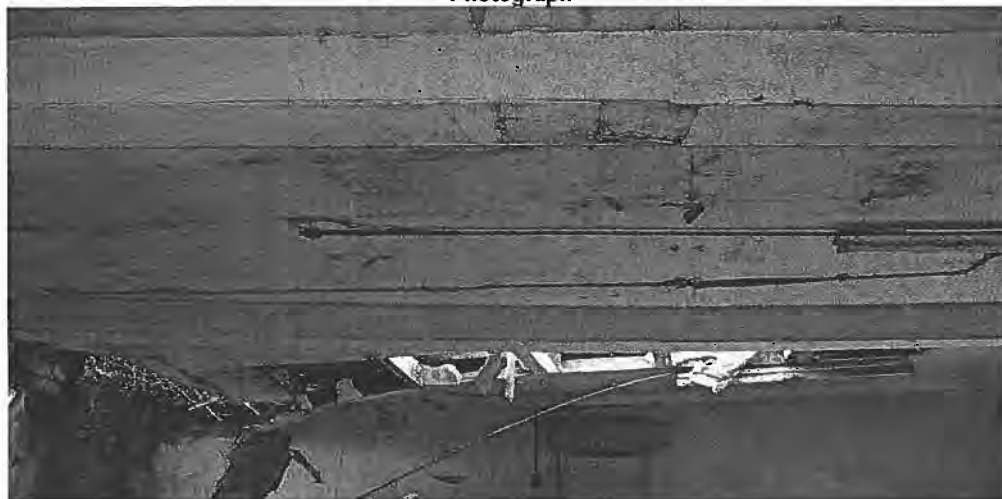
**Photograph**

| <b>Location of Survey</b><br>Cane Hill Hospital,<br>Cane Hill,<br>Coulston, Surrey,<br>CR5 3ES | | <b>Position of Sample/Photo</b><br>John Hutchinson Centre<br>Ceiling panel to flat roofed<br>room | | <b>Asbestos</b> Yes |
| <b>Material Type</b> Board | | <b>Quantity</b> 60m <sup>2</sup> | | <b>Type</b> Chrysotile (White)<br>Amosite (Brown) |

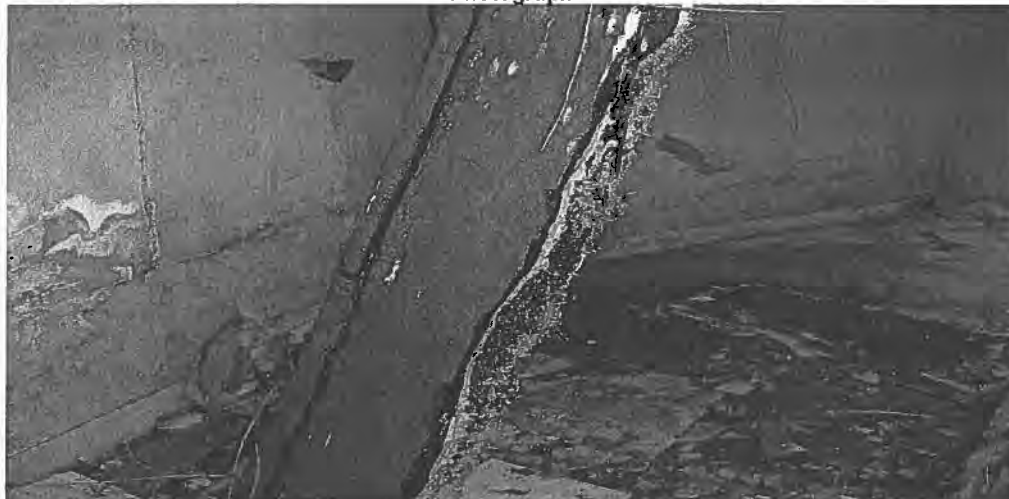
**Photograph**

| <b>Location of Survey</b><br>Cane Hill Hospital,<br>Cane Hill,<br>Coulston, Surrey,<br>CR5 3ES | | <b>Position of Sample/Photo</b><br>John Hutchinson Centre<br>Roof felt, flat roofed room | | <b>Asbestos</b><br><br><b>Type</b> | None Detected<br><br>N/A |
| <b>Material Type</b> | Bitumen | <b>Quantity</b> | 10m <sup>2</sup> | <b>Sample No</b> | 06/B/8026/194 |

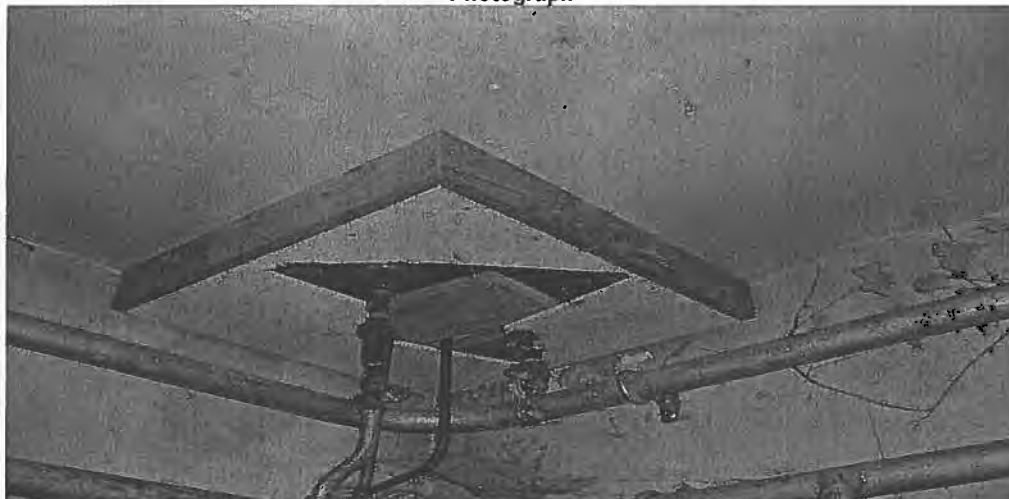
| <b>Location of Survey</b><br>Cane Hill Hospital,<br>Cane Hill,<br>Coulsdon, Surrey,<br>CR5 3ES | | <b>Position of Sample/Photo</b><br>John Hutchinson Centre<br>Store Room<br>Ceiling Panel | | <b>Asbestos</b><br><br><b>Type</b> | Yes, Strongly<br>Presumed<br><br>Chrysotile (White)<br>Amosite (Brown) |
| <b>Material Type</b> | Board | <b>Quantity</b> | 1m <sup>2</sup> | <b>Sample No</b> | As 06/B/8026/193 |

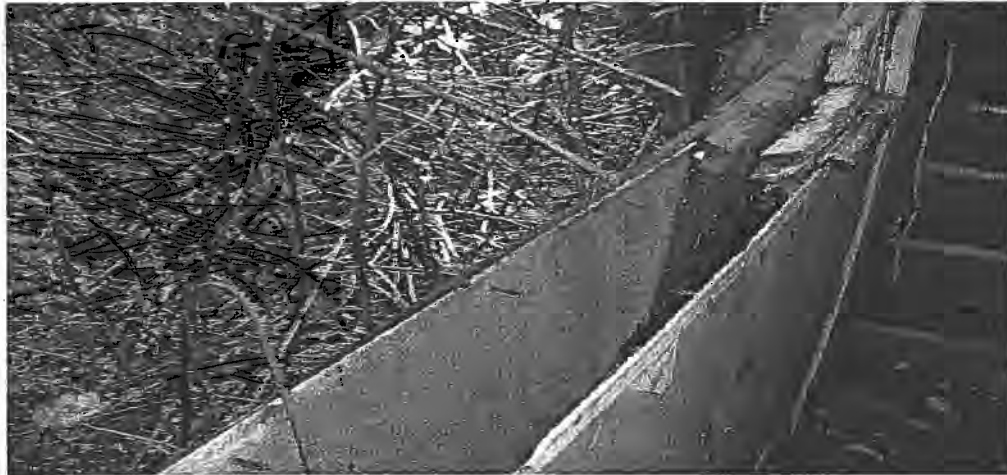
| <b>Location of Survey</b><br>Cane Hill Hospital,<br>Cane Hill,<br>Coulston, Surrey,<br>CR5 3ES | | <b>Position of Sample/Photo</b><br>John Hutchinson Centre<br>Corridor wall panels<br>(internal & external) | | <b>Asbestos</b><br><br><b>Type</b> | Yes, Strongly<br>Presumed<br><br>Chrysotile (White) |
| <b>Material Type</b><br>Cement | | <b>Quantity</b><br>10m <sup>2</sup> | | <b>Sample No</b> | As 06/B/8026/195 |

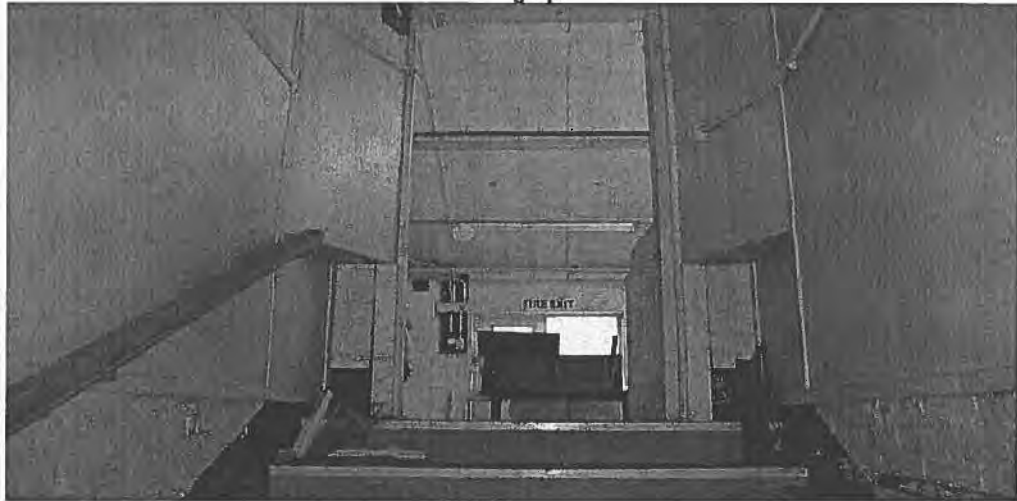
| <b>Location of Survey</b><br>Cane Hill Hospital,<br>Cane Hill,<br>Coulston, Surrey,<br>CR5 3ES | | <b>Position of Sample/Photo</b><br>John Hutchinson Centre<br>Stair surround panels | | <b>Asbestos</b><br><br><b>Type</b> | Yes, Strongly<br>Presumed<br><br>Chrysotile (White) |
| <b>Material Type</b> | Cement | <b>Quantity</b> | 4m <sup>2</sup> | <b>Sample No</b> | As 06/B/8026/195 |

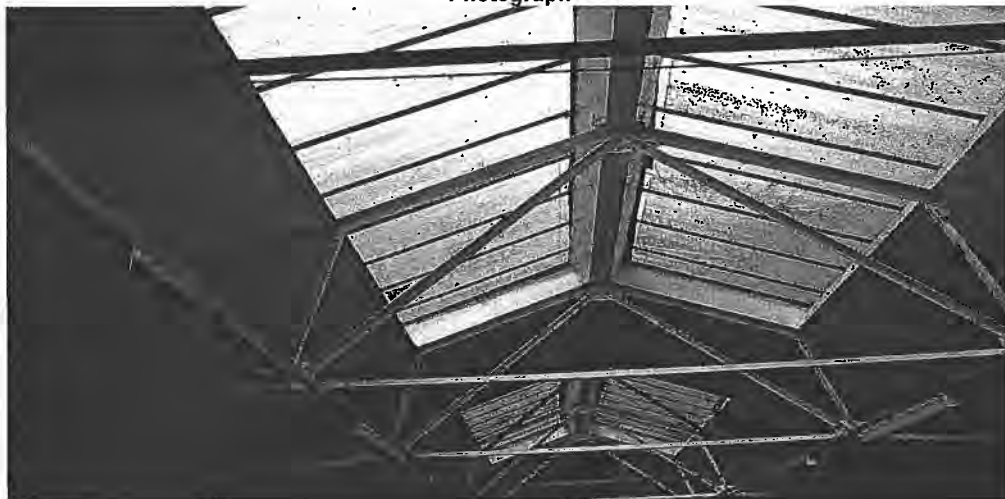
| <b>Location of Survey</b><br>Cane Hill Hospital,<br>Cane Hill,<br>Coulston, Surrey,<br>CR5 3ES | | <b>Position of Sample/Photo</b><br>John Hutchinson Centre<br>Main Hall<br>Skylight rope seal | | <b>Asbestos</b><br><br><b>Type</b> | Yes, Strongly<br>Presumed<br><br>Chrysotile (White) |
| <b>Material Type</b><br>Rope | | <b>Quantity</b><br>100m | <b>Sample No</b><br>As 06/B/8026/31 | | |
