## SURVEY INFORMATION SHEET

| <b>Location of Survey</b><br>Cane Hill Hospital,<br>Cane Hill,<br>Coulsdon, Surrey,<br>CR5 3ES | <b>Position of Sample/Photo</b><br>Workshop Garages<br>External corrugated roof sheet | <b>Asbestos</b><br><br><b>Type</b> | Yes, Strongly Presumed<br><br>Chrysotile (White) |

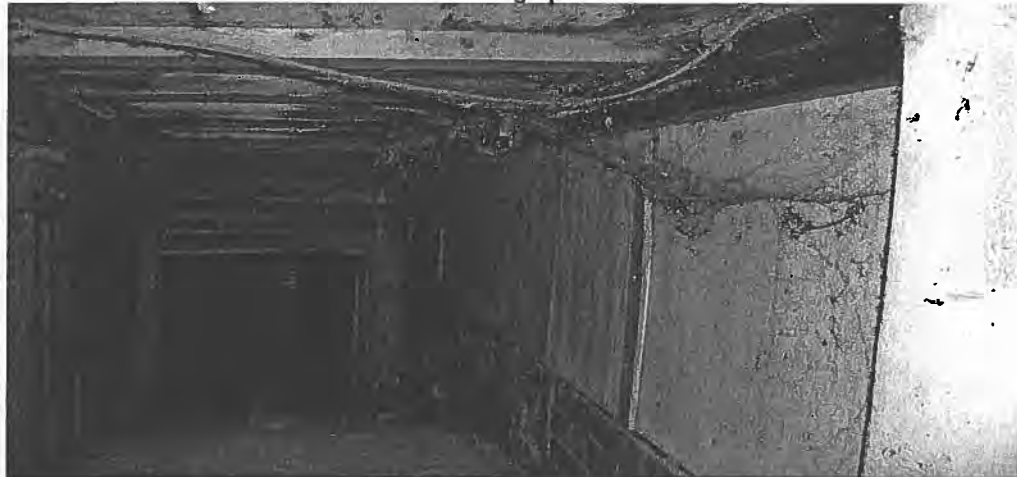
| <b>Location of Survey</b><br>Cane Hill Hospital,<br>Cane Hill,<br>Coulsdon, Surrey,<br>CR5 3ES | <b>Position of Sample/Photo</b><br>John Hutchinson Centre<br>Wall Panels adjacent conveyor | <b>Asbestos</b> Yes, Strongly Presumed<br><br><b>Type</b> Chrysotile (White) |
| <b>Material Type</b> Cement | <b>Quantity</b> 1m <sup>2</sup> | <b>Sample No</b> As 06/B/8026/195<br><br><b>Survey Date</b> 24.04 - 29.06.06<br><br><b>Date of Report</b> 18.08.06<br><br><b>Surveyor(s)</b> <span style="background-color: black; color: black;">[REDACTED]</span> |

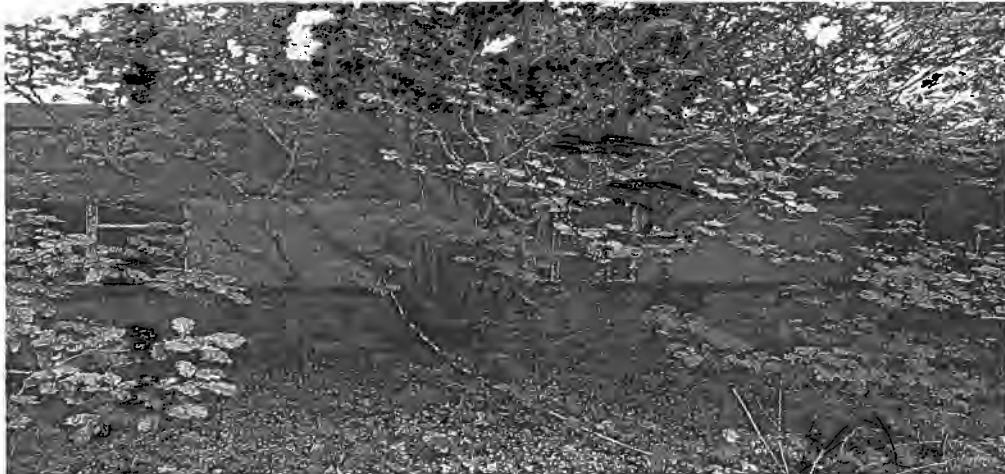
| <b>Location of Survey</b><br>Cane Hill Hospital,<br>Cane Hill,<br>Coulston, Surrey,<br>CR5 3ES | <b>Position of Sample/Photo</b><br>John Hutchinson Centre<br>External wall panels | <b>Asbestos</b> Yes, Strongly Presumed<br><br><b>Type</b> Chrysotile (White) |
| <b>Material Type</b> Cement | <b>Quantity</b> 6m <sup>2</sup> | <b>Sample No</b> As 06/B/8026/126<br><br><b>Survey Date</b> 24.04 - 29.06.06<br><br><b>Date of Report</b> 18.08.06<br><br><b>Surveyor(s)</b> <span style="background-color: black; color: black;">[REDACTED]</span> |

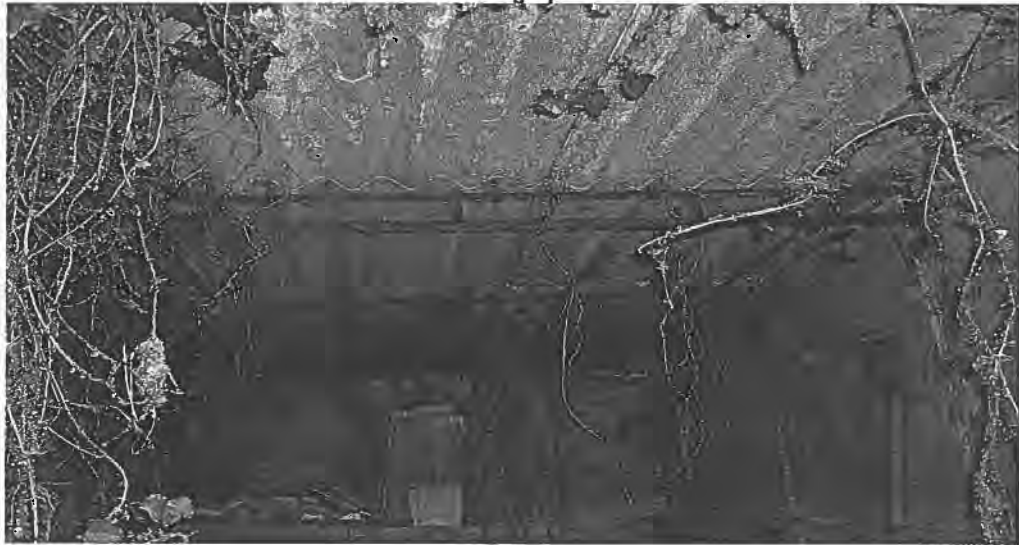
| <b>Location of Survey</b><br>Cane Hill Hospital,<br>Cane Hill,<br>Coulston, Surrey,<br>CR5 3ES | | <b>Position of Sample/Photo</b><br>John Hutchinson Centre<br>External Garage<br>Corrugated Roof sheet | | <b>Asbestos</b><br><br><b>Type</b> | Yes, Strongly<br>Presumed<br><br>Chrysotile (White) |
| <b>Material Type</b> | Cement | <b>Quantity</b> | 10m <sup>2</sup> | <b>Sample No</b> | As 06/B/8026/126 |

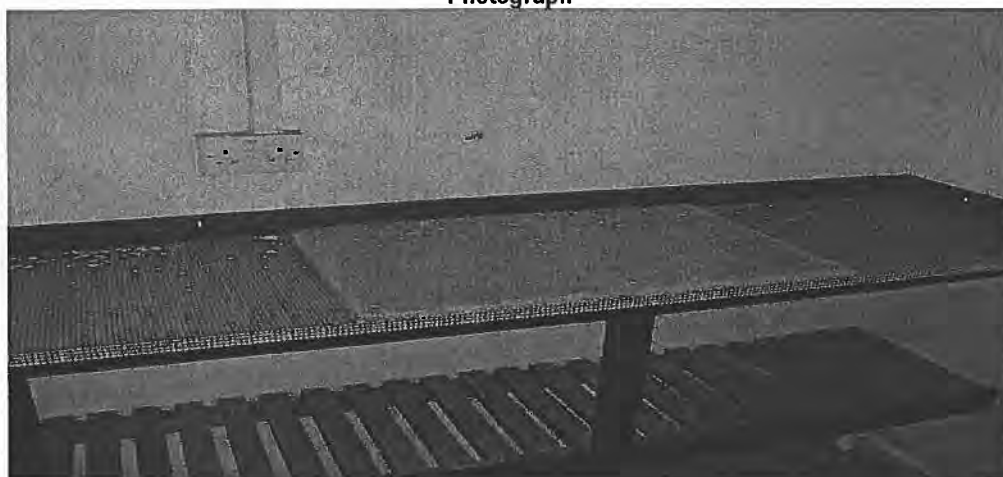
| <b>Location of Survey</b><br>Cane Hill Hospital,<br>Cane Hill,<br>Coulston, Surrey,<br>CR5 3ES | <b>Position of Sample/Photo</b><br>Nurses Block, Middle Annex,<br>First Floor Kitchen<br>Cement panel | <b>Asbestos</b> Yes<br><br><b>Type</b> Amosite (Brown) |
| <b>Material Type</b> Board | <b>Quantity</b> <1m <sup>2</sup> | <b>Sample No</b> 06/B/8026/196<br><br><b>Survey Date</b> 24.04 - 29.06.06<br><br><b>Date of Report</b> 18.08.06<br><br><b>Surveyor(s)</b> [REDACTED] |

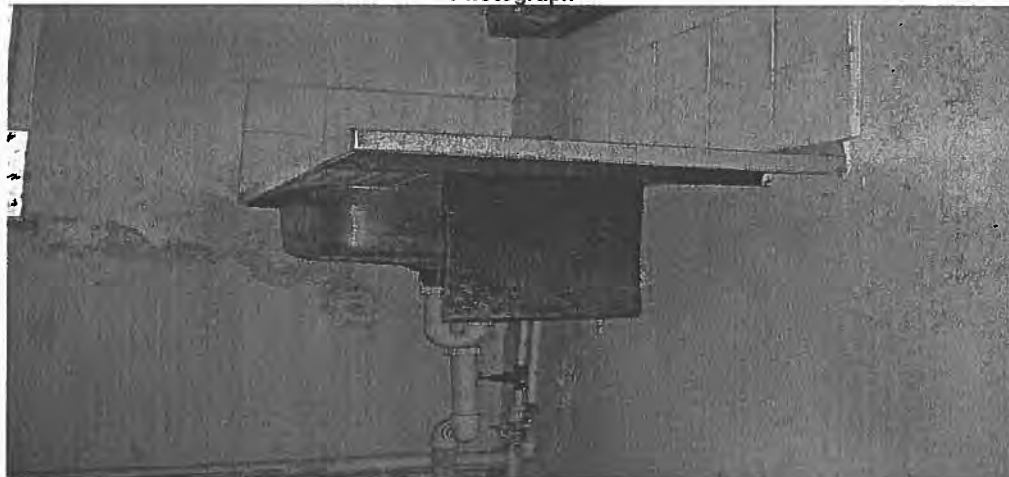
| <b>Location of Survey</b><br>Cane Hill Hospital,<br>Cane Hill,<br>Coulston, Surrey,<br>CR5 3ES | | <b>Position of Sample/Photo</b><br>Nurses Block, Middle Annex<br>First Floor Kitchen<br>Sink Pad | | <b>Asbestos</b><br><br><b>Type</b> | Yes, Strongly<br>Presumed<br><br>Chrysotile (White) |
| <b>Material Type</b> | Bitumen | <b>Quantity</b> | <1m | <b>Sample No</b> | As 06/B/8026/64 |

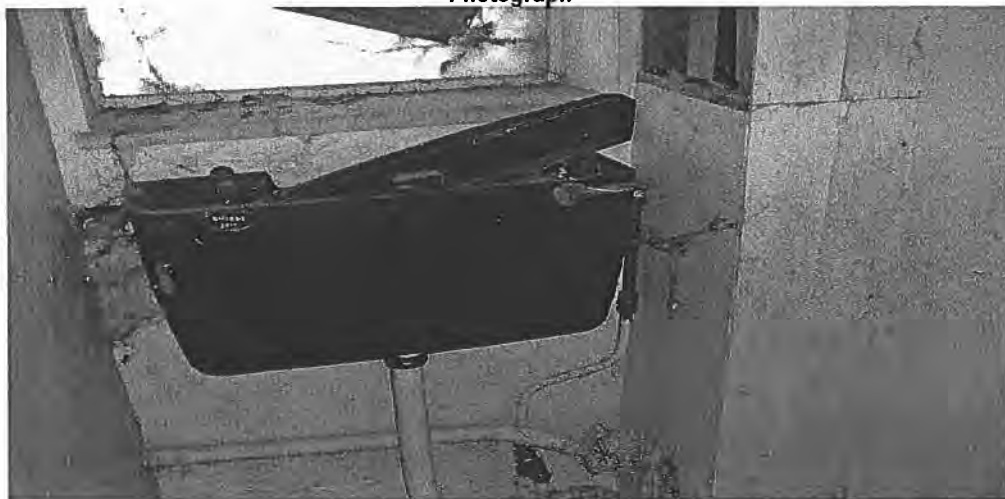
| <b>Location of Survey</b><br>Cane Hill Hospital,<br>Cane Hill,<br>Coulston, Surrey,<br>CR5 3ES | | <b>Position of Sample/Photo</b><br>Middle Annex, Nurses Block<br>W.C Cistern | | <b>Asbestos</b><br><br><b>Type</b> | Yes, Strongly<br>Presumed<br><br>Amosite (Brown) |
| <b>Material Type</b> | Plastic | <b>Quantity</b> | 1m | <b>Sample No</b> | As 06/B/8026/5 |

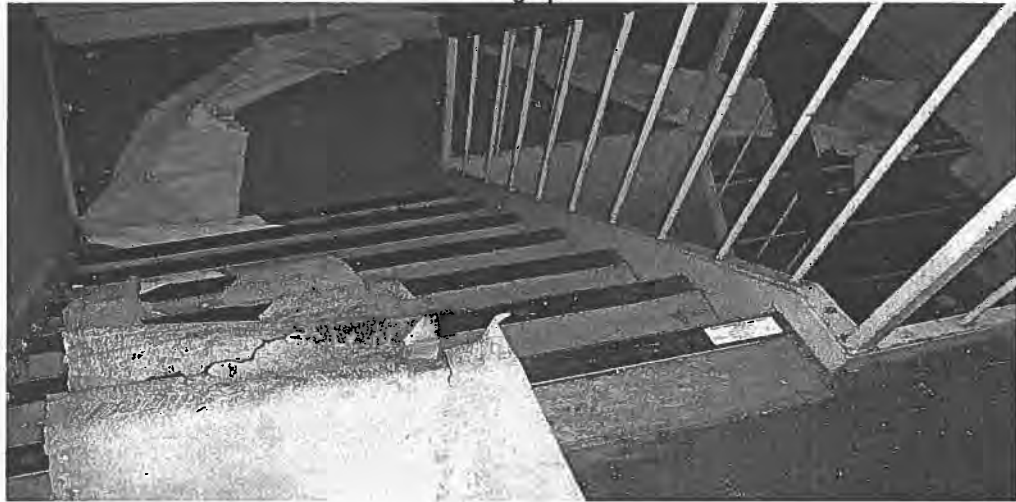
| <b>Location of Survey</b><br>Cane Hill Hospital,<br>Cane Hill,<br>Coulsdon, Surrey,<br>CR5 3ES | | <b>Position of Sample/Photo</b><br>Nurses Block, Middle Annex,<br>Black stair nosing | | <b>Asbestos</b> Yes |
| <b>Material Type</b> Vinyl | | <b>Quantity</b> 14m | | <b>Type</b> Chrysotile (White) |

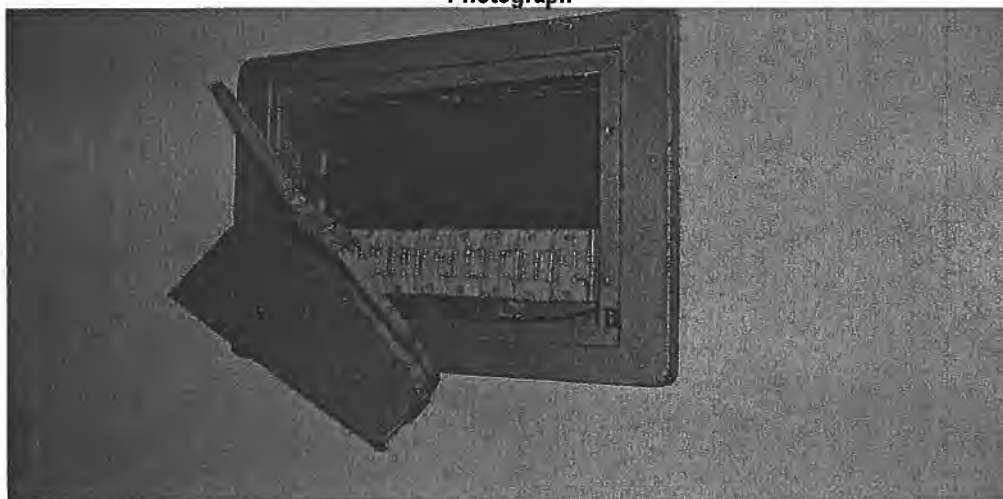
| <b>Location of Survey</b><br>Cane Hill Hospital,<br>Cane Hill,<br>Coulston, Surrey,<br>CR5 3ES | | <b>Position of Sample/Photo</b><br>Nurses Block, Middle Annex,<br>Corridor wall electrics | <b>Asbestos</b><br><br><b>Type</b> | <b>Yes, Strongly Presumed</b><br><br>Chrysotile (White) |
| <b>Material Type</b> | Rope | <b>Quantity</b> | <1m <sup>2</sup> | <b>Sample No</b> As 06/B/8026/9<br><b>Survey Date</b> 24.04 - 29.06.06<br><b>Date of Report</b> 18.08.06<br><b>Surveyor(s)</b> <span style="background-color: black; color: black;">[REDACTED]</span> |

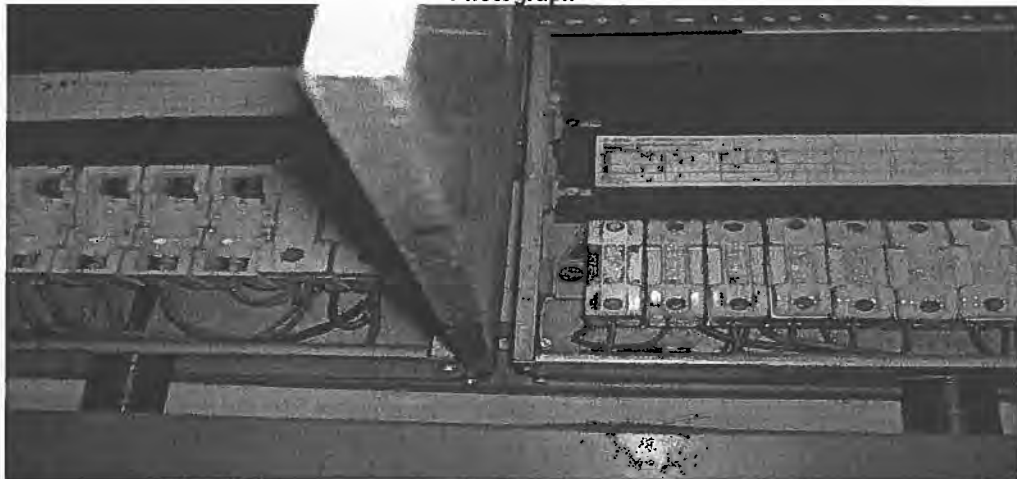
| <b>Location of Survey</b><br>Cane Hill Hospital,<br>Cane Hill,<br>Coulston, Surrey,<br>CR5 3ES | | <b>Position of Sample/Photo</b><br>Nurses Block, Middle Annex,<br>Electric Cupboard | | <b>Asbestos</b><br><br><b>Type</b> | Yes, Strongly<br>Presumed<br><br>Chrysotile (White) |
| <b>Material Type</b> | Cement | <b>Quantity</b> | <1m <sup>2</sup> | <b>Sample No</b> | As 06/B/8026/9 |

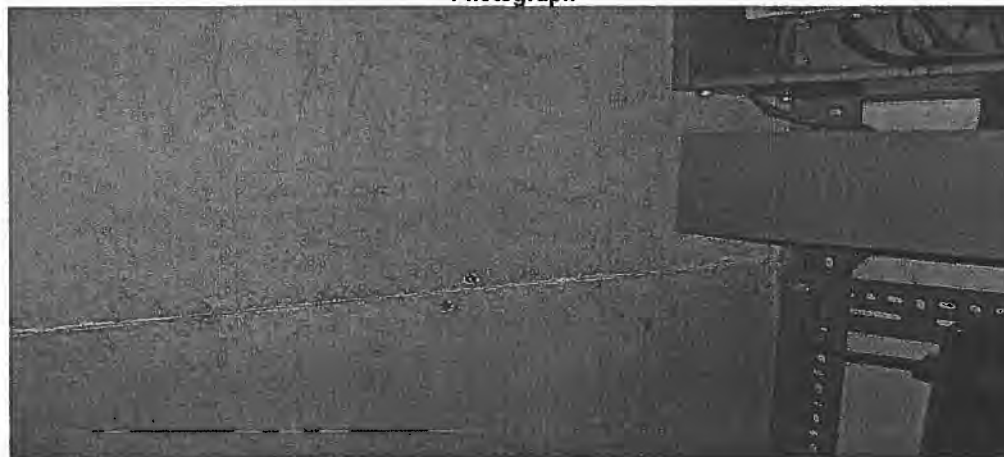
| <b>Location of Survey</b><br>Cane Hill Hospital,<br>Cane Hill,<br>Coulston, Surrey,<br>CR5 3ES | <b>Position of Sample/Photo</b><br>Nurses Block, Middle Annex,<br>Ground Floor,<br>Wall panel to electric cupboard | <b>Asbestos</b><br><br><b>Type</b> | <b>Yes</b><br><br>Amosite (Brown) |
| <b>Material Type</b><br>Board | <b>Quantity</b><br>2m | <b>Sample No</b><br><br><b>Survey Date</b><br><br><b>Date of Report</b><br><br><b>Surveyor(s)</b> | 06/B/8026/198<br>24.04 - 29.06.06<br>18.08.06<br> |

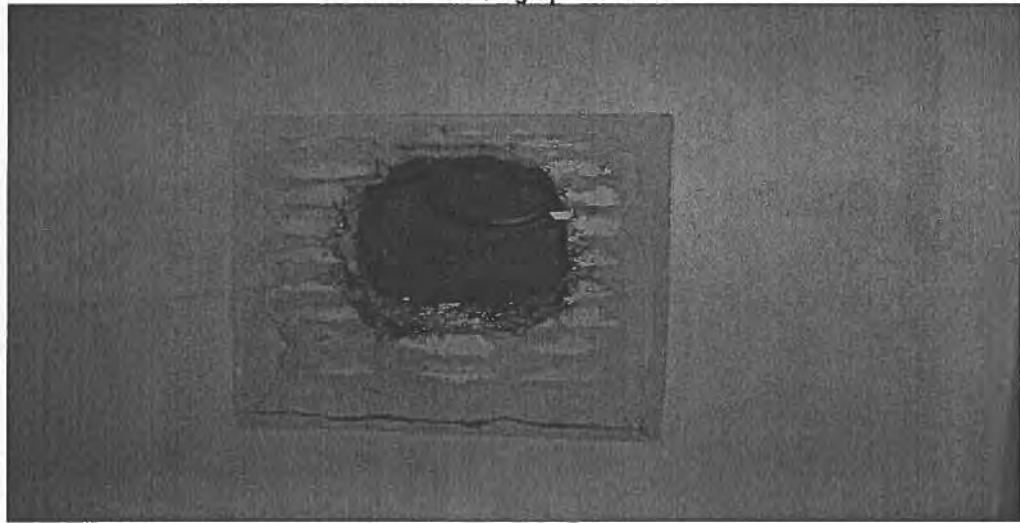
| <b>Location of Survey</b><br>Cane Hill Hospital,<br>Cane Hill,<br>Coulsdon, Surrey,<br>CR5 3ES | | <b>Position of Sample/Photo</b><br>Nurses Block, Middle Annex,<br>W.C, Redundant flue pipe | | <b>Asbestos</b><br><br><b>Type</b> | <b>Yes, Strongly Presumed</b><br><br>Chrysotile (White) |
| <b>Material Type</b> | Cement | <b>Quantity</b> | <1m | <b>Sample No</b> | As 06/B/8026/154 |

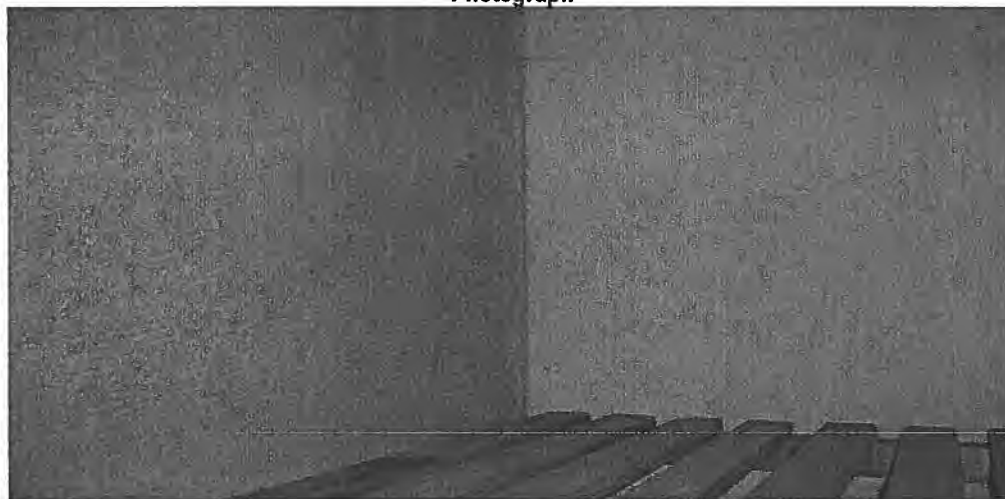
| <b>Location of Survey</b> | | <b>Position of Sample/Photo</b> | <b>Asbestos</b> | Yes, Strongly Presumed | |
| Cane Hill Hospital,<br>Cane Hill,<br>Coulsdon, Surrey,<br>CR5 3ES | | Nurses Block, Middle Annex,<br>Ground floor cupboard<br>Wall Panel | <b>Type</b> | Amosite (Brown) | |
| <b>Material Type</b> | Board | <b>Quantity</b> | 2m <sup>2</sup> | <b>Sample No</b> | As 06/B/8026/198 |

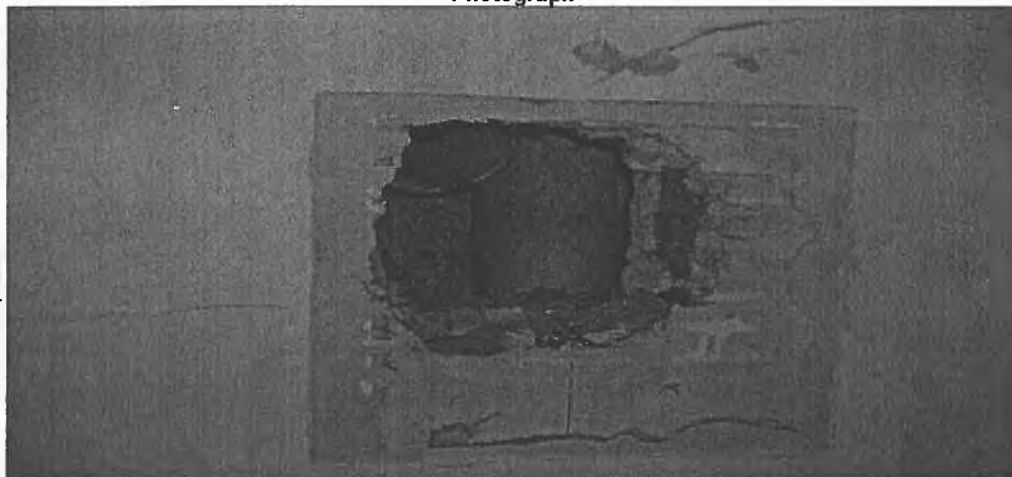
| <b>Location of Survey</b><br>Cane Hill Hospital,<br>Cane Hill,<br>Coulston, Surrey,<br>CR5 3ES | | <b>Position of Sample/Photo</b><br>Nurses Block, Middle Annex,<br>Ground floor W.C.<br>Redundant Flue pipe | | <b>Asbestos</b><br><br><b>Type</b> | <br>Yes, Strongly<br>Presumed<br><br>Chrysotile (White) |
| <b>Material Type</b><br>Cement | | <b>Quantity</b><br><1m | | <b>Sample No</b> | As 06/B/8026/154 |

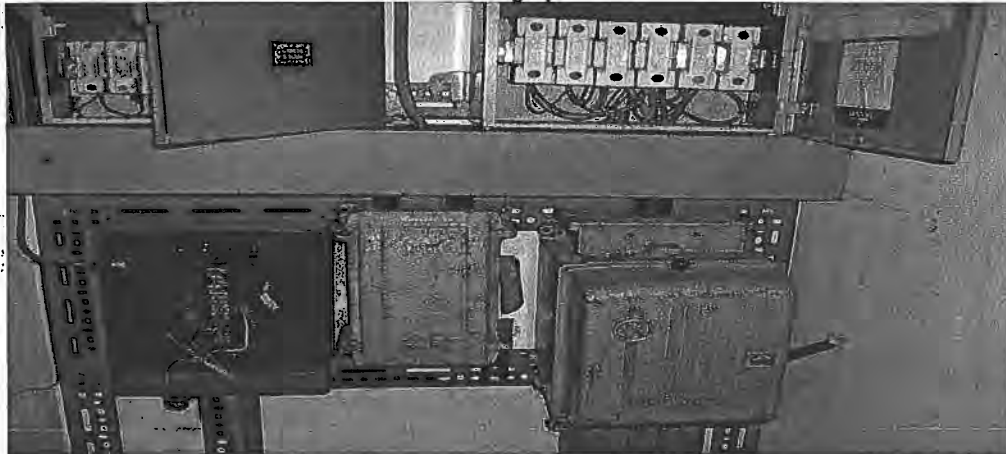
| <b>Location of Survey</b><br>Cane Hill Hospital,<br>Cane Hill,<br>Coulson, Surrey,<br>CR5 3ES | | <b>Position of Sample/Photo</b><br>Nurses Block, Rear Annex,<br>Electrics | <b>Asbestos</b><br><br><b>Type</b> | Yes, Strongly<br>Presumed<br><br>Chrysotile (White) |
| <b>Material Type</b> | Rope | <b>Quantity</b> | <1m <sup>2</sup> | <b>Sample No</b> As 06/B/8026/9<br><b>Survey Date</b> 24.04 - 29.06.06<br><b>Date of Report</b> 18.08.06<br><b>Surveyor(s)</b> [REDACTED] |

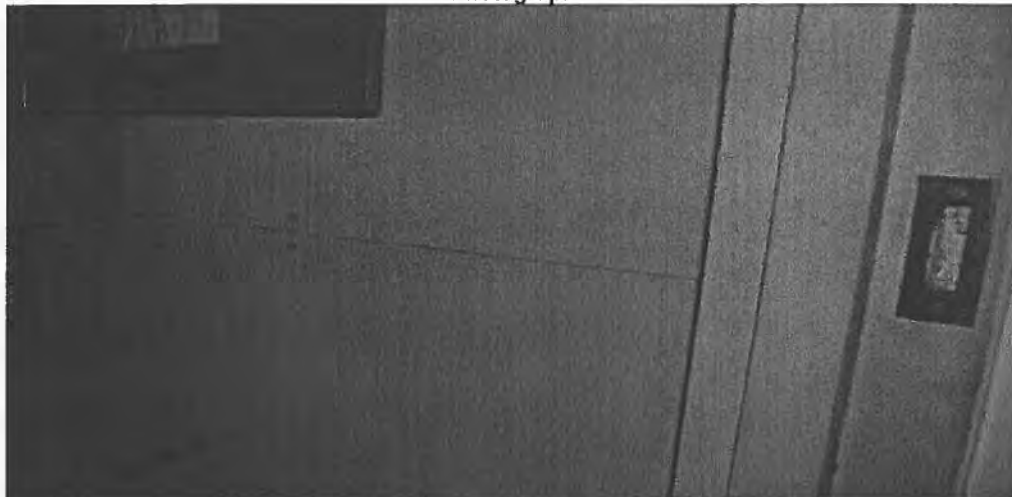
| <b>Location of Survey</b><br>Cane Hill Hospital,<br>Cane Hill,<br>Coulsdon, Surrey,<br>CR5 3ES | <b>Position of Sample/Photo</b><br>Nurses Block, Rear Annex,<br>Electric cupboard<br>Wall panel | <b>Asbestos</b><br><br><b>Type</b> | Yes, Strongly<br>Presumed<br><br>Amosite (Brown) |
| <b>Material Type</b> Board | <b>Quantity</b> 2m <sup>2</sup> | <b>Sample No</b> As 06/B/8026/198<br><br><b>Survey Date</b> 24.04 - 29.06.06<br><br><b>Date of Report</b> 18.08.06<br><br><b>Surveyor(s)</b> <span style="background-color: black; color: black;">[REDACTED]</span> | |

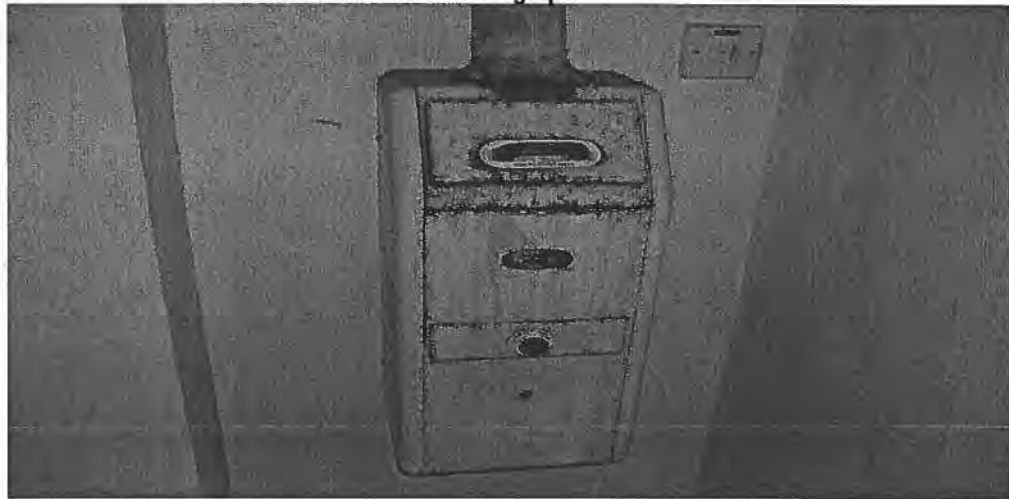
| <b>Location of Survey</b><br>Cane Hill Hospital,<br>Cane Hill,<br>Coulsdon, Surrey,<br>CR5 3ES | | <b>Position of Sample/Photo</b><br>Nurses Block, Rear Annex,<br>W.C Bunny Boiler Flue and<br>Internal Panels | | <b>Asbestos</b><br><br><b>Type</b> | Yes, Strongly<br>Presumed<br><br>Chrysotile (White) |
| <b>Material Type</b> | Cement | <b>Quantity</b> | 1m | <b>Sample No</b> | As 06/B/8026/154 |

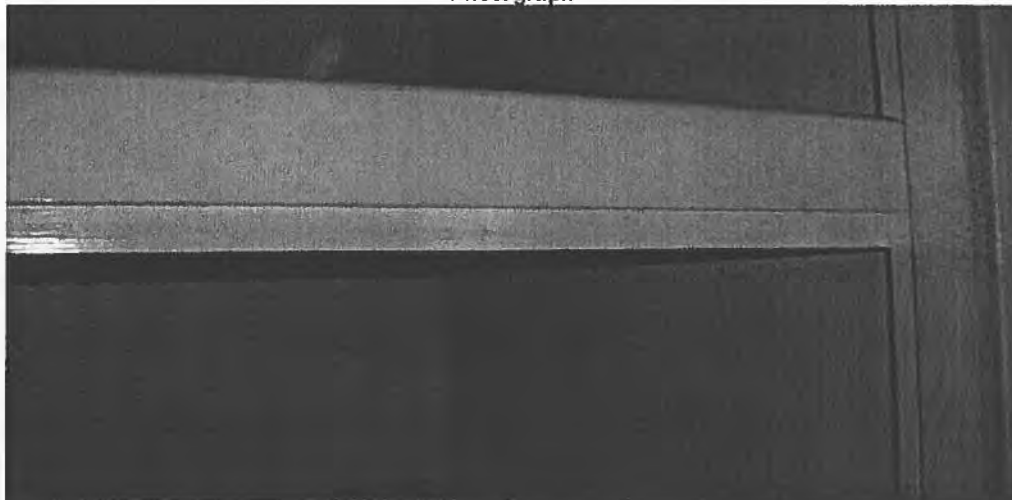
| <b>Location of Survey</b><br>Cane Hill Hospital,<br>Cane Hill,<br>Coulston, Surrey,<br>CR5 3ES | | <b>Position of Sample/Photo</b><br>Nurses Block, Rear Annex,<br>Cupboard Wall Panel | | <b>Asbestos</b><br><br><b>Type</b> | Yes, Strongly<br>Presumed<br><br>Chrysotile (White) |
| <b>Material Type</b> | Plastic | <b>Quantity</b> | 2m <sup>2</sup> | <b>Sample No</b> | As 06/B/8026/ |

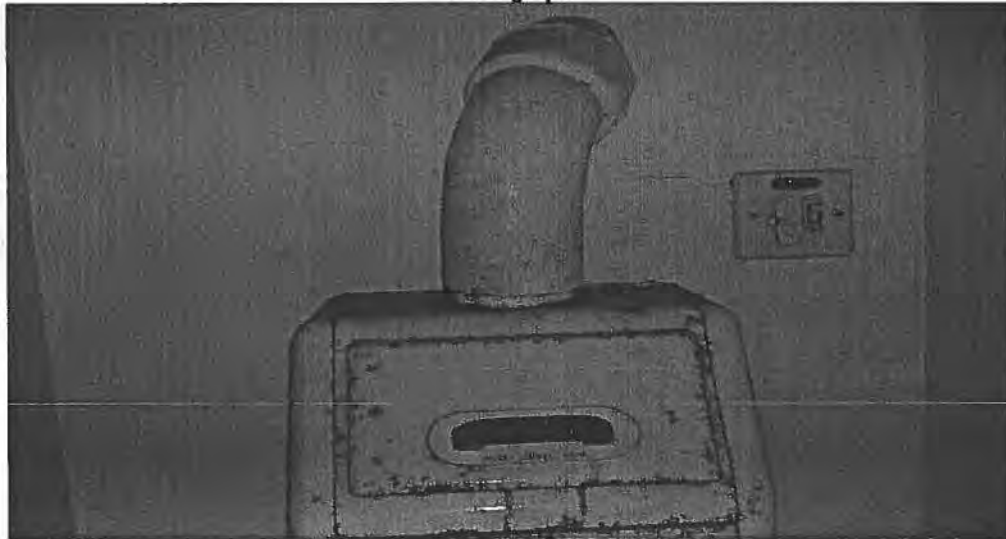
| <b>Location of Survey</b><br>Cane Hill Hospital,<br>Cane Hill,<br>Coulsdon, Surrey,<br>CR5 3ES | <b>Position of Sample/Photo</b><br>Nurses Block, Rear Annex,<br>W.C Bunny Boiler | <b>Asbestos</b><br><br><b>Type</b> | Yes, Strongly<br>Presumed<br><br>Chrysotile (White) |
| <b>Material Type</b> Cement | <b>Quantity</b> 1m | <b>Sample No</b> As 06/B/8026/154<br><br><b>Survey Date</b> 24.04 - 29.06.06<br><br><b>Date of Report</b> 18.08.06<br><br><b>Surveyor(s)</b> <span style="background-color: black; color: black;">[REDACTED]</span> | |

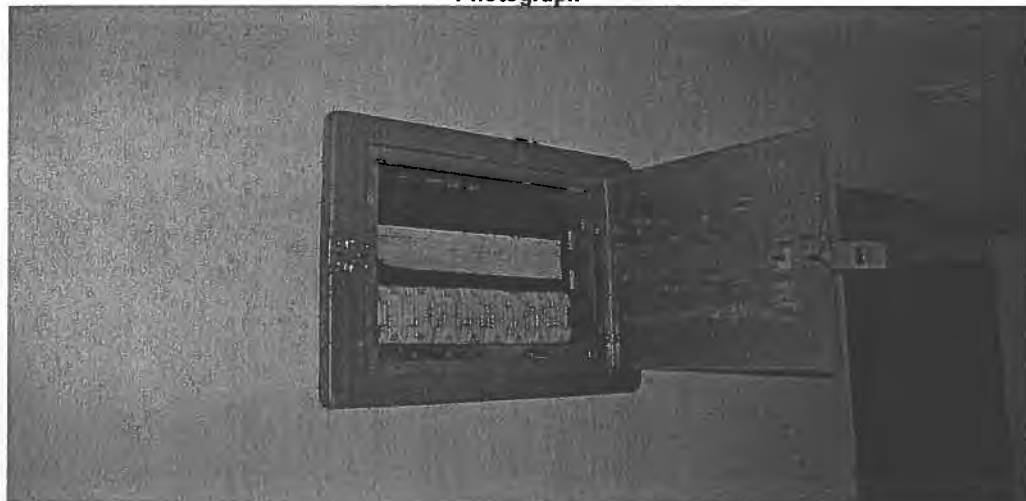
| <b>Location of Survey</b><br>Cane Hill Hospital,<br>Cane Hill,<br>Coulsdon, Surrey,<br>CR5 3ES | <b>Position of Sample/Photo</b><br>Nurses Block, Rear Annex,<br>Corridor Electrics | <b>Asbestos</b><br>Yes, Strongly Presumed | <b>Type</b><br>Chrysotile (White) |
| <b>Material Type</b><br>Rope | <b>Quantity</b><br><1m <sup>2</sup> | <b>Sample No</b><br>As 06/B/8026/9 | <b>Survey Date</b><br>24.04 - 29.06.06 |

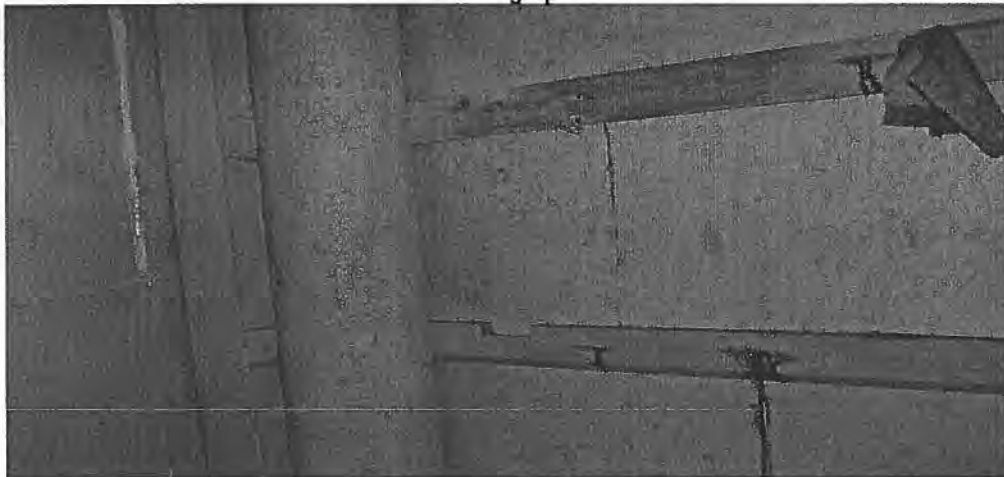
| <b>Location of Survey</b><br>Cane Hill Hospital,<br>Cane Hill,<br>Coulsdon, Surrey,<br>CR5 3ES | | <b>Position of Sample/Photo</b><br>Main Nurses Block, Second<br>Floor, Domestic Cupboards in<br>Corridor (X2), Pipe lagging<br>(noted to all floors) | | <b>Asbestos</b><br><br><b>Type</b> | Yes, Strongly<br>Presumed<br><br>Chrysotile (White)<br>Crocidolite (Blue) |
| <b>Material Type</b> | Lagging | <b>Quantity</b> | 3m per<br>cupboard<br>X2 cupboards<br>per floor | <b>Sample No</b><br><br><b>Survey Date</b><br><br><b>Date of Report</b><br><br><b>Surveyor(s)</b> | As 06/B/8026/200<br>24.04 - 29.06.06<br>18.08.06<br>[REDACTED] |

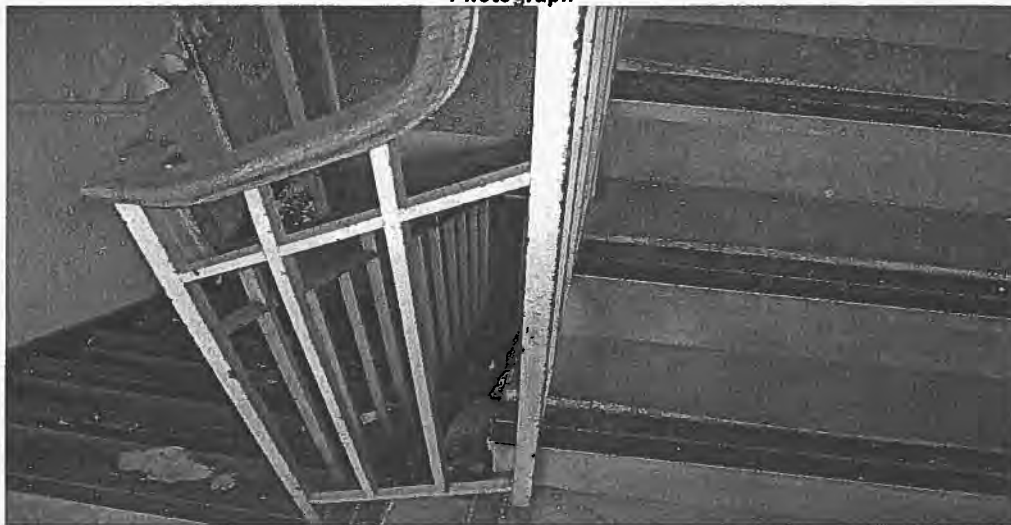
| <b>Location of Survey</b><br>Cane Hill Hospital,<br>Cane Hill,<br>Coulston, Surrey,<br>CR5 3ES | | <b>Position of Sample/Photo</b><br>Main Nurses Block<br>Stair Nosing | | <b>Asbestos</b><br><br><b>Type</b> | Yes, Strongly<br>Presumed<br><br>Chrysotile (White) |
| <b>Material Type</b> | Vinyl | <b>Quantity</b> | 200m | <b>Sample No</b> | As 06/B/8026/197 |

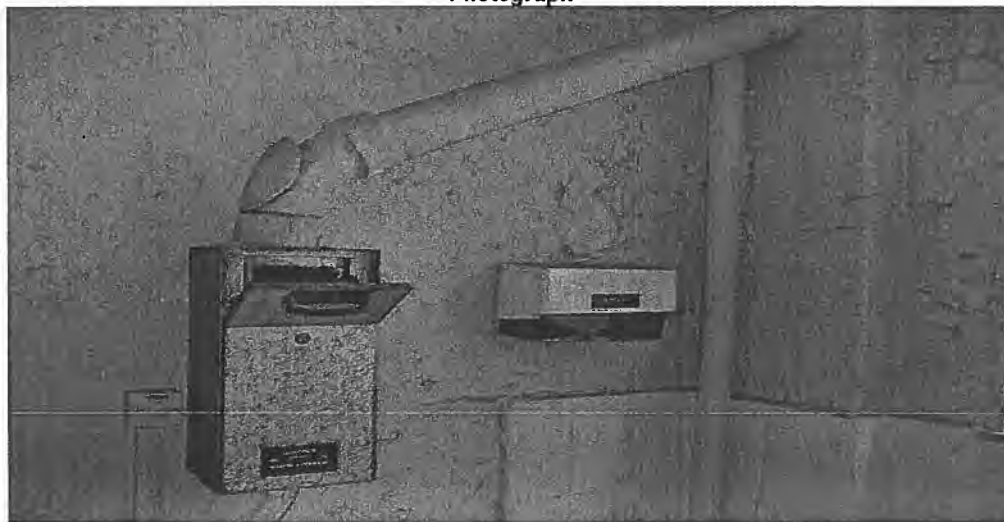
| <b>Location of Survey</b><br>Cane Hill Hospital,<br>Cane Hill,<br>Coulsdon, Surrey,<br>CR5 3ES | | <b>Position of Sample/Photo</b><br>Main Nurses Block<br>Bunny Boiler (X3) | <b>Asbestos</b><br><br><b>Type</b> | Yes, Strongly<br>Presumed<br><br>Chrysotile (White) |
| <b>Material Type</b> | Cement | <b>Quantity</b> | 2m | <b>Sample No</b> As 06/B/8026/154<br><b>Survey Date</b> 24.04 - 29.06.06<br><b>Date of Report</b> 18.08.06<br><b>Surveyor(s)</b> <span style="background-color: black; color: black;">[REDACTED]</span> |

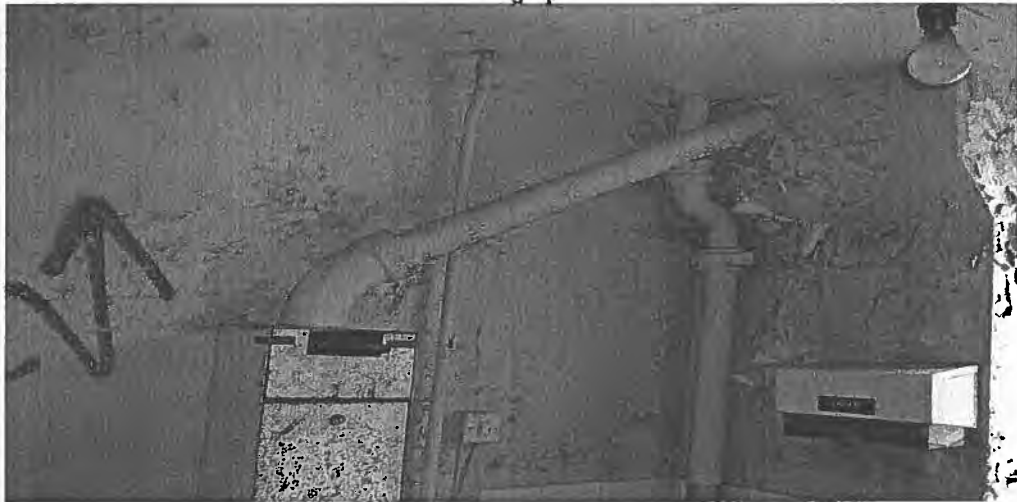
| <b>Location of Survey</b><br>Cane Hill Hospital,<br>Cane Hill,<br>Coulston, Surrey,<br>CR5 3ES | | <b>Position of Sample/Photo</b><br>Main Nurses Block<br>Bunny Boiler (X3) | | <b>Asbestos</b><br><br><b>Type</b> | Yes, Strongly<br>Presumed<br><br>Chrysotile (White) |
| <b>Material Type</b> | Cement | <b>Quantity</b> | 2m | <b>Sample No</b> | As 06/B/8026/154 |

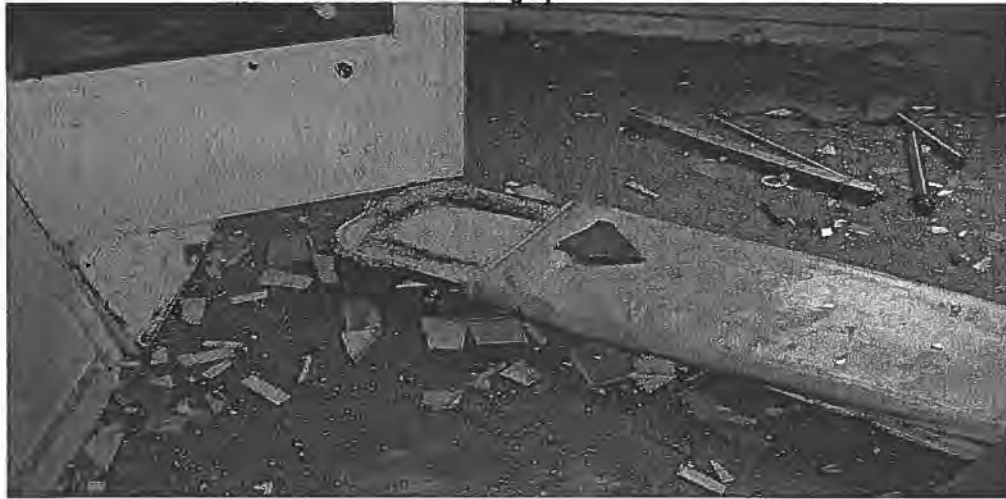
| <b>Location of Survey</b><br>Cane Hill Hospital,<br>Cane Hill,<br>Coulston, Surrey,<br>CR5 3ES | | <b>Position of Sample/Photo</b><br>Main Nurses Block<br>Ironing Board Panel | <b>Asbestos</b><br><br><b>Type</b> | <b>Yes, Strongly Presumed</b><br><br>Chrysotile (White) |
| <b>Material Type</b> | Cement | <b>Quantity</b> | <1m <sup>2</sup> | <b>Sample No</b> As 06/B/8026/20<br><br><b>Survey Date</b> 24.04 - 29.06.06<br><br><b>Date of Report</b> 18.08.06<br><br><b>Surveyor(s)</b> <span style="background-color: black; color: black;">[REDACTED]</span> |

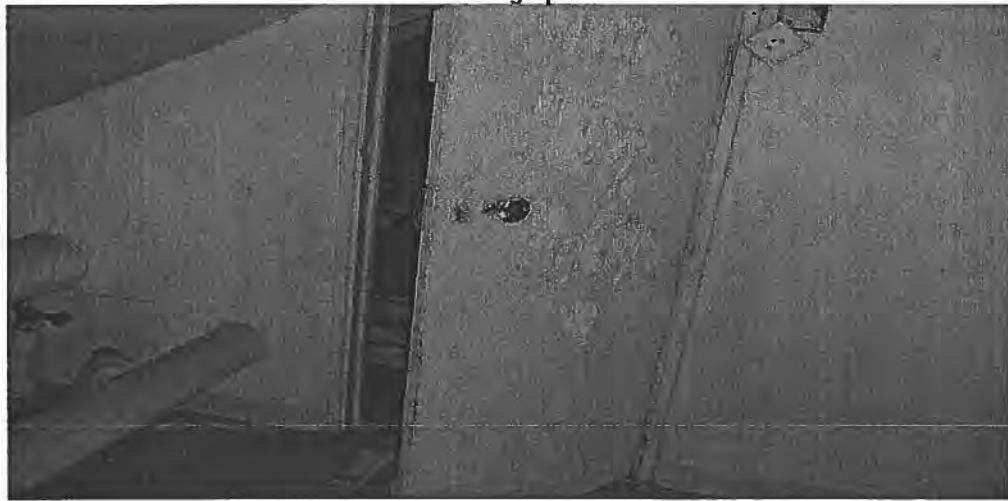
| <b>Location of Survey</b><br>Cane Hill Hospital,<br>Cane Hill,<br>Coulston, Surrey,<br>CR5 3ES | | <b>Position of Sample/Photo</b><br>Main Nurses Block<br>Loft, Door Panels (X2) | <b>Asbestos</b><br><br><b>Type</b> | Yes, Strongly<br>Presumed<br><br>Amosite (Brown) |
| <b>Material Type</b> | Board | <b>Quantity</b><br>2m <sup>2</sup> | <b>Sample No</b> | As 06/B/8026/196 |

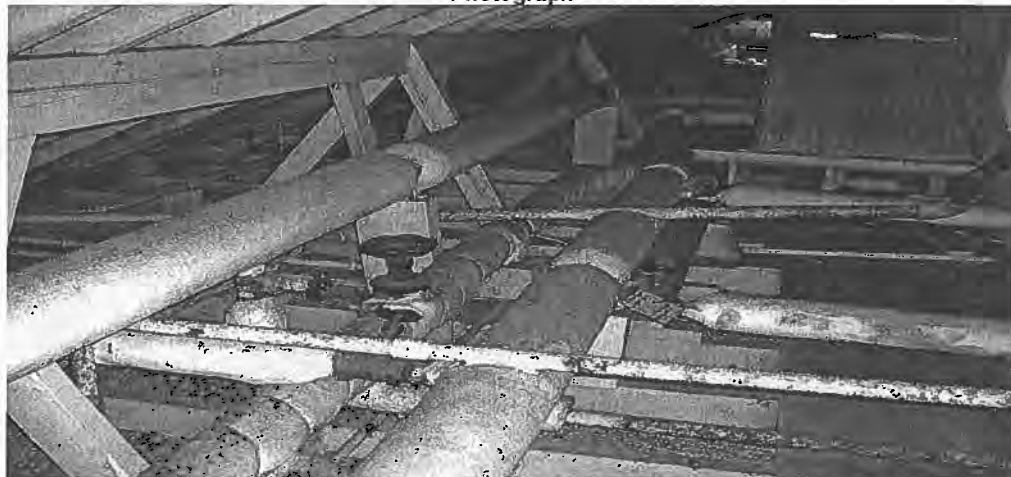
| <b>Location of Survey</b><br>Cane Hill Hospital,<br>Cane Hill,<br>Coulston, Surrey,<br>CR5 3ES | | <b>Position of Sample/Photo</b><br>Main Nurses Block (LHS)<br>Loft Pipe lagging | | <b>Asbestos</b><br><br><b>Type</b> | Yes, Strongly Presumed<br><br>Chrysotile (White)<br>Crocidolite (Blue)<br>Amosite (Brown) |
| <b>Material Type</b> | Lagging | <b>Quantity</b> | 100m | <b>Sample No</b> | As 06/B/8026/201 |

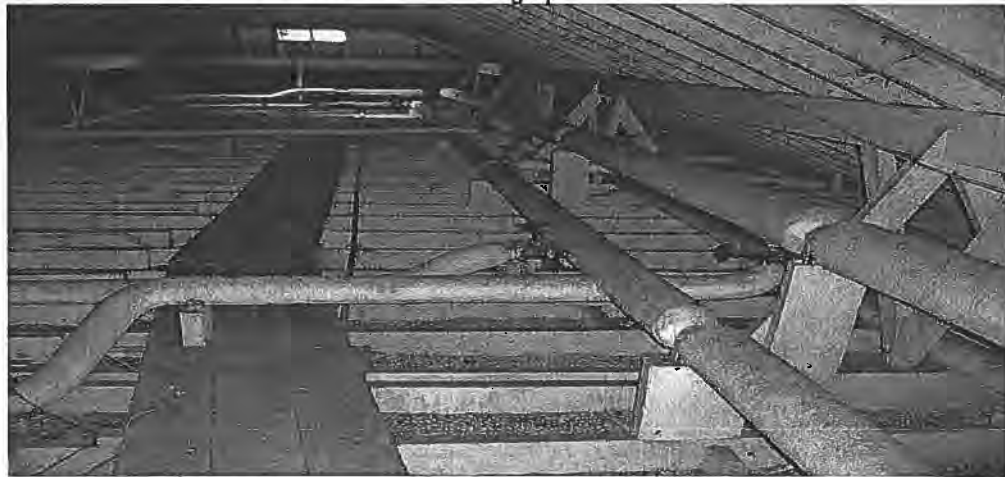
| <b>Location of Survey</b><br>Cane Hill Hospital,<br>Cane Hill,<br>Coulston, Surrey,<br>CR5 3ES | | <b>Position of Sample/Photo</b><br>Main Nurses Block (RHS)<br>Loft Pipe lagging | | <b>Asbestos</b><br><br><b>Type</b> | Yes, Strongly<br>Presumed<br><br>Chrysotile (White)<br>Crocidolite (Blue)<br>Amosite (Brown) |
| <b>Material Type</b> | Lagging | <b>Quantity</b> | 100m | <b>Sample No</b> | As 06/B/8026/201 |

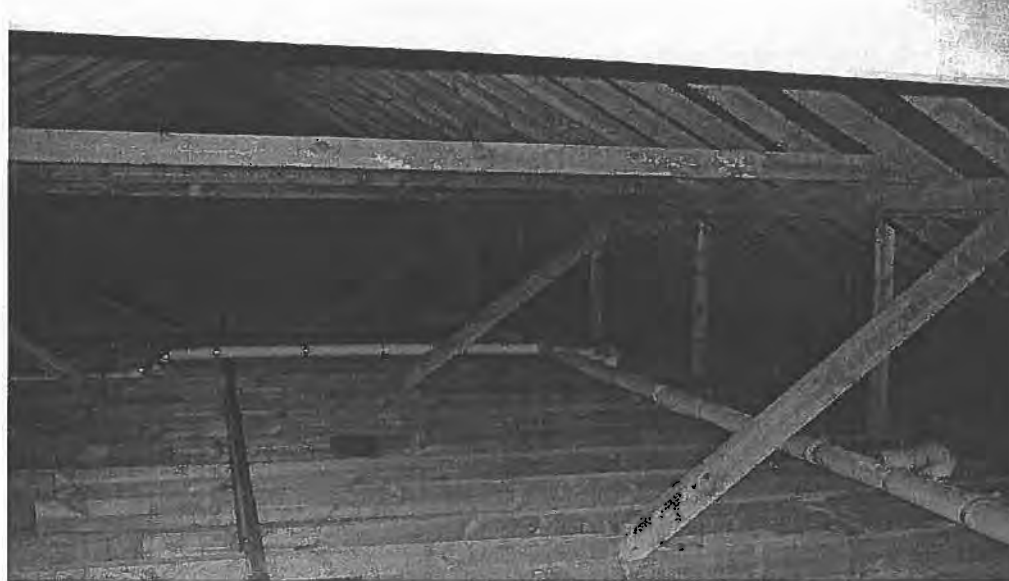
| <b>Location of Survey</b><br>Cane Hill Hospital,<br>Cane Hill,<br>Coulston, Surrey,<br>CR5 3ES | | <b>Position of Sample/Photo</b><br>Nurses Block Rear Annex,<br>Loft Sectional lagging & Flue<br>pipes | | <b>Asbestos</b><br><br><b>Type</b> | <b>Yes, Strongly<br/>Presumed</b><br><br>Chrysotile (White)<br>Amosite (Brown) |
| <b>Material<br/>Type</b> | Lagging<br>& Cement | <b>Quantity</b> | 20m | <b>Sample No</b> | As 06/B/8026/199 |

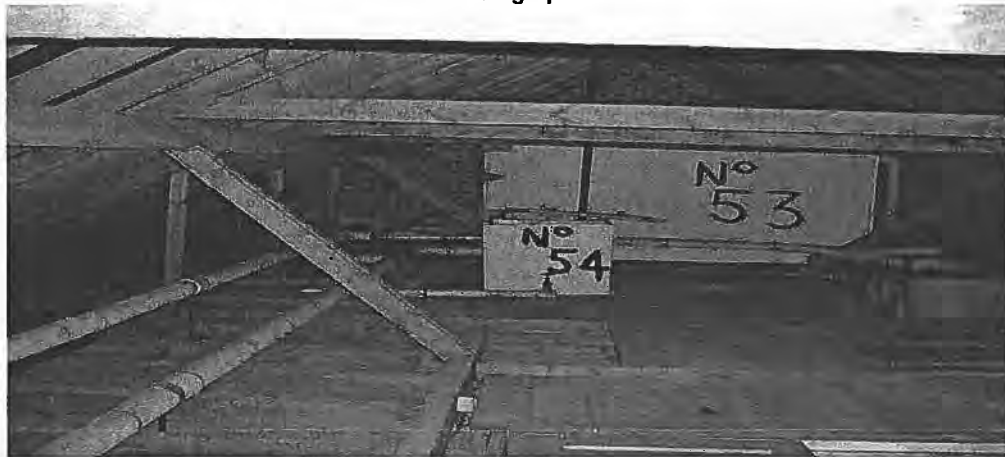
| <b>Location of Survey</b><br>Cane Hill Hospital,<br>Cane Hill,<br>Coulston, Surrey,<br>CR5 3ES | | <b>Position of Sample/Photo</b><br>Nurses Block, Rear Annex,<br>Loft, Sectional lagging | | <b>Asbestos</b><br><br><b>Type</b> | Yes, Strongly<br>Presumed<br><br>Chrysotile (White)<br>Amosite (Brown) |
| <b>Material Type</b> | Lagging | <b>Quantity</b> | 20m | <b>Sample No</b> | As 06/B/8026/202 |

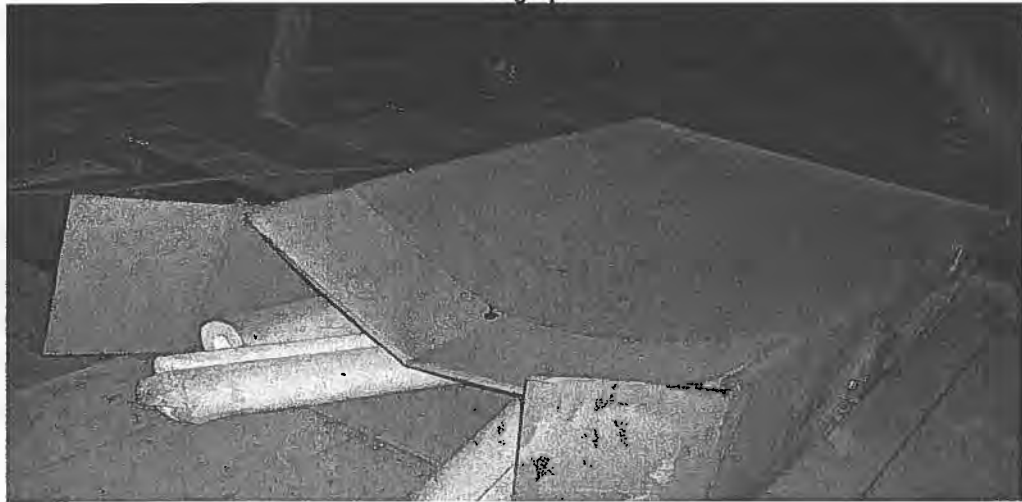
| <b>Location of Survey</b><br>Cane Hill Hospital,<br>Cane Hill,<br>Coulston, Surrey,<br>CR5 3ES | | <b>Position of Sample/Photo</b><br>Nurses Block, Rear Annex,<br>Loft, Box of Sectional lagging | | <b>Asbestos</b><br><br><b>Type</b> | Yes, Strongly<br>Presumed<br><br>Chrysotile (White)<br>Amosite (Brown) |
| <b>Material Type</b> | Lagging | <b>Quantity</b> | 1m <sup>2</sup> | <b>Sample No</b> | As 06/B/8026/202 |

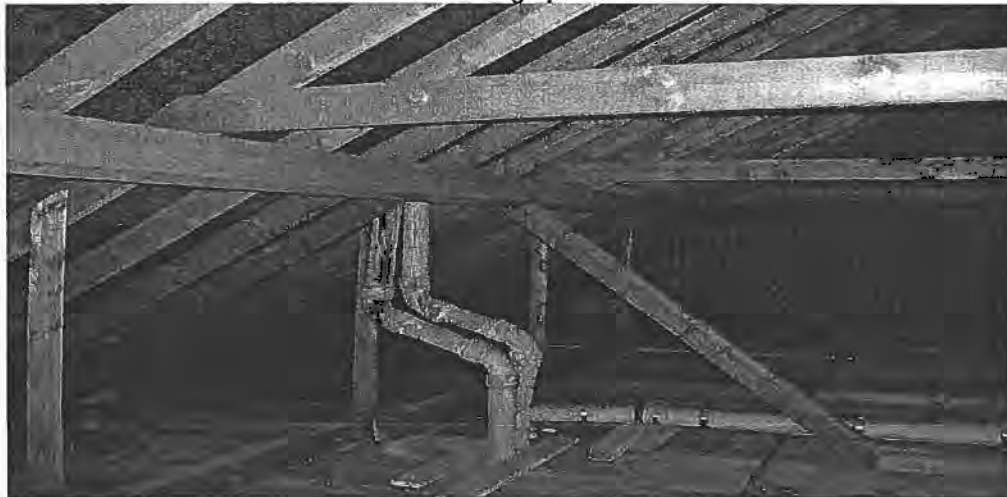
| <b>Location of Survey</b><br>Cane Hill Hospital,<br>Cane Hill,<br>Coulsdon, Surrey,<br>CR5 3ES | | <b>Position of Sample/Photo</b><br>Nurses Block, Middle Annex,<br>Loft Cement flue pipes (X2) | | <b>Asbestos</b><br><br><b>Type</b> | Yes, Strongly<br>Presumed<br><br>Chrysotile (White) |
| <b>Material Type</b> | Cement | <b>Quantity</b> | 2m <sup>2</sup> | <b>Sample No</b> | As 06/B/8026/154 |

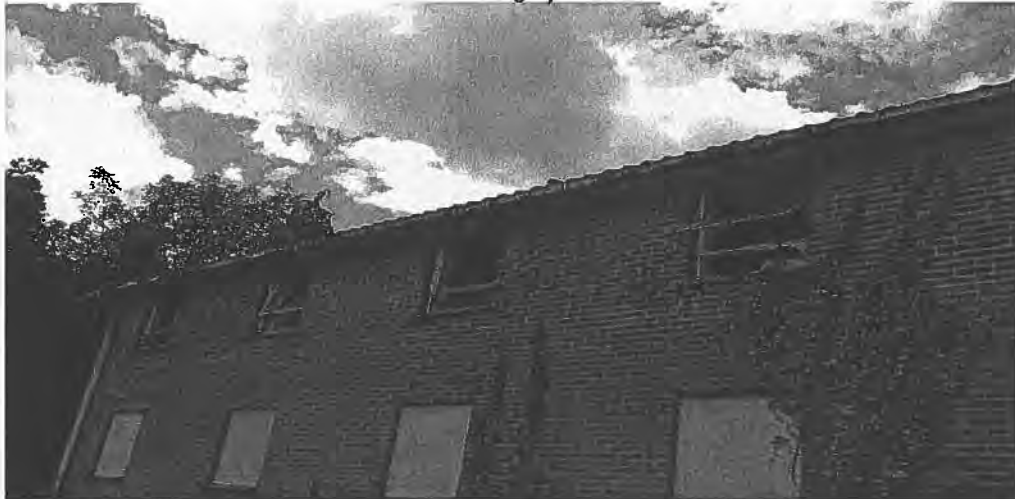
| <b>Location of Survey</b><br>Cane Hill Hospital,<br>Cane Hill,<br>Coulston, Surrey,<br>CR5 3ES | | <b>Position of Sample/Photo</b><br>Nurses Block, Rear Annex,<br>External Roof Soffit panels | | <b>Asbestos</b><br><br><b>Type</b> | <b>Yes</b><br><br>Chrysotile (White) |
| <b>Material Type</b> | Cement | <b>Quantity</b> | 180m <sup>2</sup> | <b>Sample No</b> | 06/B/8026/203 |

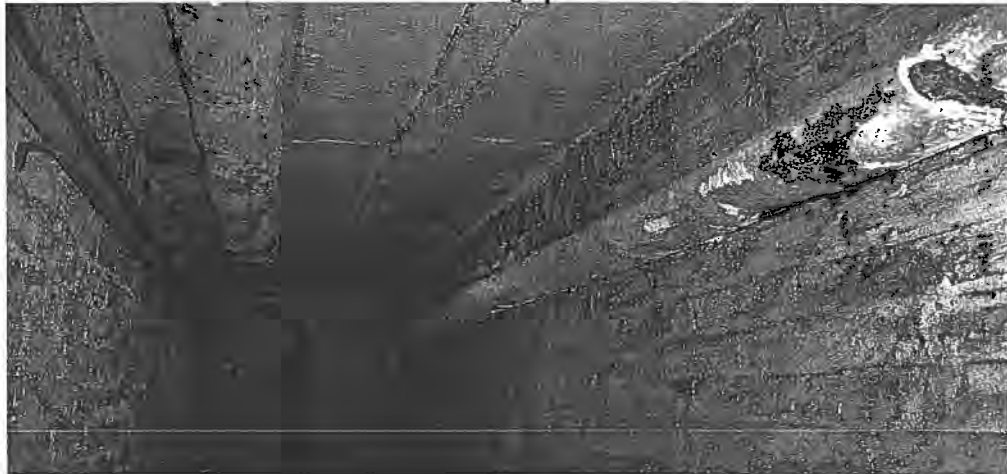
| <b>Location of Survey</b><br>Cane Hill Hospital,<br>Cane Hill,<br>Coulston, Surrey,<br>CR5 3ES | | <b>Position of Sample/Photo</b><br>Main Nurses Block<br>Basement boiler room, LHS<br>Under floor duct (X6)<br>Pipe lagging, | <b>Asbestos</b> Yes |
| <b>Material Type</b> Lagging | | <b>Quantity</b> 60m <sup>2</sup> | <b>Type</b> Chrysotile (White) |

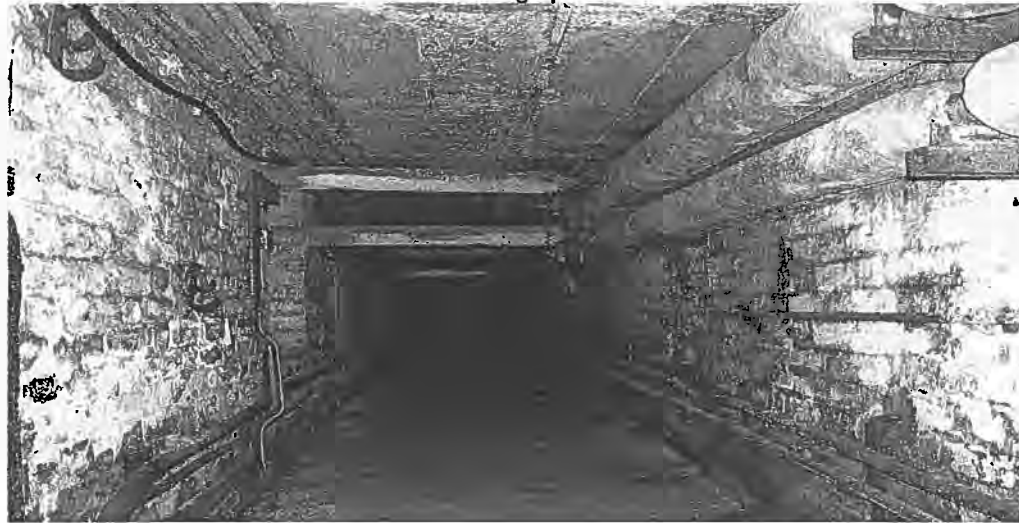
| <b>Location of Survey</b><br>Cane Hill Hospital,<br>Cane Hill,<br>Coulsdon, Surrey,<br>CR5 3ES | | <b>Position of Sample/Photo</b><br>Main Nurses Block<br>Basement boiler room,<br>Main floor duct<br>Pipe lagging, | | <b>Asbestos</b><br><br><b>Type</b> | Yes, Strongly<br>Presumed<br><br>Chrysotile (White) |
| <b>Material Type</b><br>Lagging | | <b>Quantity</b><br>40m | <b>Sample No</b><br>As 06/B/8026/204 | | |

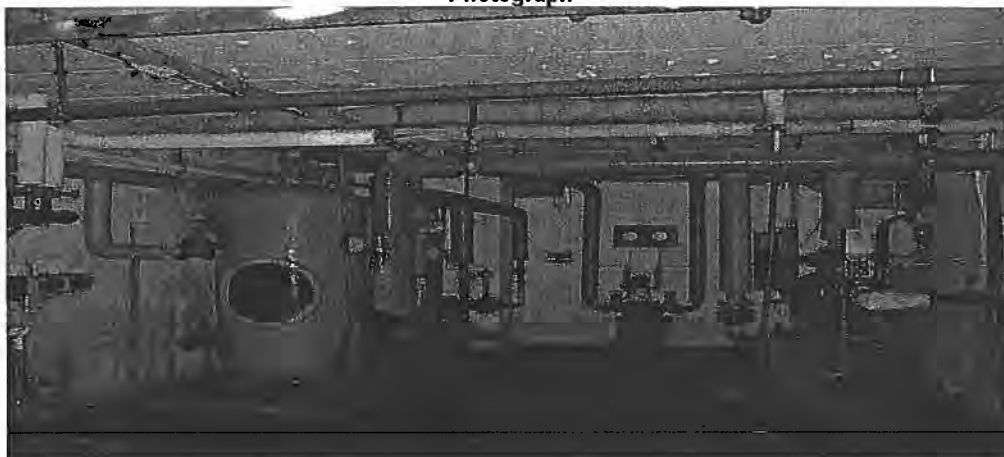
| <b>Location of Survey</b><br>Cane Hill Hospital,<br>Cane Hill,<br>Coulston, Surrey,<br>CR5 3ES | | <b>Position of Sample/Photo</b><br>Main Nurses Block<br>Basement boiler room,<br>Pipe lagging, | <b>Asbestos</b><br><br><b>Type</b> | Yes, Strongly<br>Presumed<br><br>Chrysotile (White) |
| <b>Material Type</b><br>Lagging | <b>Quantity</b><br>100m | | <b>Sample No</b> | As 06/B/8026/204 |

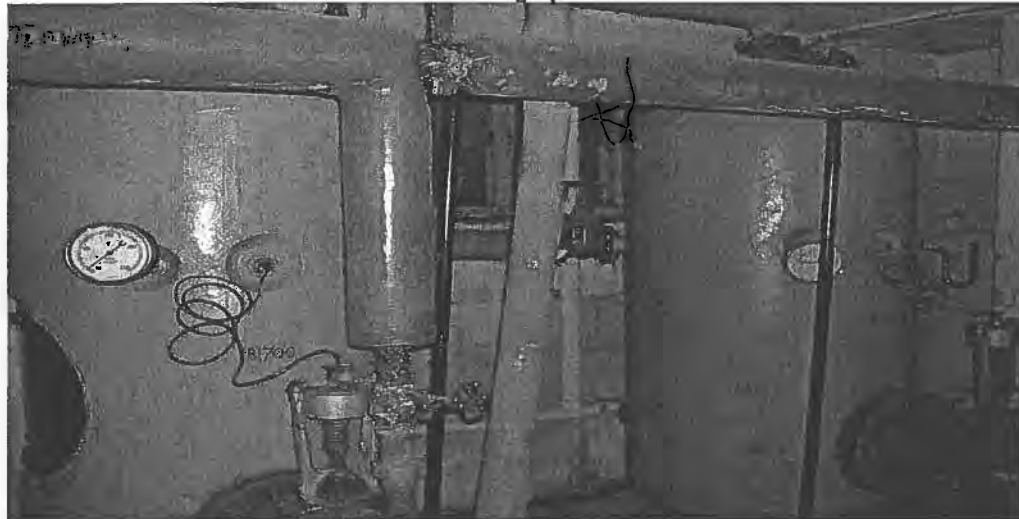
| <b>Location of Survey</b><br>Cane Hill Hospital,<br>Cane Hill,<br>Coulsdon, Surrey,<br>CR5 3ES | | <b>Position of Sample/Photo</b><br>Main Nurses Block<br>Basement boiler room,<br>Tank Pipe lagging | | <b>Asbestos</b><br><br><b>Type</b> | Yes, Strongly<br>Presumed<br><br>Chrysotile (White) |
| <b>Material Type</b> | Lagging | <b>Quantity</b> | 20m <sup>2</sup> | <b>Sample No</b> | As 06/B/8026/204 |
