## SURVEY INFORMATION SHEET

| <b>Location of Survey</b><br>Cane Hill Hospital,<br>Cane Hill,<br>Coulsdon, Surrey,<br>CR5 3ES | <b>Position of Sample/Photo</b><br>Workshop Garages<br>External corrugated roof sheet | <b>Asbestos</b><br><br><b>Type</b> | Yes, Strongly Presumed<br><br>Chrysotile (White) |

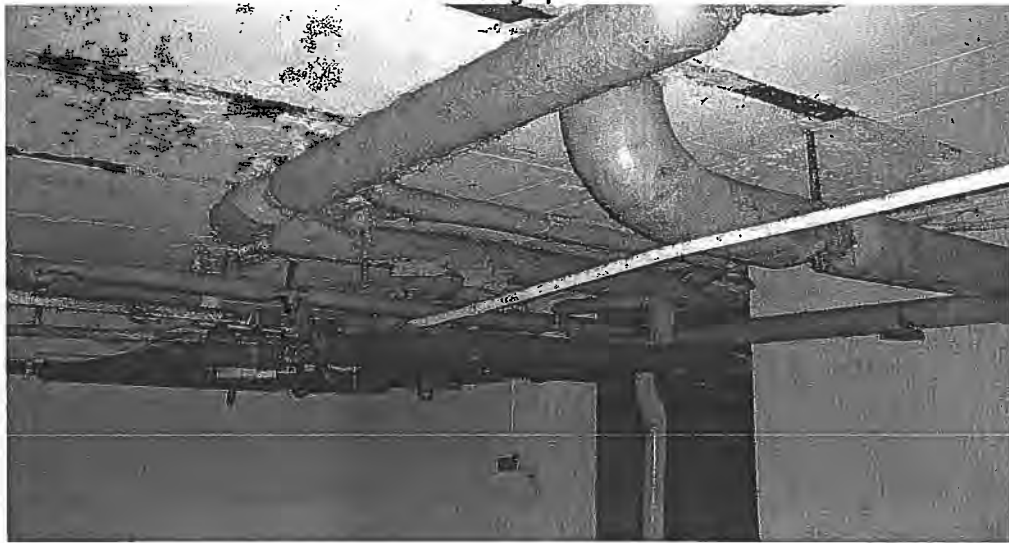
| <b>Location of Survey</b><br>Cane Hill Hospital,<br>Cane Hill,<br>Coulston, Surrey,<br>CR5 3ES | | <b>Position of Sample/Photo</b><br>Main Nurses Block<br>Store adjacent Basement<br>Boiler room, Pipe lagging | | <b>Asbestos</b><br><br><b>Type</b> | Yes, Strongly<br>Presumed<br><br>Chrysotile (White) |
| <b>Material Type</b><br>Lagging | | <b>Quantity</b><br>100m <sup>2</sup> | <b>Sample No</b><br>As 06/B/8026/204 | | |

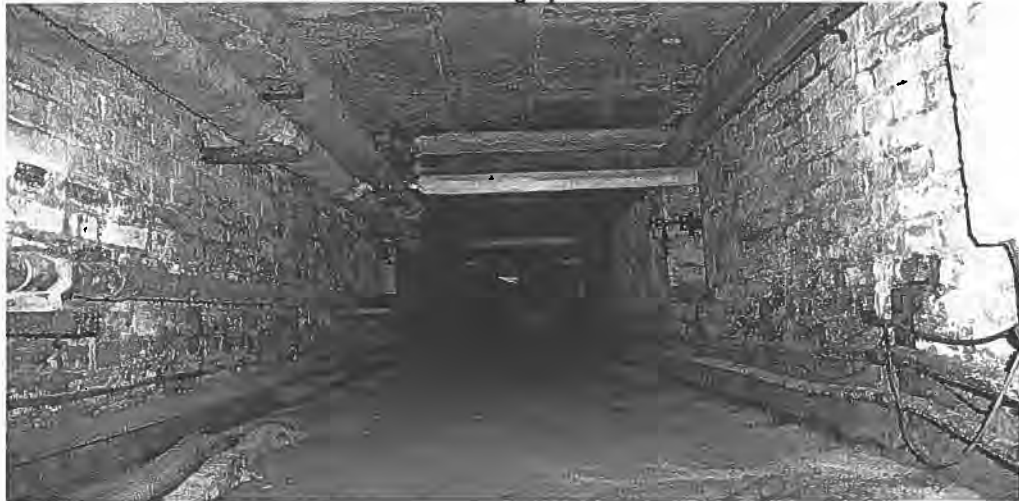
| <b>Location of Survey</b><br>Cane Hill Hospital,<br>Cane Hill,<br>Coulson, Surrey,<br>CR5 3ES | | <b>Position of Sample/Photo</b><br>Main Nurses Block<br>Basement boiler room,<br>Main duct adjacent entrance<br>Pipe lagging, | | <b>Asbestos</b><br><br><b>Type</b> | Yes, Strongly<br>Presumed<br><br>Chrysotile (White) |
| <b>Material</b><br>Lagging<br><b>Type</b> | | <b>Quantity</b><br>40m | | <b>Sample No</b> | As 06/B/8026/204 |

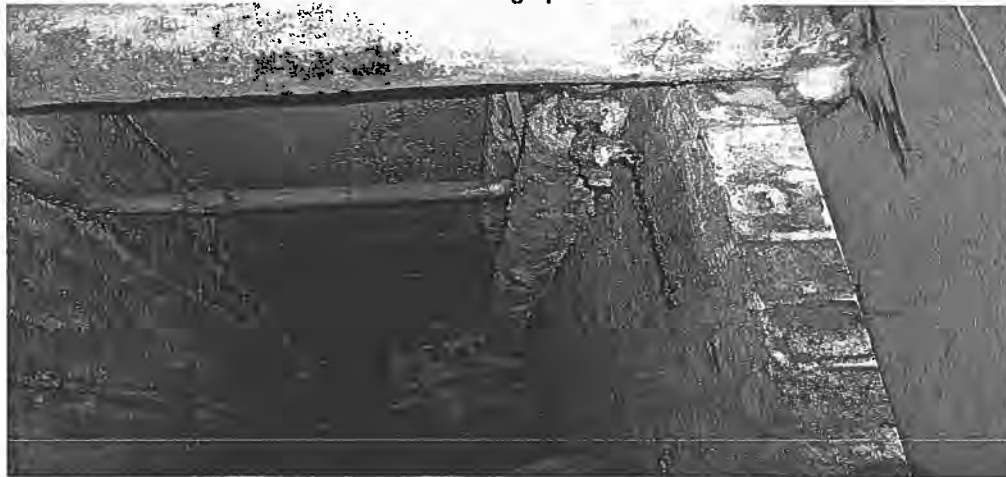
| <b>Location of Survey</b><br>Cane Hill Hospital,<br>Cane Hill,<br>Coulsdon, Surrey,<br>CR5 3ES | | <b>Position of Sample/Photo</b><br>Main Nurses Block<br>Basement boiler room, RHS<br>Under floor duct (X6)<br>Pipe lagging, | | <b>Asbestos</b><br><br><b>Type</b> | Yes, Strongly<br>Presumed<br><br>Chrysotile (White) |
| <b>Material Type</b><br>Lagging | | <b>Quantity</b><br>60m | | <b>Sample No</b> | As 06/B/8026/205 |

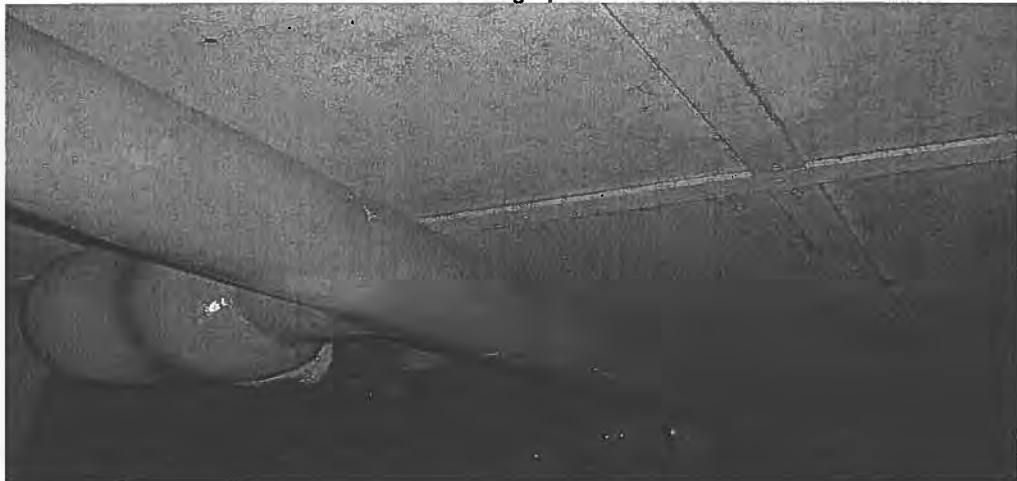
| <b>Location of Survey</b><br><br>Cane Hill Hospital,<br>Cane Hill,<br>Coulsdon, Surrey,<br>CR5 3ES | <b>Position of Sample/Photo</b><br><br>Nurses Block, Middle Annex,<br>Boiler room, Pipe lagging | <table style="width: 100%;"> <tr> <td style="width: 50%;"><b>Asbestos</b></td> <td>Yes</td> </tr> <tr> <td><b>Type</b></td> <td>Chrysotile (White)<br/>Crocidolite (Blue)</td> </tr> </table> | <b>Asbestos</b> | Yes | <b>Type</b> | Chrysotile (White)<br>Crocidolite (Blue) | | | | |
| <b>Material Type</b> Lagging | <b>Quantity</b> 10m <sup>2</sup> | <table style="width: 100%;"> <tr> <td style="width: 50%;"><b>Sample No</b></td> <td>06/B/8026/227</td> </tr> <tr> <td><b>Survey Date</b></td> <td>24.04 - 29.06.06</td> </tr> <tr> <td><b>Date of Report</b></td> <td>18.08.06</td> </tr> <tr> <td><b>Surveyor(s)</b></td> <td style="background-color: black; color: black;">[REDACTED]</td> </tr> </table> | <b>Sample No</b> | 06/B/8026/227 | <b>Survey Date</b> | 24.04 - 29.06.06 | <b>Date of Report</b> | 18.08.06 | <b>Surveyor(s)</b> | [REDACTED] |

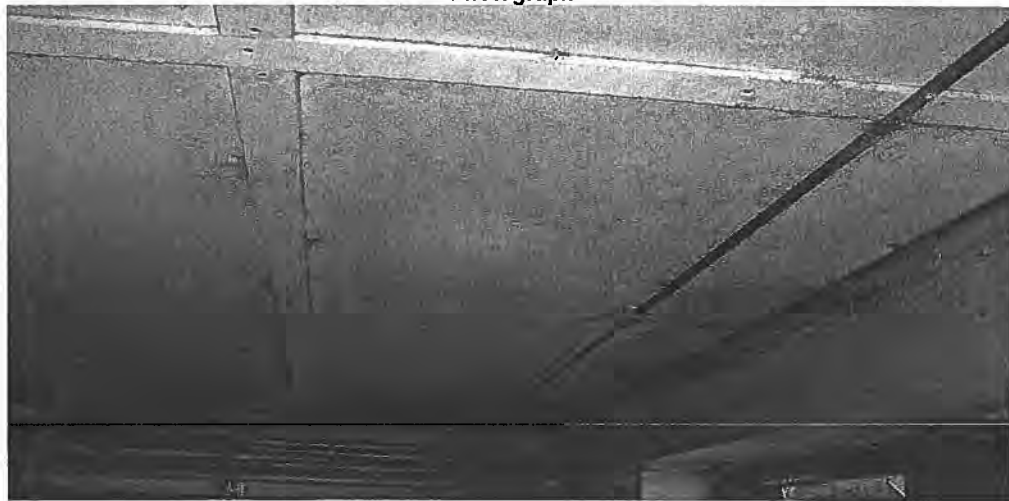
| <b>Location of Survey</b><br>Cane Hill Hospital,<br>Cane Hill,<br>Coulsdon, Surrey,<br>CR5 3ES | <b>Position of Sample/Photo</b><br>Nurses Block, Middle Annex,<br>Boiler room, Ceiling panels | <b>Asbestos</b><br><br><b>Type</b> | Yes, Strongly<br>Presumed<br><br>Amosite (Brown) |
| <b>Material Type</b><br>Board | <b>Quantity</b><br>8m <sup>2</sup> | <b>Sample No</b><br>As 06/B/8026/196<br><br><b>Survey Date</b><br>24.04 - 29.06.06<br><br><b>Date of Report</b><br>18.08.06<br><br><b>Surveyor(s)</b> | As 06/B/8026/196<br><br>24.04 - 29.06.06<br><br>18.08.06<br><br><div style="background-color: black; width: 100px; height: 40px;"></div> |

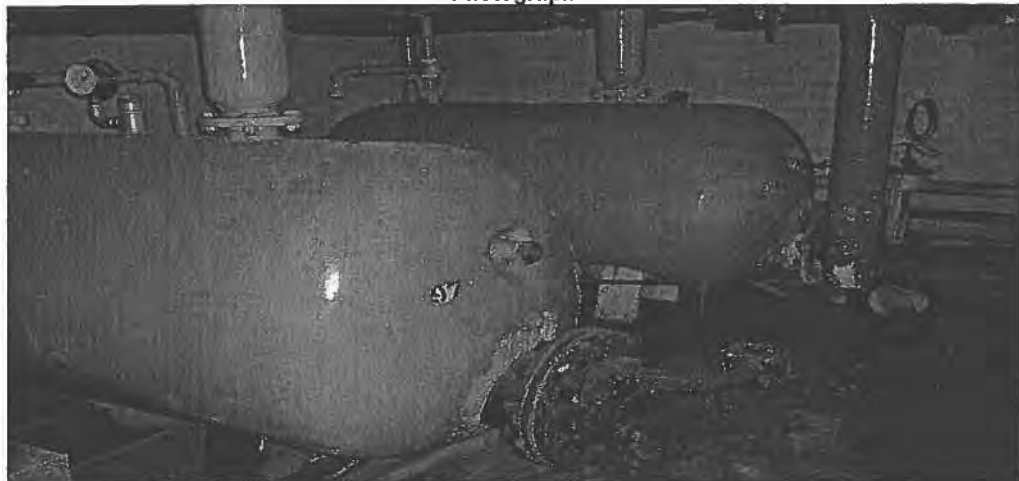
| <b>Location of Survey</b><br>Cane Hill Hospital,<br>Cane Hill,<br>Coulston, Surrey,<br>CR5 3ES | | <b>Position of Sample/Photo</b><br>Nurses Block, Middle Annex,<br>Boiler Room, Tank lagging | | <b>Asbestos</b><br><br><b>Type</b> | Yes, Strongly<br>Presumed<br><br>Chrysotile (White)<br>Crocidolite (Blue) |
| <b>Material Type</b> | Lagging | <b>Quantity</b> | 20m | <b>Sample No</b> | As 06/B/8026/200 |

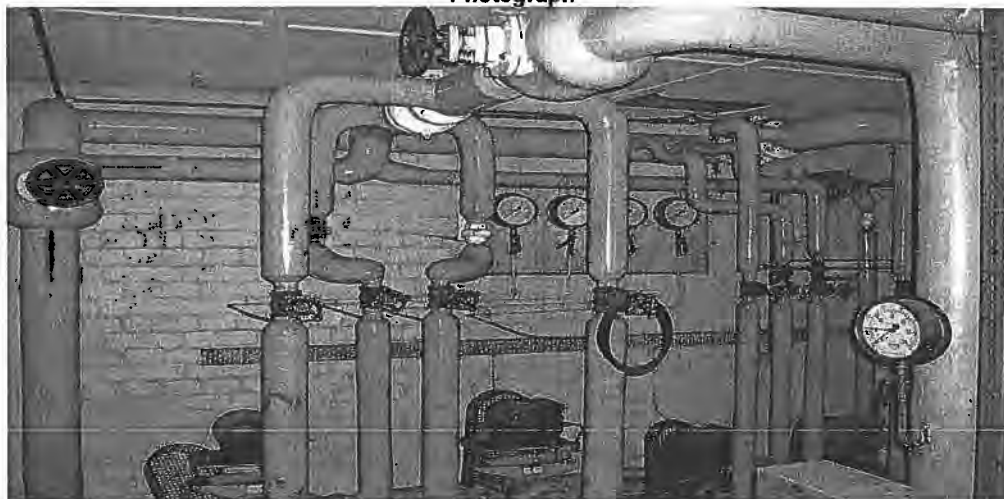
| <b>Location of Survey</b><br>Cane Hill Hospital,<br>Cane Hill,<br>Coulsdon, Surrey,<br>CR5 3ES | | <b>Position of Sample/Photo</b><br>Nurses Block, Middle Annex,<br>Boiler Room, Pipe lagging | | <b>Asbestos</b><br><br><b>Type</b> | Yes, Strongly<br>Presumed<br><br>Chrysotile (White)<br>Crocidolite (Blue) |
| <b>Material Type</b> | Lagging | <b>Quantity</b> | 20m | <b>Sample No</b> | As 06/B/8026/227 |

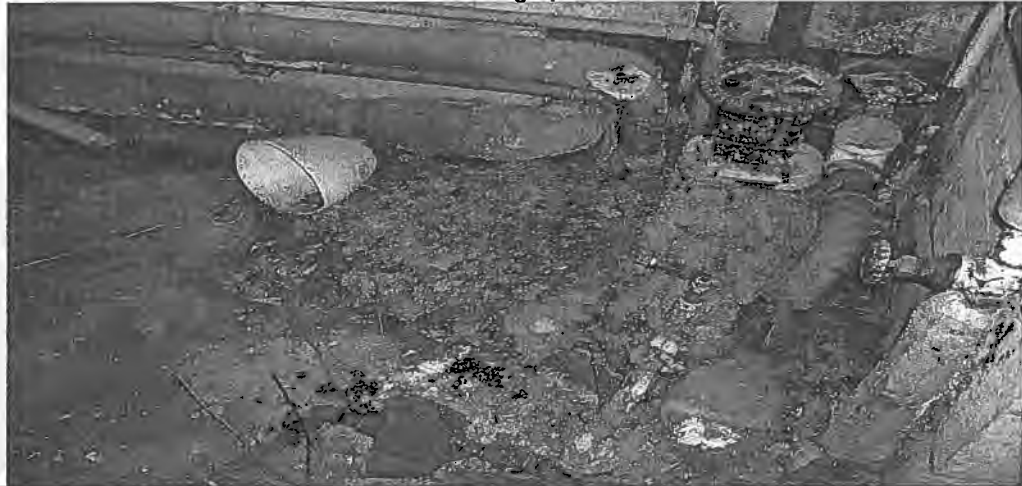
| <b>Location of Survey</b><br>Cane Hill Hospital,<br>Cane Hill,<br>Coulston, Surrey,<br>CR5 3ES | | <b>Position of Sample/Photo</b><br>Nurses Block, Middle Annex,<br>Boiler Room,<br>Pipe lagging debris | | <b>Asbestos</b><br><br><b>Type</b> | Yes, Strongly<br>Presumed<br><br>Chrysotile (White)<br>Crocidolite (Blue) |
| <b>Material Type</b><br>Lagging | | <b>Quantity</b><br><1m <sup>2</sup> | | <b>Sample No</b> | As 06/B/8026/200 |

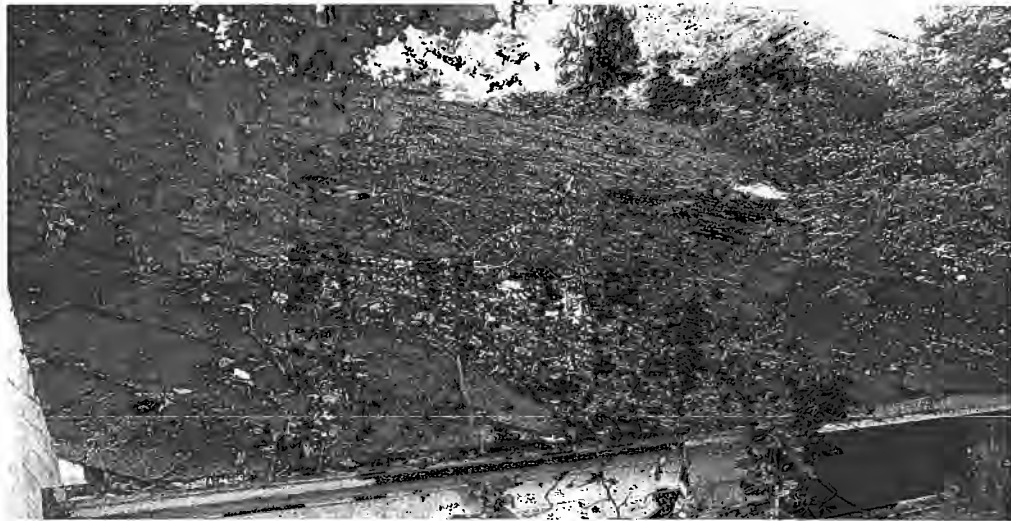
| <b>Location of Survey</b><br>Cane Hill Hospital,<br>Cane Hill,<br>Coulston, Surrey,<br>CR5 3ES | | <b>Position of Sample/Photo</b><br>Shed adjacent Main Nurses<br>Block<br>Roof tiles | | <b>Asbestos</b> Yes |
| <b>Material Type</b> Cement | | <b>Quantity</b> 60m <sup>2</sup> | | <b>Type</b> Chrysotile (White) |

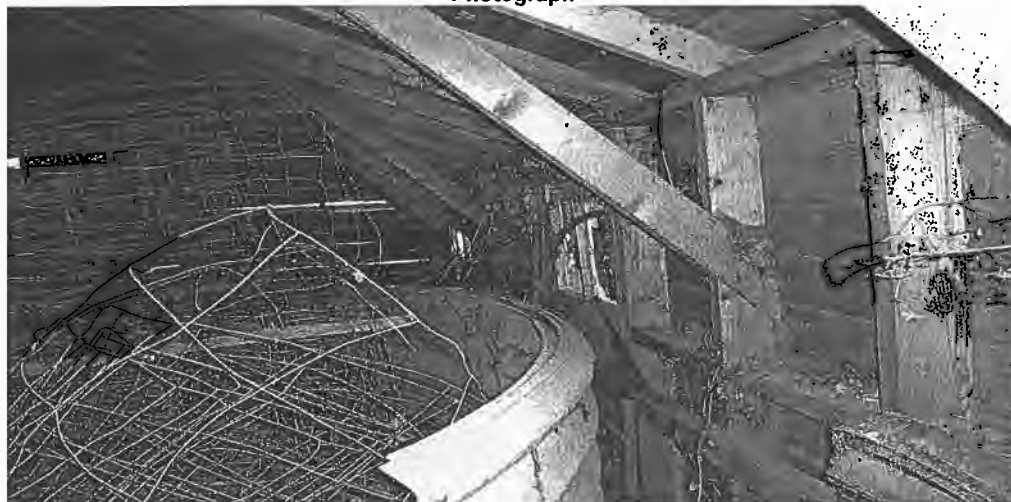
| <b>Location of Survey</b><br>Cane Hill Hospital,<br>Cane Hill,<br>Coulston, Surrey,<br>CR5 3ES | | <b>Position of Sample/Photo</b><br>Shed adjacent Main Nurses<br>Block<br>Redundant roof sheet | | <b>Asbestos</b><br><br><b>Type</b> | Yes, Strongly<br>Presumed<br><br>Chrysotile (White) |
| <b>Material Type</b> | Cement | <b>Quantity</b> | 1m <sup>2</sup> | <b>Sample No</b> | As 06/B/8026/126 |

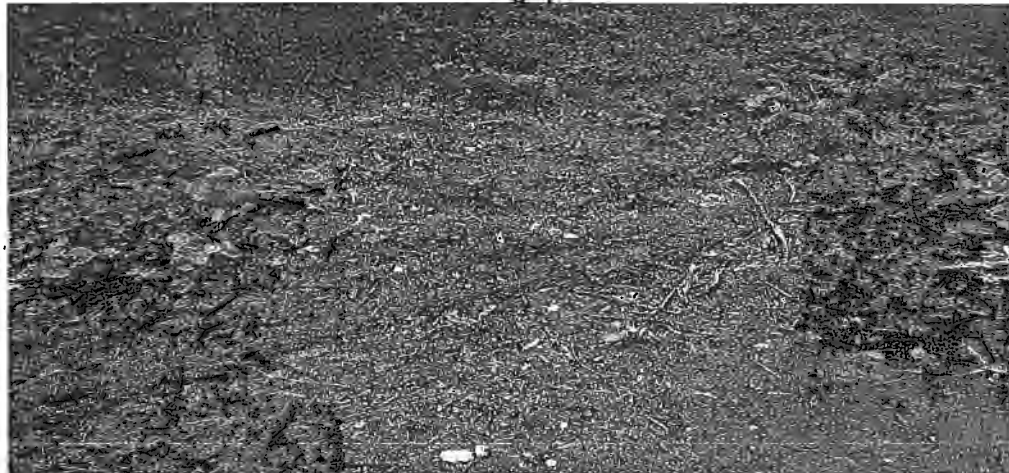
| <b>Location of Survey</b><br>Cane Hill Hospital,<br>Cane Hill,<br>Coulston, Surrey,<br>CR5 3ES | | <b>Position of Sample/Photo</b><br>Shed adjacent Main Nurses<br>Block,<br>AIB debris on ground by<br>(throughout area) | <b>Asbestos</b> Yes |
| <b>Material Type</b> Board | | <b>Quantity</b> <1m <sup>2</sup> | <b>Type</b> Amosite (Brown) |

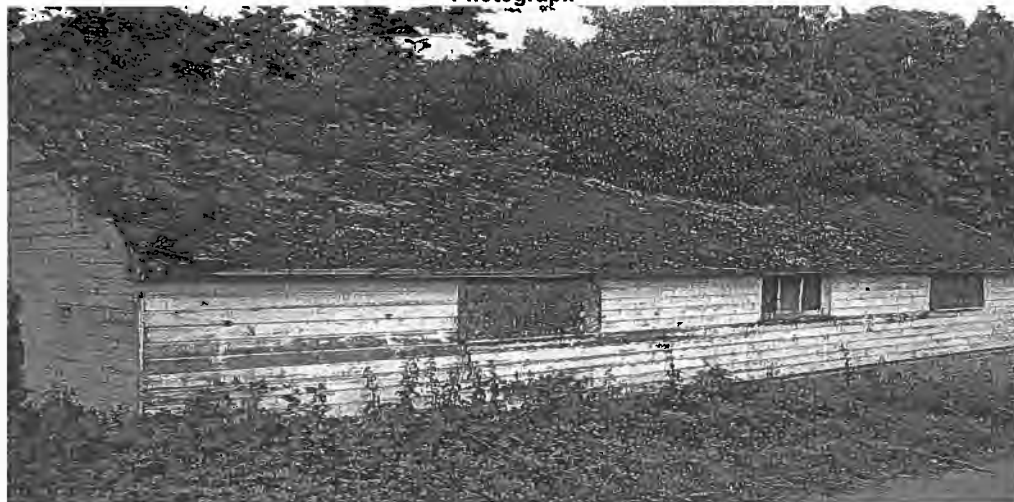
| <b>Location of Survey</b><br>Cane Hill Hospital,<br>Cane Hill,<br>Coulston, Surrey,<br>CR5 3ES | | <b>Position of Sample/Photo</b><br>Shed adjacent Main Nurses<br>Block,<br>Roof tiles | | <b>Asbestos</b><br><br><b>Type</b> | Yes, Strongly<br>Presumed<br><br>Chrysotile (White) |
| <b>Material Type</b> | Cement | <b>Quantity</b> | 60m <sup>2</sup> | <b>Sample No</b> | As 06/B/8026/205 |

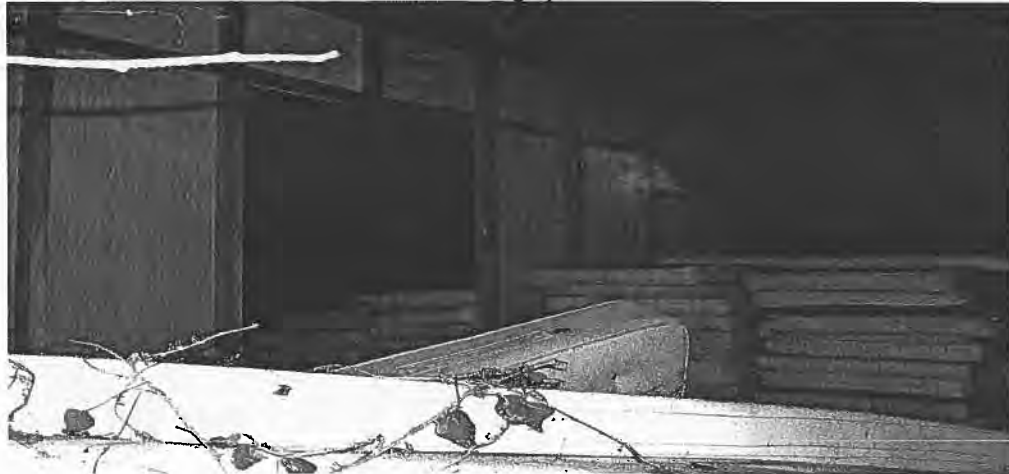
| <b>Location of Survey</b><br>Cane Hill Hospital,<br>Cane Hill,<br>Coulsdon, Surrey,<br>CR5 3ES | | <b>Position of Sample/Photo</b><br>Shed adjacent Main Nurses<br>Block<br>Partition Panels | | <b>Asbestos</b> | Yes, Strongly<br>Presumed |
| <b>Material Type</b> Board | | <b>Quantity</b> 10m <sup>2</sup> | | <b>Type</b> | Amosite (Brown) |

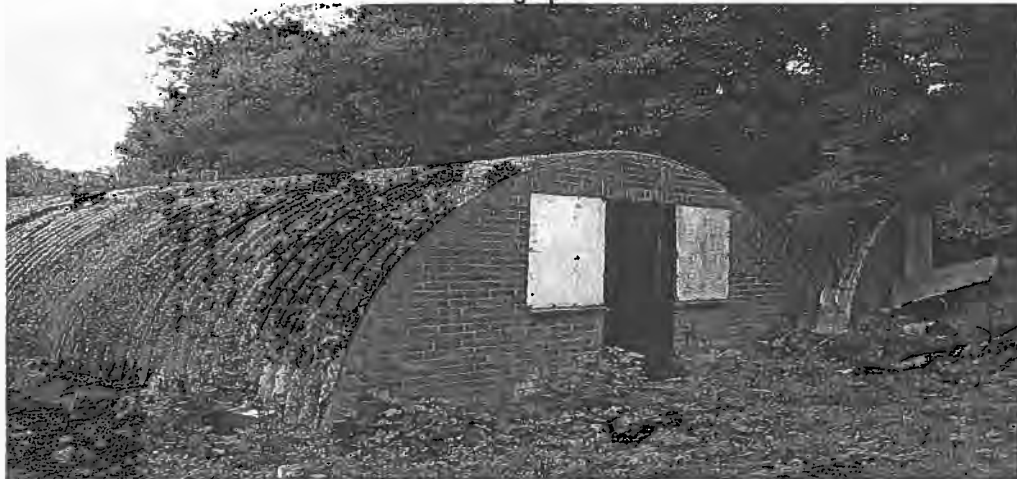
| <b>Location of Survey</b><br>Cane Hill Hospital,<br>Cane Hill,<br>Coulston, Surrey,<br>CR5 3ES | | <b>Position of Sample/Photo</b><br>Garden Stores (X4)<br>Roof | | <b>Asbestos</b><br><br><b>Type</b> | Yes, Strongly<br>Presumed<br><br>Chrysotile (White) |
| <b>Material Type</b><br>Cement | | <b>Quantity</b><br>40m <sup>2</sup> | | <b>Sample No</b> | As 06/B/8026/126 |

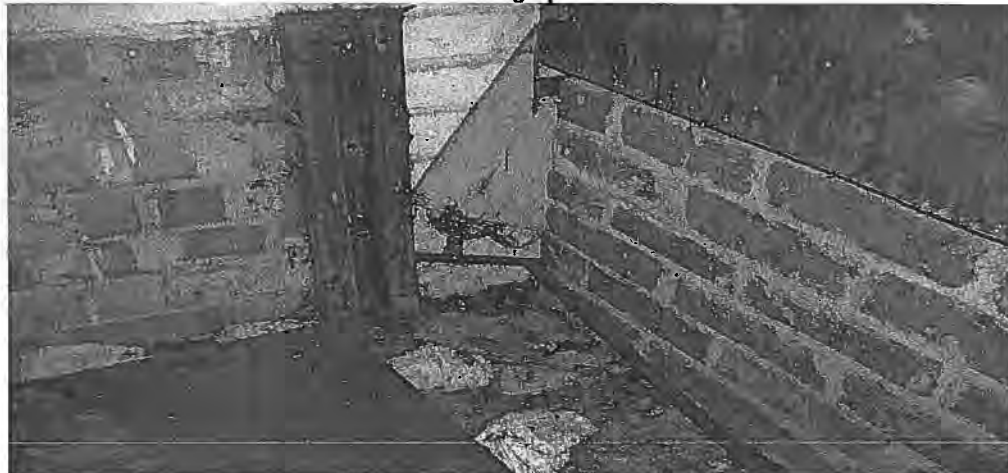
| <b>Location of Survey</b><br>Cane Hill Hospital,<br>Cane Hill,<br>Coulston, Surrey,<br>CR5 3ES | | <b>Position of Sample/Photo</b><br>Garden Store<br>Redundant panel behind tank | <b>Asbestos</b><br><br><b>Type</b> | Yes, Strongly<br>Presumed<br><br>Amosite (Brown) |
| <b>Material Type</b> | Board | <b>Quantity</b> | 1m <sup>2</sup> | <b>Sample No</b> As 06/B/8026/198<br><br><b>Survey Date</b> 24.04 - 29.06.06<br><br><b>Date of Report</b> 18.08.06<br><br><b>Surveyor(s)</b> <span style="background-color: black; color: black;">[REDACTED]</span> |

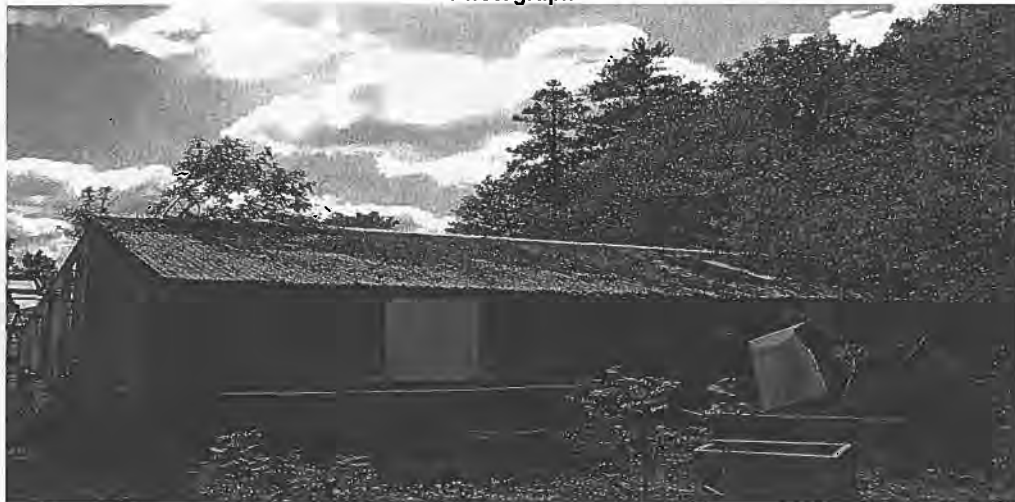
| <b>Location of Survey</b><br>Cane Hill Hospital,<br>Cane Hill,<br>Coulsdon, Surrey,<br>CR5 3ES | | <b>Position of Sample/Photo</b><br>Garden Outbuildings<br>Corrugated Roof Sheet | <b>Asbestos</b><br><br><b>Type</b> | Yes, Strongly<br>Presumed<br><br>Chrysotile (White) |
| <b>Material Type</b> | Cement | <b>Quantity</b> | 40m <sup>2</sup> | <b>Sample No</b> As 06/B/8026/126<br><br><b>Survey Date</b> 24.04 - 29.06.06<br><br><b>Date of Report</b> 18.08.06<br><b>Surveyor(s)</b> [REDACTED] |

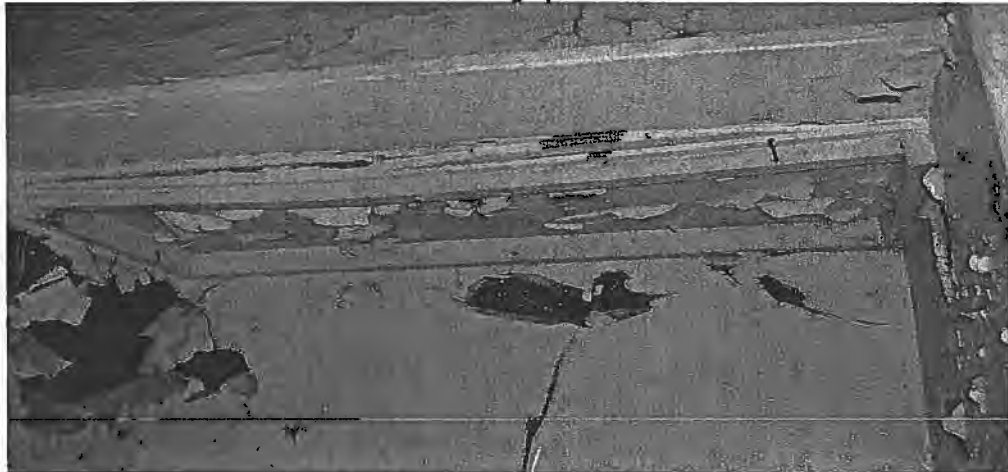
| <b>Location of Survey</b><br>Cane Hill Hospital,<br>Cane Hill,<br>Coulston, Surrey,<br>CR5 3ES | | <b>Position of Sample/Photo</b><br>Gardeners Cottage<br>Fireplace board | <b>Asbestos</b><br><br><b>Type</b> | <b>Yes, Strongly Presumed</b><br><br>Amosite (Brown) |
| <b>Material Type</b> | Board | <b>Quantity</b> | <b>Sample No</b> | As 06/B/8026/198 |

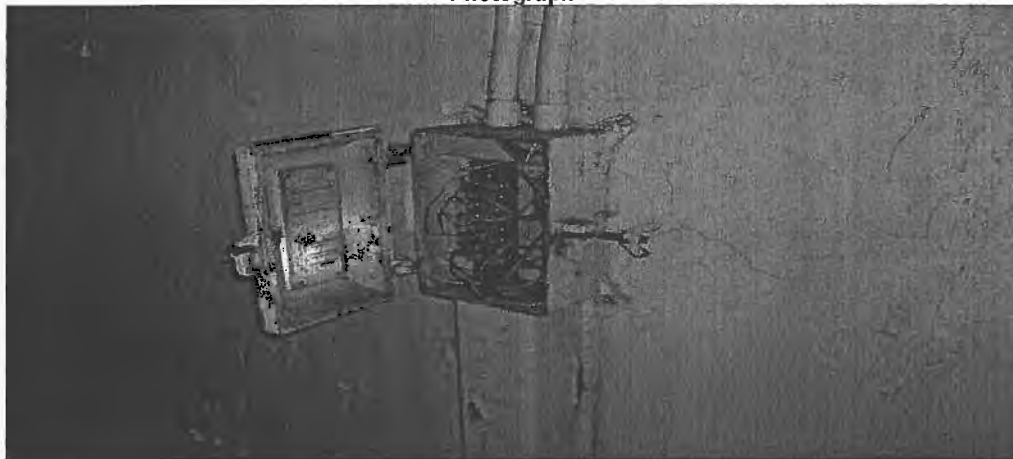
| <b>Location of Survey</b><br>Cane Hill Hospital,<br>Cane Hill,<br>Coulston, Surrey,<br>CR5 3ES | | <b>Position of Sample/Photo</b><br>Gardeners Cottage<br>Electrics | | <b>Asbestos</b><br><br><b>Type</b> | Yes, Strongly<br>Presumed<br><br>Chrysotile (White) |
| <b>Material Type</b> | Rope | <b>Quantity</b> | 1m | <b>Sample No</b> | As 06/B/8026/22 |

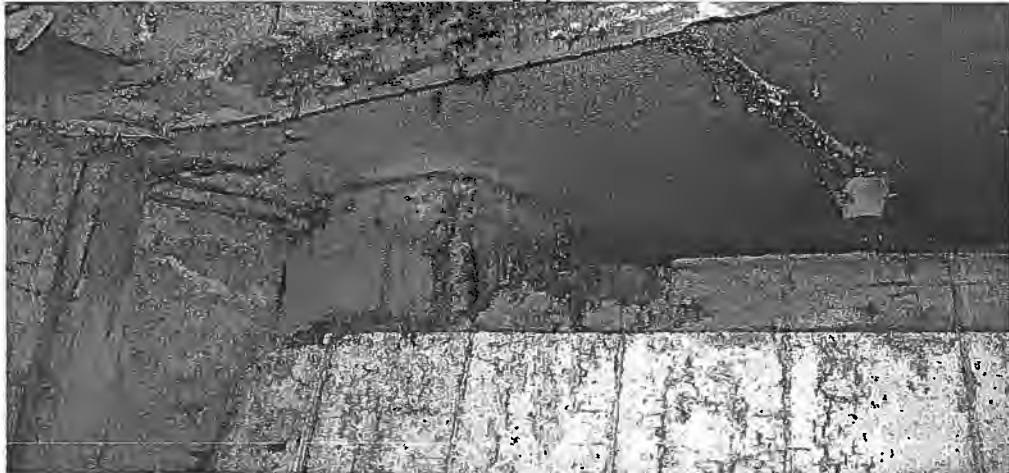
| <b>Location of Survey</b><br>Cane Hill Hospital,<br>Cane Hill,<br>Coulston, Surrey,<br>CR5 3ES | | <b>Position of Sample/Photo</b><br>Gardeners Cottage<br>Under stairs Electrics | | <b>Asbestos</b><br><br><b>Type</b> | Yes, Strongly<br>Presumed<br><br>Chrysotile (White) |
| <b>Material Type</b> | Rope | <b>Quantity</b> | 1m | <b>Sample No</b> | As 06/B/8026/22 |

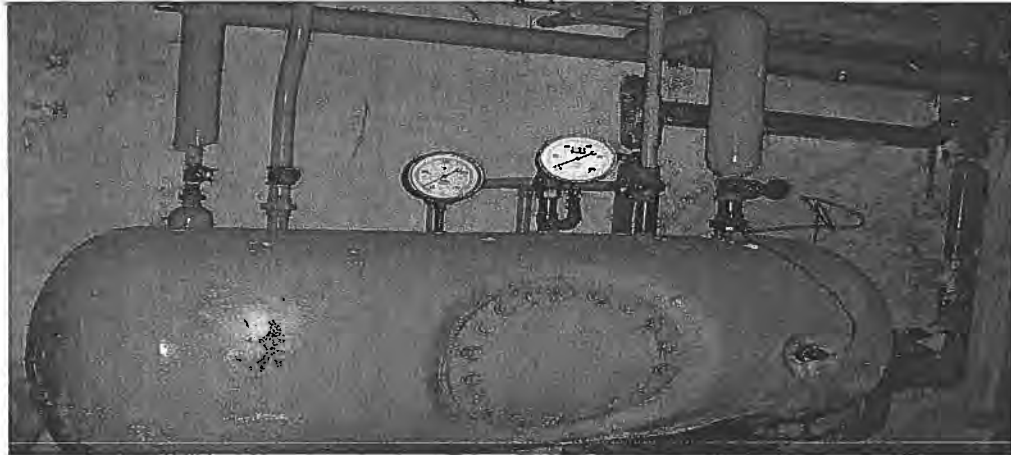
| <b>Location of Survey</b><br>Cane Hill Hospital,<br>Cane Hill,<br>Coulston, Surrey,<br>CR5 3ES | | <b>Position of Sample/Photo</b><br>Gardeners Cottage,<br>Plant Room, Tank lagging | | <b>Asbestos</b> Yes |
| | | | | <b>Type</b> Chrysotile (White)<br>Amosite (Brown) |
| <b>Material Type</b> Lagging | <b>Quantity</b> 10m <sup>2</sup> | <b>Sample No</b> 06/B/8026/207 | | |

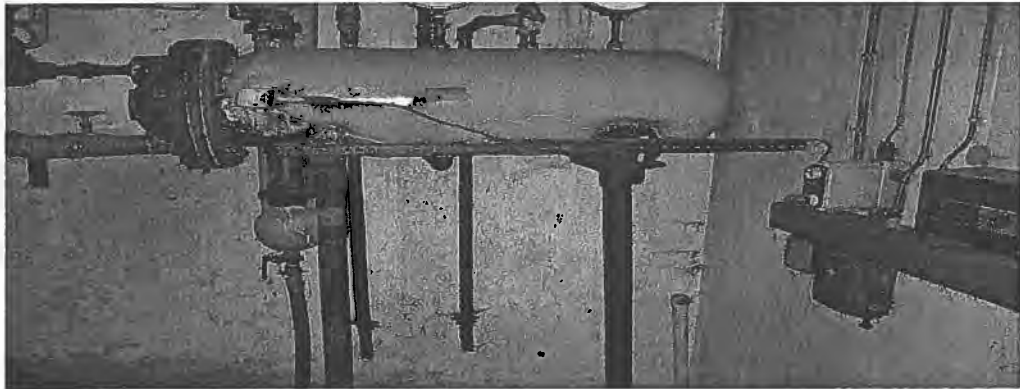
| <b>Location of Survey</b><br><br>Cane Hill Hospital,<br>Cane Hill,<br>Coulsdon, Surrey,<br>CR5 3ES | <b>Position of Sample/Photo</b><br><br>Gardeners Cottage,<br>Plant Room, Pipe lagging | <b>Asbestos</b> Yes<br><br><b>Type</b> Chrysotile (White)<br>Amosite (Brown) |
| <b>Material Type</b> Lagging | <b>Quantity</b> 2m <sup>2</sup> | <b>Sample No</b> 06/B/8026/207<br><br><b>Survey Date</b> 24.04 - 29.06.06<br><br><b>Date of Report</b> 18.08.06<br><br><b>Surveyor(s)</b> <span style="background-color: black; color: black;">[REDACTED]</span> |

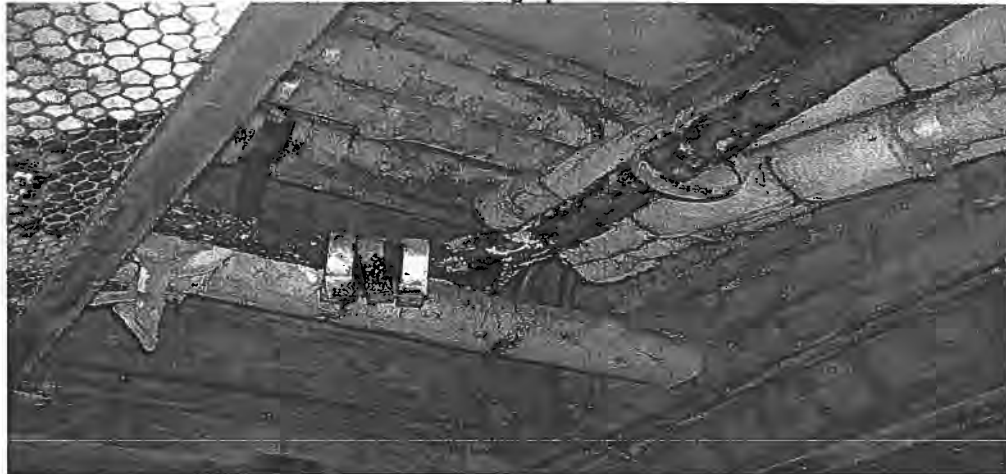
| <b>Location of Survey</b><br>Cane Hill Hospital,<br>Cane Hill,<br>Coulston, Surrey,<br>CR5 3ES | | <b>Position of Sample/Photo</b><br>Pipe Residue, Courtyard<br>corridor, Gardeners Cottage | | <b>Asbestos</b><br><br><b>Type</b> | None Detected<br><br>N/A |
| <b>Material Type</b> | Lagging | <b>Quantity</b> | 10m | <b>Sample No</b> | 06/B/8026/208 |

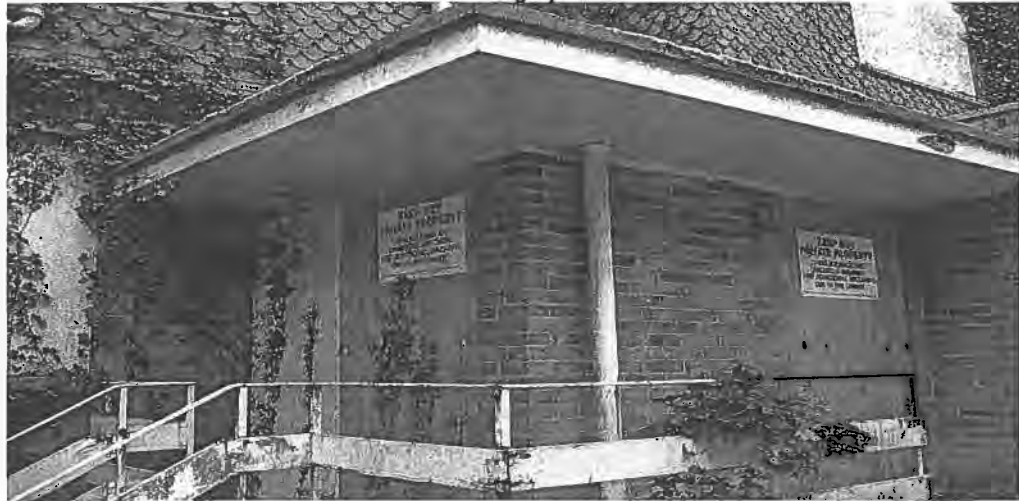
| <b>Location of Survey</b><br>Cane Hill Hospital,<br>Cane Hill,<br>Coulsdon, Surrey,<br>CR5 3ES | <b>Position of Sample/Photo</b><br>North Lodge<br>External porch panels | <b>Asbestos</b> Yes, Strongly Presumed<br><br><b>Type</b> Chrysotile (White) |
| <b>Material Type</b> Cement | <b>Quantity</b> 2m | <b>Sample No</b> As 06/B/8026/195<br><br><b>Survey Date</b> 24.04 - 29.06.06<br><br><b>Date of Report</b> 18.08.06<br><br><b>Surveyor(s)</b> <span style="background-color: black; color: black;">[REDACTED]</span> |

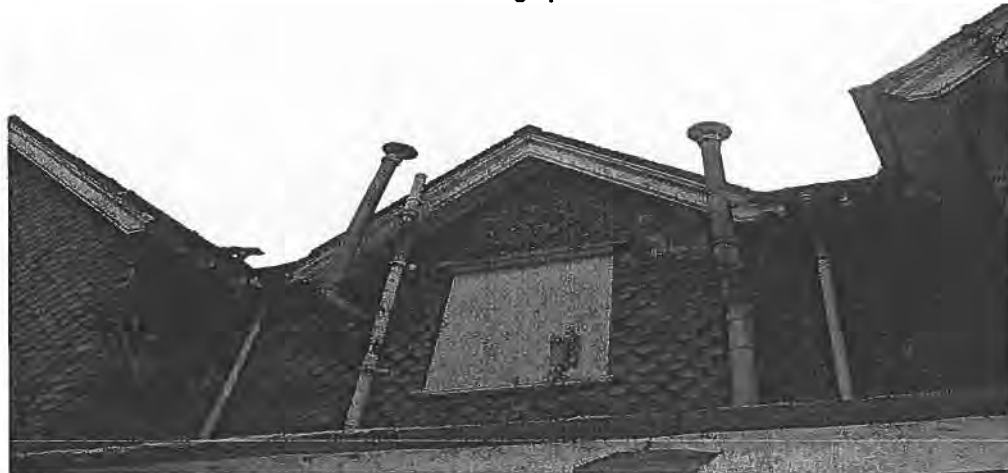
| <b>Location of Survey</b><br>Cane Hill Hospital,<br>Cane Hill,<br>Coulsdon, Surrey,<br>CR5 3ES | | <b>Position of Sample/Photo</b><br>North Lodge<br>External Flue pipes (X3) | | <b>Asbestos</b><br><br><b>Type</b> | Yes, Strongly<br>Presumed<br><br>Chrysotile (White) |
| <b>Material Type</b> | Cement | <b>Quantity</b> | 3m | <b>Sample No</b> | As 06/B/8026/154 |

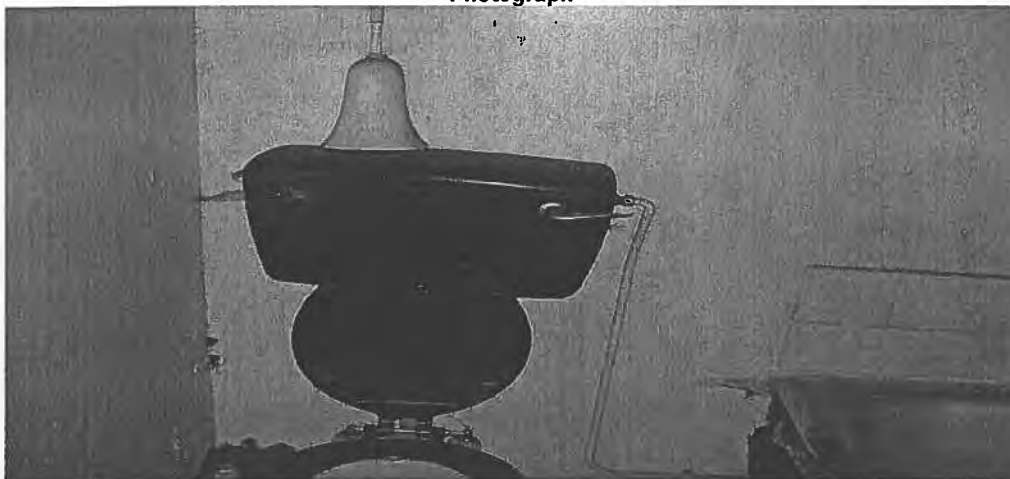
| <b>Location of Survey</b><br>Cane Hill Hospital,<br>Cane Hill,<br>Coulsdon, Surrey,<br>CR5 3ES | | <b>Position of Sample/Photo</b><br>North Lodge<br>W.C. Cistern | | <b>Asbestos</b><br><br><b>Type</b> | Yes, Strongly<br>Presumed<br><br>Amosite (Brown)) |
| <b>Material Type</b> | Plastic | <b>Quantity</b> | 1m <sup>2</sup> | <b>Sample No</b> | As 06/B/8026/5 |

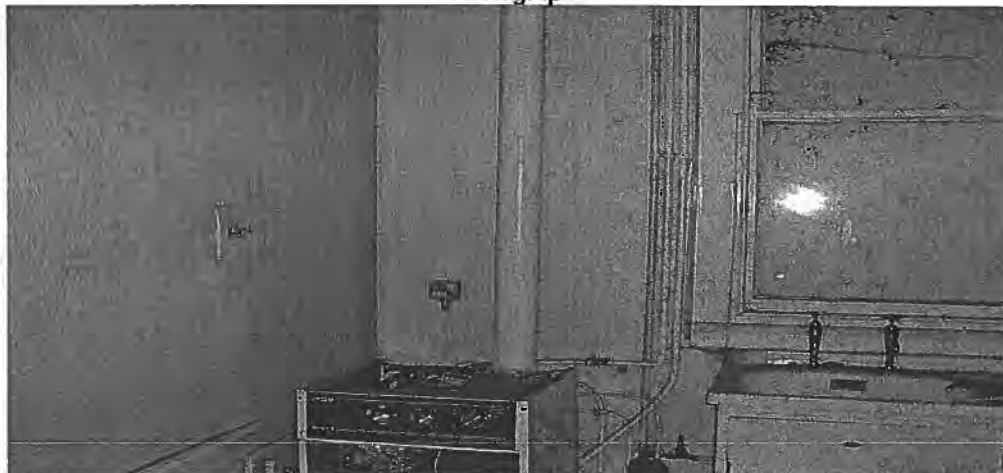
| <b>Location of Survey</b><br>Cane Hill Hospital,<br>Cane Hill,<br>Coulsdon, Surrey,<br>CR5 3ES | <b>Position of Sample/Photo</b><br>North Lodge<br>Ground Floor<br>Kitchen Boiler Flue pipe | <b>Asbestos</b><br><br><b>Type</b> | Yes, Strongly Presumed<br><br>Chrysotile (White) |
| <b>Material Type</b><br>Cement | <b>Quantity</b><br>1m | <b>Sample No</b><br>As 06/B/8026/154<br><br><b>Survey Date</b><br>24.04 - 29.06.06<br><br><b>Date of Report</b><br>18.08.06<br><br><b>Surveyor(s)</b> <div style="background-color: black; width: 100px; height: 40px; display: inline-block;"></div> | |

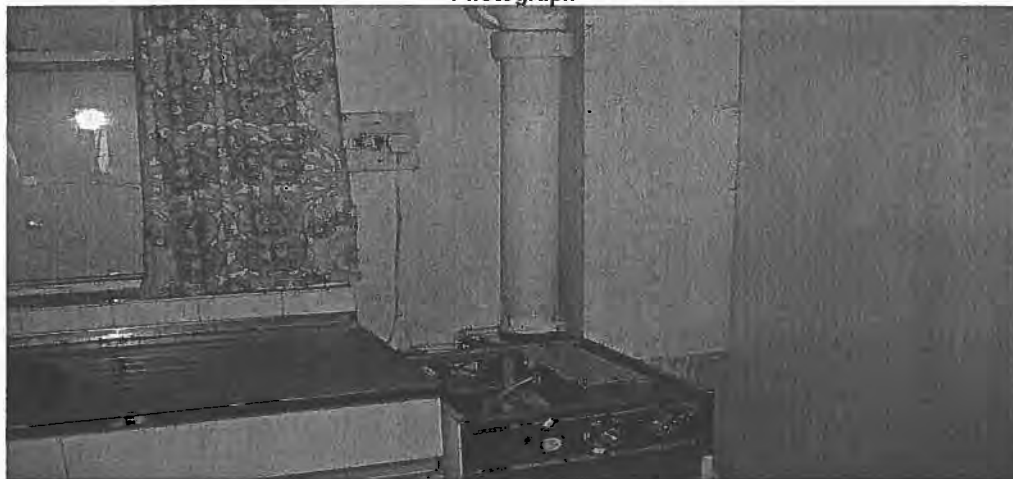
| <b>Location of Survey</b><br>Cane Hill Hospital,<br>Cane Hill,<br>Coulston, Surrey,<br>CR5 3ES | | <b>Position of Sample/Photo</b><br>North Lodge<br>First Floor<br>Kitchen Boiler Flue pipe | | <b>Asbestos</b><br><br><b>Type</b> | <b>Yes, Strongly Presumed</b><br><br>Chrysotile (White) |
| <b>Material Type</b> | Cement | <b>Quantity</b> | 1m | <b>Sample No</b> | As 06/B/8026/154 |

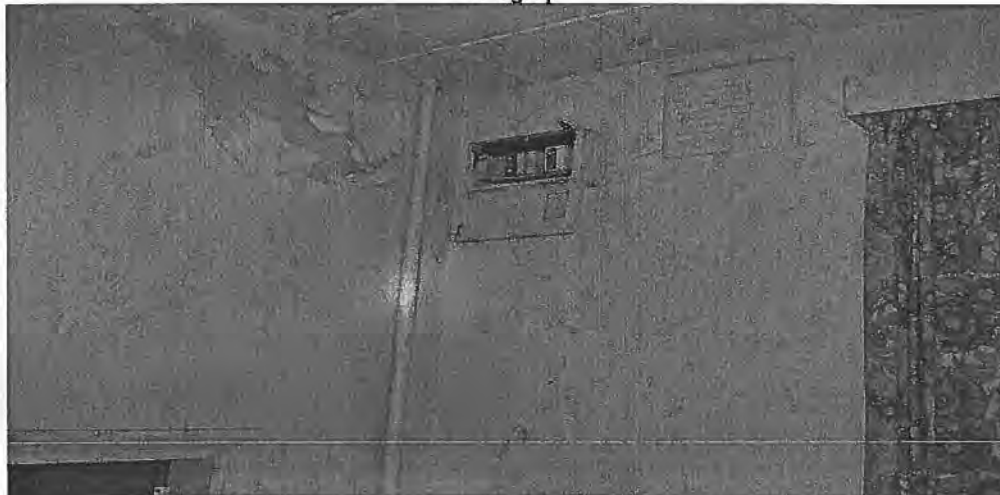
| <b>Location of Survey</b><br>Cane Hill Hospital,<br>Cane Hill,<br>Coulston, Surrey,<br>CR5 3ES | | <b>Position of Sample/Photo</b><br>North Lodge<br>First Floor<br>Kitchen electrics | | <b>Asbestos</b><br><br><b>Type</b> | Yes, Strongly<br>Presumed<br><br>Chrysotile (White) |
| <b>Material Type</b> | Rope | <b>Quantity</b> | 1m | <b>Sample No</b> | As 06/B/8026/9 |

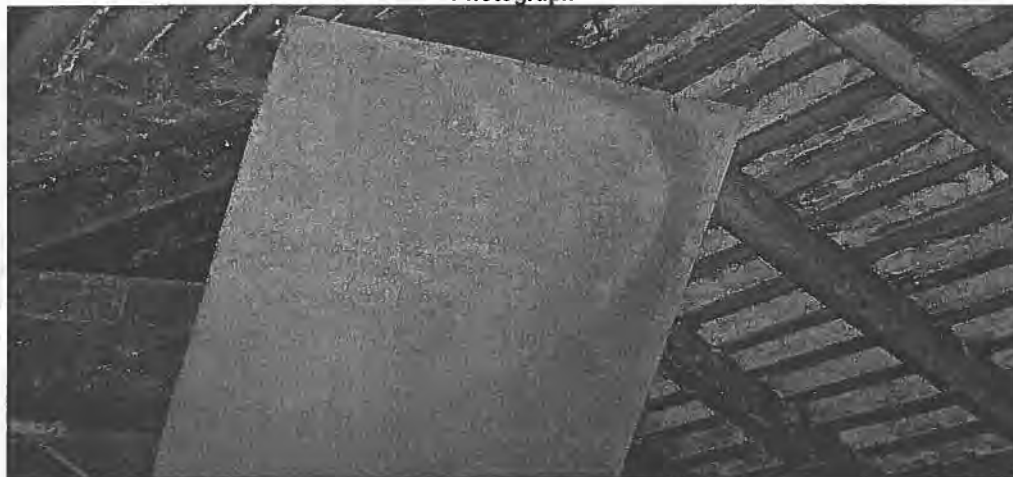
| <b>Location of Survey</b><br>Cane Hill Hospital,<br>Cane Hill,<br>Coulsdon, Surrey,<br>CR5 3ES | <b>Position of Sample/Photo</b><br>North Lodge<br>Loft<br>Redundant panels | <b>Asbestos</b><br><br><b>Type</b> | Yes, Strongly<br>Presumed<br><br>Amosite (Brown) |
| <b>Material Type</b> Board | <b>Quantity</b> 1m <sup>2</sup> | <b>Sample No</b><br><br><b>Survey Date</b><br><br><b>Date of Report</b><br><br><b>Surveyor(s)</b> | As 06/B/8026/224<br><br>24.04 - 29.06.06<br><br>18.08.06<br><br><div style="background-color: black; width: 100px; height: 30px;"></div> |

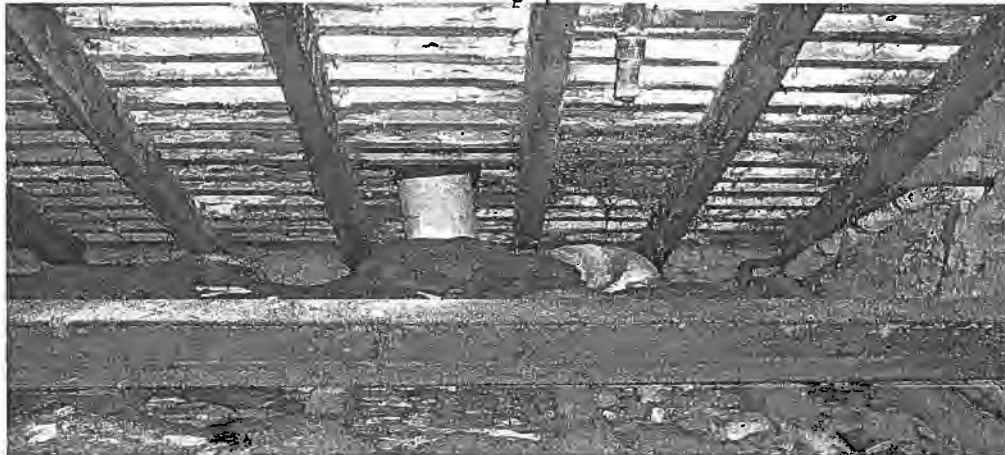
| <b>Location of Survey</b><br>Cane Hill Hospital,<br>Cane Hill,<br>Coulston, Surrey,<br>CR5 3ES | | <b>Position of Sample/Photo</b><br>North Lodge<br>Loft flue pipe | | <b>Asbestos</b><br><br><b>Type</b> | Yes, Strongly<br>Presumed<br><br>Chrysotile (White) |
| <b>Material Type</b> | Cement | <b>Quantity</b> | <1m <sup>2</sup> | <b>Sample No</b> | As 06/B/8026/154 |

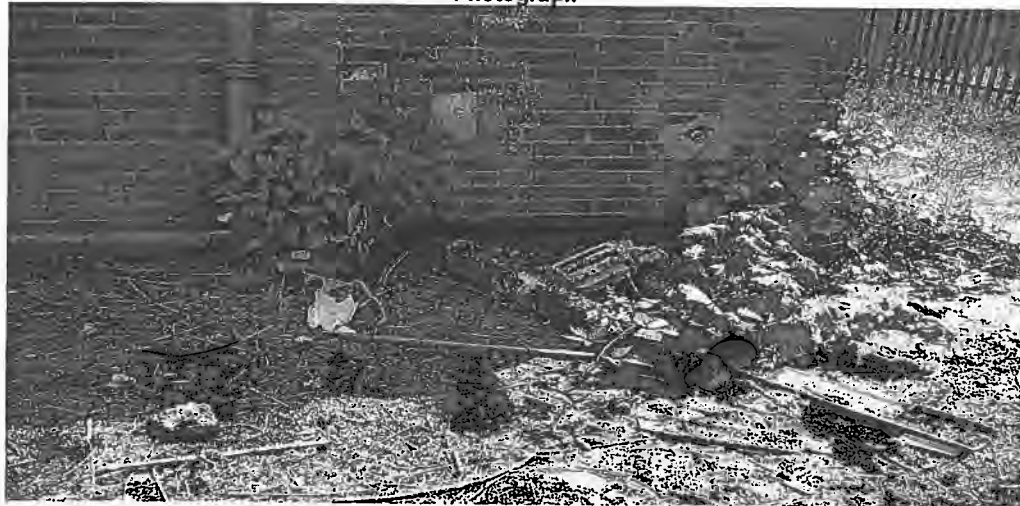
| <b>Location of Survey</b><br>Cane Hill Hospital,<br>Cane Hill,<br>Coulsdon, Surrey,<br>CR5 3ES | <b>Position of Sample/Photo</b><br>North Lodge<br>External<br>Redundant flue pipe | <b>Asbestos</b><br><br><b>Type</b> | Yes, Strongly<br>Presumed<br><br>Chrysotile (White) |
| <b>Material Type</b> Cement | <b>Quantity</b> <1m <sup>2</sup> | <b>Sample No</b> As 06/B/8026/154<br><br><b>Survey Date</b> 24.04 - 29.06.06<br><br><b>Date of Report</b> 18.08.06<br><br><b>Surveyor(s)</b> <span style="background-color: black; color: black;">[REDACTED]</span> | |

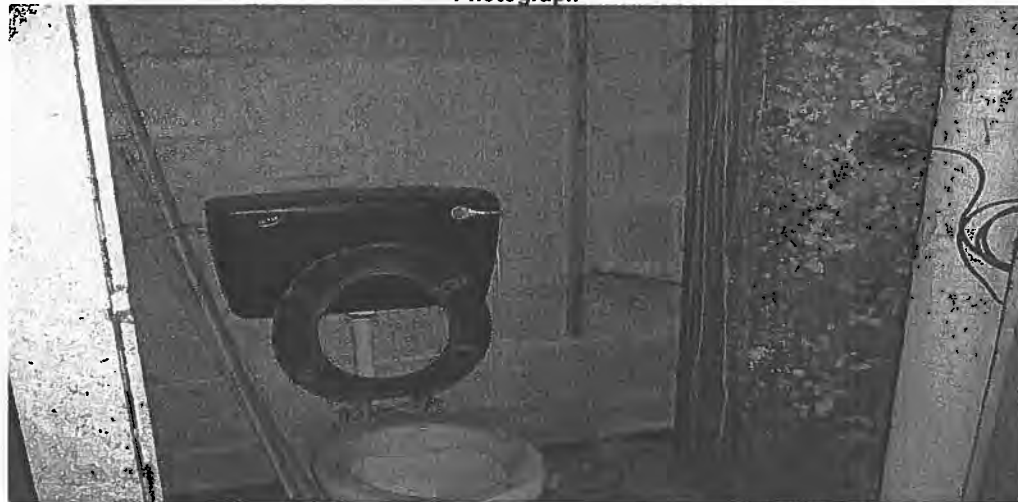
| <b>Location of Survey</b><br>Cane Hill Hospital,<br>Cane Hill,<br>Coulston, Surrey,<br>CR5 3ES | | <b>Position of Sample/Photo</b><br>Swimming Pool<br>Changing Room<br>W.C. Cistern | | <b>Asbestos</b><br><br><b>Type</b> | Yes, Strongly<br>Presumed<br><br>Amosite (Brown) |
| <b>Material Type</b> | Plastic | <b>Quantity</b> | 1m <sup>2</sup> | <b>Sample No</b> | As 06/B/8026/5 |

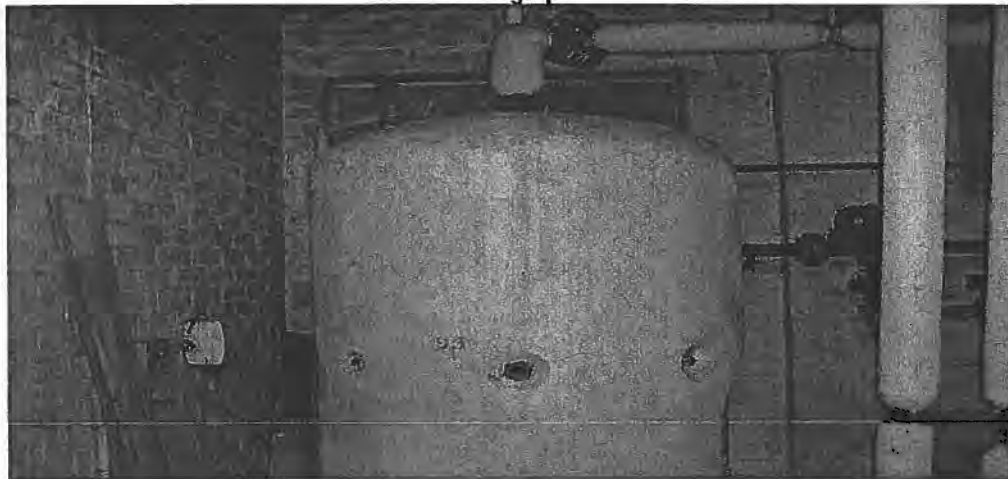
| <b>Location of Survey</b><br>Cane Hill Hospital,<br>Cane Hill,<br>Coulston, Surrey,<br>CR5 3ES | | <b>Position of Sample/Photo</b><br>Nurses Block<br>Remote Plant Room<br>Tank Lagging | | <b>Asbestos</b><br><br><b>Type</b> | Yes, Strongly<br>Presumed<br><br>Chrysotile (White)<br>Amosite (Brown) |
| <b>Material Type</b> | Lagging | <b>Quantity</b> | 10m <sup>2</sup> | <b>Sample No</b> | As 06/B/8026/207 |

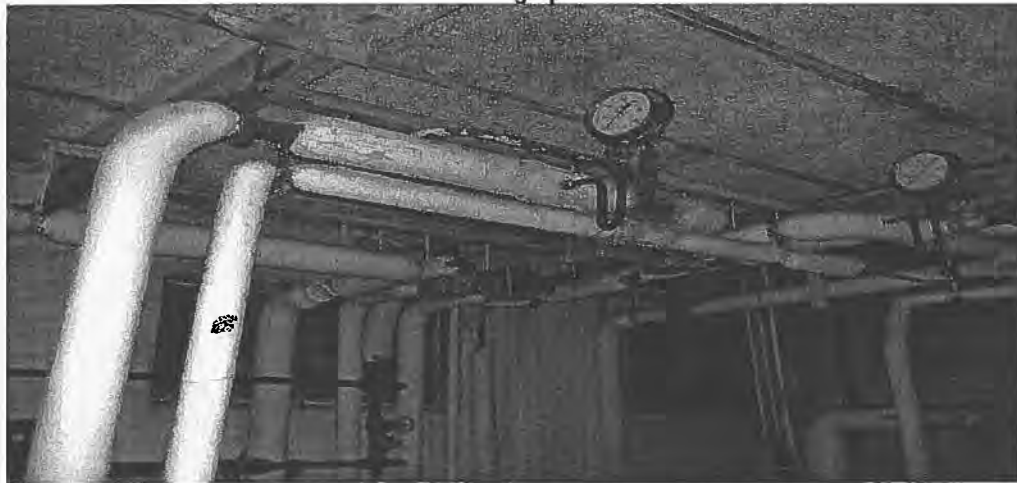
| <b>Location of Survey</b><br>Cane Hill Hospital,<br>Cane Hill,<br>Coulsdon, Surrey,<br>CR5 3ES | | <b>Position of Sample/Photo</b><br>Nurses Block<br>Remote Plant Room<br>Pipe Lagging | | <b>Asbestos</b><br><br><b>Type</b> | Yes, Strongly<br>Presumed<br><br>Chrysotile (White)<br>Amosite (Brown) |
| <b>Material Type</b><br>Lagging | | <b>Quantity</b><br>20m | | <b>Sample No</b> | As 06/B/8026/207 |

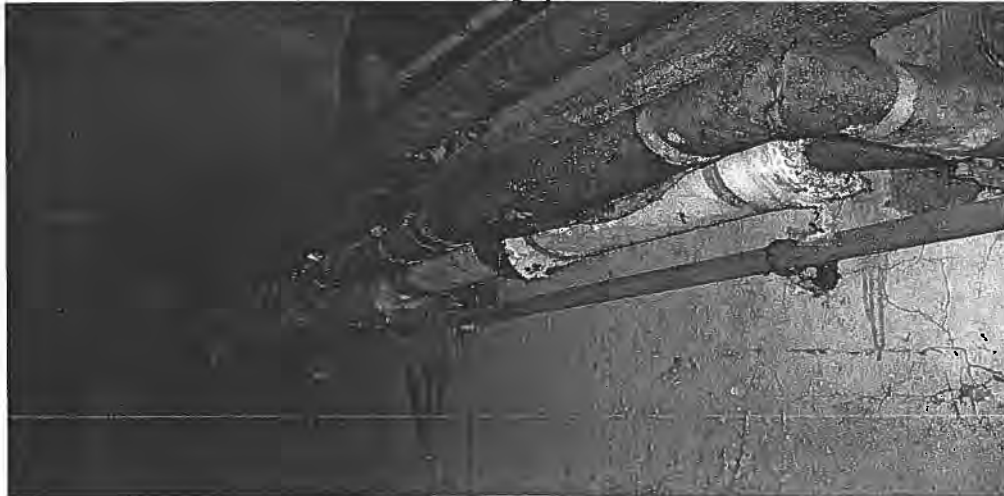
| <b>Location of Survey</b><br>Cane Hill Hospital,<br>Cane Hill,<br>Coulsdon, Surrey,<br>CR5 3ES | <b>Position of Sample/Photo</b><br>Corridor adjacent Main Hall<br>Room under corridor adjacent<br>to Derelict Main Hall<br>Sectional lagging | <b>Asbestos</b> Yes<br><br><b>Type</b> Chrysotile (White)<br>Amosite (Brown) | |
| <b>Material Type</b> Lagging | <b>Quantity</b> 20m | <b>Sample No</b> 06/B/8026/210<br><br><b>Survey Date</b> 24.04 - 29.06.06<br><br><b>Date of Report</b> 18.08.06<br><br><b>Surveyor(s)</b> <span style="background-color: black; color: black;">[REDACTED]</span> | |

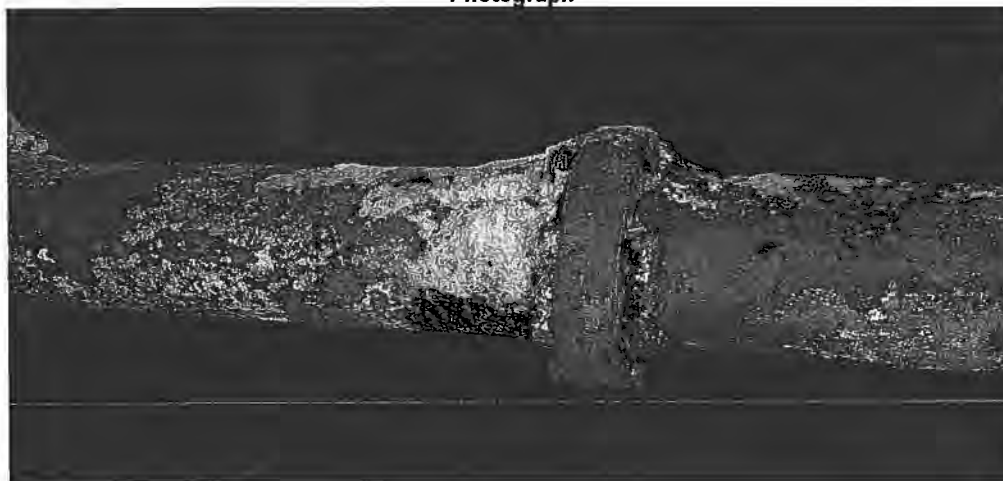
| <b>Location of Survey</b><br>Cane Hill Hospital,<br>Cane Hill,<br>Coulsdon, Surrey,<br>CR5 3ES | <b>Position of Sample/Photo</b><br>Underground Duct under<br>Generator Room adjacent to<br>Main Pipe Room<br>Pipe Lagging debris | <b>Asbestos</b> Yes<br><br><b>Type</b> Chrysotile (White)<br>Amosite (Brown) |
| <b>Material</b> Lagging<br><b>Type</b> | <b>Quantity</b> <1m | <b>Sample No</b> 06/B/8026/211<br><br><b>Survey Date</b> 24.04 - 29.06.06<br><br><b>Date of Report</b> 18.08.06<br><br><b>Surveyor(s)</b> [REDACTED] |

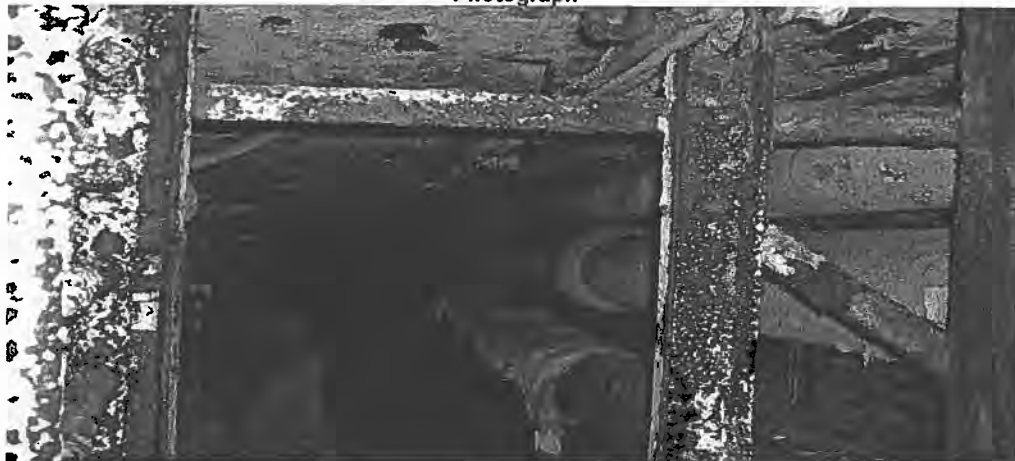
| <b>Location of Survey</b><br>Cane Hill Hospital,<br>Cane Hill,<br>Coulsdon, Surrey,<br>CR5 3ES | | <b>Position of Sample/Photo</b><br>Underground duct<br>Pipe lagging, Duct under<br>Generator Room | | <b>Asbestos</b><br><br><b>Type</b> | Yes, Strongly<br>Presumed<br><br>Chrysotile (White)<br>Amosite (Brown) |
| <b>Material Type</b> | Lagging | <b>Quantity</b> | 200m | <b>Sample No</b> | As 06/B/8026/211 |
