## SURVEY INFORMATION SHEET

| <b>Location of Survey</b><br>Cane Hill Hospital,<br>Cane Hill,<br>Coulsdon, Surrey,<br>CR5 3ES | <b>Position of Sample/Photo</b><br>Workshop Garages<br>External corrugated roof sheet | <b>Asbestos</b><br><br><b>Type</b> | Yes, Strongly Presumed<br><br>Chrysotile (White) |

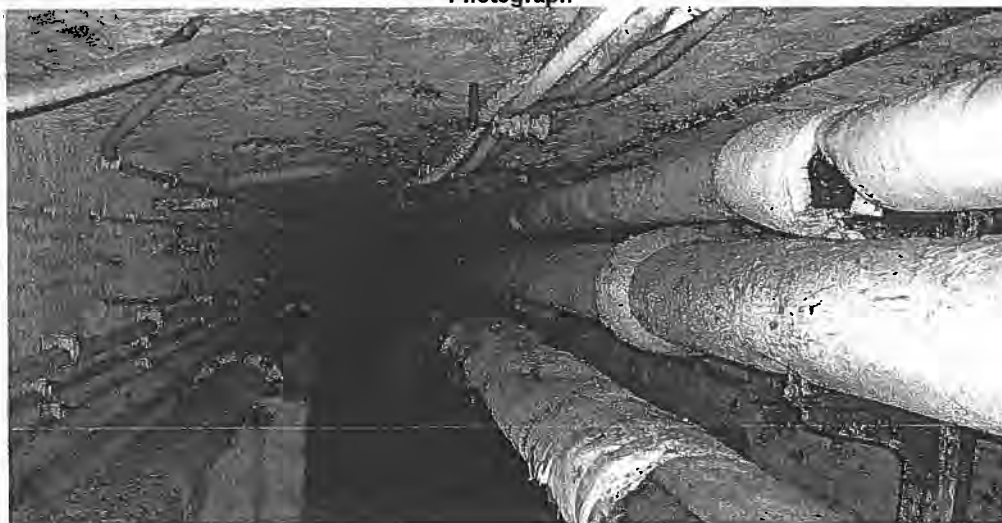
| <b>Location of Survey</b><br>Cane Hill Hospital,<br>Cane Hill,<br>Coulsdon, Surrey,<br>CR5 3ES | <b>Position of Sample/Photo</b><br>Underground duct<br>Sectional Pipe lagging, Duct<br>under generator room leading<br>towards Kitchens | <b>Asbestos</b><br><br><b>Type</b> | Yes, Strongly<br>Presumed<br><br>Amosite (Brown)<br>Chrysotile (White) |
| <b>Material Type</b> Lagging | <b>Quantity</b> 200m | <b>Sample No</b> As 06/B/8026/211<br><br><b>Survey Date</b> 24.04 - 29.06.06<br><br><b>Date of Report</b> 18.08.06<br><br><b>Surveyor(s)</b> <span style="background-color: black; color: black;">[REDACTED]</span> | |

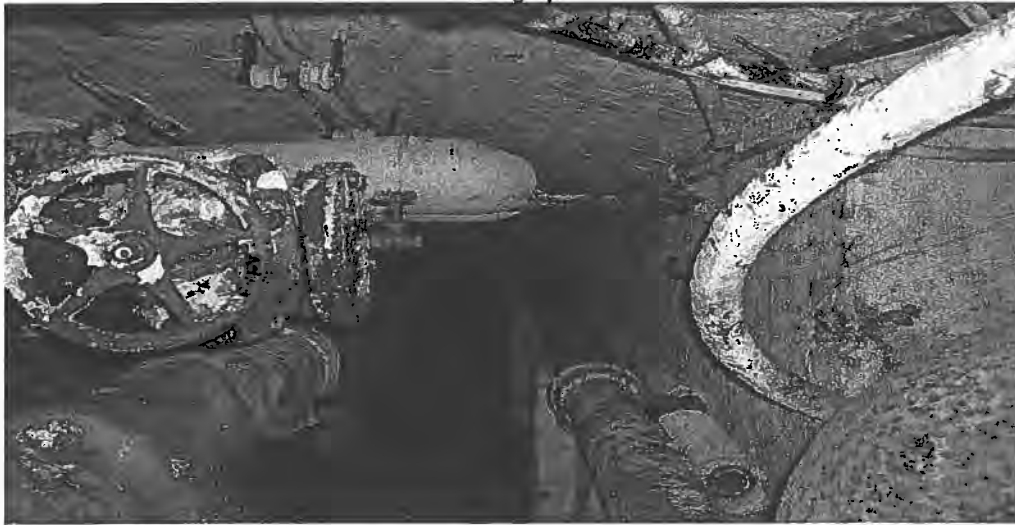
| <b>Location of Survey</b><br><br>Cane Hill Hospital,<br>Cane Hill,<br>Coulsdon, Surrey,<br>CR5 3ES | <b>Position of Sample/Photo</b><br><br>Underground duct<br>Hard set Pipe lagging in<br>Duct adjacent Generator<br>Room | <b>Asbestos</b><br><br>Yes, Strongly<br>Presumed | <b>Type</b><br><br>Chrysotile (White)<br>Amosite (Brown) |
| <b>Material Type</b> Lagging | <b>Quantity</b> 10m <sup>2</sup> | <b>Sample No</b> As 06/B/8026/211<br><br><b>Survey Date</b> 24.04 - 29.06.06<br><br><b>Date of Report</b> 18.08.06<br><br><b>Surveyor(s)</b> <span style="background-color: black; color: black;">[REDACTED]</span> | |

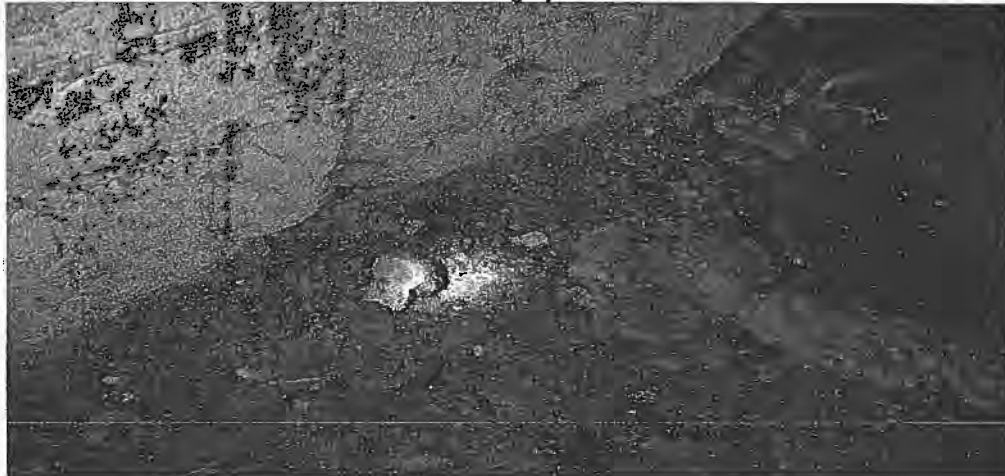
| <b>Location of Survey</b><br>Cane Hill Hospital,<br>Cane Hill,<br>Coulston, Surrey,<br>CR5 3ES | | <b>Position of Sample/Photo</b><br>Underground duct<br>Floor debris, corridor duct<br>adjacent Zachery York Ward | | <b>Asbestos</b> | None Detected |
| <b>Material Type</b><br>Debris | | <b>Quantity</b><br><1m <sup>2</sup> | | <b>Type</b> | N/A |

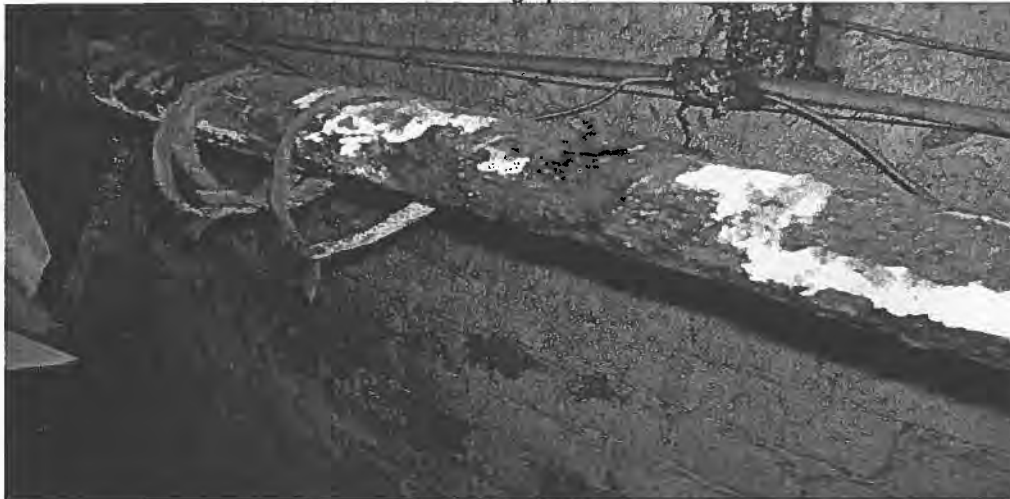
| <b>Location of Survey</b><br><br>Cane Hill Hospital,<br>Cane Hill,<br>Coulsdon, Surrey,<br>CR5 3ES | <b>Position of Sample/Photo</b><br><br>Underground duct<br>Pipe residue in corridor duct<br>adjacent to Zachery Unwin<br>Ward | <table style="width: 100%;"> <tr> <td style="width: 50%;"><b>Asbestos</b></td> <td>Yes</td> </tr> <tr> <td><b>Type</b></td> <td>Chrysotile (White)</td> </tr> </table> | <b>Asbestos</b> | Yes | <b>Type</b> | Chrysotile (White) | | | | |
| <b>Material Type</b> Lagging | <b>Quantity</b> <1m | <table style="width: 100%;"> <tr> <td style="width: 50%;"><b>Sample No</b></td> <td>06/B/8026/213</td> </tr> <tr> <td><b>Survey Date</b></td> <td>24.04 - 29.06.06</td> </tr> <tr> <td><b>Date of Report</b></td> <td>18.08.06</td> </tr> <tr> <td><b>Surveyor(s)</b></td> <td style="background-color: black; color: black;">[REDACTED]</td> </tr> </table> | <b>Sample No</b> | 06/B/8026/213 | <b>Survey Date</b> | 24.04 - 29.06.06 | <b>Date of Report</b> | 18.08.06 | <b>Surveyor(s)</b> | [REDACTED] |

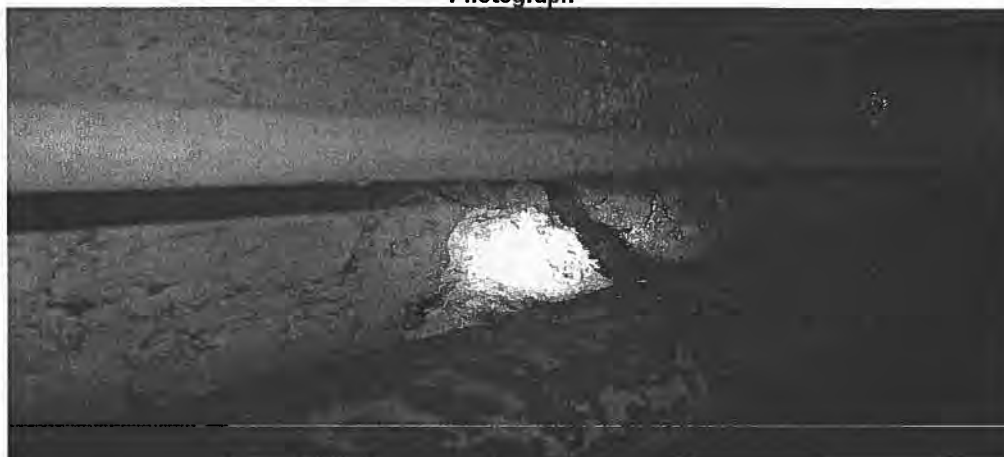
| <b>Location of Survey</b><br>Cane Hill Hospital,<br>Cane Hill,<br>Coulsdon, Surrey,<br>CR5 3ES | | <b>Position of Sample/Photo</b><br>Underground duct<br>Pipe debris in corridor duct<br>adjacent Vanbrugh Vincent<br>Ward | | <b>Asbestos</b><br><br><b>Type</b> | <b>Yes</b><br><br>Chrysotile (White) |
| <b>Material Type</b> | Lagging | <b>Quantity</b> | <1m <sup>2</sup> | <b>Sample No</b> | 06/B/8026/214 |

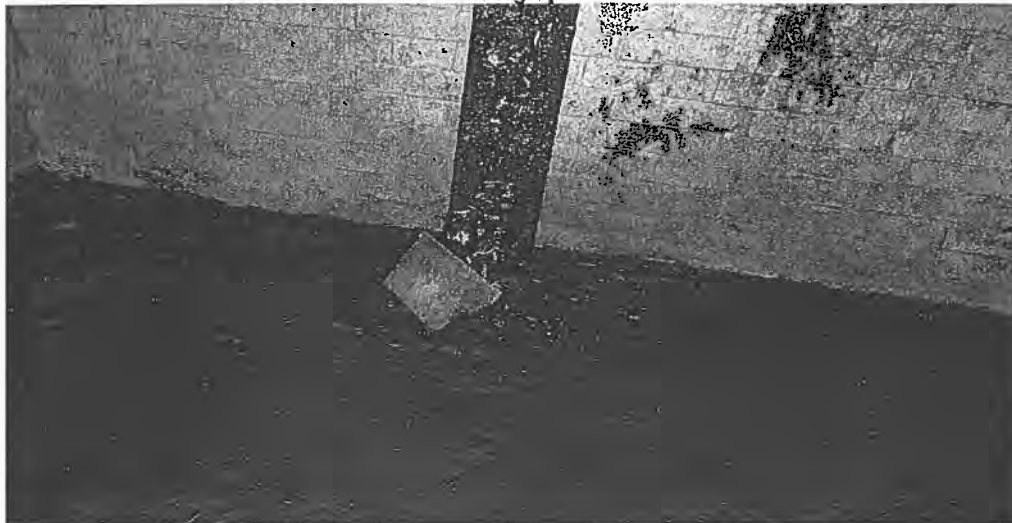
| <b>Location of Survey</b><br><br>Cane Hill Hospital,<br>Cane Hill,<br>Coulsdon, Surrey,<br>CR5 3ES | <b>Position of Sample/Photo</b><br><br>Underground duct beneath<br>Corridor adjacent Turner<br>Floor Cement Debris | <b>Asbestos</b><br><br>Yes, Strongly<br>Presumed | <b>Type</b><br><br>Chrysotile (White) |
| <b>Material Type</b><br><br>Cement | <b>Quantity</b><br><br><1m | <b>Sample No</b> As 06/B/8026/20<br><br><b>Survey Date</b> 24.04 - 29.06.06<br><br><b>Date of Report</b> 18.08.06<br><br><b>Surveyor(s)</b> <span style="background-color: black; color: black;">[REDACTED]</span> | |

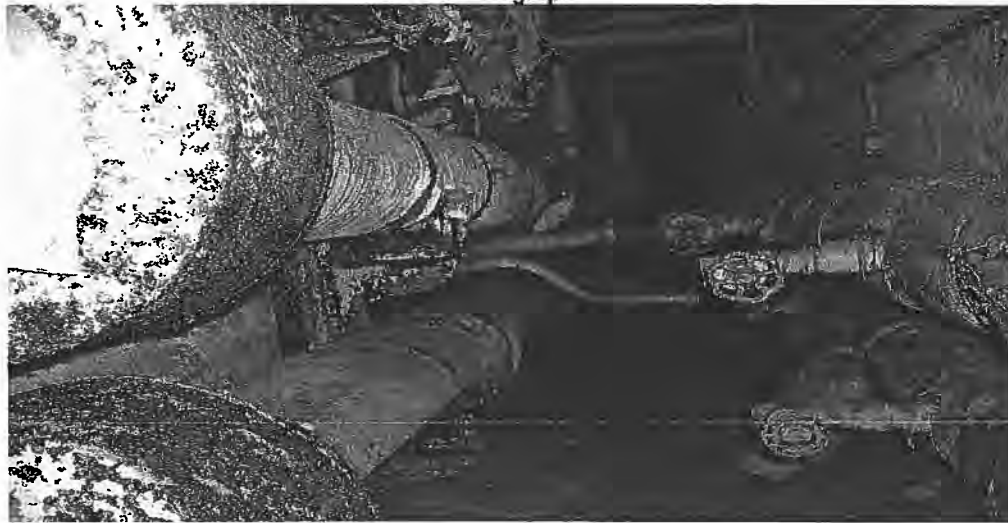
| <b>Location of Survey</b><br>Cane Hill Hospital,<br>Cane Hill,<br>Coulsdon, Surrey,<br>CR5 3ES | <b>Position of Sample/Photo</b><br>Underground duct beneath<br>Corridor adjacent Turner<br>Sectional Pipe Lagging | <b>Asbestos</b> Yes, Strongly Presumed<br><br><b>Type</b> Amosite (Brown)<br>Chrysotile (White) |
| <b>Material Type</b> Lagging | <b>Quantity</b> 200m | <b>Sample No</b> As 06/B/8026/215<br><br><b>Survey Date</b> 24.04 - 29.06.06<br><br><b>Date of Report</b> 18.08.06<br><br><b>Surveyor(s)</b> <span style="background-color: black; color: black;">[REDACTED]</span> |

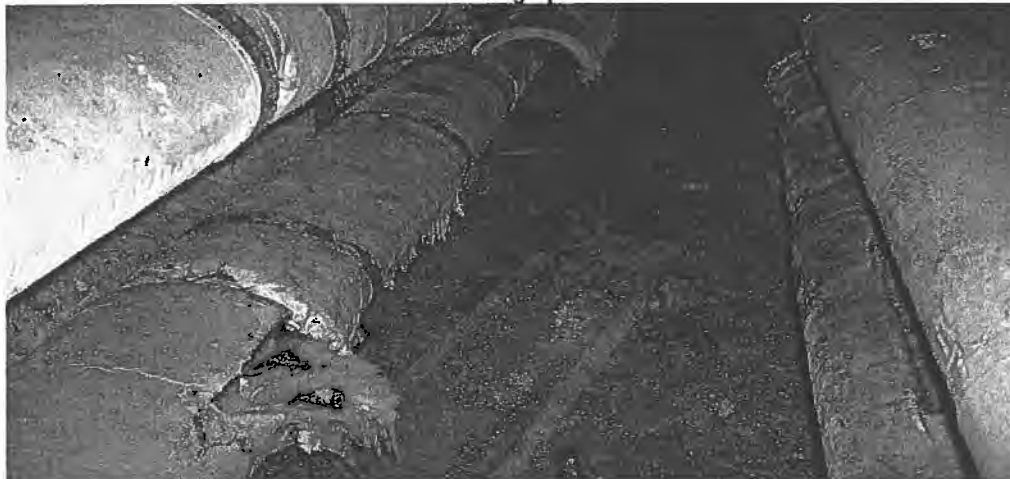
| <b>Location of Survey</b><br>Cane Hill Hospital,<br>Cane Hill,<br>Coulsdon, Surrey,<br>CR5 3ES | <b>Position of Sample/Photo</b><br>Underground duct beneath<br>Corridor adjacent<br>Shaftesbury/Salter<br>Sectional Lagging &<br>Redundant sectional lagging | <b>Asbestos</b> Yes<br><br><b>Type</b> Chrysotile (White)<br>Amosite (Brown) | |
| <b>Material Type</b> Lagging | <b>Quantity</b> 1m | <b>Sample No</b> 06/B/8026/215<br><br><b>Survey Date</b> 24.04 - 29.06.06<br><br><b>Date of Report</b> 18.08.06<br><br><b>Surveyor(s)</b> <span style="background-color: black; color: black;">[REDACTED]</span> | |

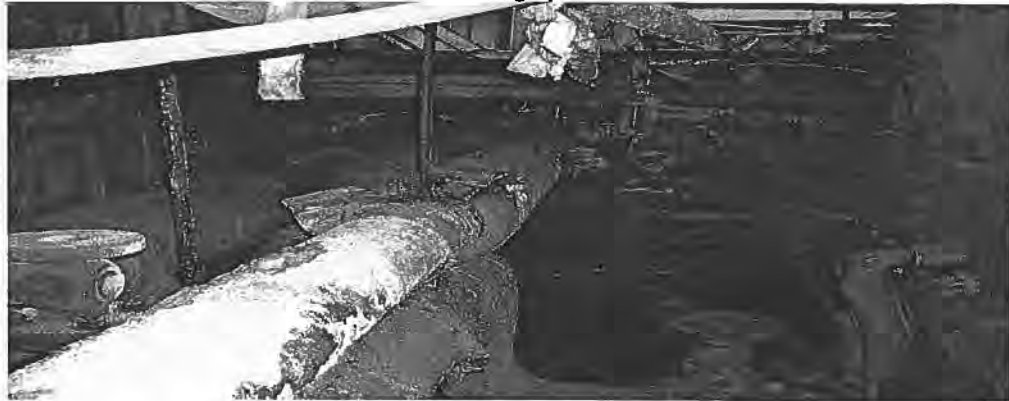
| <b>Material Type</b> Lagging | <b>Quantity</b> 100m <sup>2</sup> | <b>Sample No</b> 06/B/8026/216<br><br><b>Survey Date</b> 24.04 - 29.06.06<br><br><b>Date of Report</b> 18.08.06<br><br><b>Surveyor(s)</b> <span style="background-color: black; color: black;">[REDACTED]</span> |

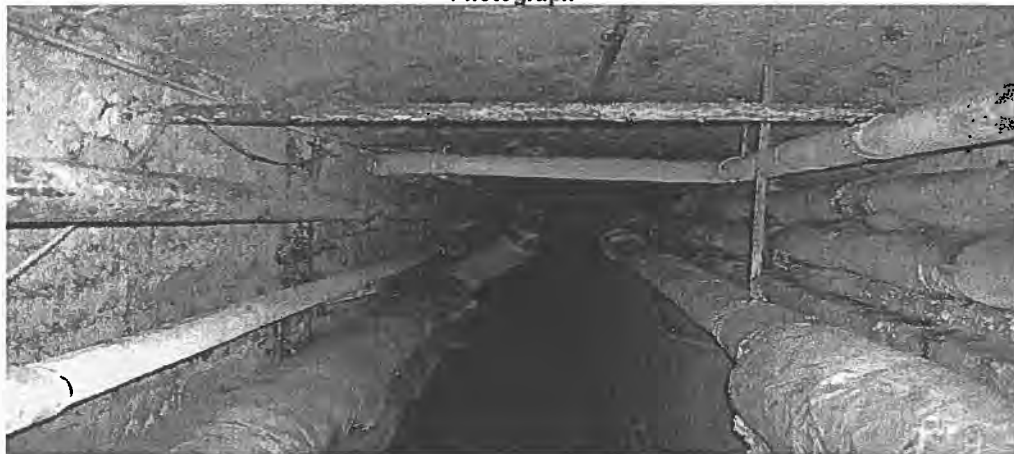
| <b>Location of Survey</b><br>Cane Hill Hospital,<br>Cane Hill,<br>Coulsdon, Surrey,<br>CR5 3ES | | <b>Position of Sample/Photo</b><br>Underground duct beneath<br>Corridor adjacent Nightingale<br>Pipe lagging | <b>Asbestos</b><br><br><b>Type</b><br>Yes, Strongly<br>Presumed<br><br>Chrysotile (White)<br>Amosite (Brown) |
| <b>Material Type</b><br>Lagging | <b>Quantity</b><br>100m | <b>Sample No</b><br>As 06/B/8026/216 | <b>Survey Date</b><br>24.04 - 29.06.06 |

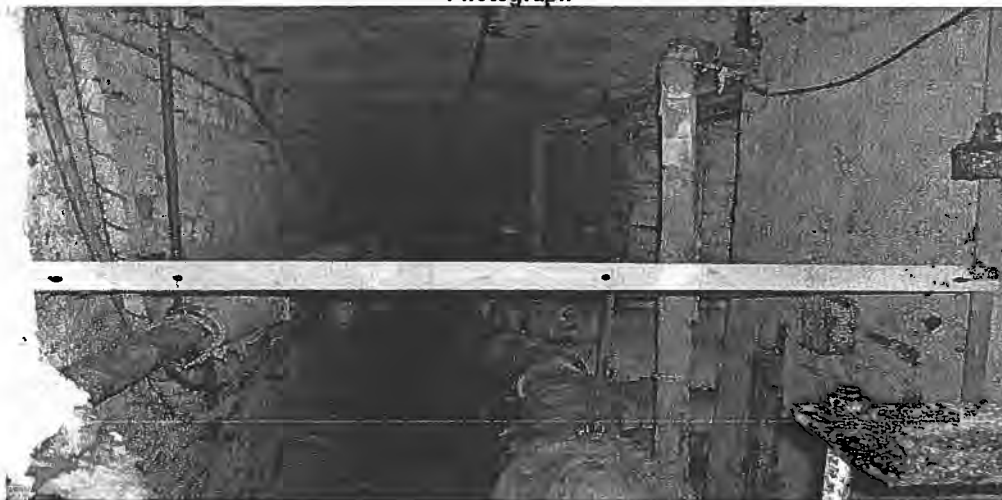
| <b>Location of Survey</b><br>Cane Hill Hospital,<br>Cane Hill,<br>Coulson, Surrey,<br>CR5 3ES | | <b>Position of Sample/Photo</b><br>Underground duct beneath<br>Corridor adjacent Nightingale-<br>Wren<br>Pipe Lagging | | <b>Asbestos</b><br><br><b>Type</b> | Yes, Strongly<br>Presumed<br><br>Amosite (Brown)<br>Chrysotile (White) |
| <b>Material Type</b> | Lagging | <b>Quantity</b> | 1m <sup>2</sup> | <b>Sample No</b> | As 06/B/8026/216 |

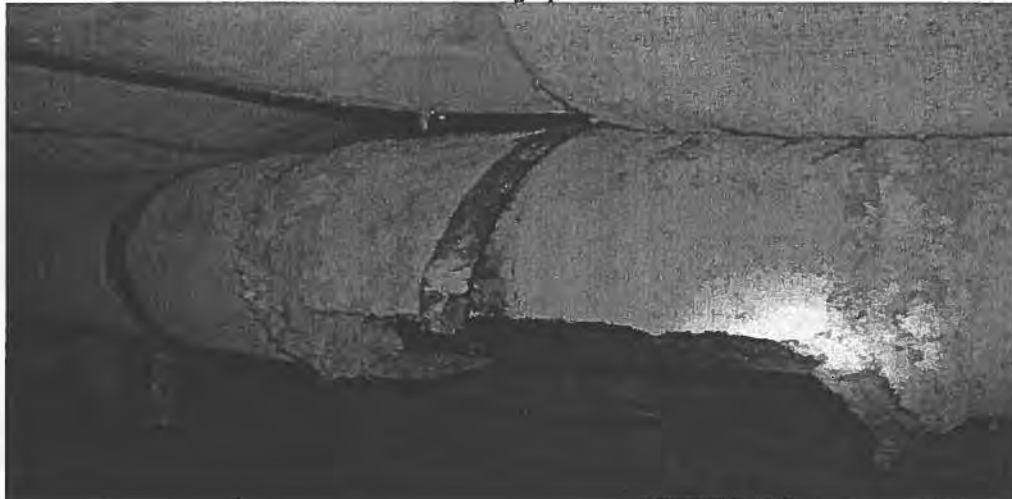
| <b>Location of Survey</b><br><br>Cane Hill Hospital,<br>Cane Hill,<br>Coulsdon, Surrey,<br>CR5 3ES | <b>Position of Sample/Photo</b><br><br>Underground duct beneath<br>Corridor adjacent Turner<br>Hardset lagging adjacent<br>MMMF lagging | <b>Asbestos</b><br><br>Yes, Strongly<br>Presumed | <b>Type</b><br><br>Amosite (Brown)<br>Chrysotile (White) |
| <b>Material Type</b><br><br>Lagging | <b>Quantity</b><br><br>200m | <b>Sample No</b><br>As 06/B/8026/216<br><br><b>Survey Date</b><br>24.04 - 29.06.06<br><br><b>Date of Report</b><br>18.08.06<br><br><b>Surveyor(s)</b><br><div style="background-color: black; width: 100px; height: 30px; margin-top: 5px;"></div> | |

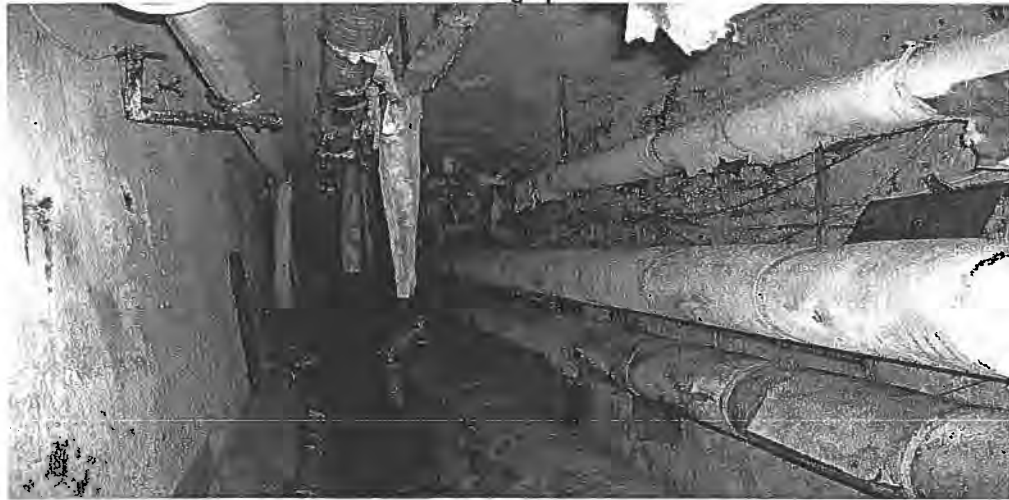
| <b>Location of Survey</b><br>Cane Hill Hospital,<br>Cane Hill,<br>Coulston, Surrey,<br>CR5 3ES | | <b>Position of Sample/Photo</b><br>Underground duct beneath<br>Corridor adjacent Stores<br>Pipe Lagging | | <b>Asbestos</b><br><br><b>Type</b> | Yes, Strongly<br>Presumed<br><br>Amosite (Brown)<br>Chrysotile (White) |
| <b>Material Type</b> | Lagging | <b>Quantity</b> | 200m | <b>Sample No</b> | As 06/B/8026/216 |

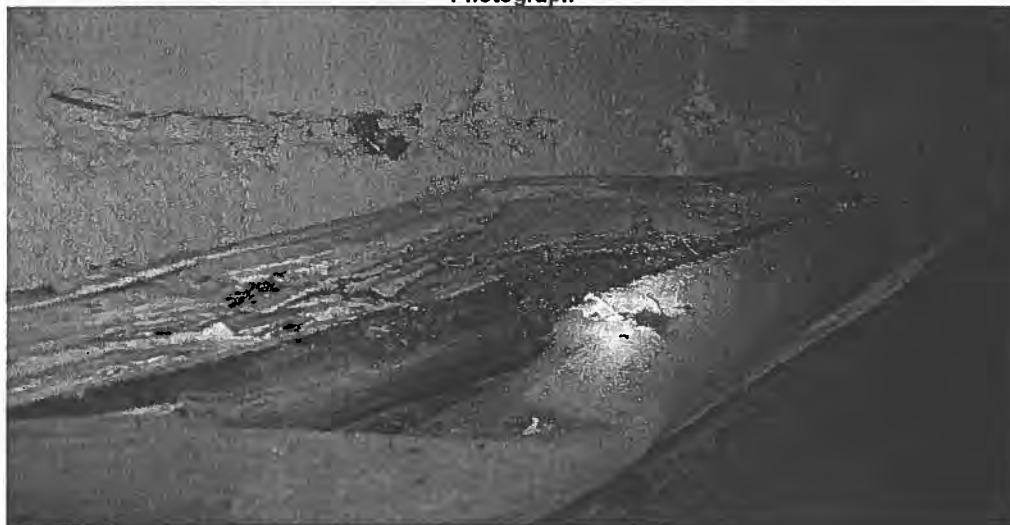
| <b>Location of Survey</b><br><br>Cane Hill Hospital,<br>Cane Hill,<br>Coulson, Surrey,<br>CR5 3ES | <b>Position of Sample/Photo</b><br><br>Underground duct beneath<br>east side corridor adjacent<br>Kitchen<br>Corrugated Foil paper lagging | <b>Asbestos</b> Yes<br><br><b>Type</b> Chrysotile (White) | |
| <b>Material Type</b> Paper lagging | <b>Quantity</b> 20m | <b>Sample No</b> 06/B/8026/217<br><br><b>Survey Date</b> 24.04 - 29.06.06<br><br><b>Date of Report</b> 18.08.06<br><br><b>Surveyor(s)</b> <span style="background-color: black; color: black;">[REDACTED]</span> | |

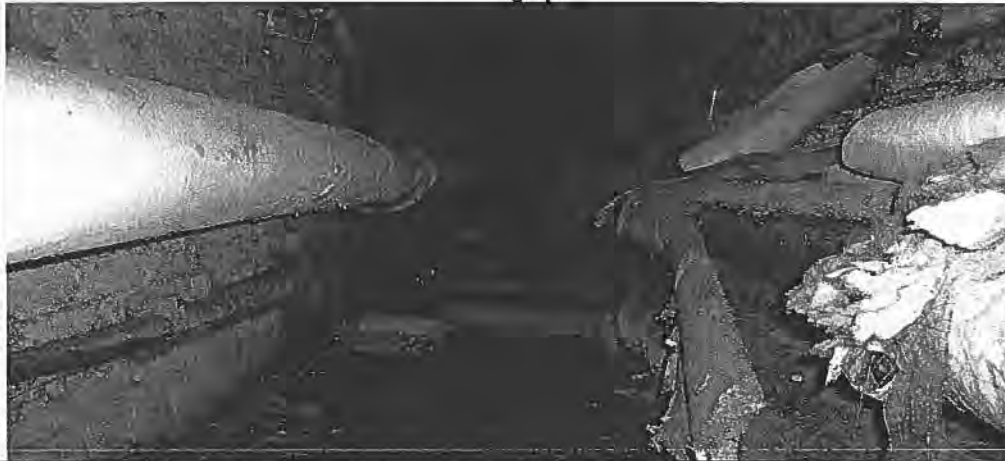
| <b>Location of Survey</b><br>Cane Hill Hospital,<br>Cane Hill,<br>Coulston, Surrey,<br>CR5 3ES | | <b>Position of Sample/Photo</b><br>Underground duct beneath<br>east side corridor adjacent<br>Kitchen, Sectional Lagging<br>adjacent MMMF lagging | | <b>Asbestos</b><br><br><b>Type</b> | Yes, Strongly<br>Presumed<br><br>Chrysotile (White)<br>Amosite (Brown) |
| <b>Material Type</b> | Lagging | <b>Quantity</b> | 1m <sup>2</sup> | <b>Sample No</b> | As 06/B/8026/216 |

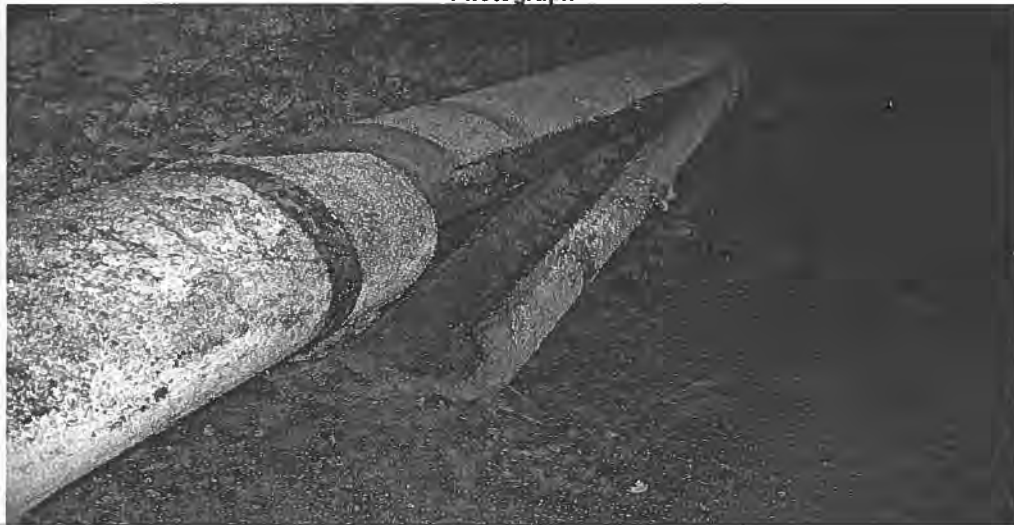
| <b>Location of Survey</b><br>Cane Hill Hospital,<br>Cane Hill,<br>Coulston, Surrey,<br>CR5 3ES | | <b>Position of Sample/Photo</b><br>Underground Corridor Duct<br>Sectional Pipe lagging<br>(presumed throughout) | | <b>Asbestos</b><br><br><b>Type</b> | Yes, Strongly<br>Presumed<br><br>Chrysotile (White)<br>Amosite (Brown) |
| <b>Material Type</b> | Lagging | <b>Quantity</b> | 1000m <sup>2</sup> | <b>Sample No</b> | As 06/B/8026/216 |

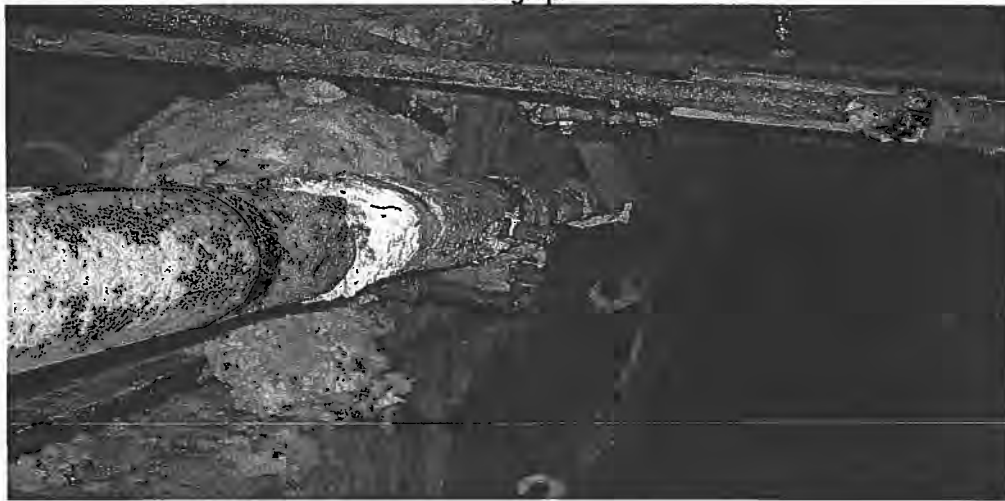
| <b>Location of Survey</b><br>Cane Hill Hospital,<br>Cane Hill,<br>Coulsdon, Surrey,<br>CR5 3ES | <b>Position of Sample/Photo</b><br>Underground duct beneath<br>Corridor adjacent to Dentist<br>Sectional lagging, | <b>Asbestos</b> Yes<br><br><b>Type</b> Crocidolite (Blue) |
| <b>Material Type</b> Lagging | <b>Quantity</b> 200m | <b>Sample No</b> 06/B/8026/218<br><br><b>Survey Date</b> 24.04 - 29.06.06<br><br><b>Date of Report</b> 18.08.06<br><br><b>Surveyor(s)</b> <span style="background-color: black; color: black;">[REDACTED]</span> |

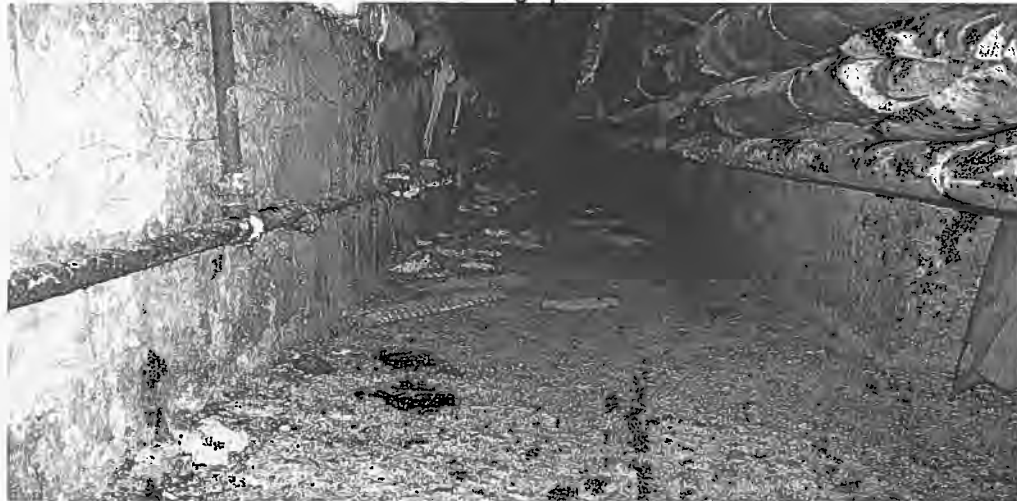
| <b>Location of Survey</b><br>Cane Hill Hospital,<br>Cane Hill,<br>Coulston, Surrey,<br>CR5 3ES | | <b>Position of Sample/Photo</b><br>Underground duct beneath<br>Corridor adjacent to Dentist<br>Sectional lagging debris, | <b>Asbestos</b> Yes<br><br><b>Type</b> Chrysotile (White)<br>Amosite (Brown) |
| <b>Material Type</b> Lagging | <b>Quantity</b> 2m | <b>Sample No</b> As 06/B/8026/219<br><br><b>Survey Date</b> 24.04 - 29.06.06<br><br><b>Date of Report</b> 18.08.06<br><br><b>Surveyor(s)</b> <span style="background-color: black; color: black;">[REDACTED]</span> | |

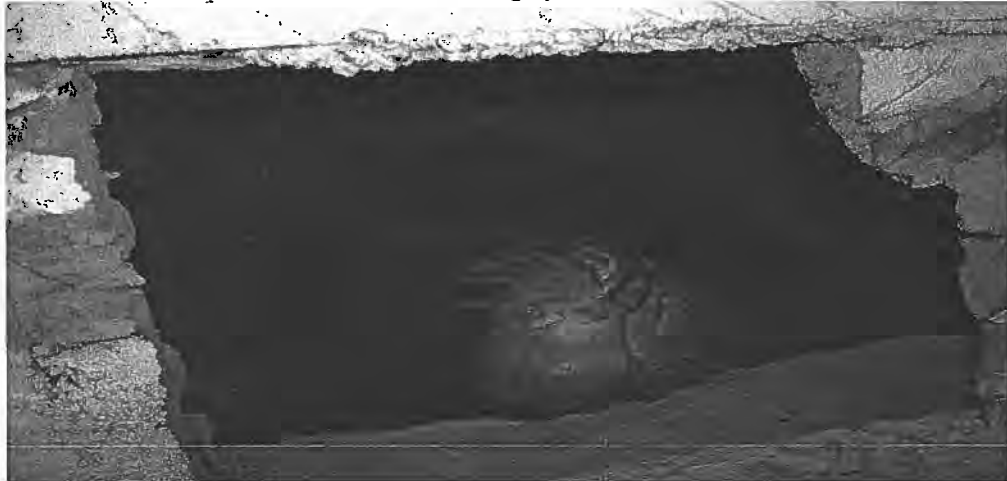
| <b>Location of Survey</b><br>Cane Hill Hospital,<br>Cane Hill,<br>Coulsdon, Surrey,<br>CR5 3ES | | <b>Position of Sample/Photo</b><br>Underground duct<br>Corridor Duct adjacent Ellis<br>Asbestos Bags in partially<br>bricked up void | | <b>Asbestos</b><br><br><b>Type</b> | Yes, Strongly<br>Presumed<br><br>Chrysotile (White)<br>Amosite (Brown)<br>Crocidolite (Blue) |
| <b>Material Type</b> | Lagging | <b>Quantity</b> | 3m <sup>2</sup> | <b>Sample No</b> | As 06/B/8026/218<br>& 219 |

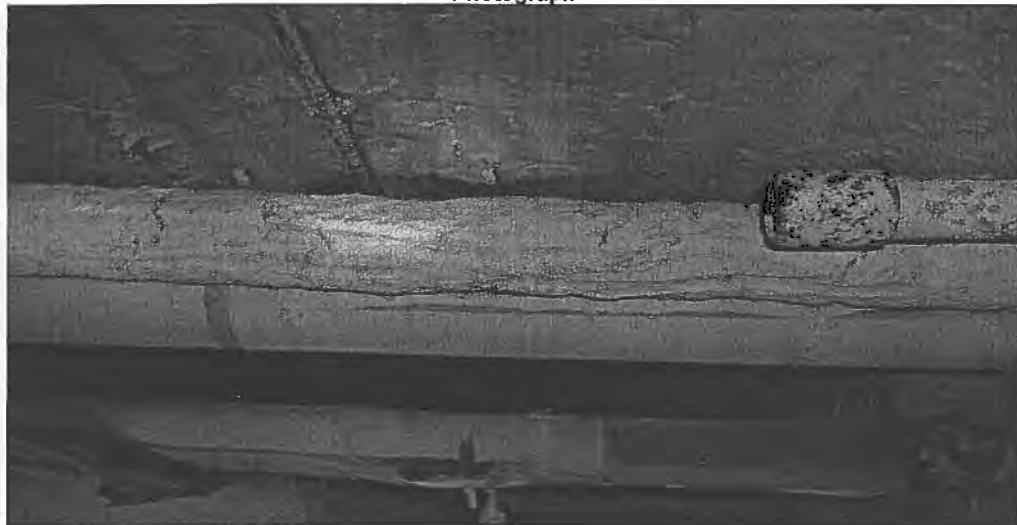
| <b>Location of Survey</b><br><br>Cane Hill Hospital,<br>Cane Hill,<br>Coulsdon, Surrey,<br>CR5 3ES | <b>Position of Sample/Photo</b><br><br>Underground duct<br>Corridor duct adjacent Ellis<br>Hard Set Lagging | <b>Asbestos</b> None Detected<br><br><b>Type</b> N/A |
| <b>Material Type</b> Lagging | <b>Quantity</b> 1m <sup>2</sup> | <b>Sample No</b> 06/B/8026/220<br><br><b>Survey Date</b> 24.04 - 29.06.06<br><br><b>Date of Report</b> 18.08.06<br><br><b>Surveyor(s)</b> <span style="background-color: black; color: black;">[REDACTED]</span> |

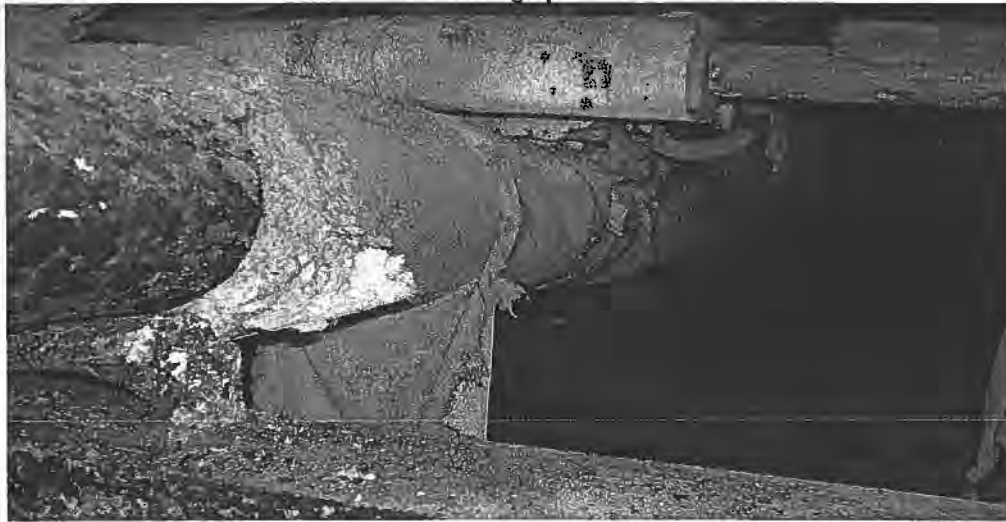
| <b>Location of Survey</b><br>Cane Hill Hospital,<br>Cane Hill,<br>Coulston, Surrey,<br>CR5 3ES | | <b>Position of Sample/Photo</b><br>Underground duct leading to<br>boiler block adjacent Faraday<br>Sectional lagging, | | <b>Asbestos</b><br><br><b>Type</b> | Yes<br><br>Amosite (Brown) |
| <b>Material Type</b> | Lagging | <b>Quantity</b> | 10m | <b>Sample No</b> | 06/B/8026/221 |

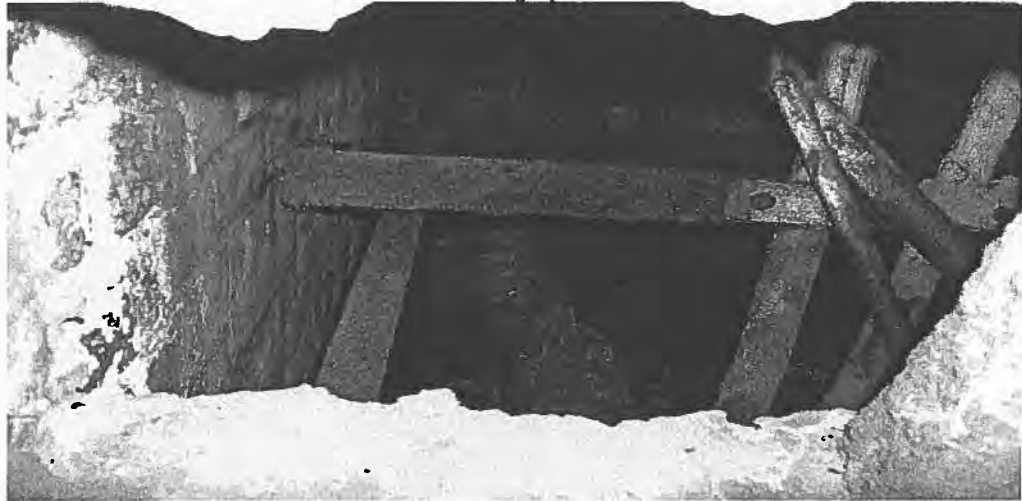
| <b>Location of Survey</b><br>Cane Hill Hospital,<br>Cane Hill,<br>Coulsdon, Surrey,<br>CR5 3ES | | <b>Position of Sample/Photo</b><br>Underground duct beneath<br>Corridor adjacent Guy Ward,<br>Asbestos Bags in partially<br>bricked up void | <b>Asbestos</b><br><br><b>Type</b> | Yes, Strongly<br>Presumed<br><br>Chrysotile (White)<br>Amosite (Brown)<br>Crocidolite (Blue) |
| <b>Material Type</b> | Lagging | <b>Quantity</b> | 2m | <b>Sample No</b> As 06/B/8026/218<br>& 219<br><br><b>Survey Date</b> 24.04 - 29.06.06<br><br><b>Date of Report</b> 18.08.06<br><br><b>Surveyor(s)</b> |

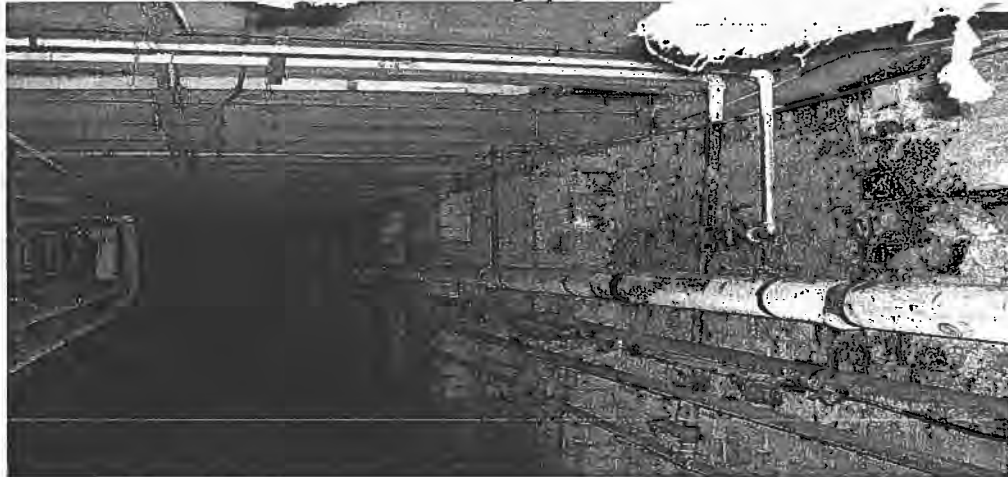
| <b>Location of Survey</b><br>Cane Hill Hospital,<br>Cane Hill,<br>Coulston, Surrey,<br>CR5 3ES | | <b>Position of Sample/Photo</b><br>Underground duct beneath link<br>corridor adjacent King Keats<br>ward<br>Sectional lagging | | <b>Asbestos</b> Yes |
| <b>Material Type</b> Lagging | | <b>Quantity</b> 200m | | <b>Type</b> Chrysotile (White) |

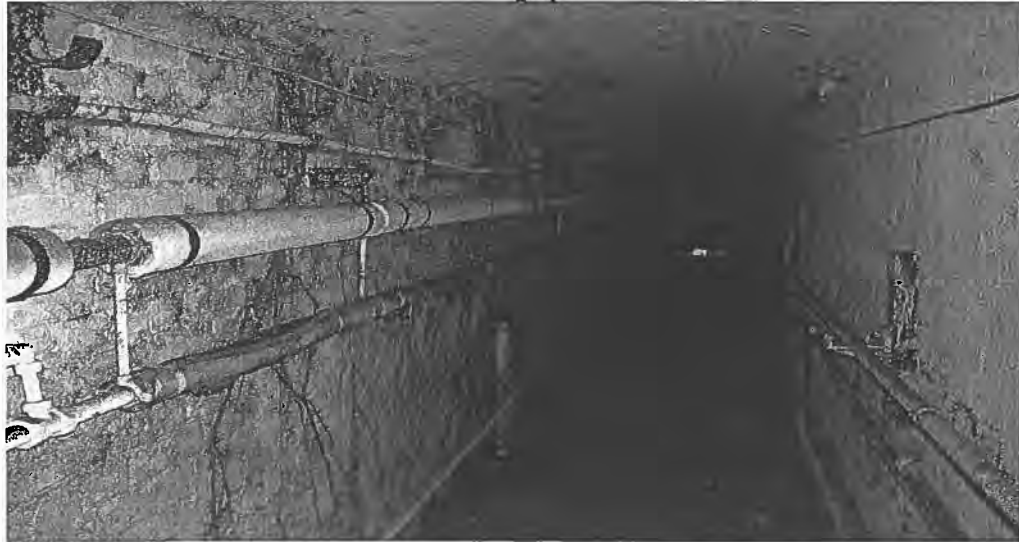
| <b>Location of Survey</b><br>Cane Hill Hospital,<br>Cane Hill,<br>Coulson, Surrey,<br>CR5 3ES | | <b>Position of Sample/Photo</b><br>Underground duct Adjacent<br>Staff Wing<br>Sectional pipe lagging | | <b>Asbestos</b><br><br><b>Type</b> | Yes, Strongly<br>Presumed<br><br>Chrysotile (White) |
| <b>Material Type</b> | Lagging | <b>Quantity</b> | 200m | <b>Sample No</b> | As 06/B/8026/222 |

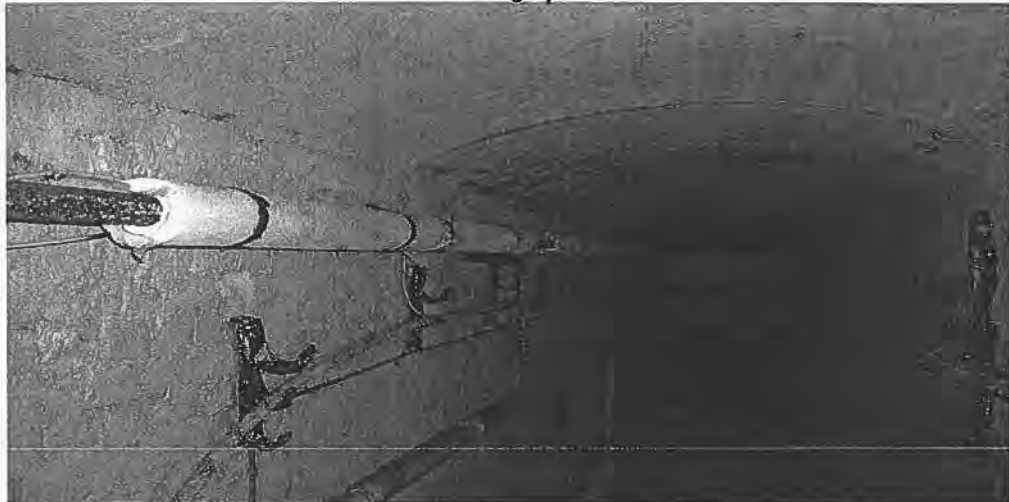
| <b>Location of Survey</b><br>Cane Hill Hospital,<br>Cane Hill,<br>Coulsdon, Surrey,<br>CR5 3ES | | <b>Position of Sample/Photo</b><br>Underground duct Adjacent<br>Liggett/Lettsom Ward<br>Sectional pipe lagging | | <b>Asbestos</b><br><br><b>Type</b> | Yes, Strongly<br>Presumed<br><br>Chrysotile (White) |
| <b>Material Type</b> | Rope | <b>Quantity</b> | 200m <sup>2</sup> | <b>Sample No</b> | As 06/B/8026/222 |

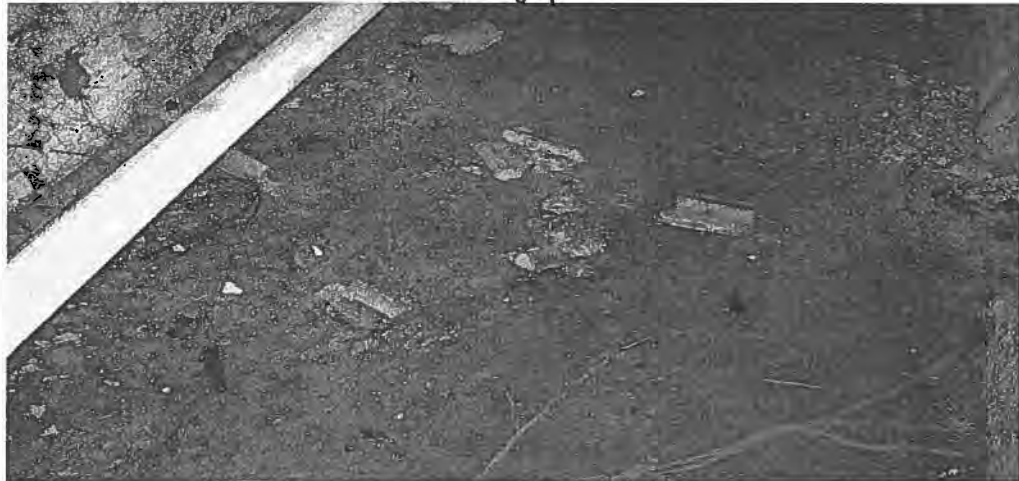
| <b>Location of Survey</b><br>Cane Hill Hospital,<br>Cane Hill,<br>Coulston, Surrey,<br>CR5 3ES | | <b>Position of Sample/Photo</b><br>Underground duct adjacent<br>Liggett/Lettsom Ward<br>Floor debris | | <b>Asbestos</b><br><br><b>Type</b> | <b>Yes, Strongly Presumed</b><br><br>Chrysotile (White) |
| <b>Material Type</b> | Lagging | <b>Quantity</b> | 1m <sup>2</sup> | <b>Sample No</b> | As 06/B/8026/222 |

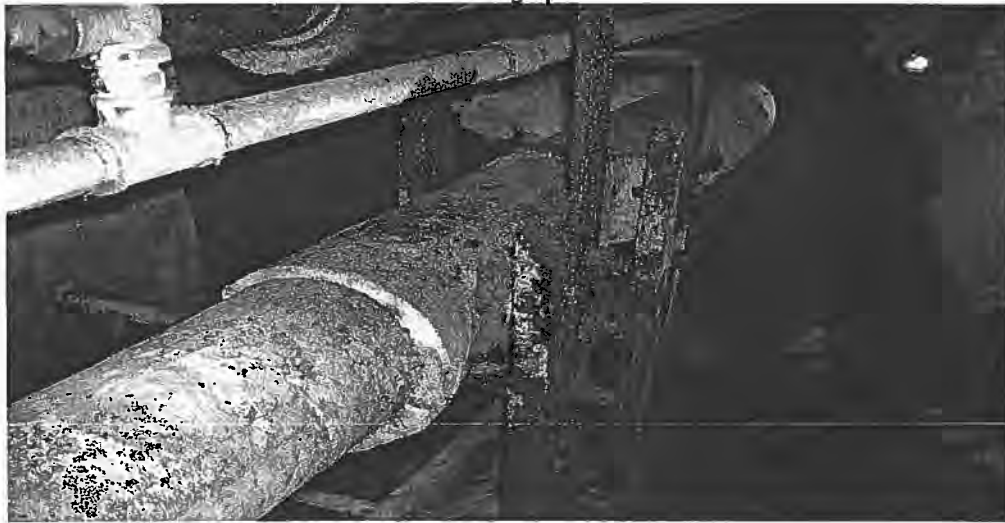
| <b>Location of Survey</b><br>Cane Hill Hospital,<br>Cane Hill,<br>Coulsdon, Surrey,<br>CR5 3ES | | <b>Position of Sample/Photo</b><br>Underground duct<br>Void adjacent Water Tower<br>Lagging to pipe work | | <b>Asbestos</b><br><br><b>Type</b> | Yes, Strongly<br>Presumed<br><br>Chrysotile (White) |
| <b>Material Type</b> | Lagging | <b>Quantity</b> | 200m | <b>Sample No</b> | As 06/B/8026/222 |

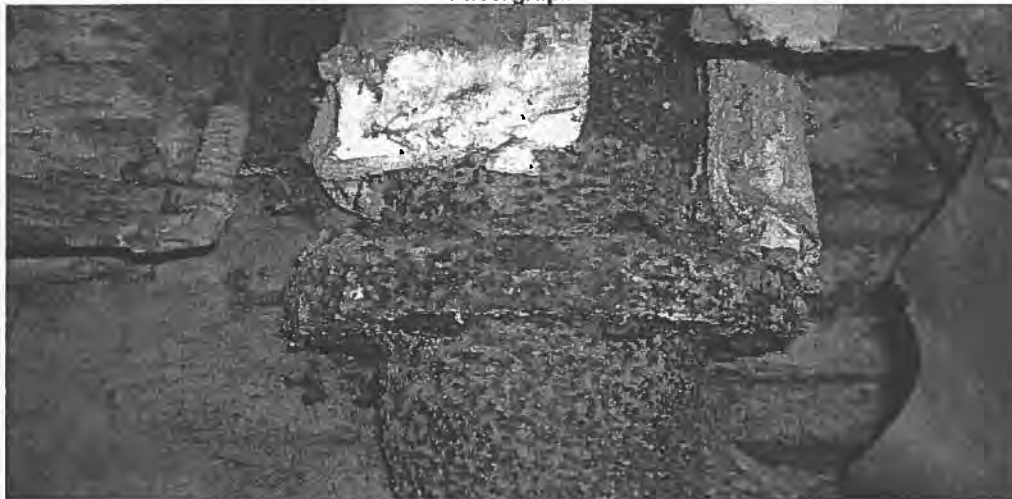
| <b>Location of Survey</b><br><br>Cane Hill Hospital,<br>Cane Hill,<br>Coulsdon, Surrey,<br>CR5 3ES | <b>Position of Sample/Photo</b><br><br>Underground duct<br>adjacent Water Tower<br>Corrugated Foil lagging | <b>Asbestos</b><br><br>Yes, Strongly<br>Presumed | <b>Type</b><br><br>Chrysotile (White) |
| <b>Material Type</b><br><br>Paper | <b>Quantity</b><br><br>1m | <b>Sample No</b><br>As 06/B/8026/217<br><br><b>Survey Date</b><br>24.04 - 29.06.06<br><br><b>Date of Report</b><br>18.08.06<br><br><b>Surveyor(s)</b><br><div style="background-color: black; width: 100px; height: 40px; margin-top: 5px;"></div> | |

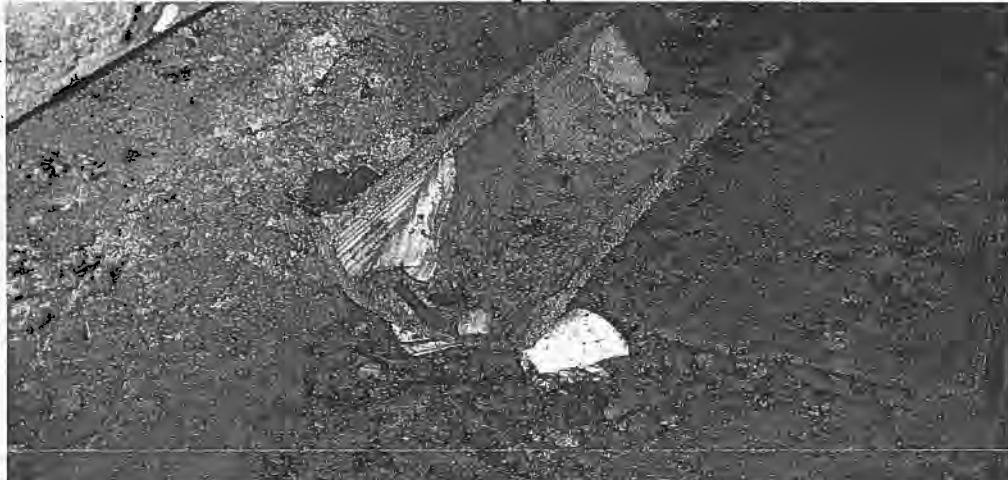
| <b>Location of Survey</b><br>Cane Hill Hospital,<br>Cane Hill,<br>Coulston, Surrey,<br>CR5 3ES | | <b>Position of Sample/Photo</b><br>Underground duct under Water<br>Tower<br>Corrugated Foil lagging debris | | <b>Asbestos</b><br><br><b>Type</b> | Yes, Strongly<br>Presumed<br><br>Chrysotile (White) |
| <b>Material Type</b><br>Paper | | <b>Quantity</b><br>1m <sup>2</sup> | | <b>Sample No</b> | As 06/B/8026/217 |

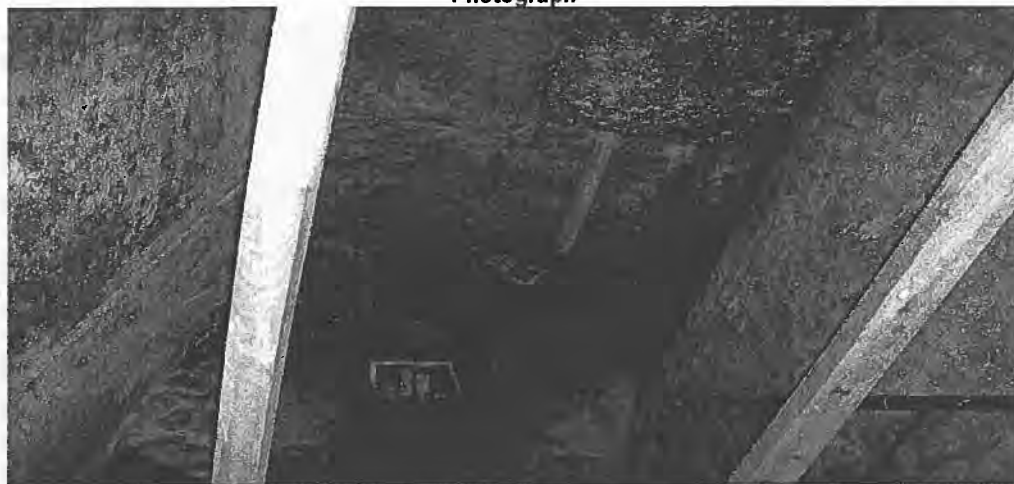
| <b>Location of Survey</b><br>Cane Hill Hospital,<br>Cane Hill,<br>Coulston, Surrey,<br>CR5 3ES | | <b>Position of Sample/Photo</b><br>Underground duct<br>Void adjacent Water Tower<br>Asbestos Waste Bags in void | | <b>Asbestos</b><br><br><br><b>Type</b> | Yes, Strongly<br>Presumed<br><br>Chrysotile (White)<br>Crocidolite (Blue)<br>Amosite (Brown) |
| <b>Material Type</b> | Lagging | <b>Quantity</b> | 1m <sup>2</sup> | <b>Sample No</b> | As 06/B/8026/218<br>& 219 |

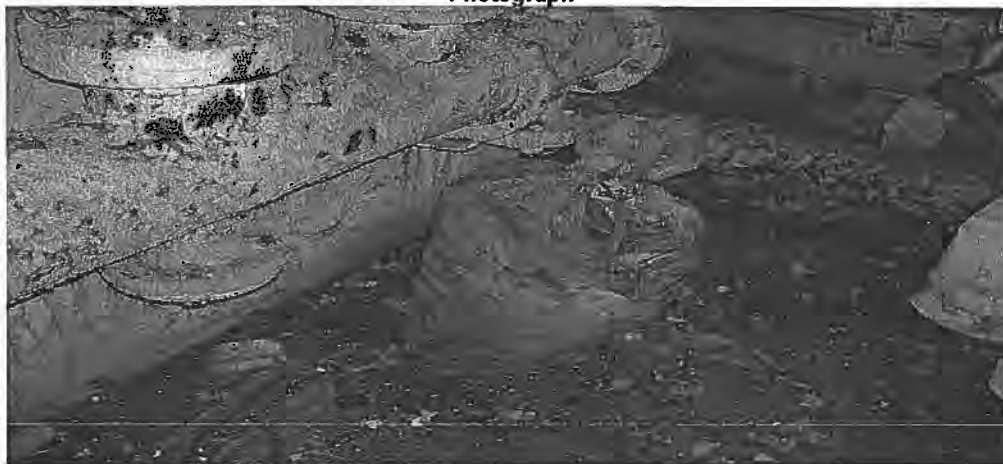
| <b>Location of Survey</b><br>Cane Hill Hospital,<br>Cane Hill,<br>Coulson, Surrey,<br>CR5 3ES | | <b>Position of Sample/Photo</b><br>Underground duct plant room<br>adjacent Nightingale Ward<br>Asbestos Waste bags | | <b>Asbestos</b><br><br><b>Type</b> | Yes, Strongly<br>Presumed<br><br>Chrysotile (White) |
| <b>Material Type</b> | Lagging | <b>Quantity</b><br><br><1m | | <b>Sample No</b> | As 06/B/8026/218<br>& 219 |

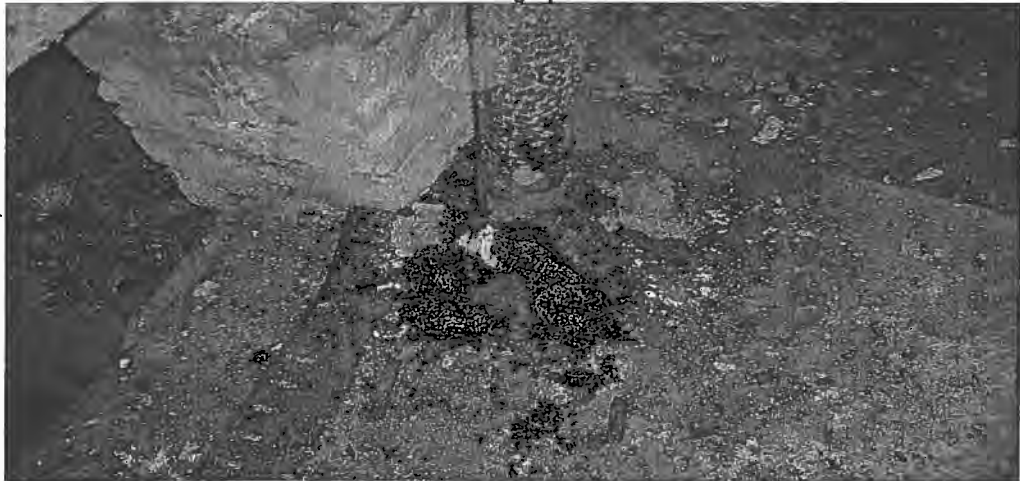
| <b>Location of Survey</b><br><br>Cane Hill Hospital,<br>Cane Hill,<br>Coulsdon, Surrey,<br>CR5 3ES | <b>Position of Sample/Photo</b><br><br>Underground duct plant room<br>adjacent Nightingale Ward<br>Floor Lagging debris | <b>Asbestos</b><br><br>Yes, Strongly<br>Presumed | <b>Type</b><br><br>Amosite (Brown)<br>Chrysotile (White) |
| <b>Material Type</b><br><br>Lagging | <b>Quantity</b><br><br><1m | <b>Sample No</b> As 06/B/8026/219<br><br><b>Survey Date</b> 24.04 - 29.06.06<br><br><b>Date of Report</b> 18.08.06<br><br><b>Surveyor(s)</b> <span style="background-color: black; color: black;">[REDACTED]</span> | |

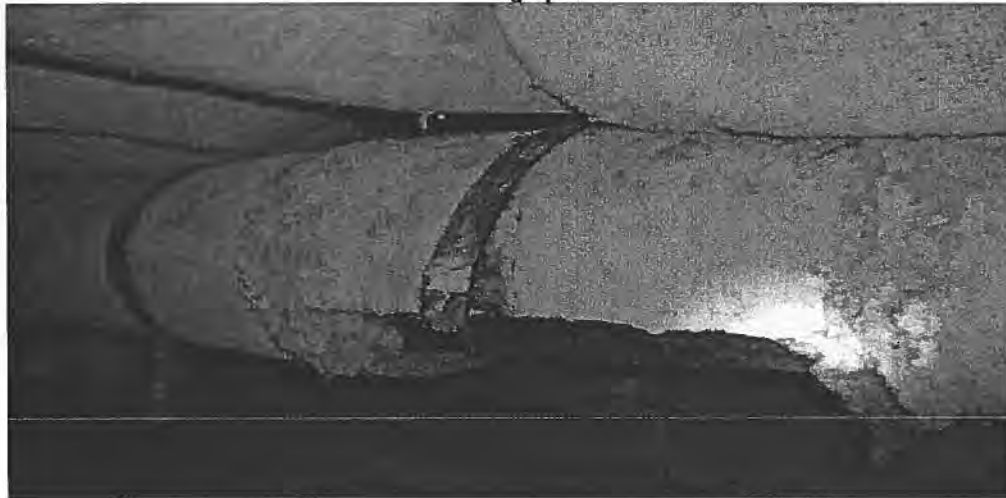
| <b>Location of Survey</b><br>Cane Hill Hospital,<br>Cane Hill,<br>Coulsdon, Surrey,<br>CR5 3ES | <b>Position of Sample/Photo</b><br>Underground duct beneath<br>Corridor adjacent Kitchen<br>Sectional Lagging | <b>Asbestos</b> Yes<br><br><b>Type</b> Amosite (Brown) |
| <b>Material Type</b> Lagging | <b>Quantity</b> 200m | <b>Sample No</b> 06B8026/223<br><br><b>Survey Date</b> 24.04 - 29.06.06<br><br><b>Date of Report</b> 18.08.06<br><br><b>Surveyor(s)</b> <span style="background-color: black; color: black;">[REDACTED]</span> |
