TFL_PSF_9131 SITE INVESTIGATIONS: SMALL SITES INITIATIVE LAND AT NEWHAM WAY, LONDON, E13 8PF

Geotechnical and Geo-Environmental Desk Study

FEBRUARY 2019

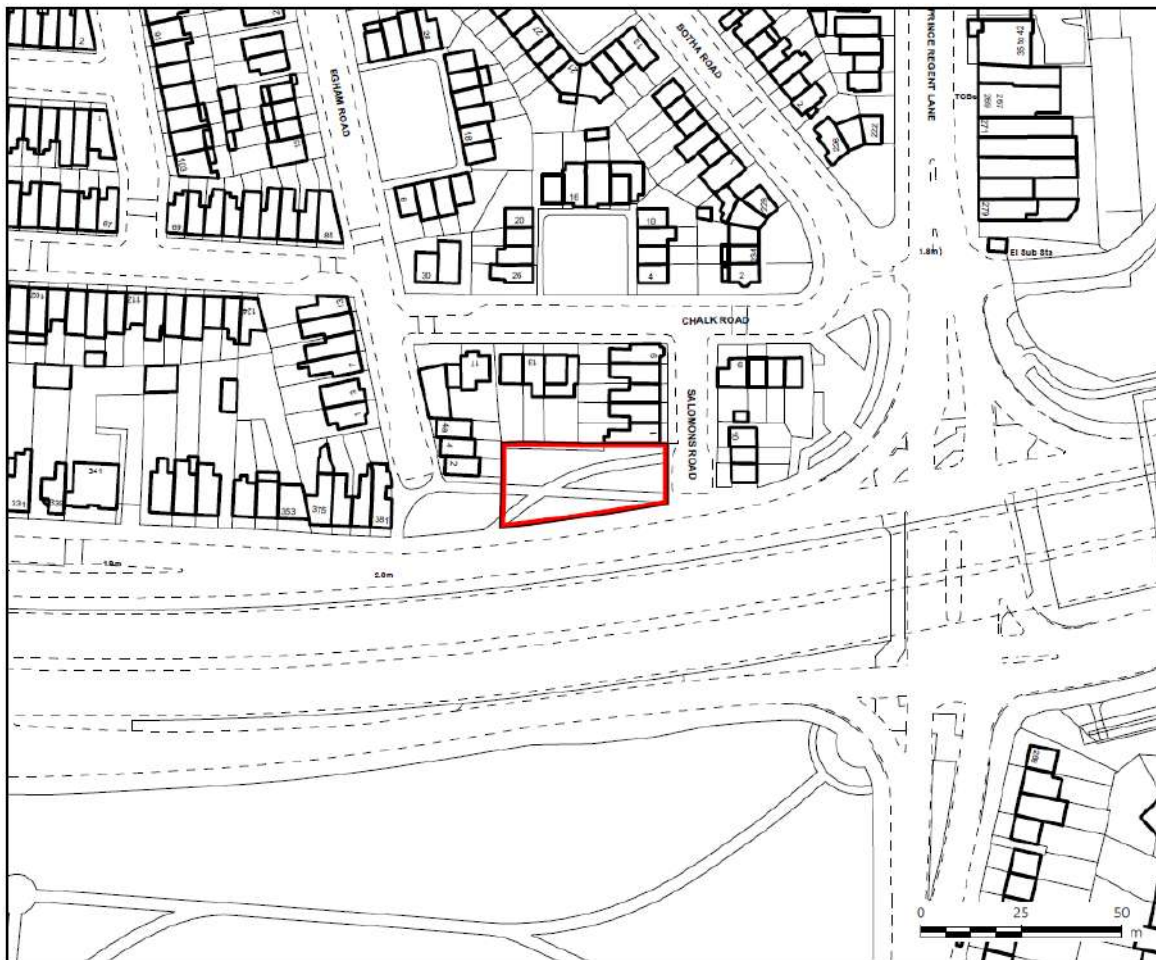
Figure 1: Site Location Plan provided by TfL

The site location is shown in Figure 1 below.

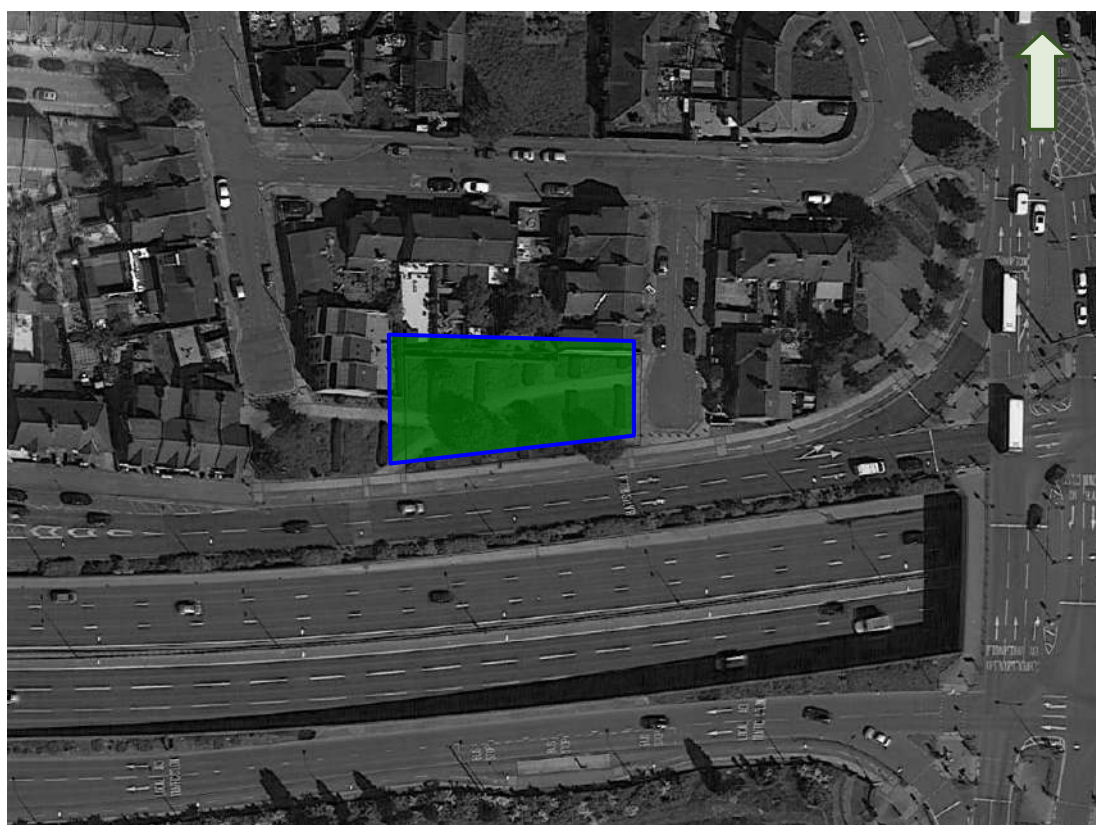
Figure UXO hazard zone plan of the Site

Given this, it is considered that the Site has a low UXO hazard level, as shown in the following Figure, reproduced as Figure 5 in the main report.

Given this, it is considered that the Site has a low UXO hazard level, as shown in Figure 5.

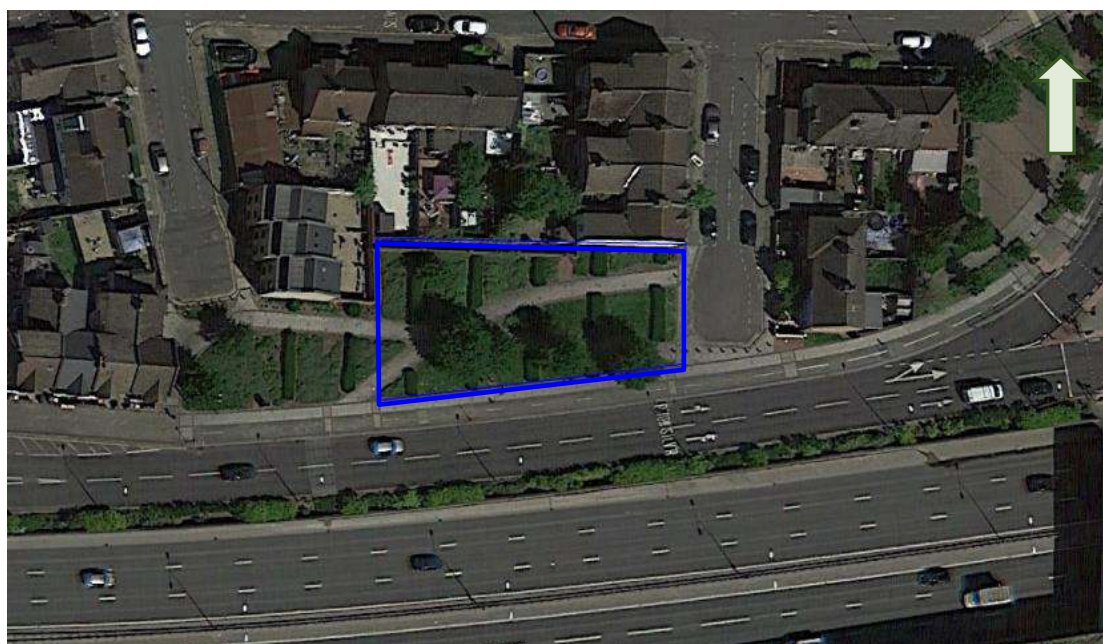
Plate 1 Recent aerial photograph of the Site

Figure 1 is a Site location map and Plate 1 is a recent aerial photograph of the Site.

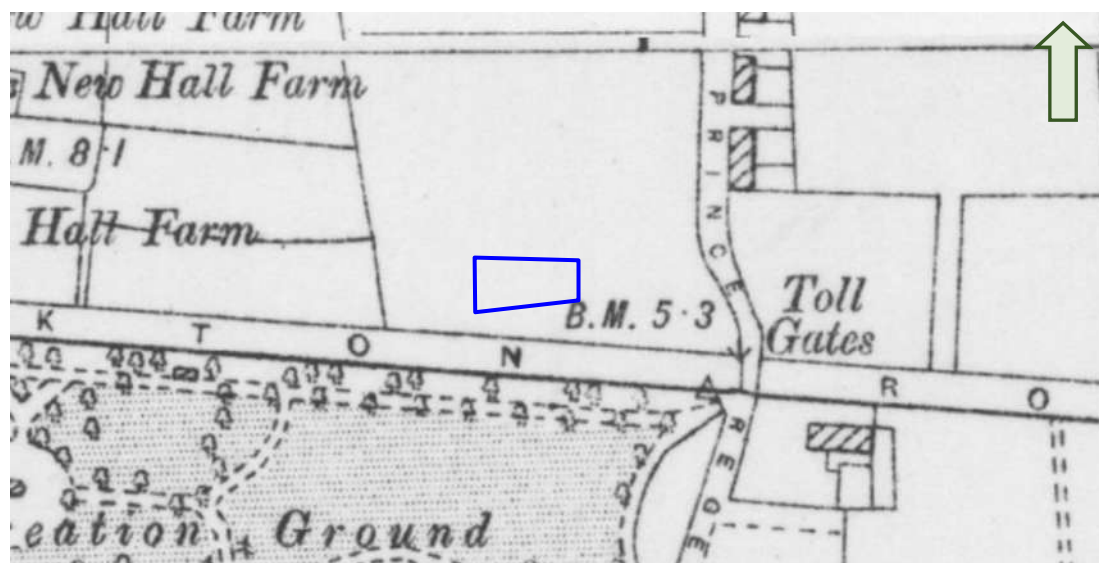
Figure 2 Historical map, 1898

The historical map of 1899 (Figure 2) shows that in the late 19th century the Site comprised open land. The surrounding area predominantly comprised open ground. Beckton Road ran in close proximity to the southern part of the Site.

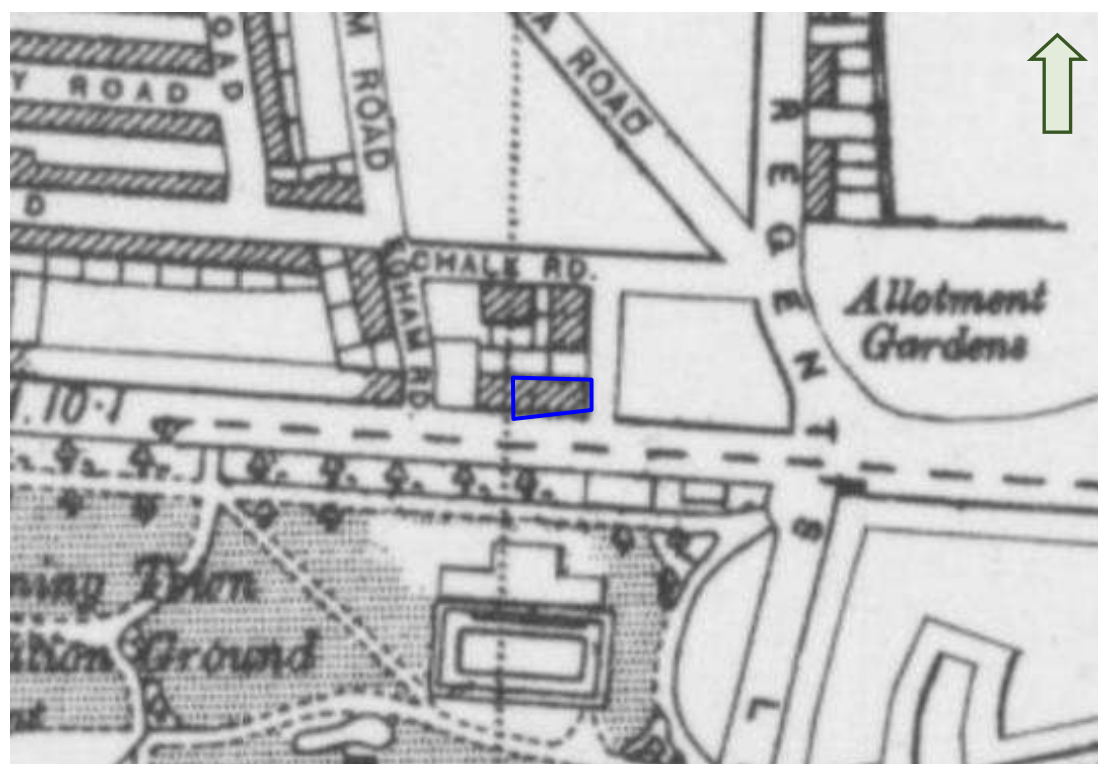
Figure 3 Historical map, 1946

These developments are shown in the historical map of 1946 (Figure 3).

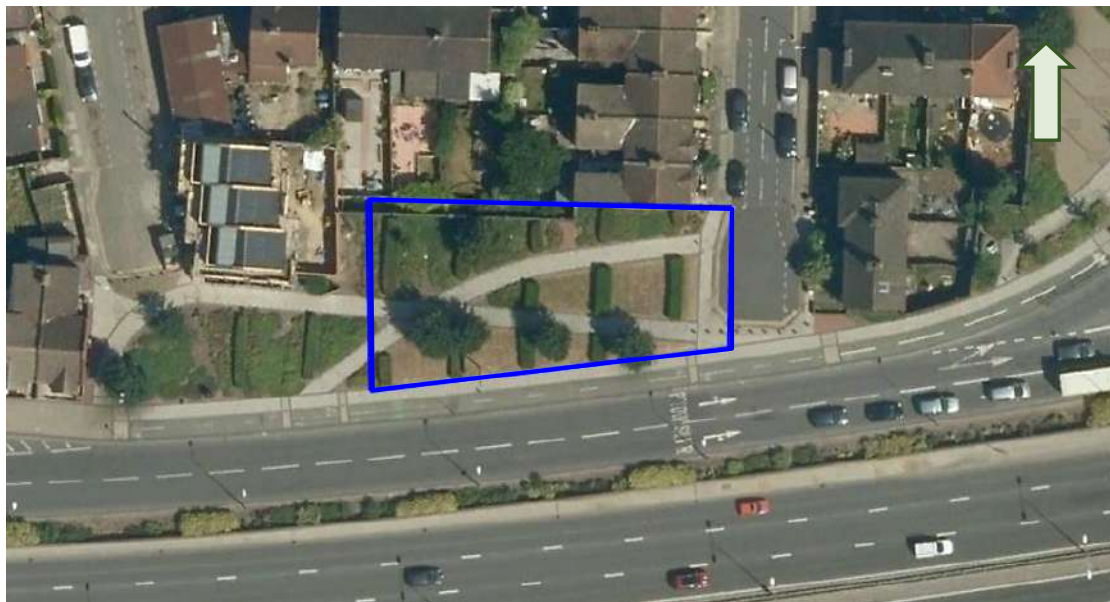
Plate 2	Aerial photograph, 2013

<p>Source: Google Earth Not to Scale</p>	
Legend	Site boundary —
<p>Since 2013 no significant development has occurred on the Site (see Plate 1).</p>	
<h2>2.4 Pre-WWI Military Activity</h2>	
<p>No records of any significant pre-WWI military activity on or in close proximity to the Site have been found.</p>	
<h2>2.5 WWI Military Activity</h2>	
<p>No records of any significant WWI military activity on or in close proximity to the Site have been found.</p>	
<p>During WWI an estimated 9,000No. German bombs were dropped over Britain. It was the first time that strategic aerial bombing had been used.</p>	
<p>No records have been found indicating that the Site was bombed during WWI. The nearest recorded incident is described below.</p>	
<p>19th May 1918</p>	
<p>1No. HE bomb fell near Barclay Road, approximately 0.3km northeast of the Site.</p>	
<p>In response to the air raids, Anti-Aircraft (AA) guns were established. These were potential sources of Unexploded AA (UXAA) shells which could land up to 13km from the firing point, although more typically fell within 10km during WWI.</p>

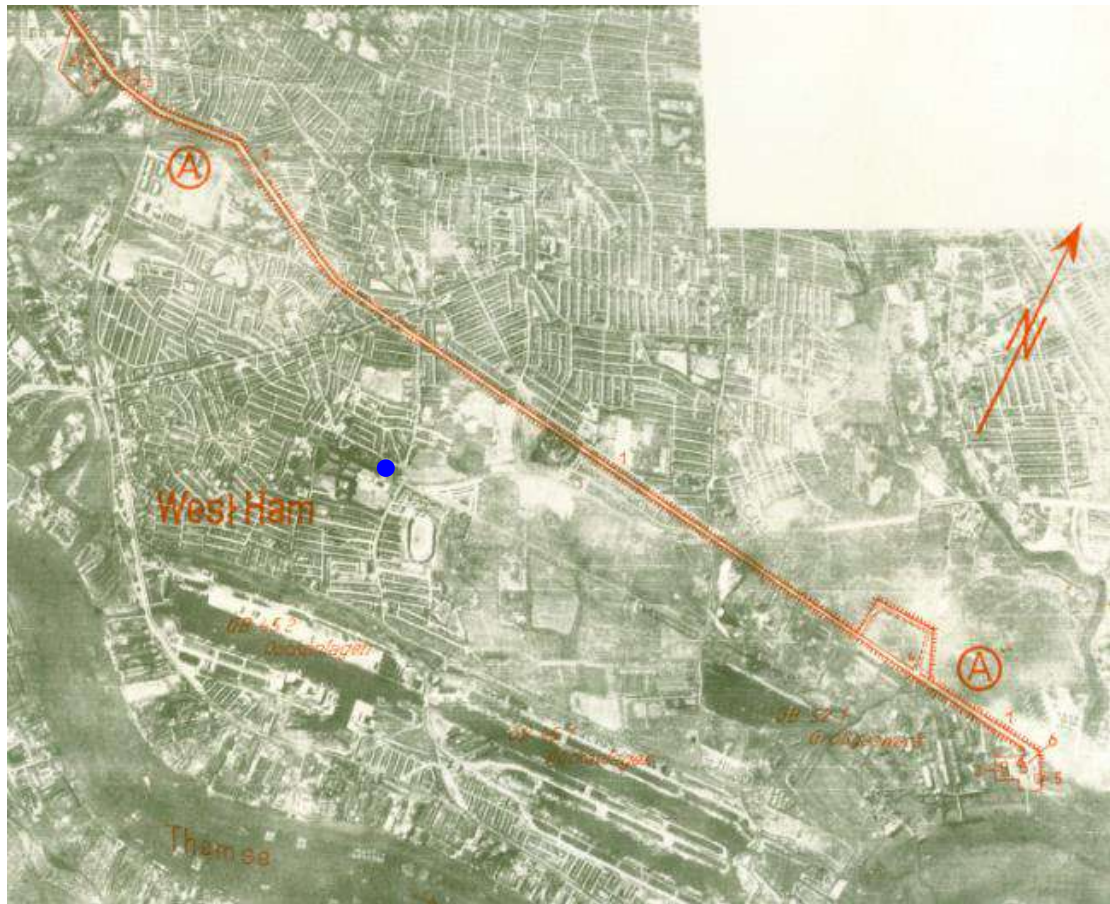
Plate 3	Luftwaffe target photograph of the Northern Outfall Sewer, 20 th June 1940

Plate 3 is a Luftwaffe target photograph dated the 20th June 1940. It identifies the Northern Outfall Sewer (A) and Beckton Gas Works (GB 52 1).

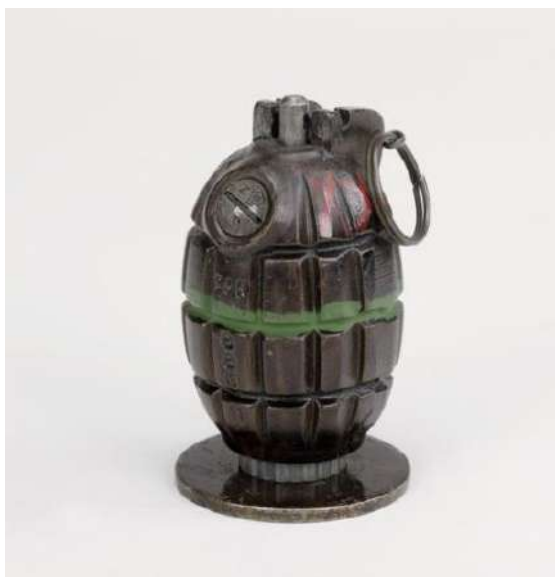
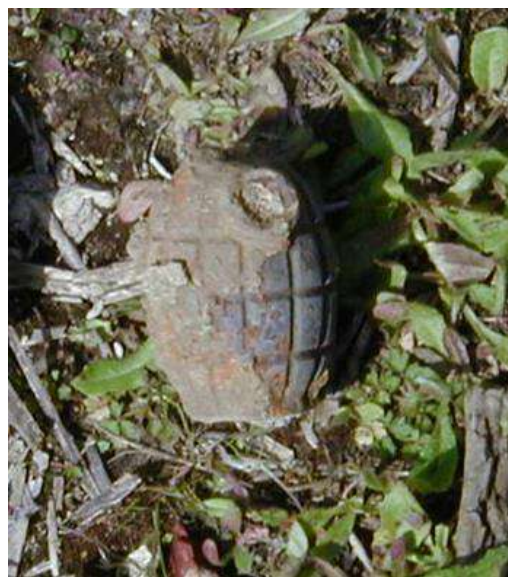
Plate	Photographs of a typical and an excavated WWII No. 36 hand grenades
--------------	---

The Plate below illustrates the typical character and condition of the most commonly found No. 36 hand grenades (Mills Bombs).

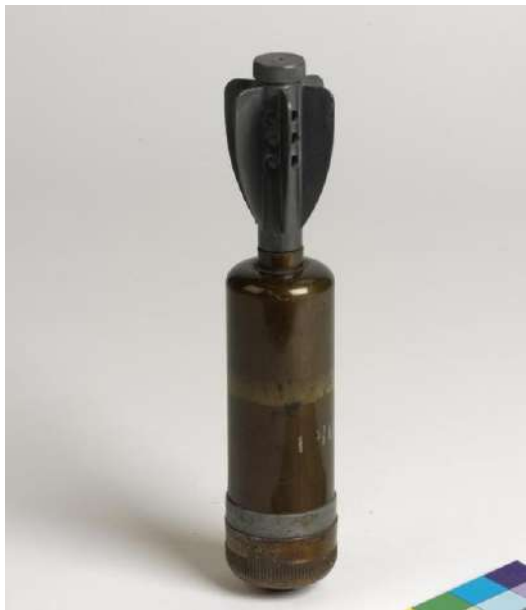
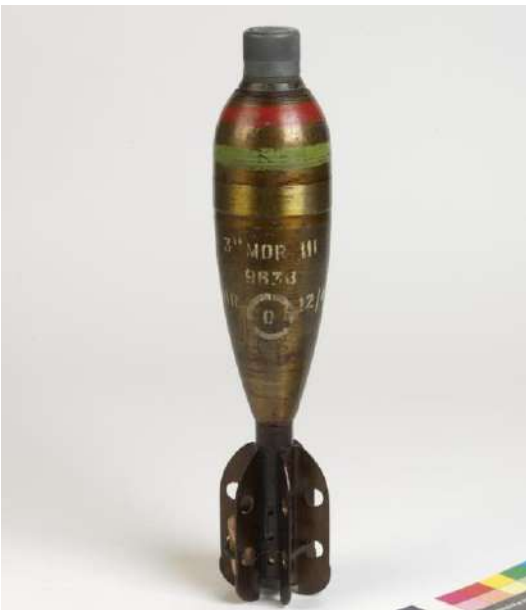
Plate	Photographs of WWII 2-inch and 3-inch mortars
<div data-bbox="256 344 783 952">

The Plate below shows typical 2-inch (left) and 3-inch (right) mortar bombs.

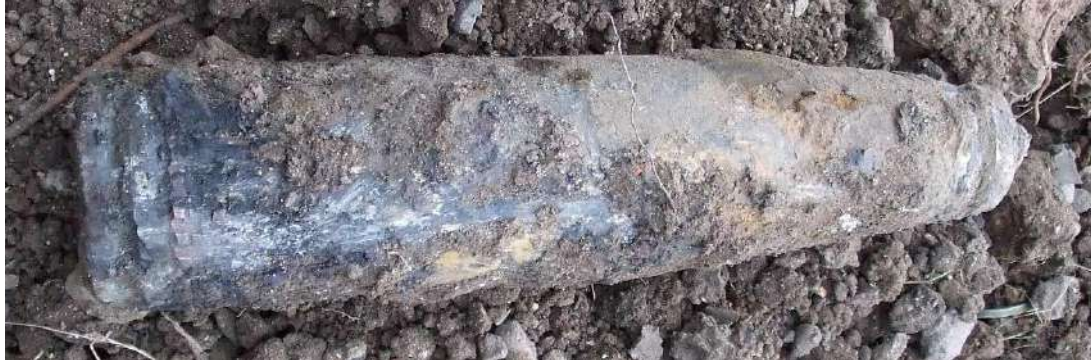
Plate	Photograph of a recently excavated 3.7" AA shell
<div data-bbox="256 1543 1350 1901">

</div>	
<p>Source: IWM</p>	
<p>A2.5 Shells</p> <p>Shells are a projectile containing an explosive charge designed to burst the casing that can contain High Explosives, pyrotechnic compounds or other chemicals.</p> <p>Shells can be found in a range of sizes, from <20mm to several times this size. The most likely shells to be found on the Site are Small Arms Ammunition (SAA) or UXAA shells that have fallen back to the ground unexploded.</p> <p>Most commonly used anti-aircraft shells were 2" and 3.7" HE shells.</p> <p>If fired and found as UXO, shells can offer a particular hazard from accidental detonation as they can have sensitive fuze mechanisms. A fuze is a device which incorporates mechanical, electrical, chemical or hydrostatic components to initiate a train of fire or detonation.</p> <p>The Plate below is a photograph of a 3.7" UXAA shell found in Camberwell, London.</p>

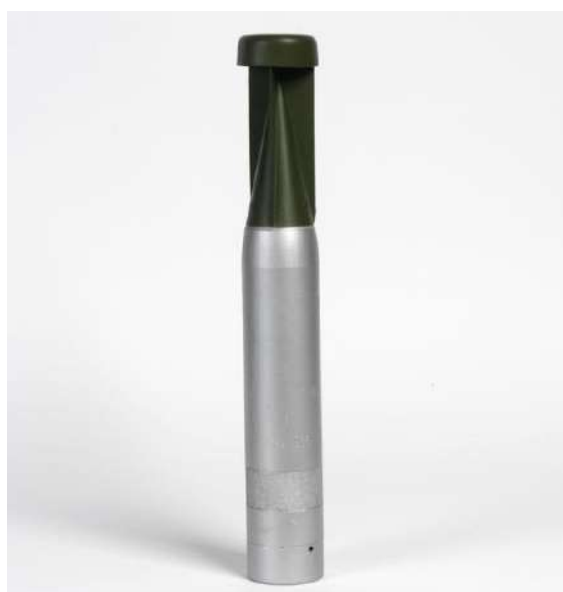
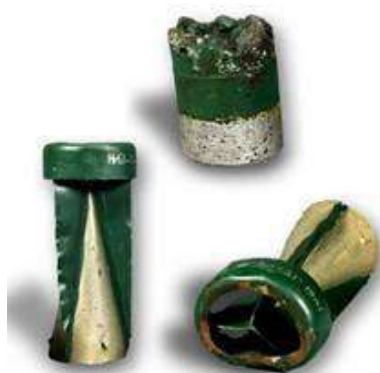
Plate Photographs of a 1kg IB and IB fragments

The Plate below shows a 1kg IB and a variety of fragmentary remains of IBs recovered by the Civil Defence during WWII.

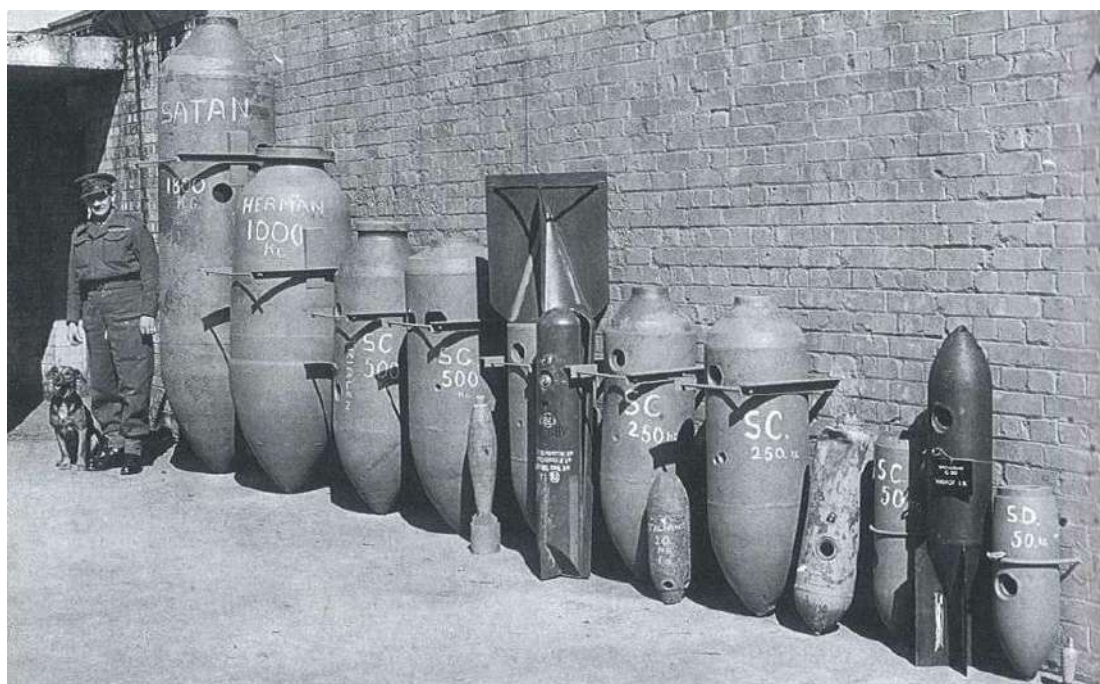
Plate Photograph of a variety of UXB recovered by the Civil Defence during WWII

The Plate below shows the variety of UXB recovered by the Civil Defence during WWII.

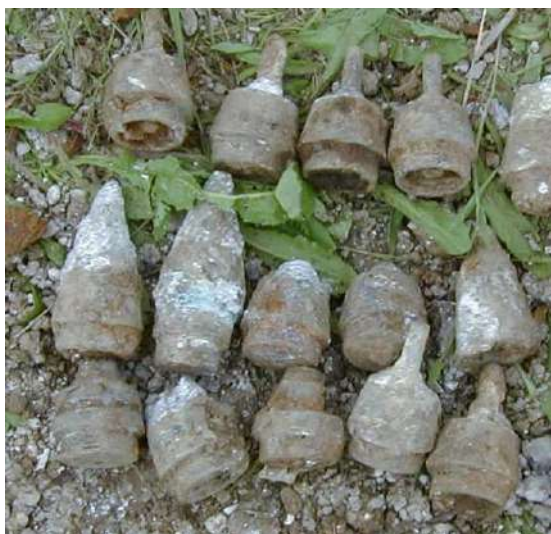
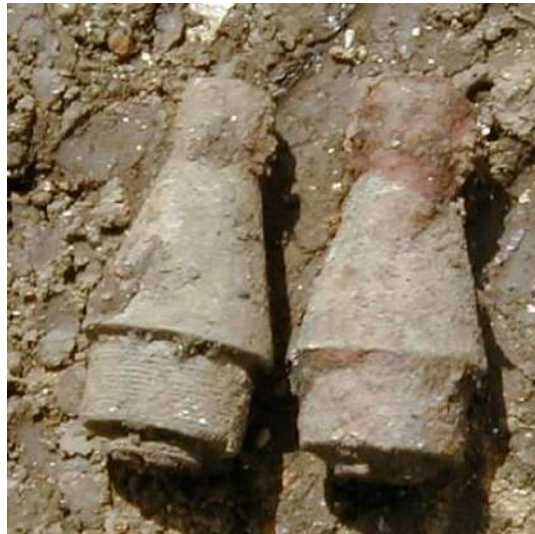
Plate	Photographs showing examples of WWII fuzes
-------	--

A wide variety of these components were used and examples of some common fuzes are shown in the Plate below.

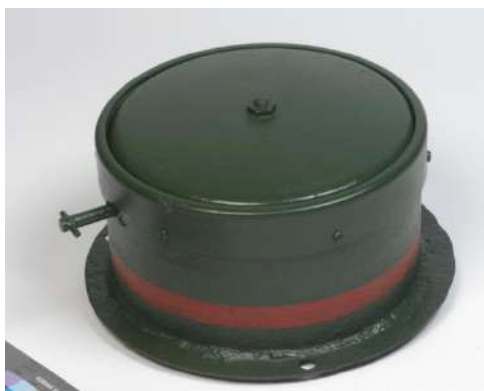
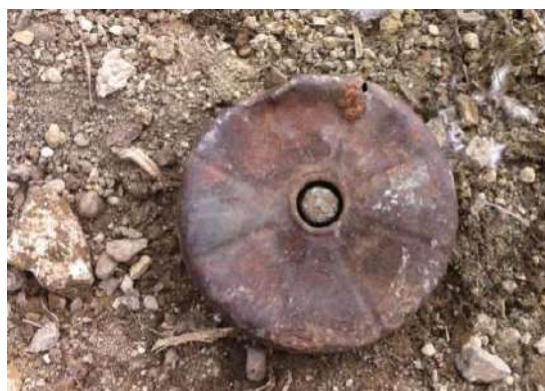
Plate	Photographs of original and recently excavated WWII land mines
-------	--

The Plate below is a photograph of a typical WWII land mine used on the land area, beaches and cliffs around Britain. The example on the right was found at Gatwick Airport, formerly RAF Gatwick.

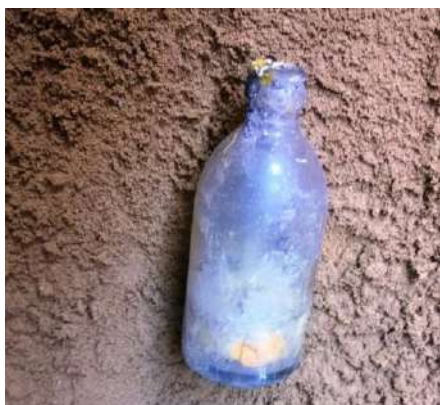
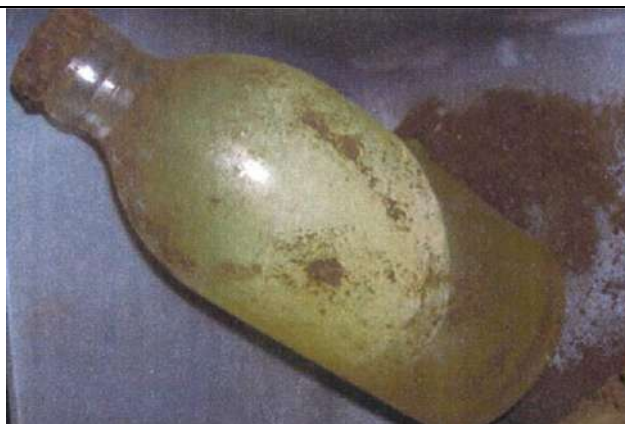
Plate	Photograph of No. 76 SIP grenades
--------------	-----------------------------------

The Plate below shows 2No. recently discovered SIP grenades.
